Table 2.1.1 Soil Samples (Continued)
Summary of Laboratory Results
Radio Island, Main Station Area

2.2 Additional Sampling, Leachable Levels of Lead

3.0 MATERIALS AND DEBRIS INVENTORY

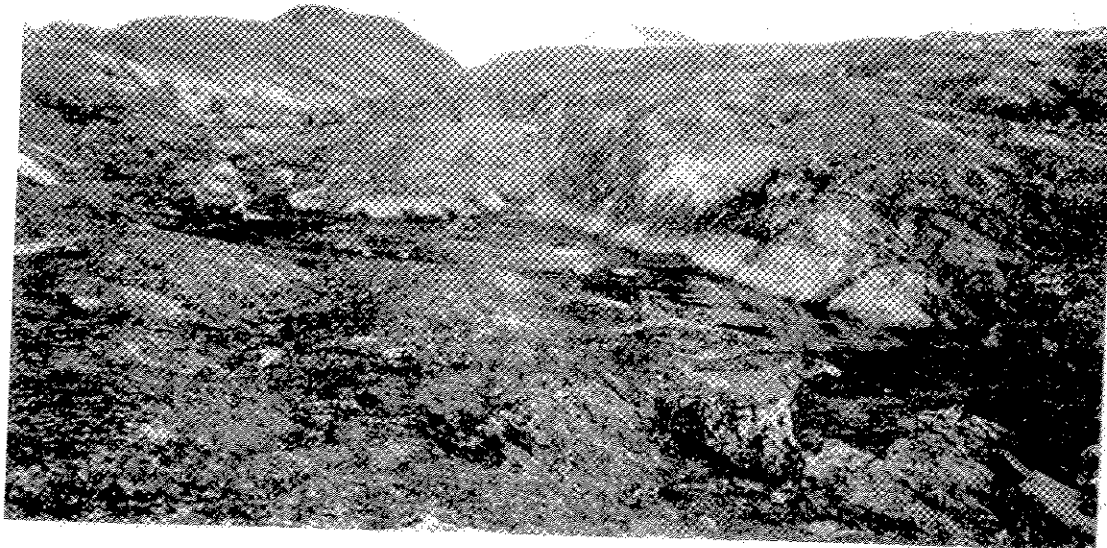
Photo 2.3 Facing north at location ESG-68 far background in ravine, RI-06 near sampler, RI-05 in middle and RI-04 on right.

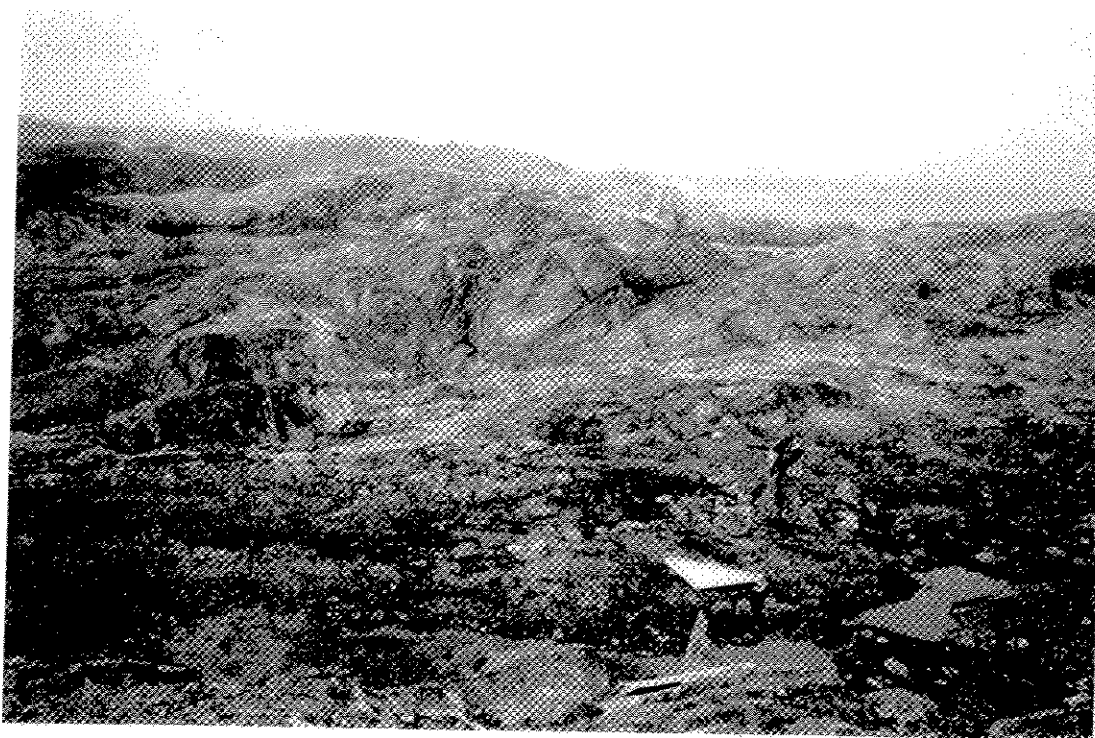
Photo 2.4 Facing southeast at ESG-64 on far left, RI-09 left foreground, RI-07 centre and RI-08 on right near edge of water.

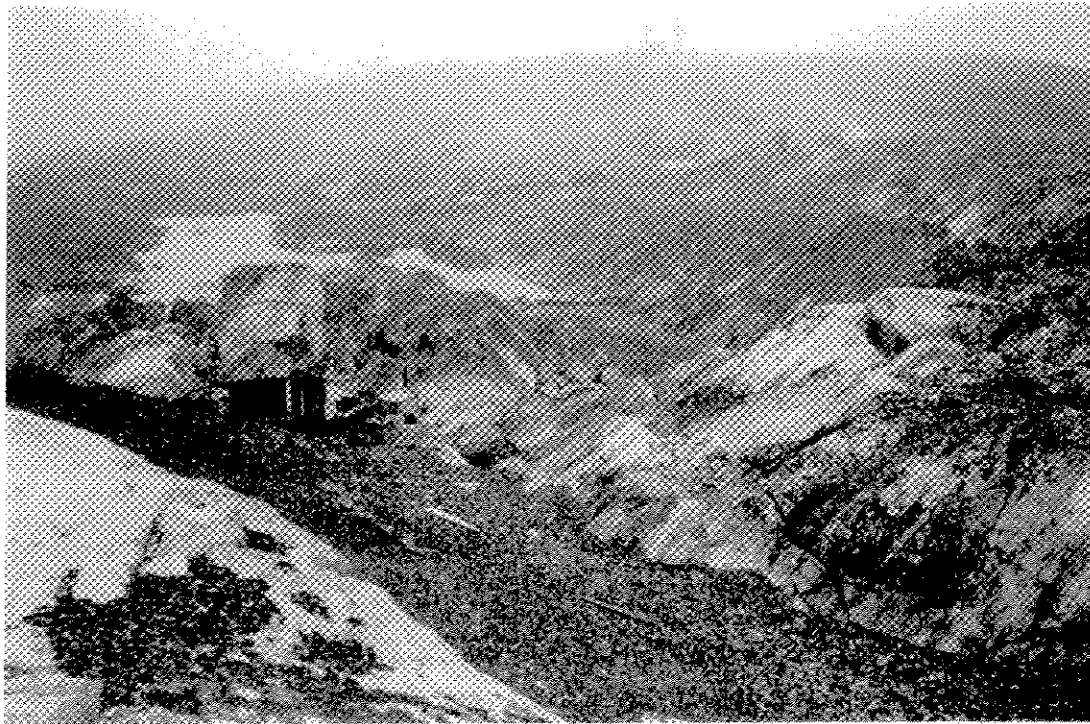
Photo 2.7 Facing south at ESG-59, right and foreground and RI-15 in center.

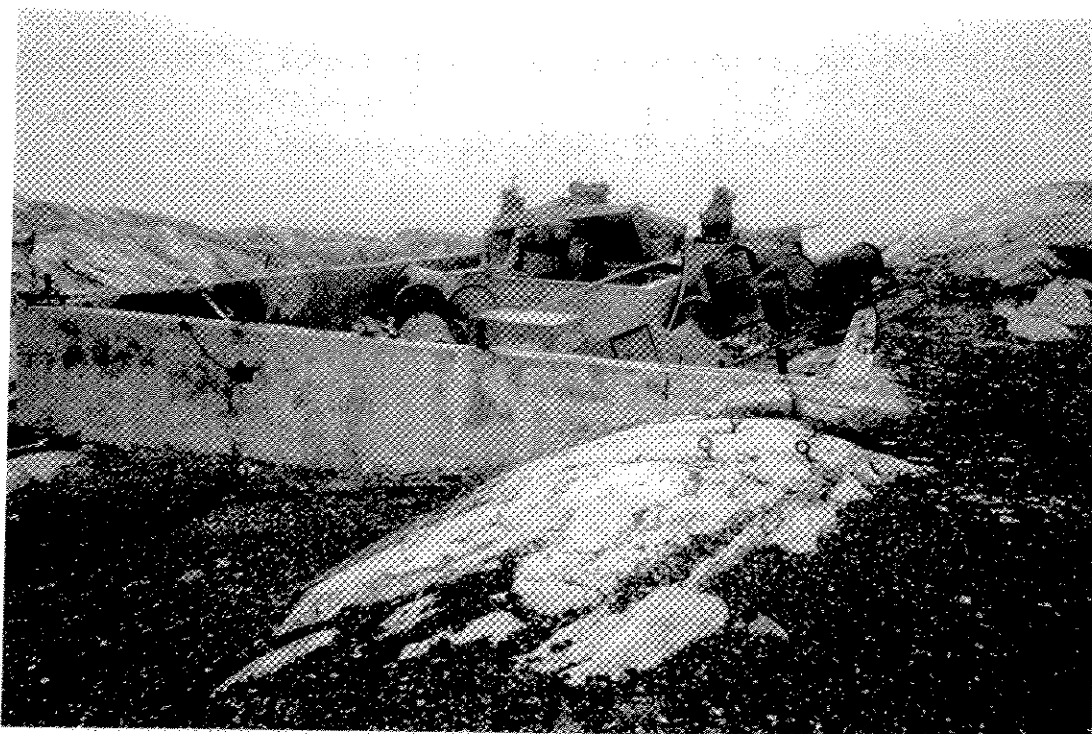
Photo 2.8 Facing northwest at ESG-50 along south wall of powerhouse. RI-16 (not shown) south of ESG-50.

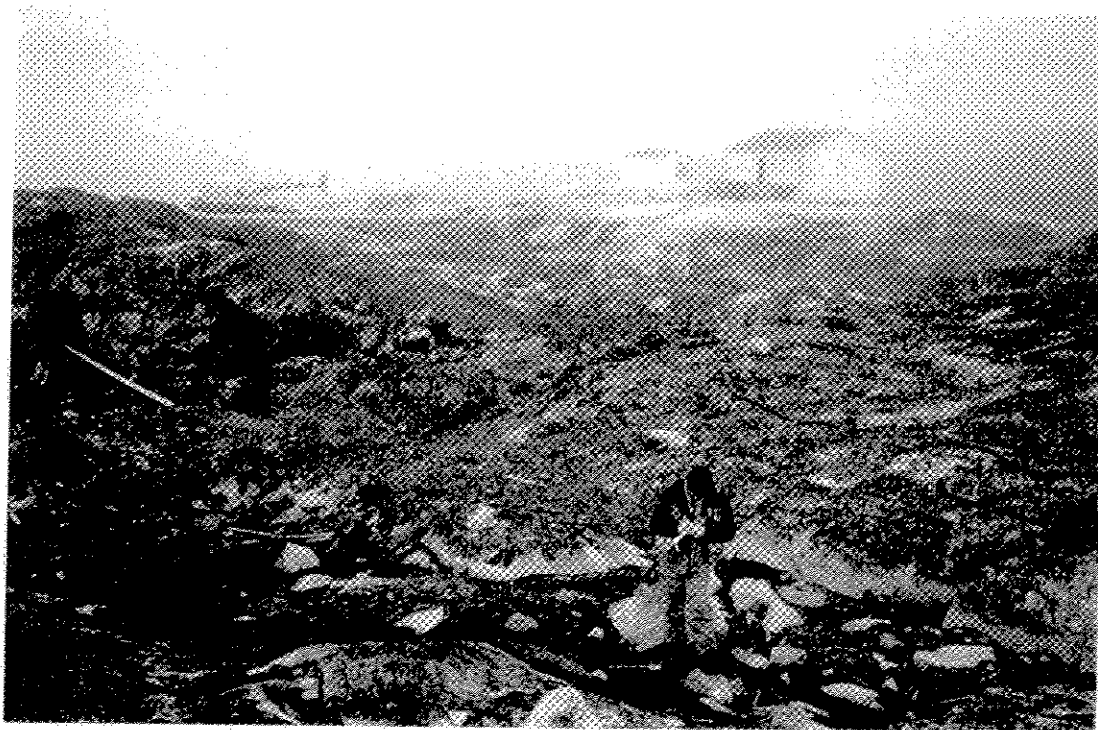
Photo 2.11 Facing northeast at RI-19 near sample. Note main house, winch shed, freshwater pond, and helipad in background.

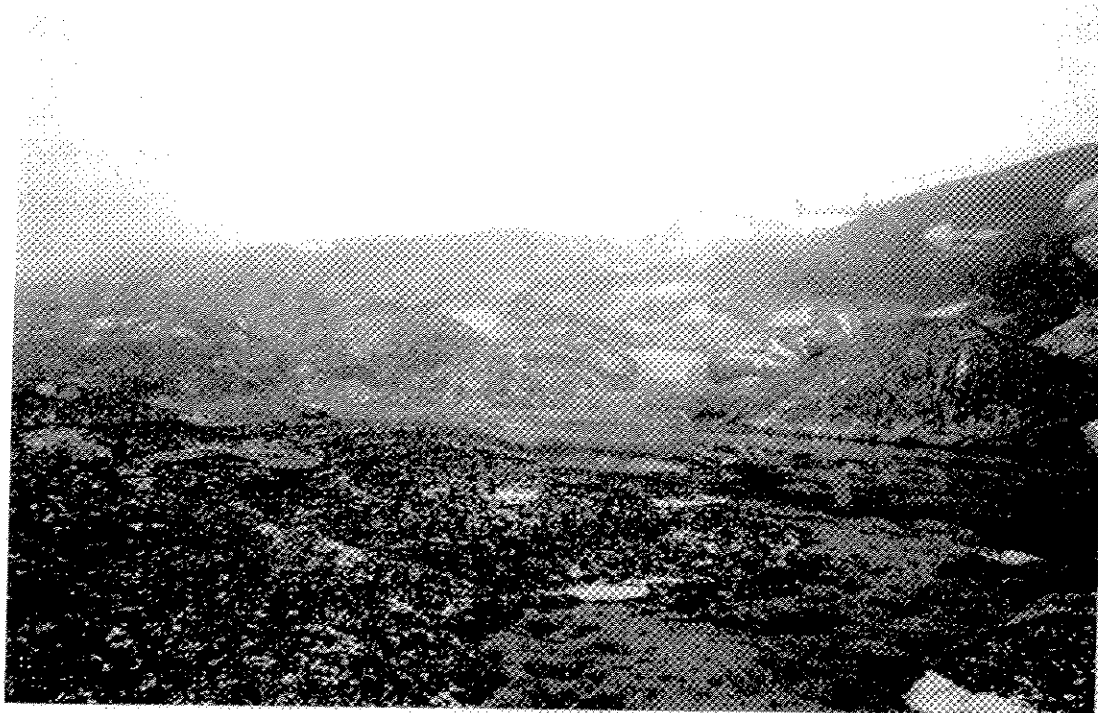
Photo 2.12 Facing southeast at low flat area northwest of helipad (background). From left RI-20, 21, 22. ESG-41 in slope/drainage pattern near barrel in background.
