Remedial Action Plan
Former Navigational Aid and Weather Station
Radio Island, Nunavut

January 2006

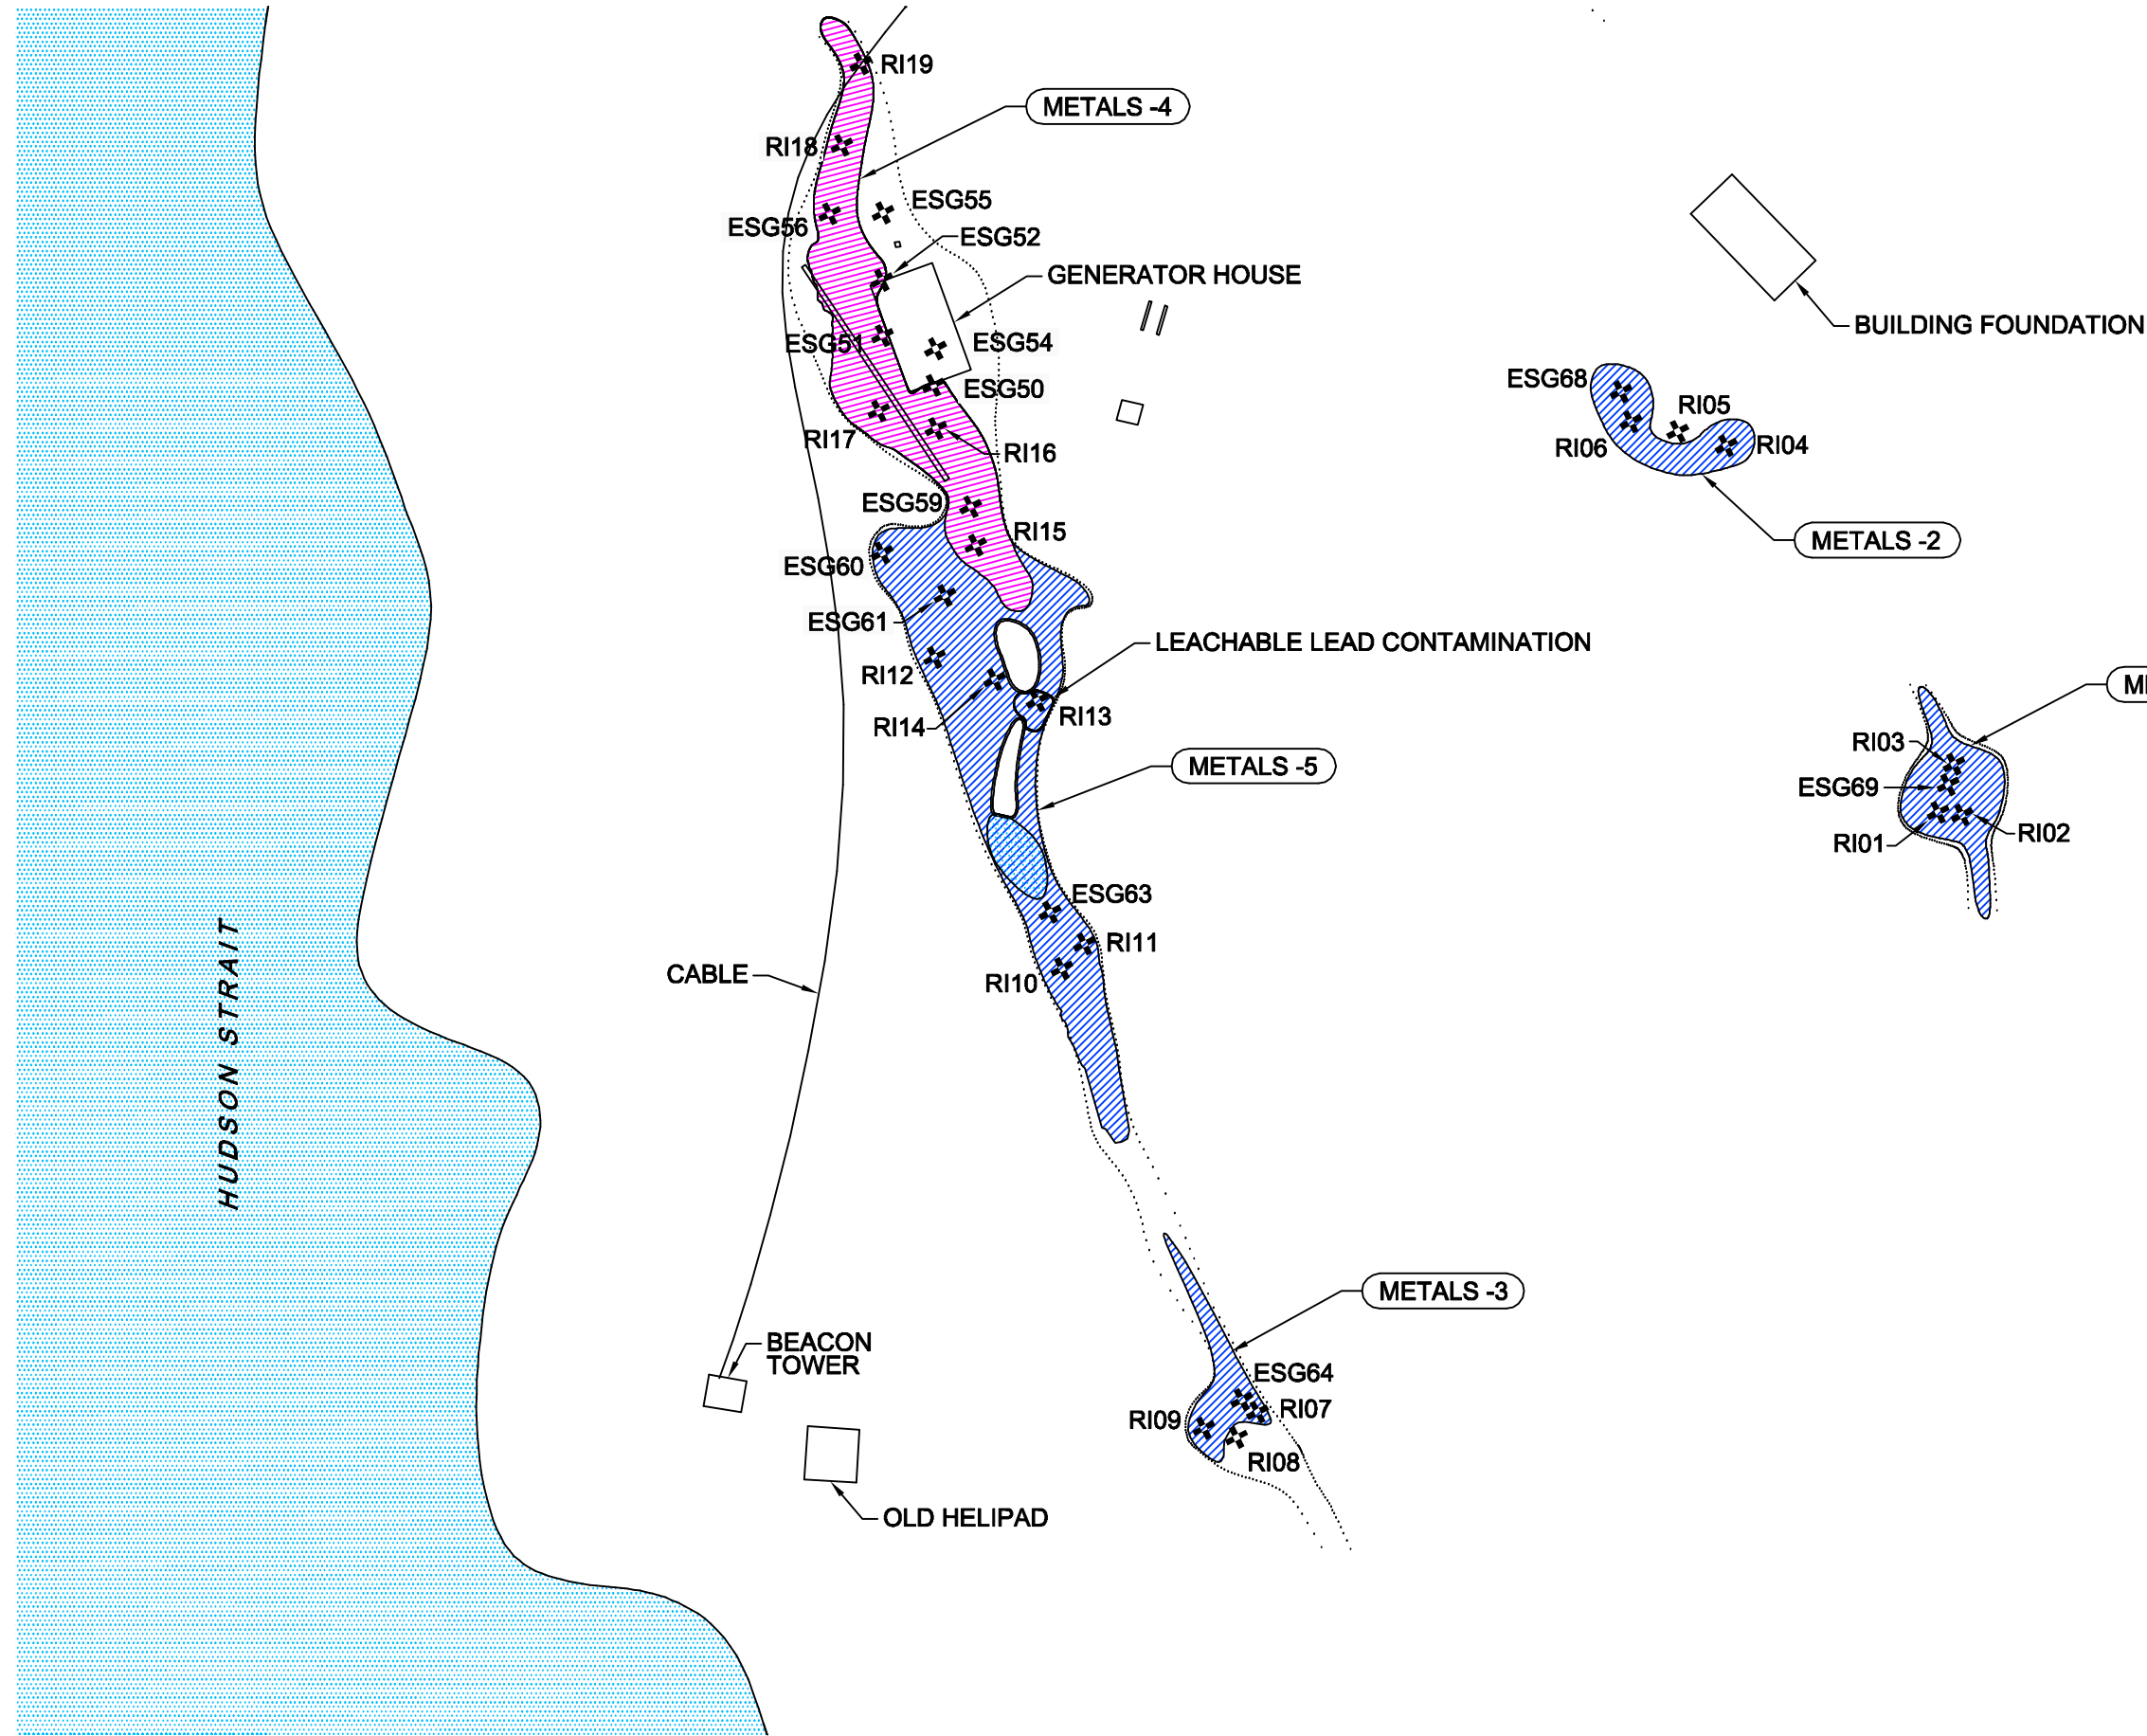
Main Station
Area South
Figure - 1.1

CONTAMINATED SOIL TO BE EXCAVATED*		
AREA NAME	APPROX. AREA OF CONTAMINATION (m ²)	ESTIMATED IN PLACE VOLUME (m ³)
METAL CONTAMINATION		
METALS - 1	115	60
METALS - 2	92	45
METALS - 3	69	35
METALS - 4	442	220
METALS - 5	532	270

The contaminated soils identified at the site will be collected and shipped off-site for disposal. The contaminated soils are typically located in the bedrock gullies. The clean-up activities must ensure that all contaminated soils are collected from any bedrock crevices and fissures. The design drawings will provide information to the Contractor with respect to the required collection limits.

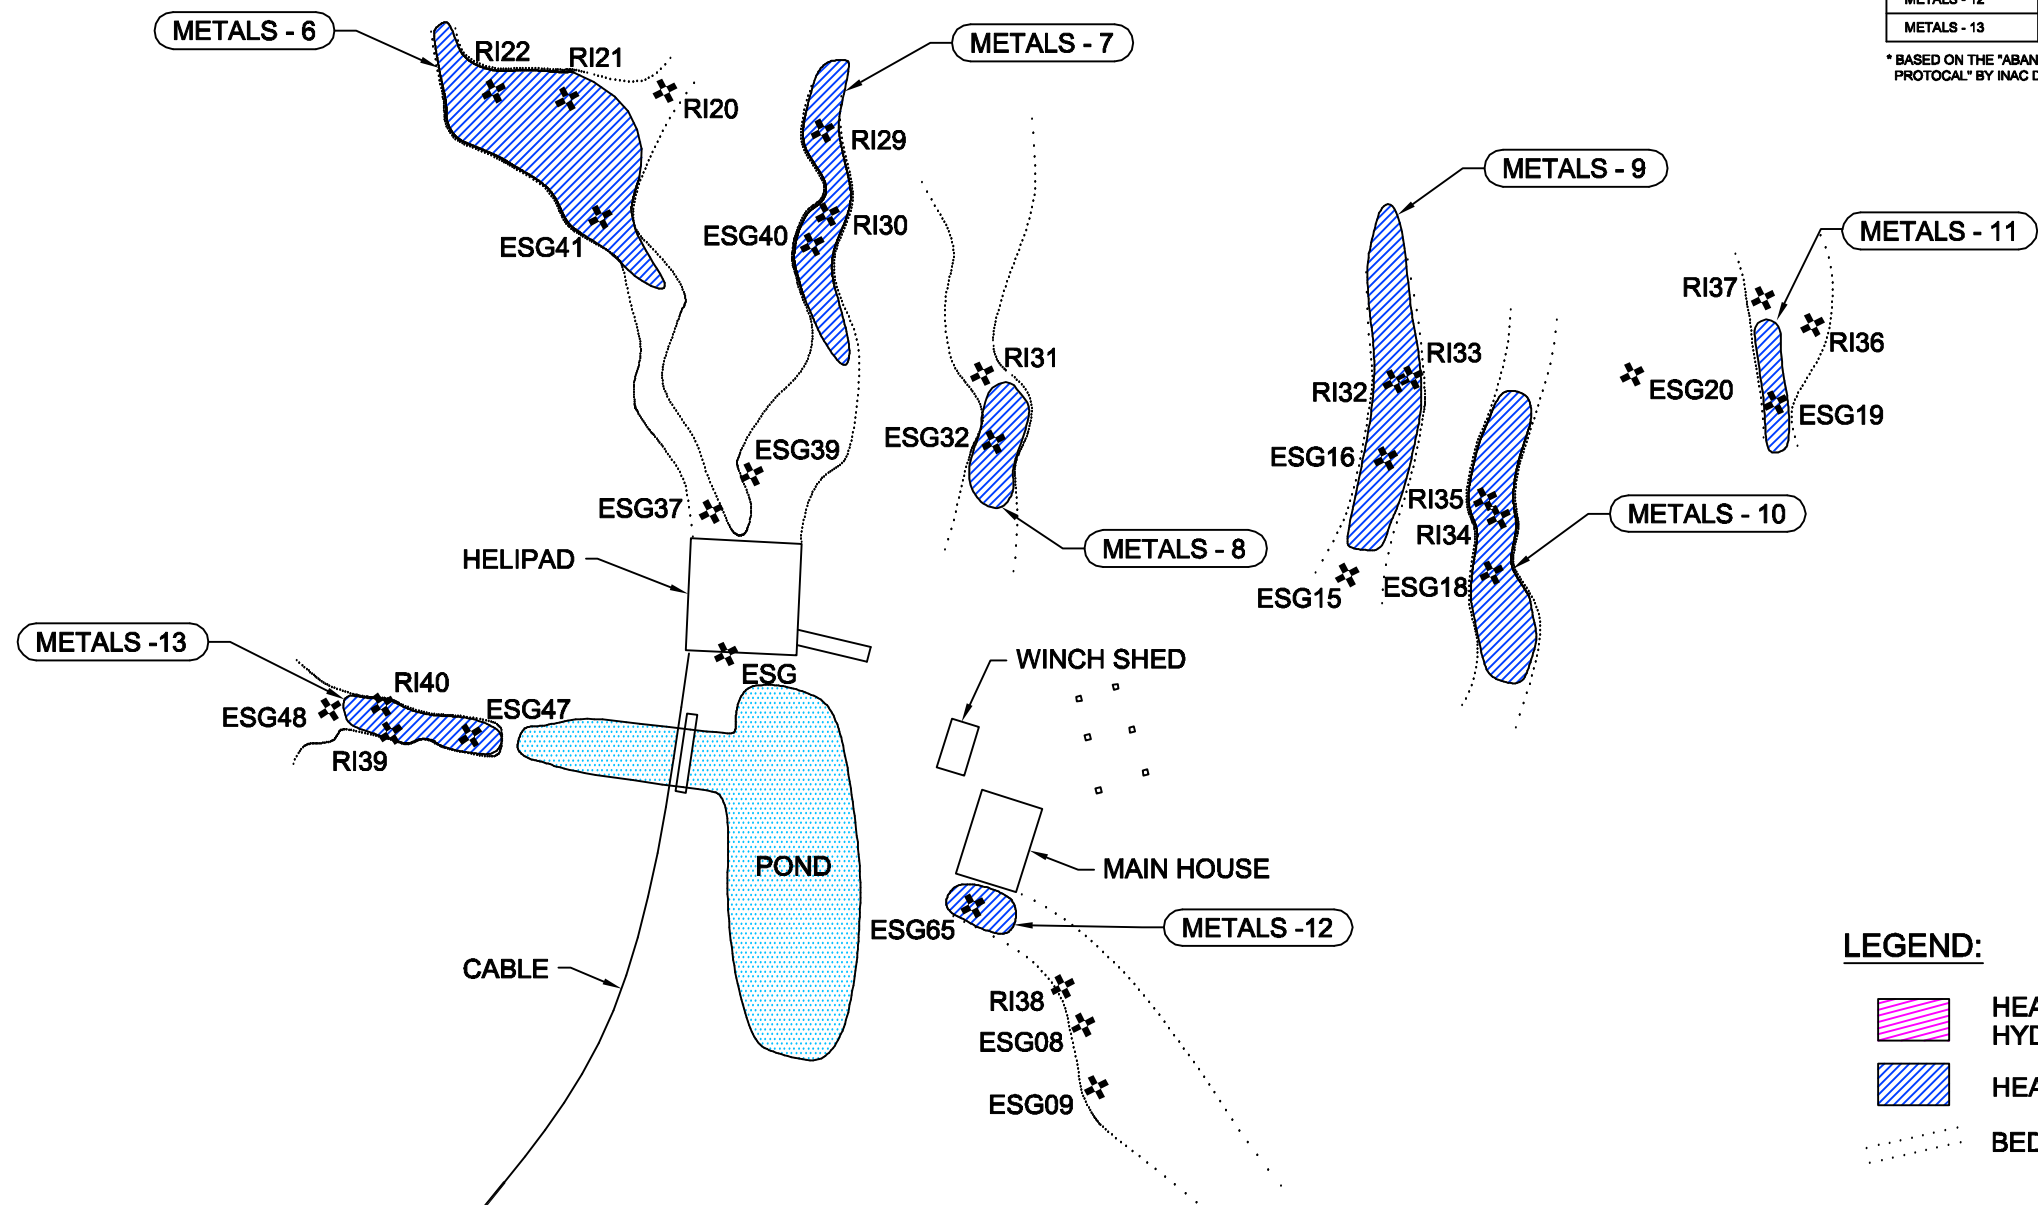
CONTAMINATED SOIL TO BE EXCAVATED*		
AREA NAME	APPROX. AREA OF CONTAMINATION (m ²)	ESTIMATED IN PLACE VOLUME (m ³)
METAL CONTAMINATION		
METALS - 6	240	120
METALS - 7	98	50
METALS - 8	49	25
METALS - 9	141	70
METALS - 10	129	65
METALS - 11	30	15
METALS - 12	24	12
METALS - 13	48	25

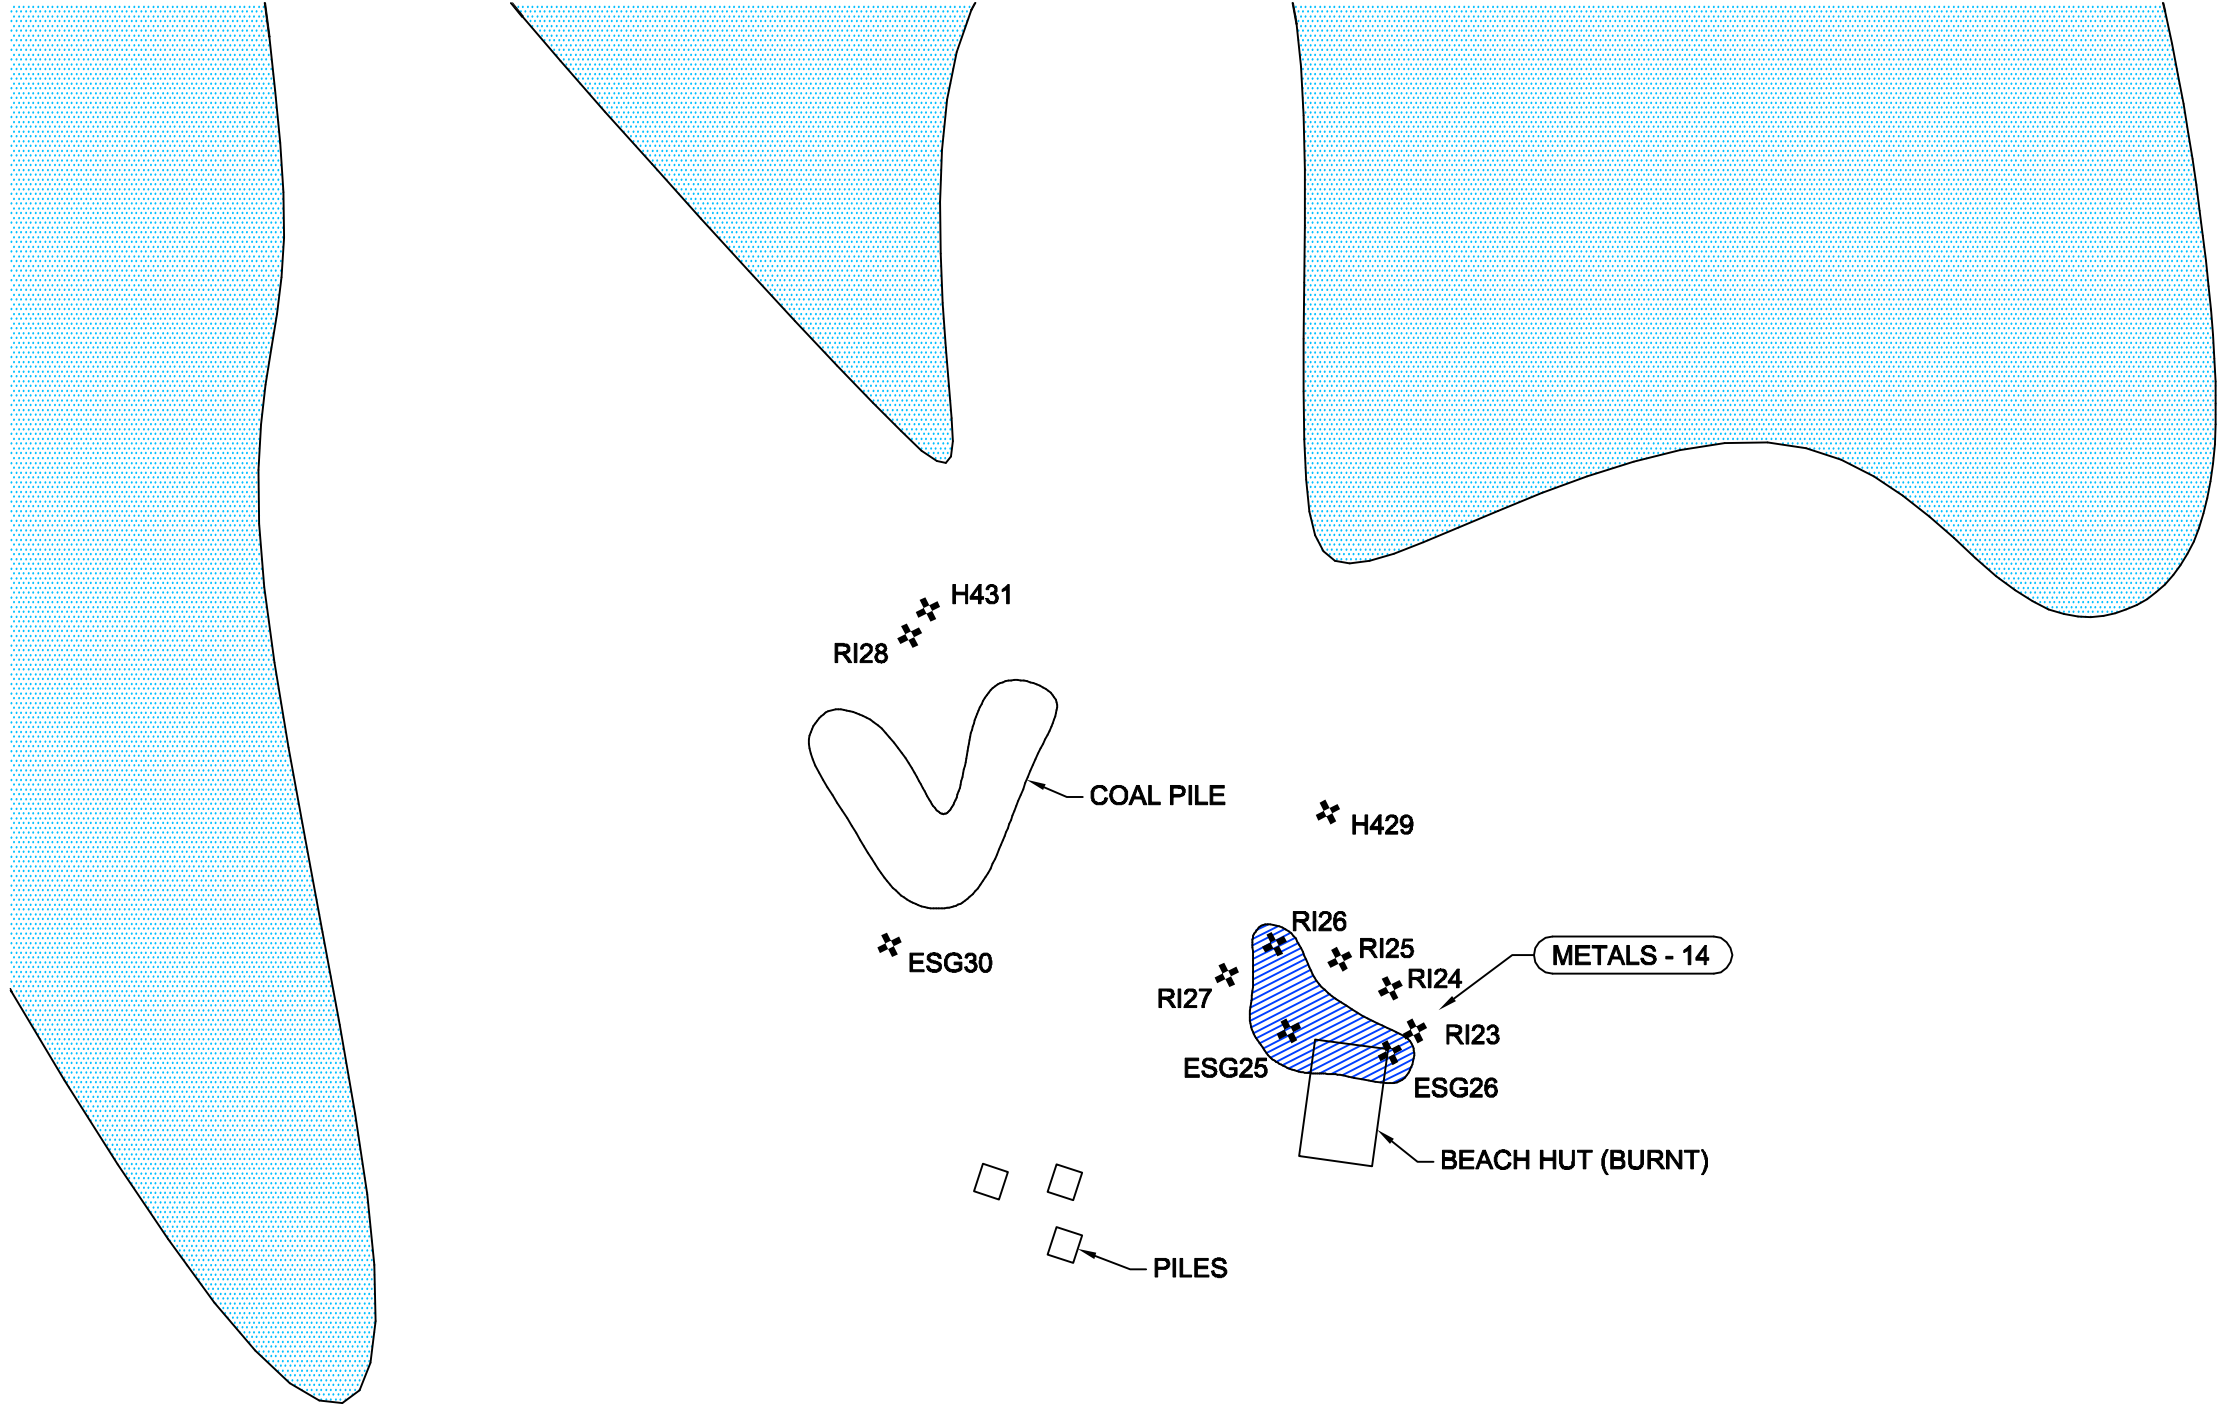
CONTAMINATED SOIL TO BE EXCAVATED*		
AREA NAME	APPROX. AREA OF CONTAMINATION (m ²)	ESTIMATED IN PLACE VOLUME (m ³)
METAL CONTAMINATION		
METALS - 14	39	20

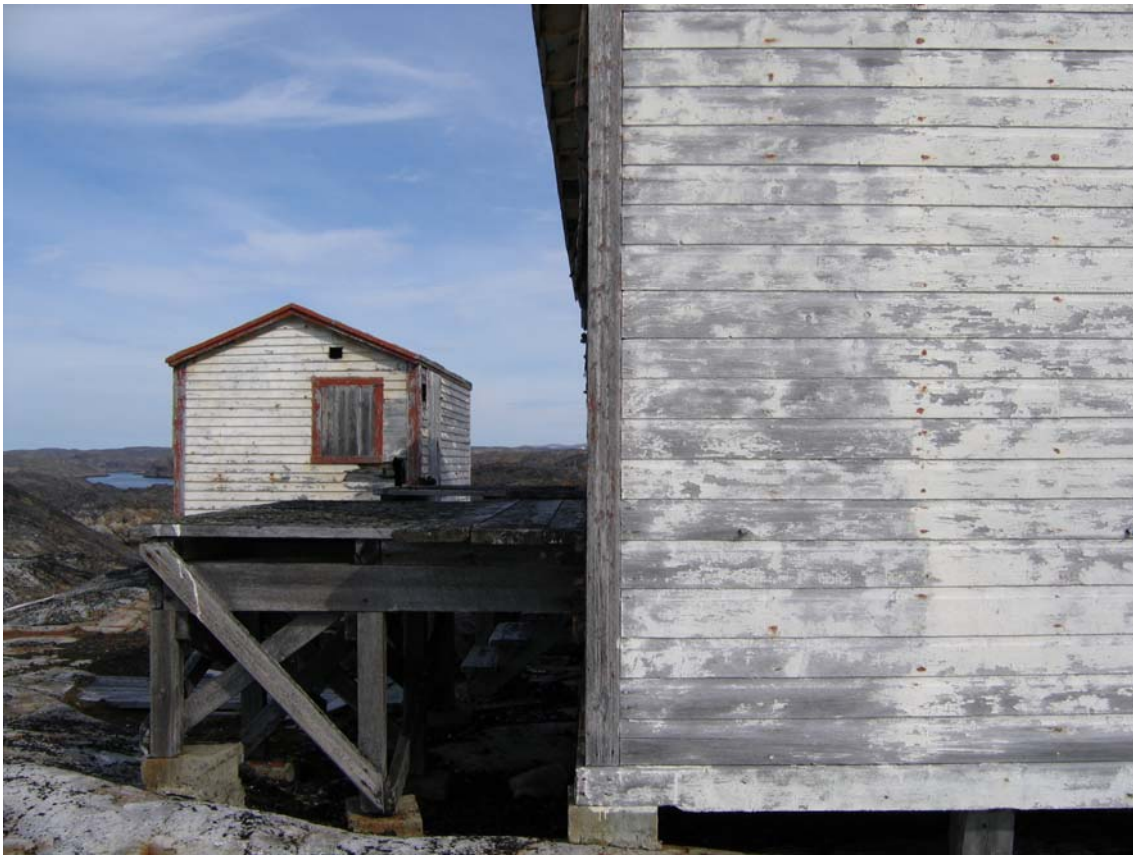
The buildings and infrastructure remaining at the site consist of two intact structures, the Main House and the Winch Shed; and the remains of three buildings, the Generator House, a burnt out house and a building foundation. In addition, there are two helipads and a beacon tower at the site. These structures are all in a deteriorated condition, with the exception of the Main House, which appears to be structurally sound. The Beacon Tower is currently operational.

View of Main House (right) and Winch Shed (left)

All the buildings and infrastructure at the site will be demolished, to foundation, with the exception of the Main House and the beacon tower. Prior to demolition, all hazardous materials will be removed from the buildings and disposed of off-site in accordance with the protocol identified in Section 5.4. This includes the removal of building components covered with lead based paint, asbestos, lead acid batteries, etc. The non-hazardous demolition debris will also be disposed of off-site in an engineered landfill.

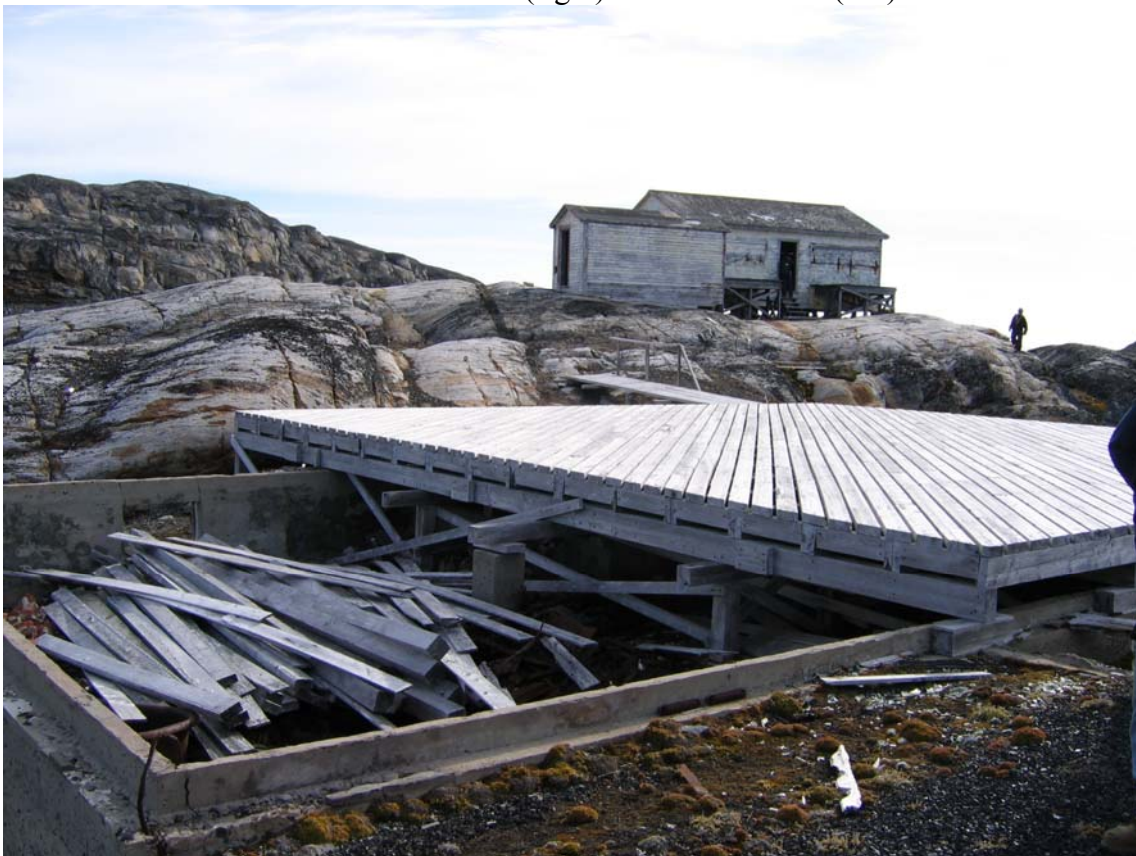
View of Helipad, Winch Shed and Main House

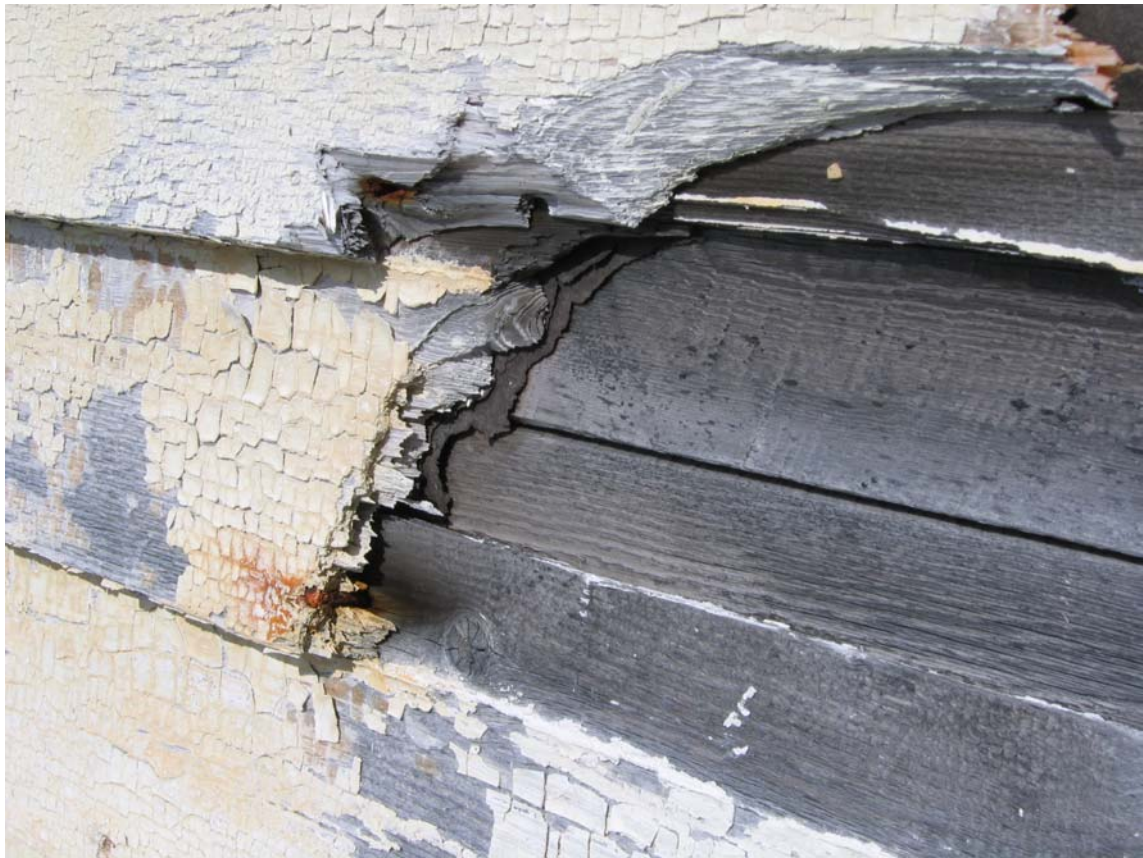
Close-up of Lead based pain on Winch Shed

- Mobilization to site by sea lift in June/July
- Removal of lead based paints from buildings
- Containerization and shipping of all hazardous materials off-site for disposal
- Demolition of buildings and infrastructure and disposal off site.
- Collection of non-hazardous debris and disposal off-site
- Collection and off-site disposal of metal contaminated soil
- Treatment of metals impacted surface water in pond
- Demobilization from site by sea lift in September/October

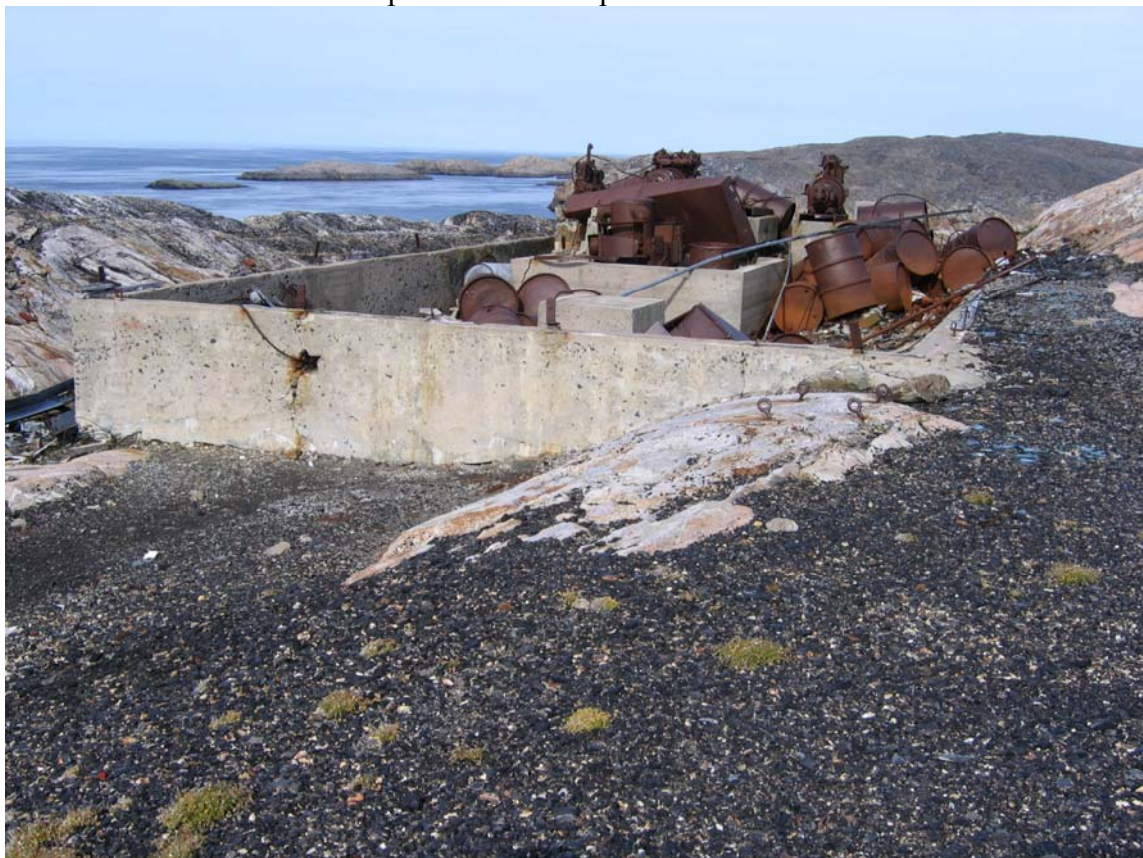
View of Generator Building Foundation and Debris

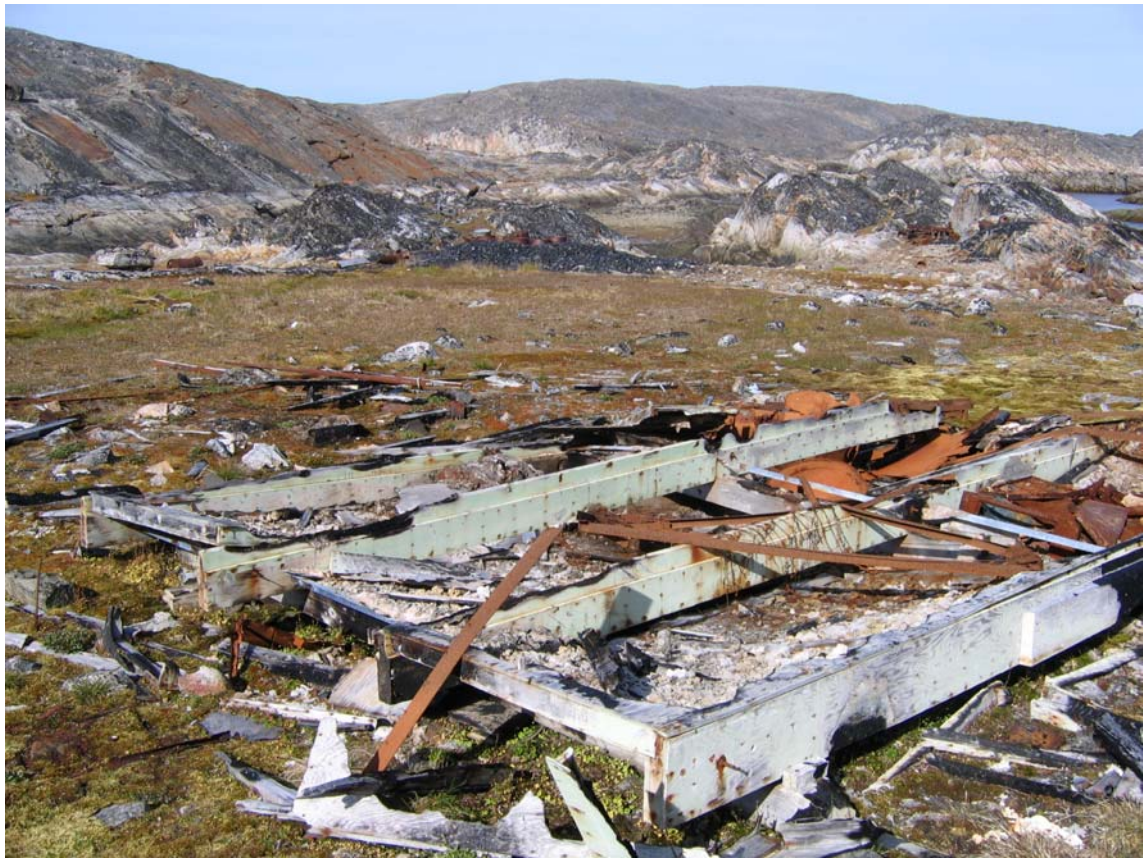
View of Beach Hut (Burnt)

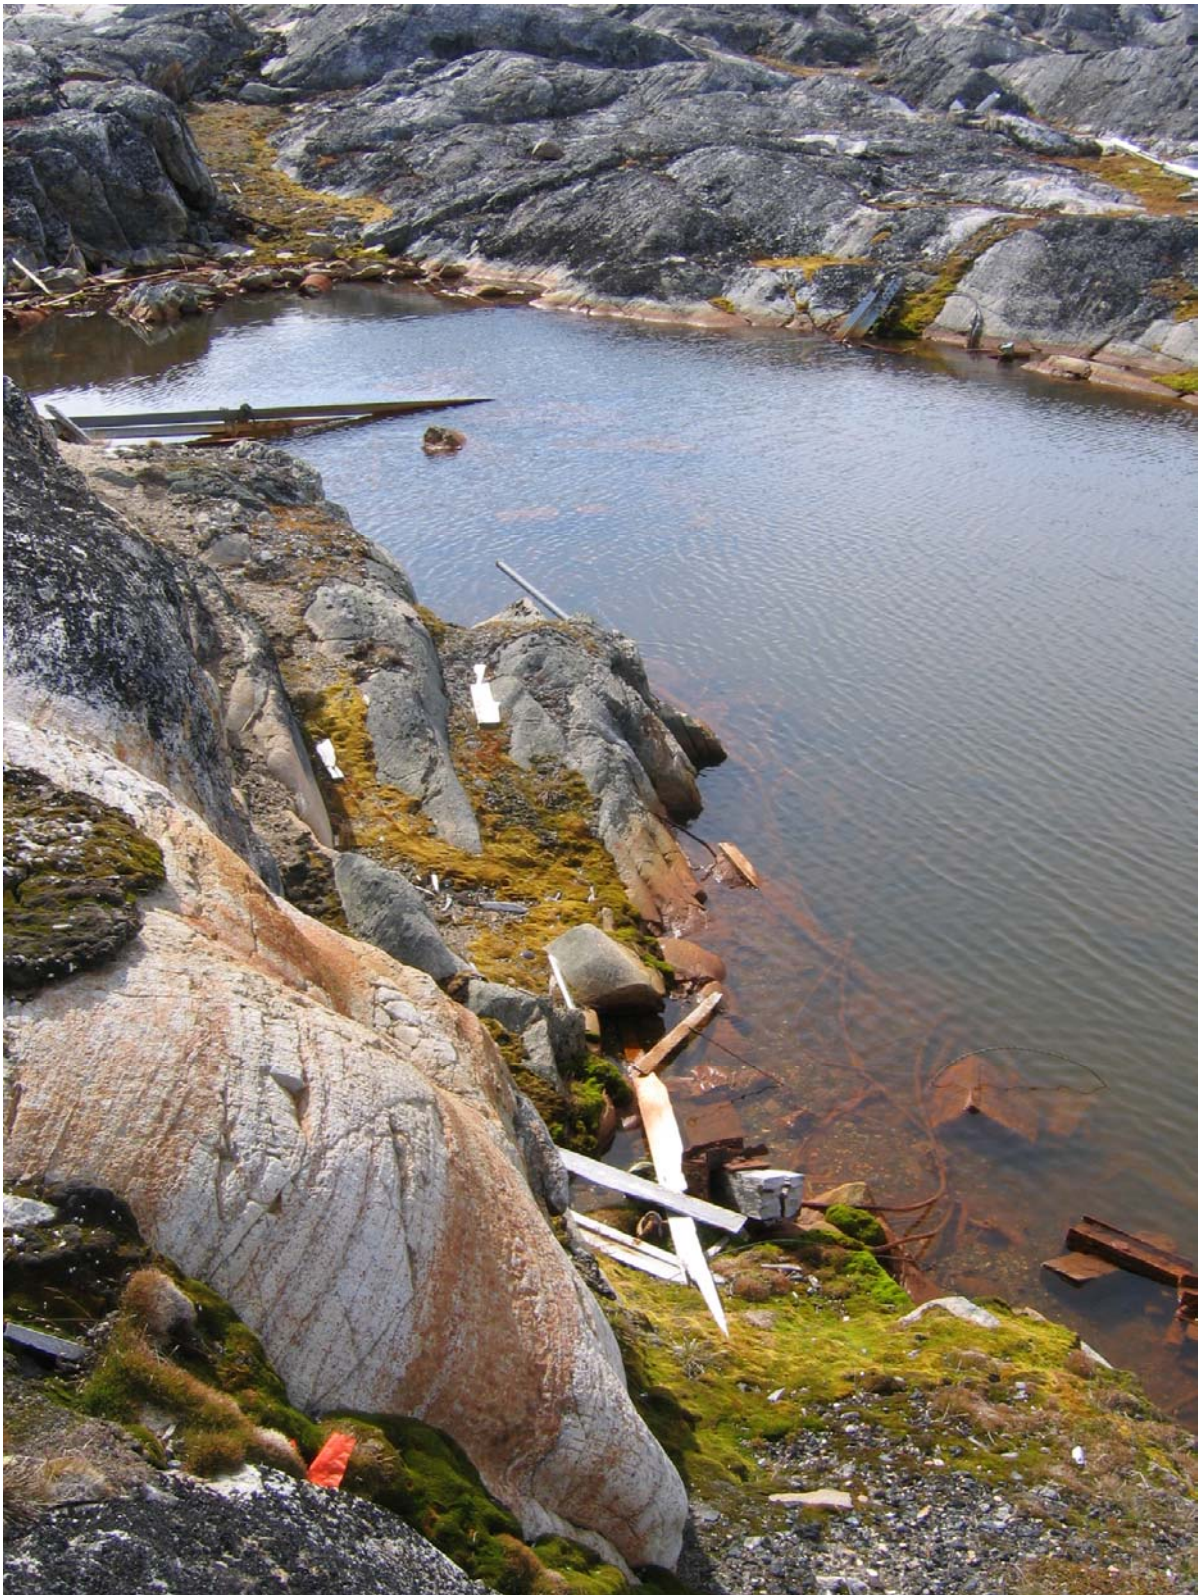
View of man-made Pond and Debris west of Main House
