Water Licence: 2BE-MSX0712 Silvermet Inc.; Land Use Permit: 2007J0012 (Valley Lake)

Inspection photographs –July 28, 2010 for “Site 1” at coordinates N66° 45’ 11.5” W115° 11’ 29.8” (NAD 83)
(taken by Water Resource Officer M. Joy)

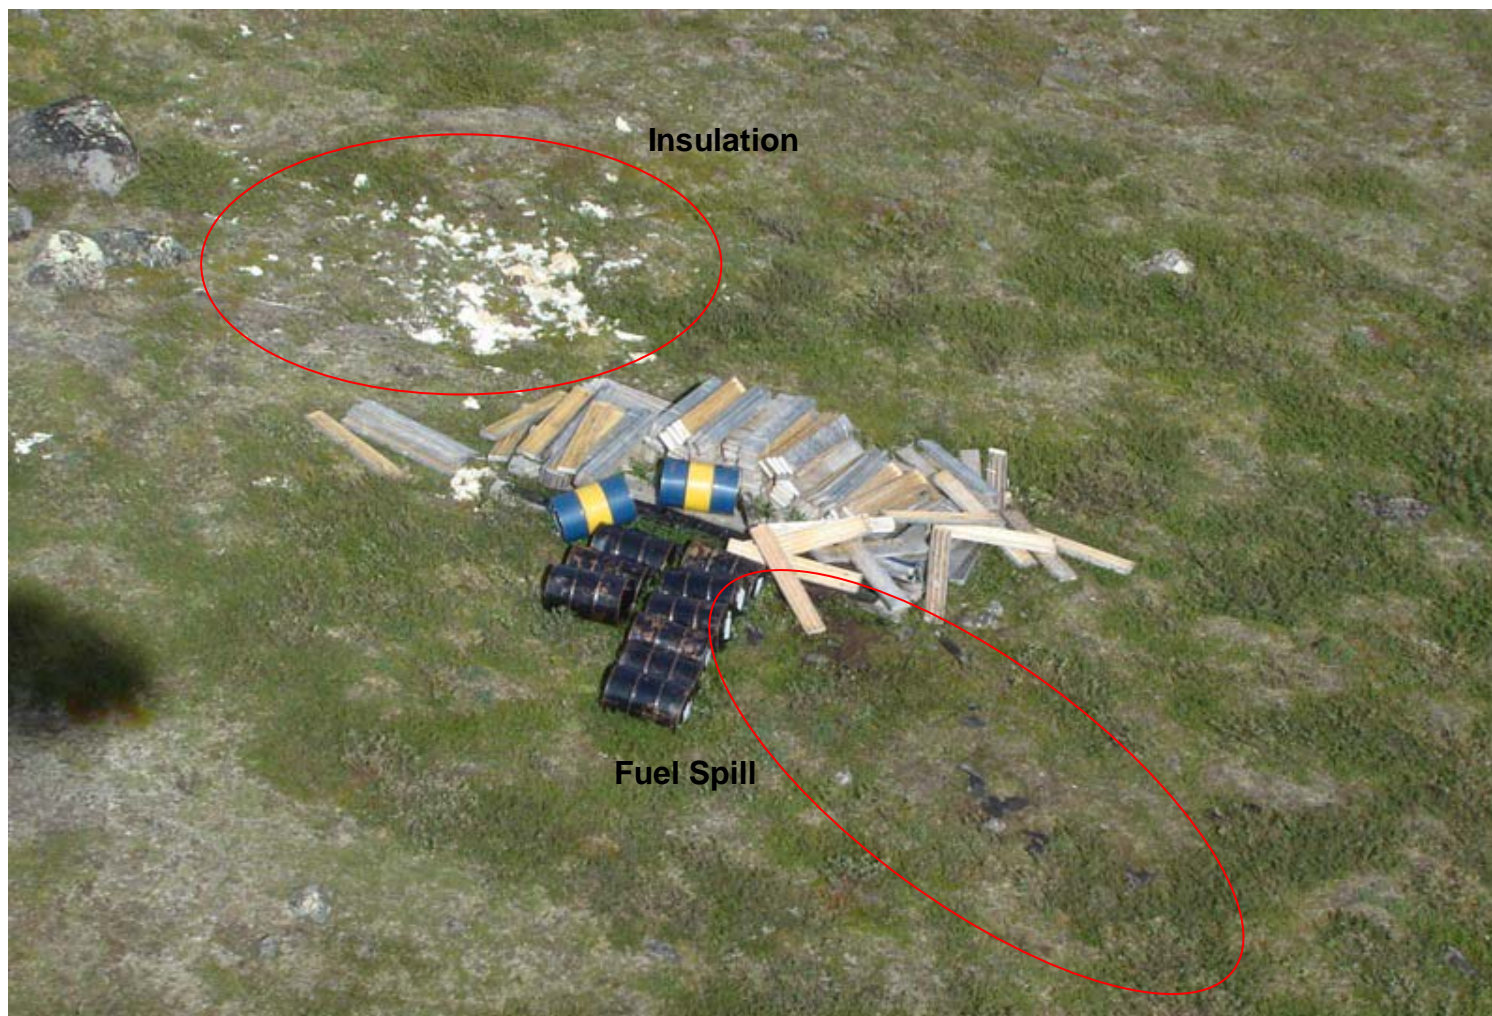
Photograph 1: Aerial view “Site 1” drill laydown area -core boxes, fuel cache, scattered insulation and unreported fuel spill visible.

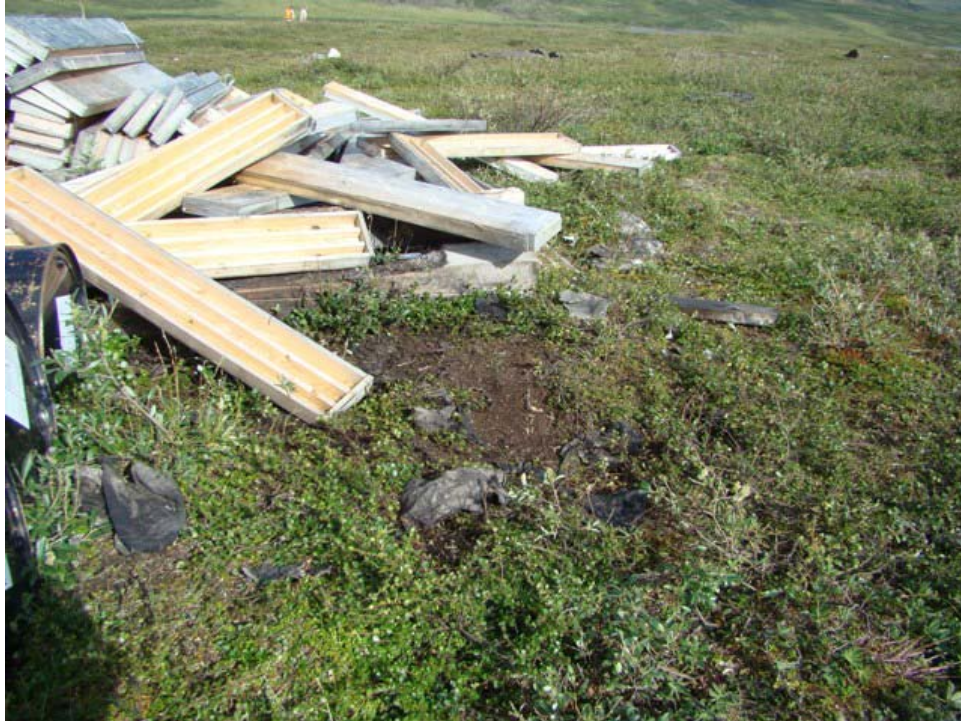
Photograph 2.

Photographs 2 & 3: View of spill site –hydrocarbon stained substrate and used spill absorbant pads left behind.

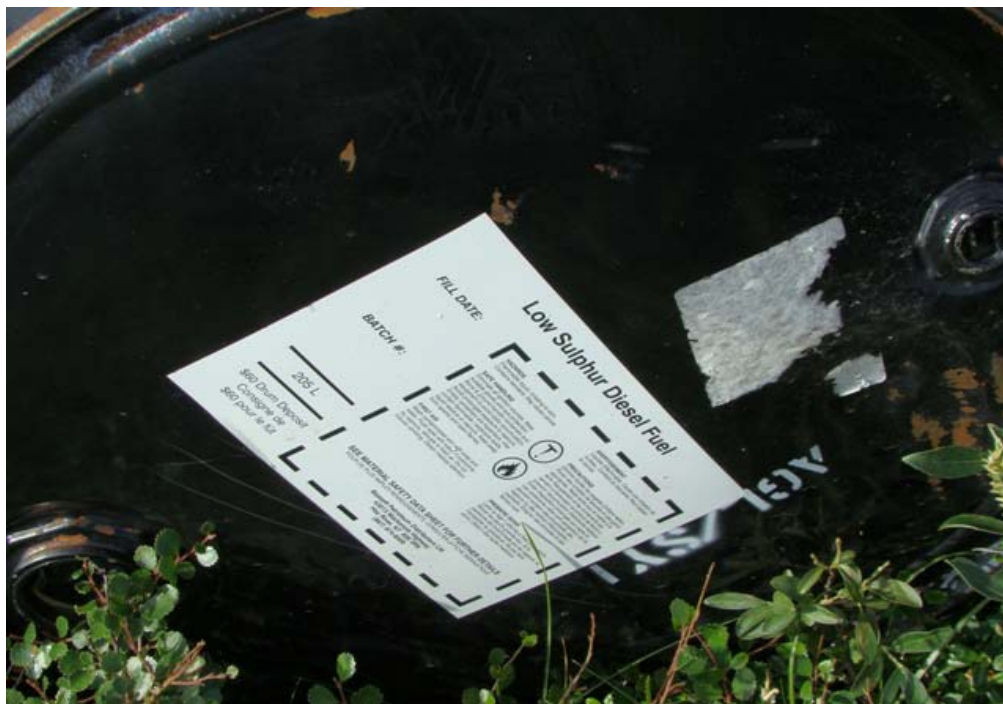
Photograph 4: Fuel drum marked as “AGL/SYP”

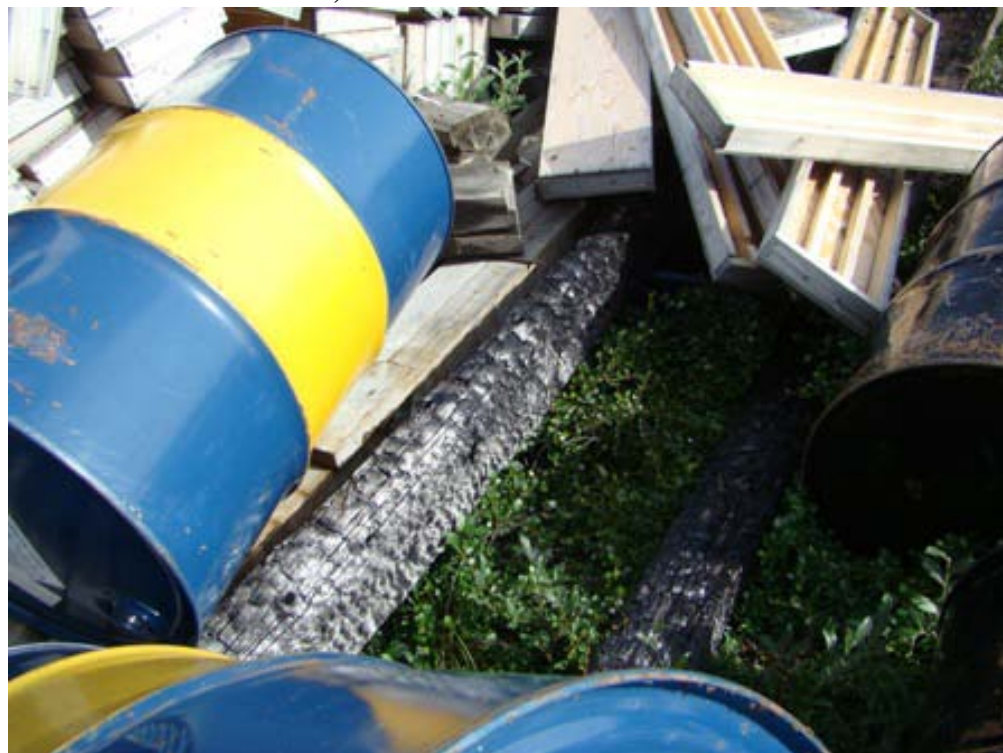
Photograph 5: View of charred timbers, coreboxes and several fuel drums

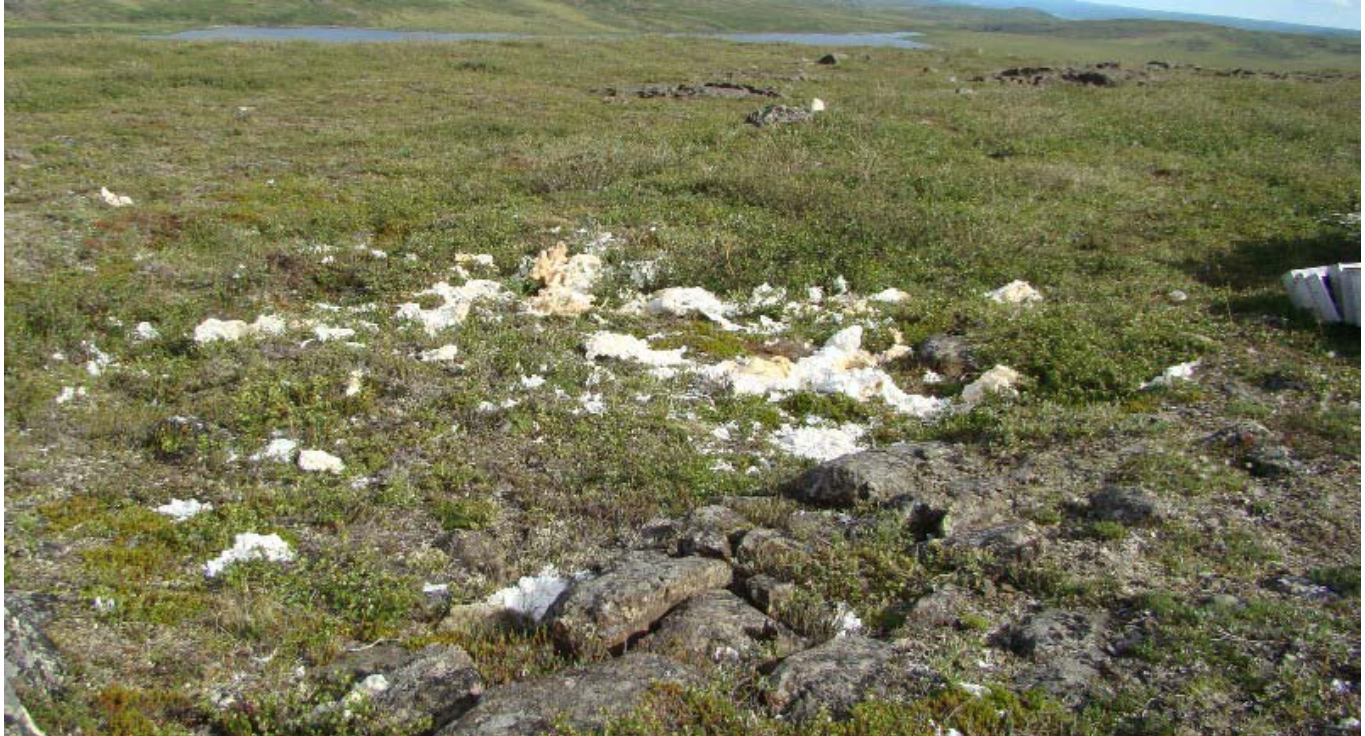
Photograph 6: Insulation was scattered throughout the immediate area at the site.

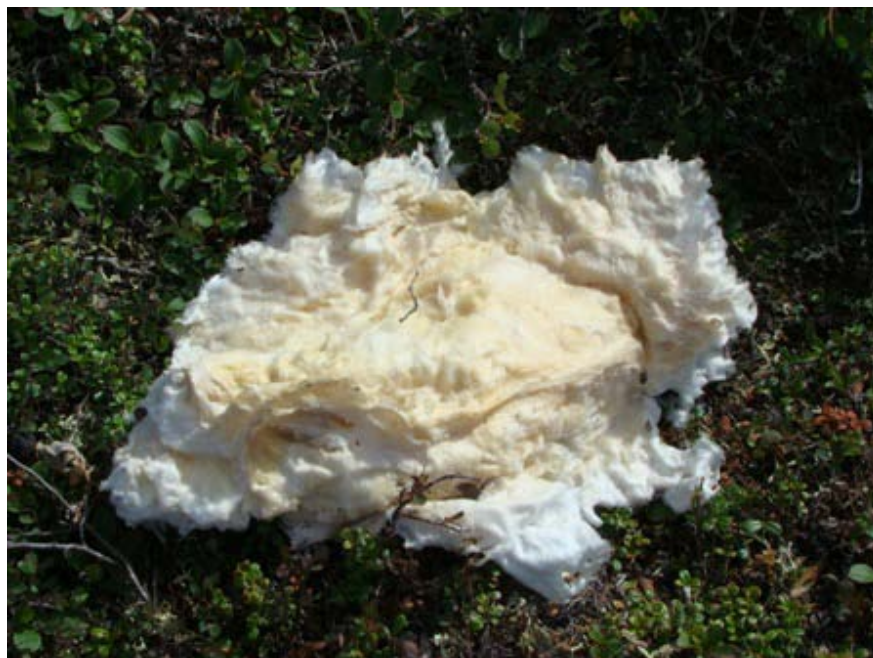
Photograph 7: Close-up view of insulation.
