**NUNAVUT TUNNGAVIK
INCORPORATED**

MEMORANDUM

To: Carson Gillis – Director of Lands and Resources
Re: HBJV - Windy Lake Camp – Petroleum Product Spill
Date: August 29th, 2002

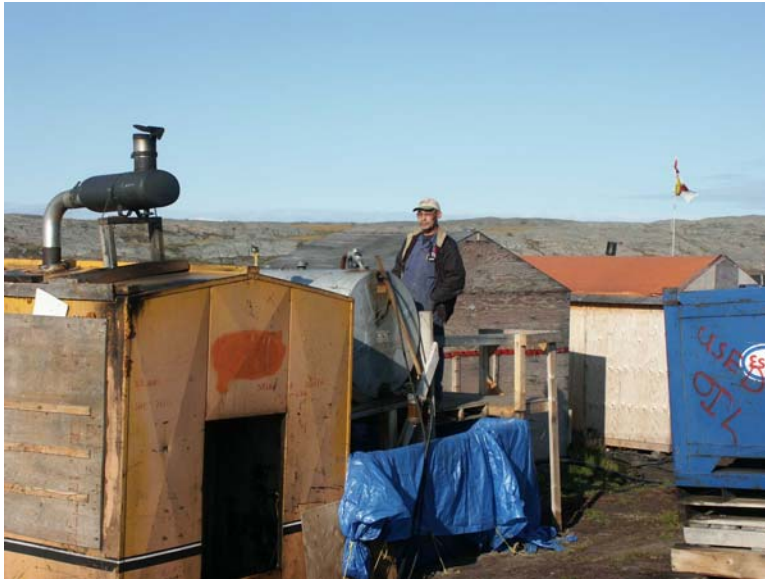
On August 1st, 2002, the power generator was having its tank filled up from the direct line to

one of the storage tanks. During the process of filling the generator tank, the employee left fuel flowing into the generator tank while attending to other matters in camp as there were a lot of aircraft shuttling into the site at the dock. The employee forgot that they had left the fuel flowing and it spilled for approximately 3 hours, releasing approximately 8,000 litres of product onto vegetation covered beach deposits (sand, gravel, silt and clay).

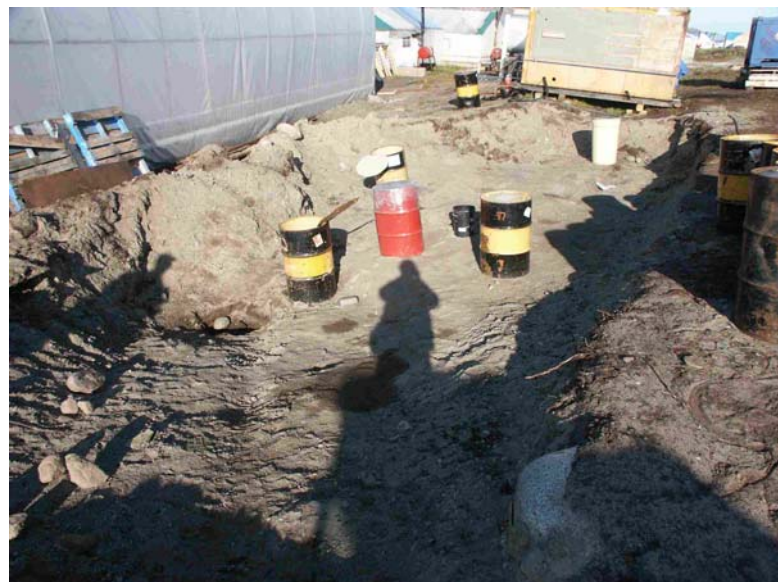
initiated. The spill had ponded between two natural berms which are probably the result of old lake shorelines in the unconsolidated beach sediments. The berms trapped the ponded product and enabled crews to recover half of the spilled material, or about 4,000 litres. The remainder had infiltrated the pore spaces in the sand and migrated into the sediments and down slope.

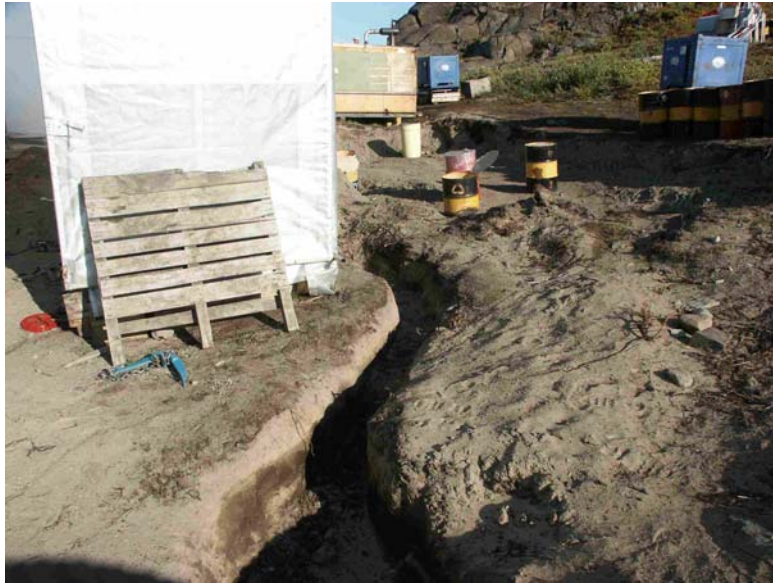
excavating the site and storing the contaminated beach sediments in sealed 205 litre drums for shipment out and disposal. Much of the infiltrated product was trapped against a non-permeable clay layer and removed with the soil excavation technique. An area of approximately 10m x 6m was excavated to a depth of about 1 metre.

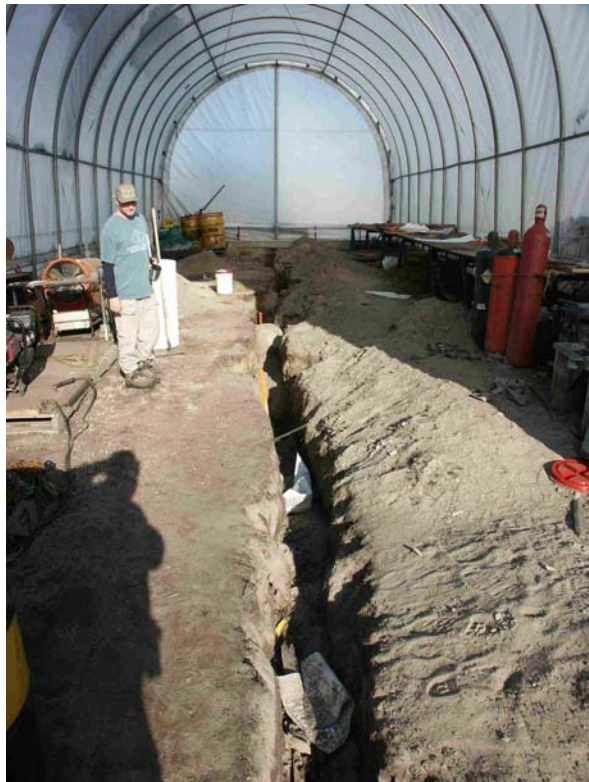
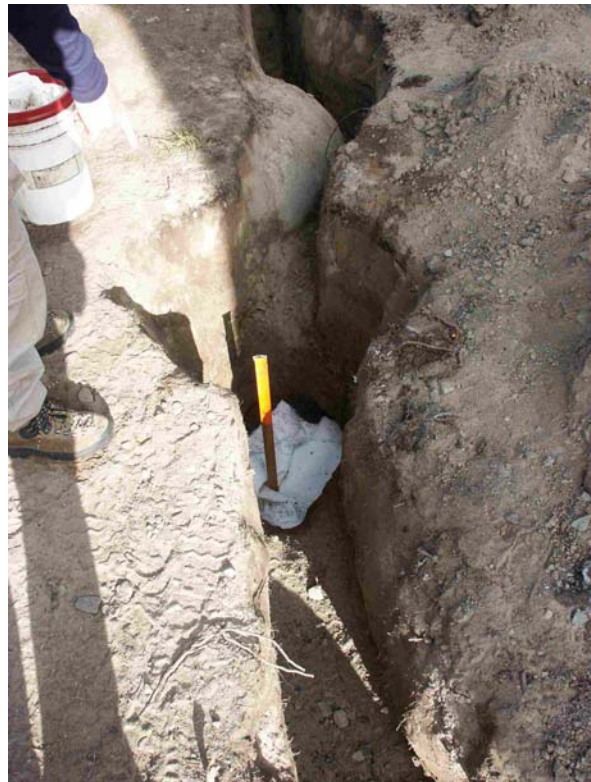
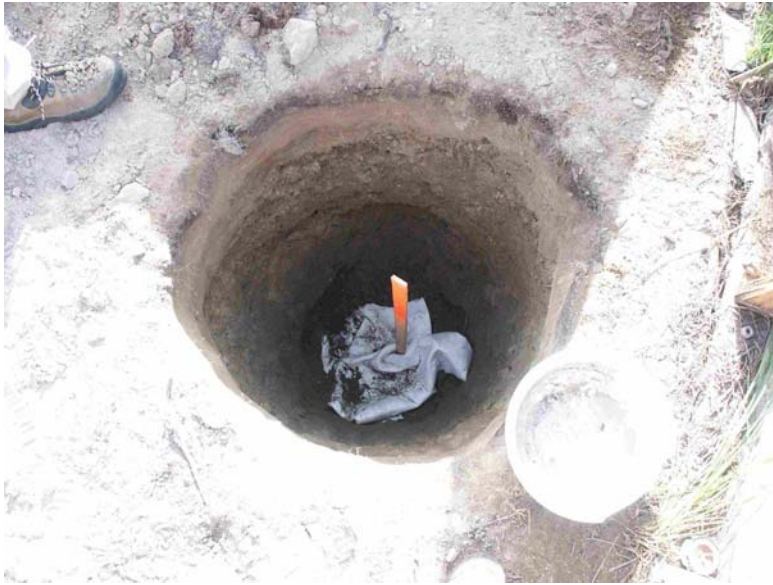
Lateral migration of the petroleum product towards a large shed on the site required the excavation of two monitoring trenches with monitoring pits dug into them at intervals to detect and stop and product from reaching Windy Lake. The east side of the shed has a trench along its southern half. The second trench extends the entire length of the shed on its inside floor, effectively putting this facility out of commission for the foreseeable future. This trench has four 1 metre monitoring pits. There are also a monitoring pit on the inside, west wall of the shed, and another across the main camp roadway outside and down slope.

To date, two employees are tasked full time with checking for any contaminant in the monitoring pit and trench network. They are also responsible for changing the fuel absorbent materials if they pick up any diesel fuel, and properly sealing them for transportation and eventual disposal. No petroleum product has been detected in the furthest westerly pit. The shed trench (number 2 in photos) is picking up any material that comes off the end of the impermeable clay layer.
