WOLFDEN RESOURCES INC.

2006 GEOTECHNICAL INVESTIGATION PROGRAM

HIGH LAKE PROJECT, NU

PROJECT NO.: 0385-003-15
DATE: MARCH 26, 2007

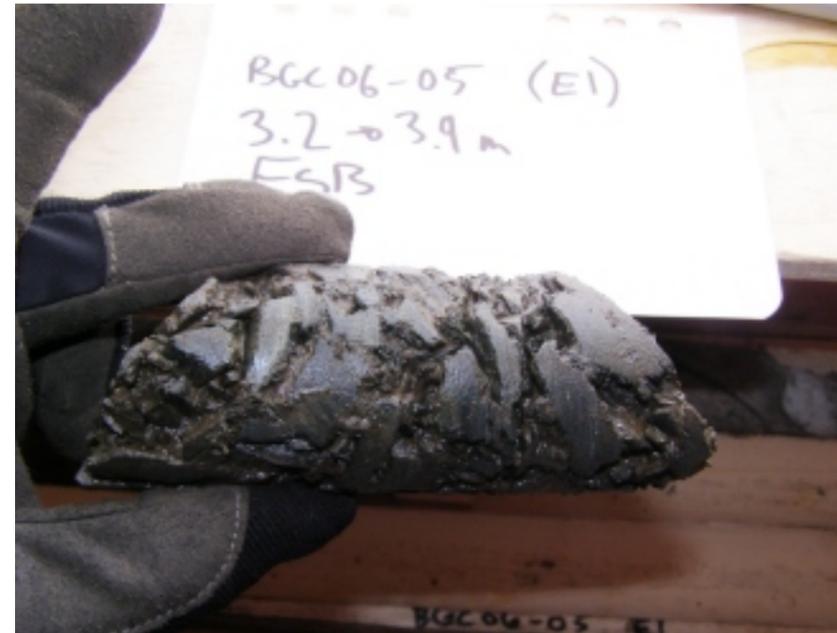
Example of frost affected bedrock and till encountered between 3.2 and 3.9 m at BGC06-05. Ice content was estimated to be 10%.

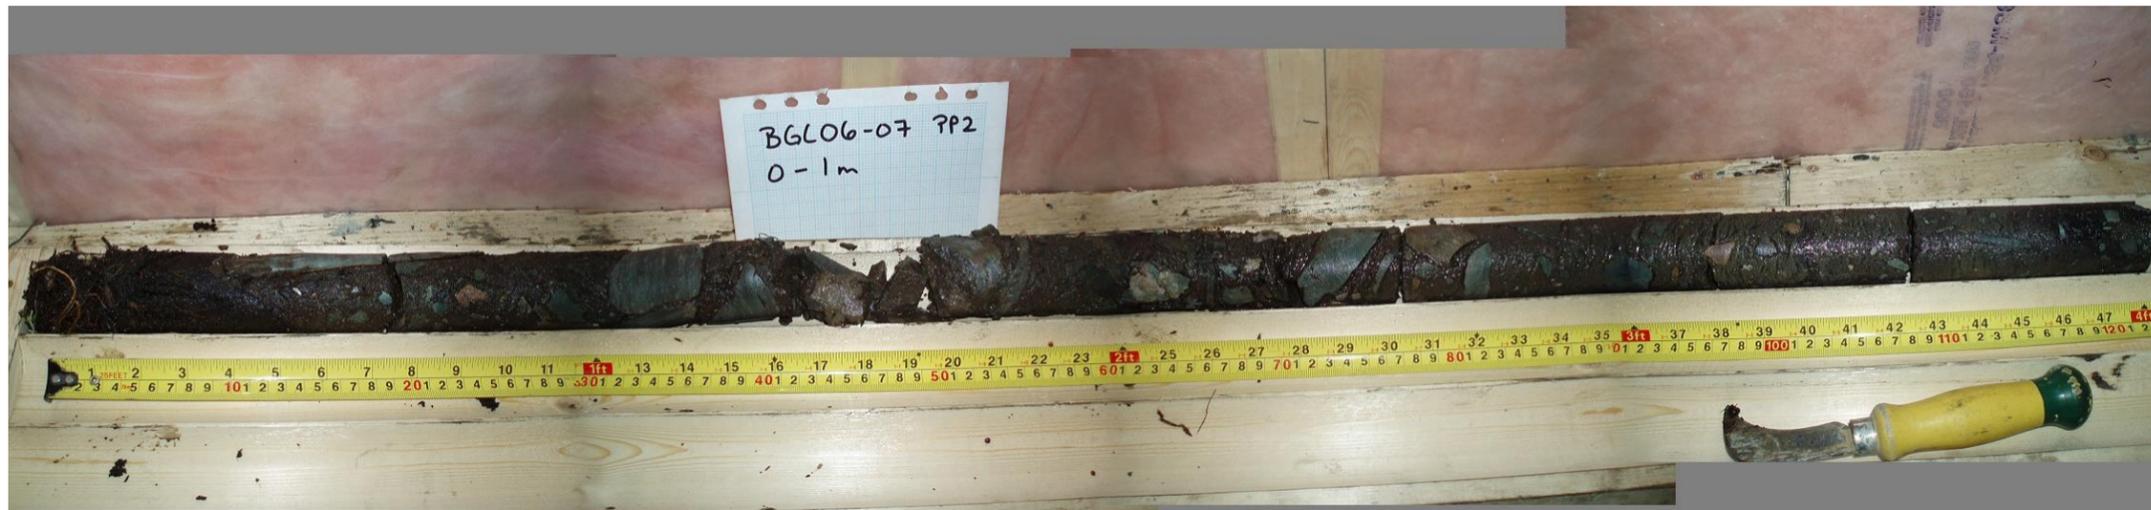
Recovered till core between 0 and 1 m at BGC06-07. Ice content ranged between 1% and 5% between 0 and 0.60 m. Stratified ice content was 30% to 40% between 0.6 and 1.0 m.

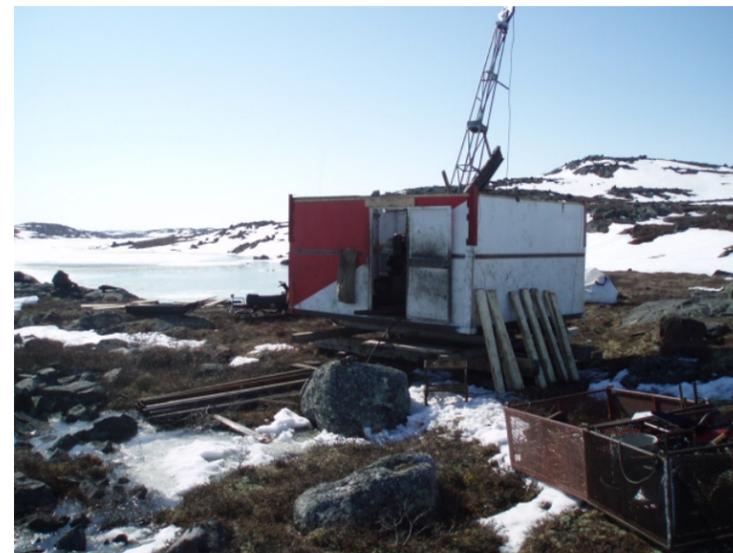
Drilling at BGC06-15, Northwest Channel Dam. Note the standing water on permafrost.

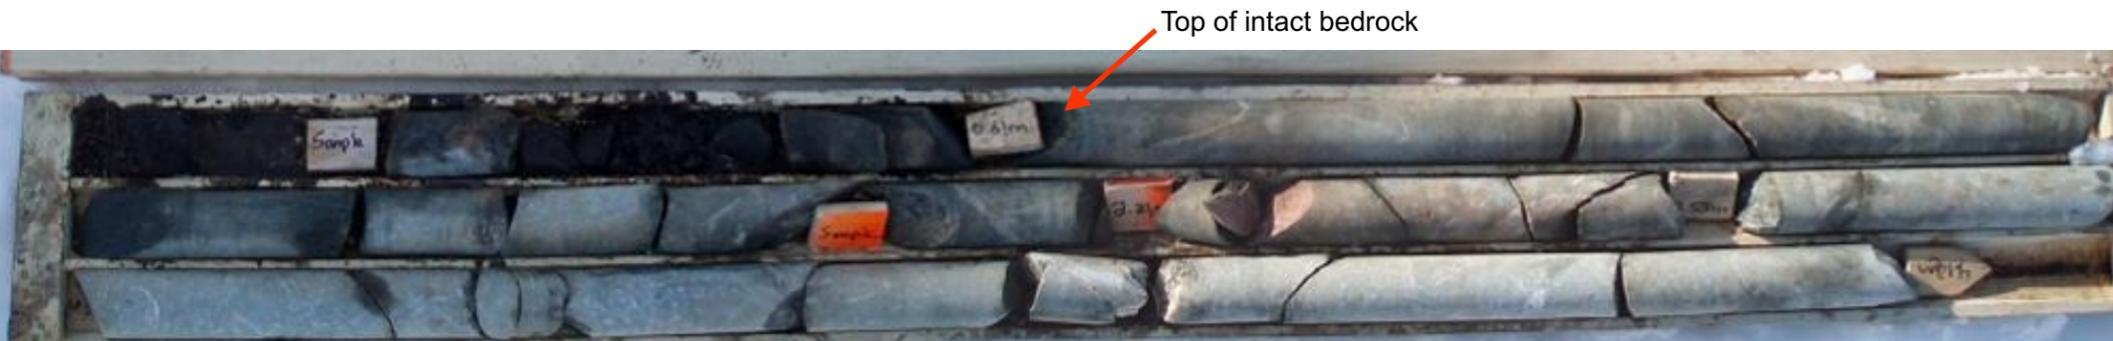
BGC06-11 Northeast Dam Box 1, Depth 0-4.12 m. Frost affected bedrock and intact rock contact is 0.6 m.

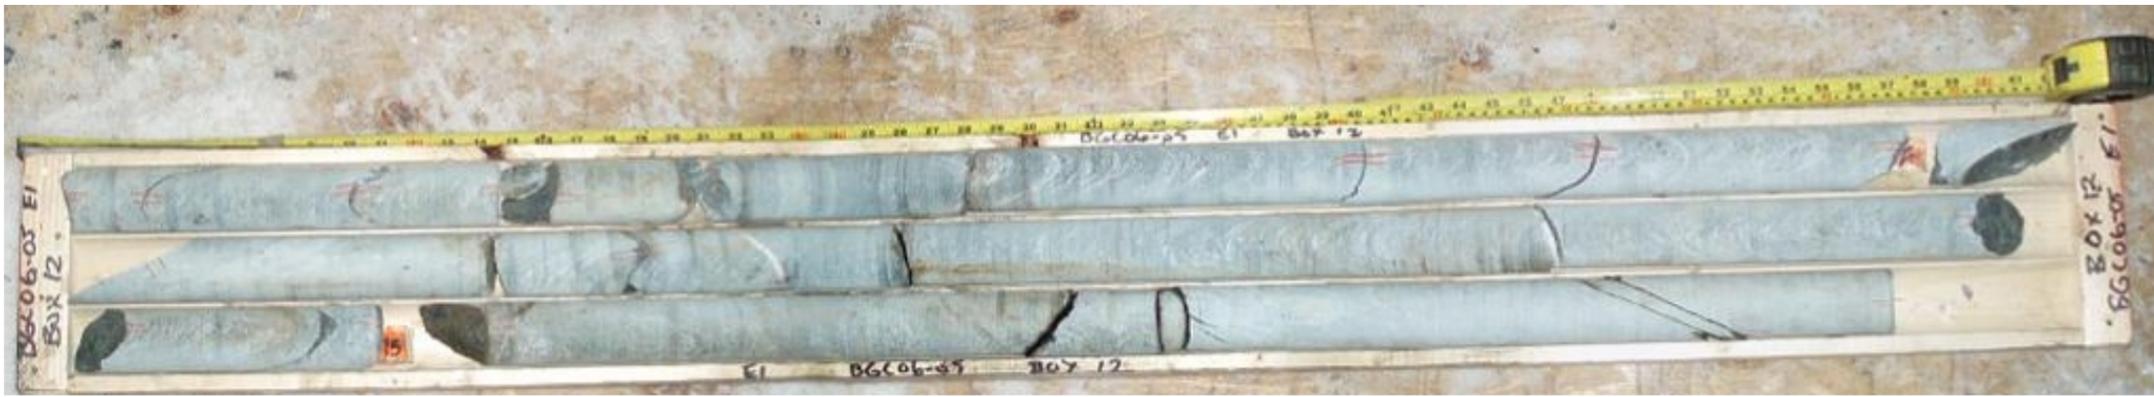
Massive tuff bedrock between 45.0 and 48.5 m at BGC06-05 (East Dam). RQD was found to range between 83% and 100%.

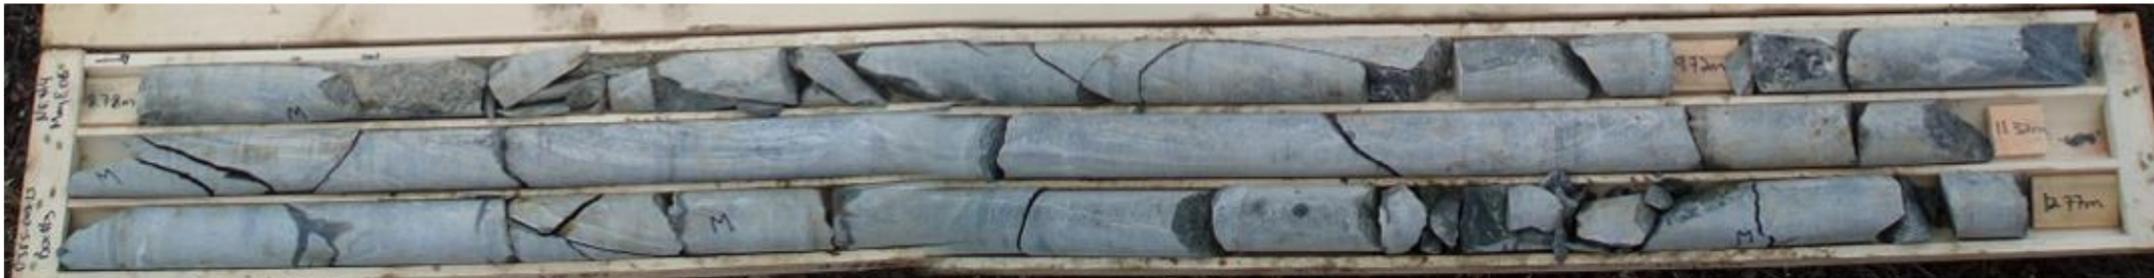
Moderately jointed metavolcanic bedrock encountered between 8.8 and 12.8 m at BGC06-10 (Northeast Dam). The RQD was found to range between 0% and 75%.

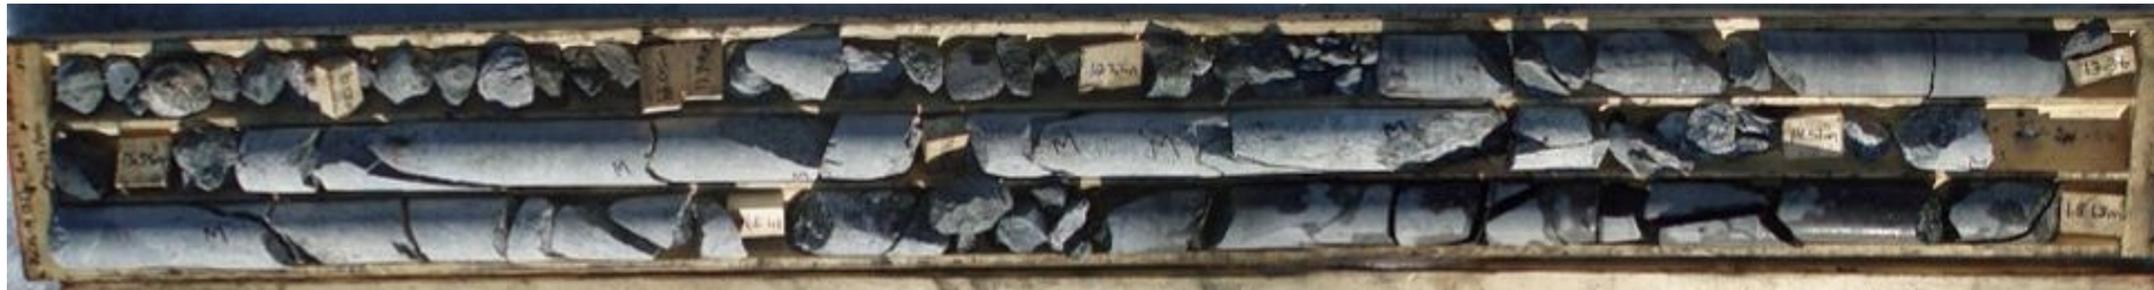
Very fractured and broken metavolcanic bedrock encountered between 10.8 and 15.6 m at BGC 06-14 (A/B Toe Dike). The RQD was found to range between 0% and 31%.

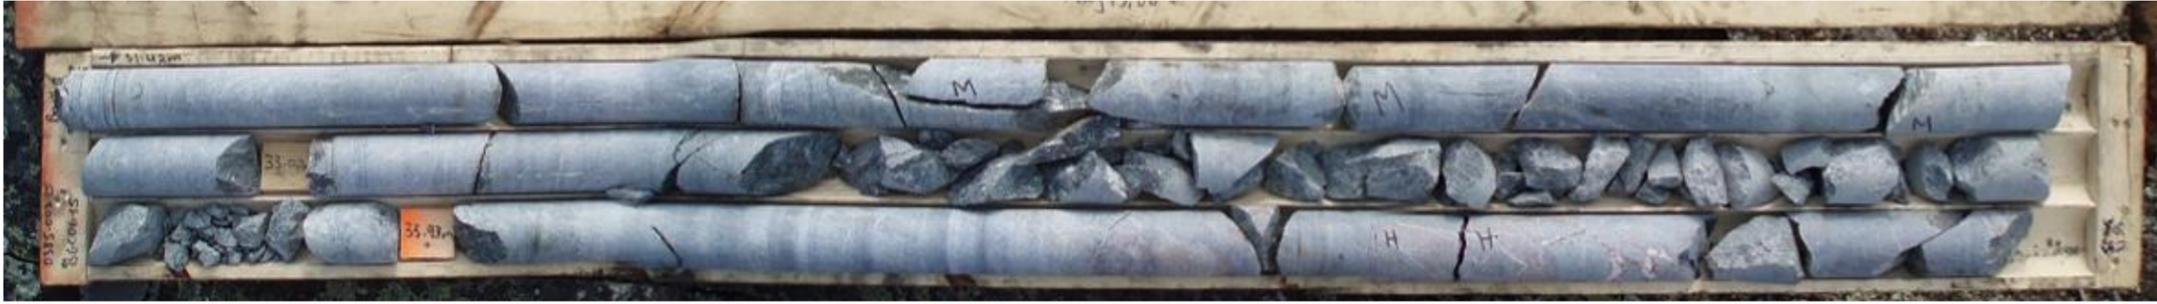
Varied metavolcanic bedrock quality between 31.4 and 35.1 m at BGC06-15. The RQD was found to range between 13% and 91%.

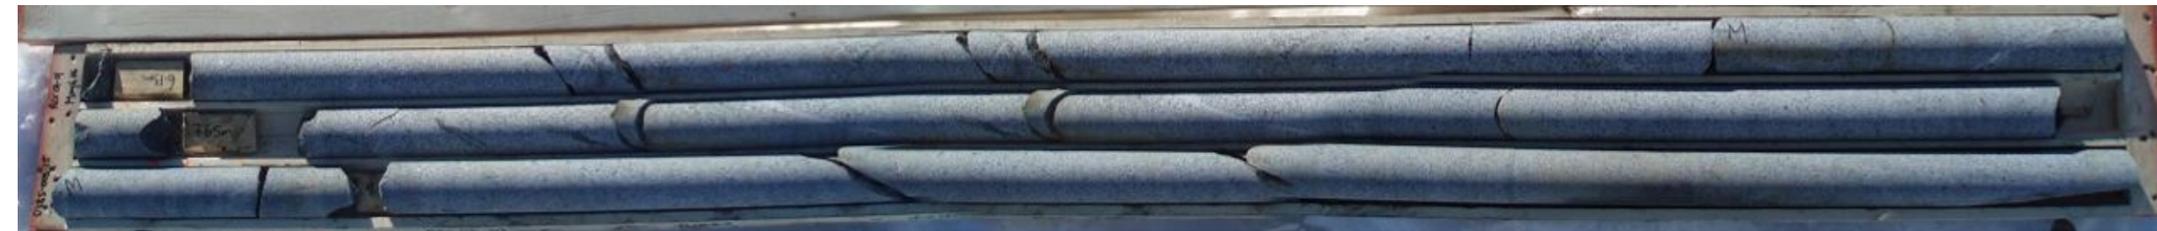
Massive intact gradodiorite bedrock encountered between 6.1 and 10.3 m at DS-BGC06-01. The RQD was found to range between 71% and 94%.

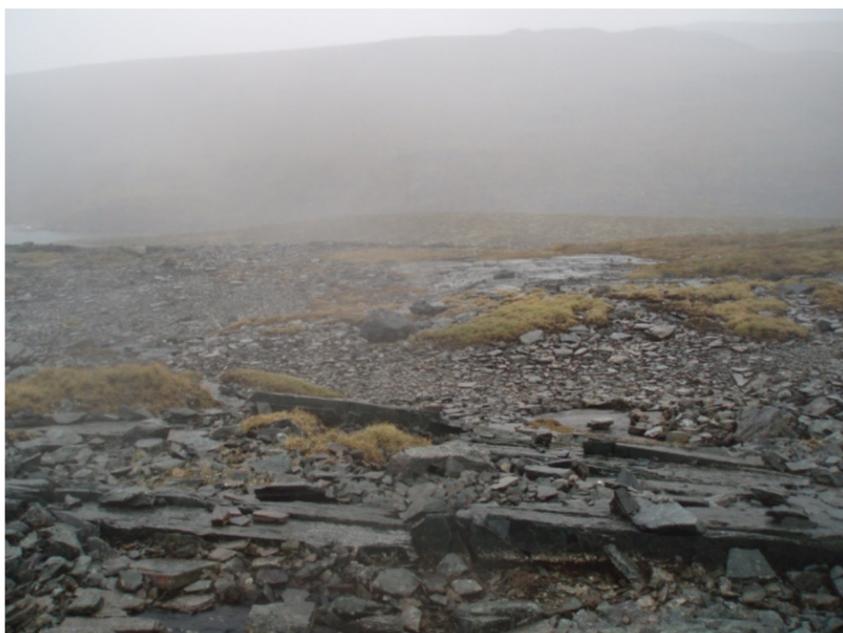
Frost affected bedrock and fluvial channel in the vicinity of the downstream toe of the East Dam.

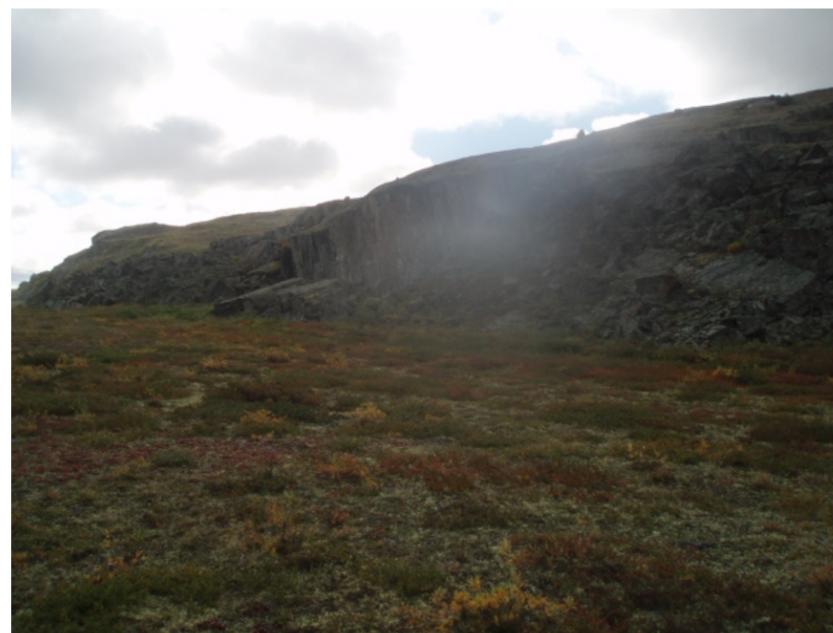
Looking west at a toppling failure along the lower bench near BGC06-04.

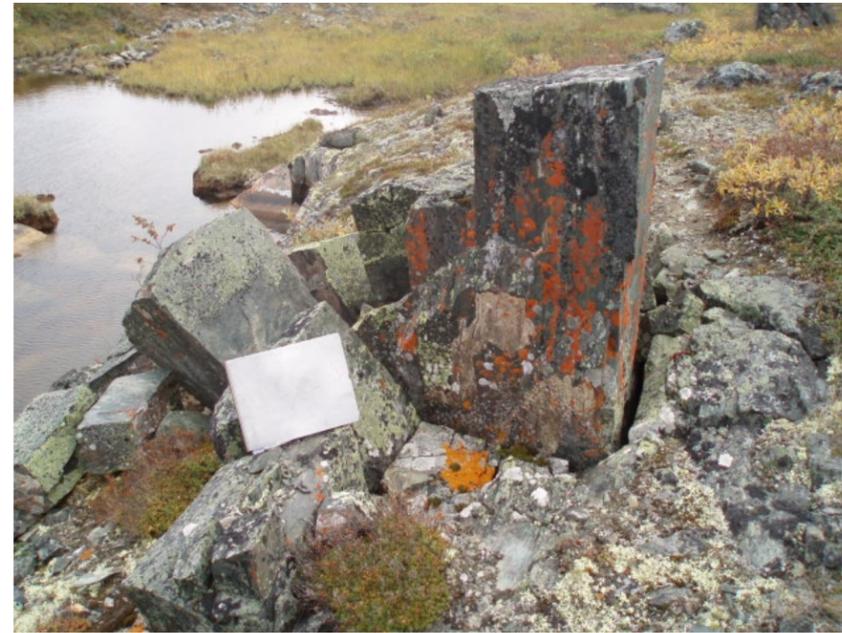
View of frost affected rock in the channel near BH-GT-05-07.

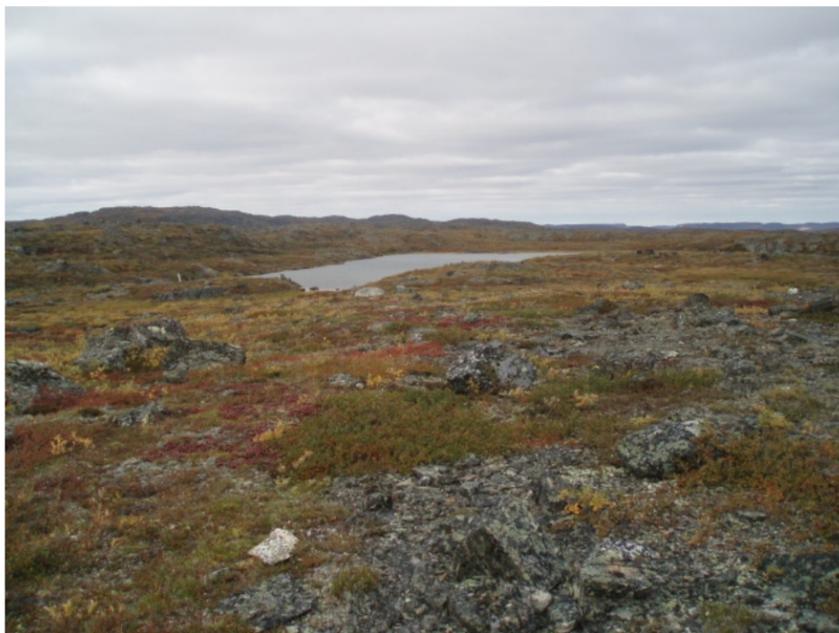
View of the left abutment area of the Northwest Dam. Note the frost affected bedrock.

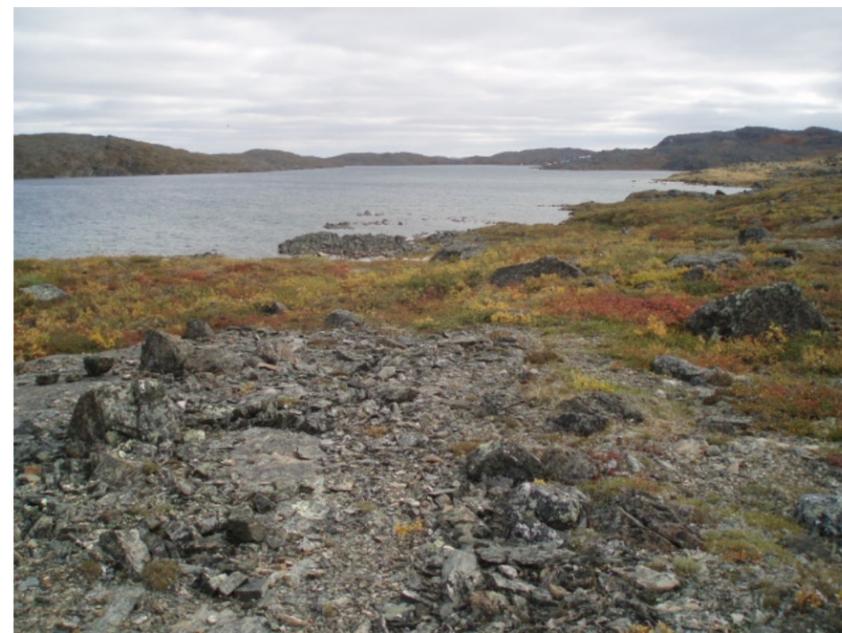
View of frost affected bedrock and boulders in seepage area between Northwest Dam and Northwest Channel Dam.

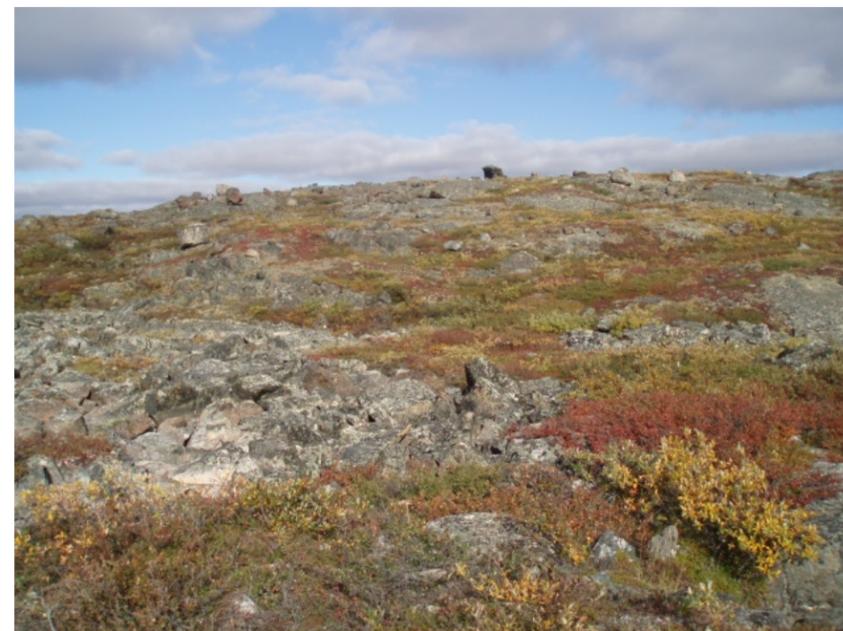
View of right abutment area. Note the frost affected bedrock.

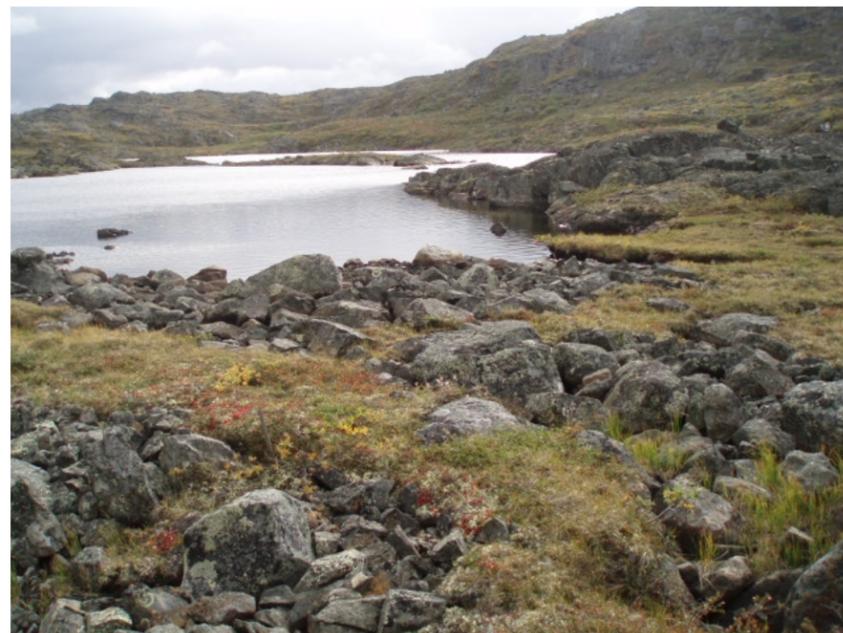
Frost affected bedrock and felsenmeer at the north end of Contact Lake.

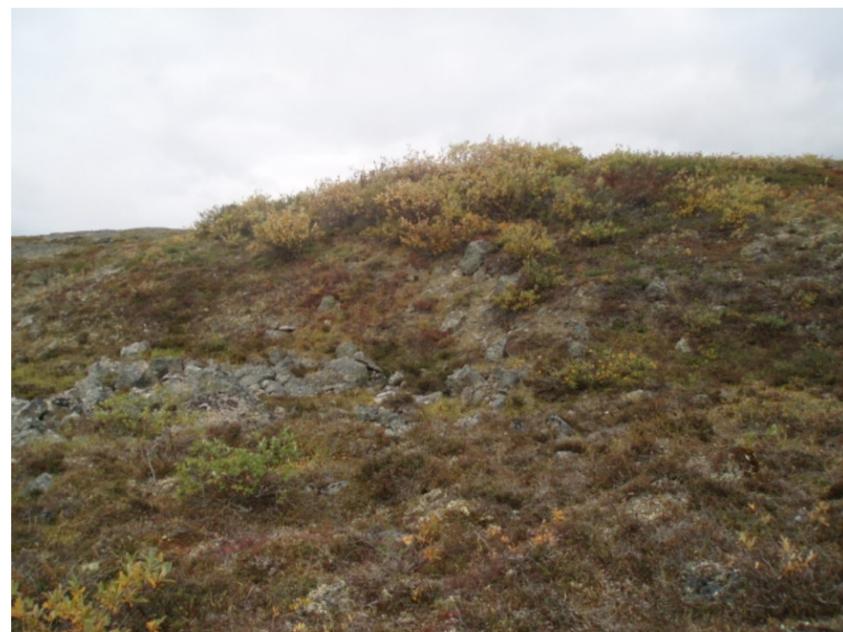
Glacial till found in the vicinity of the left abutment of the Polishing Pond Dam.
