**Re: Diamondex Resources Ltd (Peregrine Project) Water Licence 2BE-PER0610 Inspection on July 13, 2009**

## WATER USE INSPECTION REPORT

<b>Date:</b> July 13, 2009	<b>Licensee Rep. (Name/Title):</b> David Ritcey
<b>Licensee:</b> Diamondex Resources Ltd	<b>Water Licence No.:</b> 2BE-PER0610 <b>Land Use Permit:</b> N2005C0021

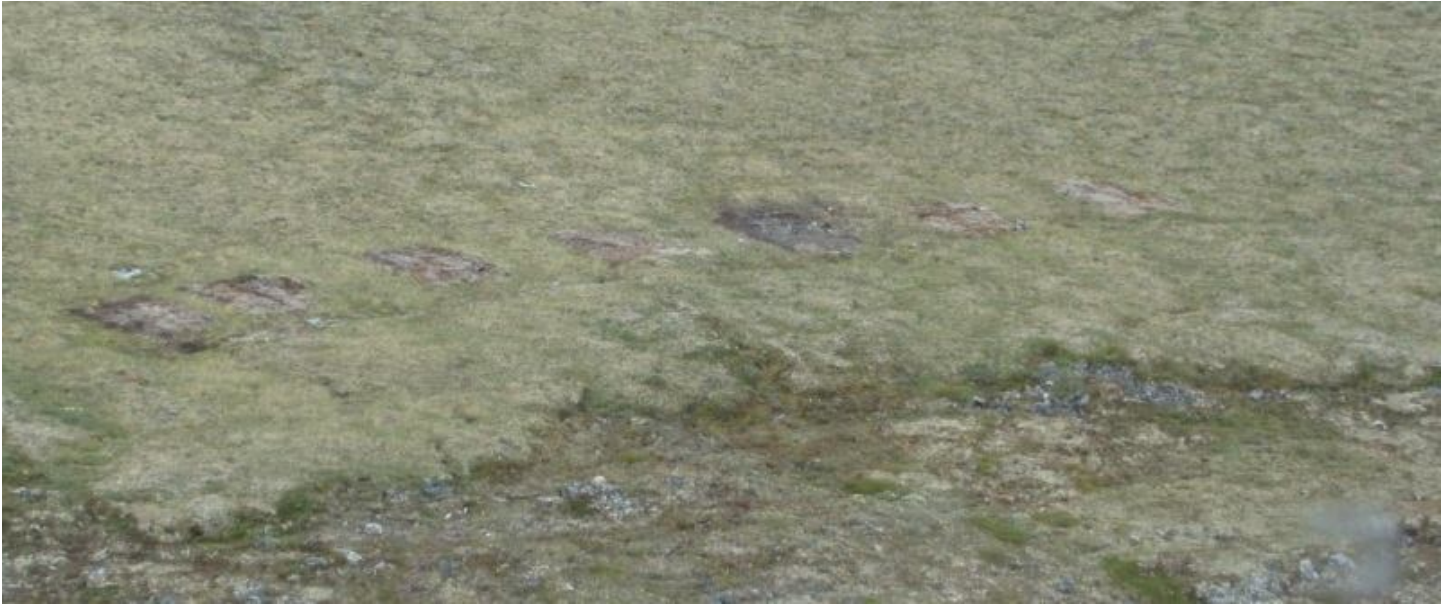
- Seven tent/building locations and generator shack location were immediately visible during the aerial survey. Vegetation in former tent frame locations has not yet recovered; it did not appear that any methods had been used, such as scarification, to promote re-growth of these areas.

Photograph 1: Aerial survey of former Peregrine camp location. Seven former tent frame locations and sump area are visible in this view.

As per section 7: In order to promote natural growth of vegetation...all disturbed surfaces shall be prepared by ripping, grading, or scarifying the surface to conform to the natural topography.

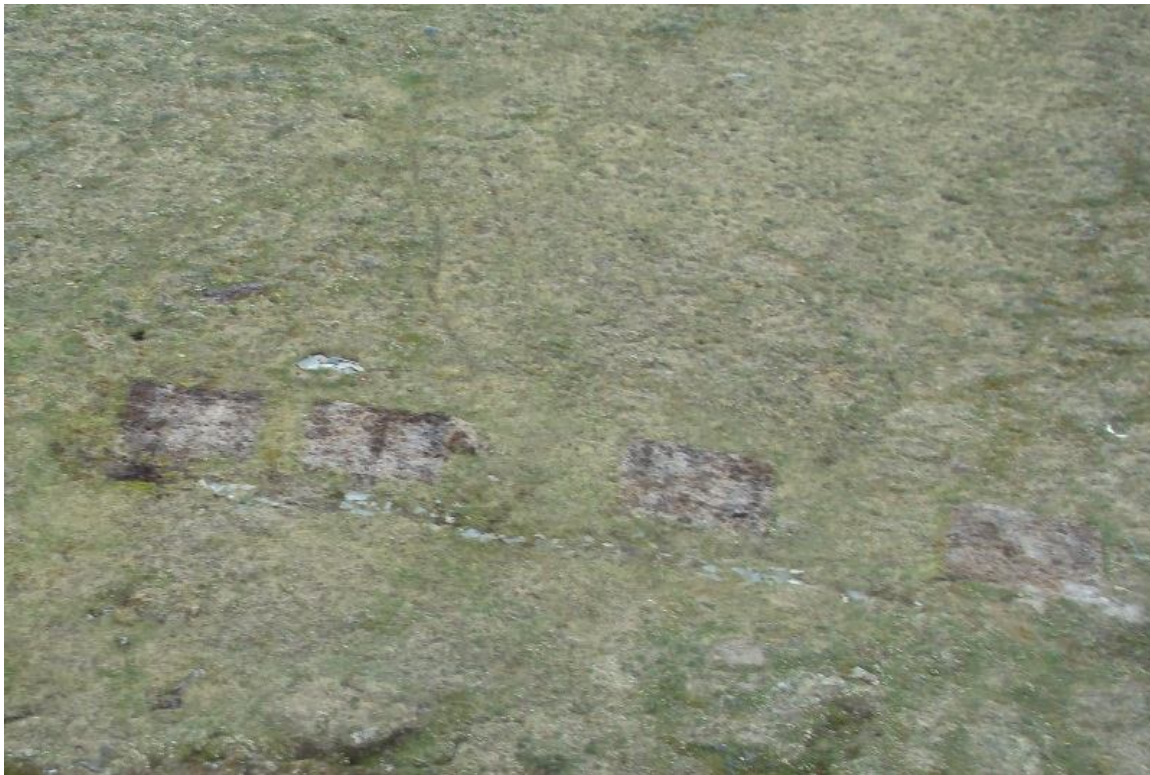
- Flagstones used for pathways were left in place; some of these rock slabs had been placed inside the sump as fill material.
- Sump area has not been restored properly; material used for backfill is too large for proper contouring and compaction.
- Some woody debris near shore was found (appeared to be part of a pallet); no other debris was visible in the immediate area.

Photograph 2: Aerial survey showing flagstone pathway, several tent frame areas and sump.

As per section 3: Licensee shall backfill and restore, to the satisfaction of an Inspector, all sumps to the pre-existing natural contours of the land.

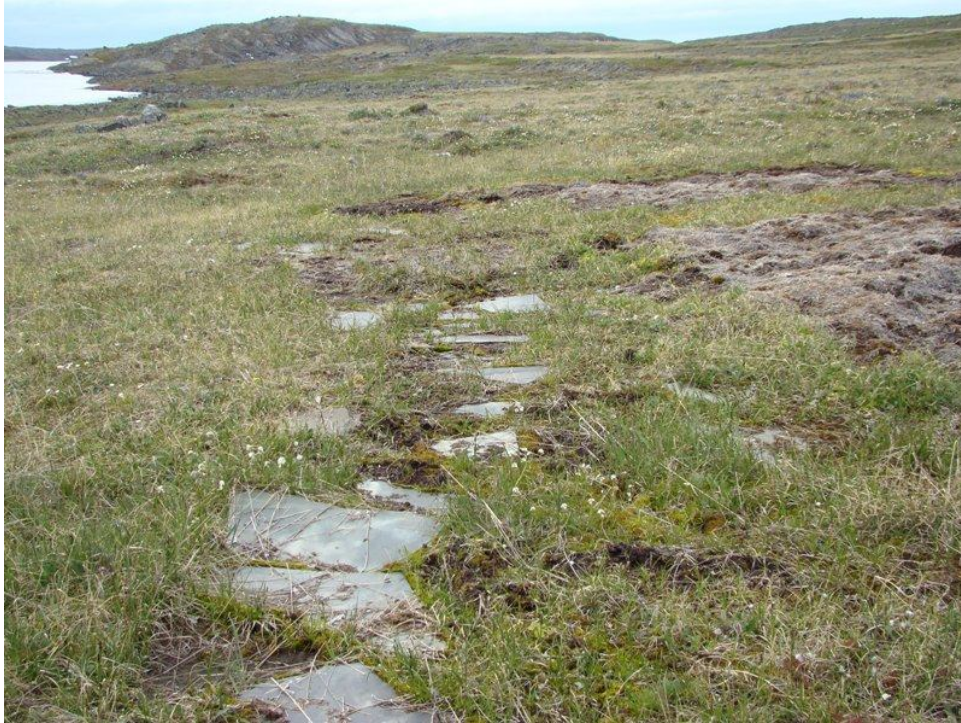
Photograph 3: View showing flagstone pathway and several former tent frame locations.

As per section 4: Licensee shall remove from the site infrastructures and site material.

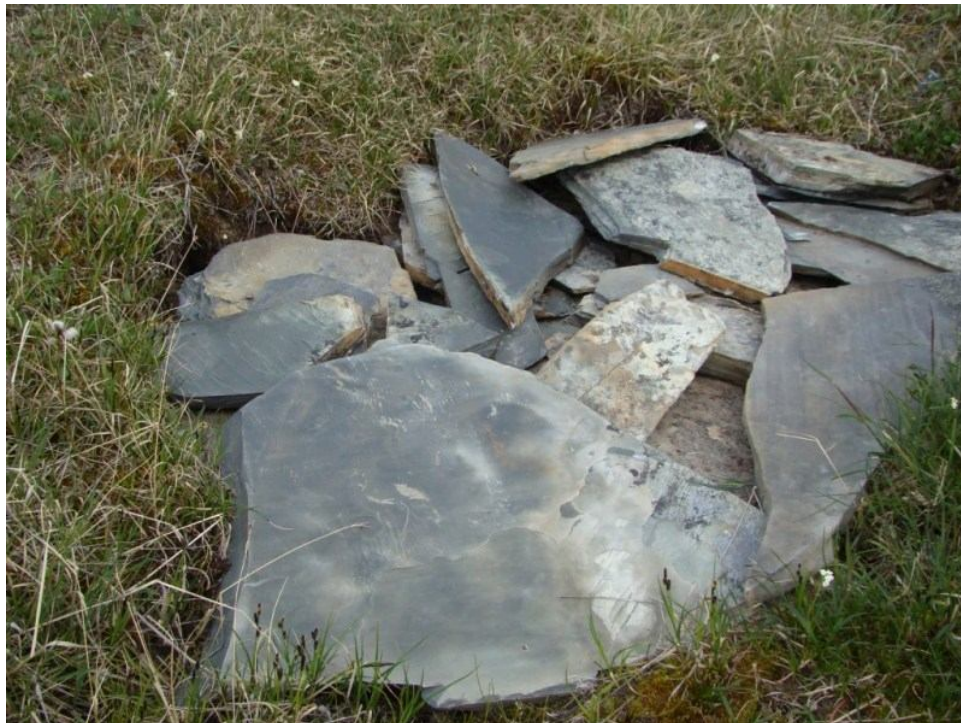
Photograph 4: Sump location. Sump has not been restored properly; material used for backfill is too large for proper contouring and compaction.

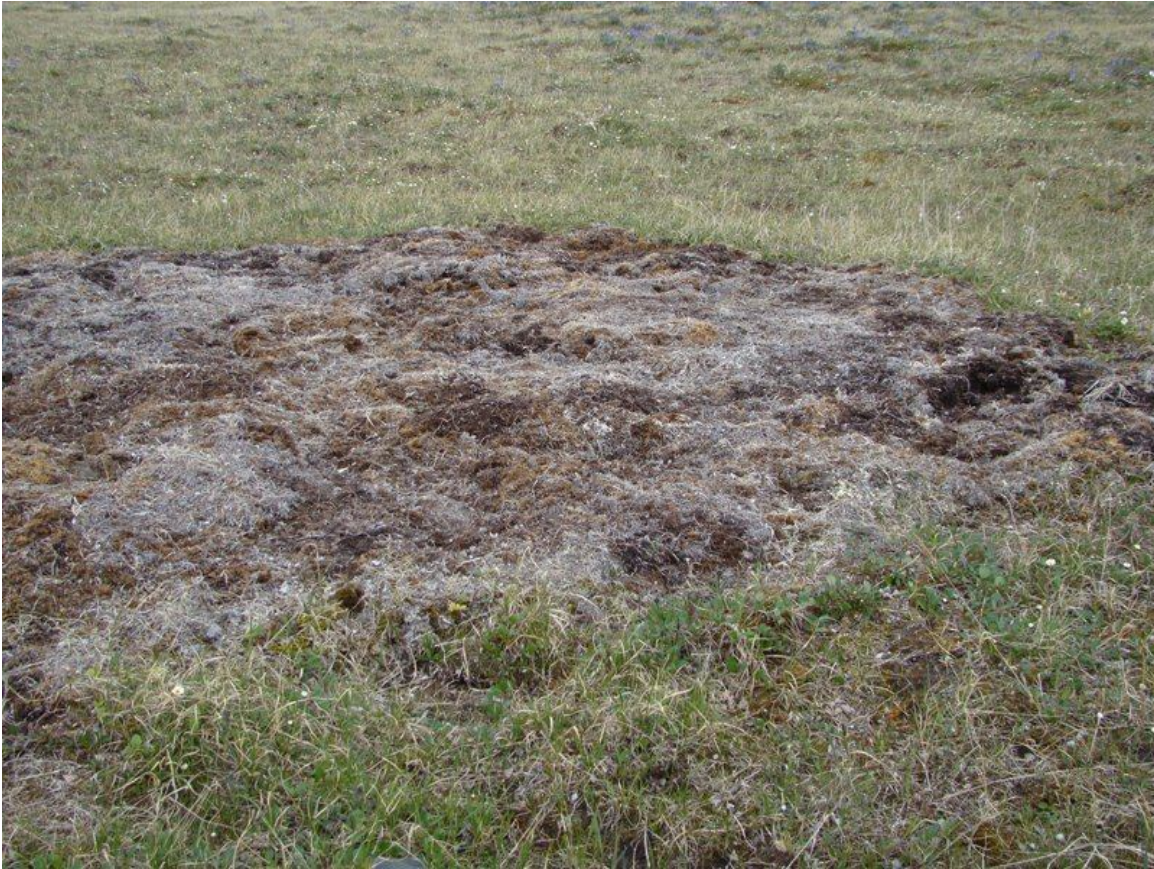
Photograph 5: Closer view of former tent frame area. Vegetation has not yet recovered; there are no signs of methods used, such as scarification, to encourage re-growth.
