WATER LICENCE INSPECTION FORM

Licensee		Licensee Representative	
Agnico Eagle Mines Limited		Phillip Roy	
Licence No. / Expiry		Representative's Title	
2BW-MEL1525/ June 8 <sup>th</sup> 2025		Environmental Tech	
Land / Other Authorizations		Land / Other Authorizations	
2BB-MEL1424		N2013C0002	
Date of Inspection		Inspector	
09/06/15		WRO Wilson	
Activities Inspected			
<input type="checkbox"/> Camp	<input type="checkbox"/> Drilling	<input type="checkbox"/> Mining	<input type="checkbox"/> Construction
<input checked="" type="checkbox"/> Roads/Hauling	<input checked="" type="checkbox"/> Other: Culvert		<input type="checkbox"/> Reclamation
		<input checked="" type="checkbox"/> Other: Bridge	<input type="checkbox"/> Fuel Storage

PHOTO LOG

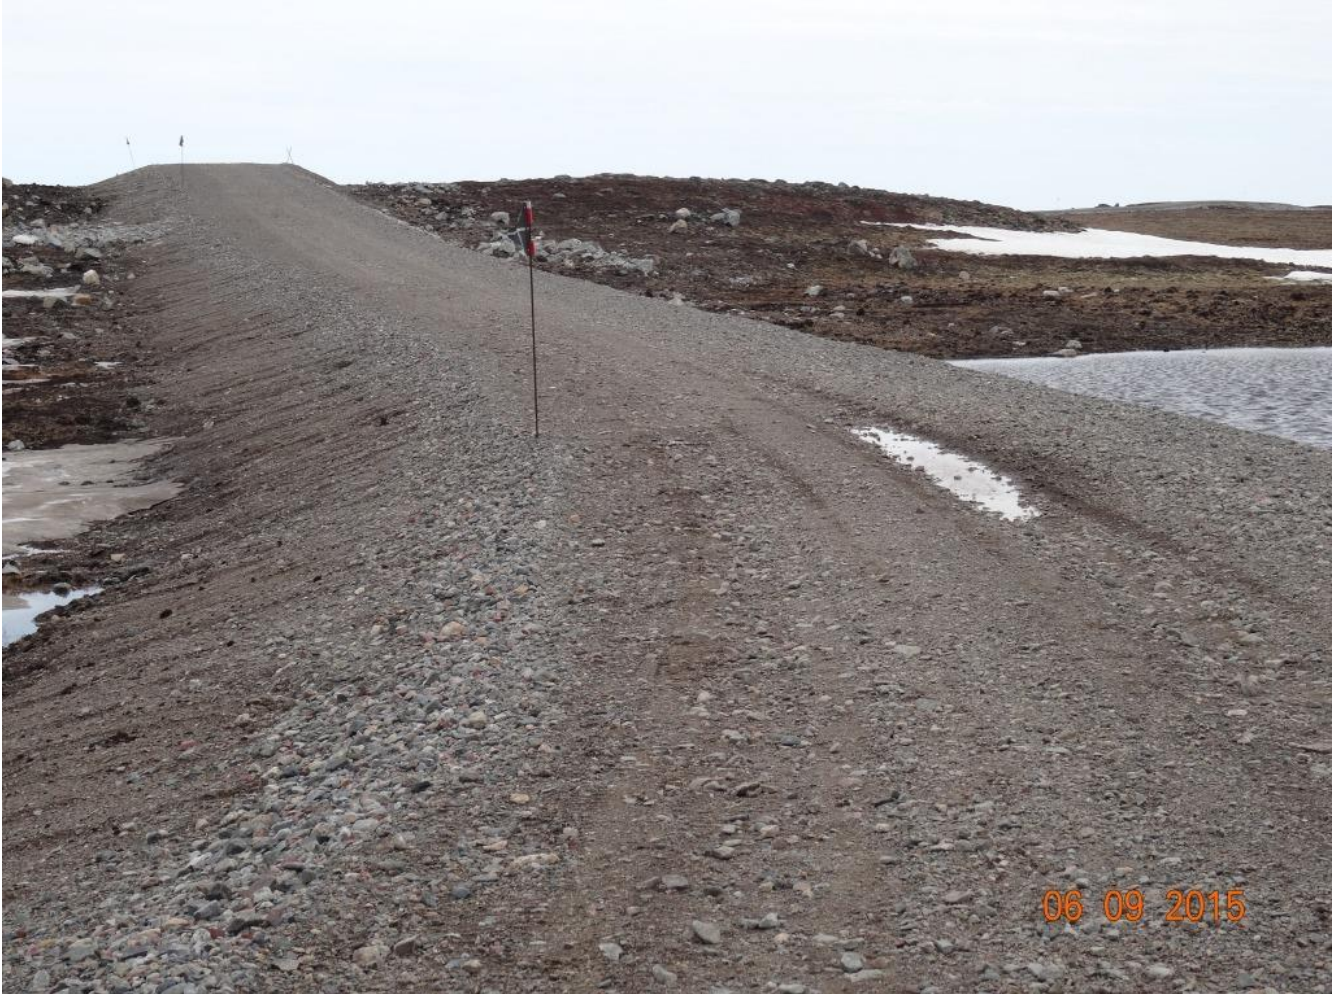
Date:	Authorization Number:	Camera/Model:	Inspector
Jun 9 <sup>th</sup> , 2015	2BW-MEL1524	Sony DSC-HX50V Cyber shot	WRO Wilson
Locations name:		Lat/Long (DD.MM.SS.SS, NAD83)	
Photo 1		N62 59 13.76 W92 9 22.63

**Description:**  
Ponded water- Agnico Eagle’s All weather Access Road to Meliadine Project

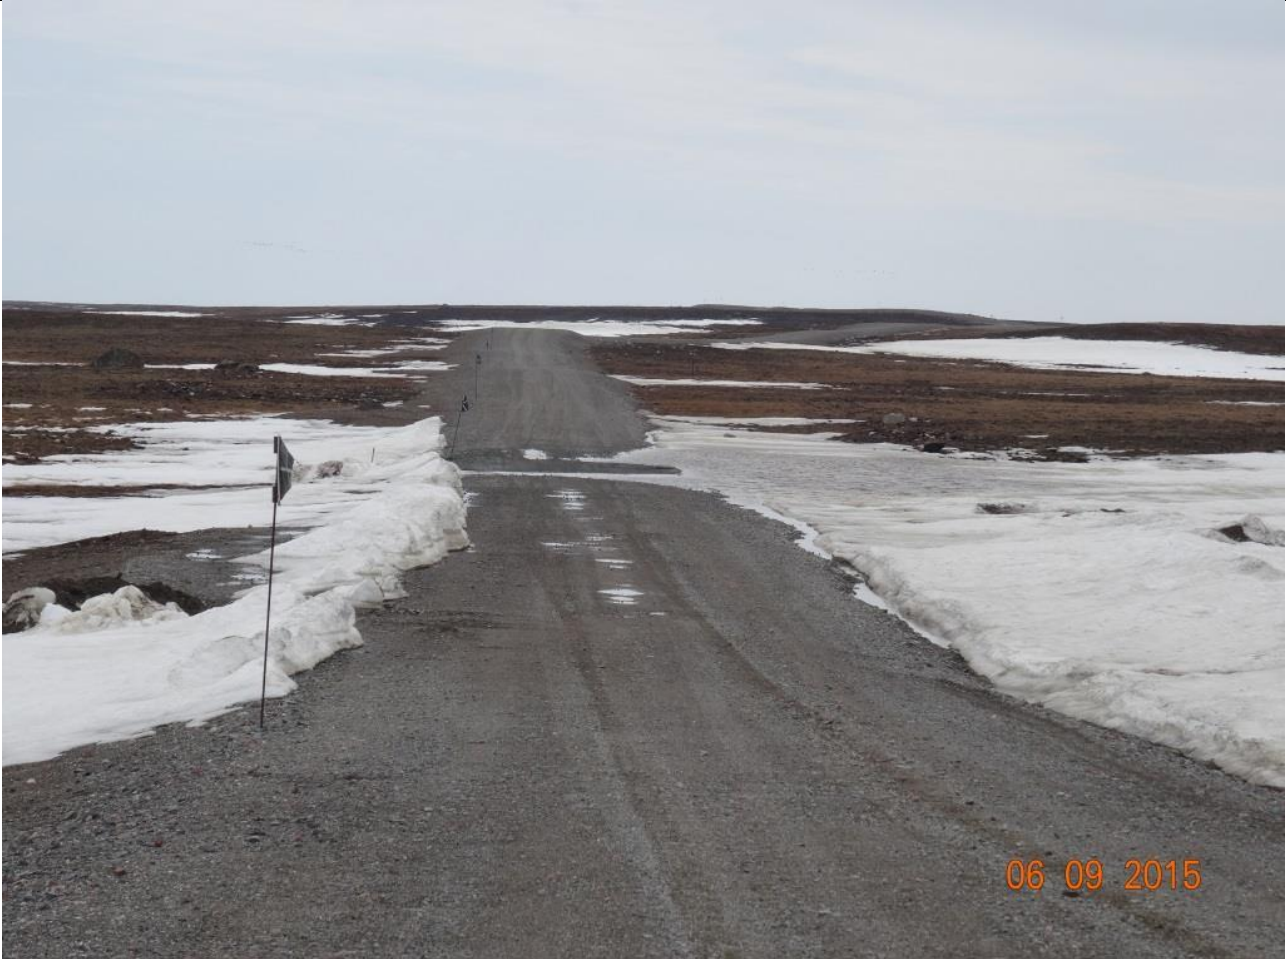
Locations name:	Lat/Long (DD.MM.SS.SS, NAD83)
Photo 2	N62 59 44.75 W92 10 47.12

**Description:**  
Water over topping Road- Agnico Eagle’s All weather Access Road to Meliadine Project

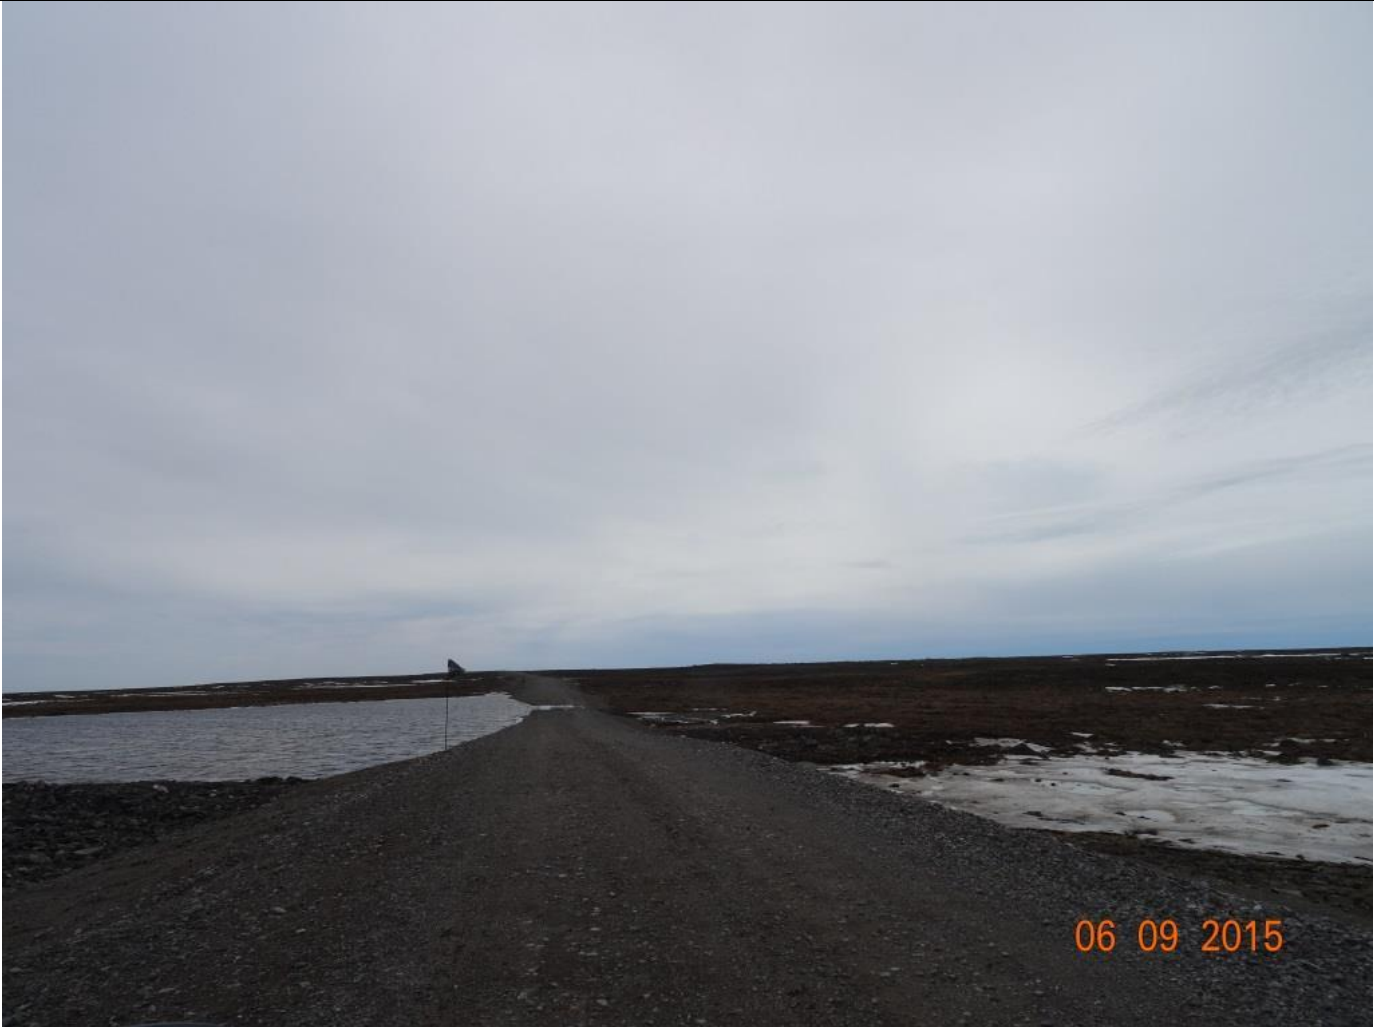
Locations name:	Lat/Long (DD.MM.SS.SS, NAD83)
Photo 3a	N62 58 12.68 W92 07 43.5

<b>Descirption:</b> Plugged culverts effecting natural surface drainage- Agnico Eagle’s All weather Access Road to Meliadine Project
---

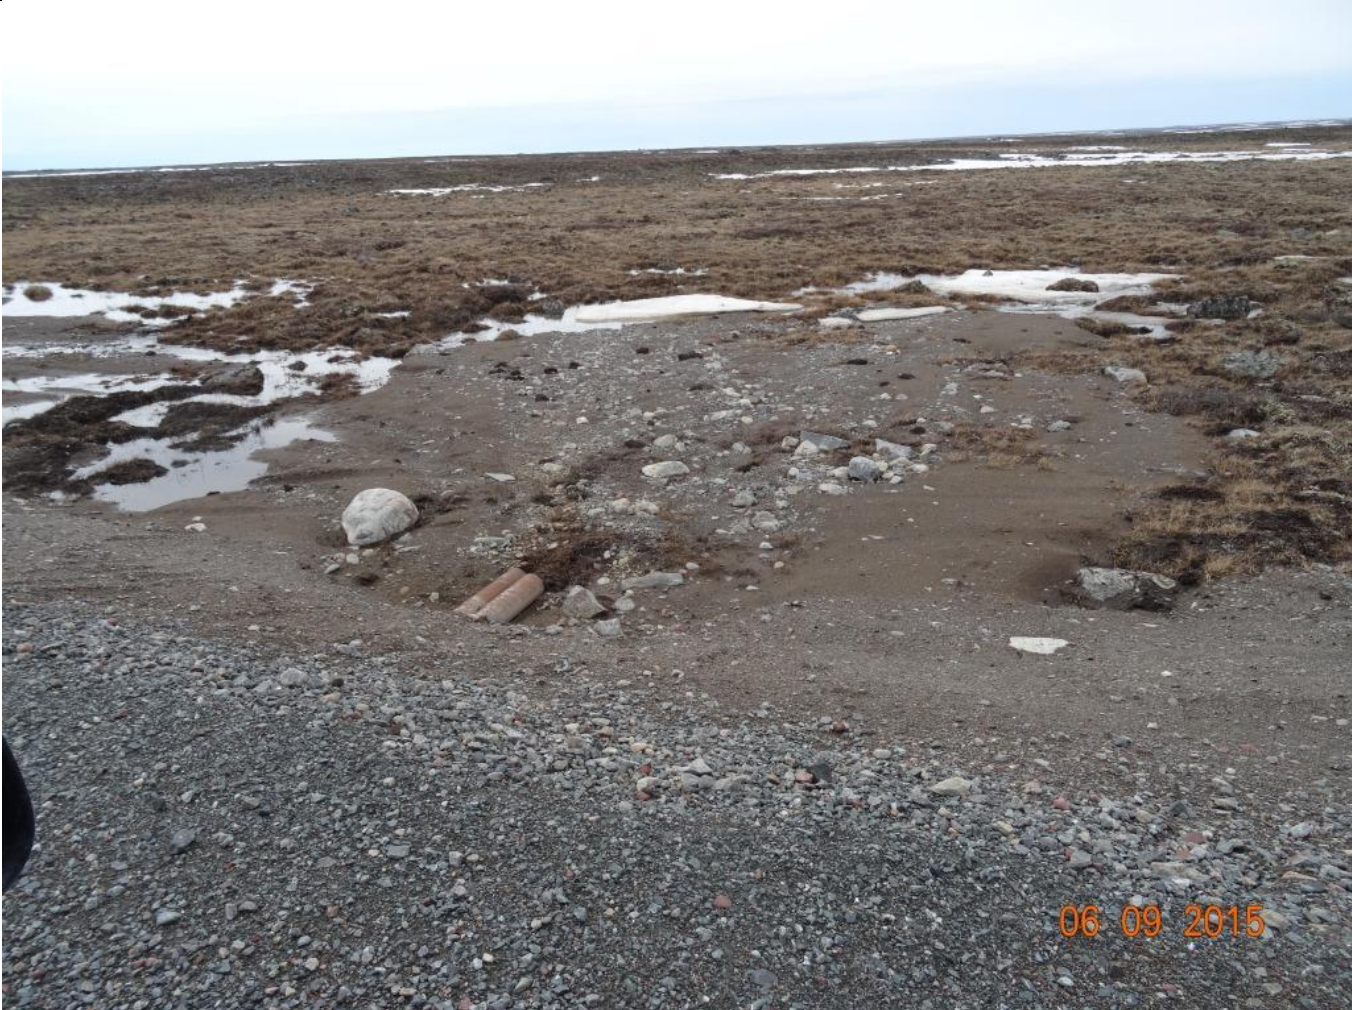
Locations name:	Lat/Long (DD.MM.SS.SS, NAD83)
Photo 3b	N62 58 10.59 W92 07 40.7

<b>Descirption:</b> Opposite site of culvert picture in photo 3a (Plugged culverts effecting natural surface drainage) - Agnico Eagle’s All weather Access Road to Meliadine Project
---
