WATER LICENCE INSPECTION FORM

Licensee		Licensee Representative	
8BC-MEL1516		Alexandre Gauthier	
Licence No. / Expiry		Representative's Title	
December 31 st , 2016		Environmental Technician	
Land / Other Authorizations		Land / Other Authorizations	
IOL		2BB-MEL1424	
Date of Inspection		Inspector	
October 8 th , 2015		WRO C. Wilson	
Activities Inspected			
<input type="checkbox"/> Camp	<input type="checkbox"/> Drilling	<input type="checkbox"/> Mining	<input checked="" type="checkbox"/> Construction
<input checked="" type="checkbox"/> Roads/Hauling	<input type="checkbox"/> Other: Water Discharge	<input type="checkbox"/> Reclamation	<input type="checkbox"/> Fuel Storage
<input type="checkbox"/> Other:

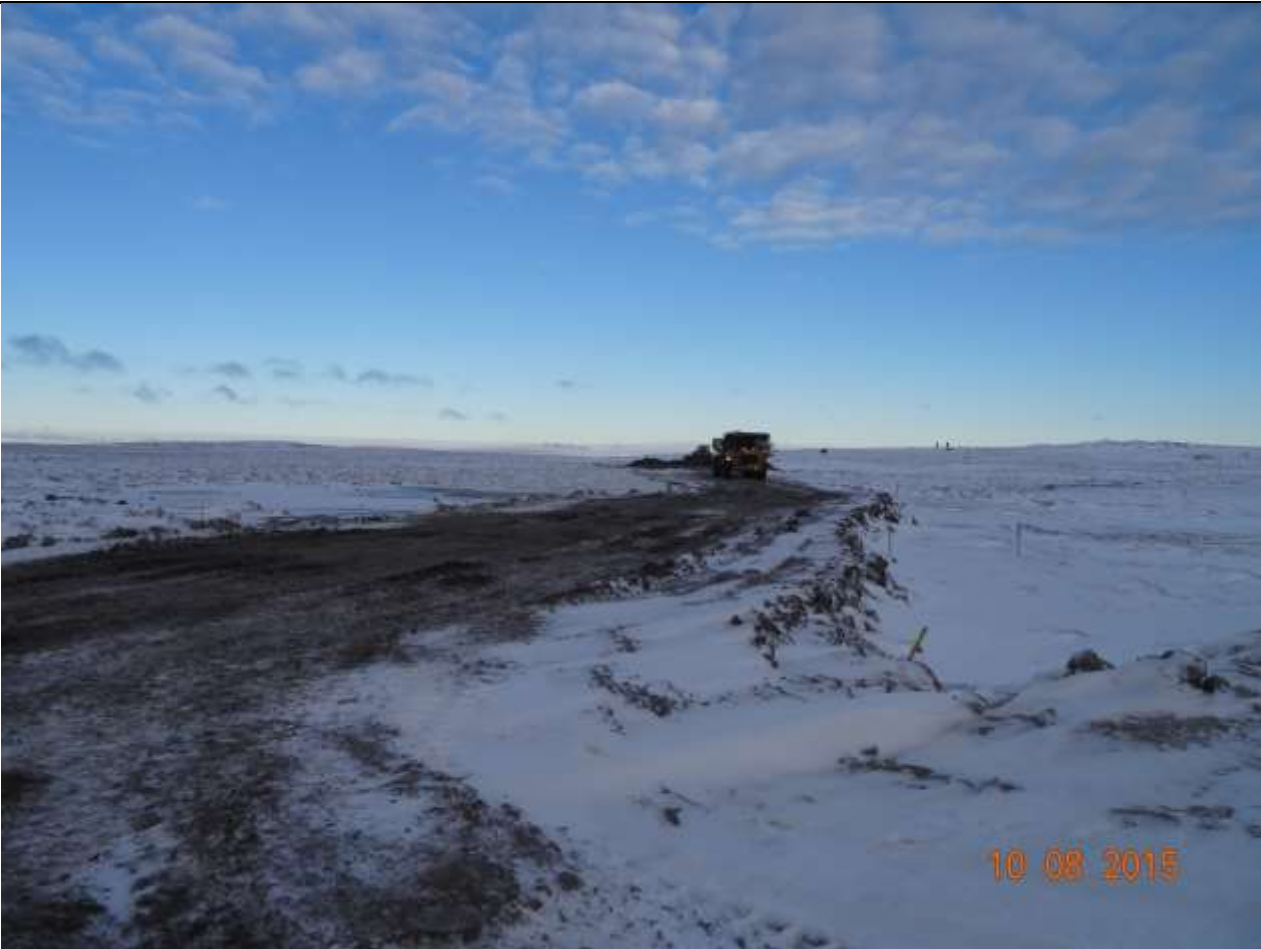
Photo 3

End of Road as of 10.08.15

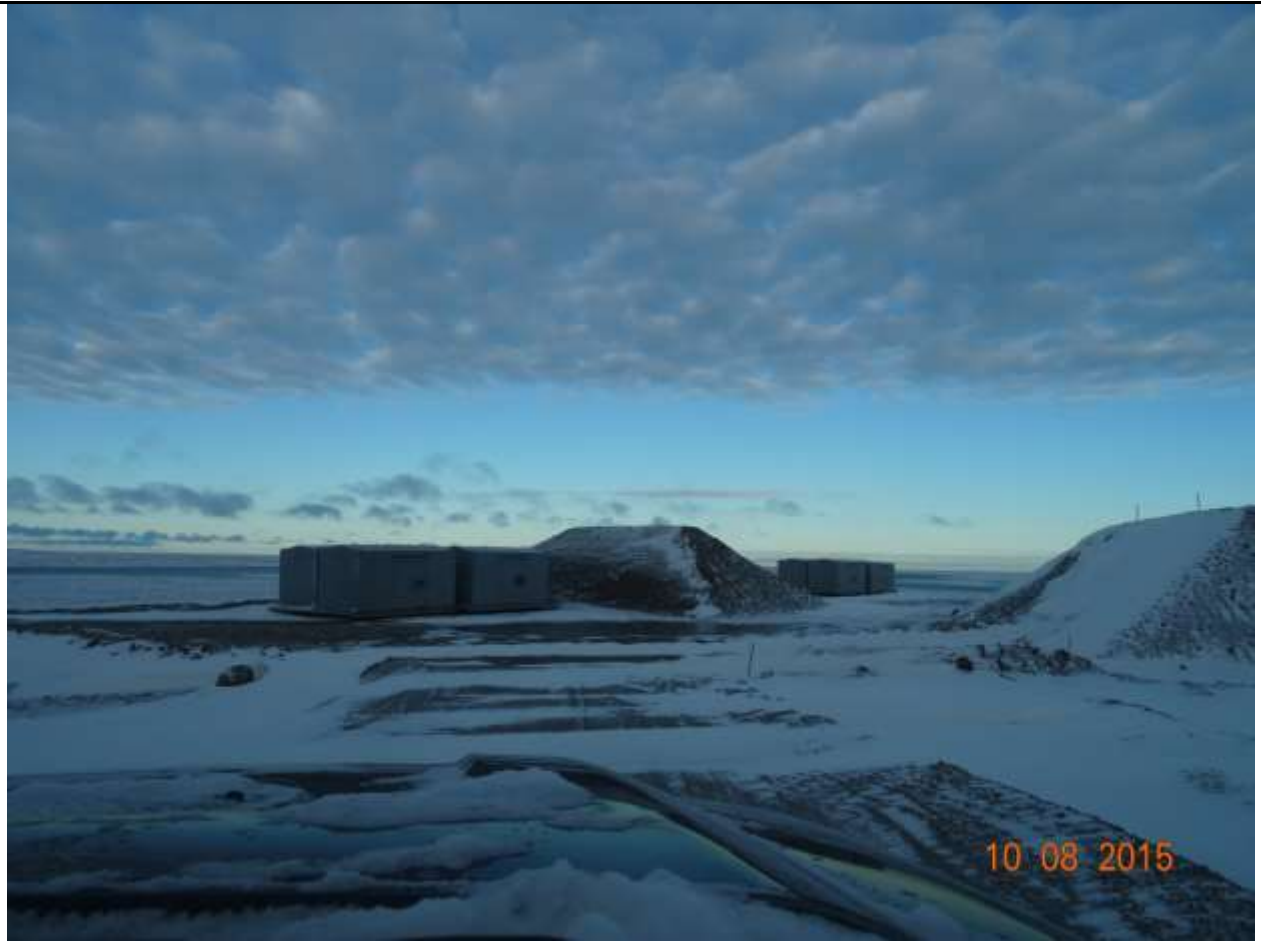
Photo 4

Explo Bunkers
