**APPENDIX E.7**  
**INSPECTION REPORTS**

**APPENDIX E.7.1**  
**AANDC INSPECTION REPORTS AND BAFFINLAND RESPONSE**

**RE: Water Licence Inspection Report – Mary River Project – Mary River Camp and Milne Inlet Camp May 4&5 2013.**

# May 2013 Water License Inspection

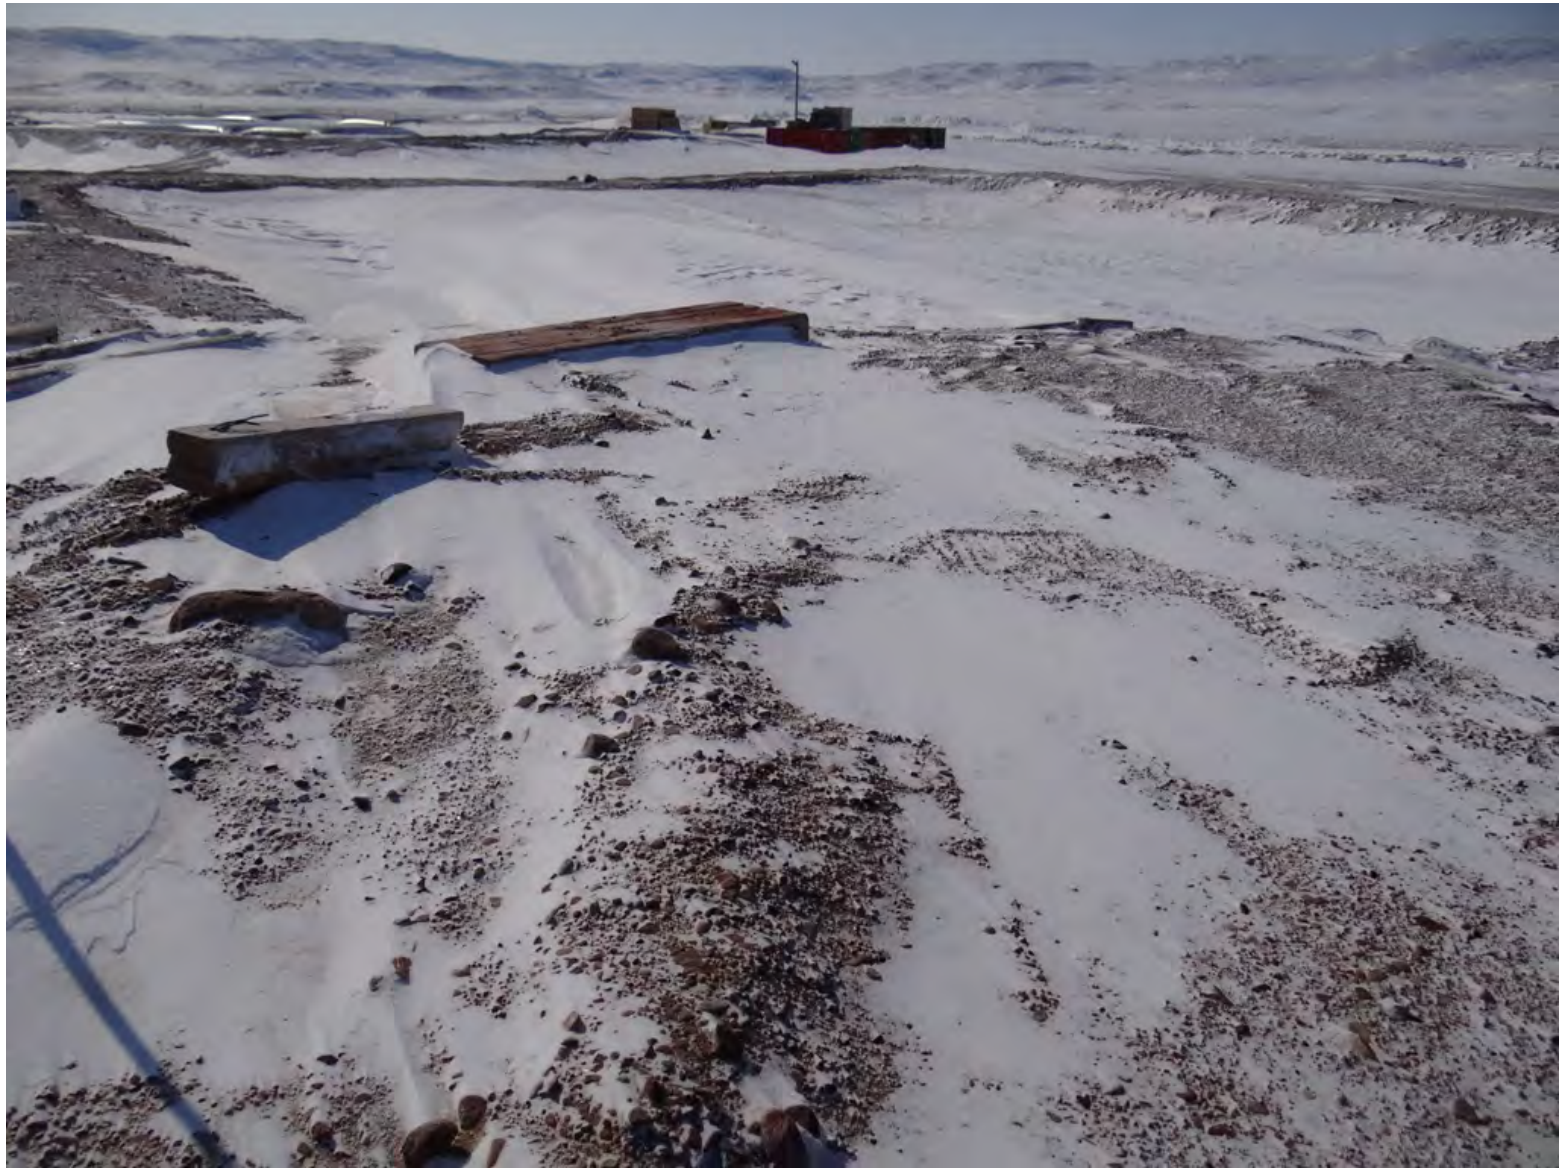
**Milne Inlet Waste Water Polishing Pond – Truck Drop**

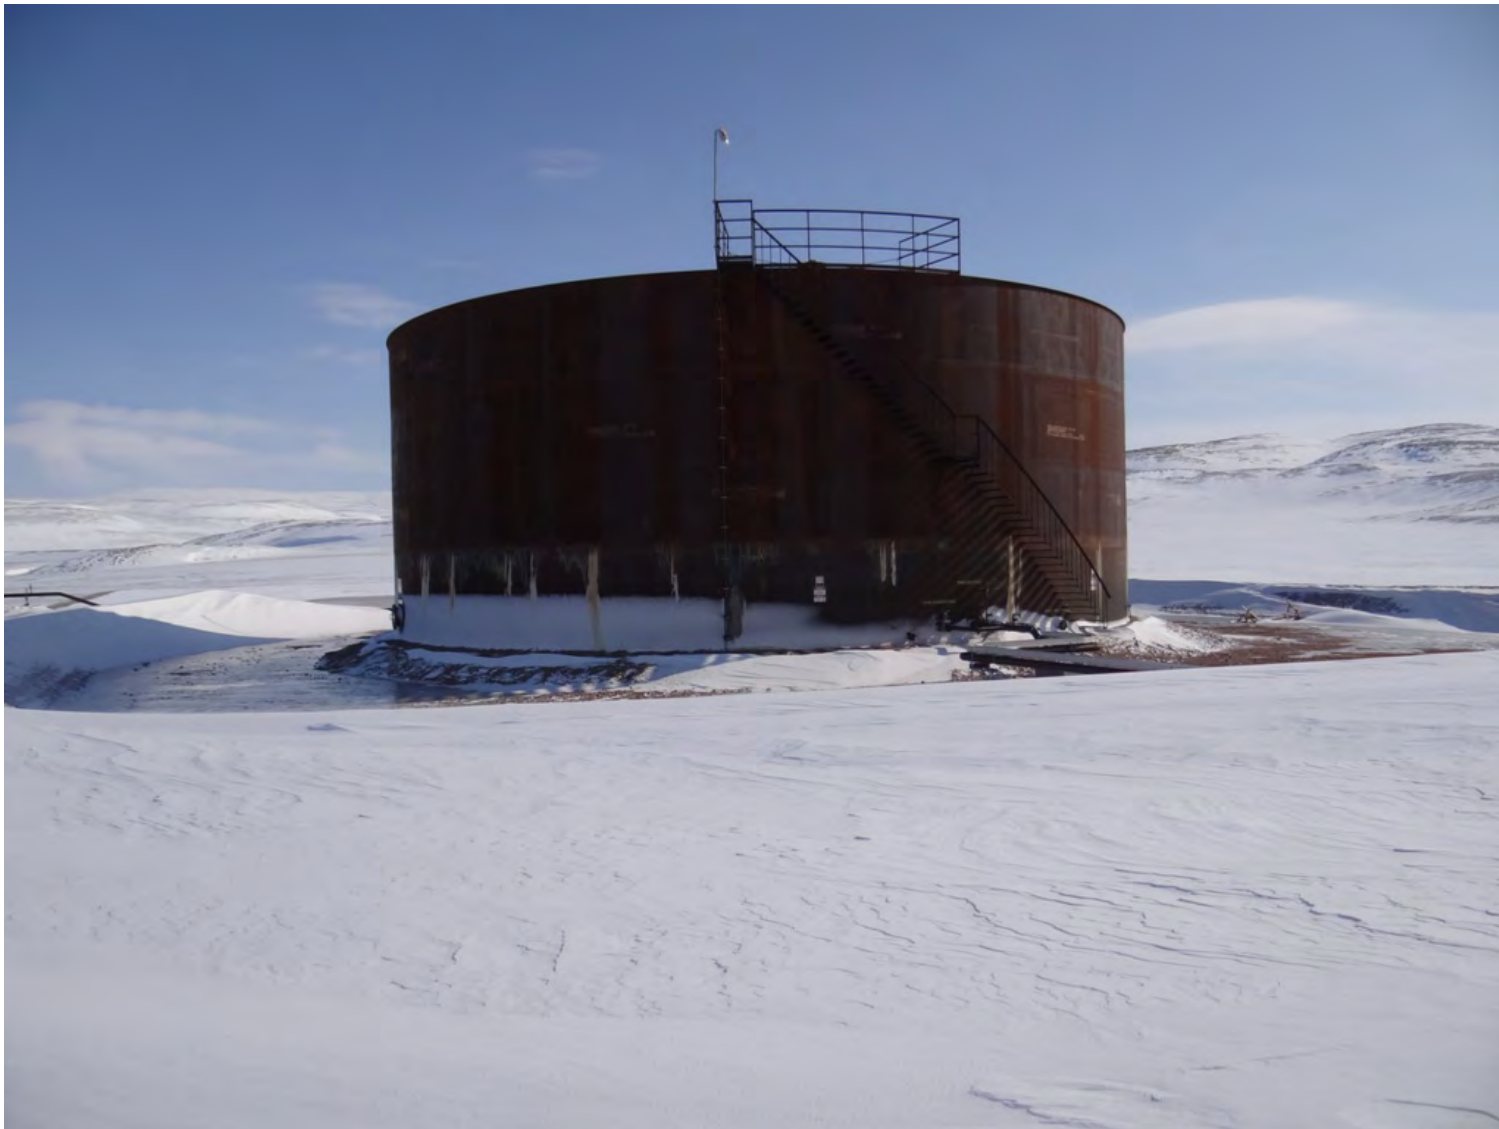
**Single new 5M liter tank containing fuel at time of inspection-  
Milne Inlet**

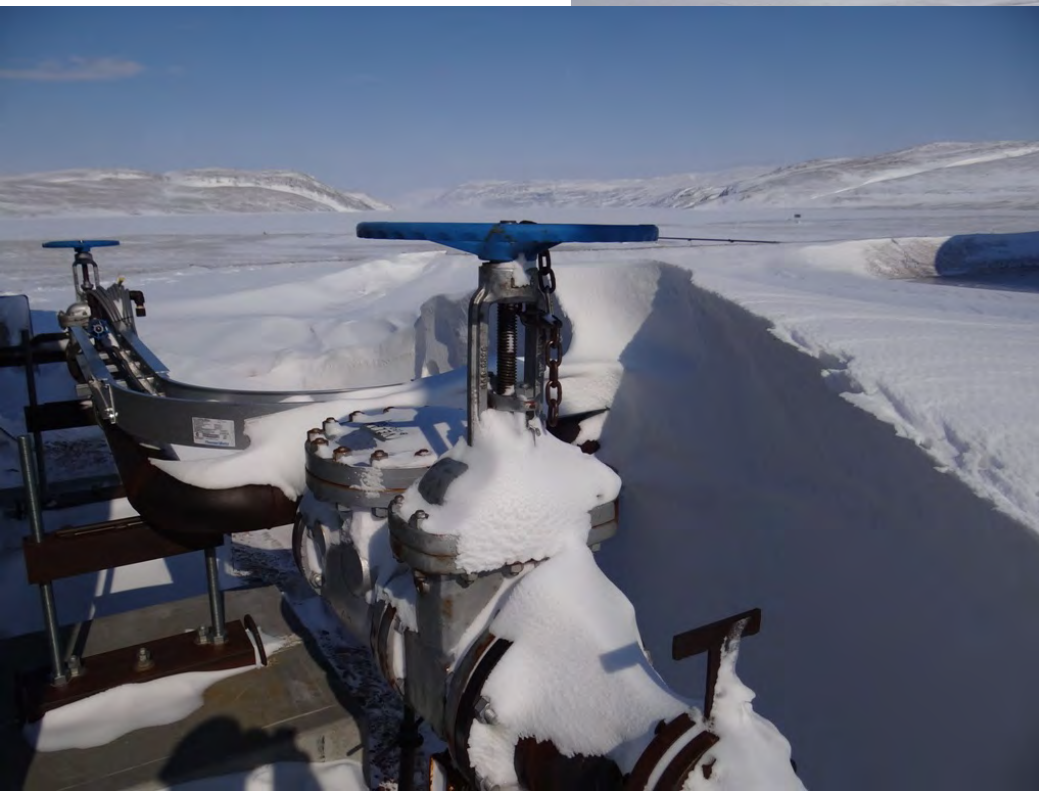
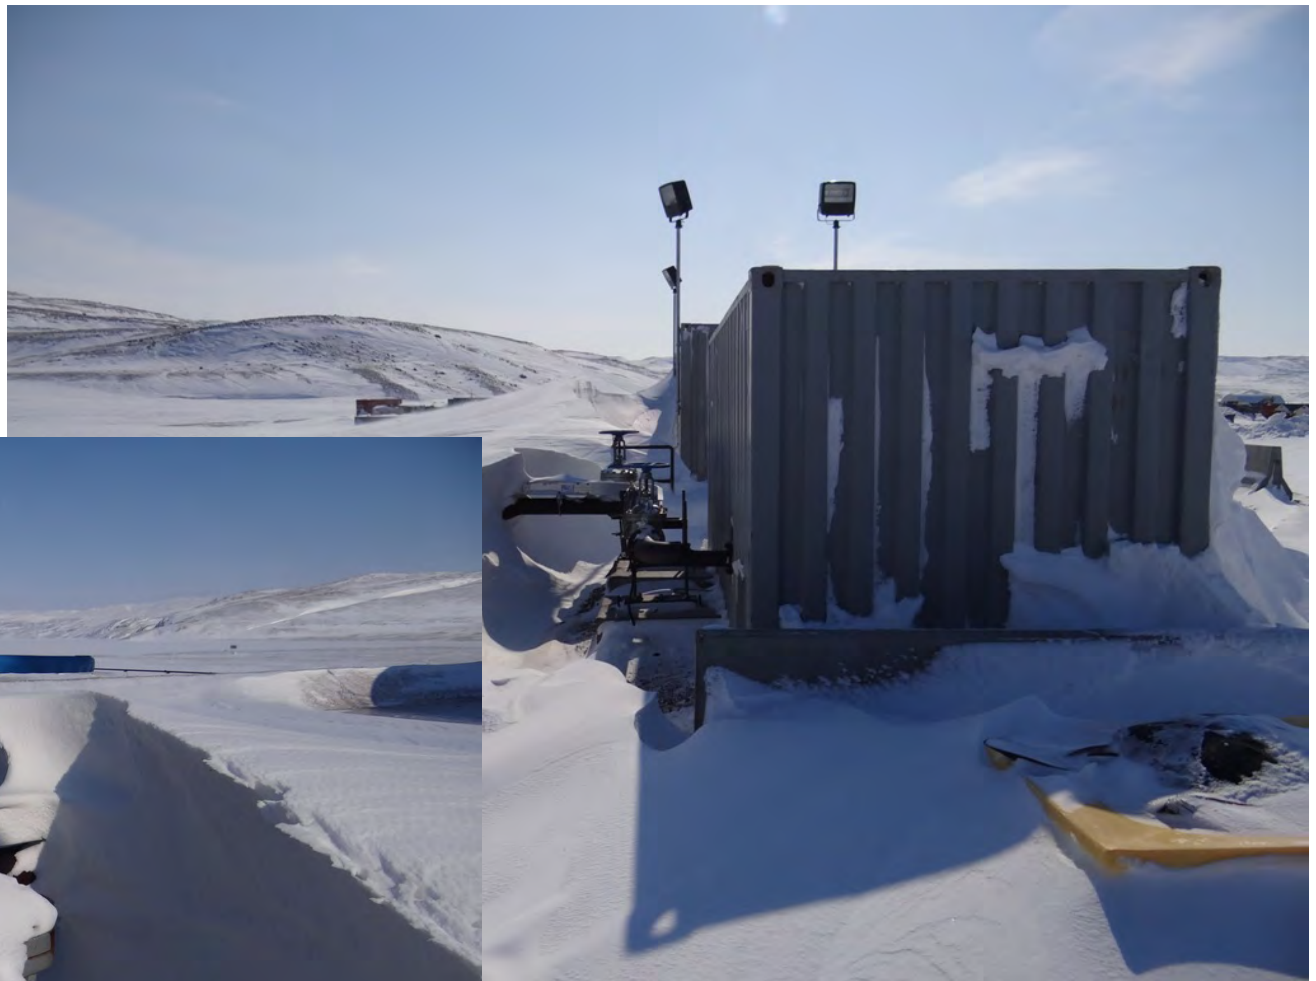
**Fuel Pump Station (not commissioned) locked out  
Milne Inlet**

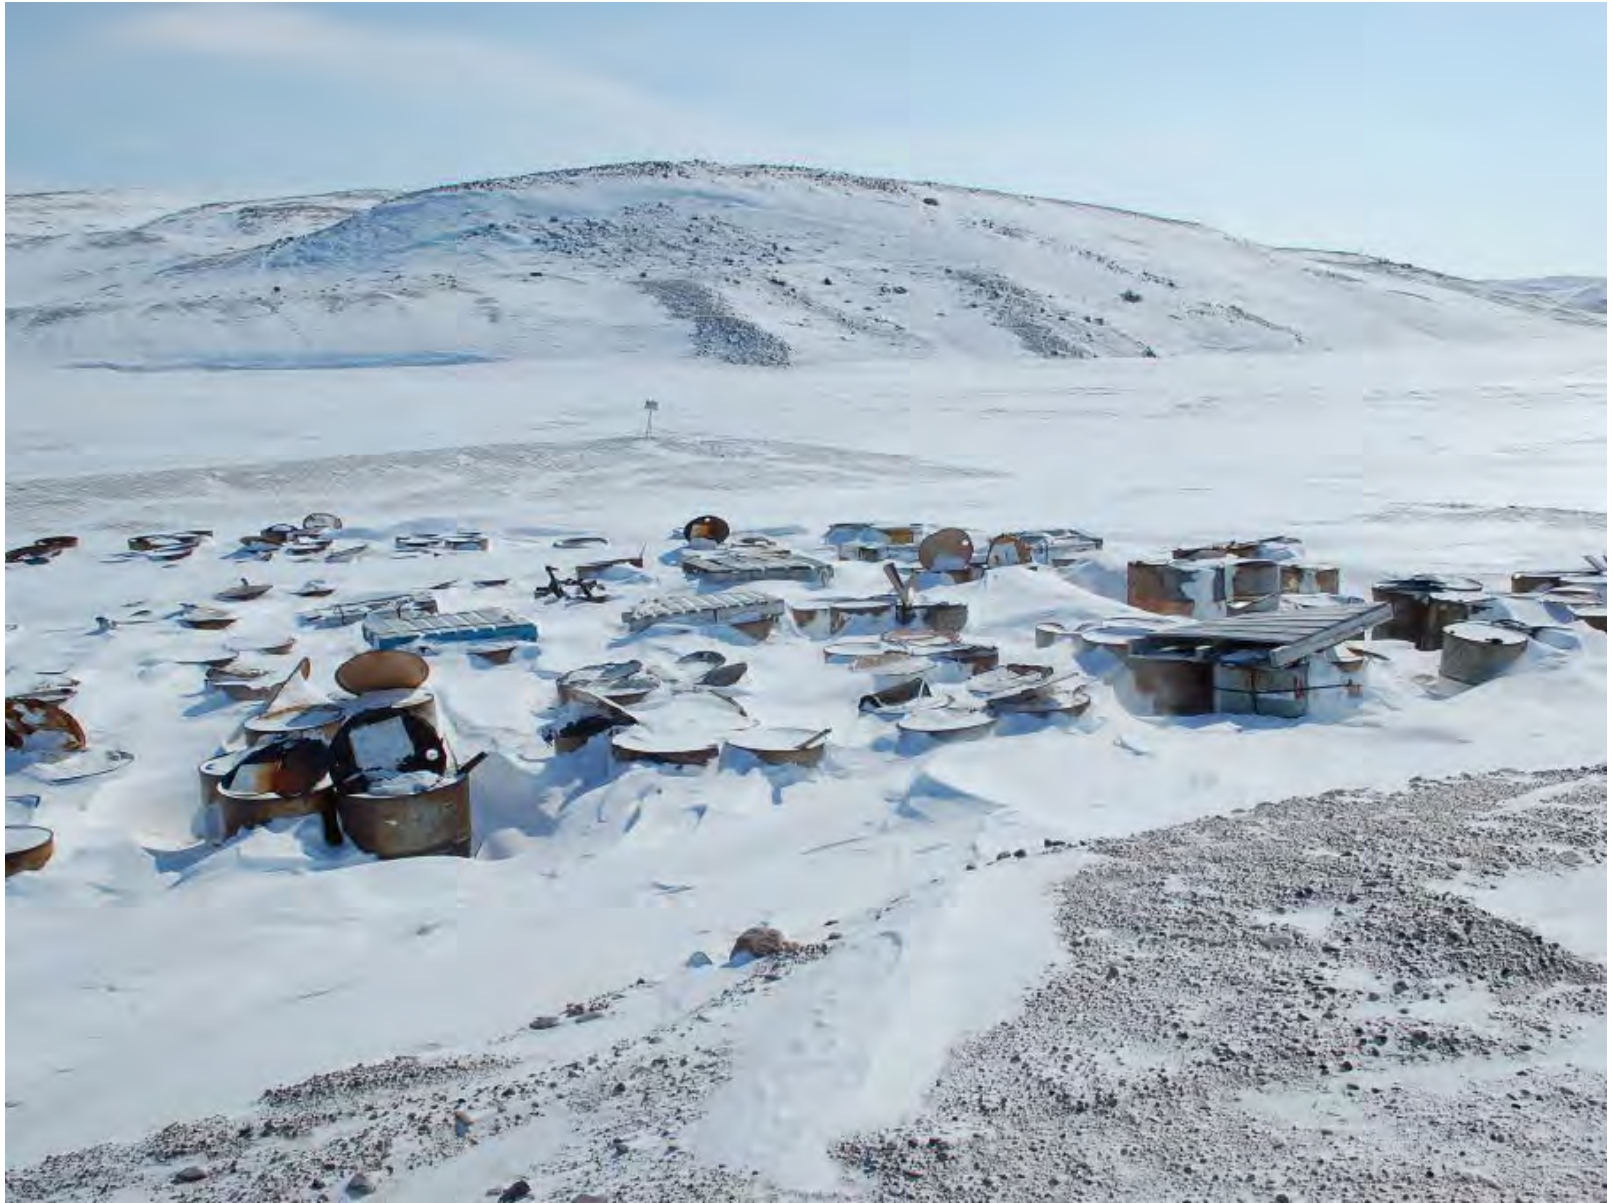
**Haz-materials storage area - Milne Inlet**

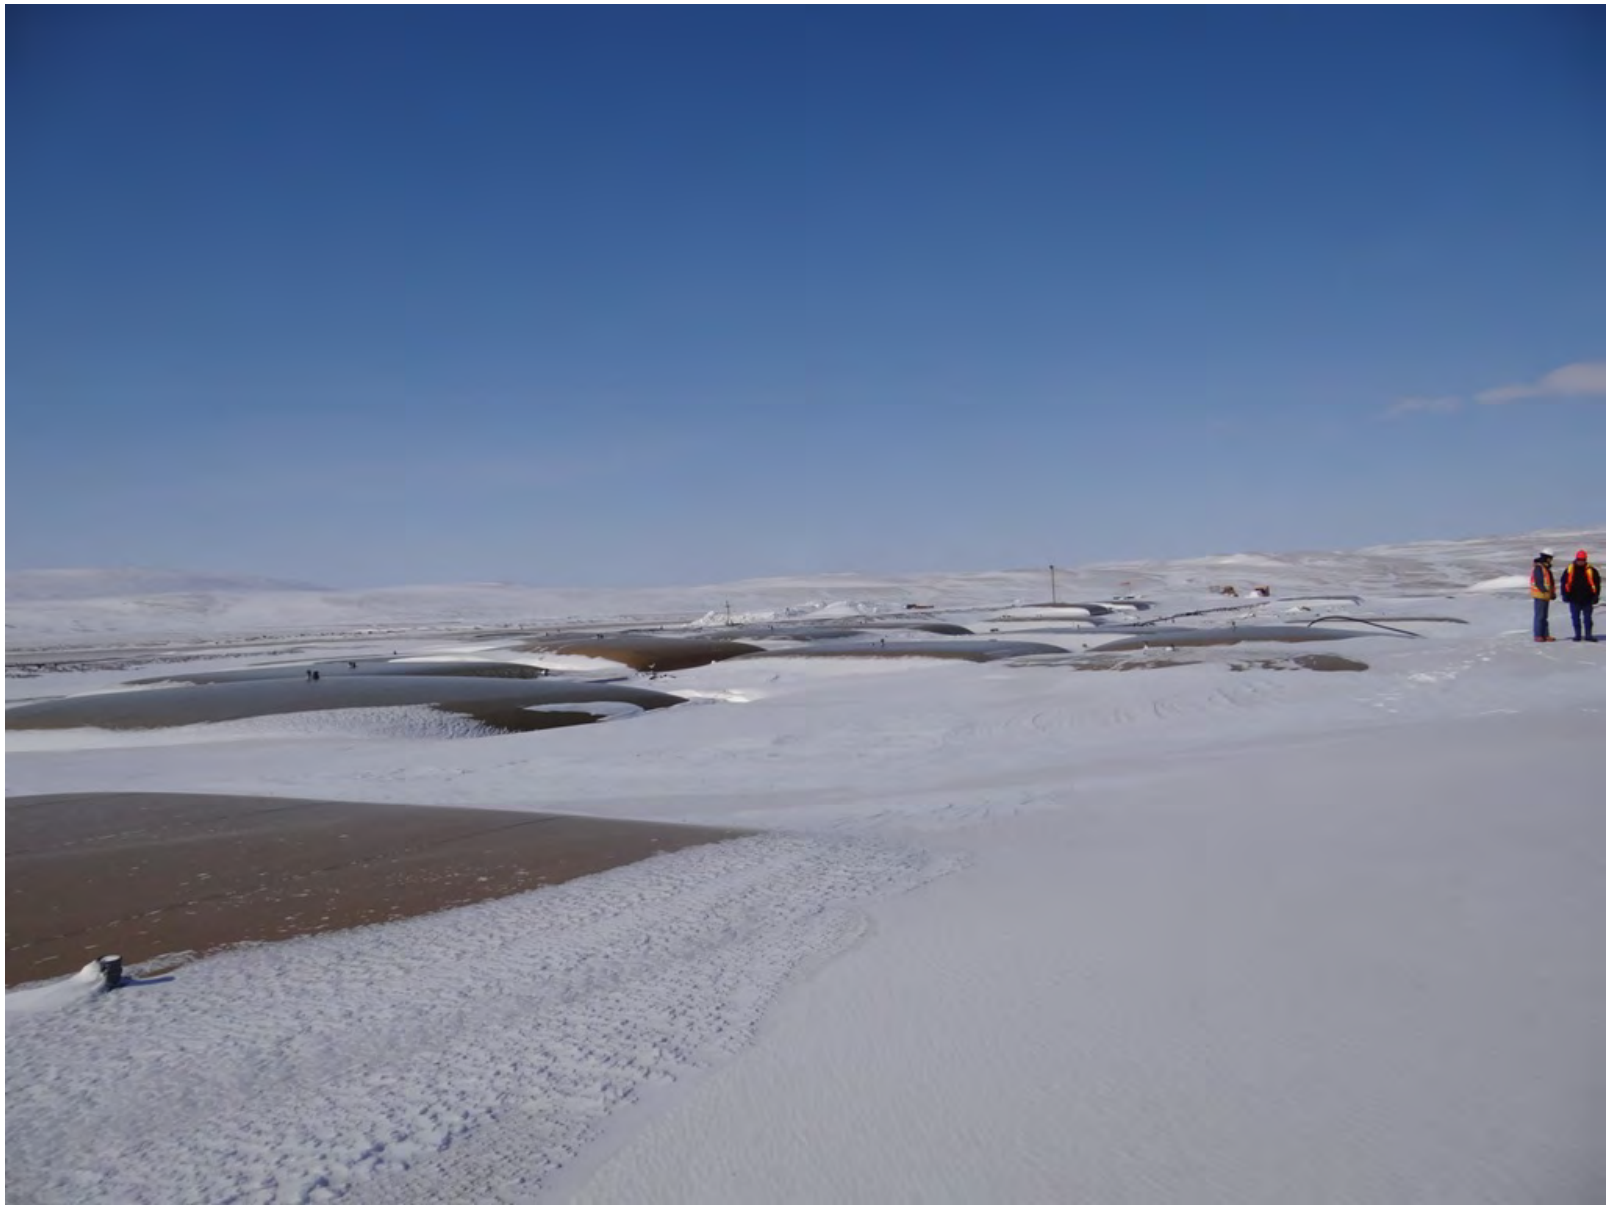
**Milne Inlet Bladder farm**

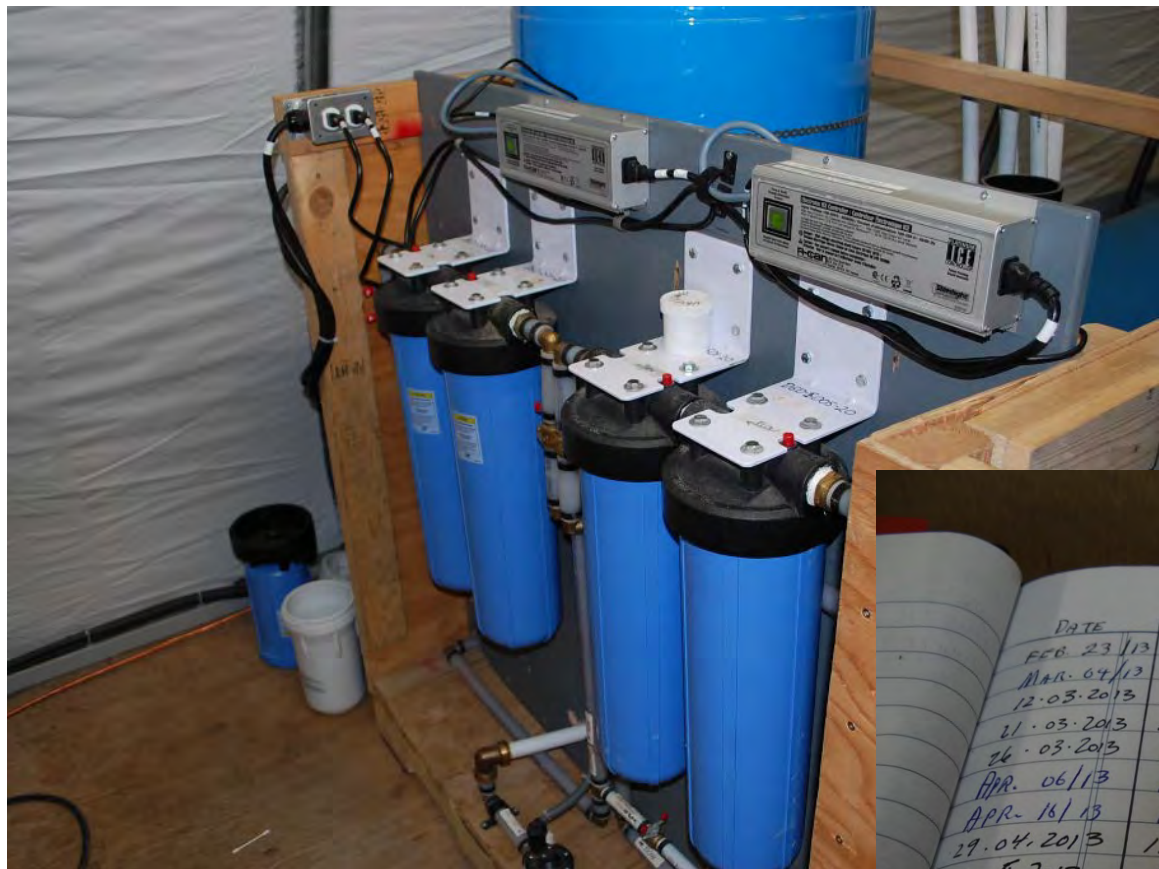
**Raw Water Treatment System and usage records – Mary River camp**

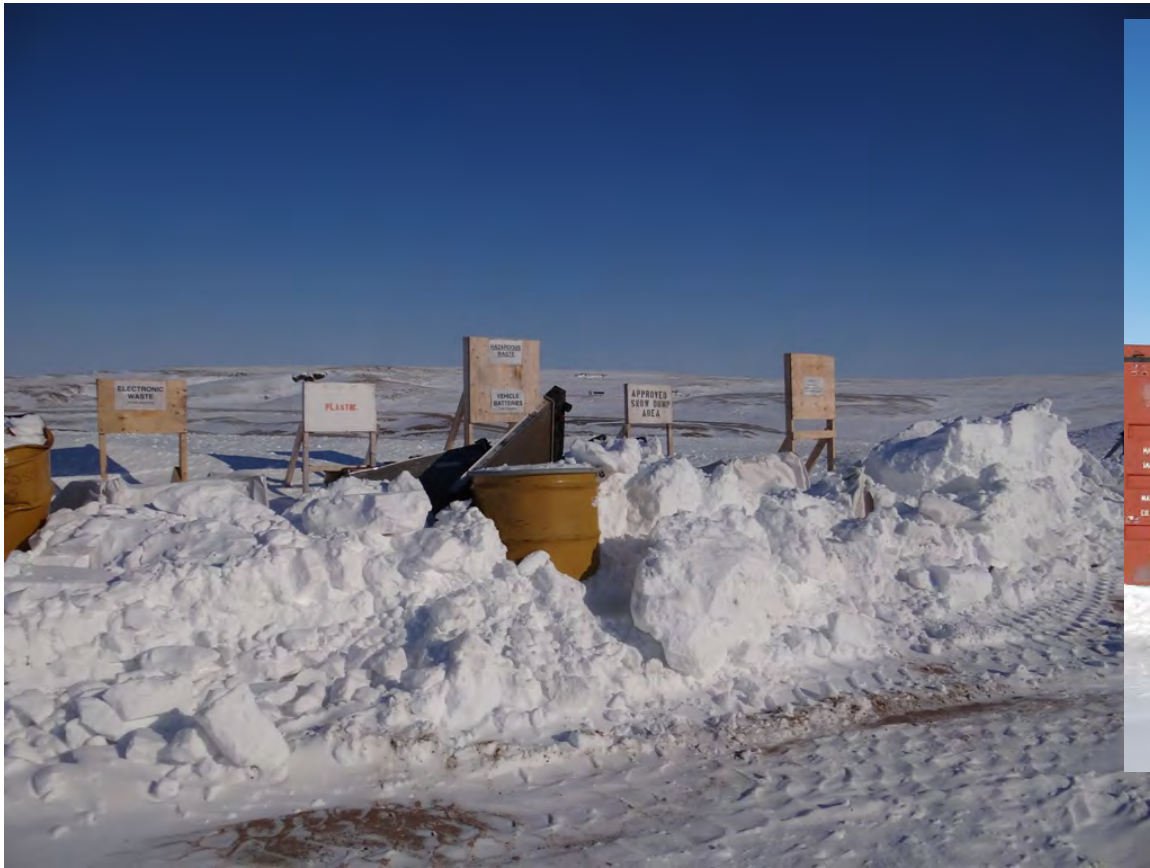
**Mary River Solid Waste  
Management Area**

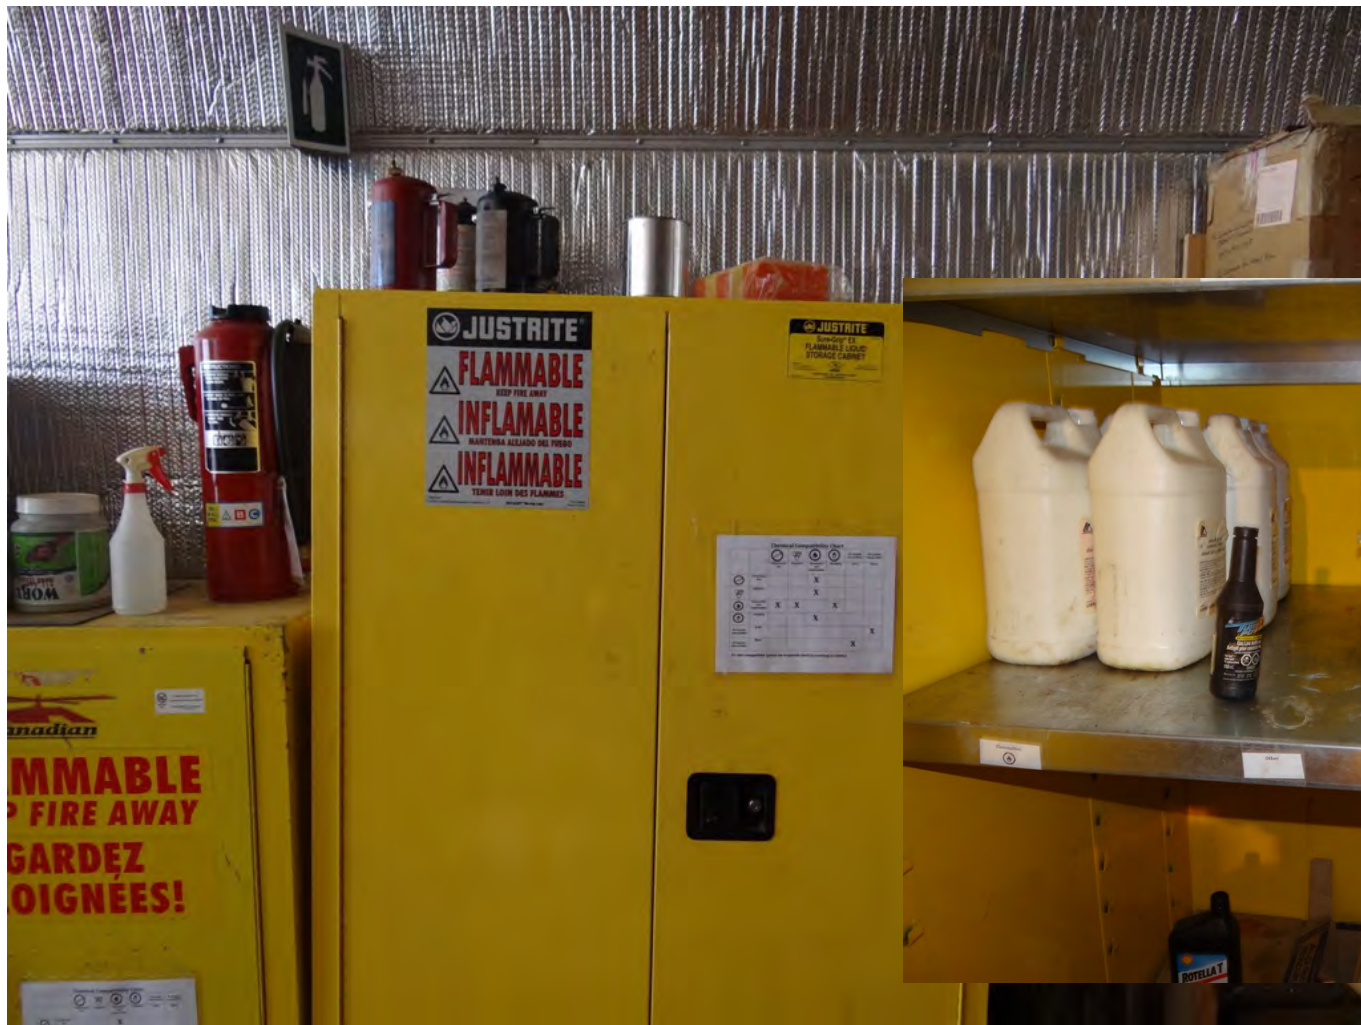
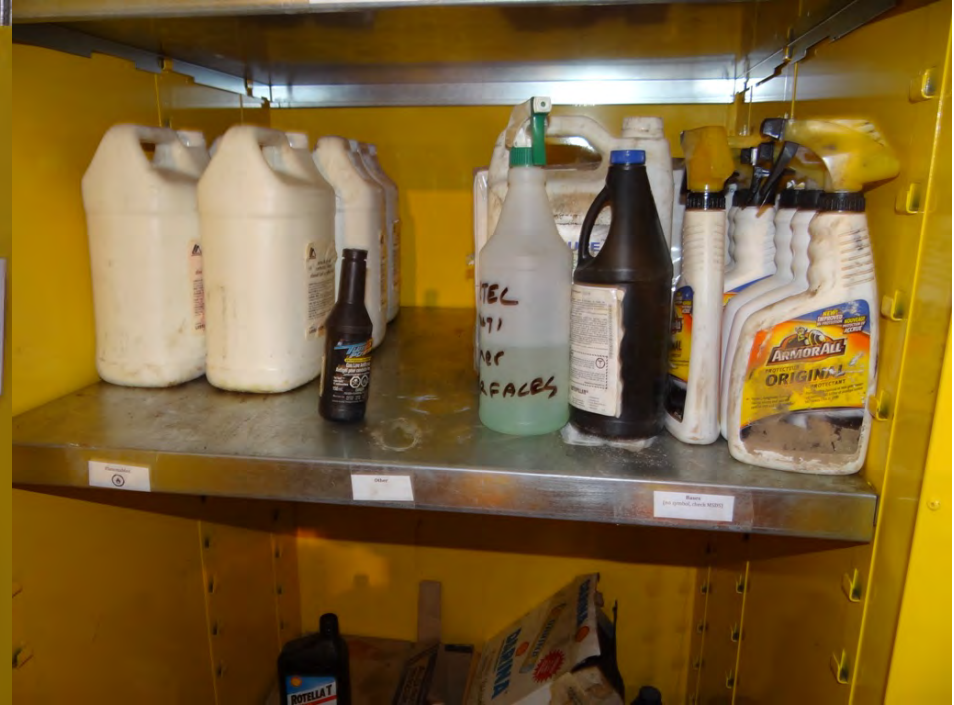
**Mary River Haz Mat Lockers with Up-to date labeling and notifications**

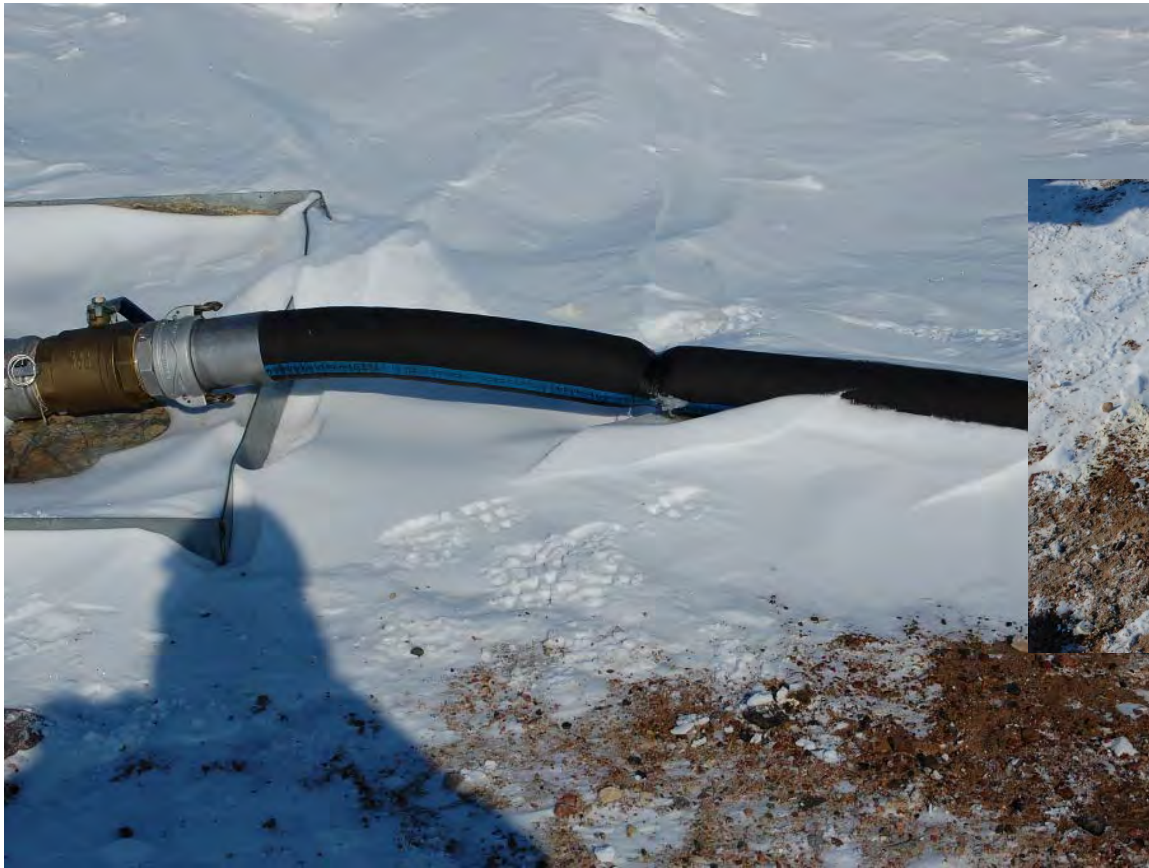
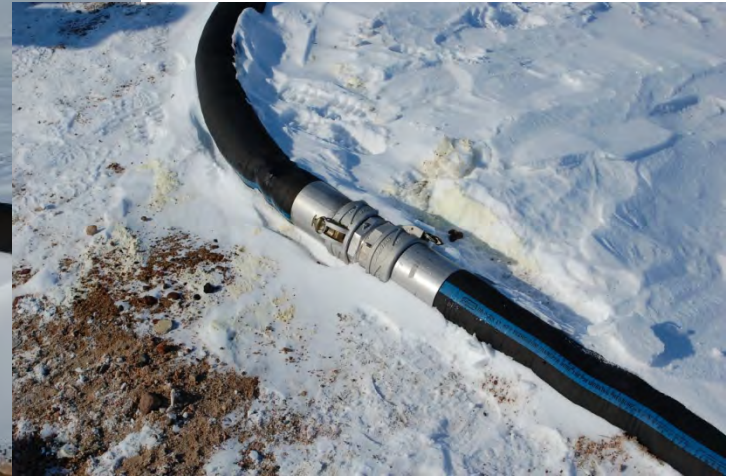
**Kinked and damaged hose at Mary River Fuel Storage**

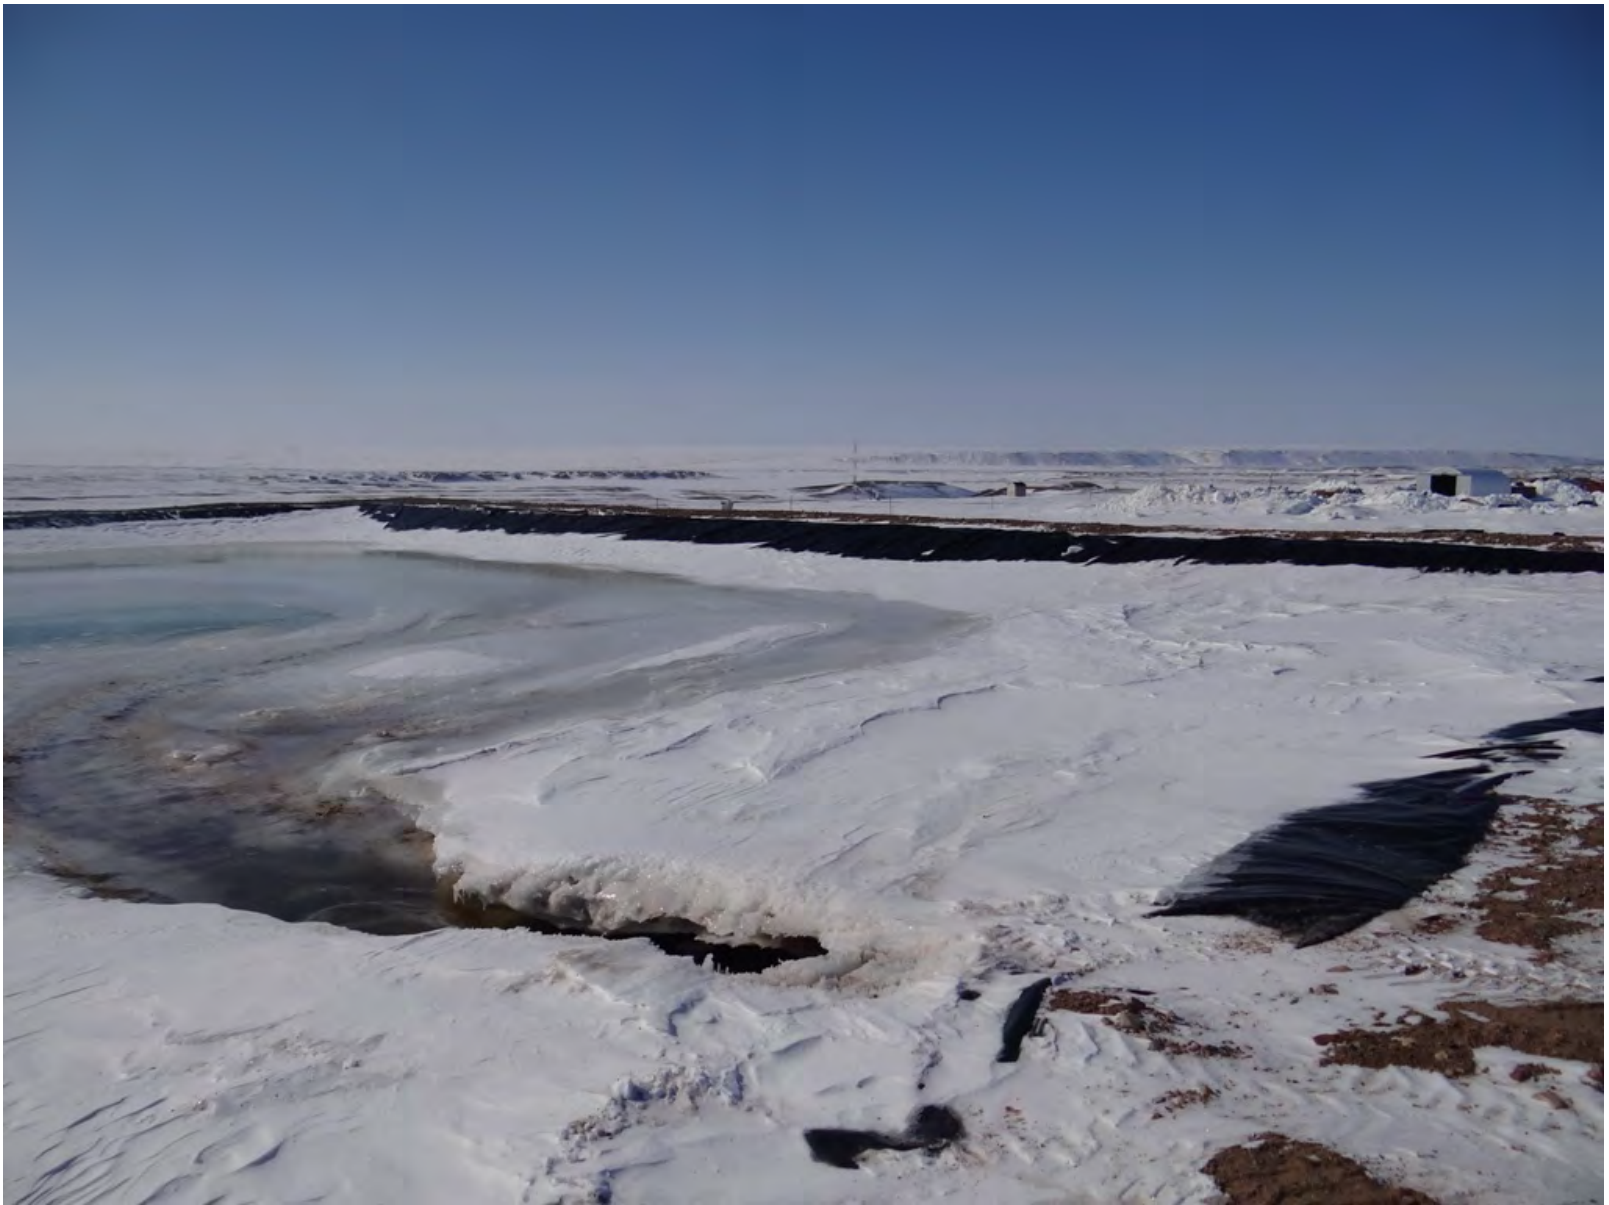
**Mary River Waste Water Polishing Pond #3 – Truck deposit location**

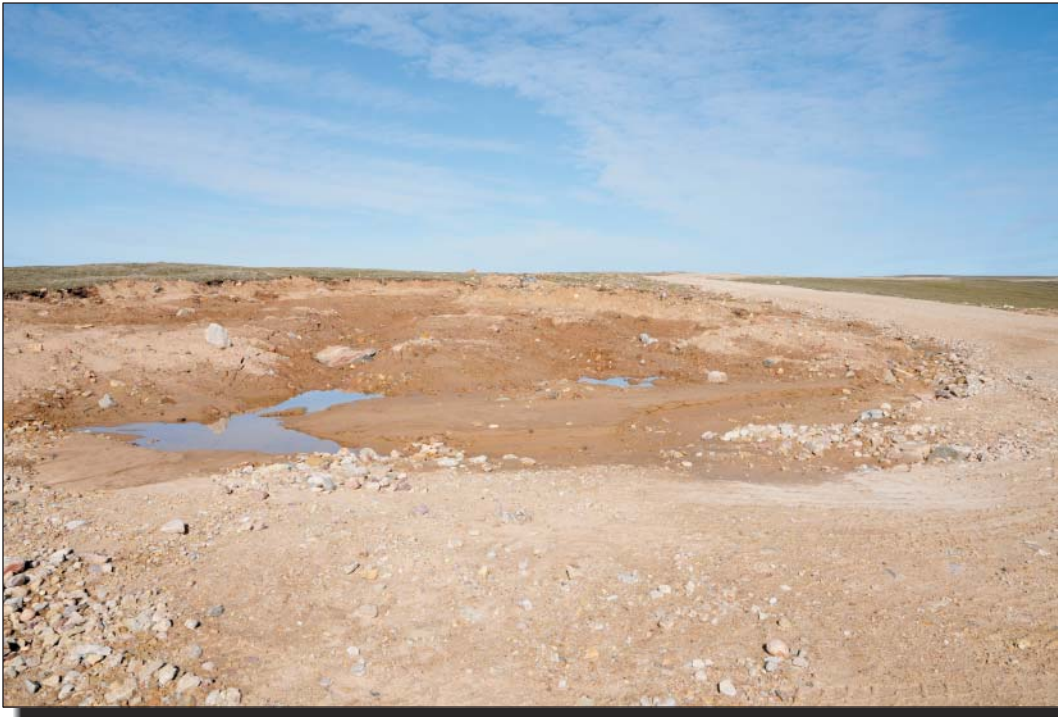
**Photo 4 (DWH 691)**

Pit at km 71.8 (WP 23) typical sinkholes in pit bottom from thaw of segregated ice common in fine-grained lacustrine soils.

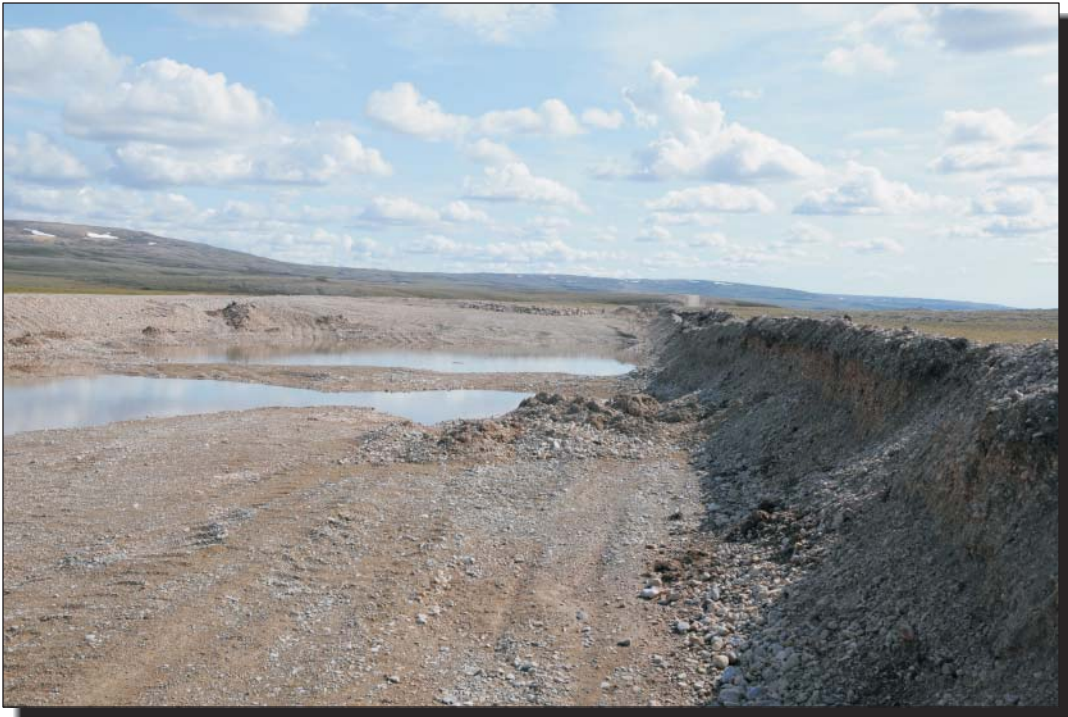
**Photo 8 (DWH 722)**

Pit at km 27.5 (WP 63) vertical cut slope 2 to 3 m high. The thaw-stable soils at this site are stable at this slope. The slope can be graded back to 3:1 by cut and fill.

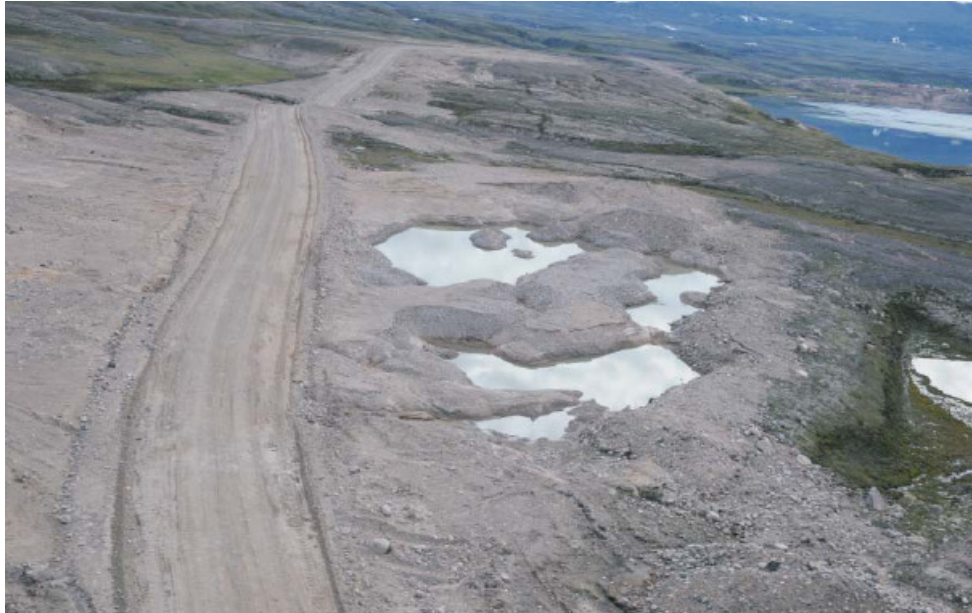
**Photo 3-1: Km97 Borrow Source: Typical depression formation from thaw of massive ice**

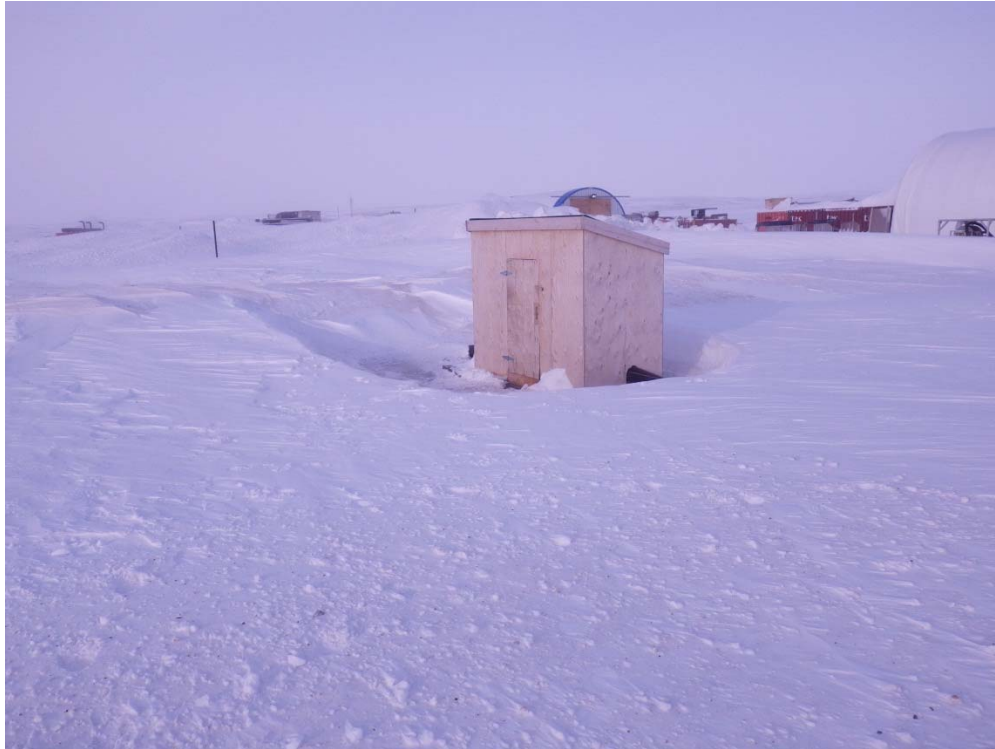
**Photo 1** Photo of spill location (Looking North).

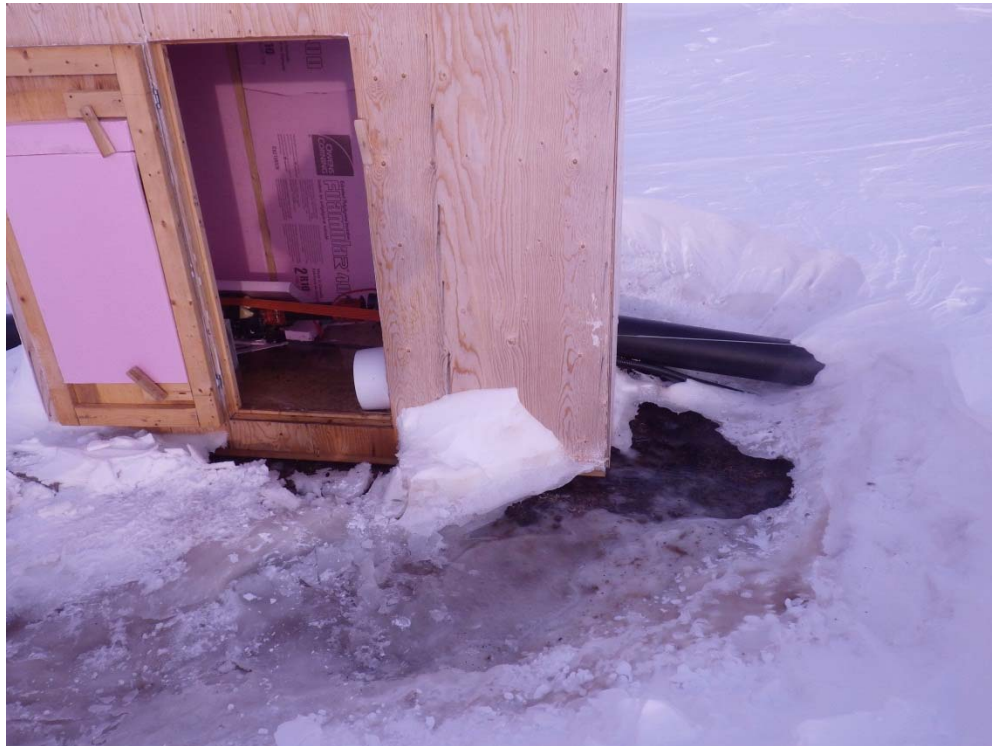
**Photo 2** Photo of spill location.

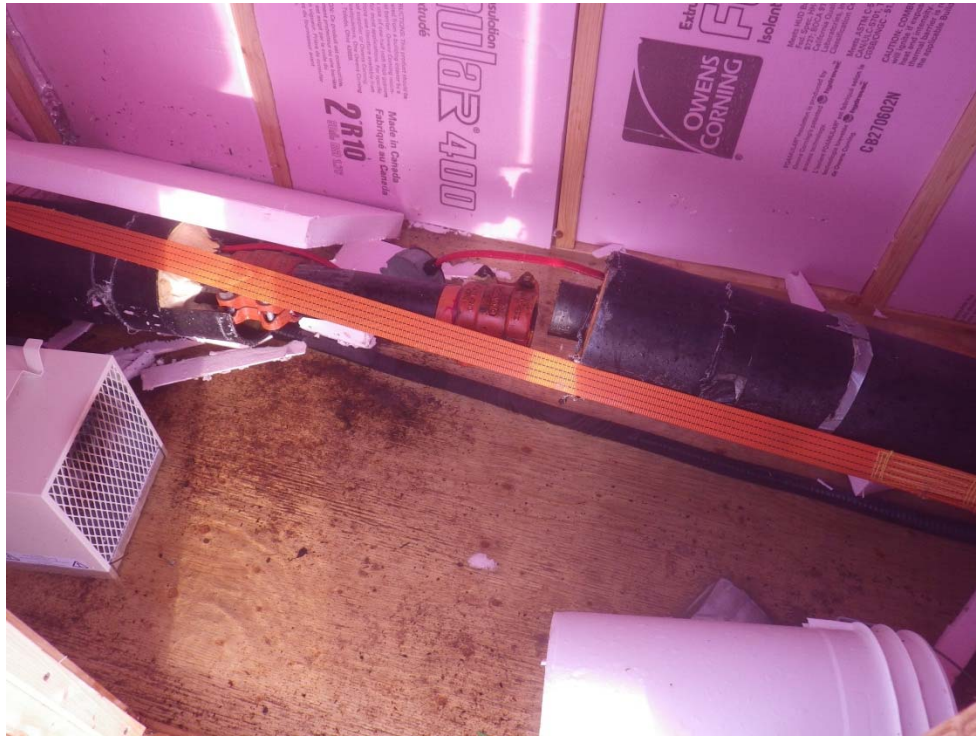
**Photo 3** Failed Pressure Fit Coupler

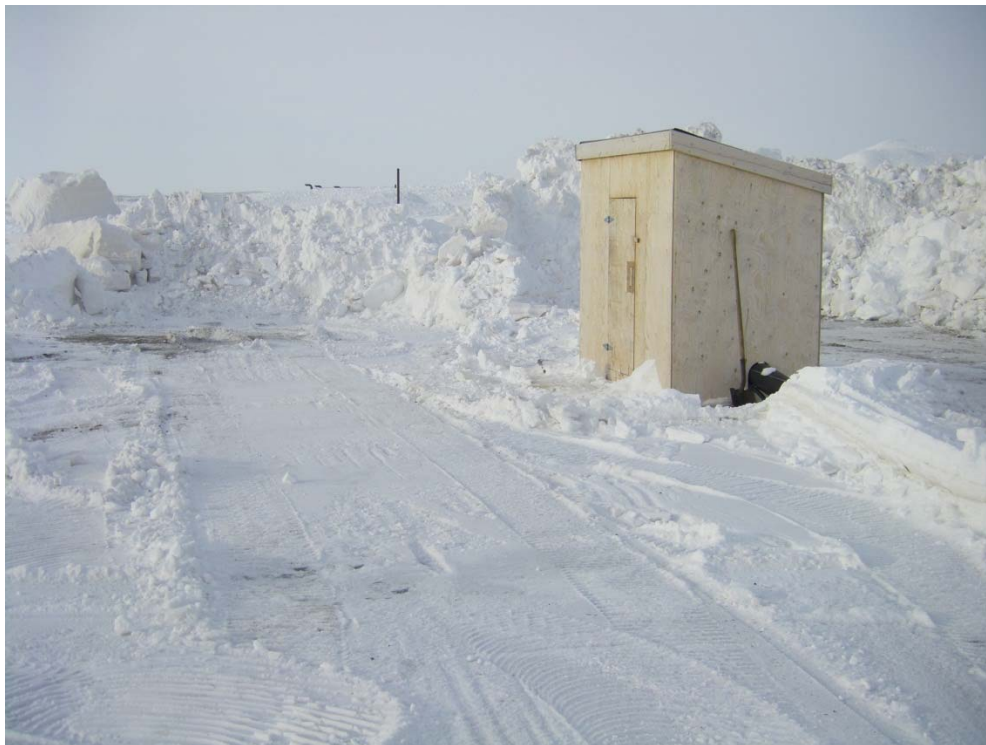
**Photo 4** Spill Clean up

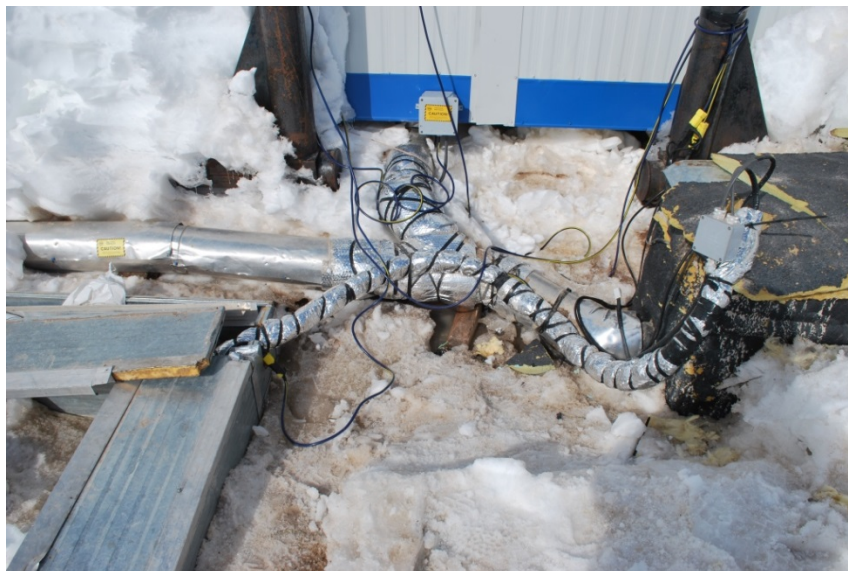
**Photo 2 –Cracked Pipe**

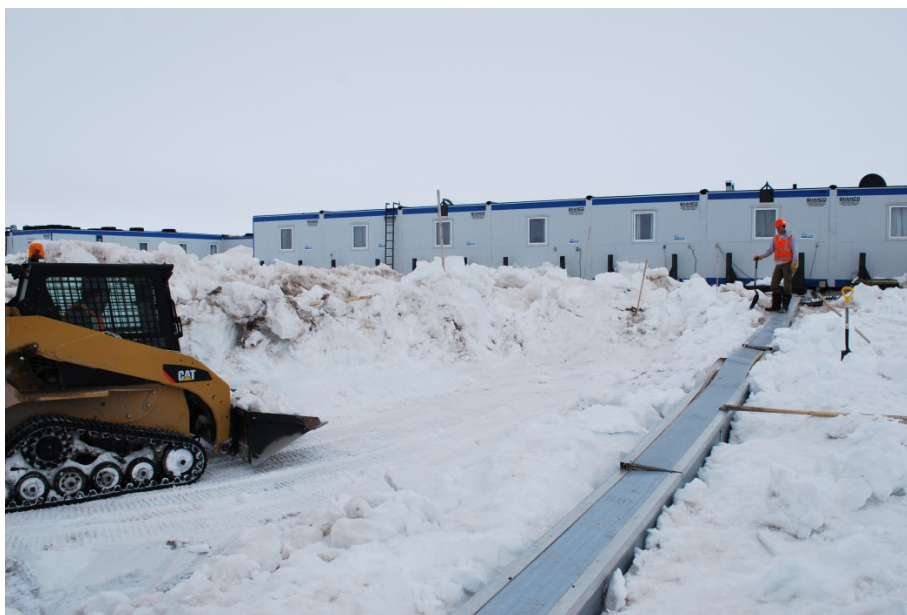
**Photo 3 – Contaminated Snow Removal**
