**APPENDIX E.7**  
**INSPECTION REPORTS**

**APPENDIX E.7.1**  
**AANDC INSPECTION REPORTS AND BAFFINLAND RESPONSE**

**RE: Water Licence Inspection Report – Mary River Project – Mary River Camp and Milne Inlet Camp May 4&5 2013.**

# May 2013 Water License Inspection

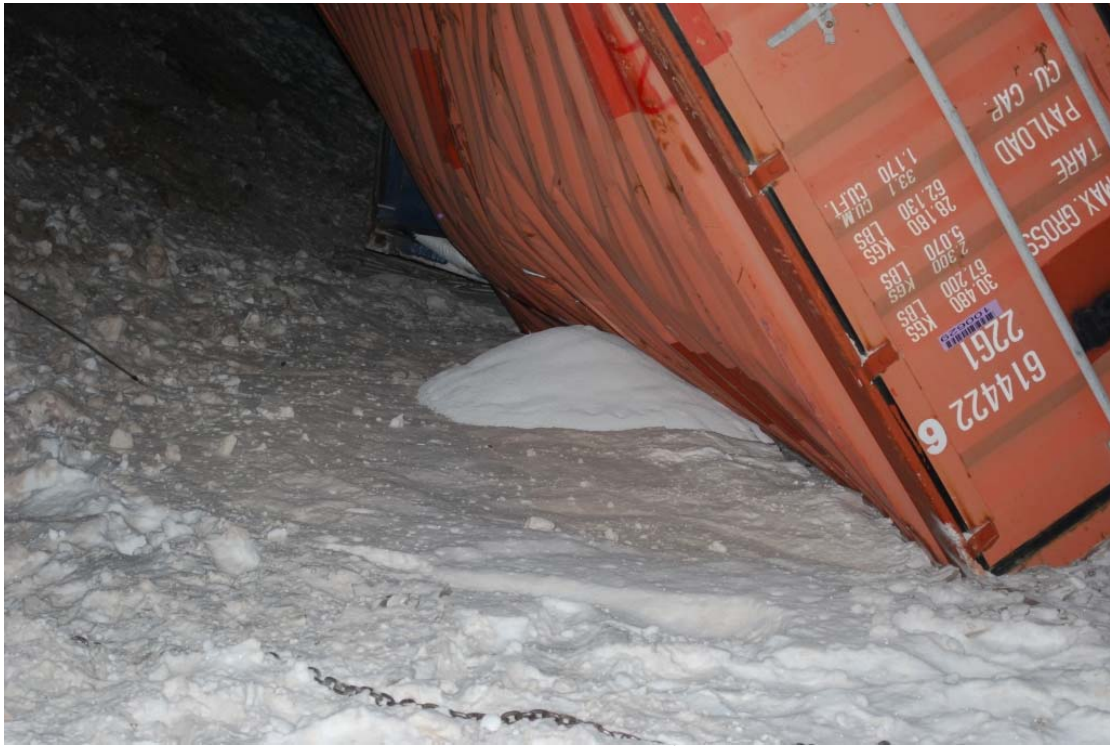
Photo 1 – Spilt Ammonium Nitrate (approx. 1 m<sup>3</sup>)

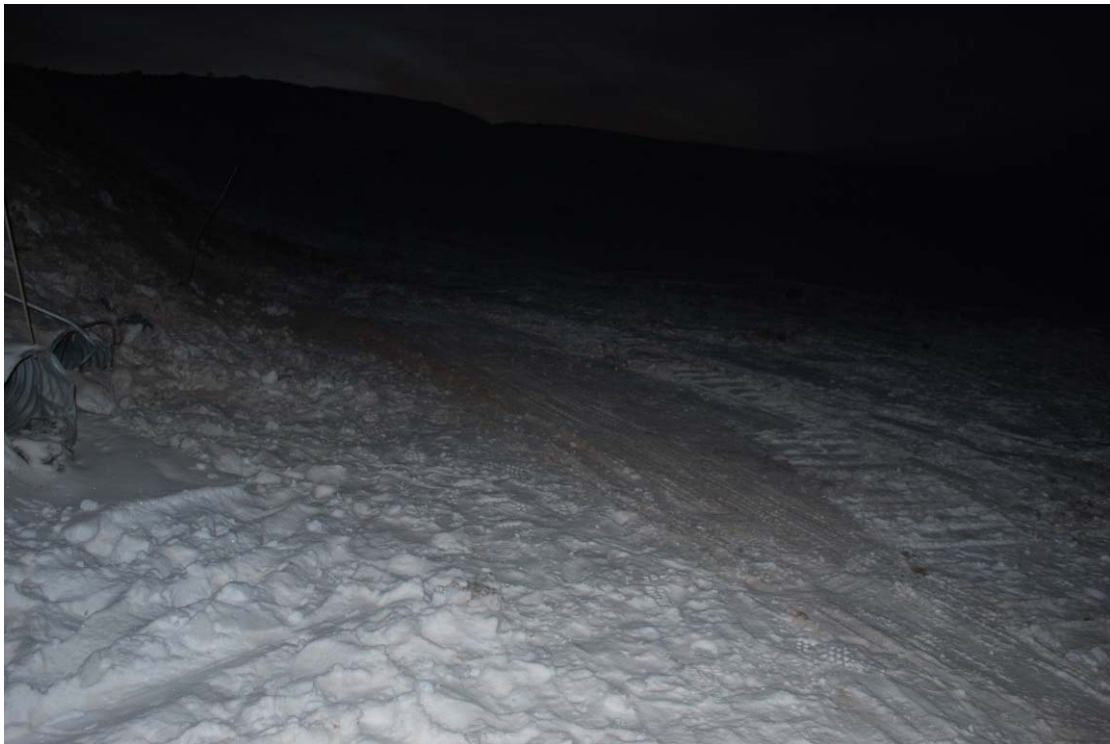
Photo 2 – Scene of the Incident after Recovery and Spill Clean up
