2015 QIA and NWB Annual Report

APPENDIX D AS BUILT REPORTS

APPENDIX D.1 CONSTRUCTION SUMMARY REPORTS

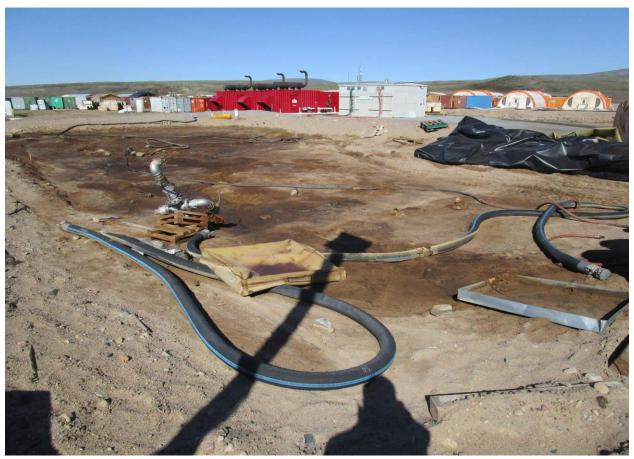
Bulk Fuel Storage Facility showing one former fuel bladder in use.

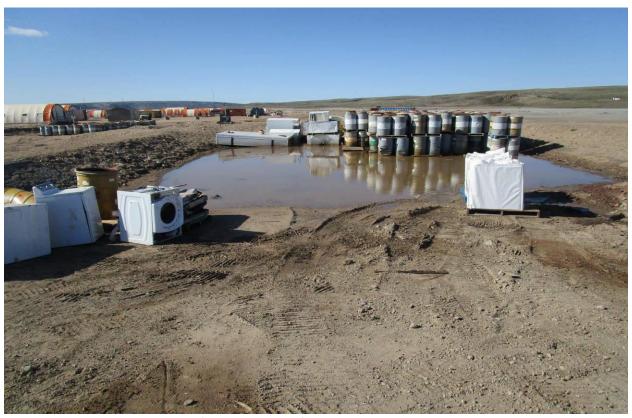
The north dyke in the north cell has had a track fork lift travel over the berm at the east end. We recommend signage to prevent this before damage occurs to the liner.

Barrel Fuel Containment – Shows travel over side dyke of cell. (Now MP-HWB-3)

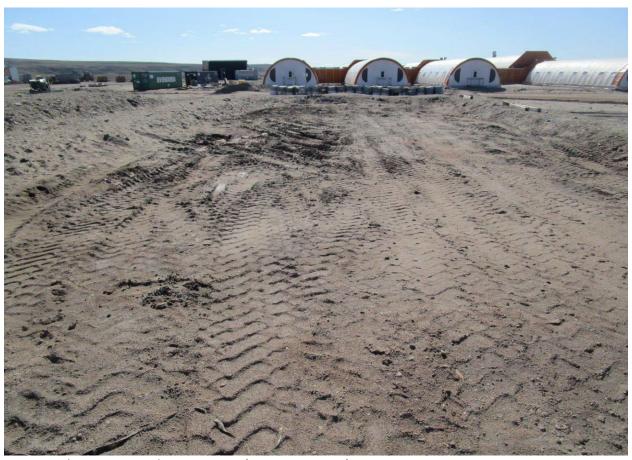
The structure appears to be stable in its present condition. The water confirms the integrity of the liner.

Hazardous Waste Containment. (Now MS-HWB-2)

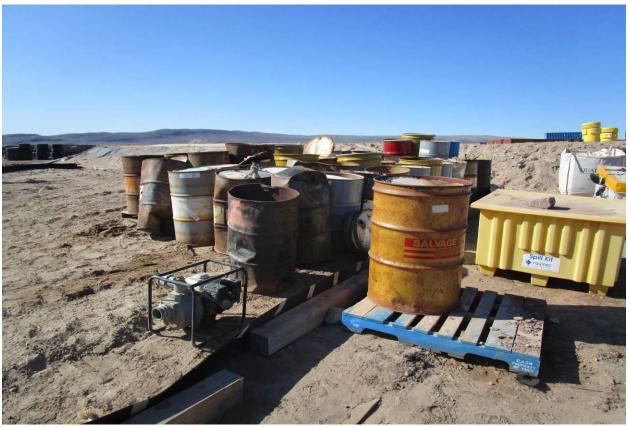
This cell actually stores hazardous waste in containers, barrel fuel, and lubricant cubes and does not have the integrity to resist a large spill. There are now bladders with contaminated water in each cell. A new hazardous waste storage facility has now been constructed near the loadout area for storing hazardous waste to be shipped out.

Temporary Hazardous Storage. (Now MP-HWB-5)

We recommend that the use of the temporary third cell, recently constructed, be discontinued when possible.

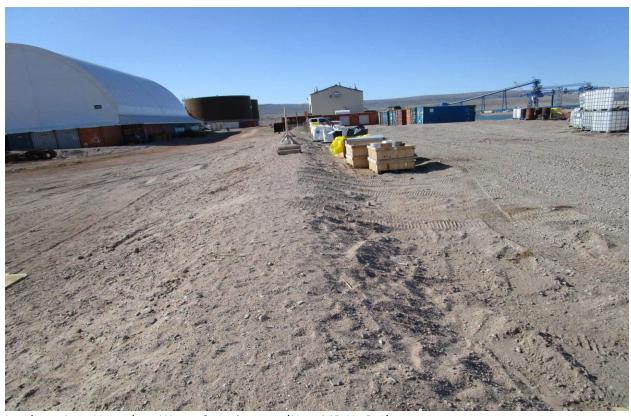
It appears that travel has taken place over the north dyke in the placing of containers. It does not appear that the liner has been damaged.

Load-out Area Hazardous Waste Containment. (Now MP-HwB-1)

We recommend that action be taken to prevent travel over the berms before liner damage takes place.

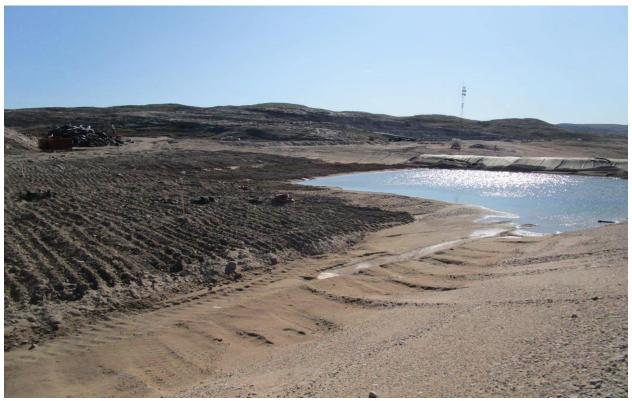
Land Farm Containment.

We recommend that the remaining dyke structure without protective cover over it be covered as per the design drawings, if any activity is expected in this area.

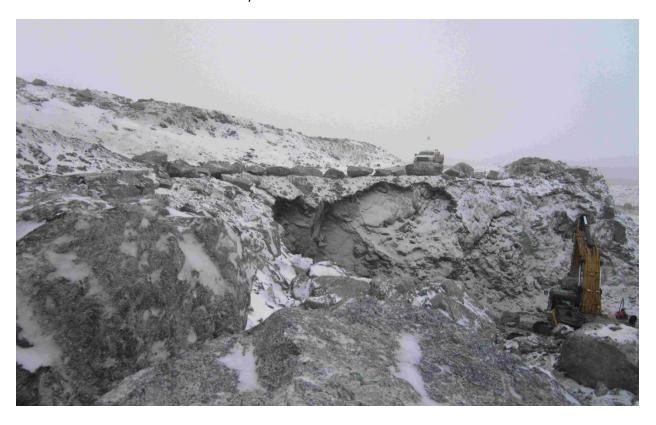
There are a number of cobbles and larger boulders at the upper edge however that appear to act as a hazard at this time.

Mary River Quarry Bench Undermining

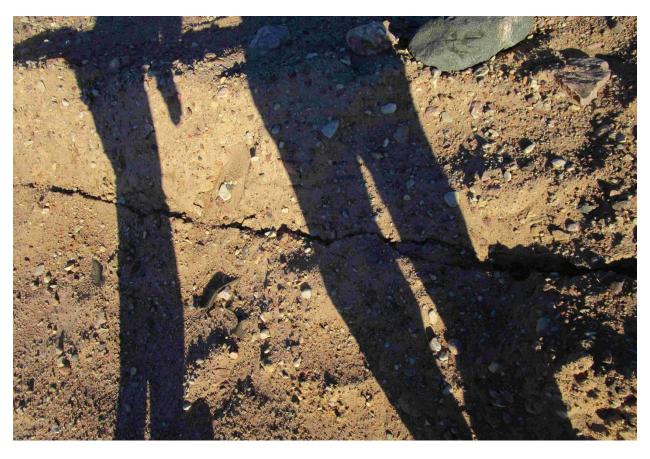
Indicates Movement in Anchorage at Sediment Pond East
