PHASE 2 OF THE HOPE BAY PROJECT
DRAFT ENVIRONMENTAL IMPACT STATEMENT

2008 Roberts Bay Fisheries Authorization Monitoring Report

**2008 ROBERTS BAY JETTY
FISHERIES AUTHORIZATION
MONITORING REPORT**

- FINAL REPORT -

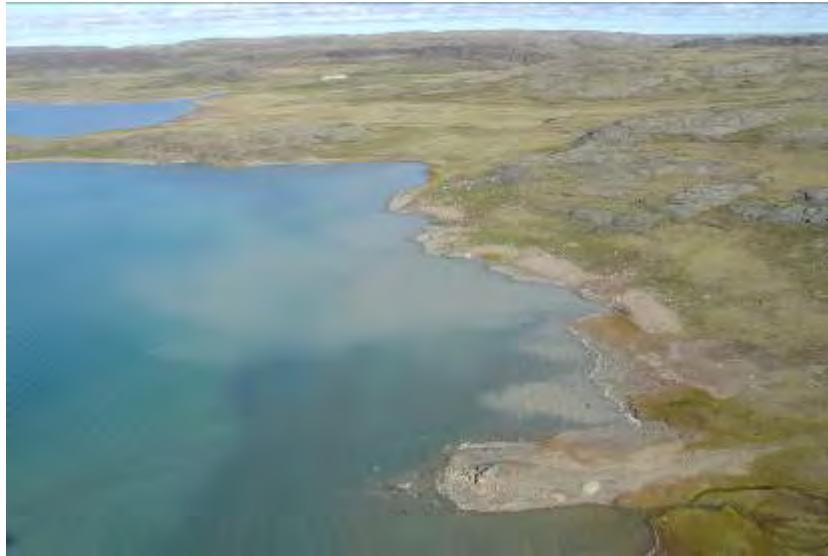
Photo 2.1 Aerial View Facing East at Roberts Bay (Pre-construction; note sediment plume in Roberts Bay), July 2006.

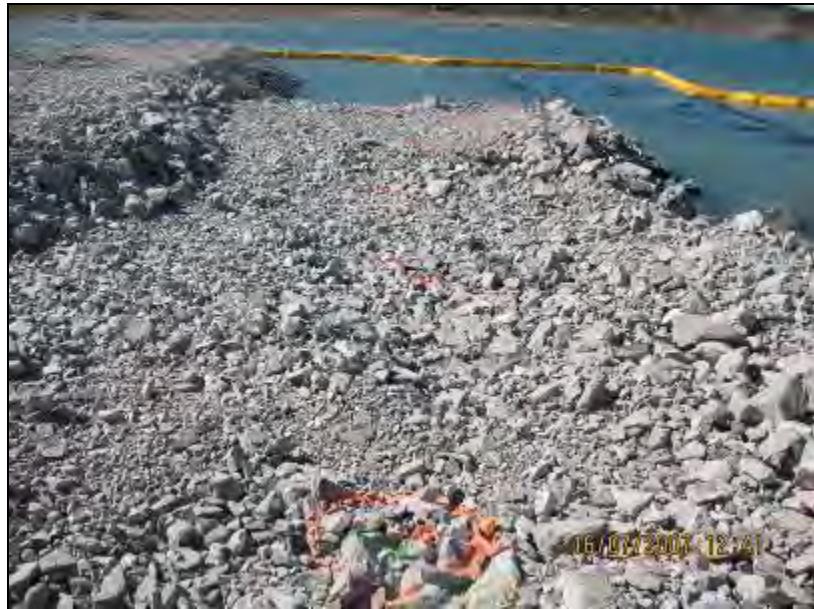
Photo 2.19 Facing West Along the Jetty Head - Note the Slope Grading and the Settlement Beacons, 16 July 2007.

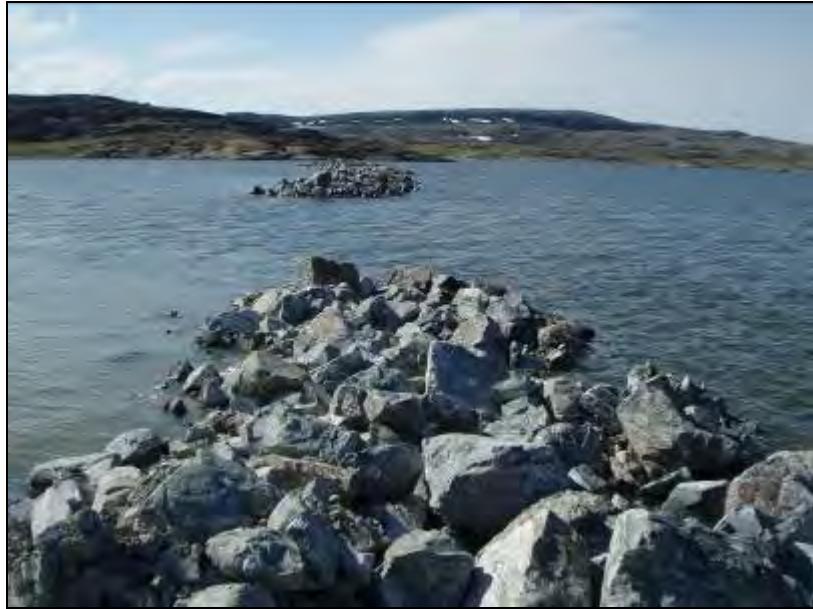
Photo 2.24 **Facing North-West Along Compensation Shoals Showing Shoals Resting on the Frozen Substrate, 11 July 2008** (Photo: Matt Kawei, HBML).

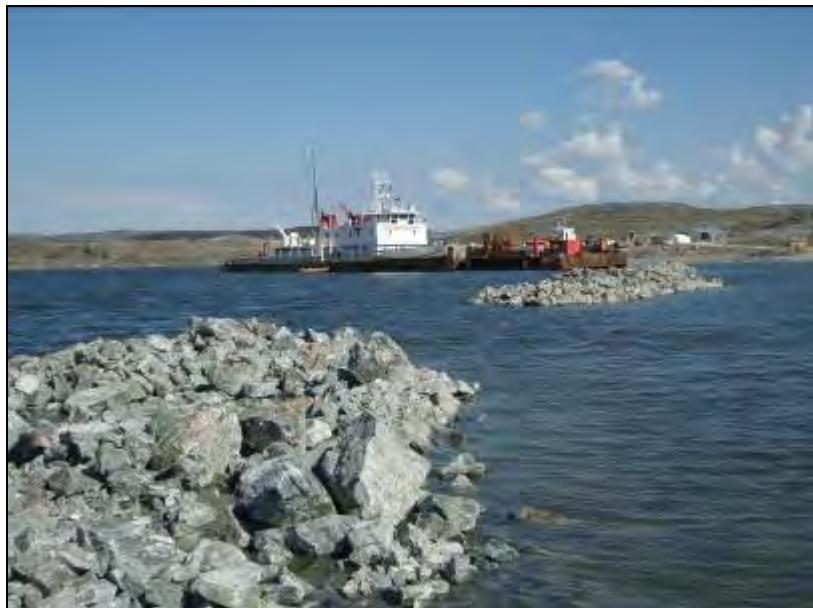
Photo 2.25 **Facing South-East Along the Compensation Shoals, Showing Shoals Resting on the Frozen Substrate, 11 July 2008** (Photo: Matt Kawei, HBML).

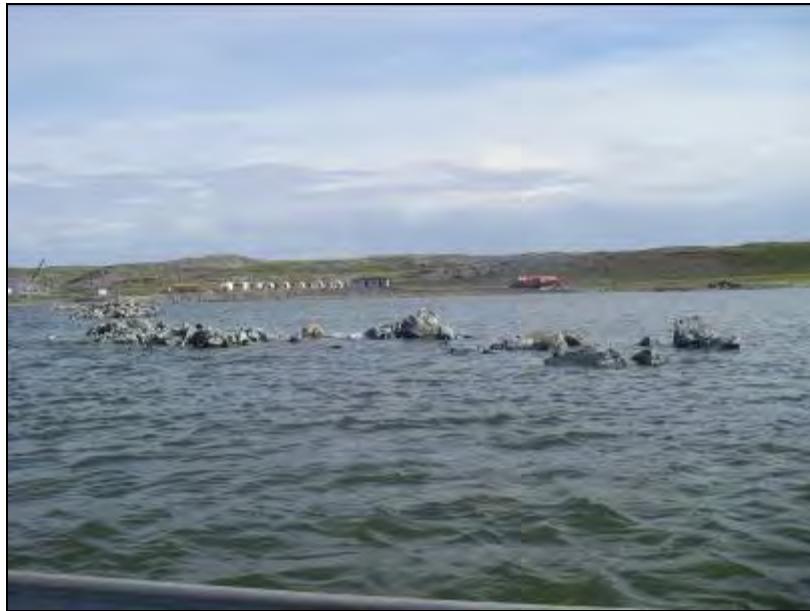
Photo 2.26 Looking South-East at Compensation Structures, 13 July 2008. Note the Structures are Settling as the Ice Below Them Melts.

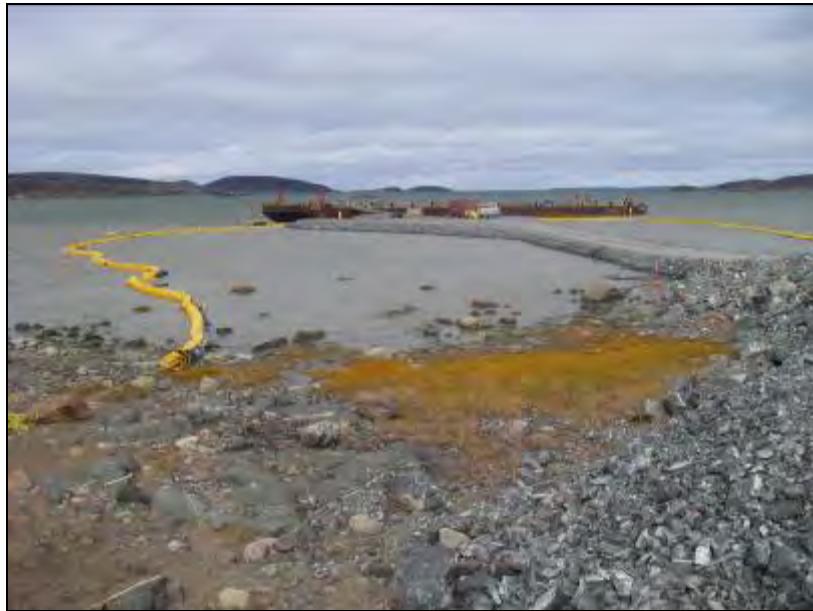
After initial construction of the Roberts Bay jetty in 2007, the fill materials had settled and wave action eroded the face of the jetty. The jetty was upgraded between 5 and 9 September 2008. A Golder environmental monitor was on-site for the in-water work. Prior to the Golder monitor arriving at Roberts Bay, Nuna Logistics had installed a silt curtain around the jetty to prevent silt dispersion and potential impacts to fish habitat. The sediment boom remained in place until 16 September 2008, 10 days after the in-water work was completed. Photos of the jetty upgrade were taken from three main vantage points along the shoreline at Roberts Bay and from a helicopter (Photos 2.29 to 2.38).

Photo 2.29 Facing North at Jetty Before Upgrade, 5 September 2008.

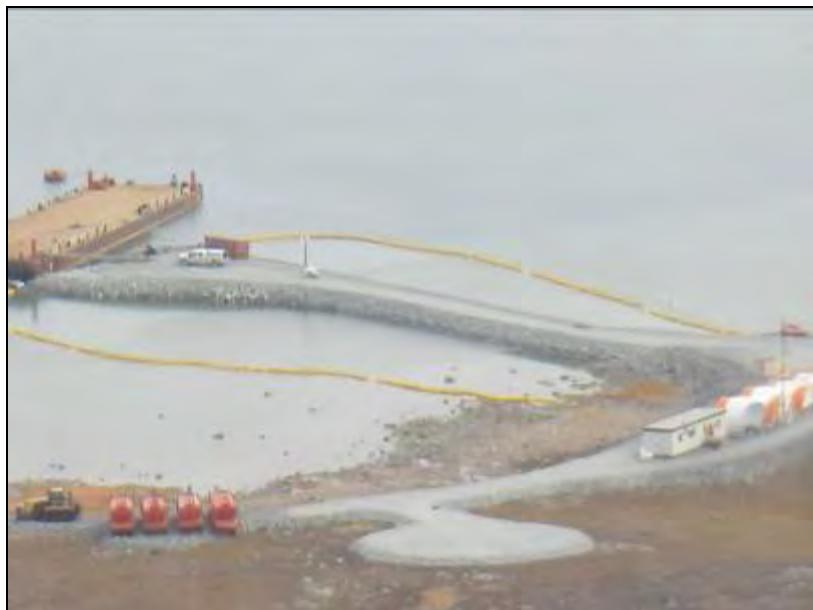
Photo 2.36 Aerial View of the Jetty With Upgrade Completed, 13 September 2008.

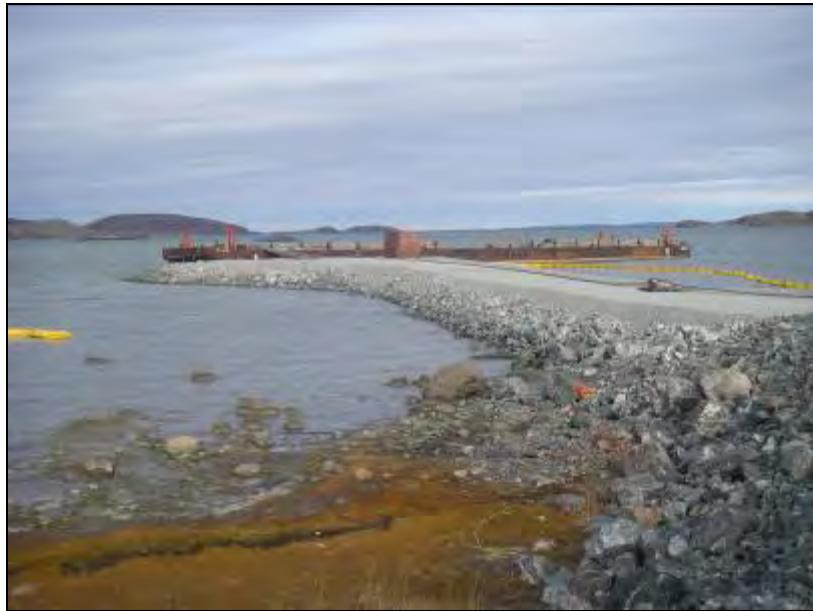
Photo 2.37 Facing North, Looking at Jetty Post-Upgrade with Top Gravel Layer, 17 September 2008.

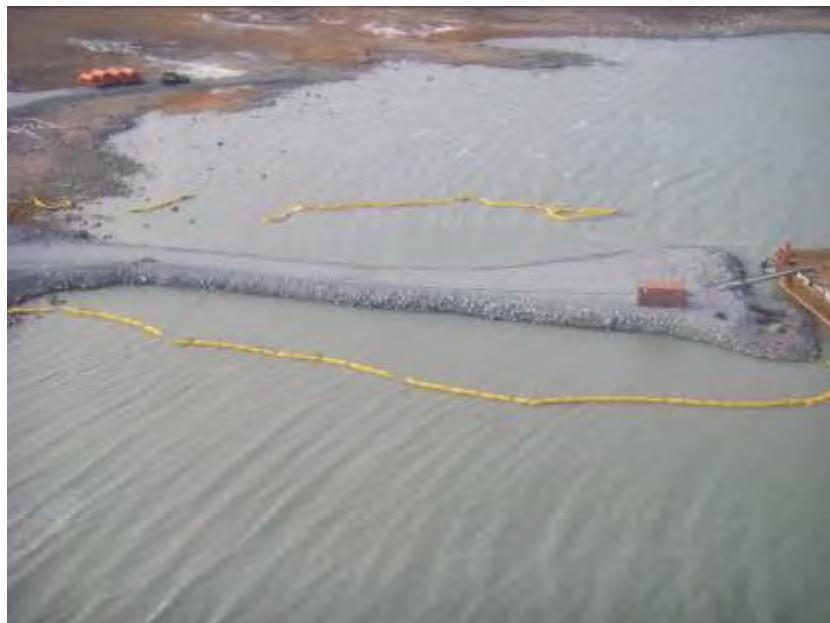
Photo 2.38 Aerial View Facing West, Looking at Jetty Post-Upgrade with Top Gravel Layer, 17 September 2008.
