Nunavut Impact Review Board 2019 Site Update Report

Back River Gold Mine Project

Sabina Gold and Silver Corporation

NIRB File No. 12MN036

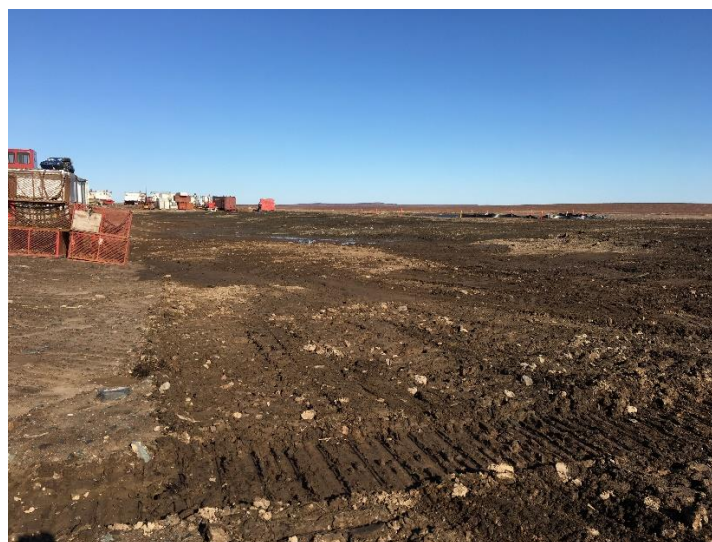
Photo 8: Backfilled Trench

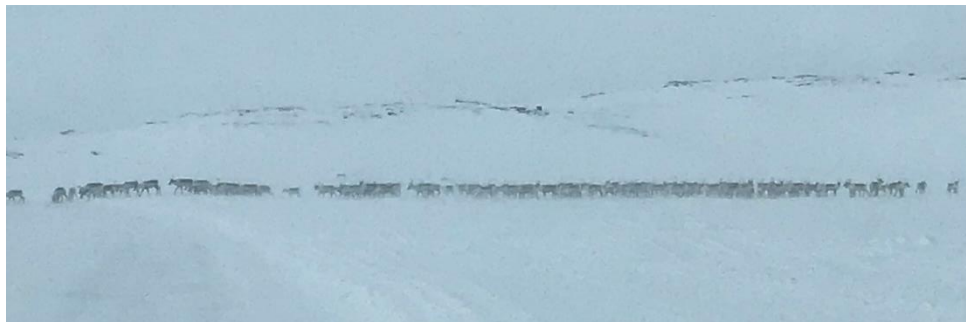
Photo 31: Caribou crossing the WIR

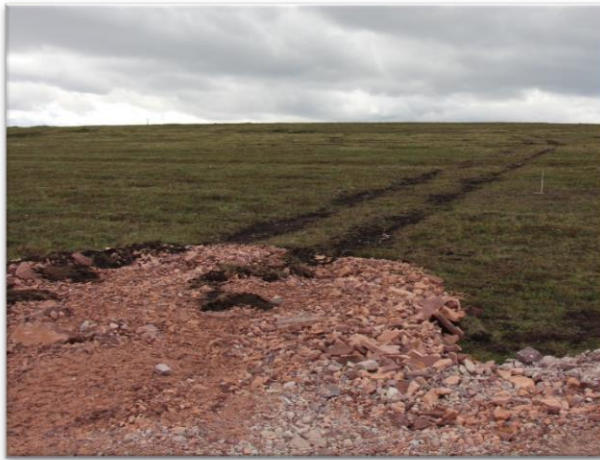
During the 2018 site visit the Monitoring Officer observed some damage (tracks) had occurred on the tundra near the Goose Lake Quarry and at the MLA from the shore to the camp area as well as at some additional areas at the MLA site. Sabina staff noted at the time that these areas are to be repaired and monitored as part of the vegetation monitoring program being established. Sabina staff also noted that they would be developing as part of their Vegetation Monitoring Plan a revegetation and reclamation strategy to maximize revegetation to the damaged areas on the tundra.

Photo 32: 2018 Damage to tundra MLA

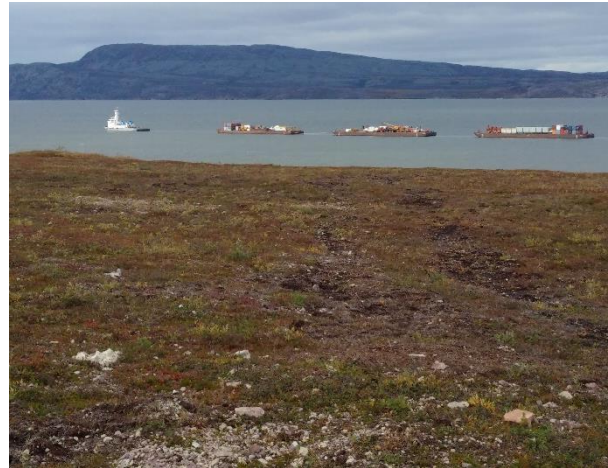
In 2019 the Proponent has provided photos of the track that show that the vegetation in this area is recovering naturally.

Photo 33: 2019 Natural Recovery of Tundra
(note looking opposite direction)
