WATER LICENCE INSPECTION FORM

Licensee Sabina Gold and Silver Corporation	Licensee Representative Merle Keefe, Michael Marchildon, Glenn Winsor
Licence No. / Expiry 2AM-BRP1831	Representative's Title Env. Permitting Manager, Camp Manager, WIR Construction Manager
Land / Other Authorizations	Land / Other Authorizations
Date of Inspection January 30 2019	Inspector Jeremy FRASER
Activities Inspected <input checked="" type="checkbox"/> Camp <input type="checkbox"/> Drilling <input type="checkbox"/> Mining <input checked="" type="checkbox"/> Construction <input type="checkbox"/> Reclamation <input checked="" type="checkbox"/> Fuel Storage <input type="checkbox"/> Roads/Hauling <input type="checkbox"/> Other: <input type="checkbox"/> Other: Winter Ice Road

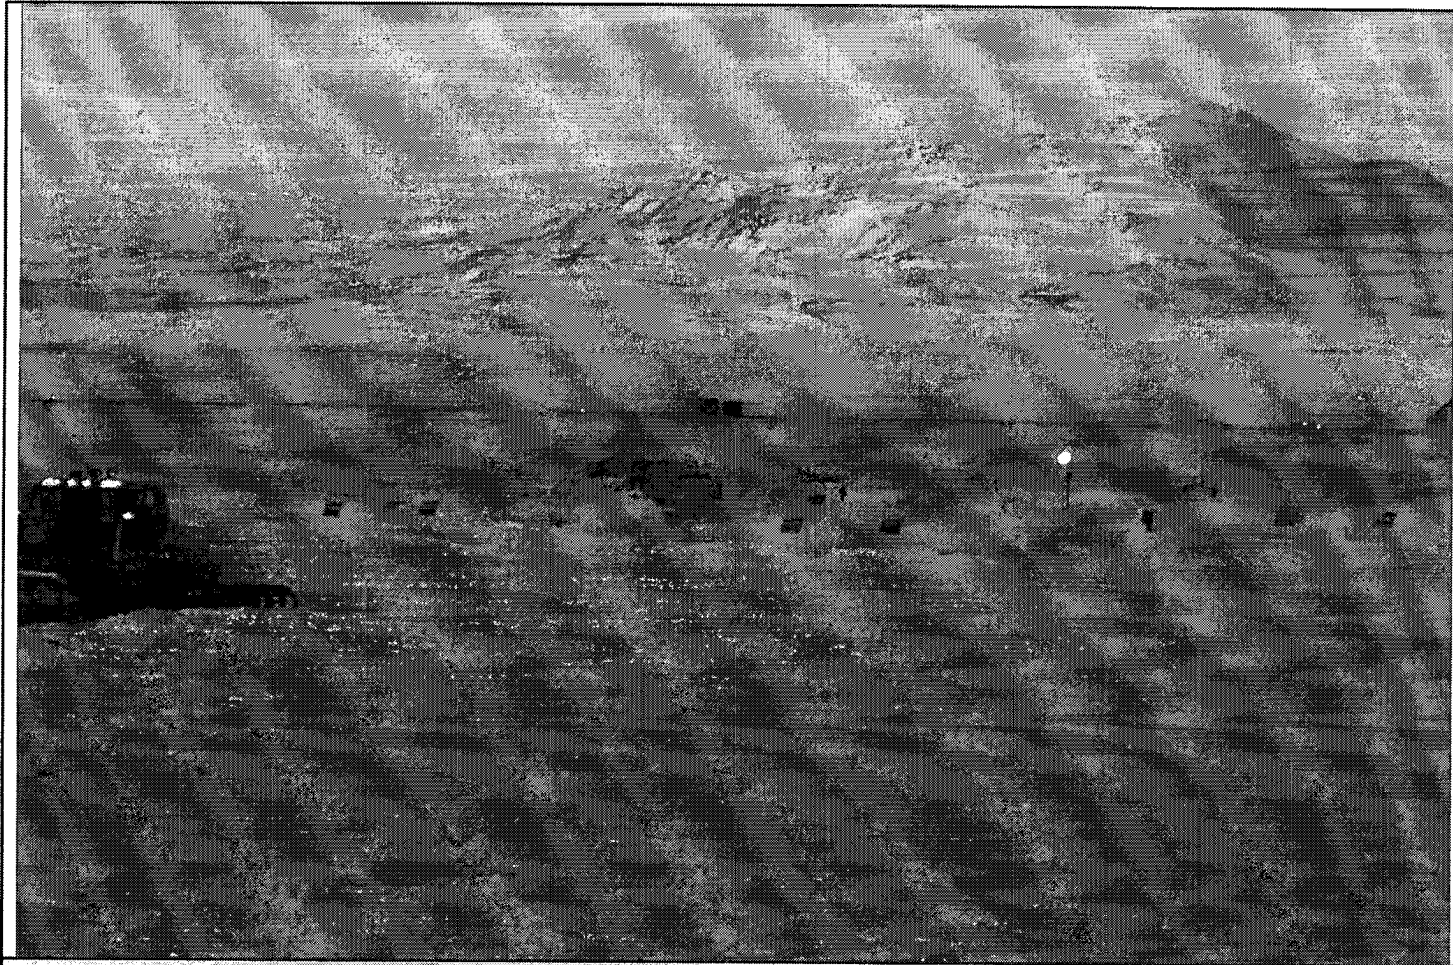
Photo Log # 2		Location (NAD 83 DD MM SS.SS)	
Photo #2		N	W

An inspection of the Fuel storage areas was conducted during this inspection. The bulk fuel storage area during the time of this inspection was mostly covered in snow due to a sever blizzard prior to the inspector arriving to site. It was noted that Sabina is working to remove the snow from the Berms containing the bulk fuel storage tanks (See photo 1, 2). There was approximately 70,000L of fuel on site during this inspection. No concerns were noted.

Description: Bulk fuel storage facility with drifting snow to be removed.

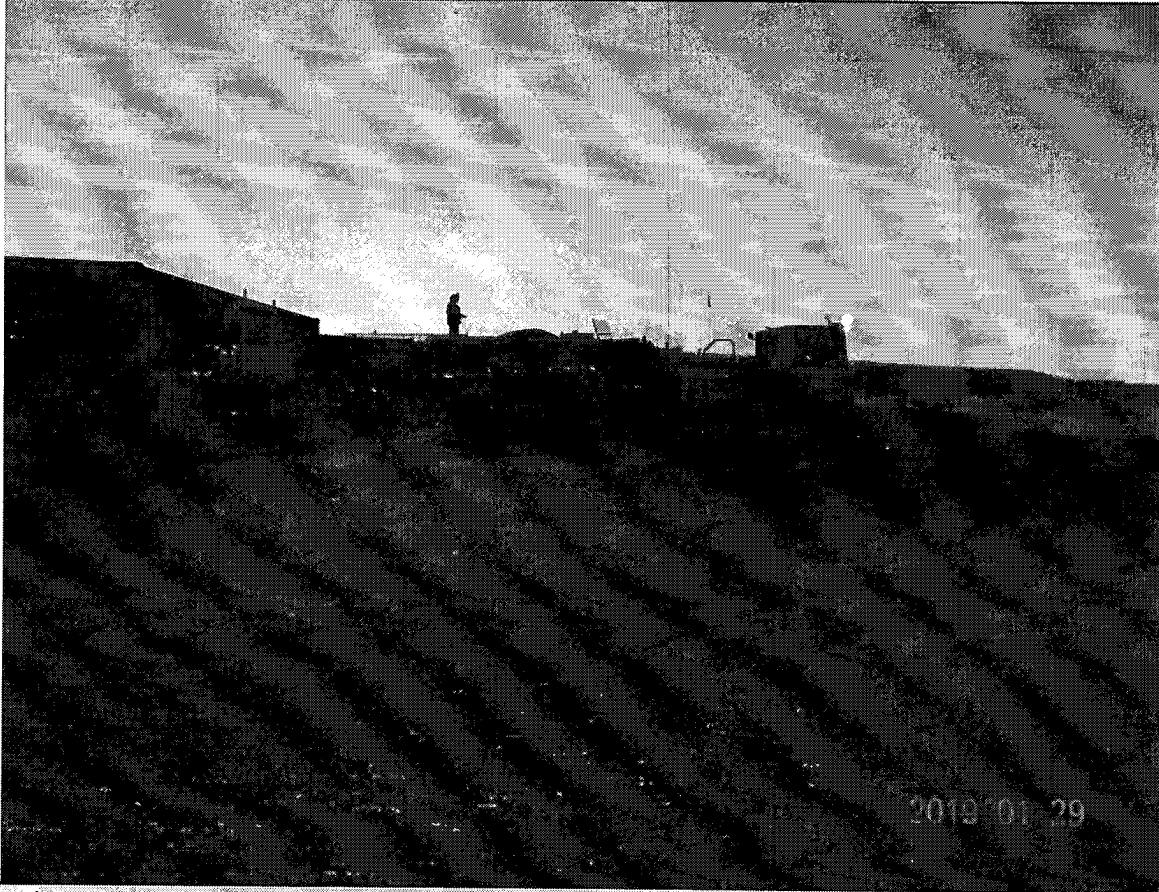
Photo Log # 3	Location (NAD 83 DD MM SS.SS)	
Photo #3	N	W

Lower Laydown area – This area is located north east of the MLA camp set approximately 200m off the runway. This area is used to store equipment off loaded from the sealift, (ie: sea cans, heavy equipment, and equipment related to the undertakings) assemble heavy equipment, and is the beginning of the WIR from MLA camp to Goose camp (See photo 3, 4) No concerns were noted.

Description: Southwest corner of Lower Laydown. As see in photo a piece of machinery used to construct WIR is being assembled.

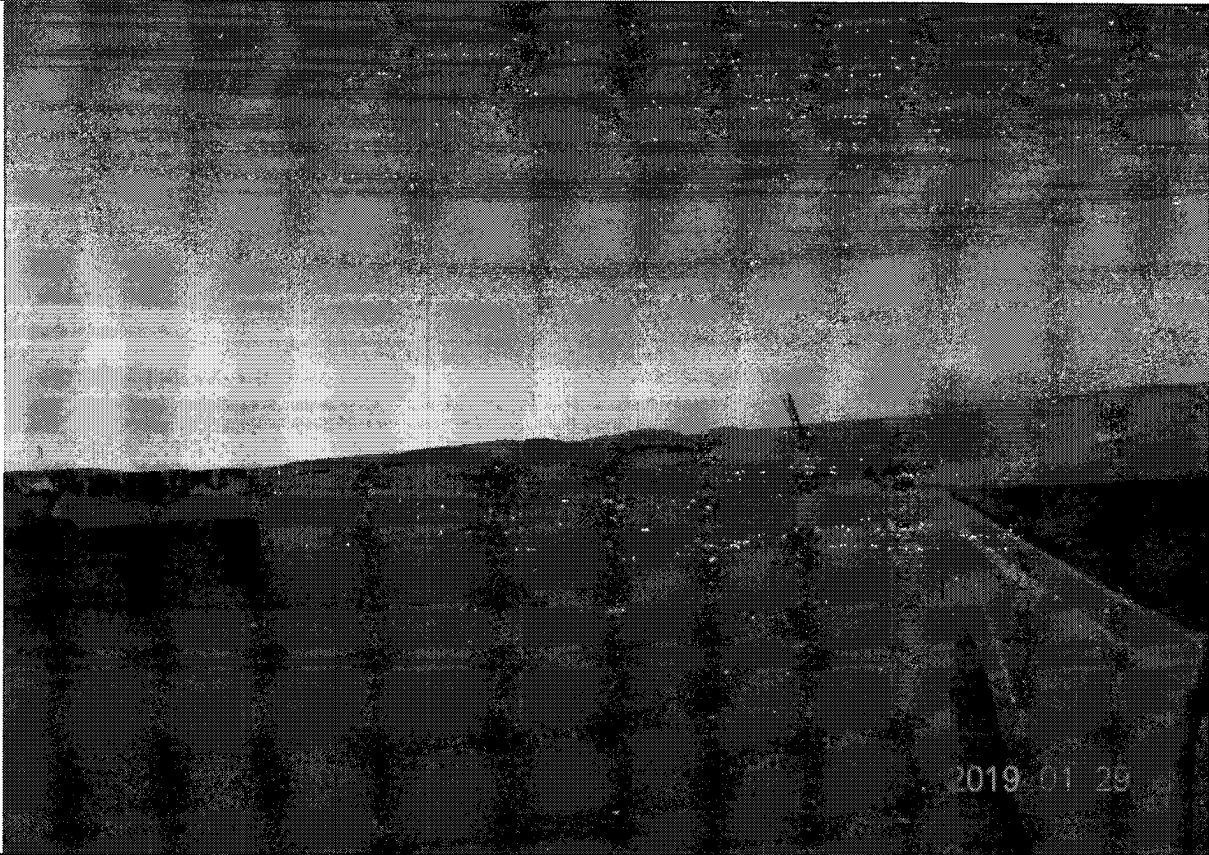
Photo Log # 4	Location (NAD 83 DD MM SS.SS)	
Photo #4	N	W

Description: Northeast end of Lower laydown used to assemble machinery during time of inspection.
