WATER LICENCE INSPECTION FORM

Licensee	Licensee Representative
Sabina Gold and Silver	Merle Keefe and Michael Marchildron
Licence No. / Expiry	Representative's Title
2AM-BRP1831	Environmental Permitting Manager and Camp Manager
Land / Other Authorizations	Land / Other Authorizations
Date of Inspection	Inspector
09/05/2019	Candice Pedersen
Activities Inspected	
<input type="checkbox"/> Camp	<input type="checkbox"/> Drilling
<input type="checkbox"/> Roads/Hauling	<input type="checkbox"/> Mining
	<input type="checkbox"/> Construction
	<input type="checkbox"/> Reclamation
	<input type="checkbox"/> Fuel Storage
	<input checked="" type="checkbox"/> Other: Interconnecting Winter Ice Road
	<input type="checkbox"/> Other:

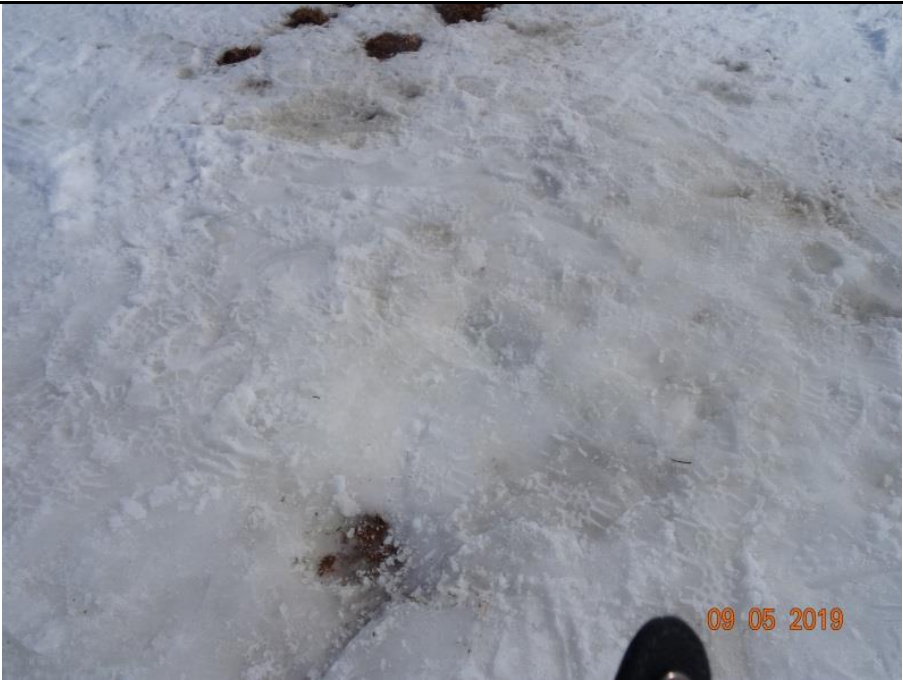
Photo Log # 3		Location (NAD 83 DD MM SS.SS)	
Photo #3		N66 19 43.3	W107 12 8.7

Description: After spill was cleaned up

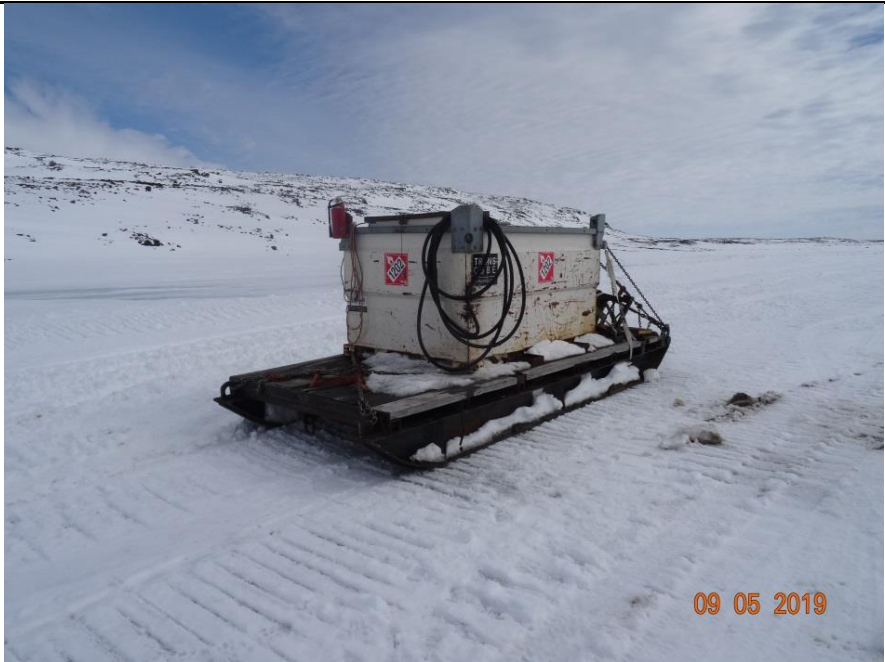
Photo Log # 4

Description: Trans fuel cube let on a small lake

SECTION 2	<input type="checkbox"/> Comments	<input type="checkbox"/> Non-Compliance with Act or Licence	<input checked="" type="checkbox"/> Action Required
Inspector reminds Sabina to not store fuel on ice unless it is for immediate use.

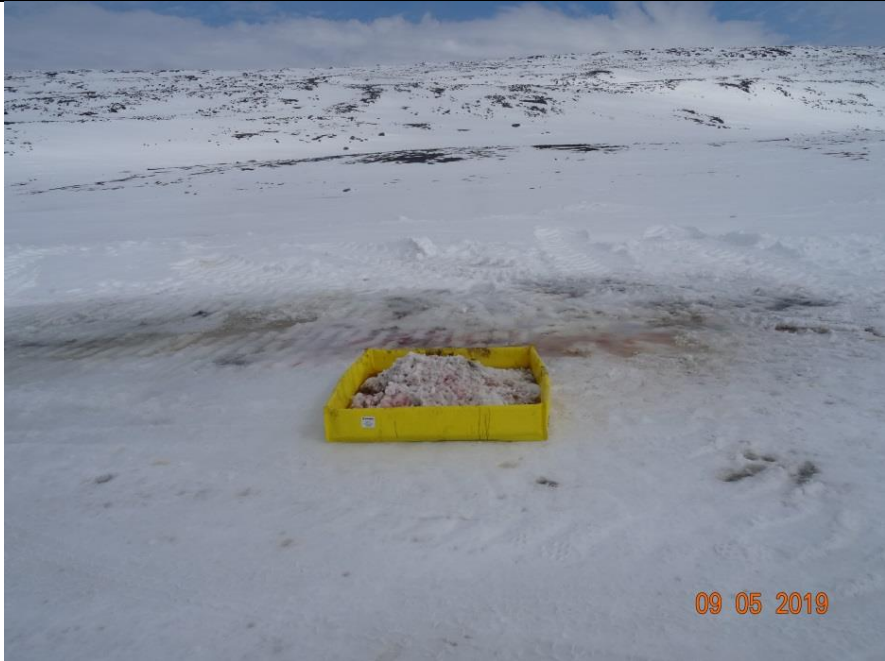
Photo Log # 5

Description: Hydraulic spill on a small lake
