WATER LICENCE INSPECTION FORM

☒ Follow-Up Report

Licensee		Licensee Representative	
Sabina Gold and Silver Corp.		Rob Davidson	
Licence No. / Expiry		Representative's Title	
2AM-BRP1831		Operations Manager	
Land / Other Authorizations		Land / Other Authorizations	
Not applicable		Not applicable	
Date of Inspection		Inspector	
September 4, 2021		Omer Pasalic	
Activities Inspected			
<input checked="" type="checkbox"/> Camp	<input type="checkbox"/> Drilling	<input checked="" type="checkbox"/> Mining	<input checked="" type="checkbox"/> Construction
<input type="checkbox"/> Reclamation	<input checked="" type="checkbox"/> Fuel Storage		
<input checked="" type="checkbox"/> Roads/Hauling	<input type="checkbox"/> Other: Potable Water Source, Waste Water Treatment Facility, Solid Waste Facility		
<div>SECTION 1<div><input checked="" type="checkbox"/> Comments (s.____)</div><div><input type="checkbox"/> Non-Compliance with Act or Licence (s.____)</div><div><input type="checkbox"/> Action Required (s.____)</div></div>

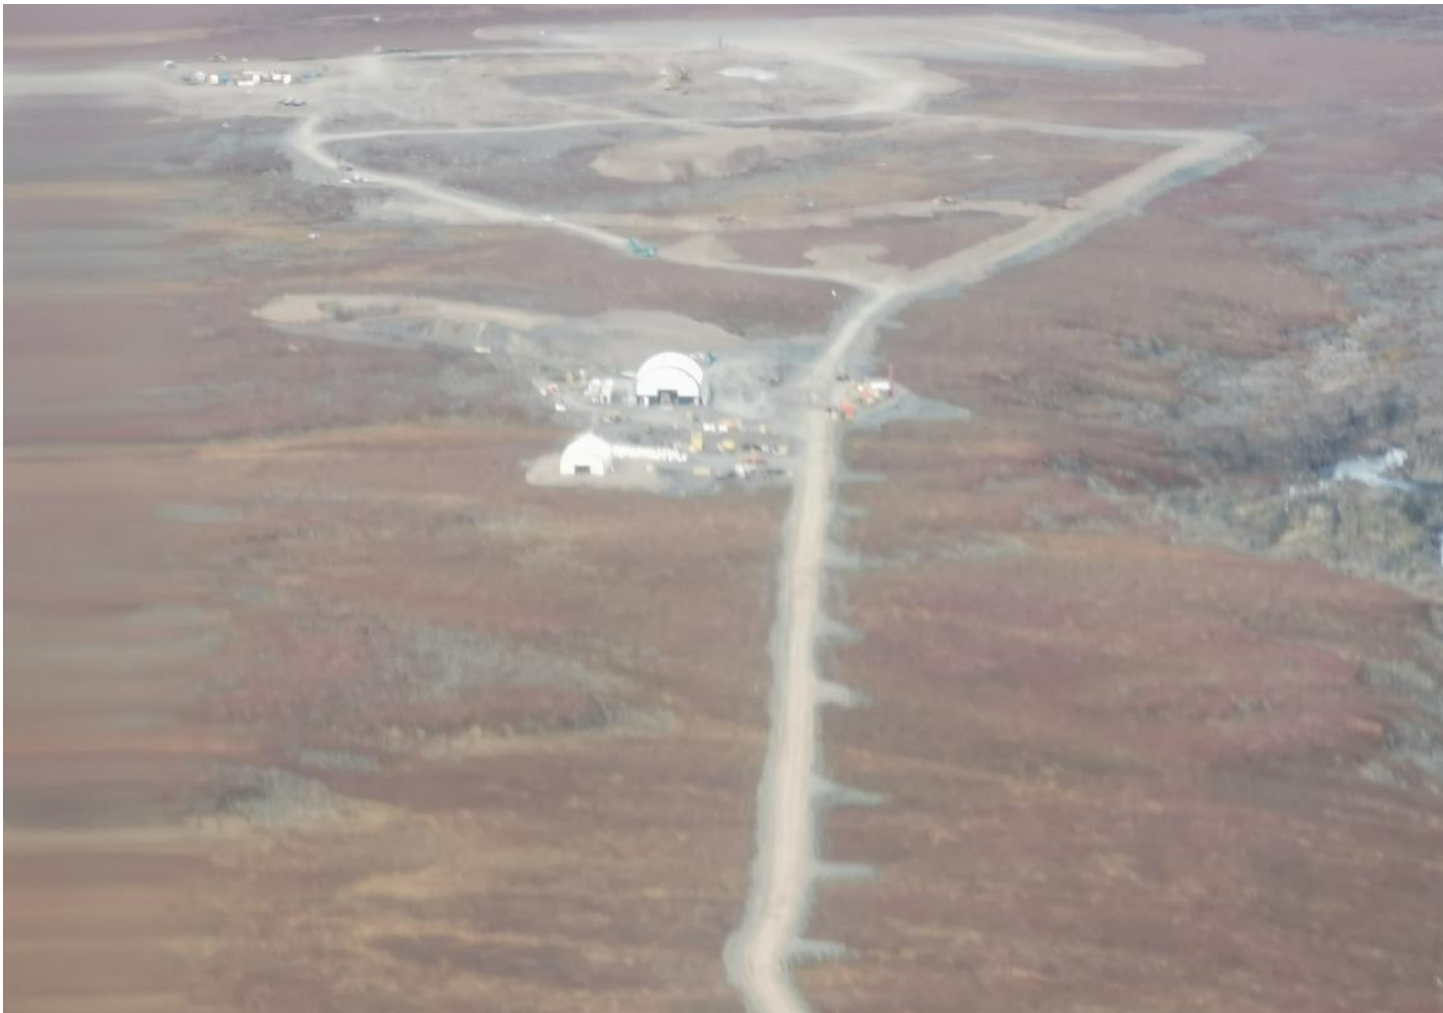
New constructions on the site were also observed. In addition to the construction of the new camp and fuel storage facility located about 4 kilometers N/S from the existing Goose Bay site’s location, a two new bridges connecting the two sites were built within the last two years. Photographs of the new construction and built bridges are attached to this report.

Goose Bay – New Construction Overall picture

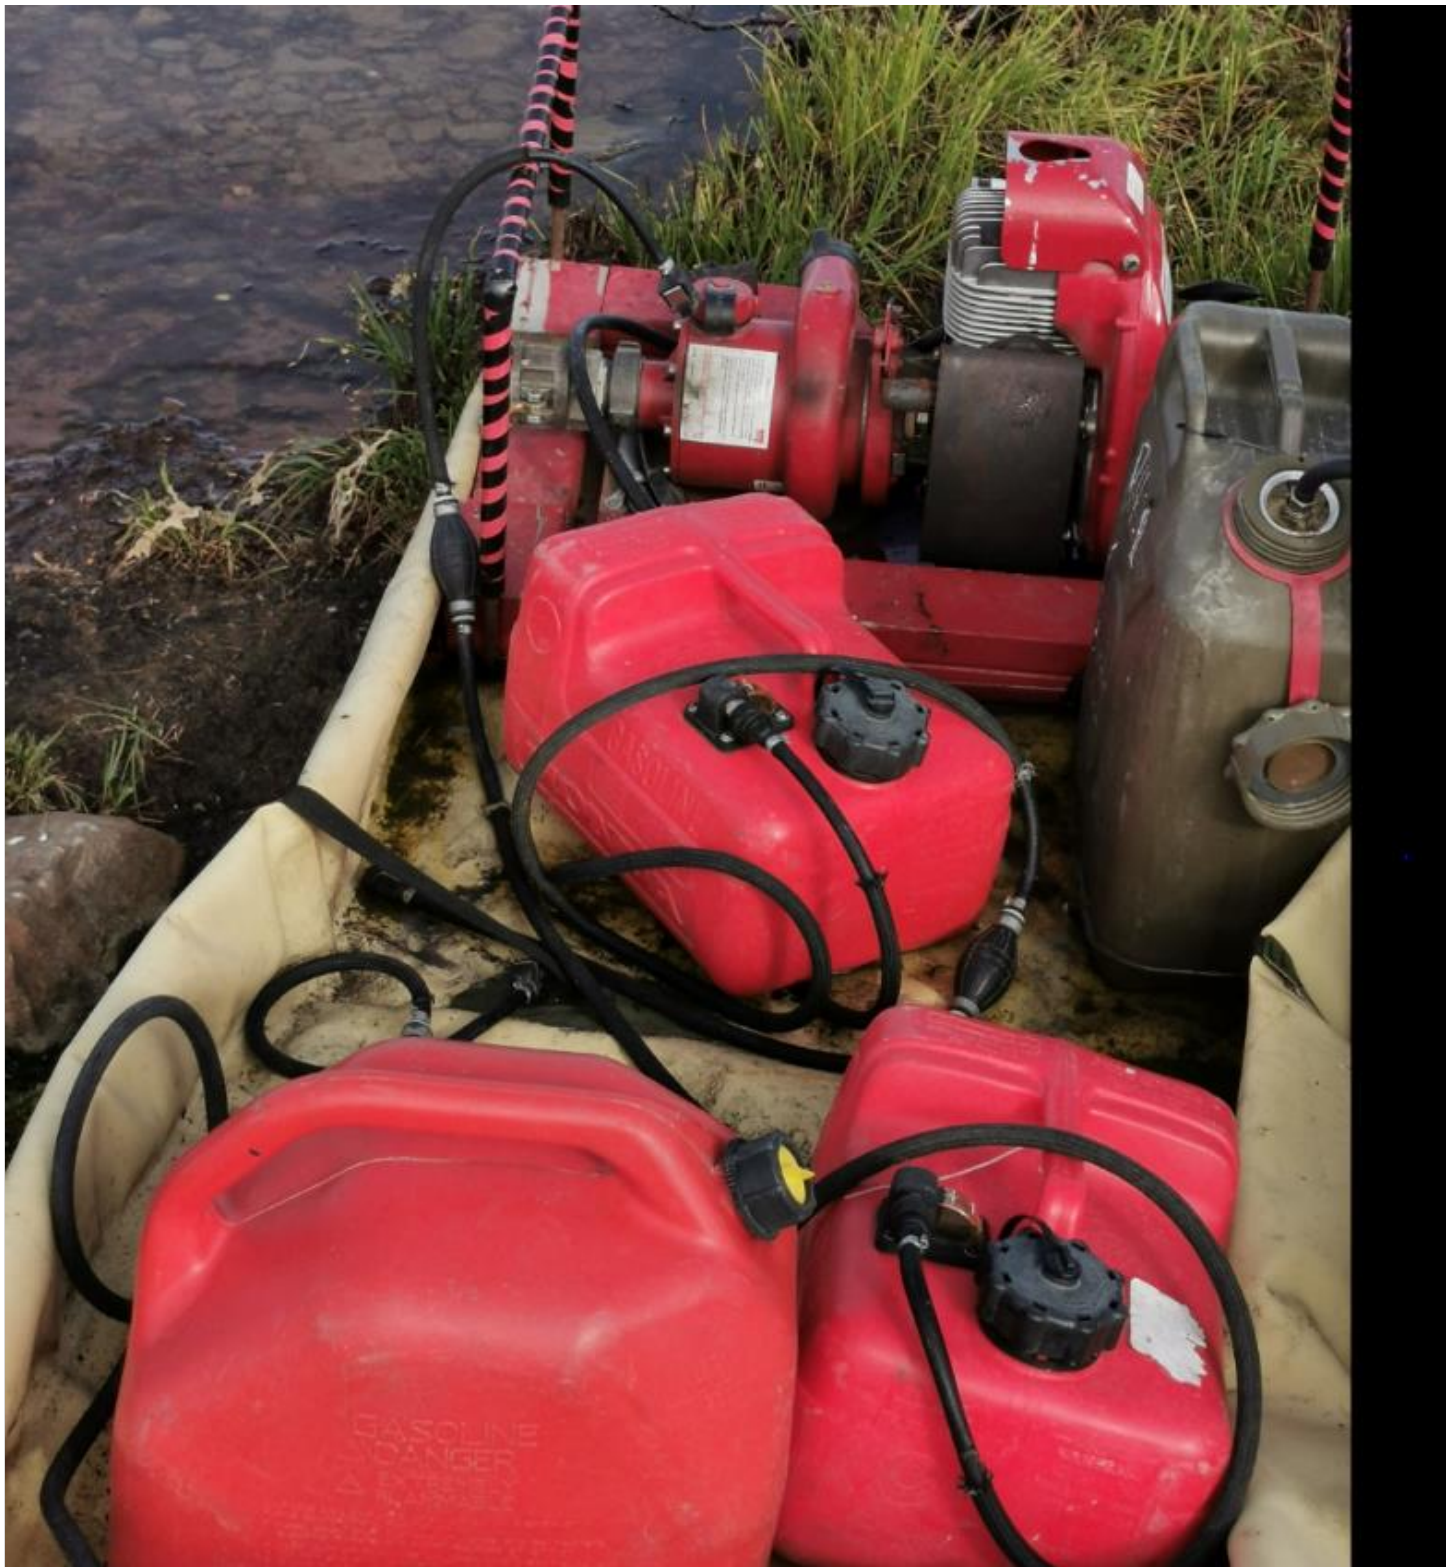
Jetty area of the Goose Bay site, appeared to have debris laying around, a car battery left unattended on the dock of the lake, gas cans next to the water were also observed. Photographs of the jetty are included with this report.

Fuel cans at the edge of the nearby water intake – Goose Lake

- granted. REDACTED.
3. Remove items near jetty area to prevent contamination of water. REDACTED. ( this is a deep cycle marine battery utilized for boating and environmental monitoring and baseline data collection ).

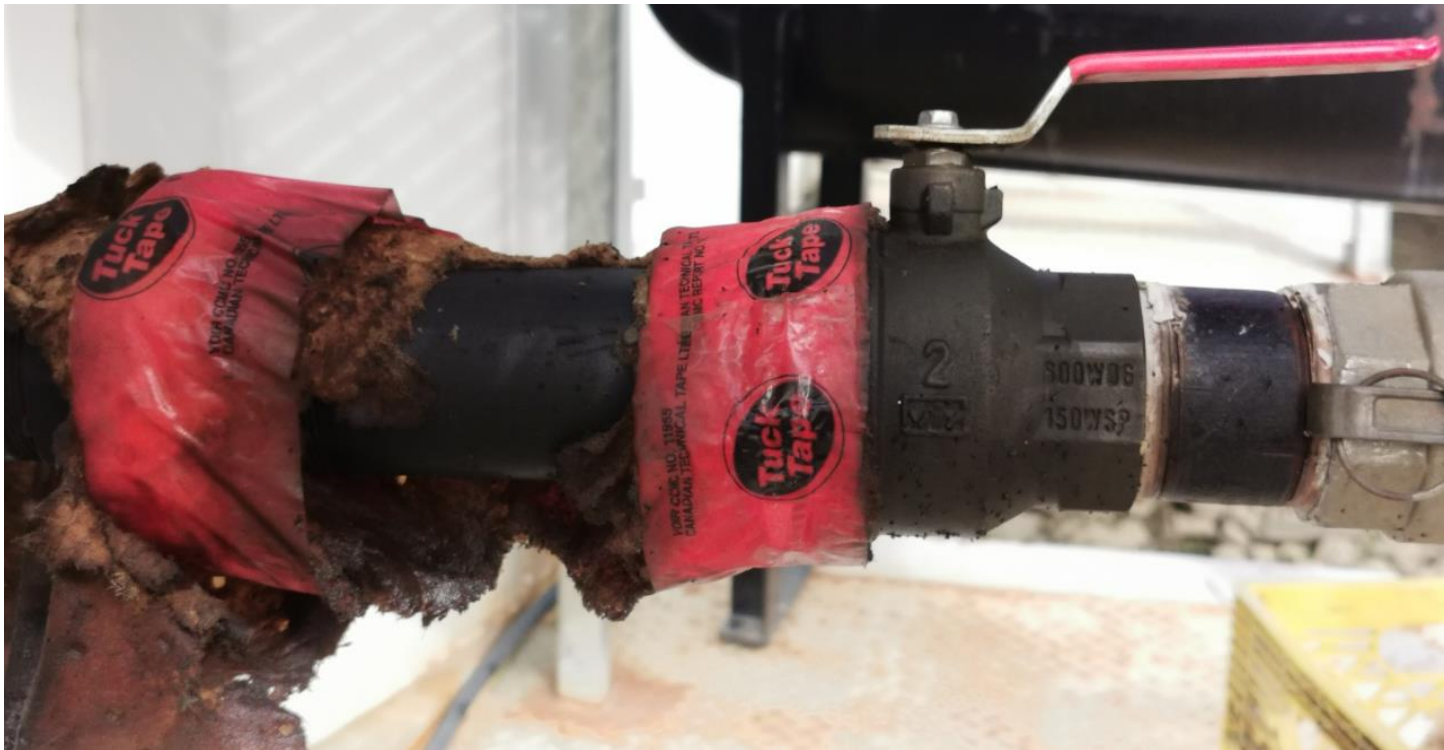
Coupling device attached to tank number 7 where the spill occurred from. Improper temporary fix in order to prevent further discharge.

6. Provide quantity of spill identified in the report above. Diesel fuel/tank number 7, plan for remediation and future preventable measures put in place. REDACTED. ( secondary containment has been installed and is in use )

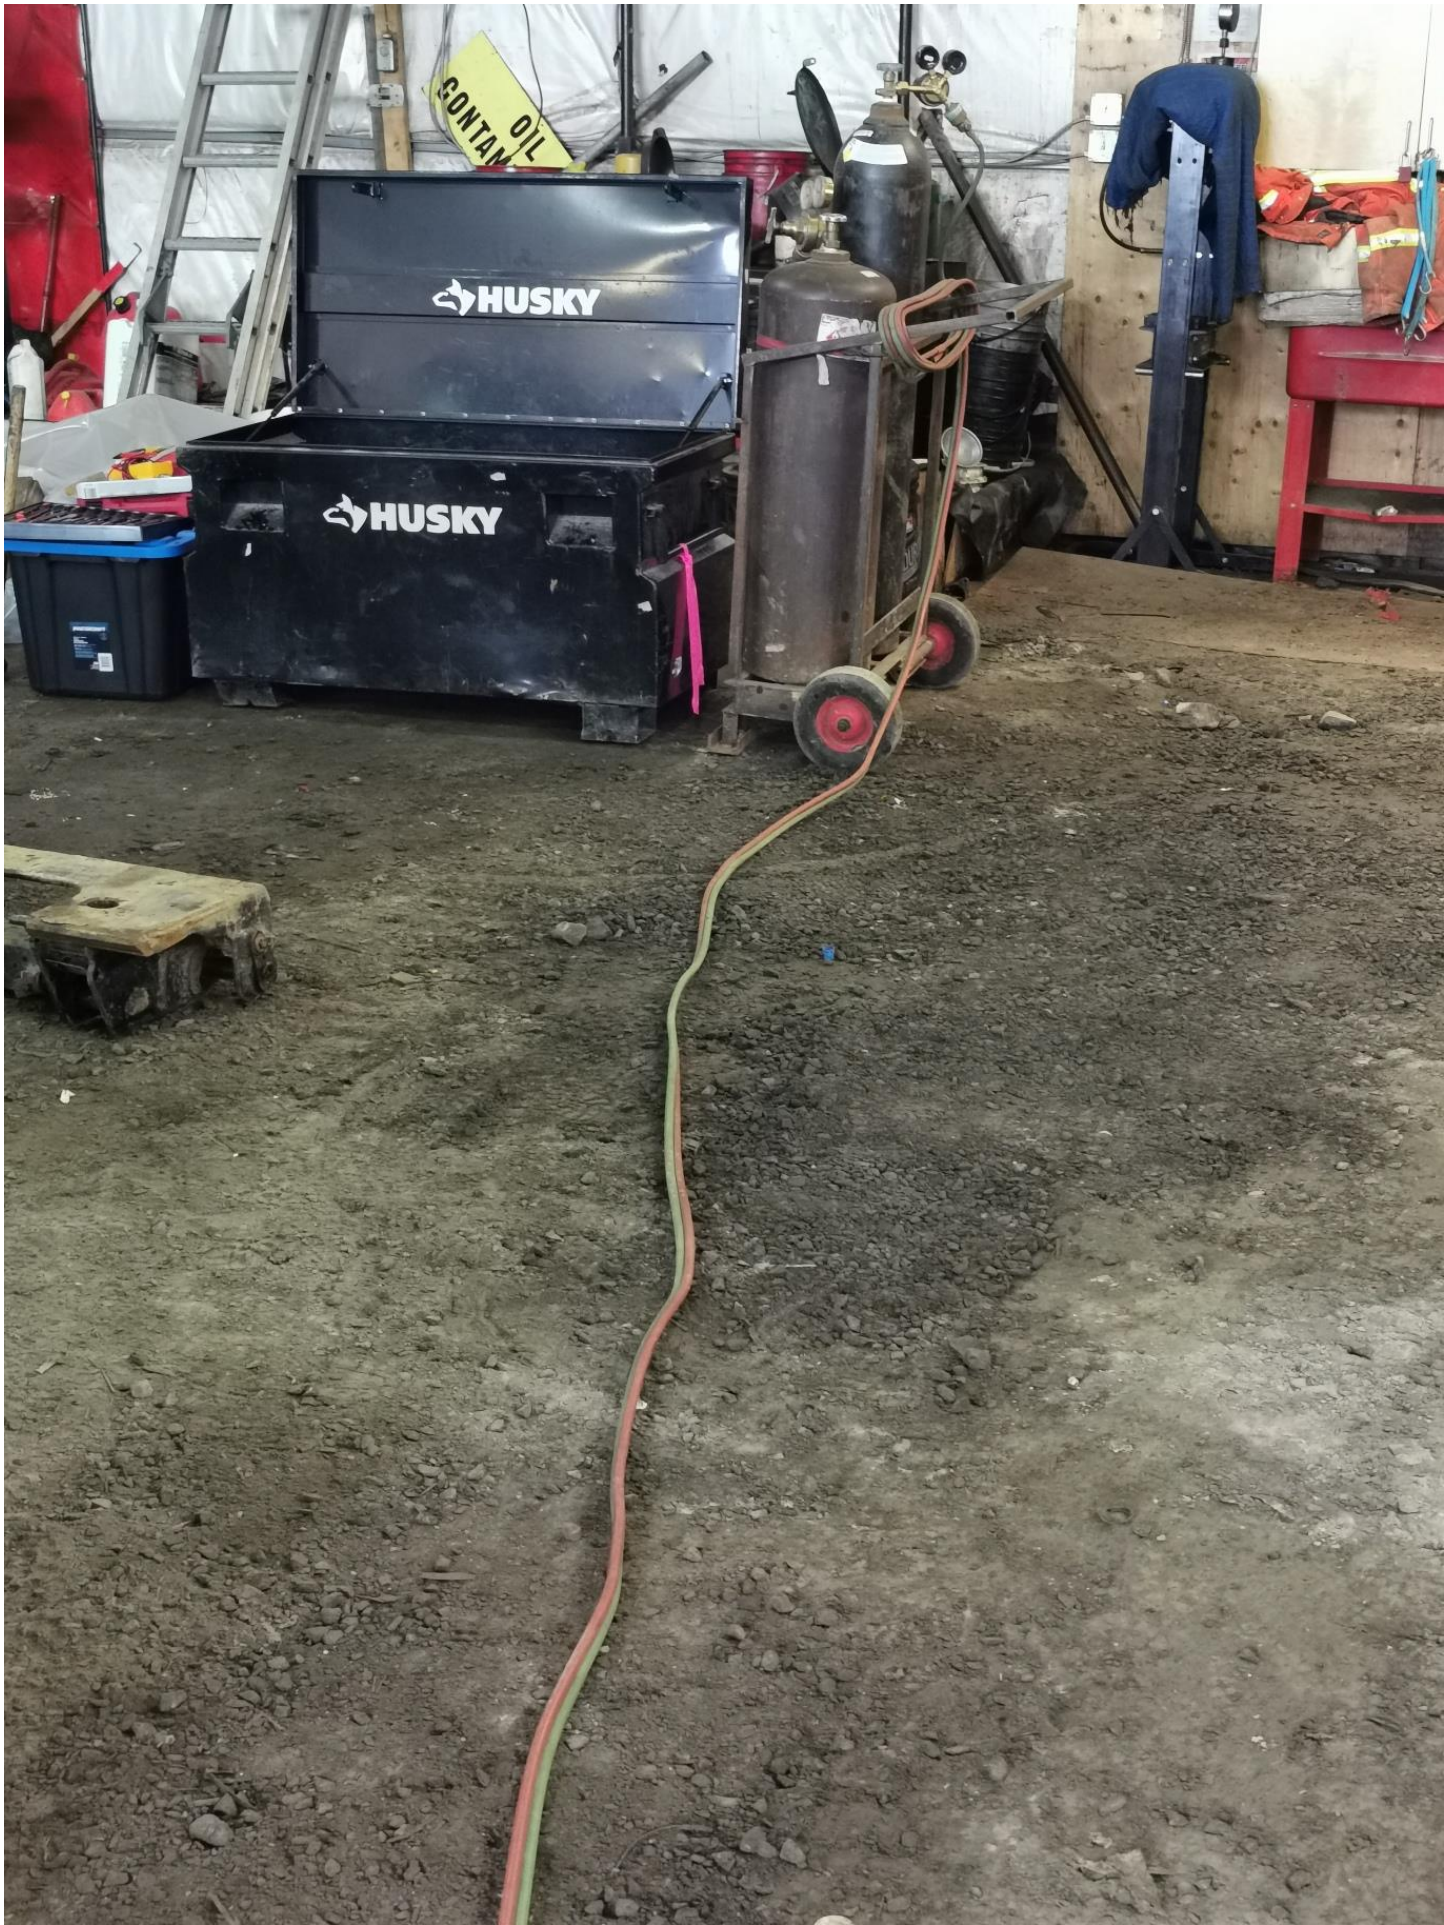
Repair garage floor had visible fuel leaks on the ground. These leaks have been contributed to the heavy equipment entering the garage and seeping the fuel directly onto the ground, however with containment. Photographs of the leaks are included with this report.

Fuel spill detected inside the maintenance vehicle garage. No secondary containment found or seen.

4. Install and maintain secondary fuel spill containment to prevent fuel seeping onto the ground. ( Maintenance garage ). REDACTED.
5. Immediately report any and all spills, regardless of quantity, to the NWT/NU Spill line at the numbers provided above in Section 2. REDACTED. ( As per the spill group agreement ).

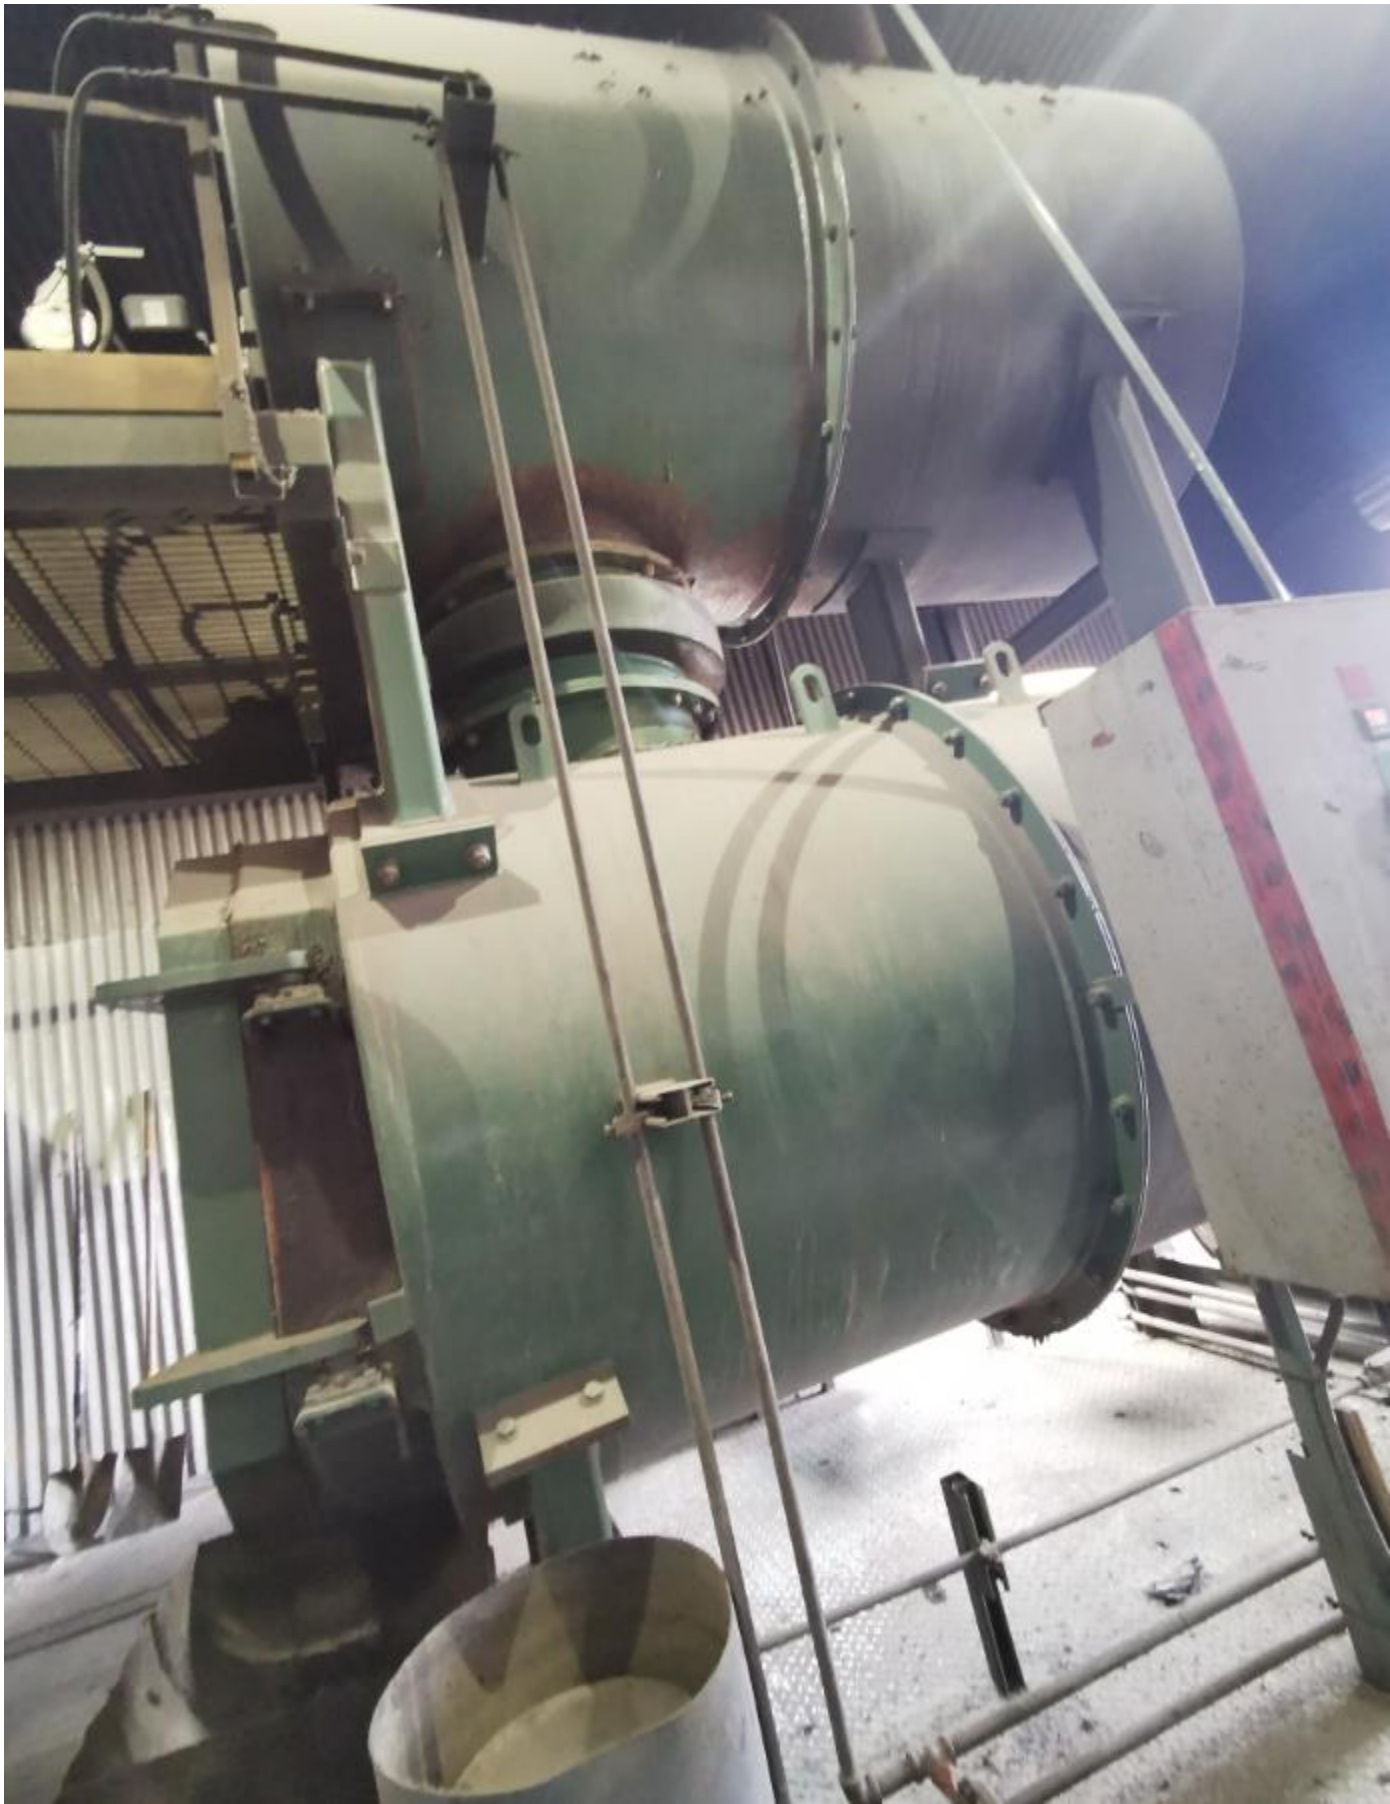
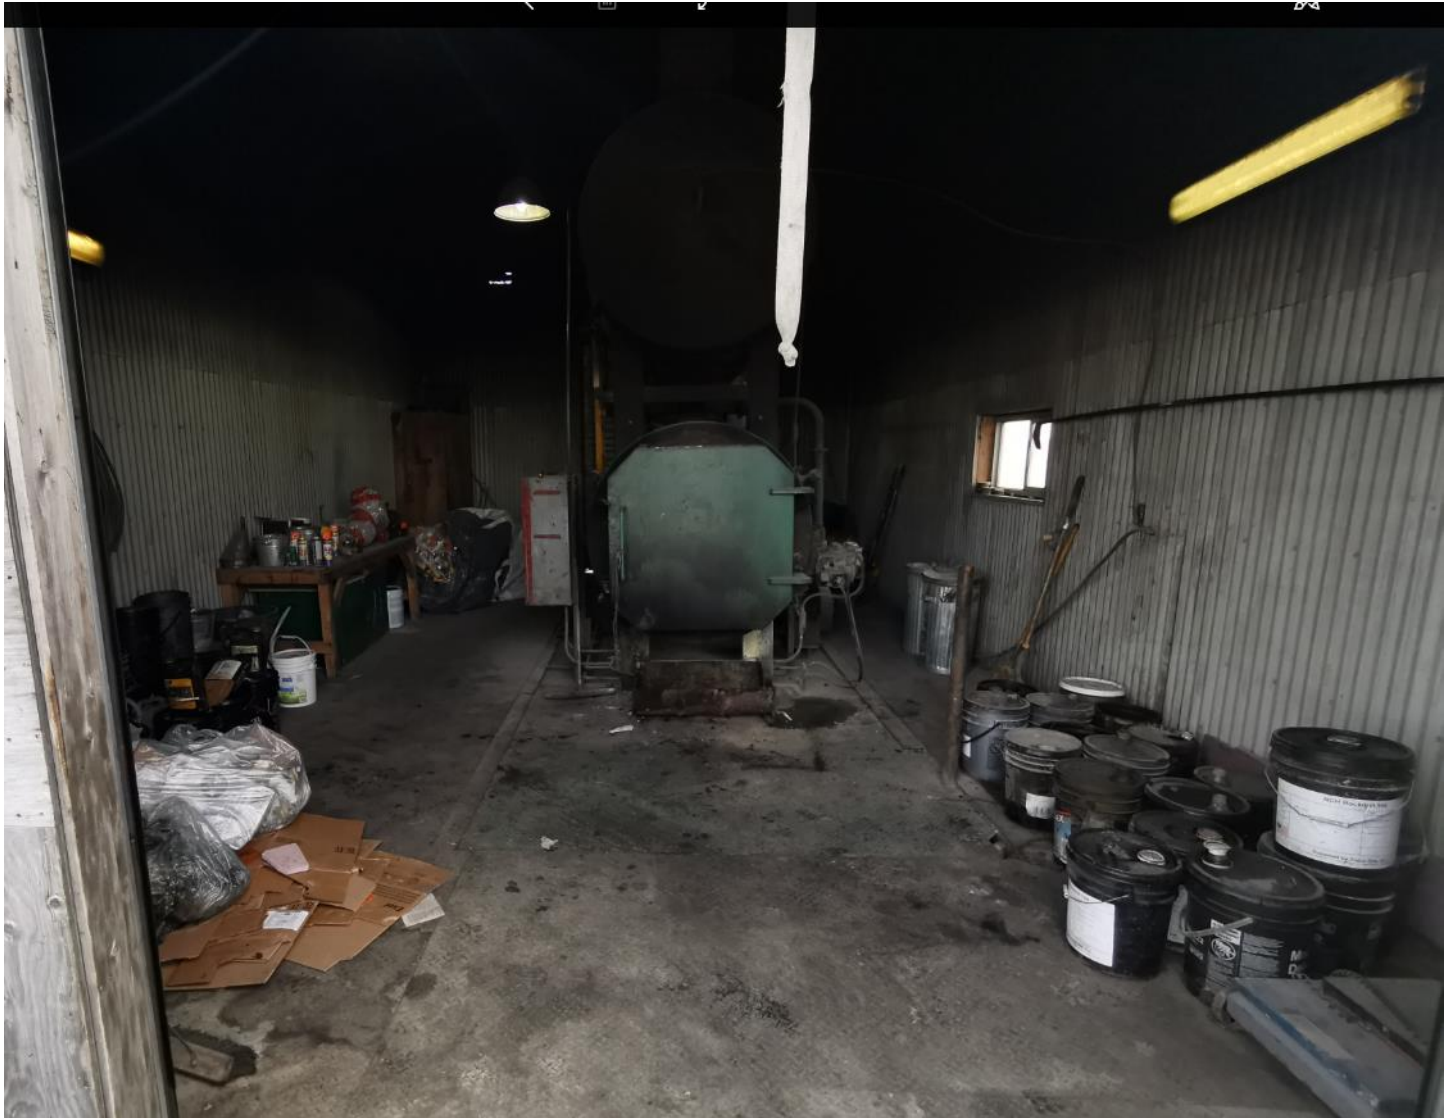
For disposal of sewage, the licensee is using a two-tank incinerator located at the main camp of Goose Bay site. No visible items not authorized by the license have been observed at or near the incinerator facility. Photographs of incinerator are included with this report.

Incinerator. Photograph number 1.

Incinerator. Photograph number 2.

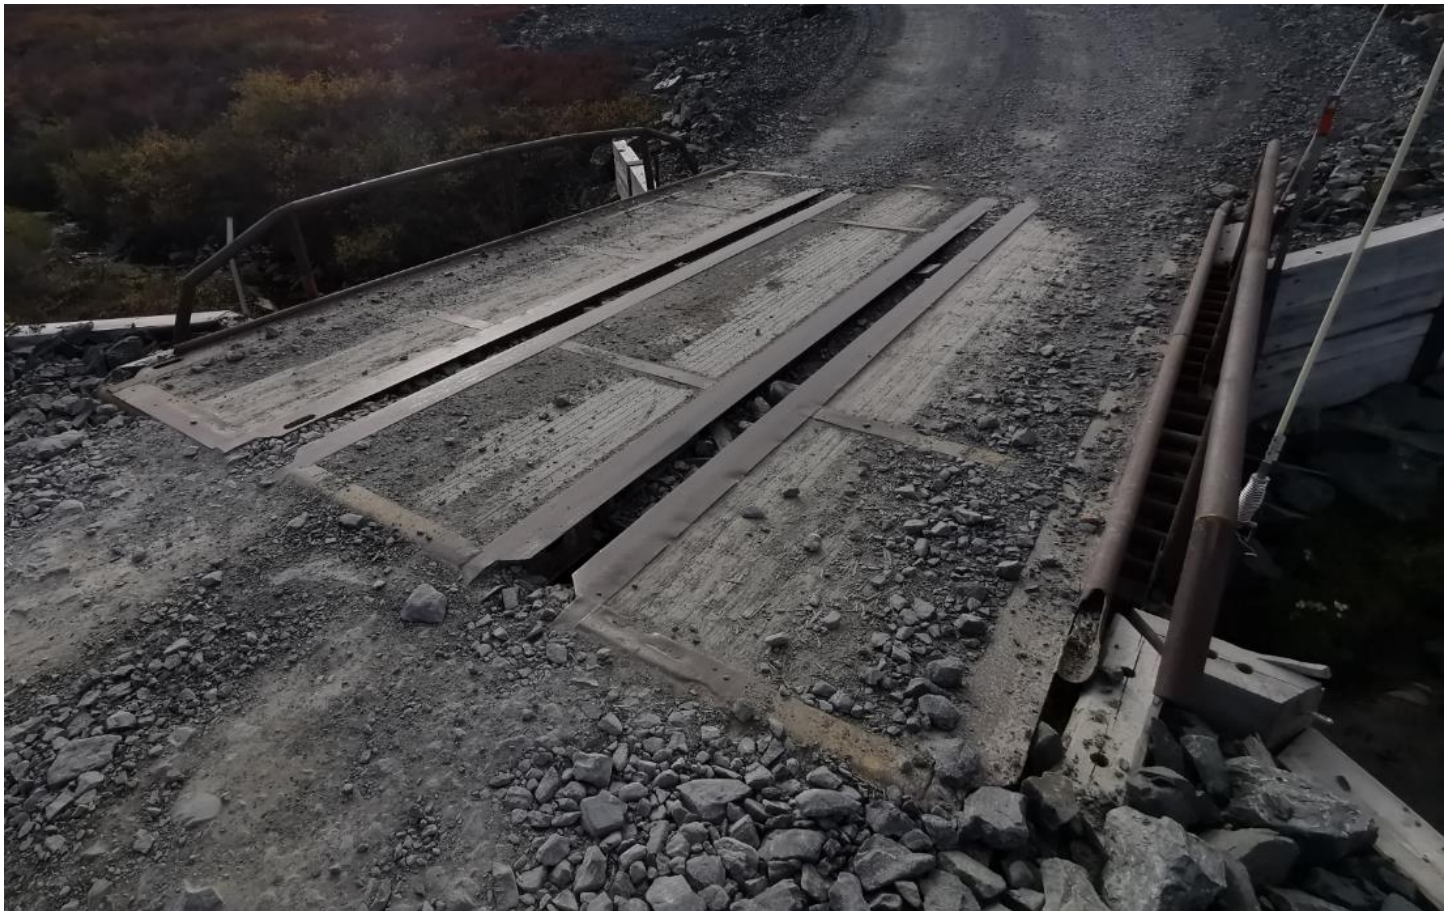
Newly constructed bridge number 1.

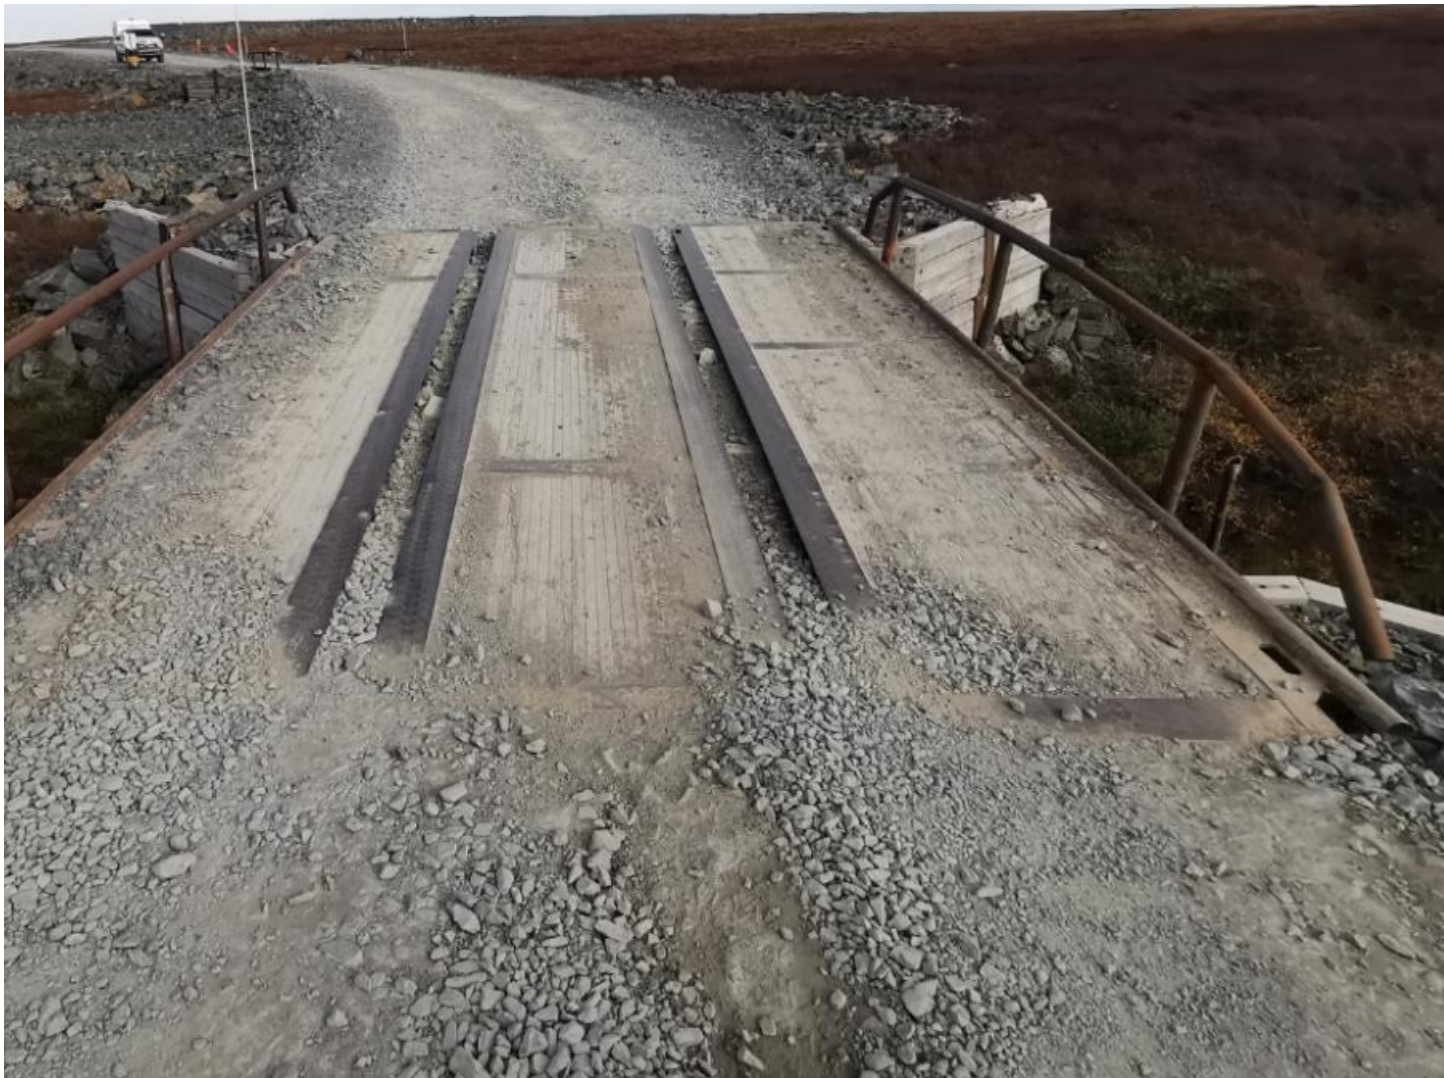
Newly constructed bridge number 2.

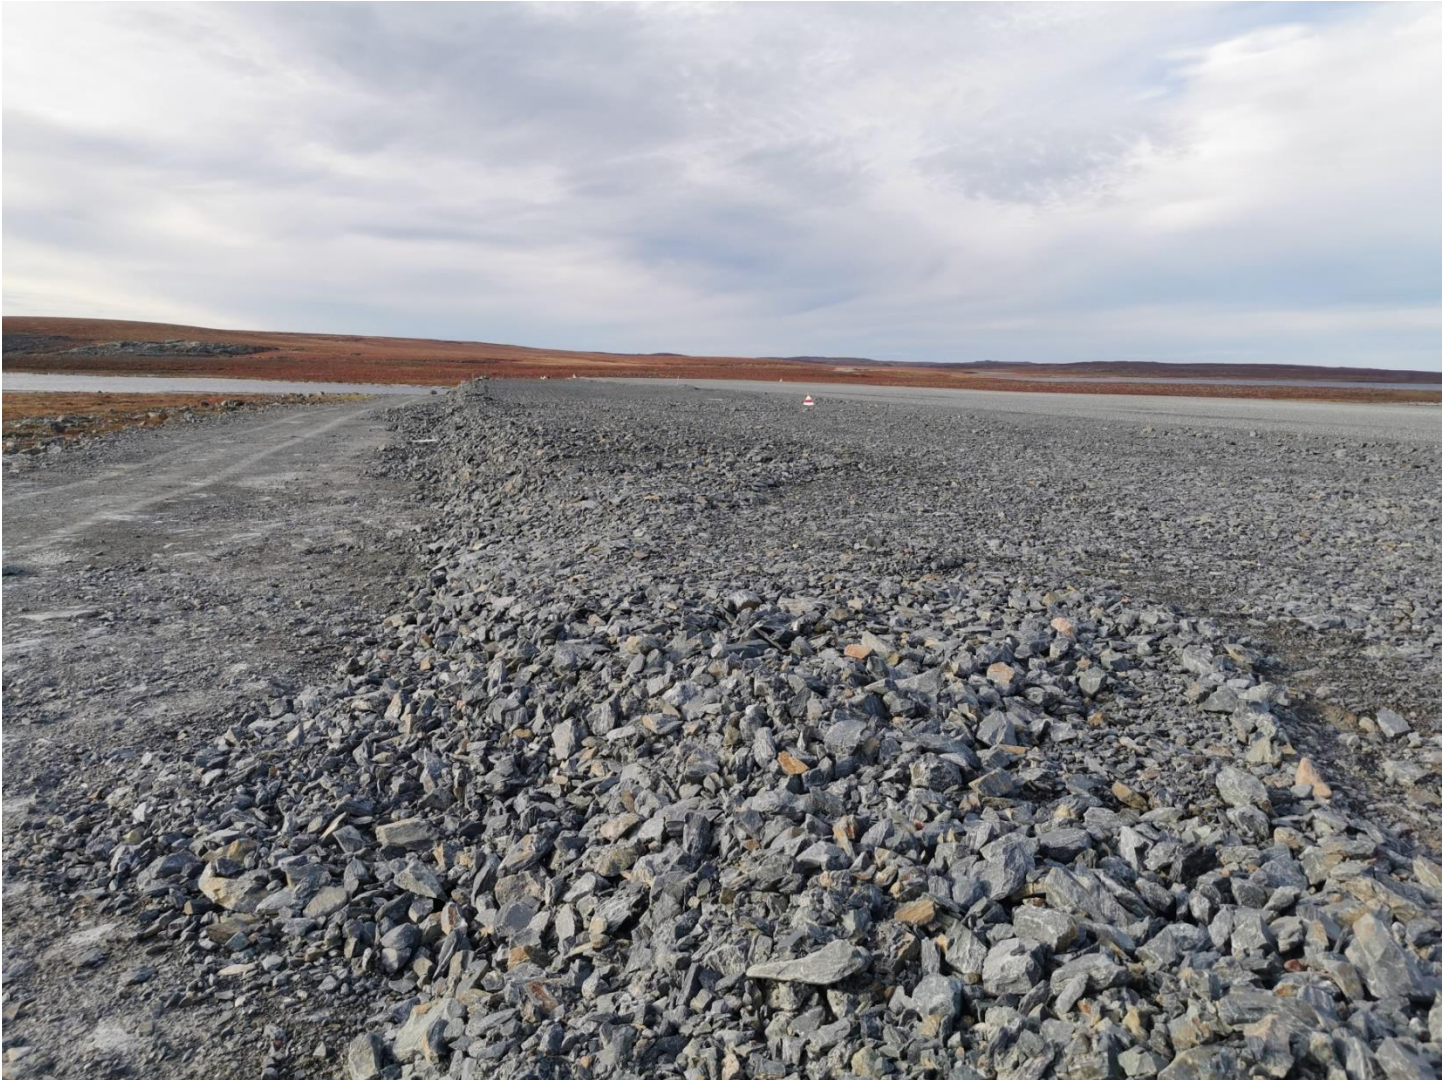
Currently, the licensee is expanding the air strip to allow for larger and heavier airplanes to operate to and from the site. The expansion currently under way is 50 feet widening of the air strip. Photographs of the air strip are attached to this report.

Air strip widening.
