WATER LICENCE INSPECTION FORM

Licensee	Licensee Representative
Sabina Gold and Silver	Thomas Bolt
Licence No. / Expiry	Representative's Title
2AM-BRP1831	Environmental coordinator
Land / Other Authorizations	Land / Other Authorizations
	--
Date of Inspection	Inspector
March 22, 2023	Jonathan MESHER
Activities Inspected	
<input checked="" type="checkbox"/> Camp	<input type="checkbox"/> Drilling
<input type="checkbox"/> Roads/Hauling	<input type="checkbox"/> Other:
<input checked="" type="checkbox"/> Mining	<input type="checkbox"/> Construction
	<input type="checkbox"/> Other:
<input type="checkbox"/> Reclamation	<input type="checkbox"/> Fuel Storage

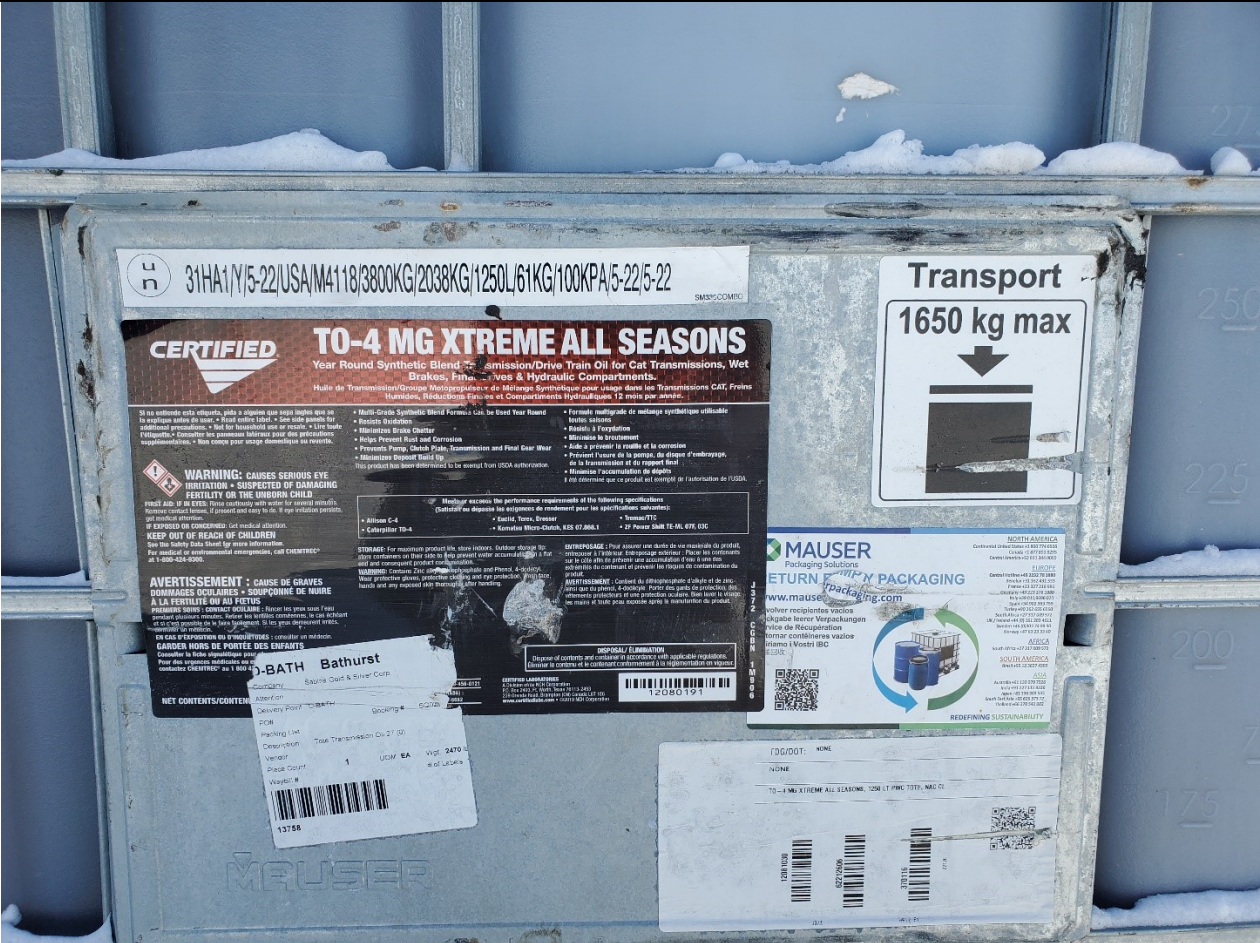
Date	Camera	Inspector	Authorization
March 22, 2023	Sony Cyber-shot	J.Mesher	2AM-BRP
Photo Log			
Photo 2

Description: approximately 58 totes of transmission fluid outside containment.

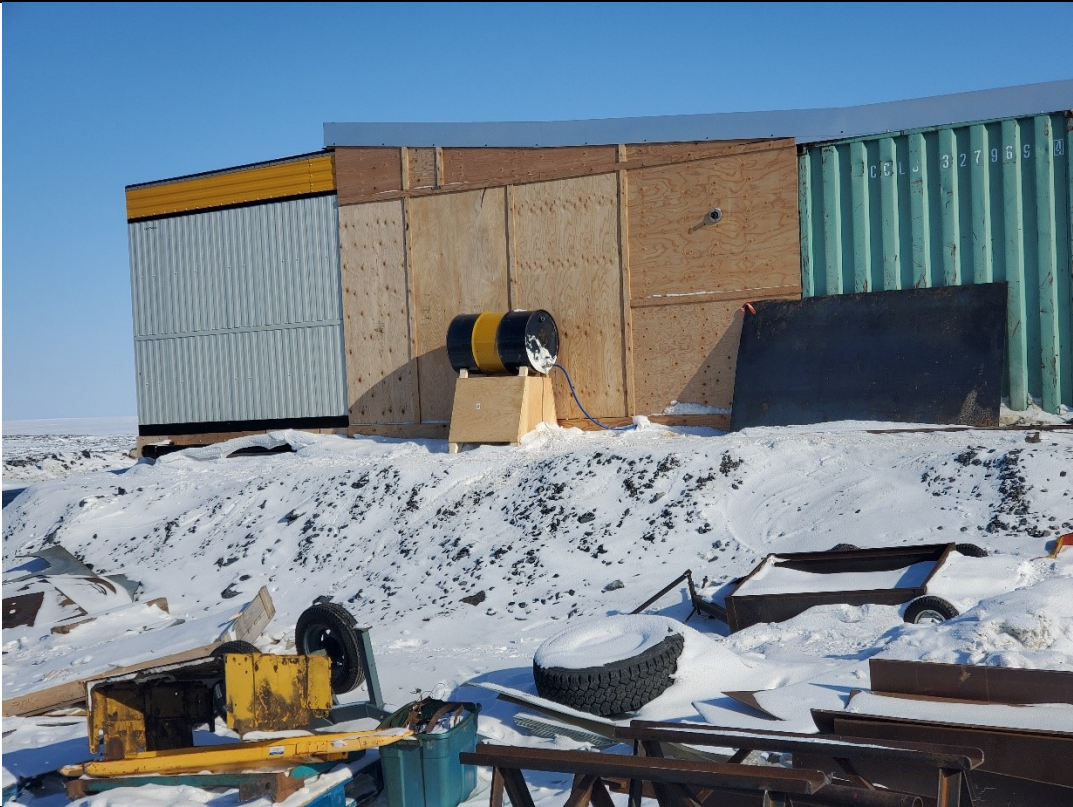
Date	Camera	Inspector	Authorization
March 22, 2023	Sony Cyber-shot	J.Mesher	2AM-BRP
Photo Log			
Photo 3

Description: portal shop fuel tank outside of containment.

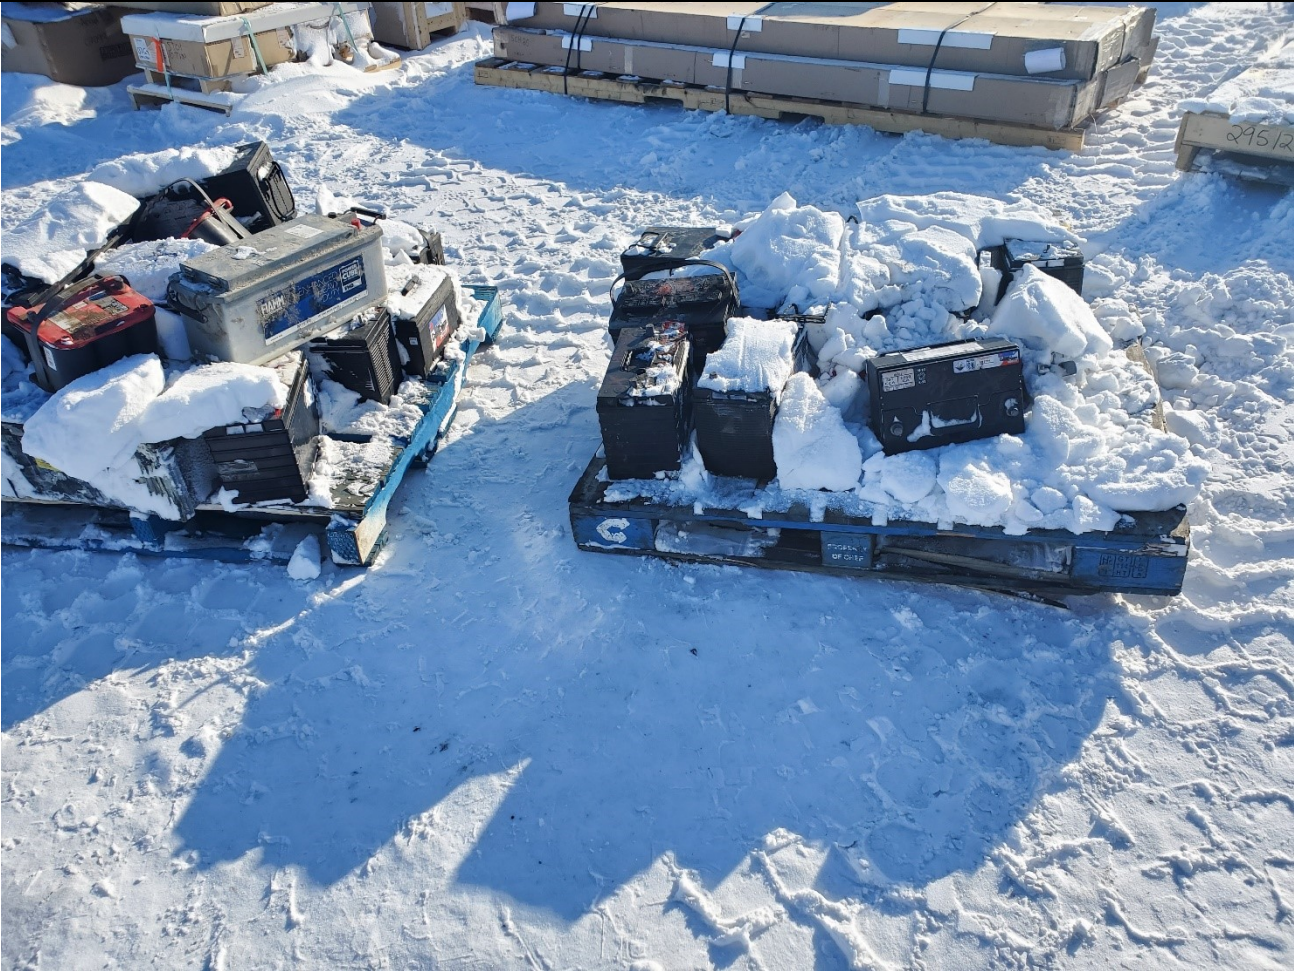
Photo 4

Description: Used batteries (hazardous waste) outside of containment.

Section 2	<input type="checkbox"/> Comments	<input type="checkbox"/> Non-Compliance with Act or Licence	<input checked="" type="checkbox"/> Action Required
<p><u>The licensee is to provide a plan 3 weeks after receiving the report to ensure the following concerns are addressed, this plan shall include a timeline for implementation.</u></p> <p>1) The licensee is to remove the barrels of historical waste from the snow pile near the runway.</p> <p>2) During the last 3 inspections the inspector has noted improper storage of hazardous materials and hazardous wastes in the temporary waste storage facility and throughout the site, it appears the licensee has a capacity issue and is unable to handle their waste in accordance with the terms and conditions of the licence 2AM-BRP, the licensee must? provide a plan to ensure all Hazardous materials are properly contained in accordance with the licence and management plans. Due to the frequency of this issue the inspector may proceed with enforcement actions if this issue is present in the upcoming inspections.</p> <p>3) The licensee is to ensure all hazardous waste and hazardous materials is stored in a way to prevent waste from entering water and is consistent with the approved licence/Management plans.</p>
