WATER LICENCE INSPECTION FORM

Licensee		Licensee Representative	
B2Gold Nunavut		Merle Keefe	
Licence No. / Expiry		Representative's Title	
2AM-BRP1831		Environmental Manger	
Land / Other Authorizations		Land / Other Authorizations	
Date of Inspection		Inspector	
14/11/2024		Isaiah James Bolt	
Activities Inspected			
<input checked="" type="checkbox"/> Camp	<input type="checkbox"/> Drilling	<input type="checkbox"/> Mining	<input type="checkbox"/> Construction
<input type="checkbox"/> Roads/Hauling	<input type="checkbox"/> Other:	<input type="checkbox"/> Reclamation	<input checked="" type="checkbox"/> Fuel Storage
<input type="checkbox"/> Other: Care & Maintenance

On November 14, 2024, I, Isaiah James Bolt, Inspector with the Crown Indigenous Relations and Northern Affairs Canada (CIRNAC), accompanied by Inspector Jonathan Mesher with CIRNAC, conducted an inspection of 2AM-BRP1831 to ensure compliance against their License.

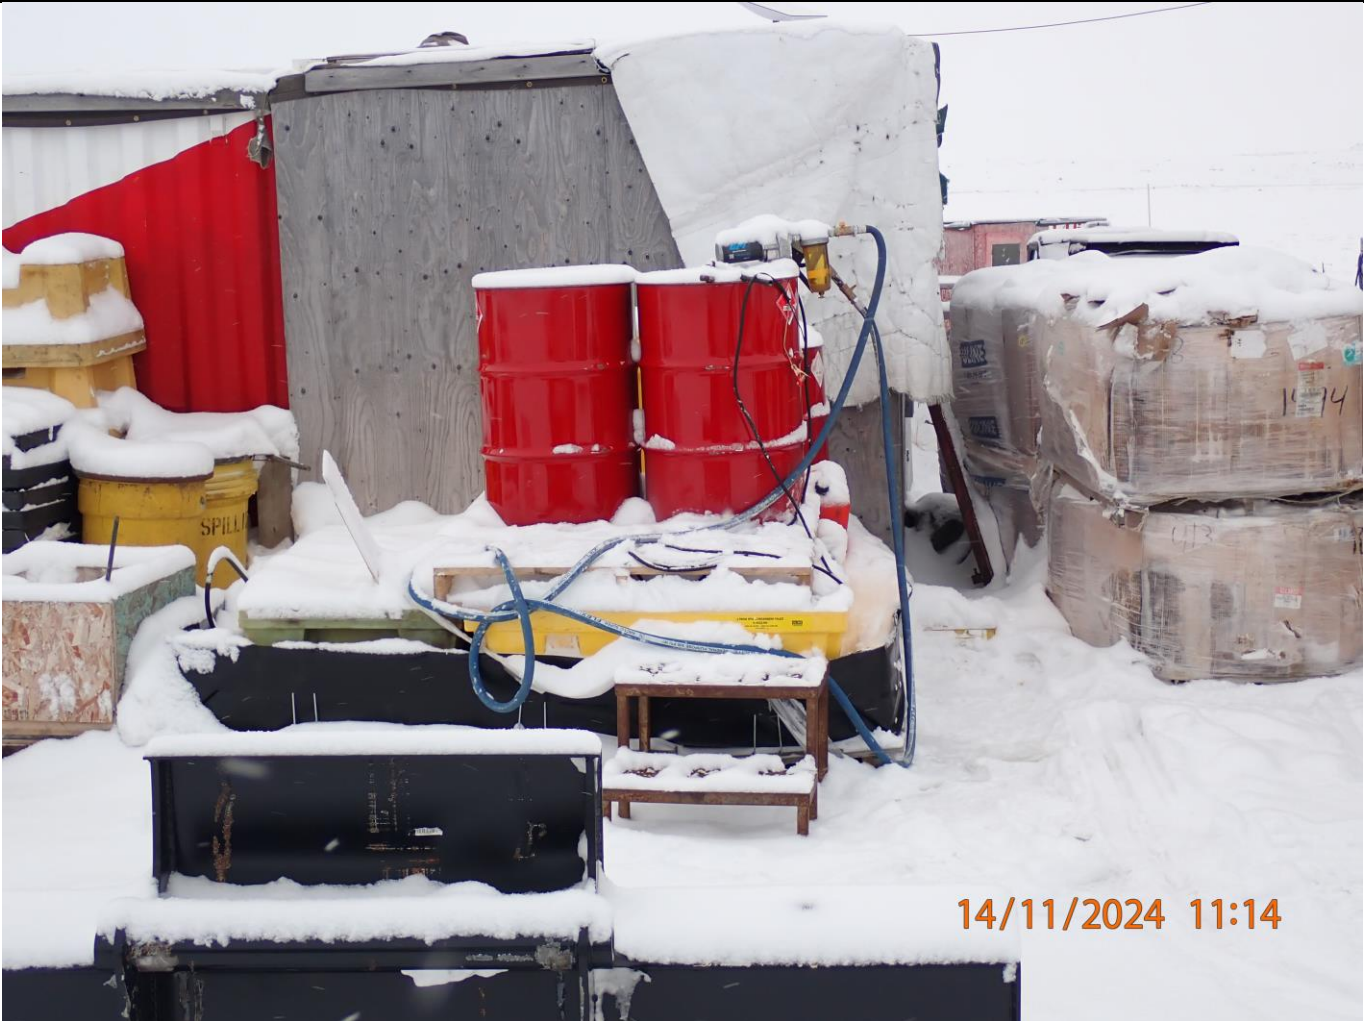
Photo 1

2. At the drilling laydown, 2 drums of gasoline were stored in secondary containment but the hose used for refuelling was out of containment. Potential leaks from the connections on the hose, filter and nozzle could migrate out of containment by flowing down the hose and onto the ground. (Photo #1).

-Mobile refuelling station hoses out of secondary containment and Hazardous materials and hydrocarbons drums stored outside of secondary containment. Part D, item 12 of Amendment No.1 of 2AM-BRP1831 states “The licensee shall prevent any chemicals, petroleum products, fuel, or wastes associated with the Undertaking from entering any Water body.” Part H item 3 of Amendment No.1 of 2AM-BRP1831 states: “The licensee shall provide secondary containment for fuel and chemical storage as required by applicable standards and acceptable industry practice.”

Fuel drums stored in secondary containment, refuelling hose not in containment.

- The licensee shall store all fuel drums and hazardous materials in secondary containment. Drip trays shall be utilized in areas where refueling occurs and used for preventative measures for potential leaks on all hose connections.
- Flow meters shall be installed and maintained at all water intake and effluent discharge facilities.
- Empty fuel drums shall be consolidated and prepped for shipment off site to ensure on going reclamation.
- Plastics shall be removed from the open burn pile. Plastics shall be sorted out of the burnable material before the material is placed in the open burn area.

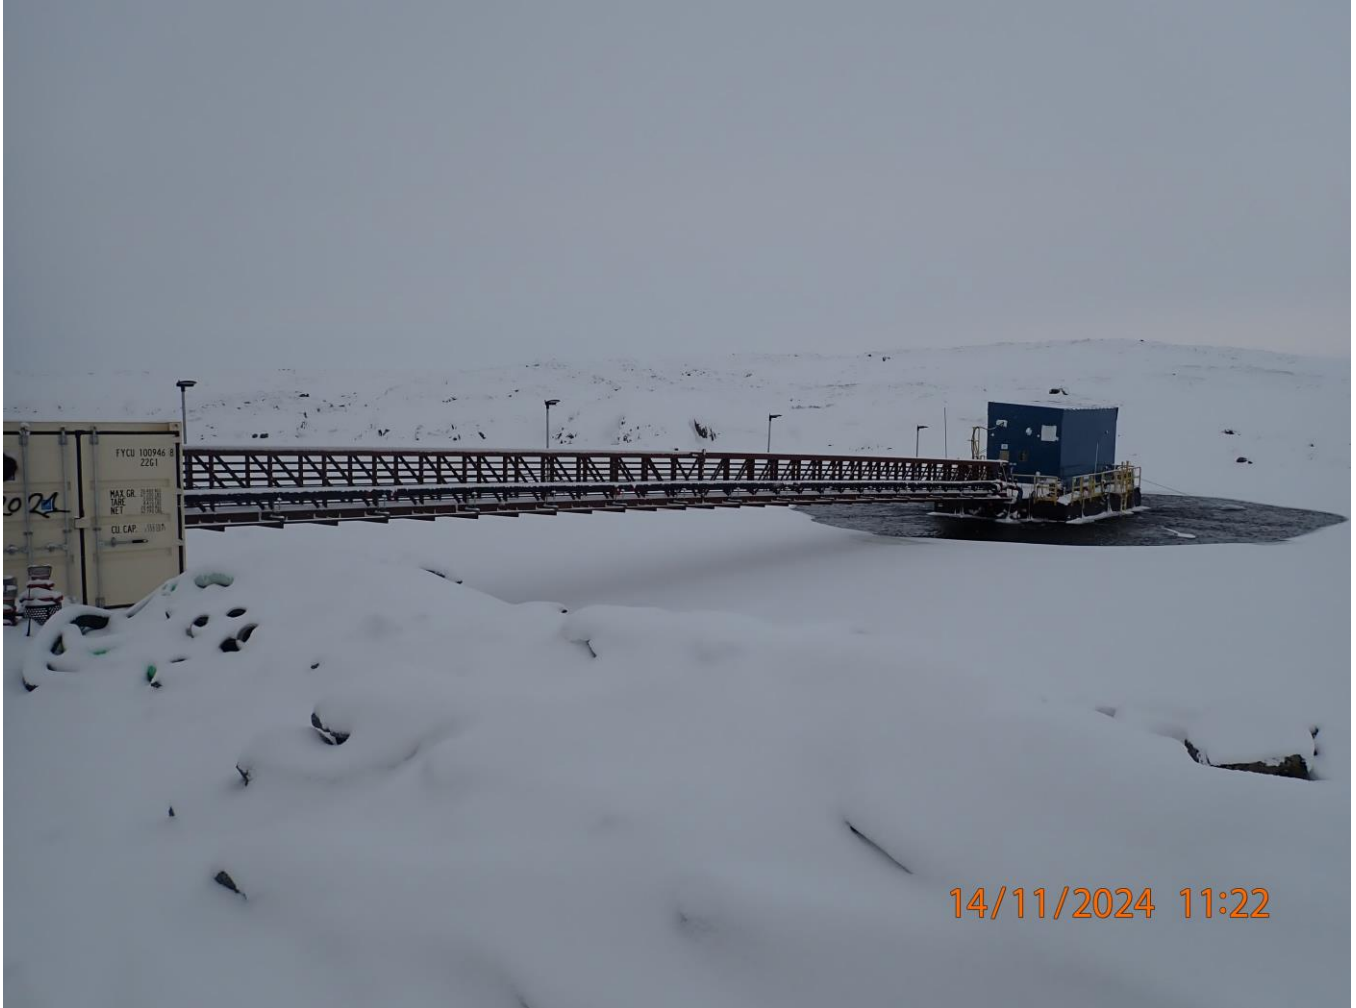
Photo 2

3. The main water source pump house was inspected. (Photo #2) Inspectors noted that there was no flow meter on the water pumps. Chris LeGoffe from B2gold had stated that flow meters were ordered and not yet installed. The camp is using water logs on the water trucks to track how much water is being used in camp. (Photo #3) shows one of the water intake screens.

-No flow meter at the water intake station. Part I Item 3 of Amendment No. 1 of 2AM-BRP1831 states: “The Licensee shall install and

maintain flow meters or other such devices, or implement suitable methods required to measure Water use and Effluent discharge volumes, to be operated and maintained to the satisfaction of the inspector.”

Water intake facility, Main camp.

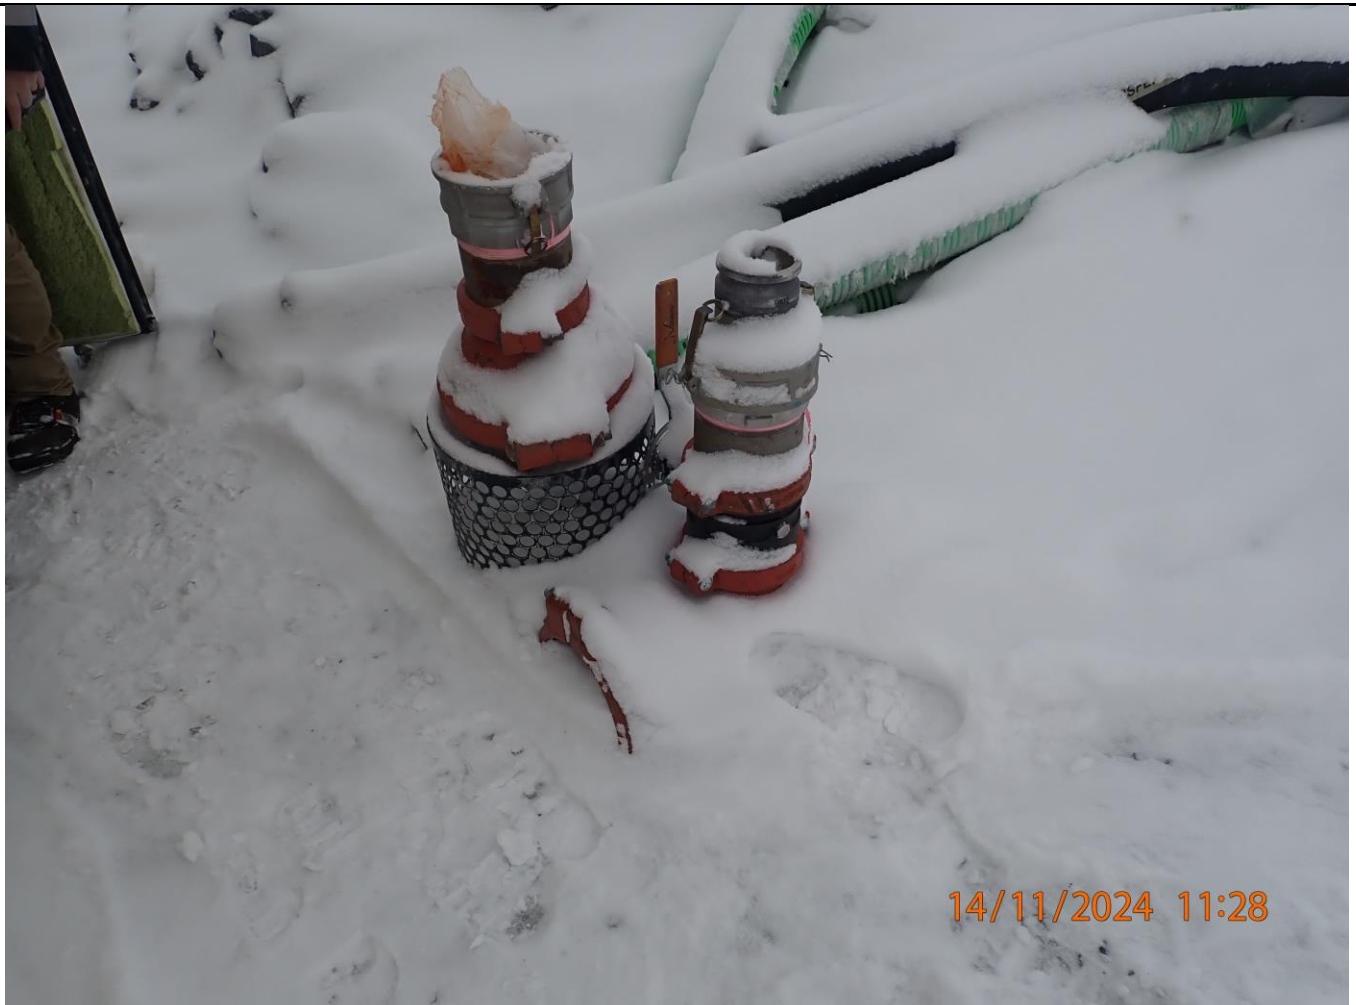
Photo 3

Water intake screen.

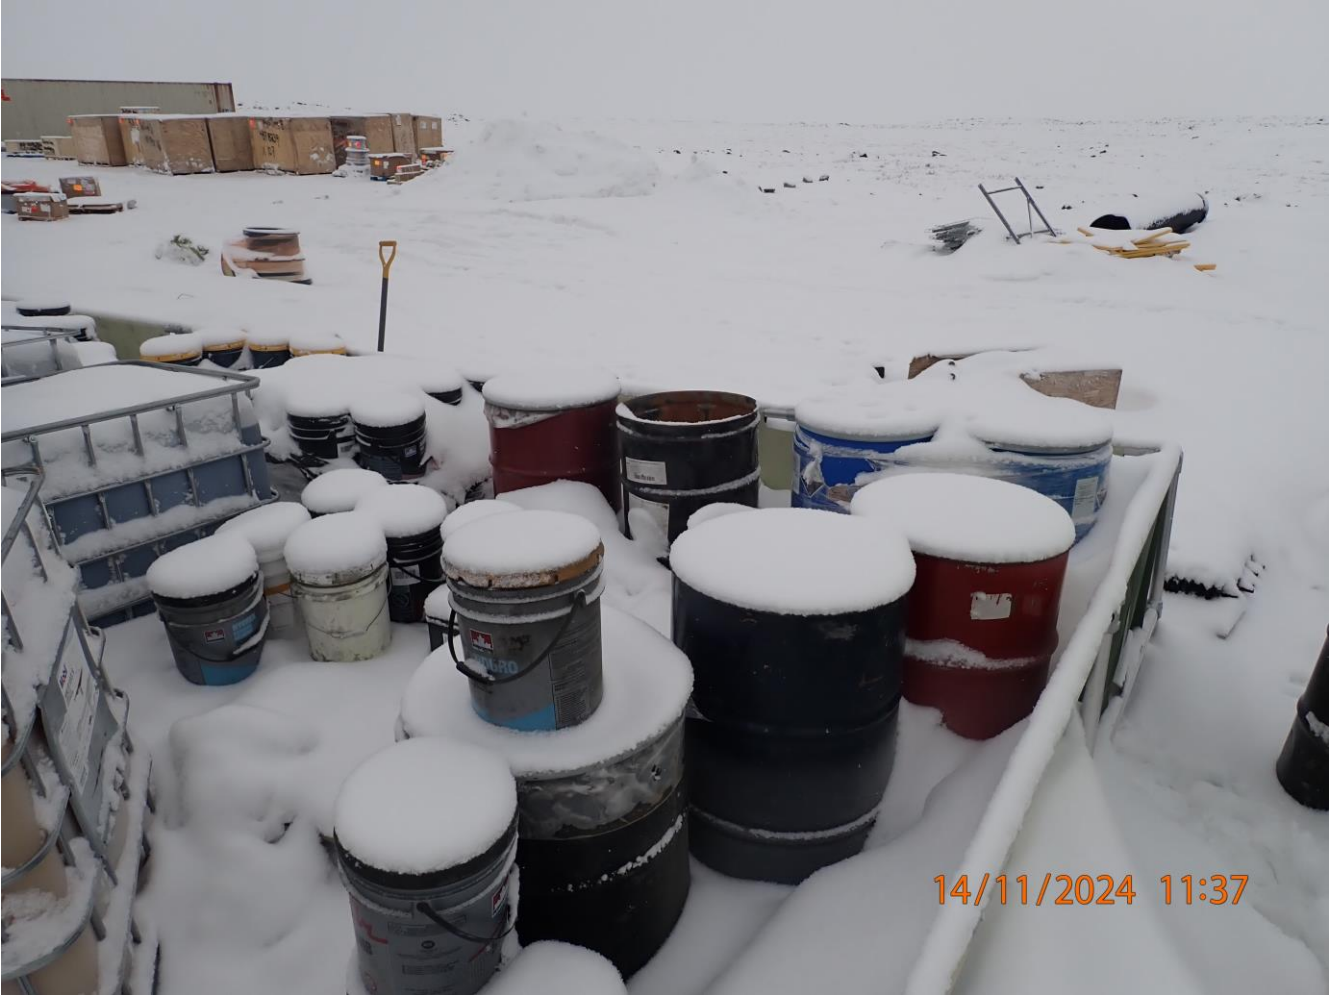
Photo 4

4. Hazardous containment: (Photo #4) shows a drum in secondary containment with no lid. (Photo #5) shows Nexseal 2.0 out of secondary containment and the information on the drum. The information sticker on the drum (Photo #6) shows a corrosive symbol on it and under the Accidental Release Measures it states “Do not allow to enter drains, sewers, or watercourses”.

Open container inside insta berm. Hazardous waste containers shall be sealed from the elements.

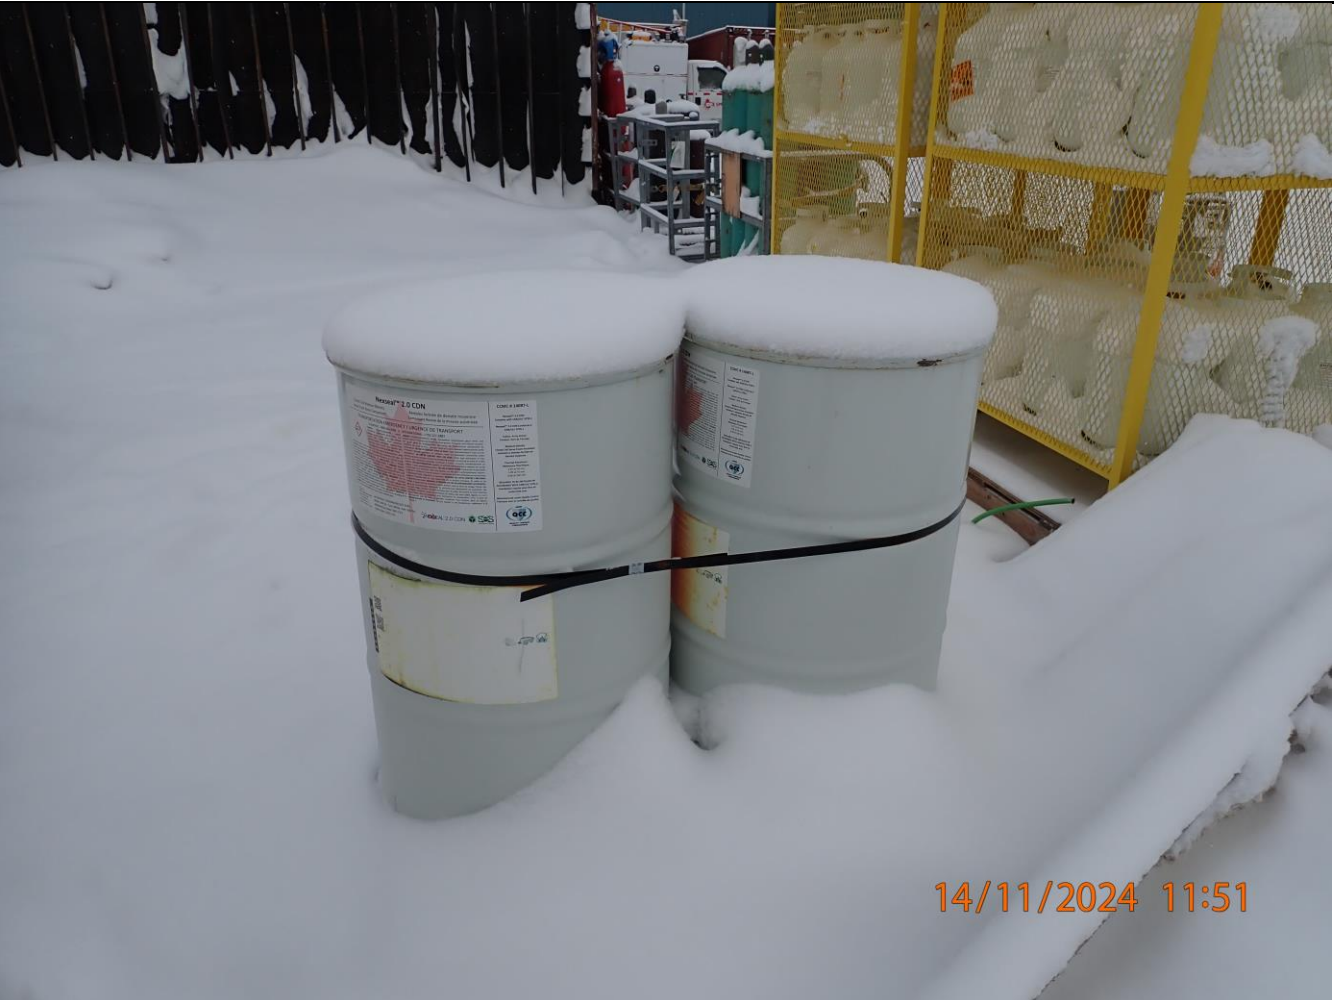
Photo 5

Nexseal 2.0 stored outside of secondary containment

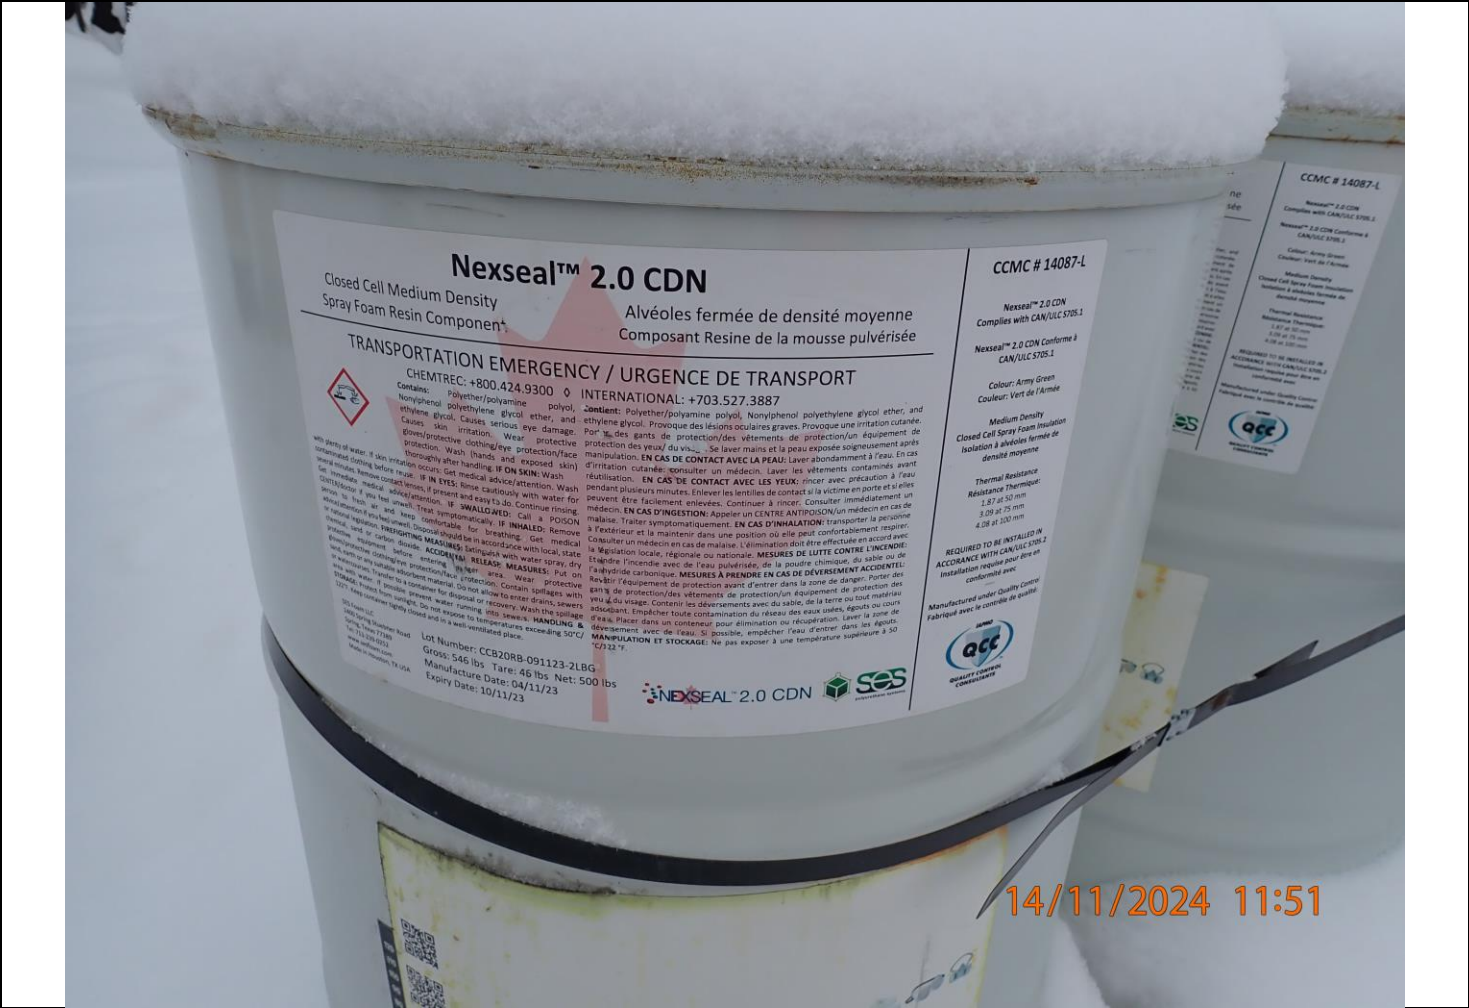
Photo 6

Nexseal 2.0 information sticker, showing corrosive symbol.

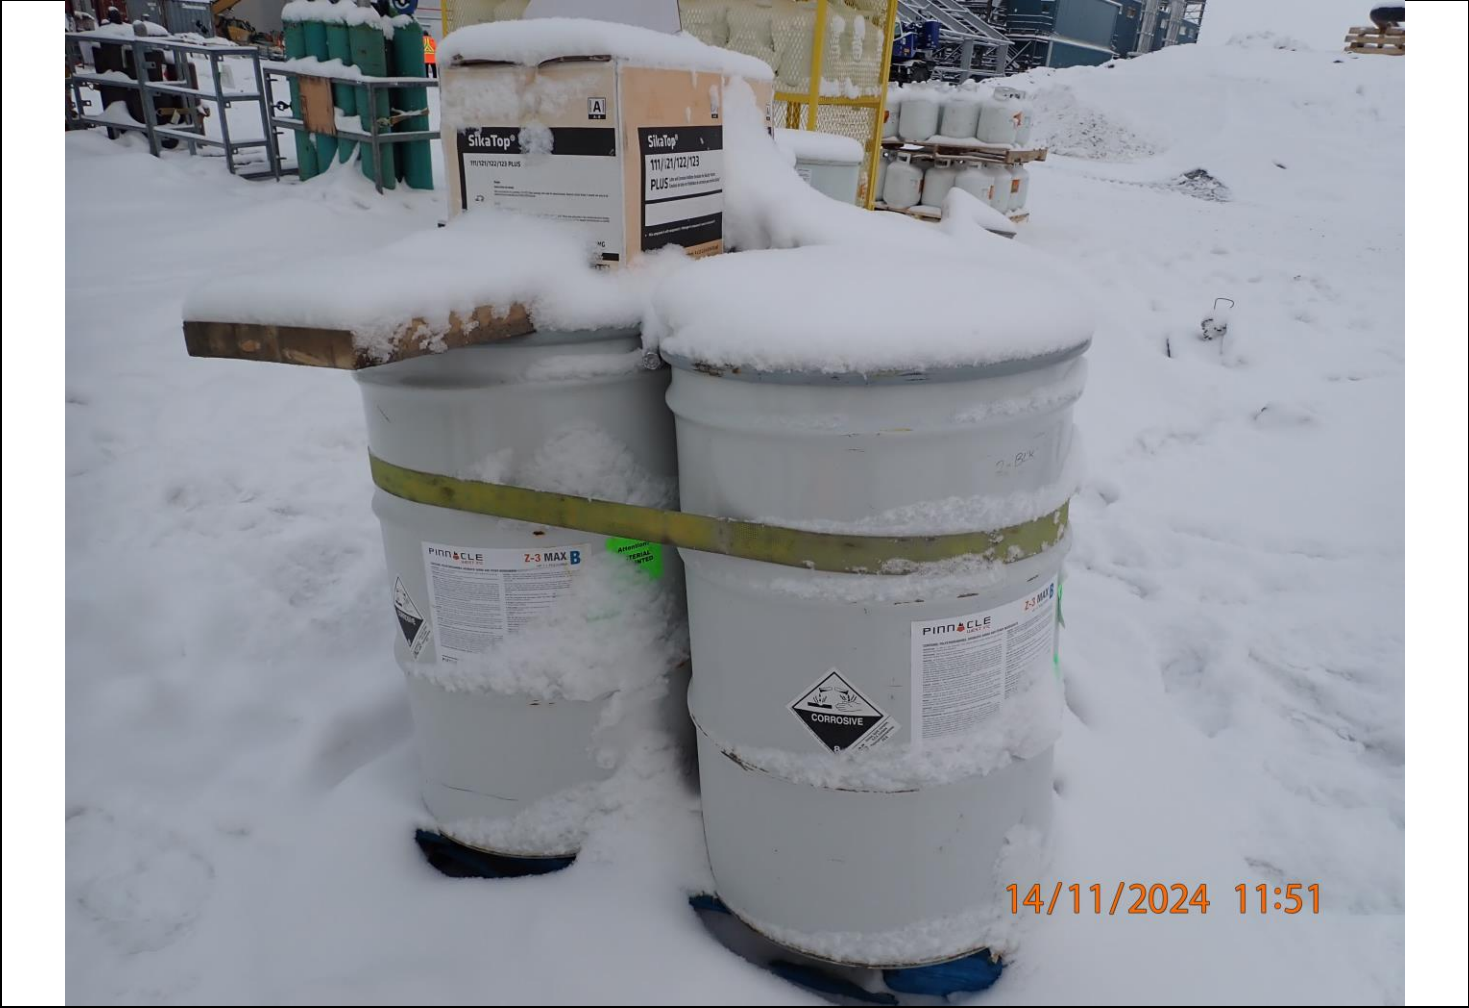
Photo 7

5. Z-3 MAX, a corrosive material, was also observed outside of secondary containment. (Photo #7)

Z-3MAX stored outside of secondary containment, corrosive material sticker shown.

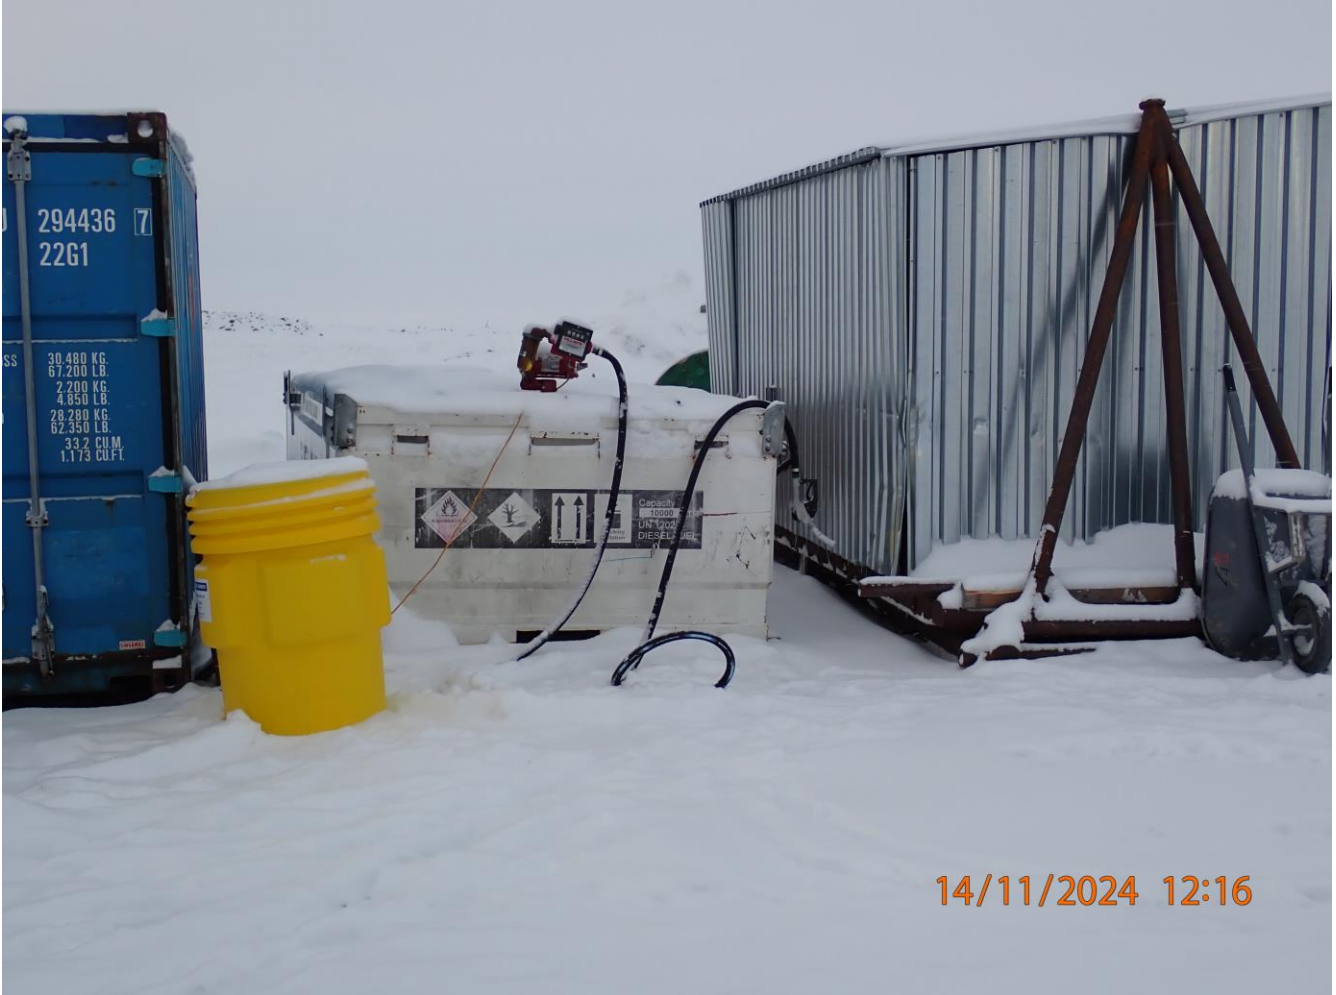
Photo 8

6. Similar to comment #1, A hose from a refuelling station was observed out of secondary containment (Photo #8)

Refueling station hose and nozzle not stored in drip tray. Potential leaks can migrate from connections down the hose and onto the ground.

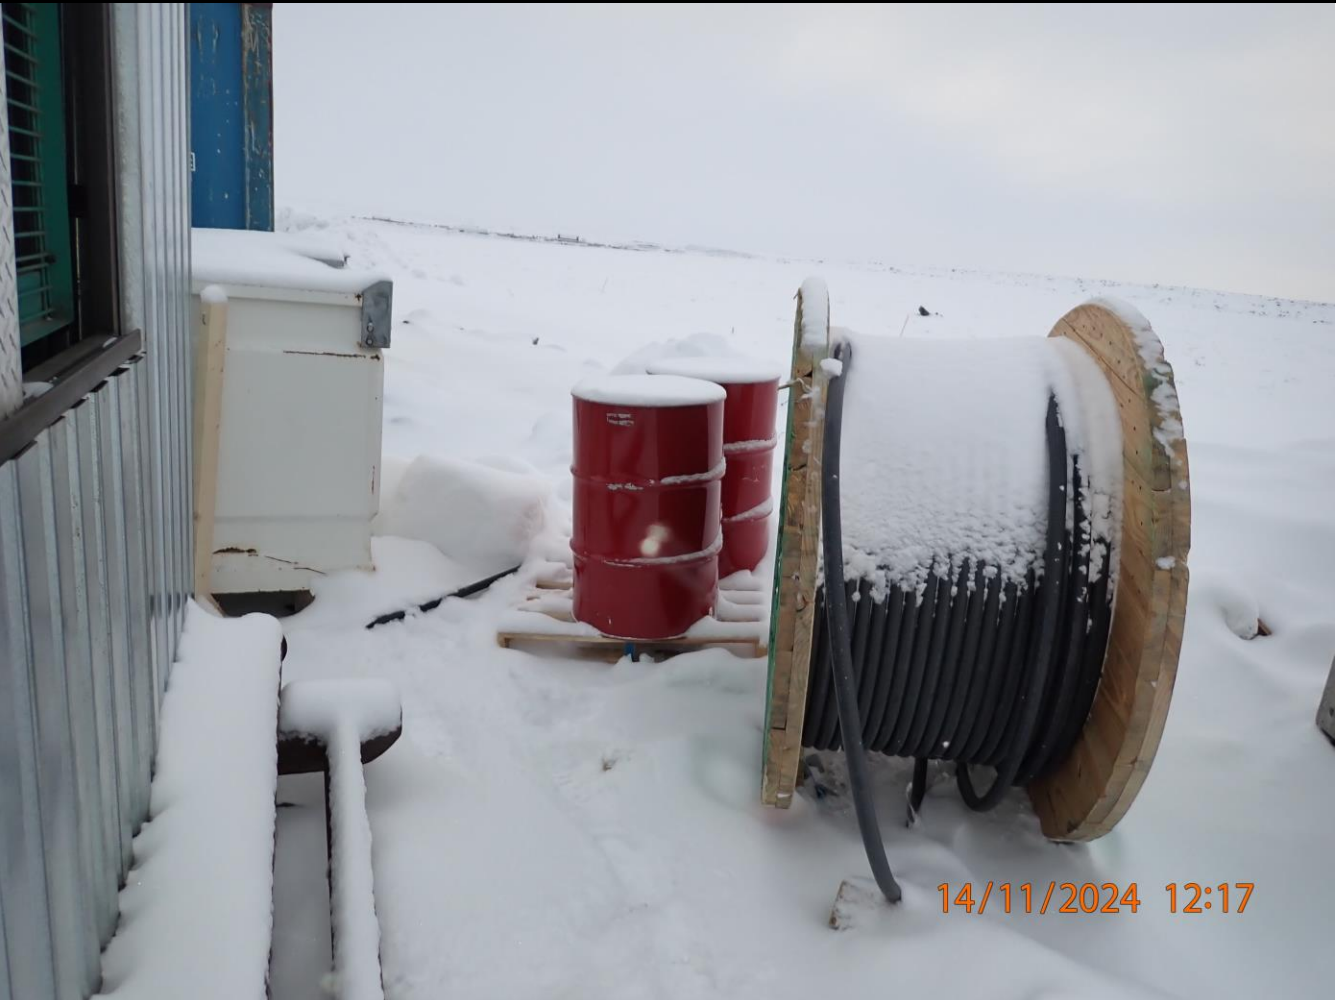
Photo 9

7. At the emulsion plant, 2 drums of gasoline were observed out of secondary containment.

Gasoline outside of secondary containment at the emulsion plant area.

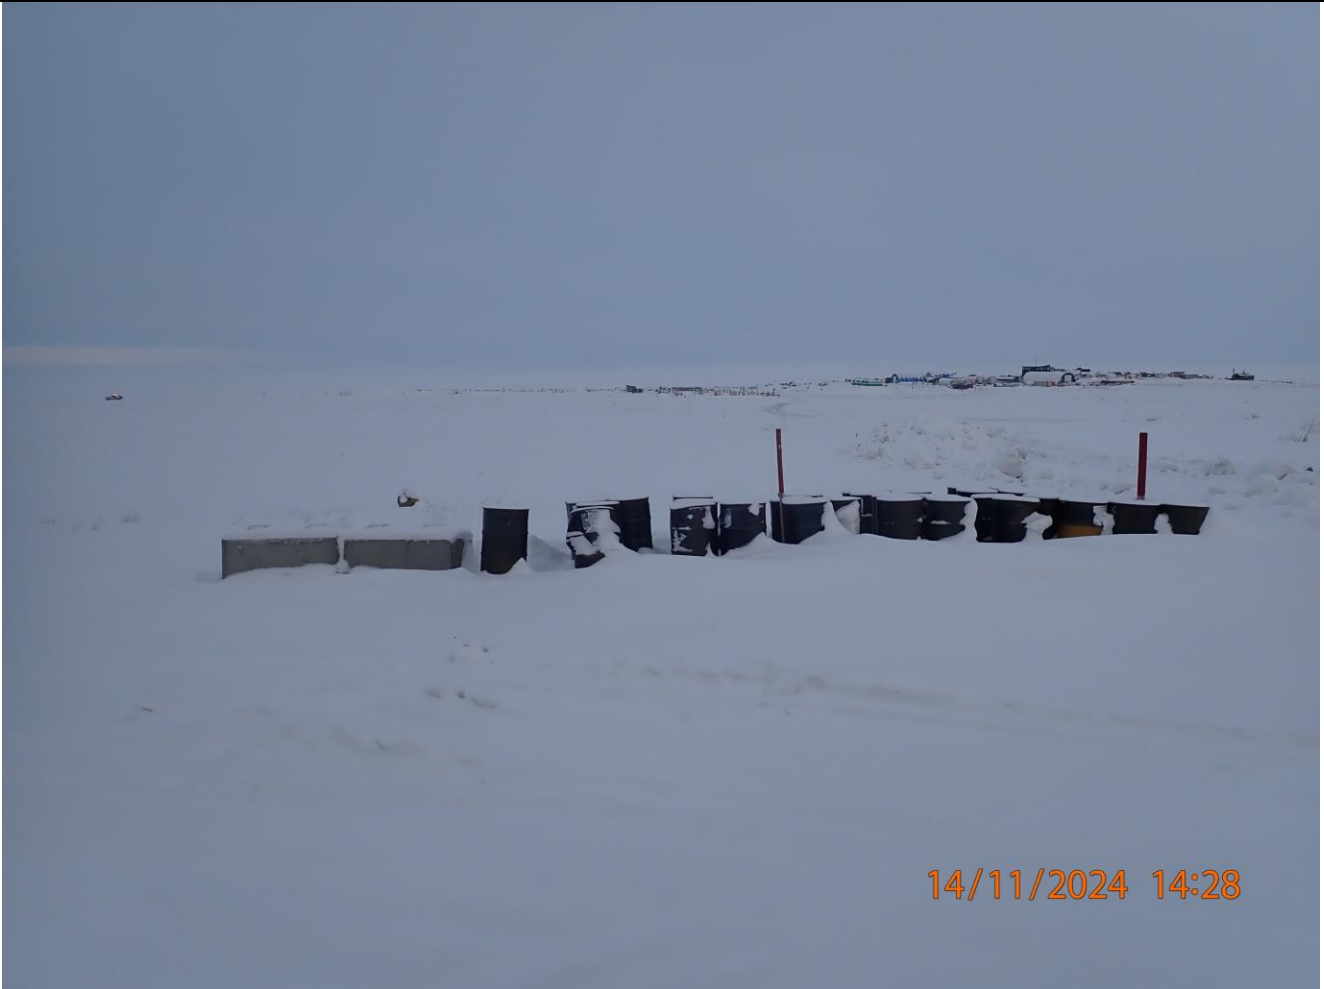
Photo 10

8. Approximately 30 empty drums were observed stored beside the air strip outside of secondary containment.

Empty fuel drums stored beside the air strip.

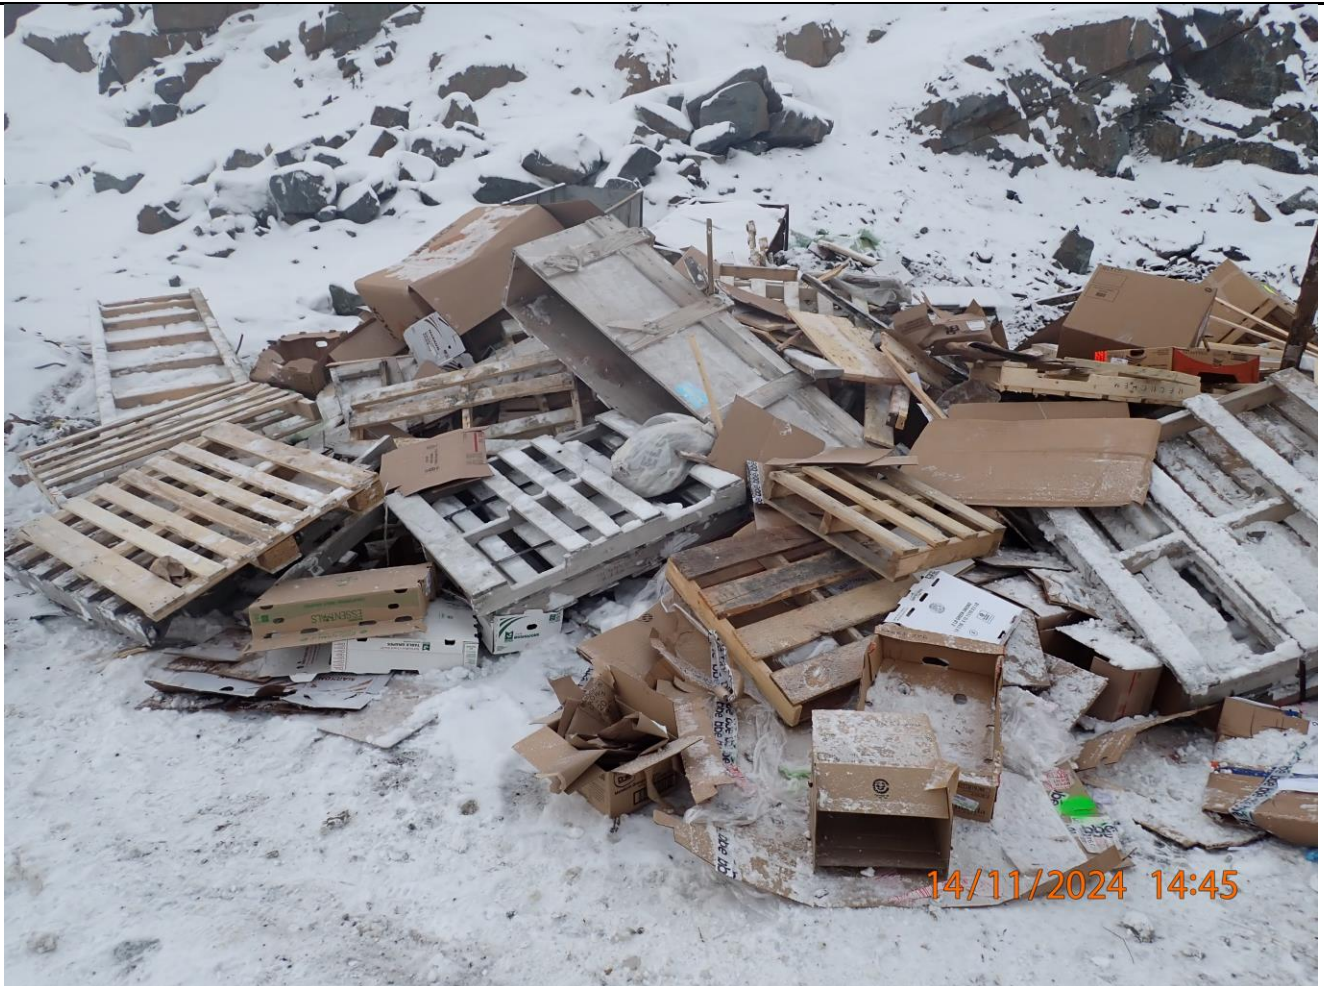
Photo 11

9. The pile of wood and cardboard beside the open burn area was observed to have plastics mixed in with the burnable items. Plastic is not an acceptable open burn item. Non burnable items shall be removed and proper sorting shall be achieved before open burning occurs.

-Non burnable items observed mixed in with burnable materials. (Open burn area) Part F, item 14 of Amendment No.1 of 2AM-BRP1831 states: “The Licensee shall not open burn plastics, wood treated with preservatives, electric wire, Styrofoam, asbestos or painted wood to prevent the deposition of waste materials of incomplete combustion and/or leachate from contaminated ash residual, from impacting any surrounding Waters, unless otherwise approved by the board in writing.”

Wood, cardboard and plastics mixed together at the open burn area.
