Water Licence Inspection Report

Authorization	Representative
Sabina Gold & Silver (B2Gold)	Christoph LeGoffe
Authorization No. / Expiry	Representative's Title
2AM-BRP1831/December 31, 2031	Environmental Superintendent
Inspection Date	Inspector
March 18-20	James Bolt
Other Authorization/s	
2BE-GOO2028, 2BE-GEO2025, 2BE-MLL2328, N2024C0024, N2024F0027, Goose Lease 076G9-1-2, MLA Lease 076J12-7-2	
Activities Inspected	
<input type="checkbox"/> Municipal <input type="checkbox"/> Camp, Commercial <input type="checkbox"/> Drilling <input checked="" type="checkbox"/> Mining <input type="checkbox"/> Construction <input type="checkbox"/> Reclamation <input checked="" type="checkbox"/> Fuel Storage <input checked="" type="checkbox"/> Roads/Hauling <input checked="" type="checkbox"/> Winter Hauling <input type="checkbox"/> Camp, Private <input type="checkbox"/> Other Click or tap here to enter text.

On March 18, 2025 Resource Management Officer Isaiah James Bolt (Inspector) for Crown Indigenous Relations and Northern Affairs Canada (CIRNAC), conducted an inspection of 2AM-BRP1831 (License) issued to B2Gold (Proponent) to ensure compliance against their license.

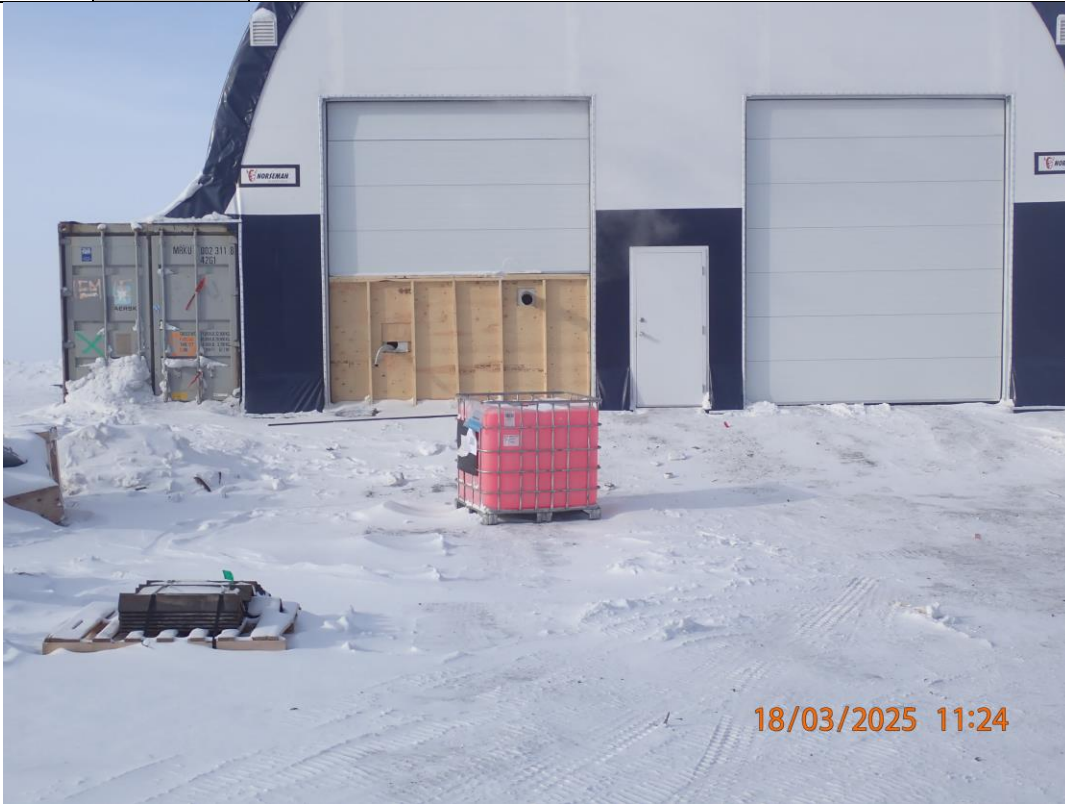
Photo # 4 Coordinates:

2. The totalizer at the water intake barge had been observed and photographed.
3. 1000L totes were observed stored outside of containment throughout the project (Photo #4,#7,#19,#21). (Photo#20 shows a stack of secondary containment designed for 1000L totes that are unutilized.)

1000L Tote outside of containment

- Ensure all fuel and oil vessels are placed in secondary containment.
- Ensure heating fuel on stands are placed in appropriate secondary containment.
- Ensure segregation of metals from open burn material and place in landfill or haul off site if required.
- Clean up and store contaminated soils from truck shops/garages to ensure contaminates/hydrocarbons are not making their way into the environment.
- Ensure all contaminated snow around site is consolidated and stored appropriately for treatment.
- Ensure signage is present on all discharge locations/sampling sites/monitoring stations.

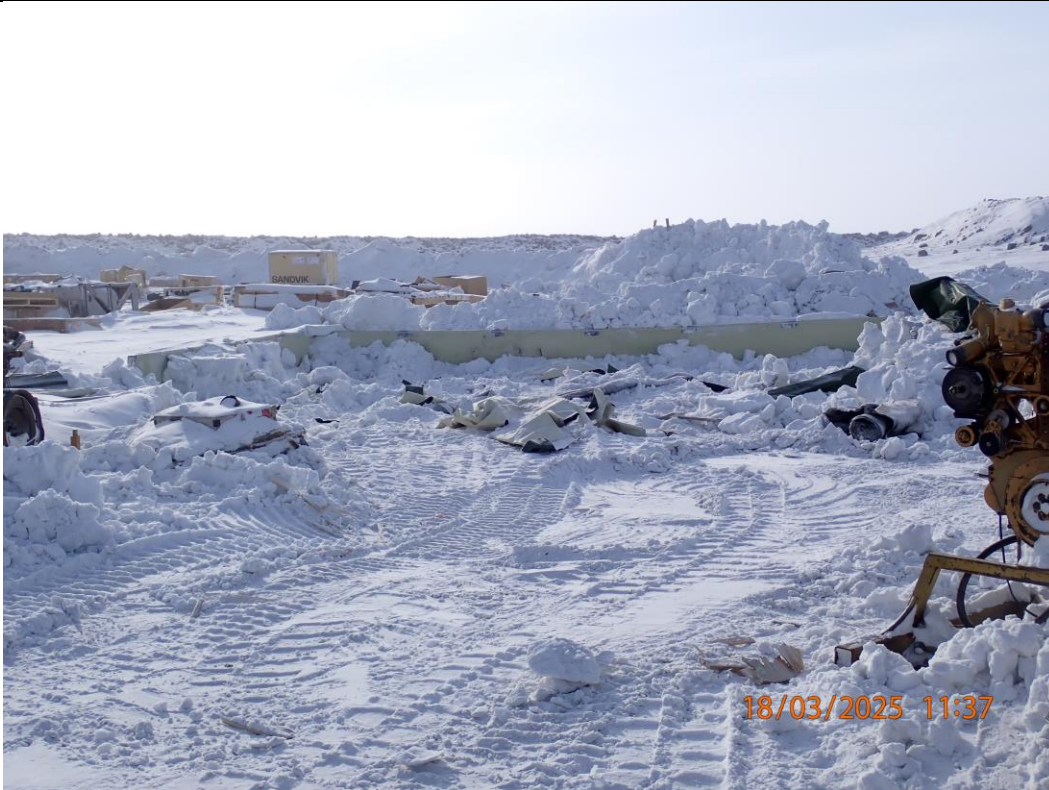
Photo # 6 Coordinates:

5. A large insta-berm had been emptied of all stored product and demobilized. Snow and pieces of the berm were observed inside the berm still (Photo #6)

Insta-Berm demobilization

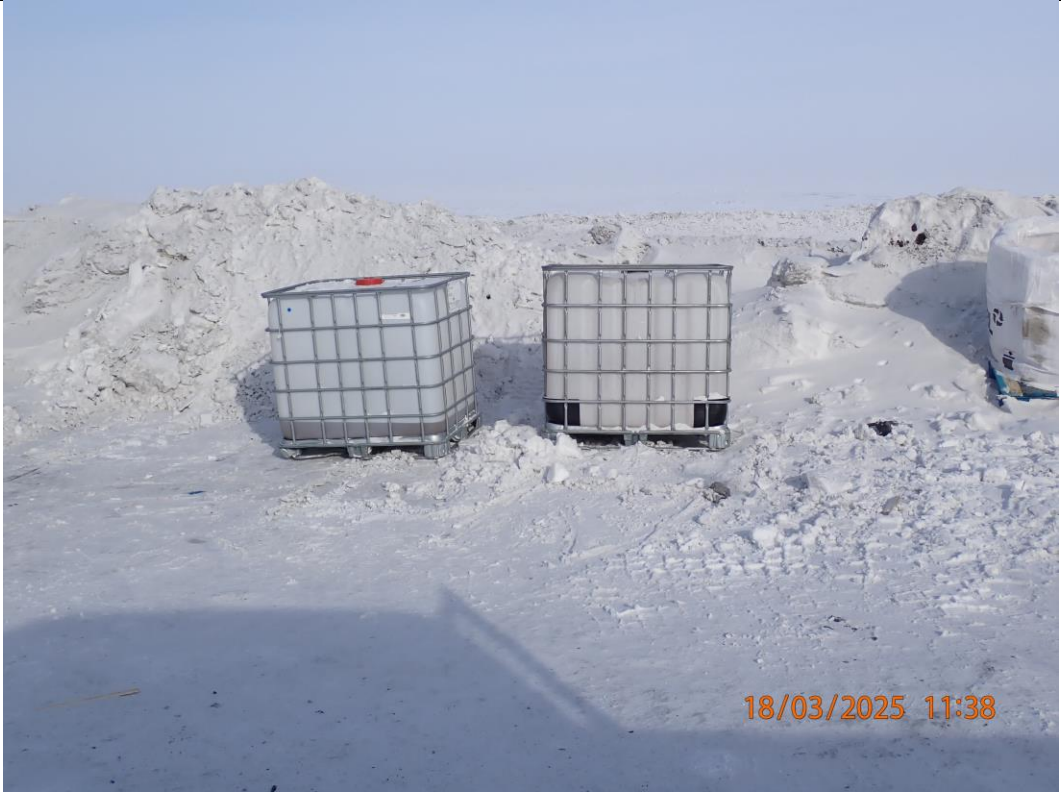
Photo #	7	Coordinates:	
---------	---	--------------	--

Totes outside of containment. Left side has product in it.

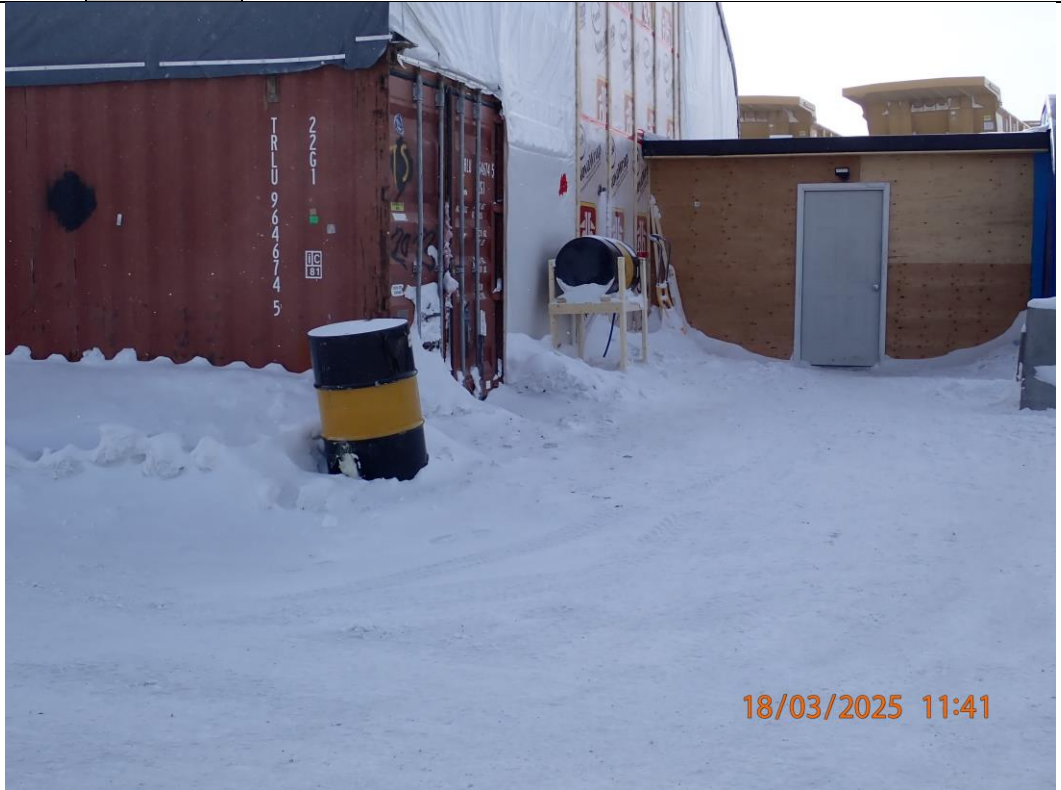
Photo #	8	Coordinates:	
---------	---	--------------	--

6. 45 gallon drums were observed on wooden stands with no secondary containment under them. Leaks from the drums hose connections have been observed. Outside the mine ops building a similar structure was observed and also another 45 gallon drum was observed sitting on the ground (Photo #8)

45 gallon drum on a wooden stand outside of containment. In the foreground, a drum outside of containment on the ground.

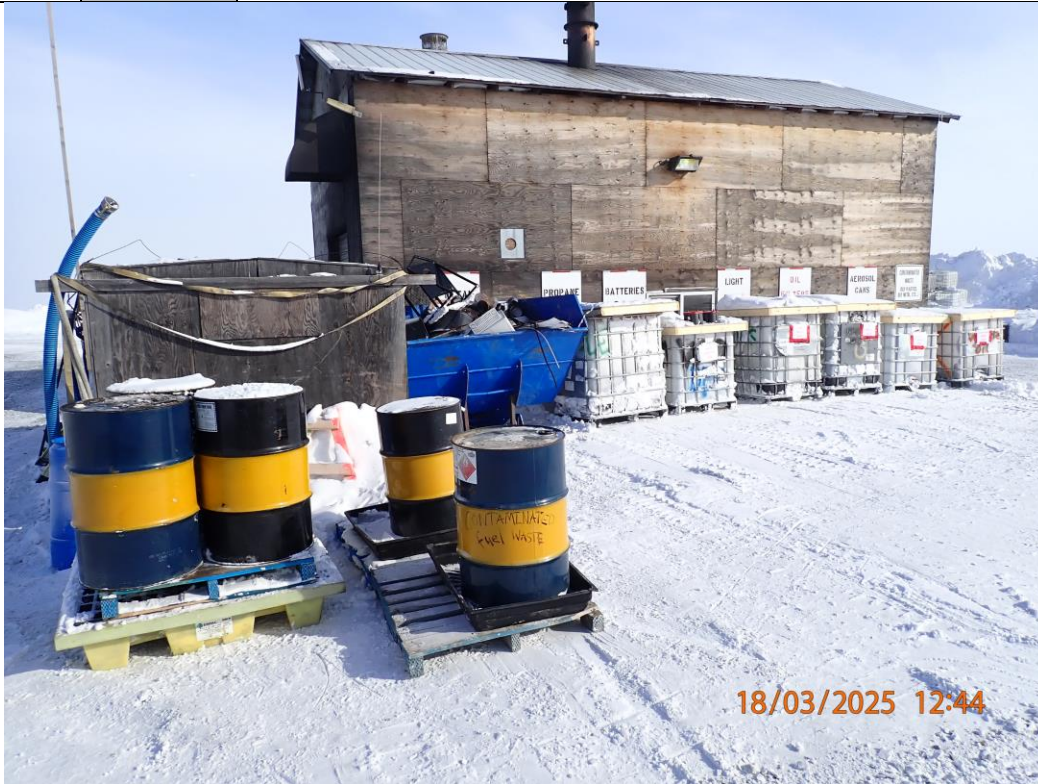
Photo # 9

Well organized sorting area at the incinerator beside the exploration camp.

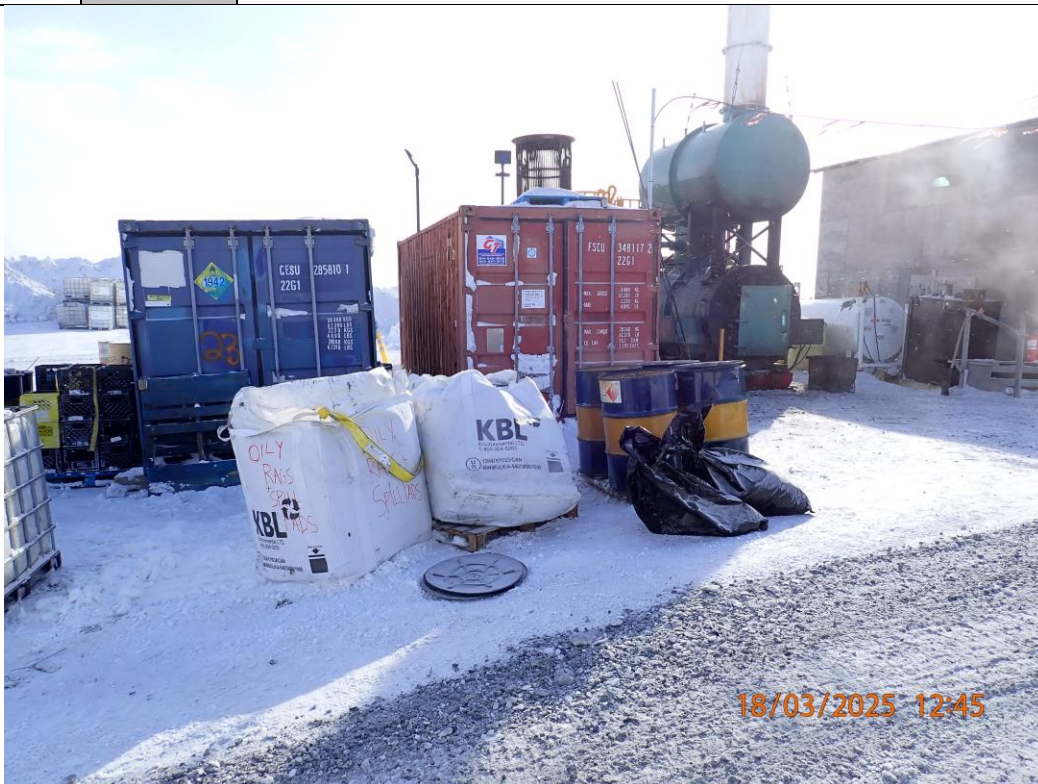
Photo # 10

7. The waste sorting at the incinerator is well organized.(Photo #9) Although, open containers were observed, trash bags were observed on the ground (Photo #10), and pieces of burnt materiel were observed on the ground. At the time of inspection a red fox had come up beside the incinerator, picked up an unknown item and walked off with it (Photo #11).

Open ash barrels, open oily rag quatrix bag and black trash bags on the ground.

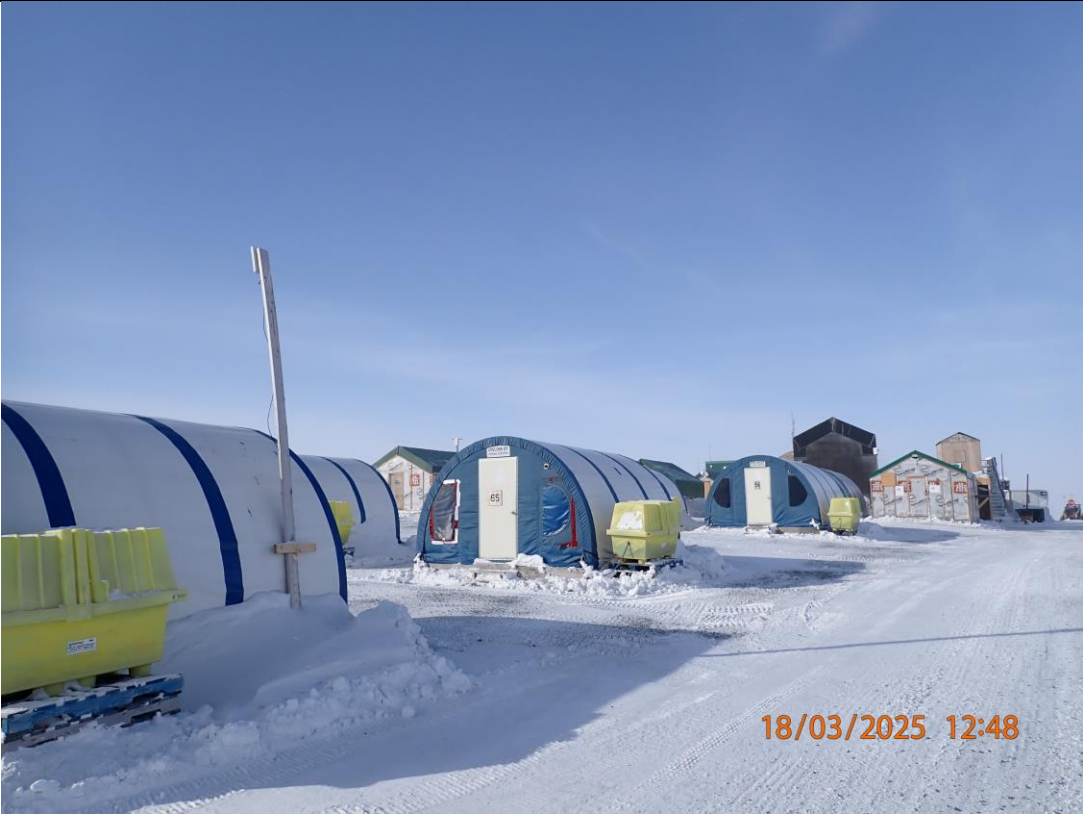
Photo #	12	Coordinates:

8. Exploration site has the best secondary containments I've seen around the project. The entire 45 gallon drum/stand are encapsulated in a hard plastic berm with a plastic top. This kind of containment should be considered for in all areas that use 45 gallon drums on stands as a source of fuel for heaters (Photo #12).

Description: Exploration camp accommodations, showing their heating fuel stands that are secondarily contained and covered.

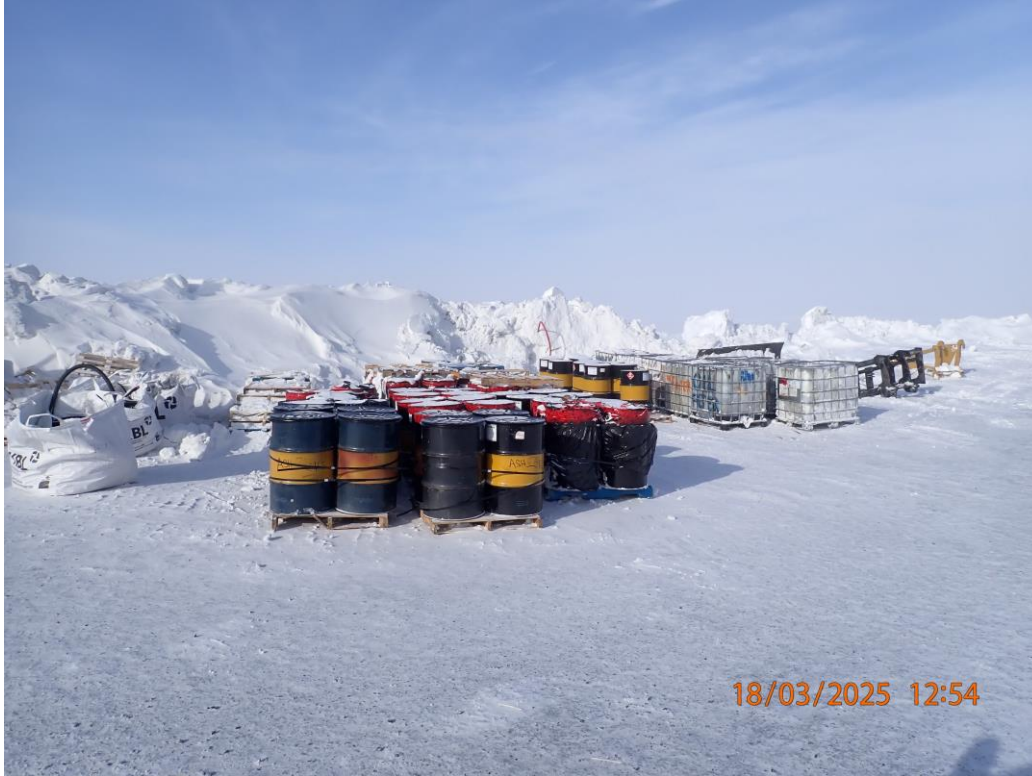
Photo # 14

10. Hazardous waste that is planned for removal from site sits on pallets near the terminal (Photo #14). Pallets should be placed in a secondary containment berm.

Ash barrels and 1000L totes out of containment outside of the airport terminal.

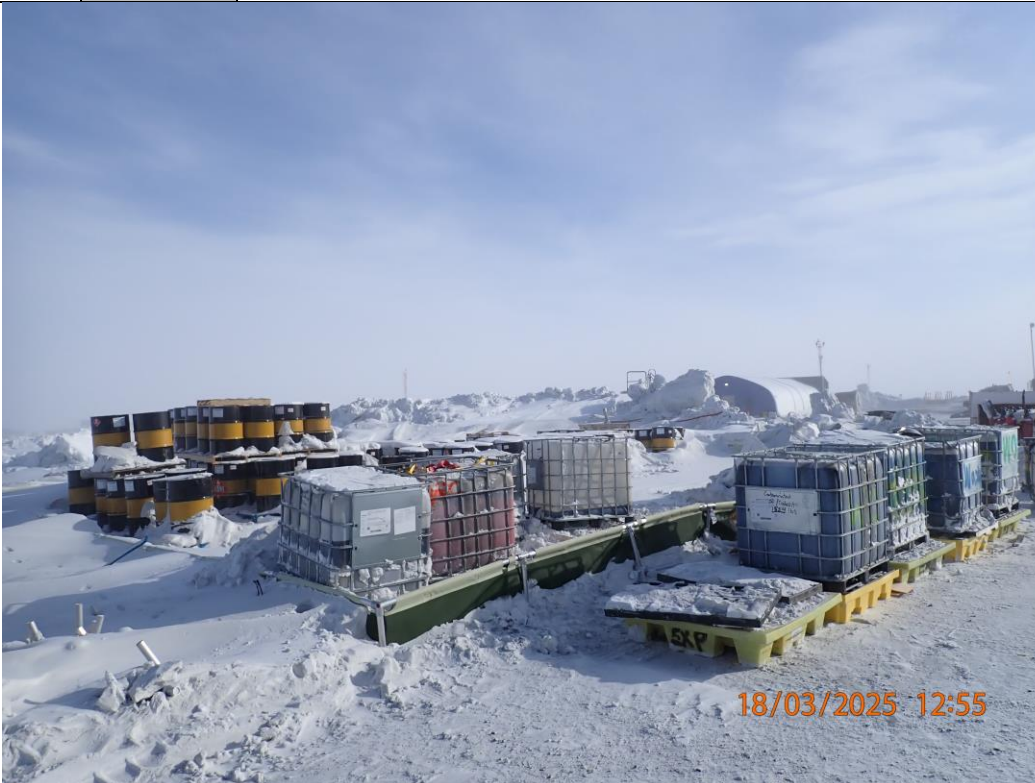
Photo # 15

11. The insta berm located beside the air strip was observed and photographed (Photo #15). A lot of snow has built up inside the berm. Chris LeGoffe had mentioned that the berm did have a hole in the bottom, but it had been patched. Inspector Bolt had mentioned that it should be monitored for leaks during freshet and changed out if required.

Insta-berm filled with various fuels/oils. Snow accumulation in the berm and patched hole in the bottom cause concern.

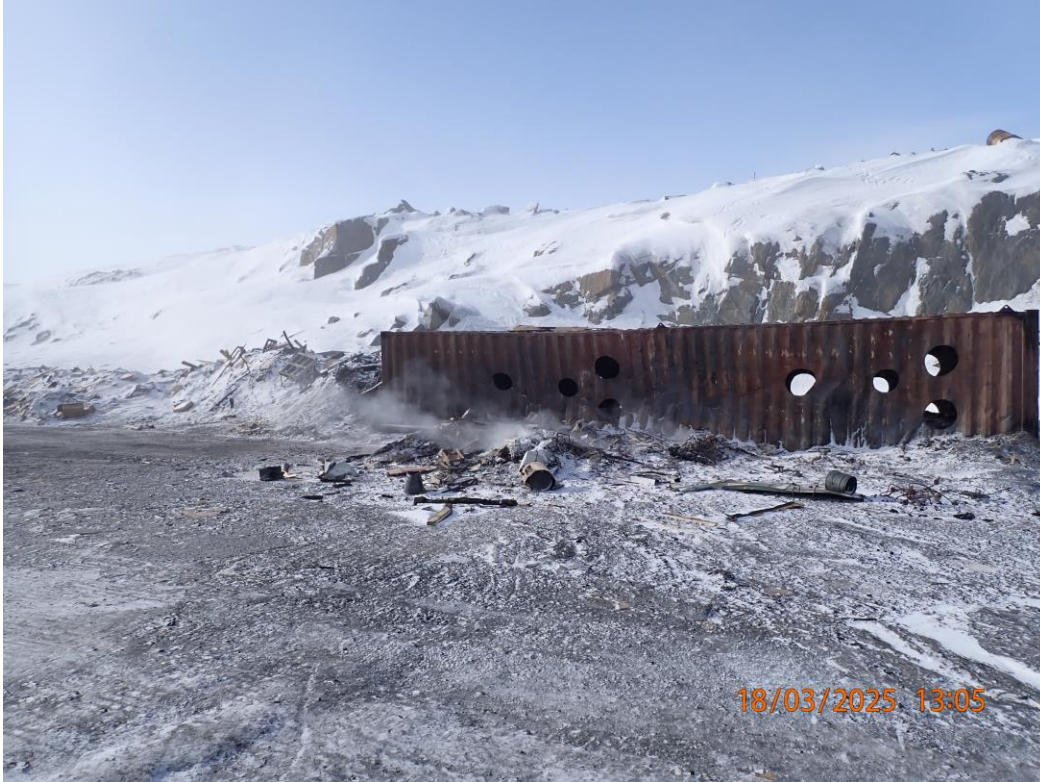
Photo # 16

12. At the open burn facility less plastics were observed in the waste pile. Although, Inspector Bolt noted that a lot of metal debris was observed to be burned as well (Photo #16).

3. Metals in the open burn area. -Part F, Item 8 of Amendment No.1 of 2AM-BRP1831 states: *"The Licensee shall, for all Project related non-hazardous solid Wastes, backhaul to a licenced facility, dispose of and contain at the Landfill, or dispose of as otherwise approved by the Board in writing."*

Open Burn Area. Metals are observed mixed in with burnable items.

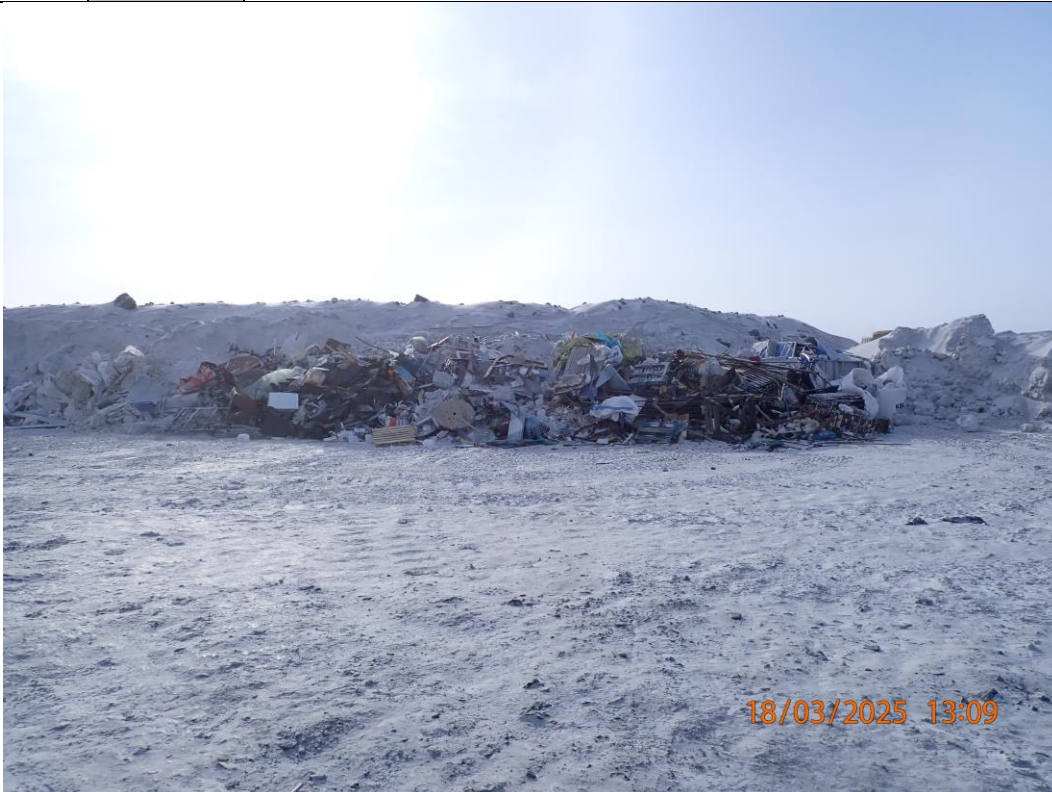
Photo # 17

13. Landfill Cell #2 was observed, no concerns noted (Photo #17).

Cell #2 active landfill.

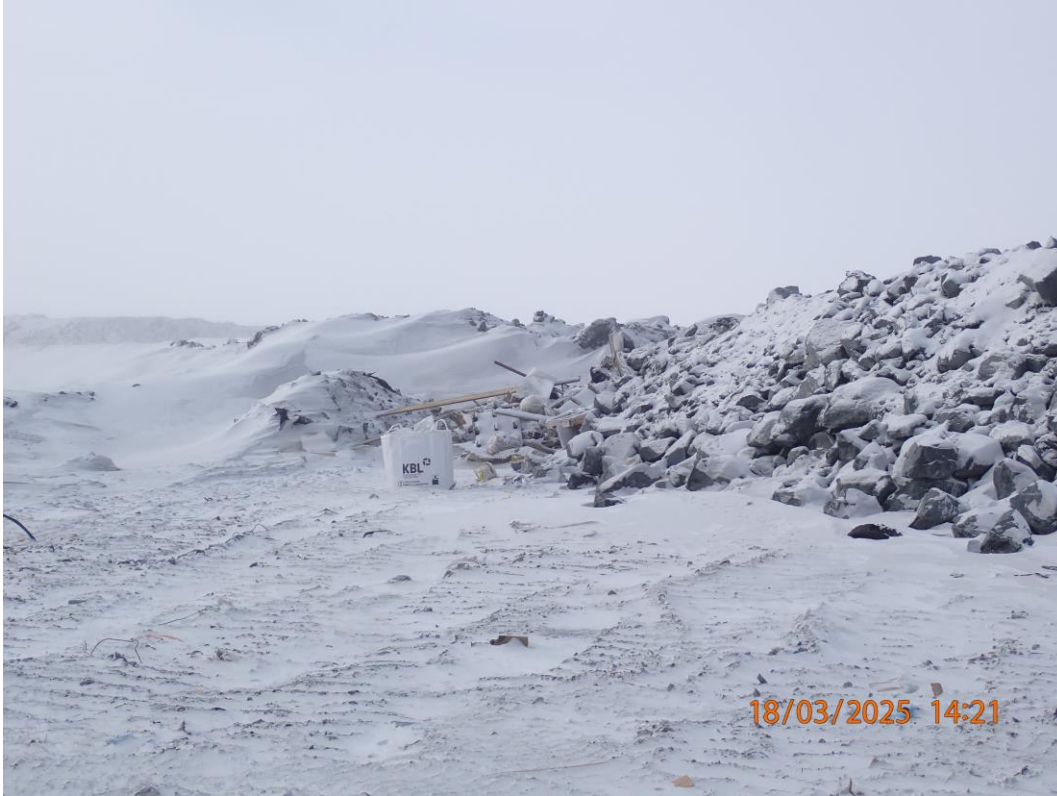
Photo # 18

14. Landfill Cell #1 was also observed and photographed. At the time of inspection there were still some garbage left uncovered at the end of the capped landfill (Photo #18).

Cell #1, closed landfill. Showing garbage still exposed.

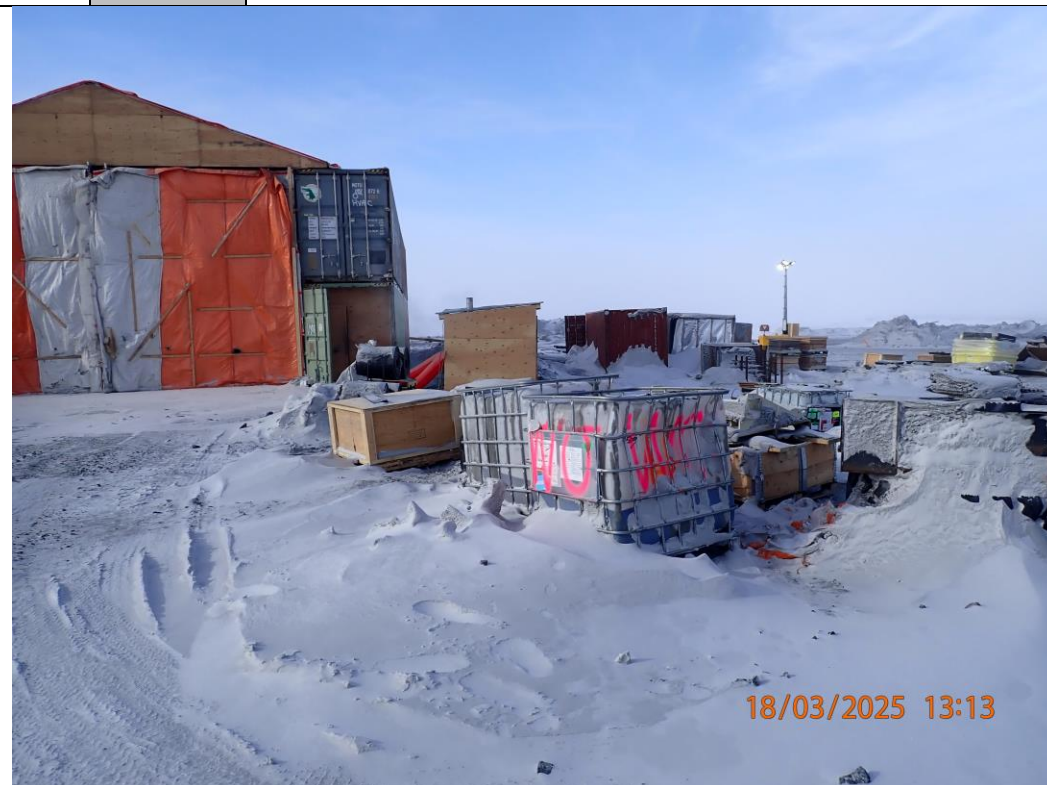
Photo # 19

1000Litre totes stored out of containment. Secondary containment platforms seen on the right of the image.

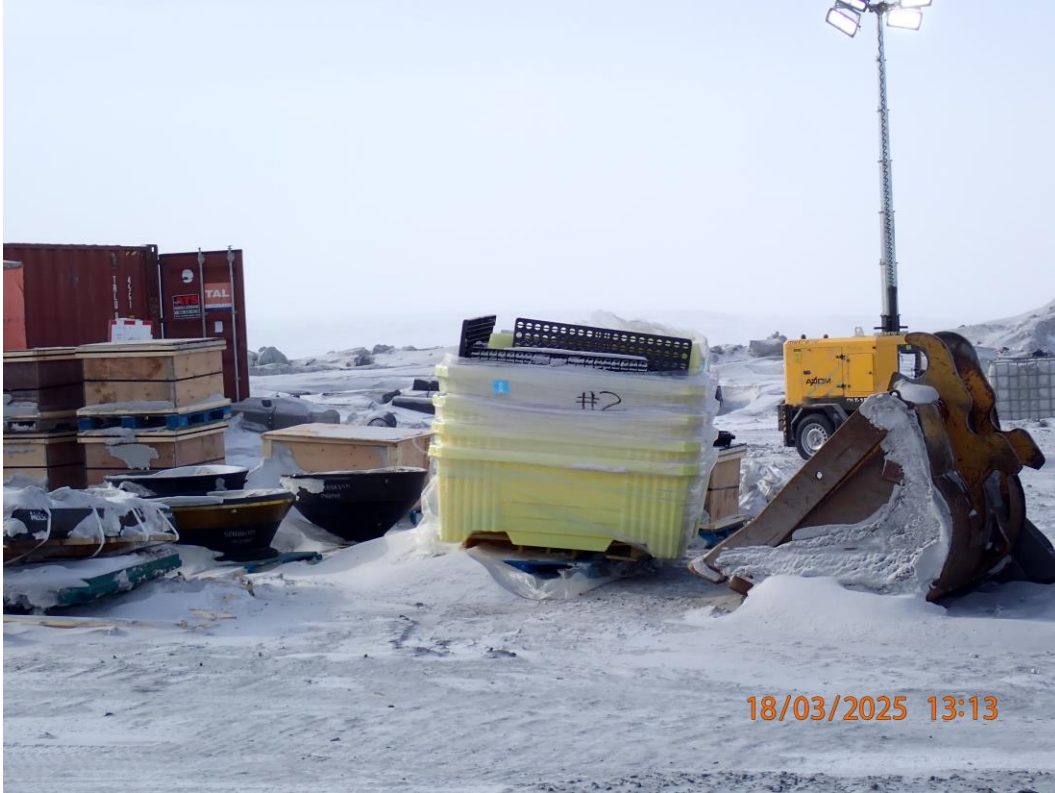
Photo # 20

1000L secondary containment not being utilized.

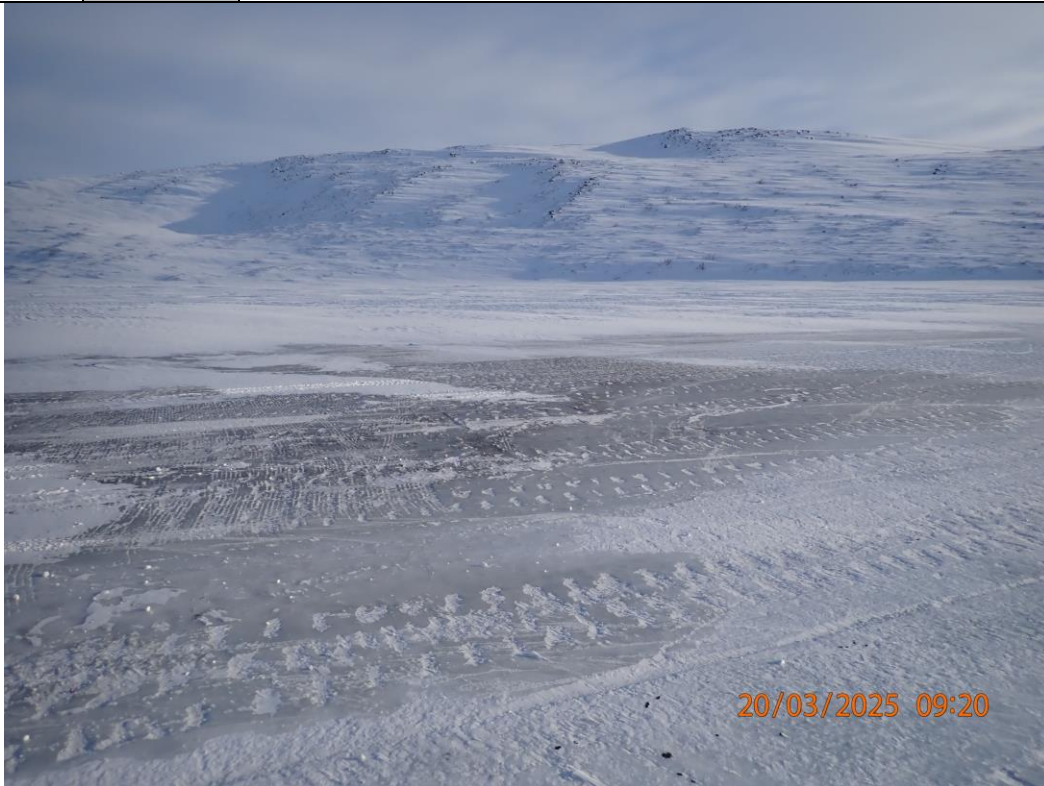
26

Location of the tanker truck fire. Water used to extinguish fire observed on the ice.

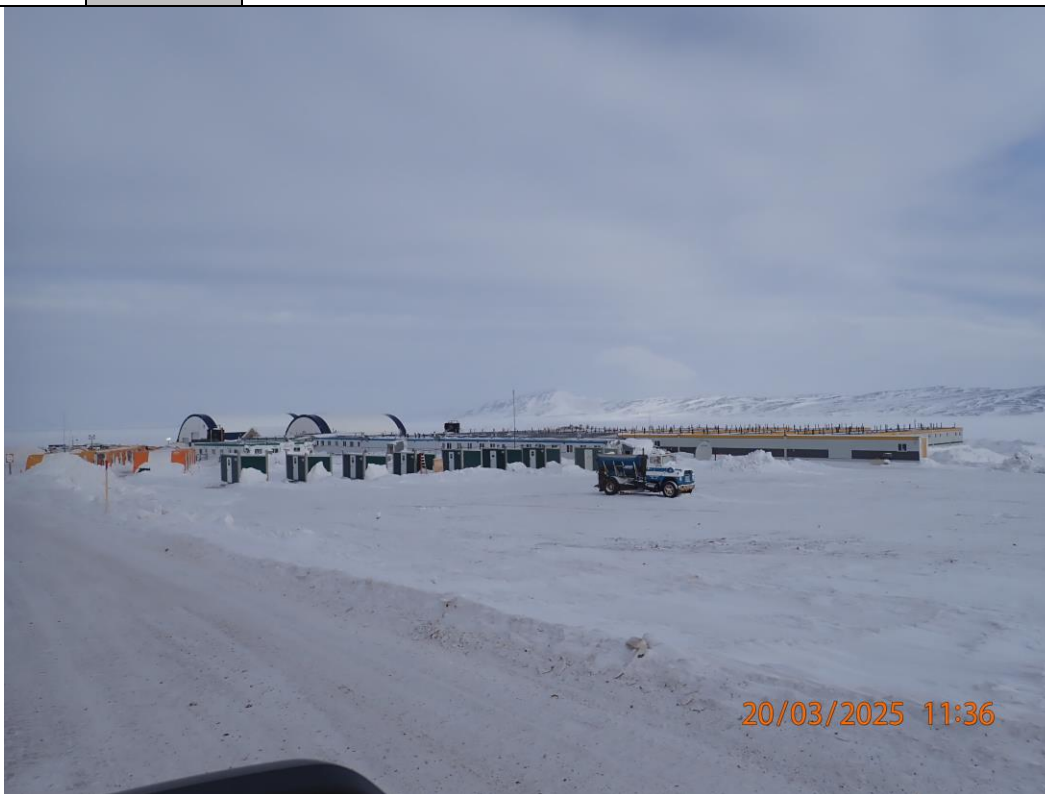
Photo # 28

17. MLA camp had increased in size since the last visit. A large kitchen, more accommodations and more washroom facilities have been connected to the old accommodation buildings (Photo #28). New buildings have yellow trim, old buildings have blue trim.

MLA observed from beside the airstrip. Blue trim is old accommodations, Yellow trim is new buildings.

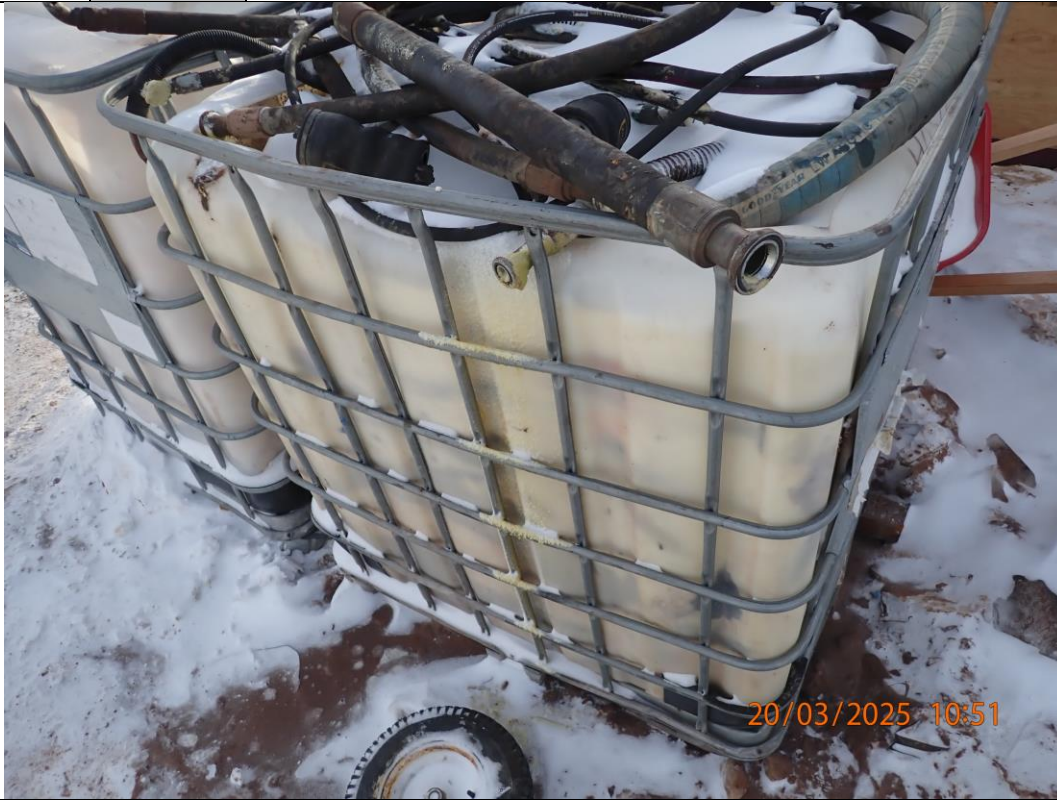
Photo # 32

21. Also behind the truck shop were 1000L totes that have been cut open for us as a bin. In the 1000L were hydraulic hoses. One of the hoses was sticking out of the top of the tote and leaked hydraulic fuel onto the ground and the side of the tote (Photo #32)

1000L tote used as a bin for hoses showing signs of leaking hose onto the side and ground.

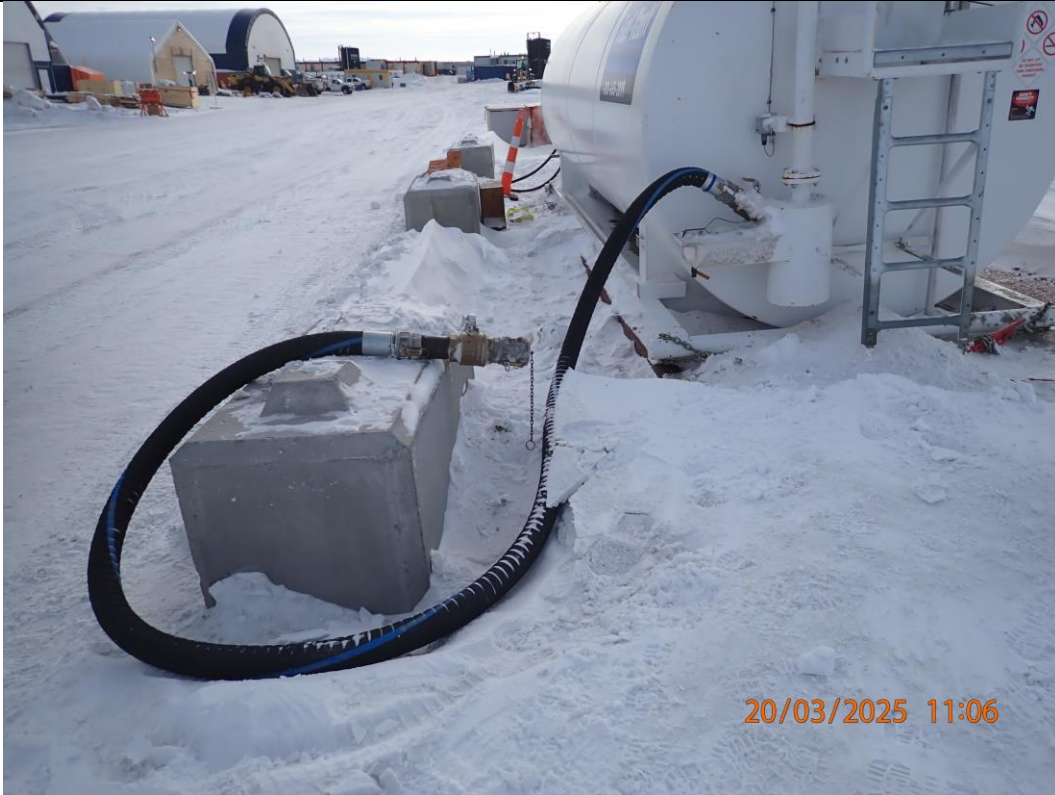
Photo # 33

Heavy Equipment refuelling hose with no drip tray. This hose had signs of a leak at the connection to the tank.

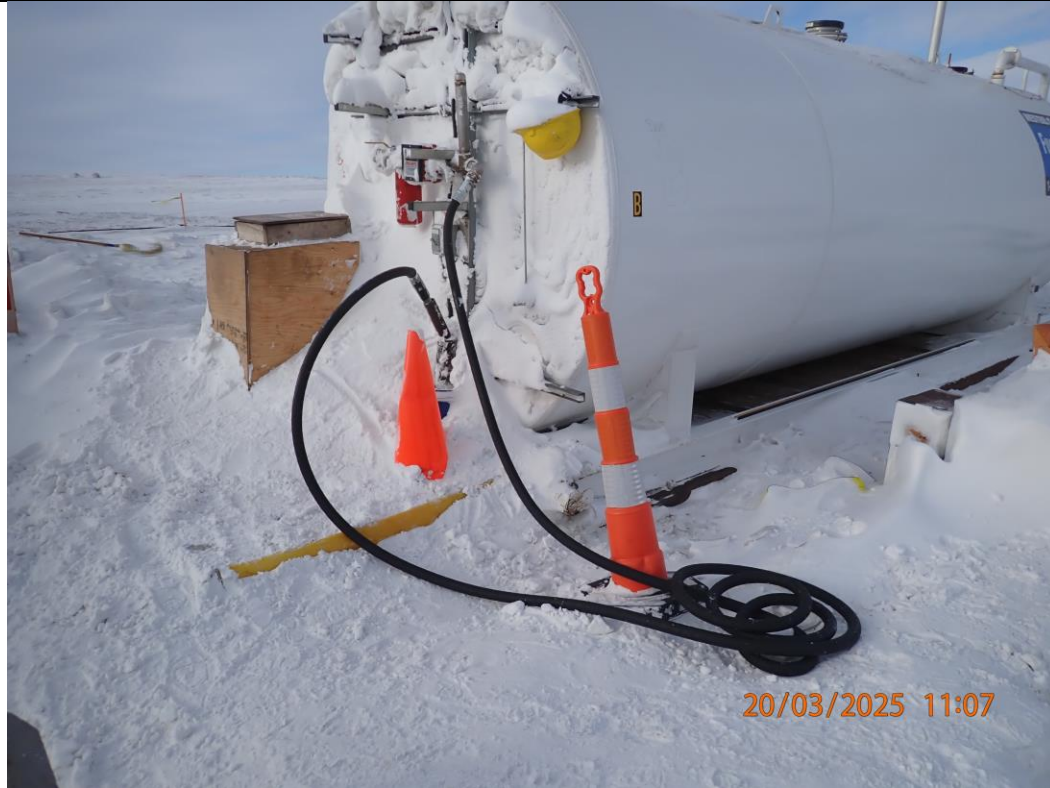
Photo # 34

22. Refuelling locations at MLA had a lack of spill trays at the time of inspection. A refuelling station in MLA camp had shown signs of leaking connections on the heavy equipment hose (Photo#33). (Photo #34 is of the same fuel tank but showing the light vehicle fuel pump and its respective hose on the ground not in a spill tray).

A light vehicle refuelling station. Secondary containment/drip tray buried in snow, hose out of drip tray.

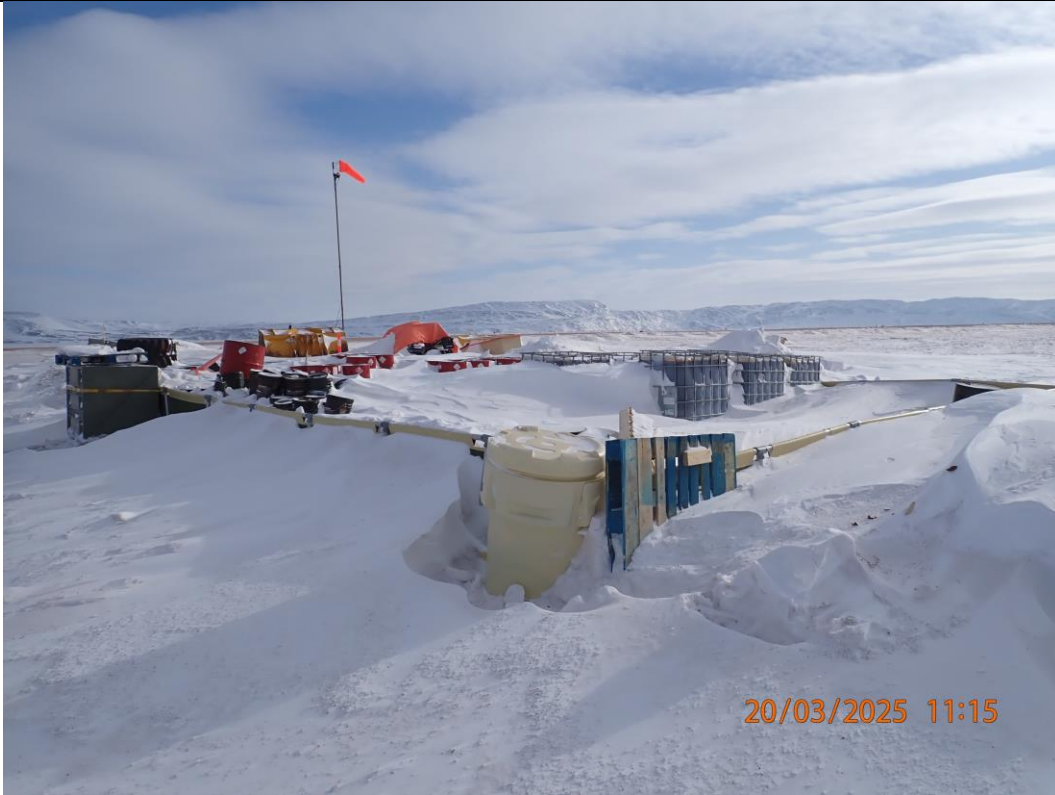
Photo # 35

23. An Insta-berm was observed on the south side of the airstrip on the north side of the tank farm (Photo #35). The insta berm was filled with snow and had approximately 17 gasoline drums, 7 full 1000L totes, 3 diesel drums and some assorted buckets. A spill kit was available right beside the berm.

Insta-Berm beside the airstrip at MLA. Gasoline barrels and 1000L totes stored inside. A spill kit is in the foreground.

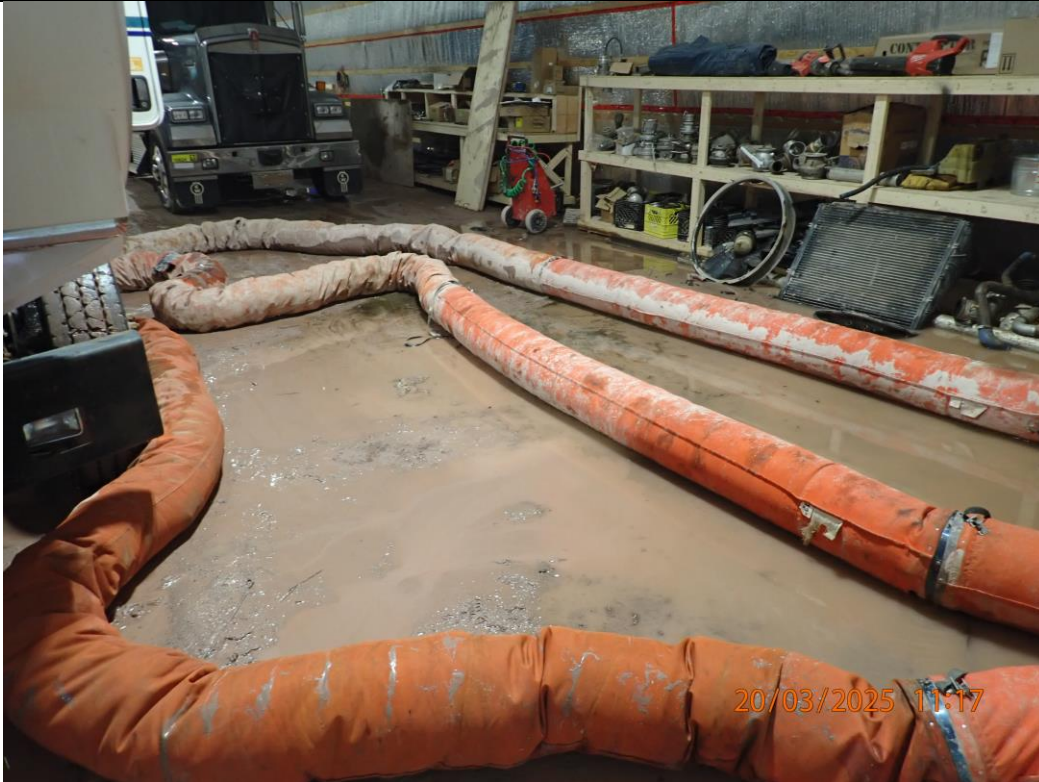
Photo # 36

Inside the large tent truck shop at MLA showing flooded gravel/sand floor.

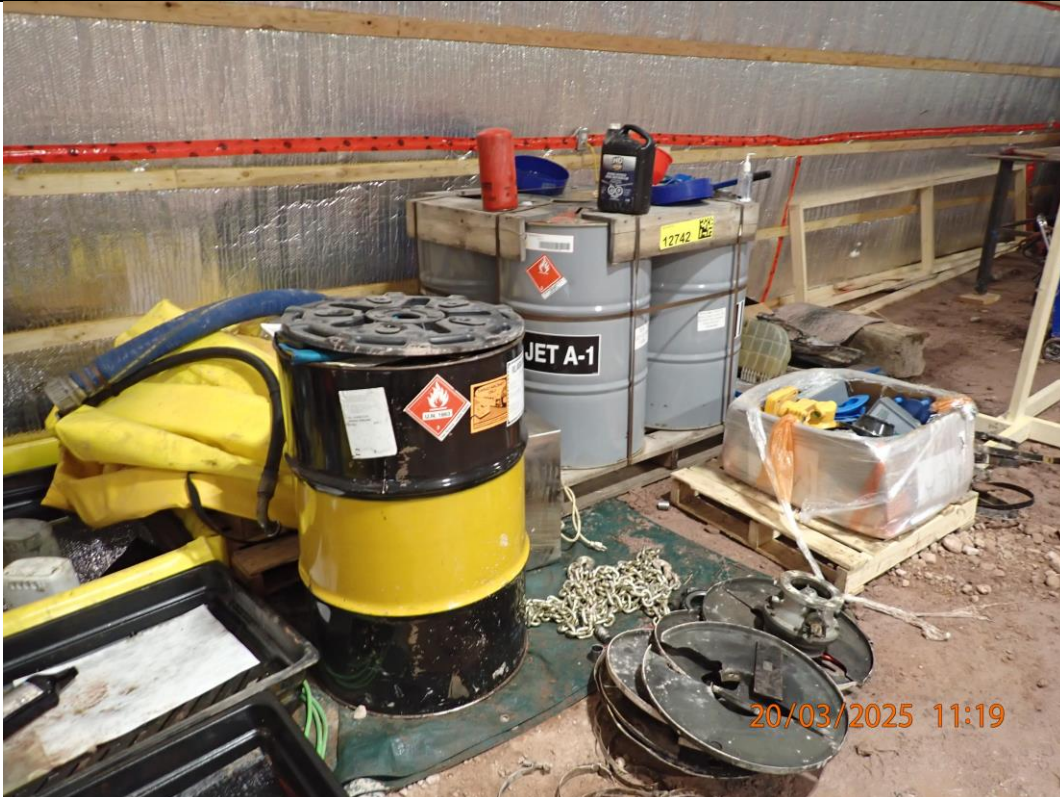
Photo # 37

24. The inside of the truck shops at MLA were inspected. Pooling was observed inside of the larger truck shop on the south side of the air strip (Photo #36) Inside the same shop were 4 fuel drums out of containment (Photo #37).

Inside the large tent truck shop at MLA showing Jet A-1 out of containment.

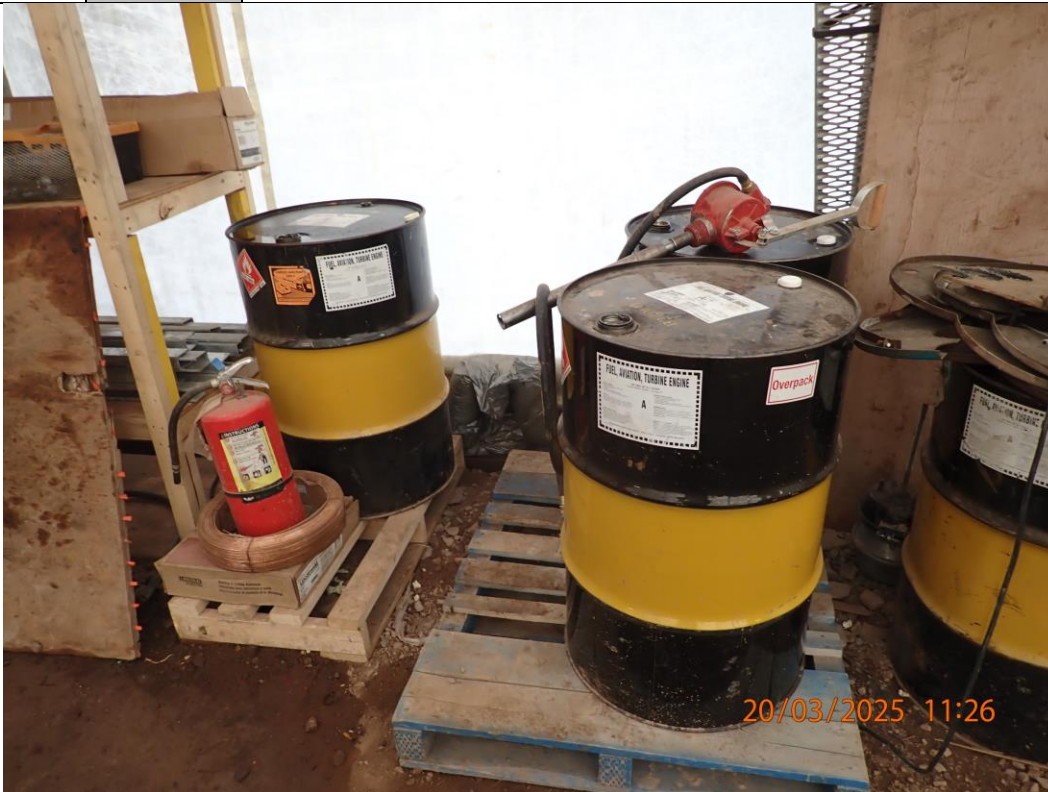
Photo # 38

Small tent truck shop at MLA showing fuel drums out of containment. Left side barrel had product observed on the top.

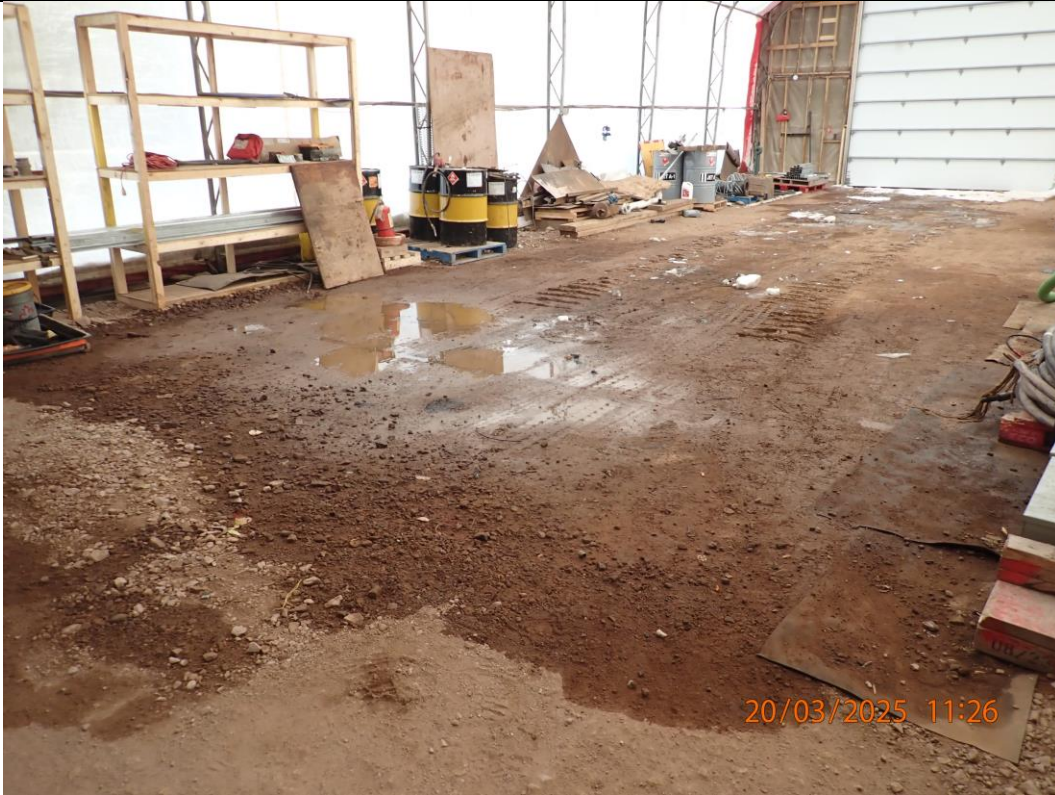
Photo # 39

25. The smaller truck shop also on the south of the airstrip was inspected. Inside the shop were 4 full fuel drums out of containment (Photo #38,#39 and #40). 1 of the drums had a leak at the bung of the drum and product had leaked out of the drum while standing upright, this may have been cause by pressure build up after the drum had warmed up. Product was observed on the top of the drum. Photo #40 shows a spill tray with oil and spill pads inside. Excess waste oil shall be placed into waste oil totes/drums and hauled off site. A strong smell of fuel is present in the building, staining of the gravel floor is obvious. (Photo #39) Contaminated soil needs to be removed and treated or hauled off site.

Small tent truck shop at MLA showing a stained gravel. Water is present in the pic but majority of the stain is fuel.
