Water Licence Inspection Report

Authorization	Representative
Sabina Gold & Silver (B2Gold)	Christoph LeGoffe
Authorization No. / Expiry	Representative's Title
2AM-BRP1831/December 31, 2031	Environmental Superintendent
Inspection Date	Inspector
March 18-20	James Bolt
Other Authorization/s	
2BE-GOO2028, 2BE-GEO2025, 2BE-MLL2328, N2024C0024, N2024F0027, Goose Lease 076G9-1-2, MLA Lease 076J12-7-2	
Activities Inspected	
<input type="checkbox"/> Municipal <input type="checkbox"/> Camp, Commercial <input type="checkbox"/> Drilling <input checked="" type="checkbox"/> Mining <input type="checkbox"/> Construction <input type="checkbox"/> Reclamation <input checked="" type="checkbox"/> Fuel Storage <input checked="" type="checkbox"/> Roads/Hauling <input checked="" type="checkbox"/> Winter Hauling <input type="checkbox"/> Camp, Private <input type="checkbox"/> Other Click or tap here to enter text.

On March 18, 2025 Resource Management Officer Isaiah James Bolt (Inspector) for Crown Indigenous Relations and Northern Affairs Canada (CIRNAC), conducted an inspection of 2AM-BRP1831 (License) issued to B2Gold (Proponent) to ensure compliance against their license.

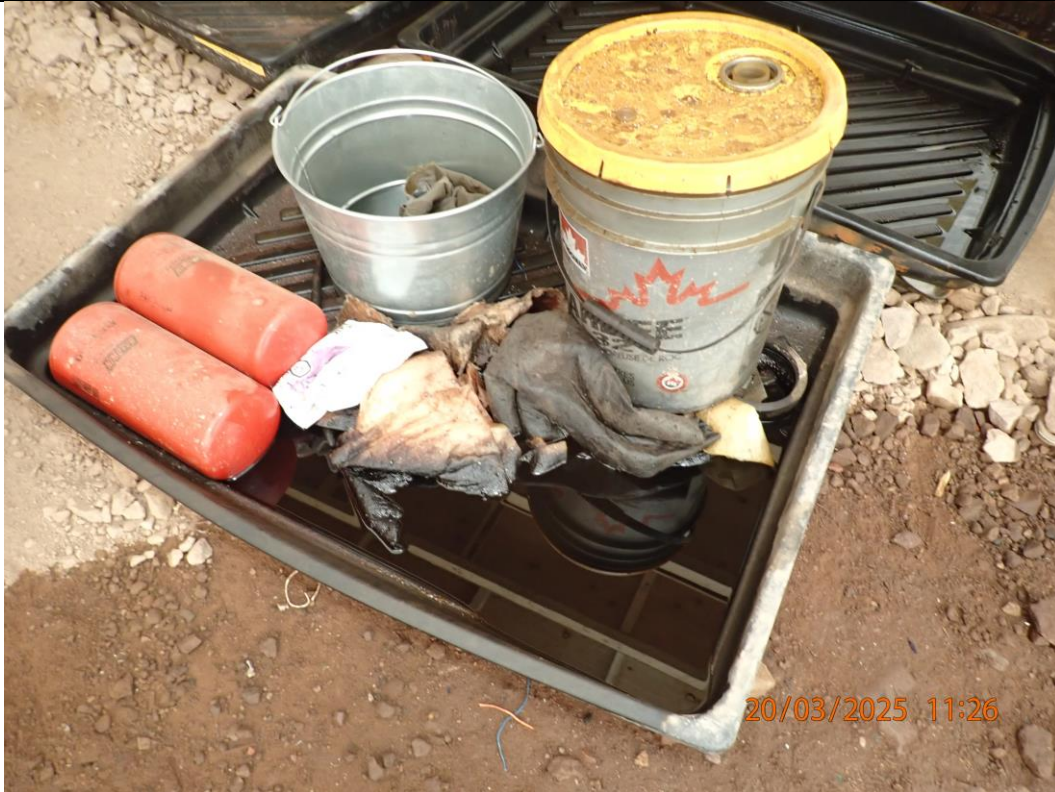
Photo # 40

Oil drip tray filled with oil, oil filters, buckets and oily rags.

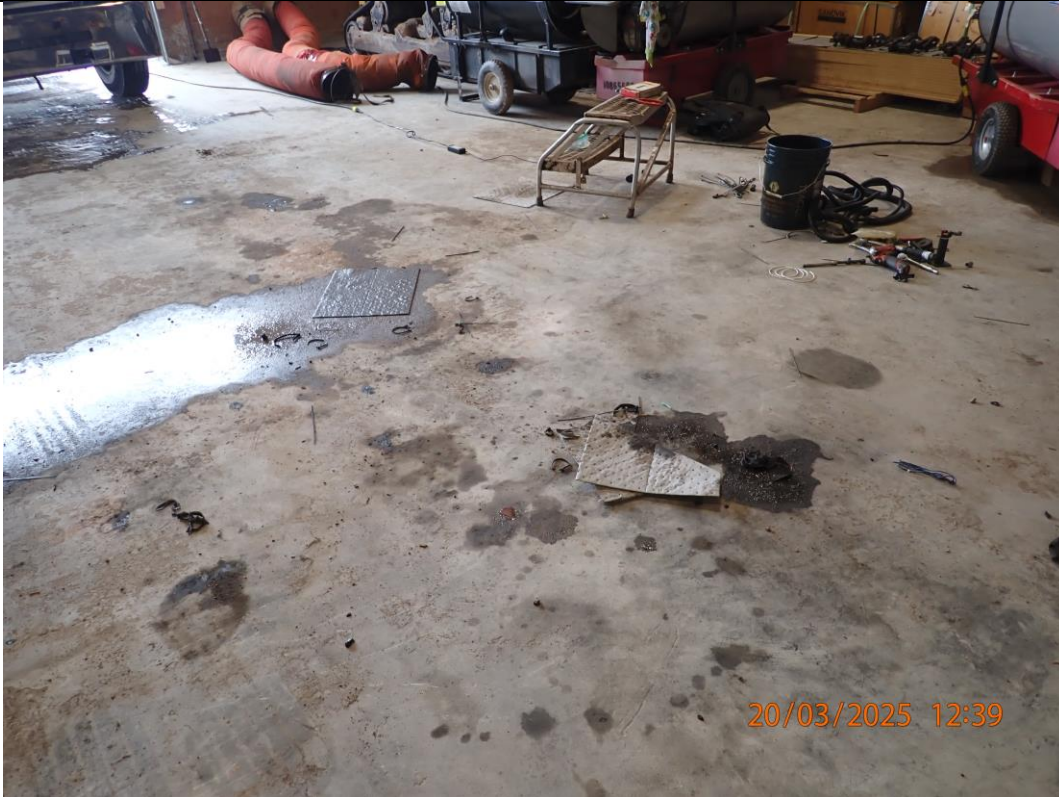
Photo # 41

26. The truck shop on the north side of the airstrip, close to the accommodations, was also inspected. A photo was taken of a spill and spill pads being utilized. Spill pads are burned in the incinerator once contaminated (Photo #41).

Large truck shop beside accommodations, showing use of absorbent rags.

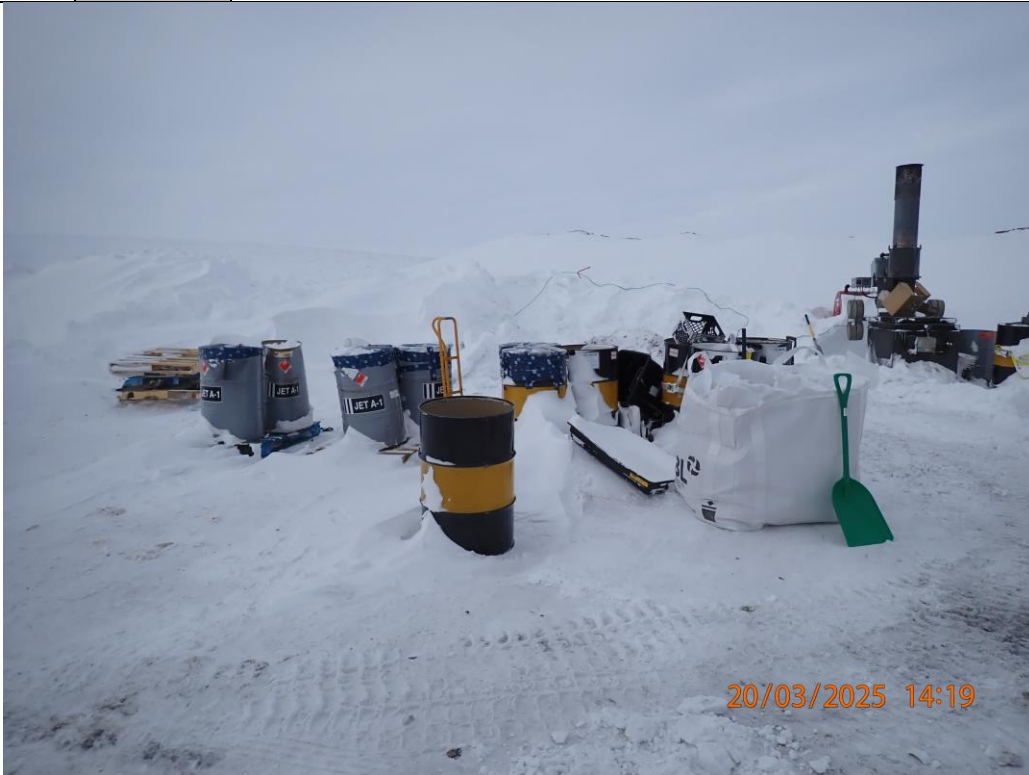
Photo # 42

Incinerator at MLA forward camp. Ash barrels observed with open lids.

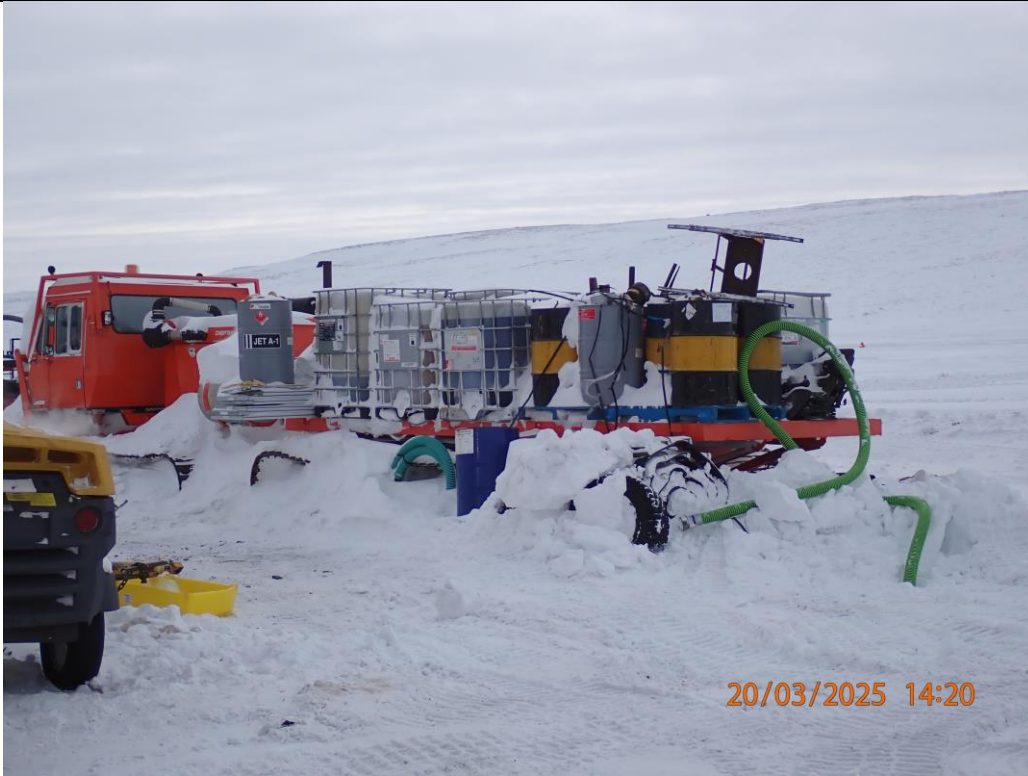
Photo # 43

1000L Totes and waste drums stored on top of a Cat train trailer.

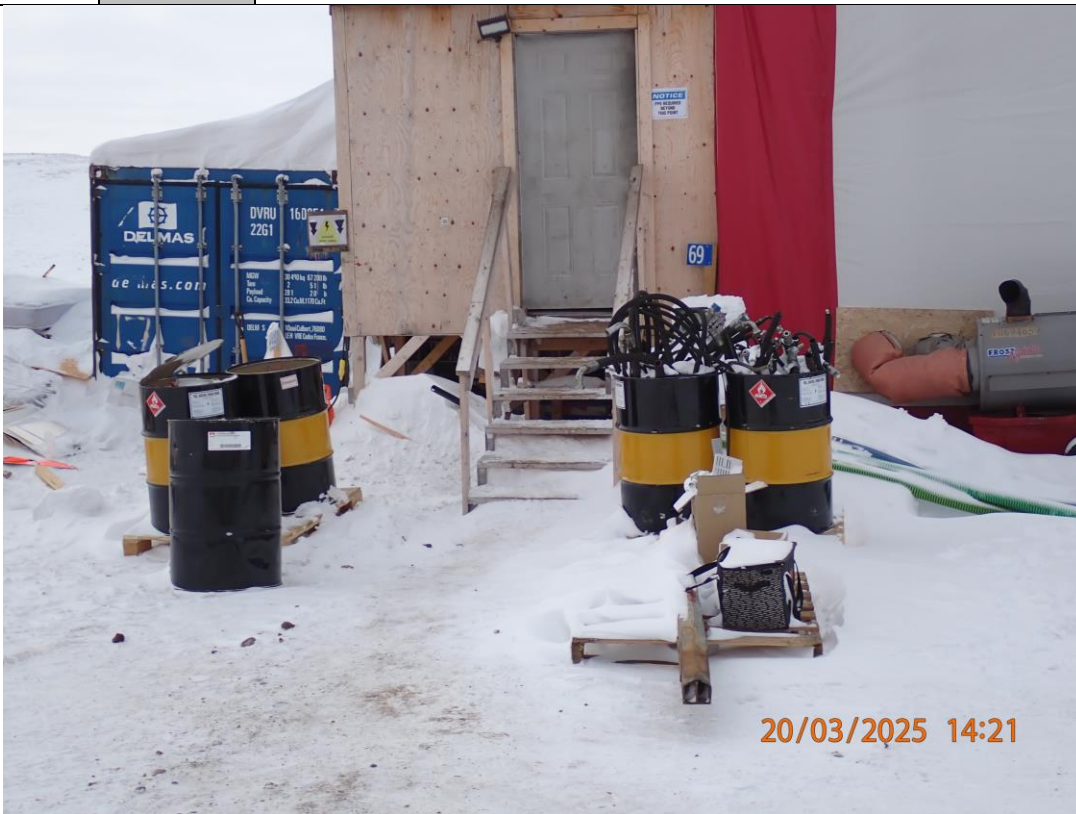
Photo # 44

29. On the north side of the truck shop at MLA forward 5 waste drums were observed outside of the building (Photo# 44). 2 of the 5 drums were holding assorted hydraulic hoses. The rest of the drums were open tops with some aerosols in one and metals and wastes in the others.

Waste drums with hoses and other garbage stored outside of the truck shop at MLA forward. Open to the environment.

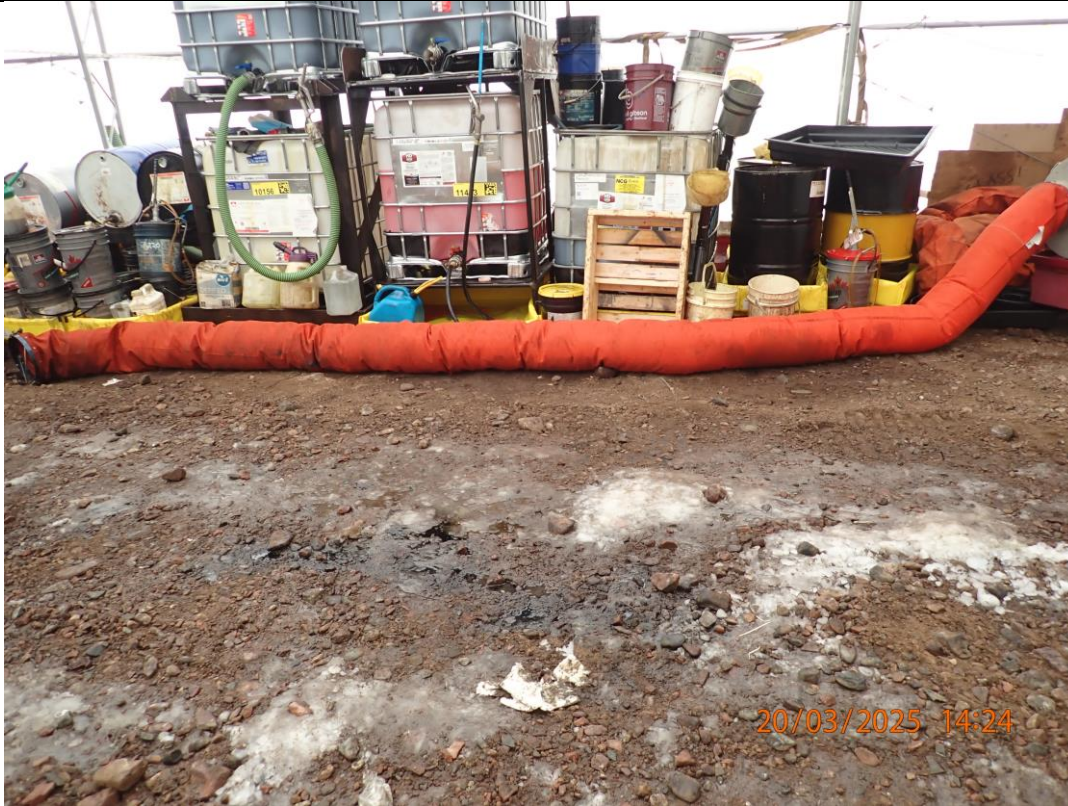
Photo # 45

30. Inside of the truck shop at MLA forward was inspected. They have most of their oils/products stored in secondary containment. The only concerns would be the staining on the floor. Contaminated soil shall be removed and stored for treatment or removal from site (Photo #45)

1000L totes, drums, buckets, jerry cans and other products stored in secondary containment. Stain observed on the ground.

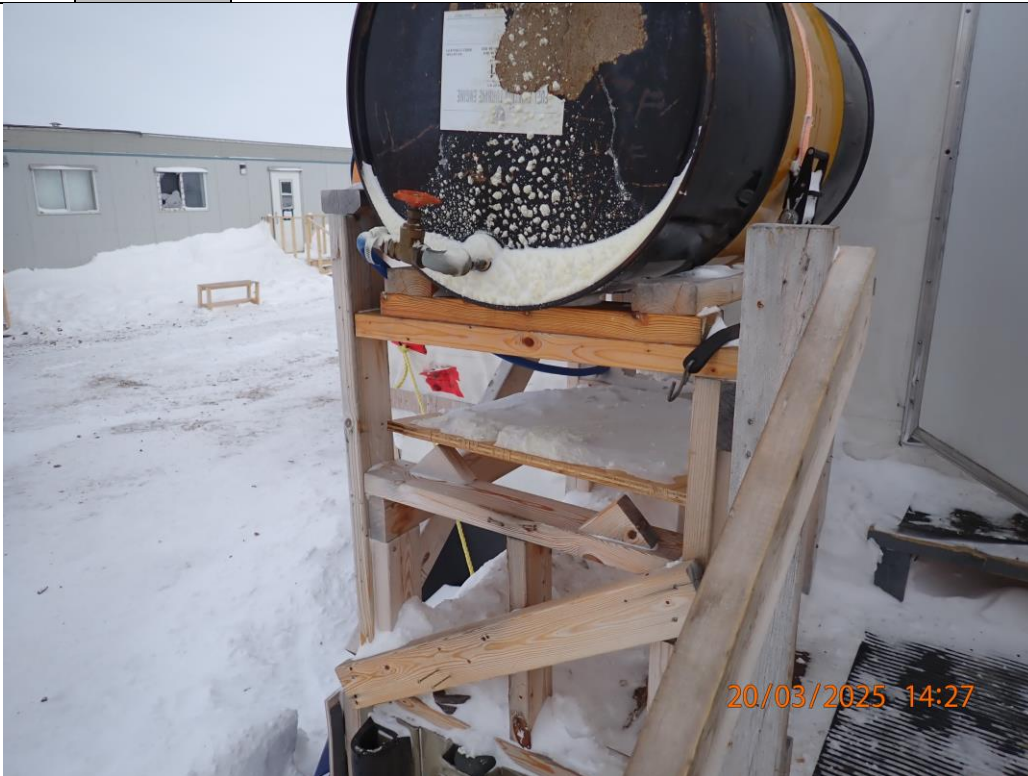
Photo # 46

31. Outside of the kitchen a fuel drum was observed on a wooden stand (Photo #46). Slushy snow was observed around the hose connection showing signs of a leak. The drum and stand were not in secondary containment. It did not appear to be a large leak as the snow below was not impacted. Any contaminated snow shall be removed and the drum shall be stored in a covered secondary containment.

Outside of MLA forward kitchen. A leaking fuel drum on a stand outside of secondary containment.

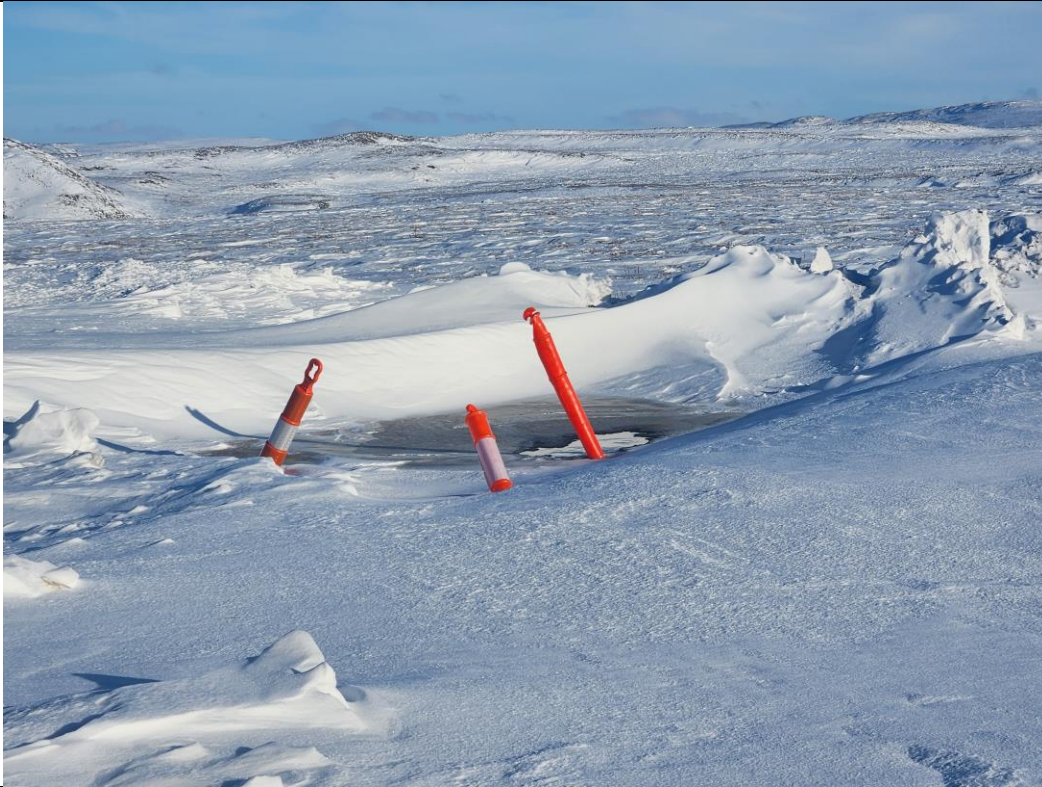
Photo # 47

MLA forwards effluent discharge location. No signage.

- Ensure all fuel and oil vessels are placed in secondary containment.
- Ensure heating fuel on stands are placed in appropriate secondary containment.
- Ensure segregation of metals from open burn material and place in landfill or haul off site if required.
- Clean up and store contaminated soils from truck shops/garages to ensure contaminates/hydrocarbons are not making their way into the environment.
- Ensure all contaminated snow around site is consolidated and stored appropriately for treatment.
- Ensure signage is present on all discharge locations/sampling sites/monitoring stations.

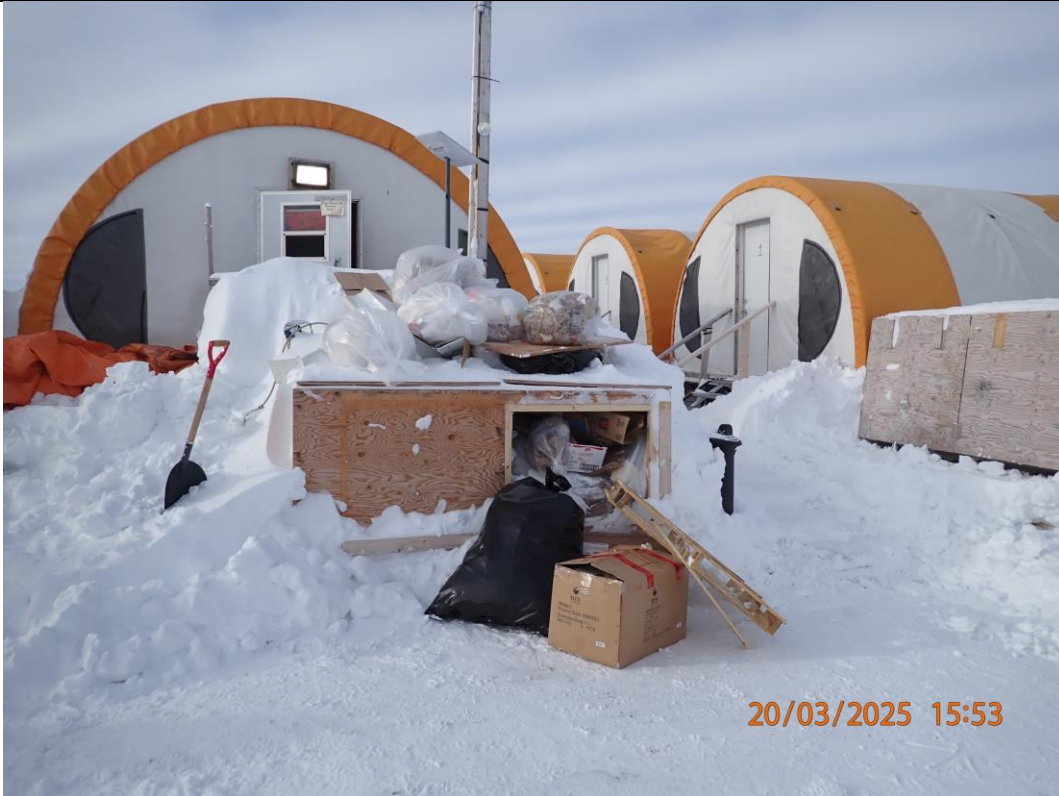
Photo # 48

33. Upon arrival to Goose Forward, it was observed that a large pile of garbage was store on top of a wooden box and on the ground. The wooden box was full of garbage as well and had an open door. The staff in the kitchen had mentioned that they requested a new garbage bin. All garbage shall be stored in containment with a lid or a door to prevent access/attraction from wildlife (Photo#48).

Goose Forward camp. Garbage bin showing garbage on top and on the ground.

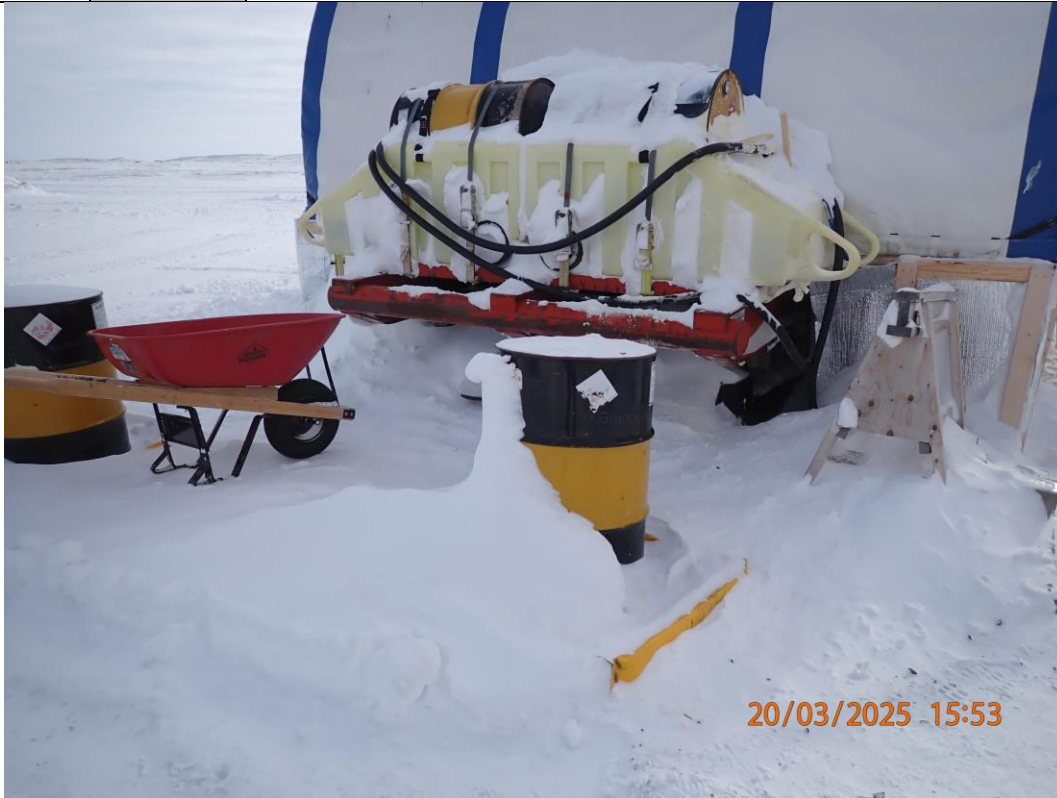
Photo # 49

34. (Photo #49) shows fuel drums on the ground in secondary containment that is full of snow. Also shown in the photo is a fuel drum on a stand that is secondary containment but has filled with snow. Upon closer inspection is was obvious that the snow had been contaminated with fuel, as the snow showed yellowing (Photo #50). Chris LeGoffe had sent an updated photo of the drum on March 24th 2025, (Photo #51).

4 drums all in secondary containment, but the 2 on the ground are buried in snow and the containment stand is filled with snow.

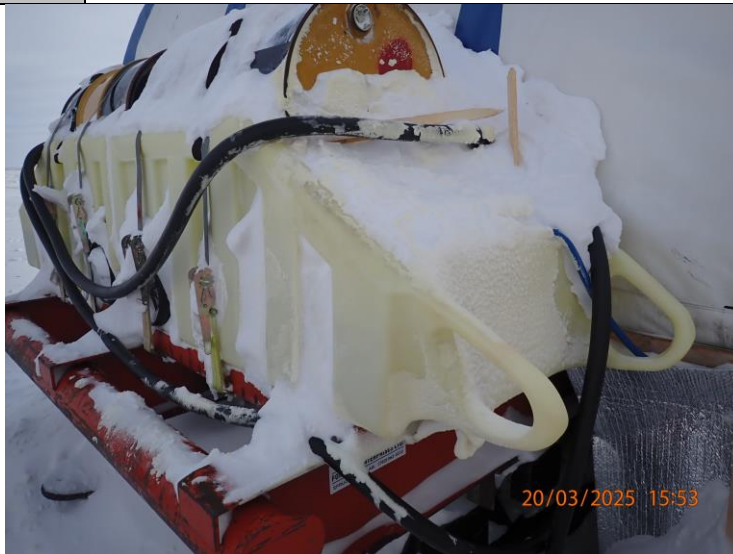
Photo # 50

Up close of the image above. Leaking drum is causing yellowing of the snow.

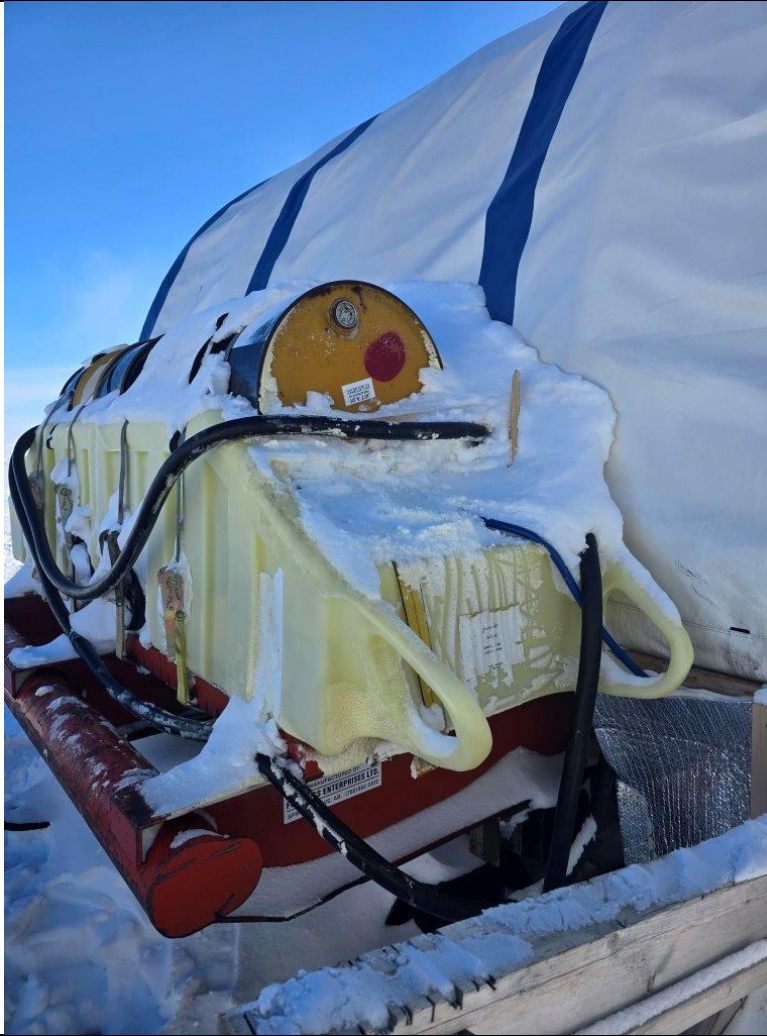
Photo # 51

An Updated photo of the images above sent by Chris LeGoffe.

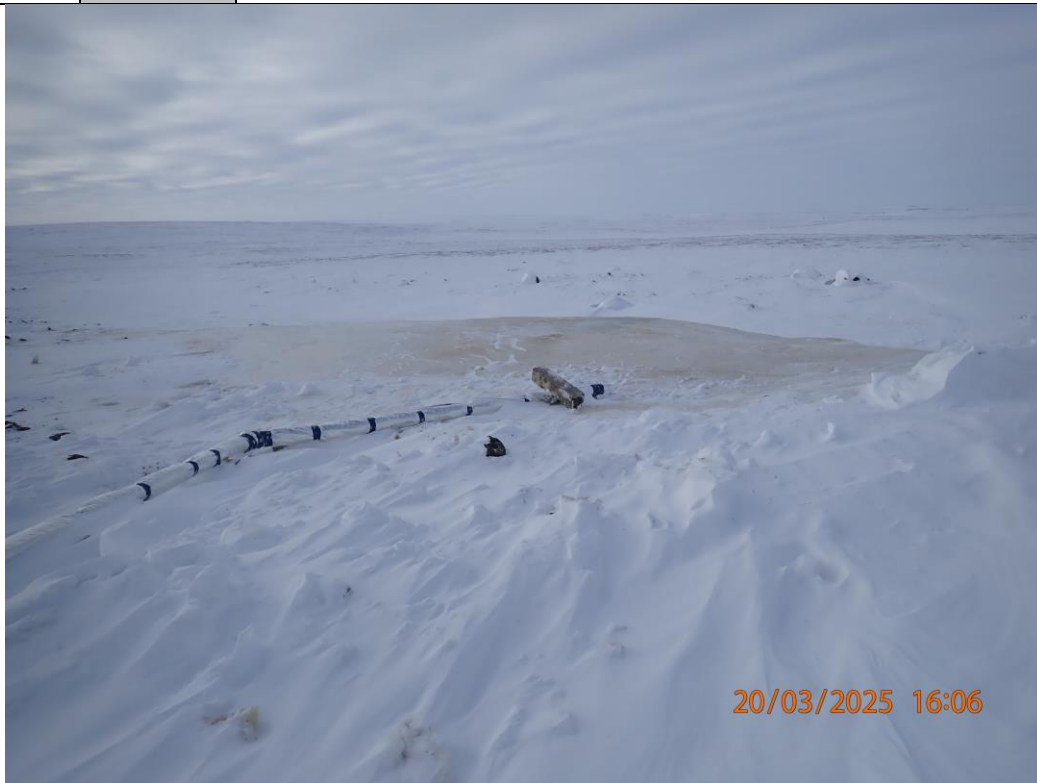
Photo # 55

Effluent discharge location at Goose forward. No Signage.

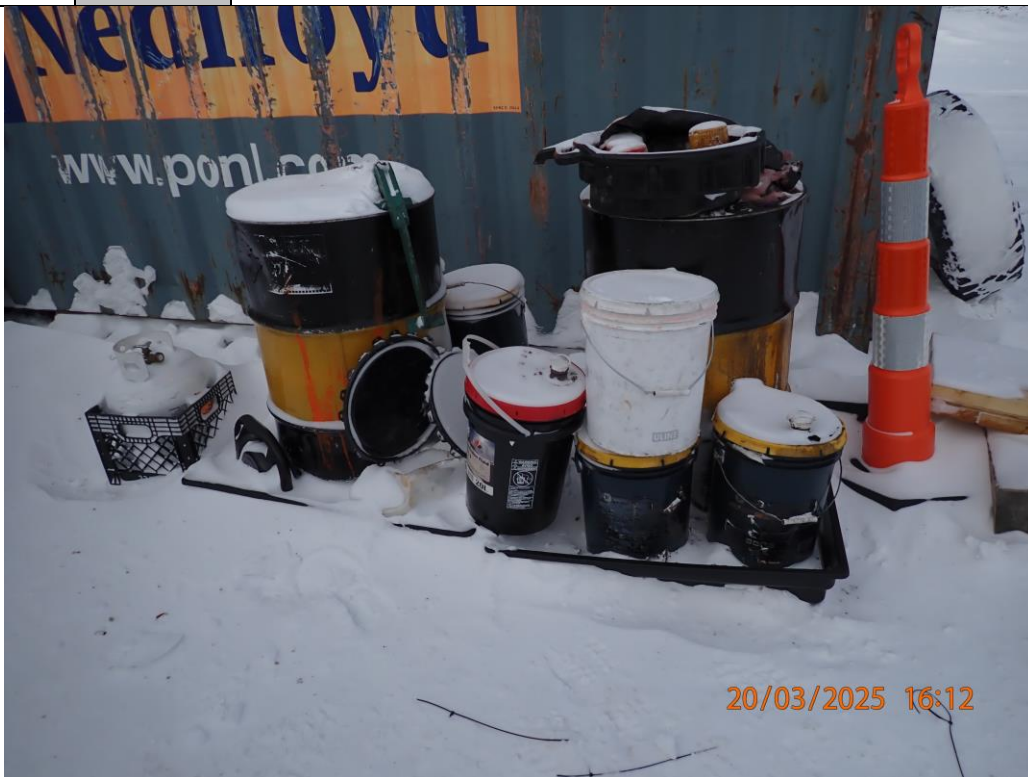
Photo # 56

36. The effluent discharge (grey water) discharge was inspected (Photo #55). No signage present at the time of inspection.
37. A secondary containment berm was observed to have waste oil drums, buckets and a used filled oil pan exposed to the elements. (Photo #56 and #57). Snow had accumulated in the oil pan and on top of the drum staining the snow red with oil. Chris LeGoffe had sent updated photos of the area on March 25th 2025. The area had been cleaned up but the oil pan was still present on top of the drums exposed to the elements (Photo #58).

Secondary containment tray with drums, buckets and a filled oil pan.

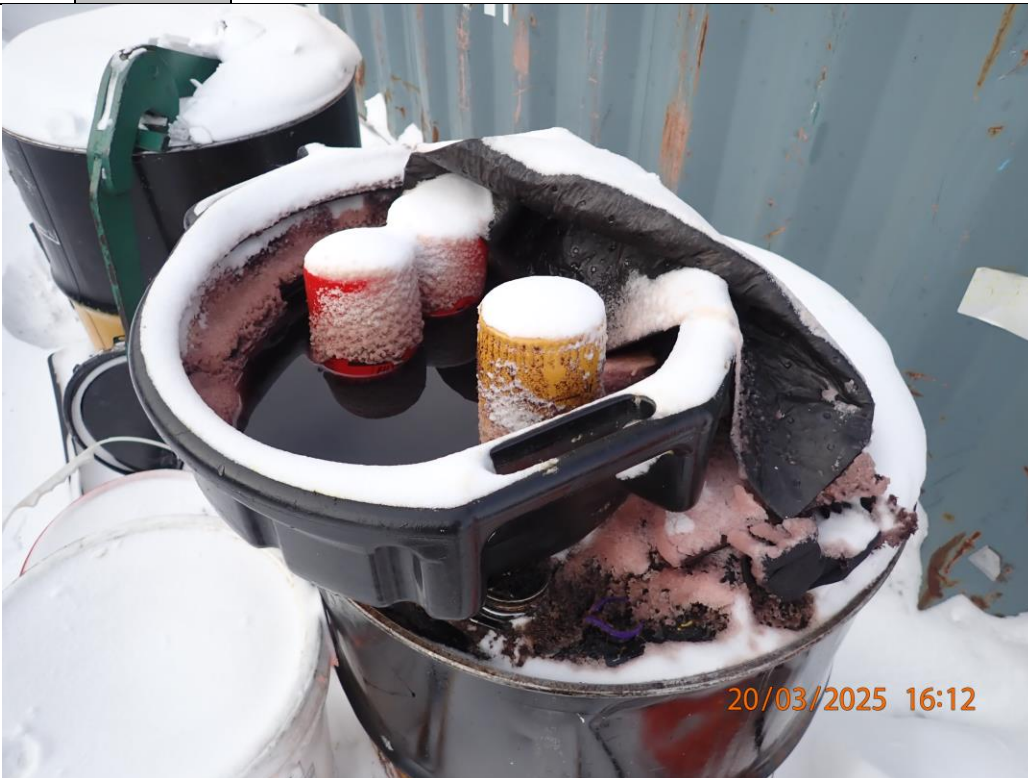
Photo # 57

Up close image of the oil pan that is filled with used oil and oil filters.

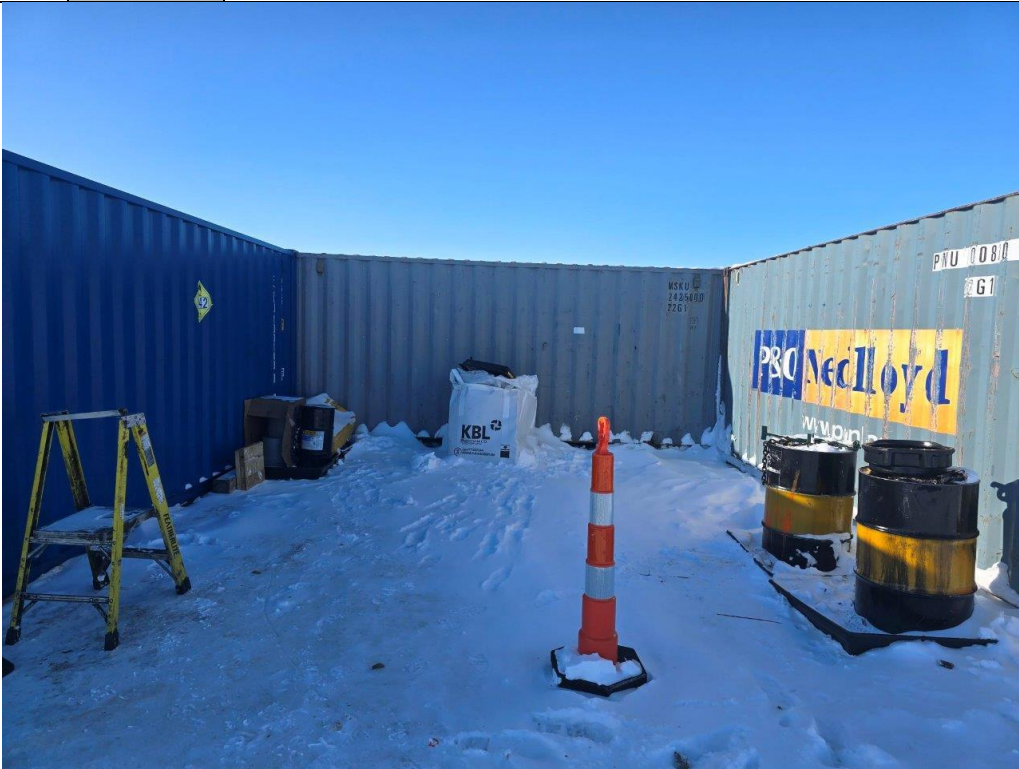
Photo # 58

an updated image sent by Chris LeGoffe of the secondary containment tray. Oil pan still open to the elements.

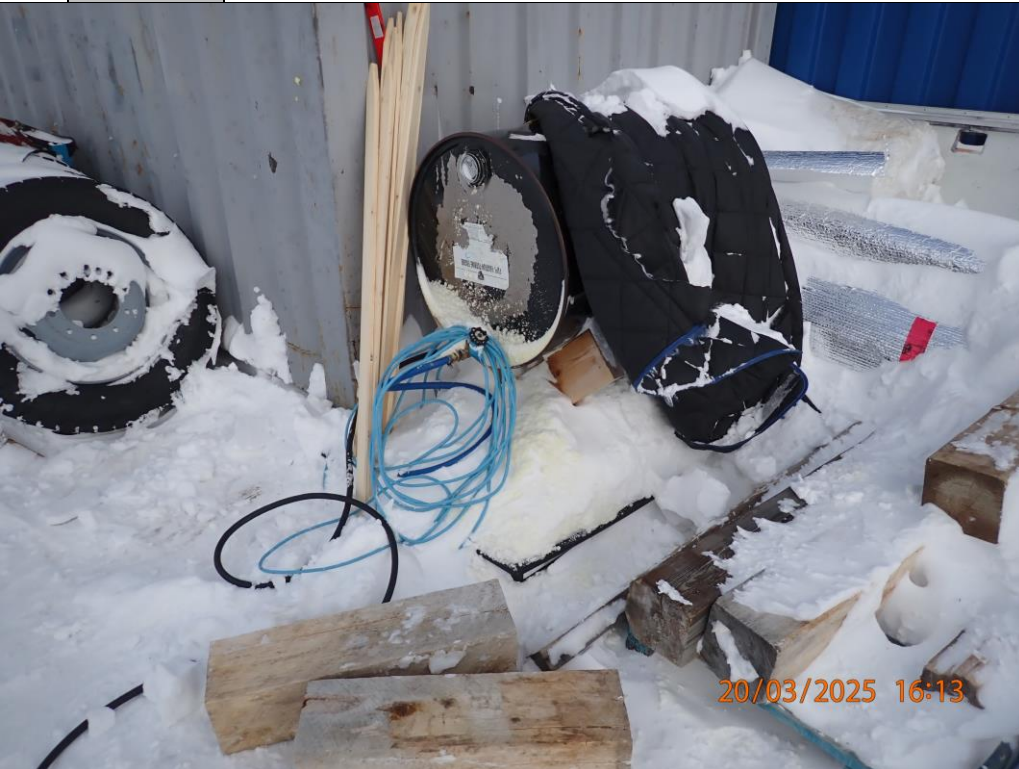
Photo # 59

38. A fuel drum on a wooden stand was observed in secondary containment. The secondary containment was filled with snow and the hose connection was leaking fuel onto the snow (Photo #59). Contaminated snow shall be stored properly and treated for hydrocarbons.

A fuel drum on a stand in secondary containment. The containment is filled with snow and a leak onto the snow is observed.
