Water Licence Inspection Report

Authorization	Representative
B2 Gold Corp.	Chris LeGoffe
Authorization No. / Expiry	Representative's Title
2AM-BRP1831	Superintendent, Environment
Inspection Date	Inspector
March 5, 2026	RMO Kyle Amsel
Other Authorization/s	
Activities Inspected	
<input checked="" type="checkbox"/> Camp, Commercial <input type="checkbox"/> Drilling <input type="checkbox"/> Mining <input checked="" type="checkbox"/> Construction <input checked="" type="checkbox"/> Reclamation <input checked="" type="checkbox"/> Fuel Storage <input checked="" type="checkbox"/> Roads/Hauling <input type="checkbox"/> Winter Hauling <input type="checkbox"/> Camp, Private <input checked="" type="checkbox"/> Other Runway

The purpose of the inspection was general compliance. This Inspection report is for the Marine Laydown Area (MLA) and MLA forward Camp.

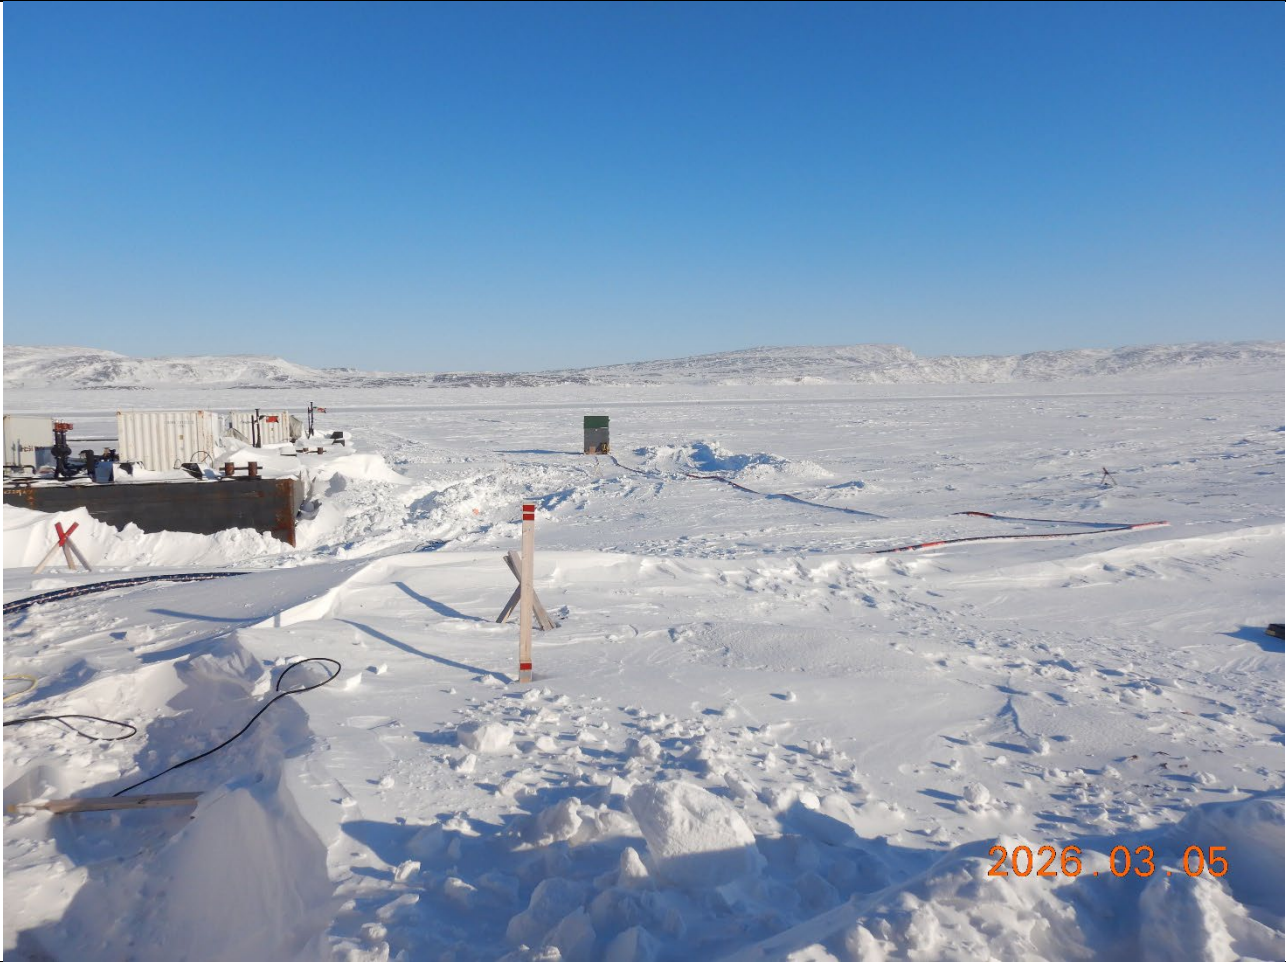
Date:	Authorization Number:	Camera/Model:	Inspector
Tuesday, March 3, 2026	2AM-BRP1831	Panasonic Coolpix	RMO Kyle Amsel
Photo No.	Lat/Long (DD.MM.SS.SS, NAD83)		
Photo 1	N66° 38' 55" W107° 40' 59"

- 1) Water Usage for the MLA is obtained from the Marine Environment. (Photo 1). Salt water is run through a Reverse Osmosis desalination unit. (Photo 2) As of March 5, total fresh water used by the camp is 1,703m³ from the desalination unit.

Description: Water Intake hut in Bathurst Inlet. This is a marine environment.

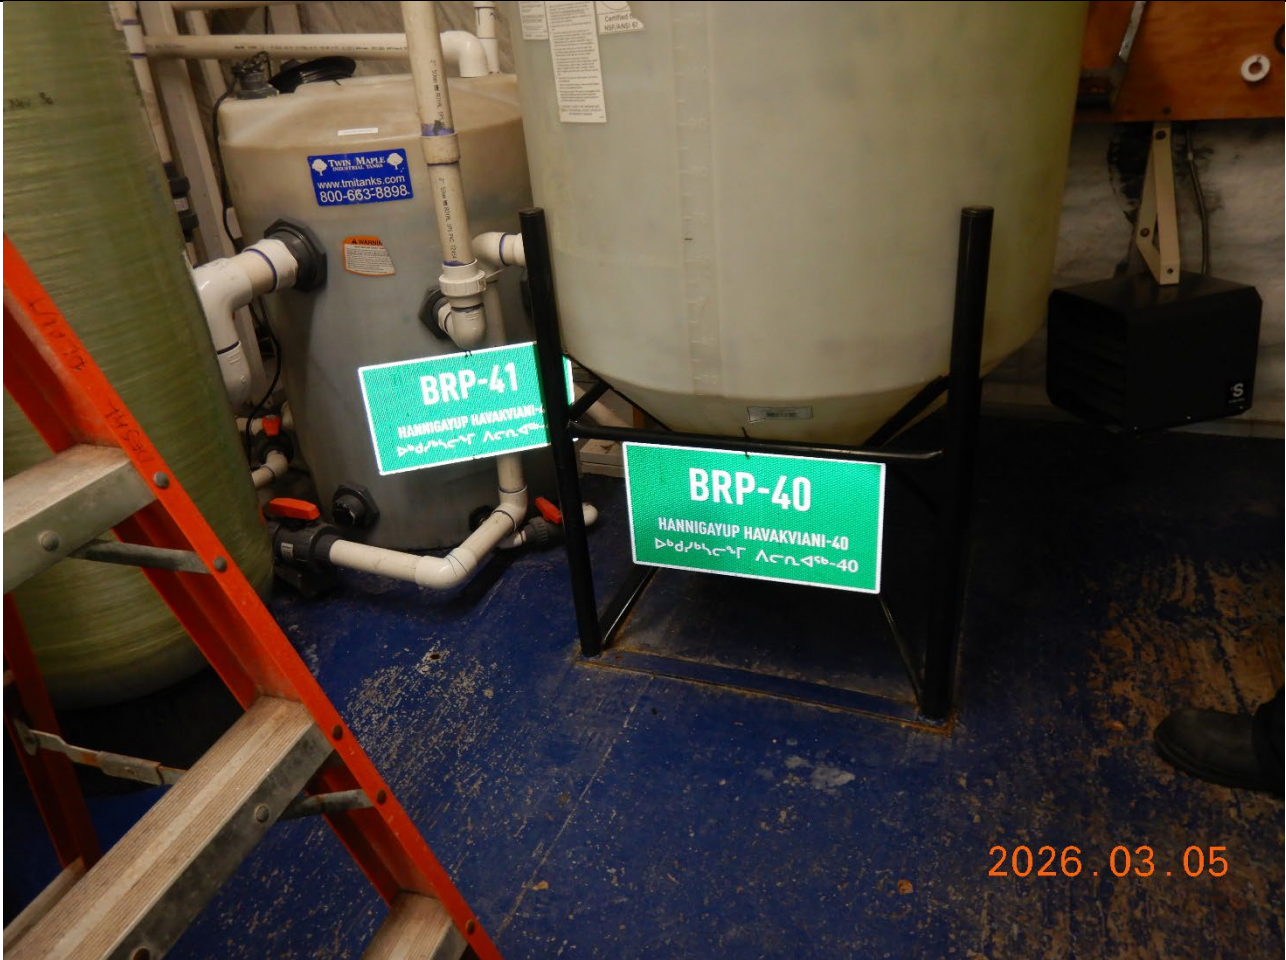
Photo No.	Lat/Long (DD.MM.SS.SS, NAD83)
Photo 2	NA

Description: Inside reverse osmosis plant at MLA. Note signs for monitoring.

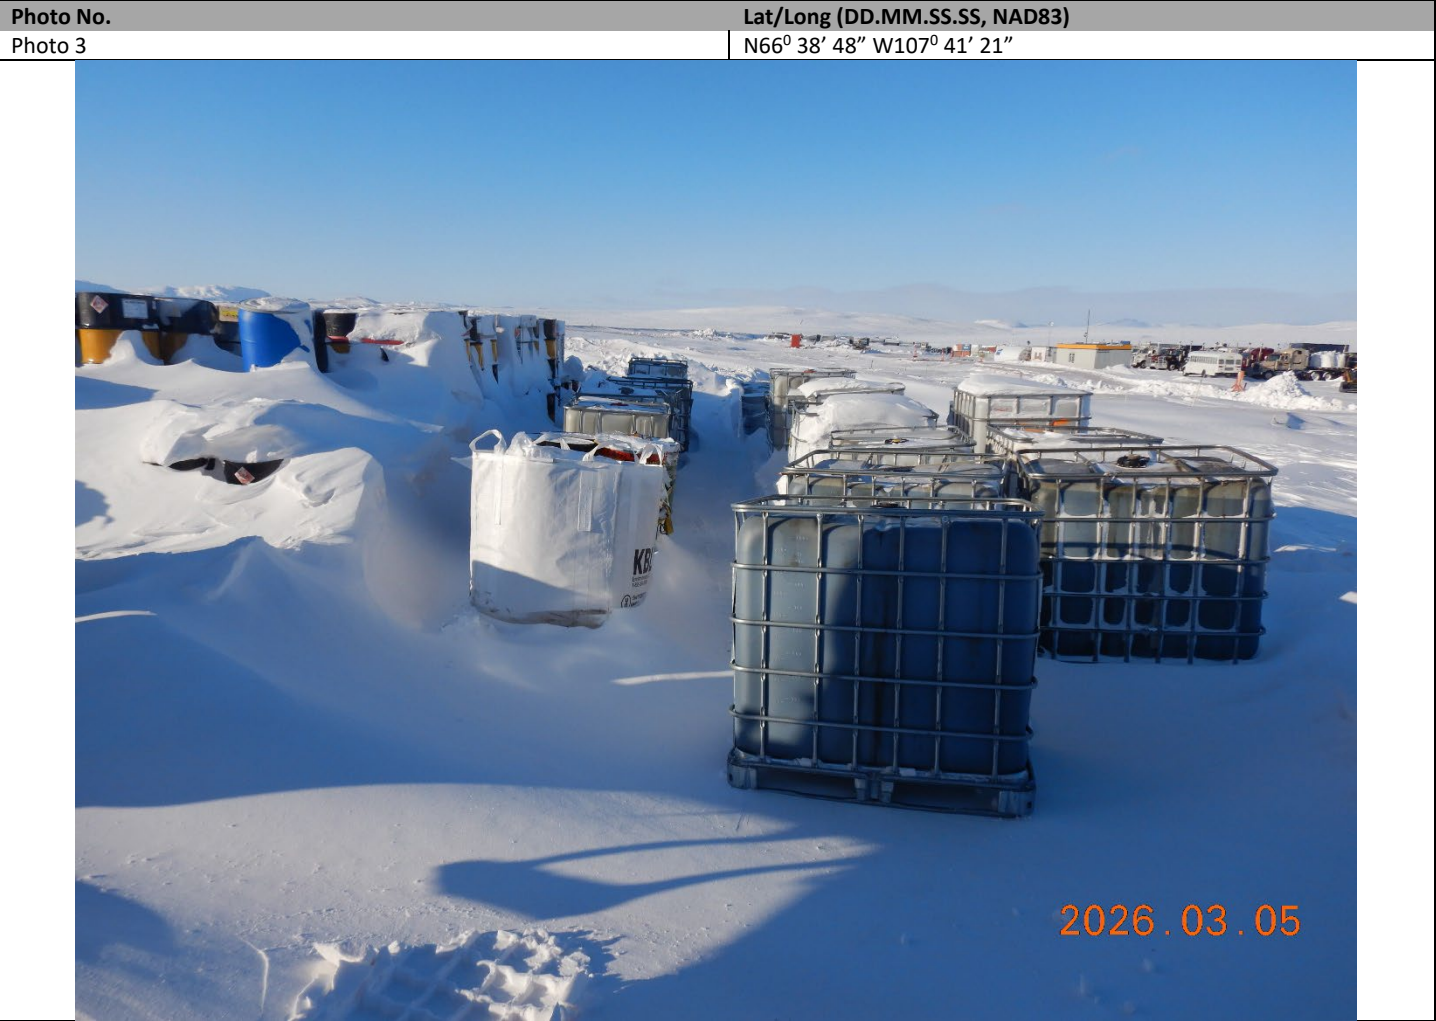
- b) Several totes of dust suppressant were stores outside of second containment. A review of the applicable MSDS notes this material is non-toxic and sugar based. (Photo 3)

Description:
 MLA tote storage on left. Dust suppressant totes on right.

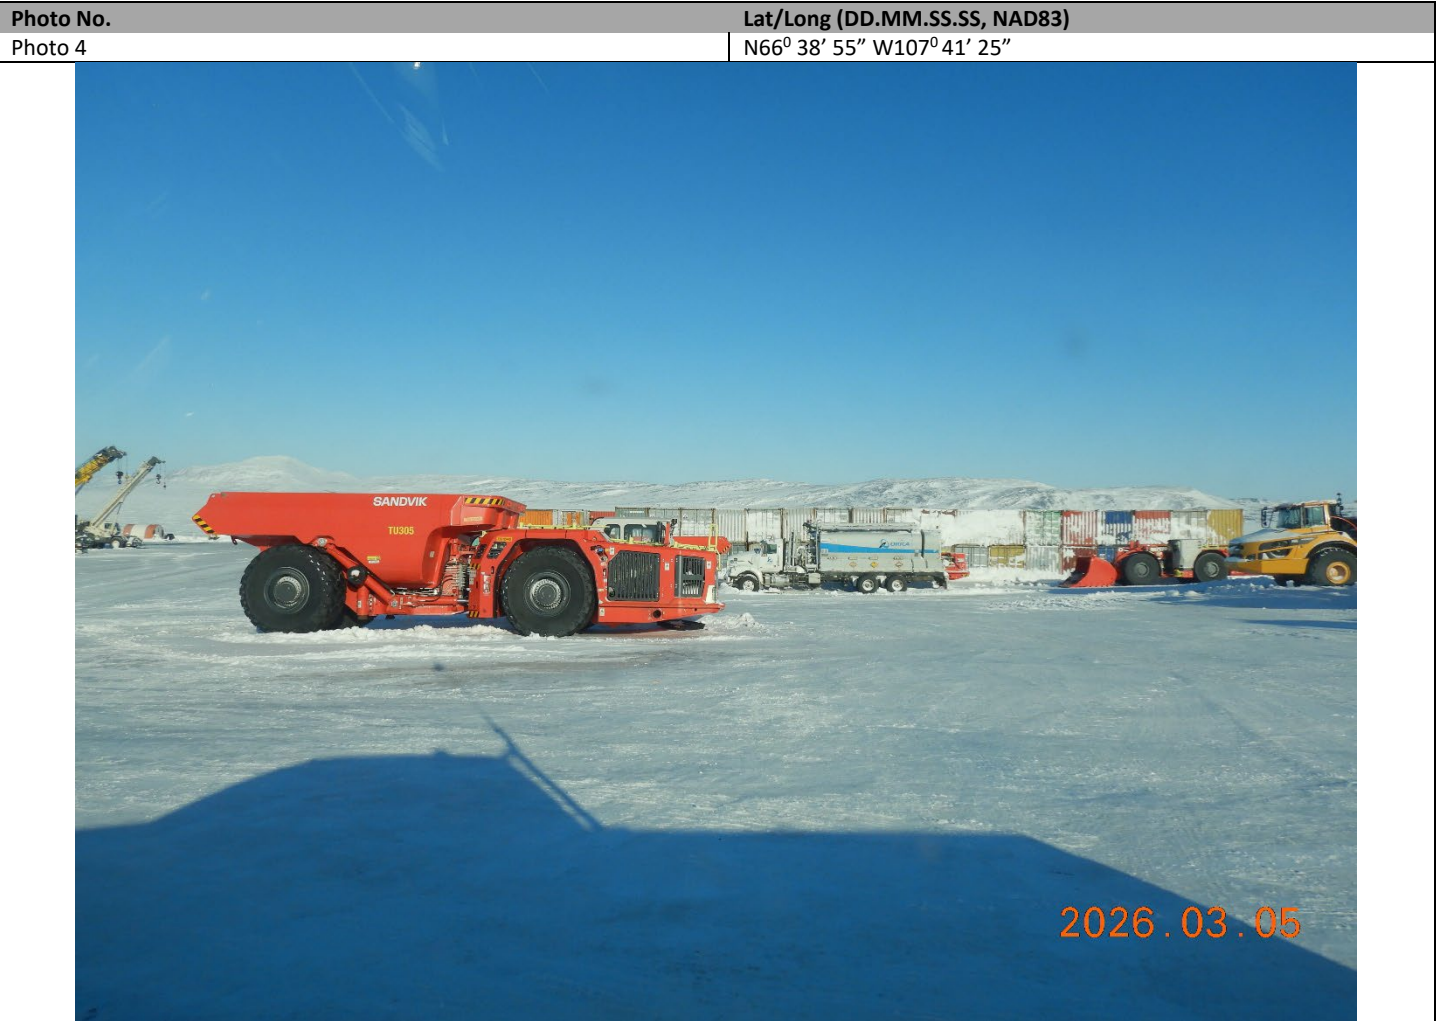
- c) Drip pans are located under parked vehicles. (Photo 4)
 - d) Mechanic shops noted in report 2025-KIT-001-JB have been retrofitted and upgraded with concrete floors to prevent soil contamination from vehicle maintenance. (Photo5 & 6)

Description:
 Parked equipment with drip trays appropriately placed.

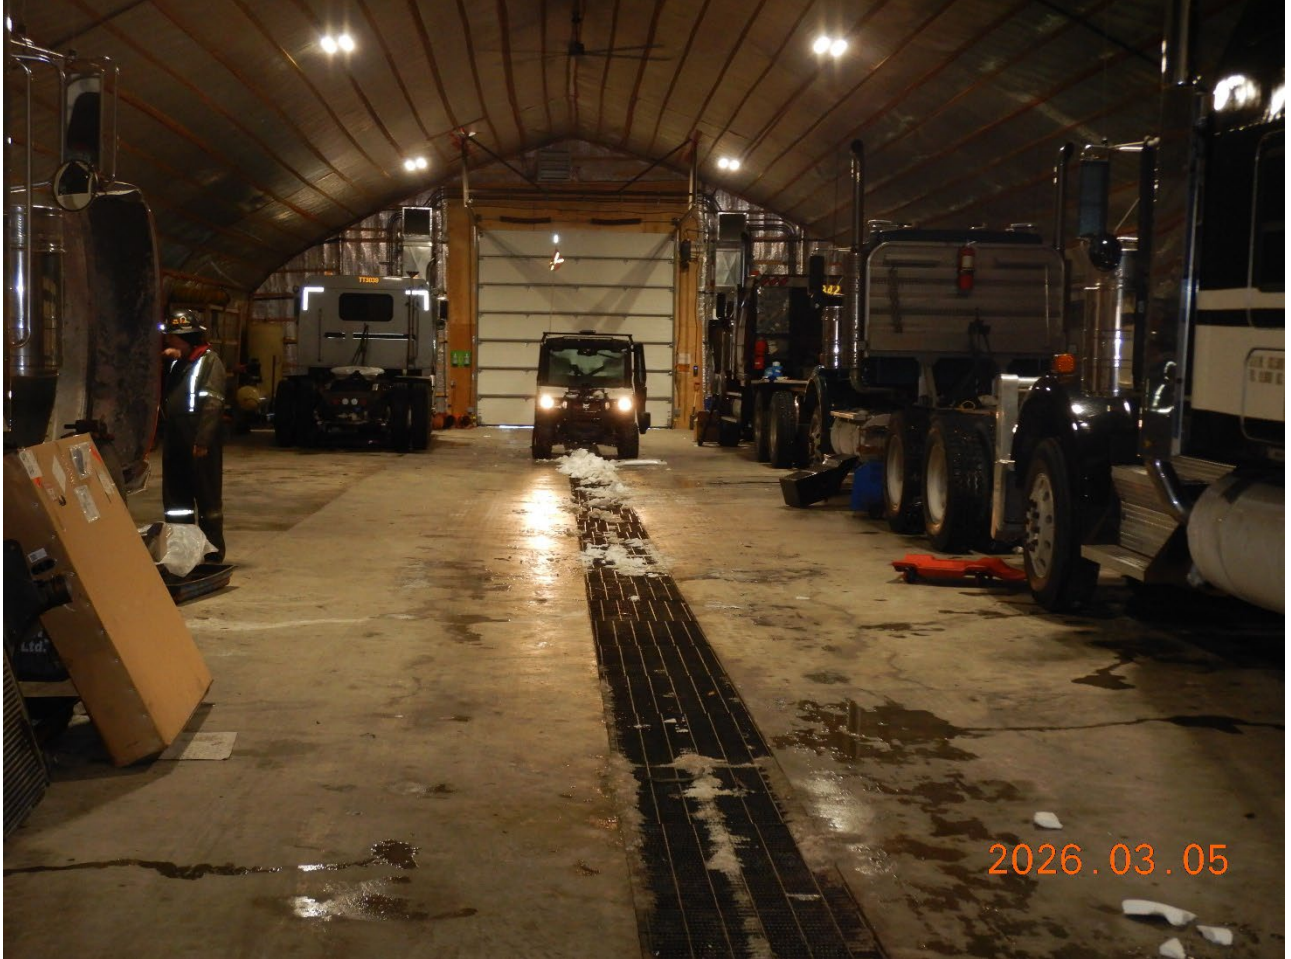
Photo No.
Photo 5

Description:
Newly installed concrete floors.

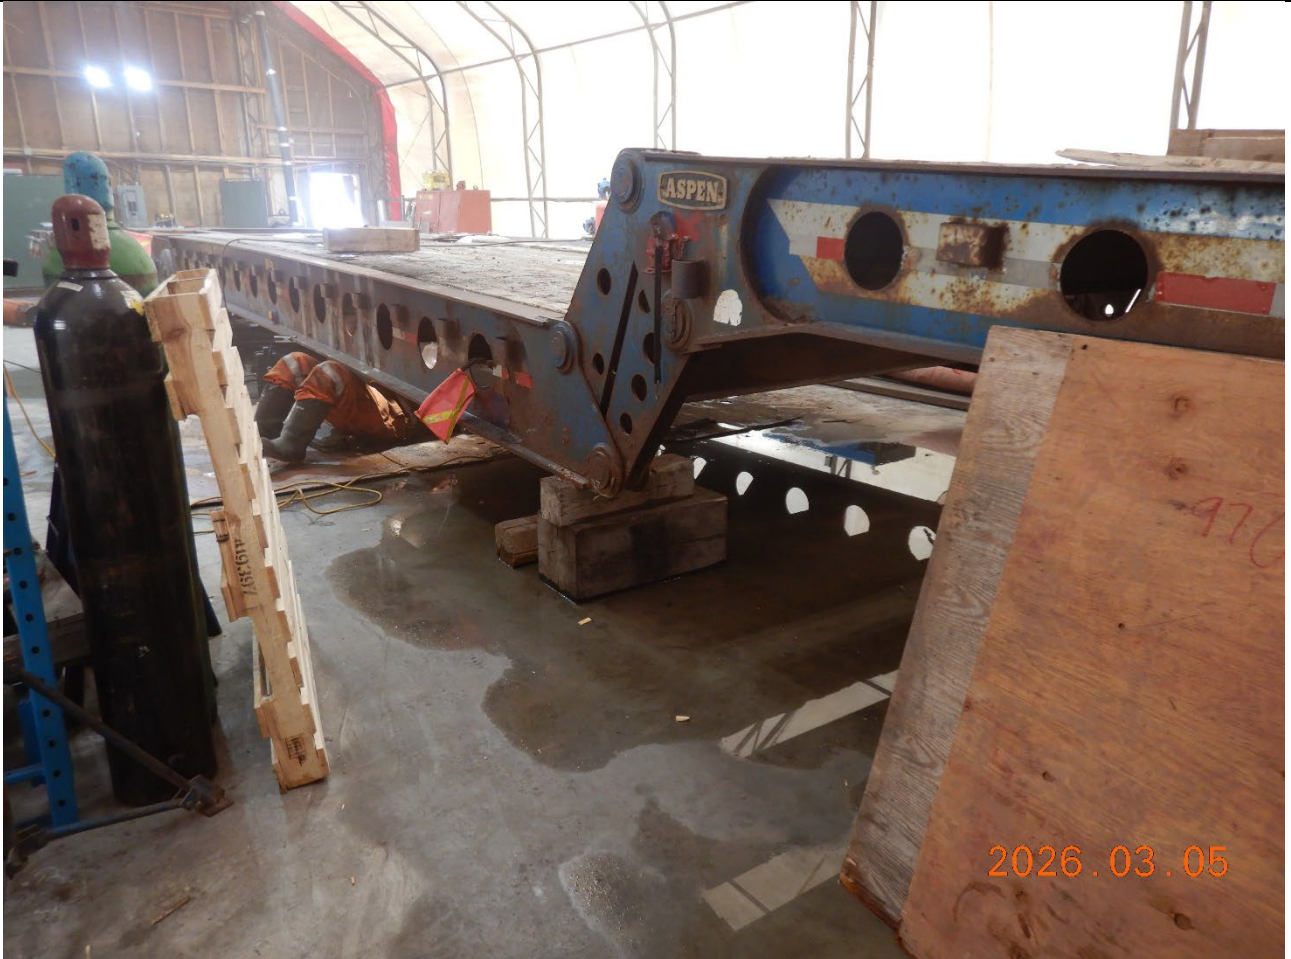
Photo No.
Photo 6

Description:
Newly installed concrete floors.

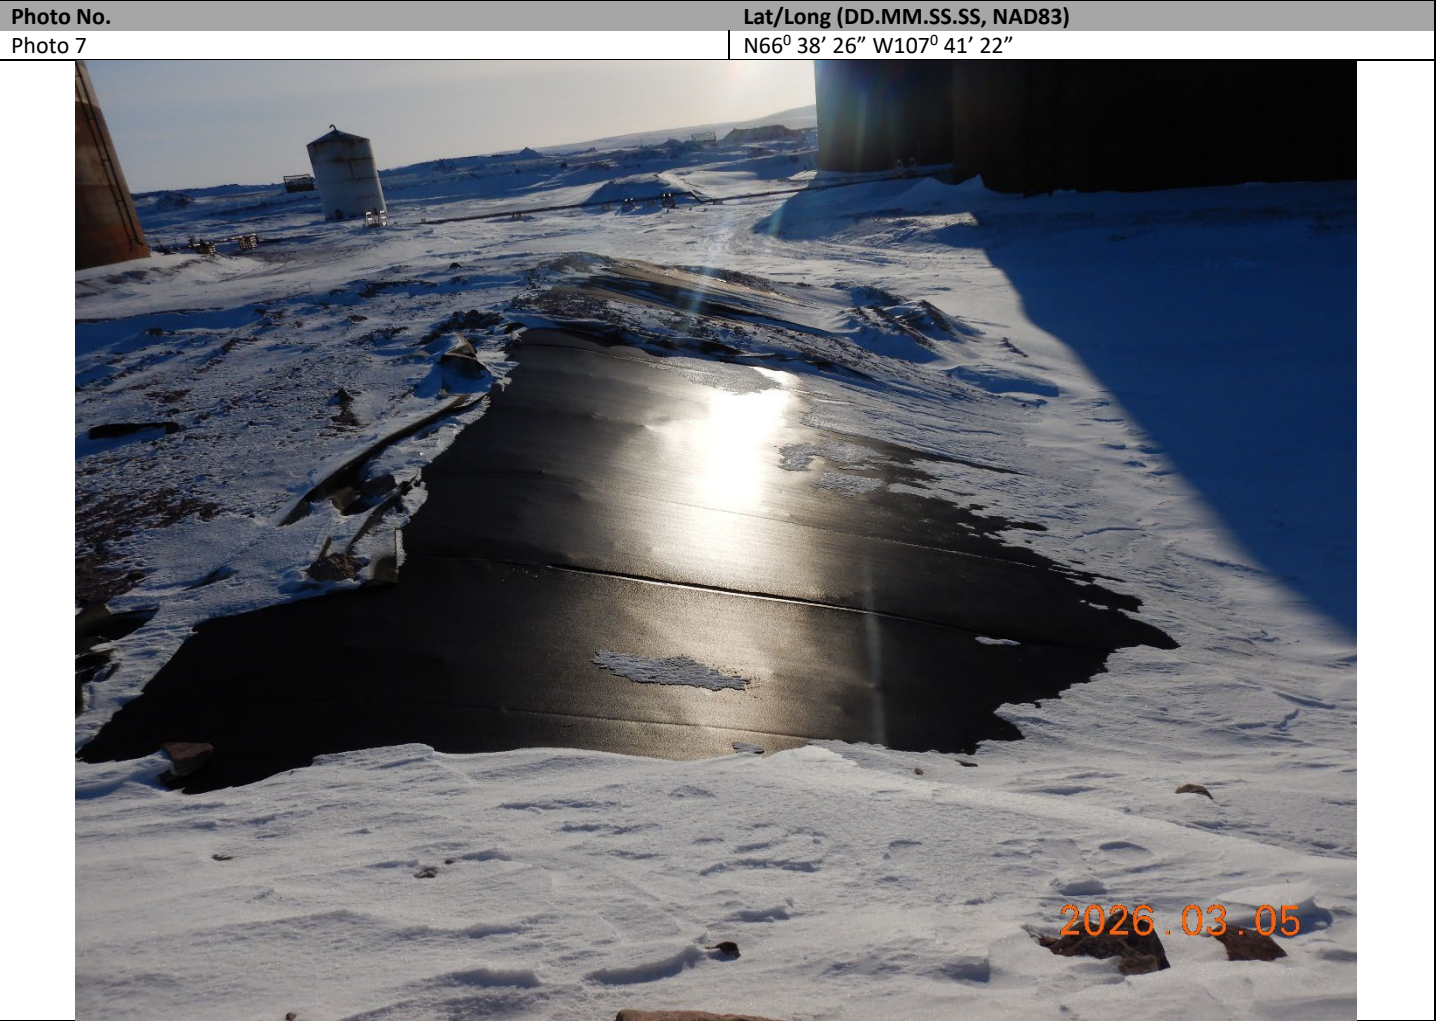
- e) An area of geotextile at the bulk fuel storage facility is damaged leaving the HDPE liner exposed. Representatives stated this was identified on the recent geotechnical inspection. Plans are in place for the repair. (Photo 7)

Description:
Exposed HDPE Liner.

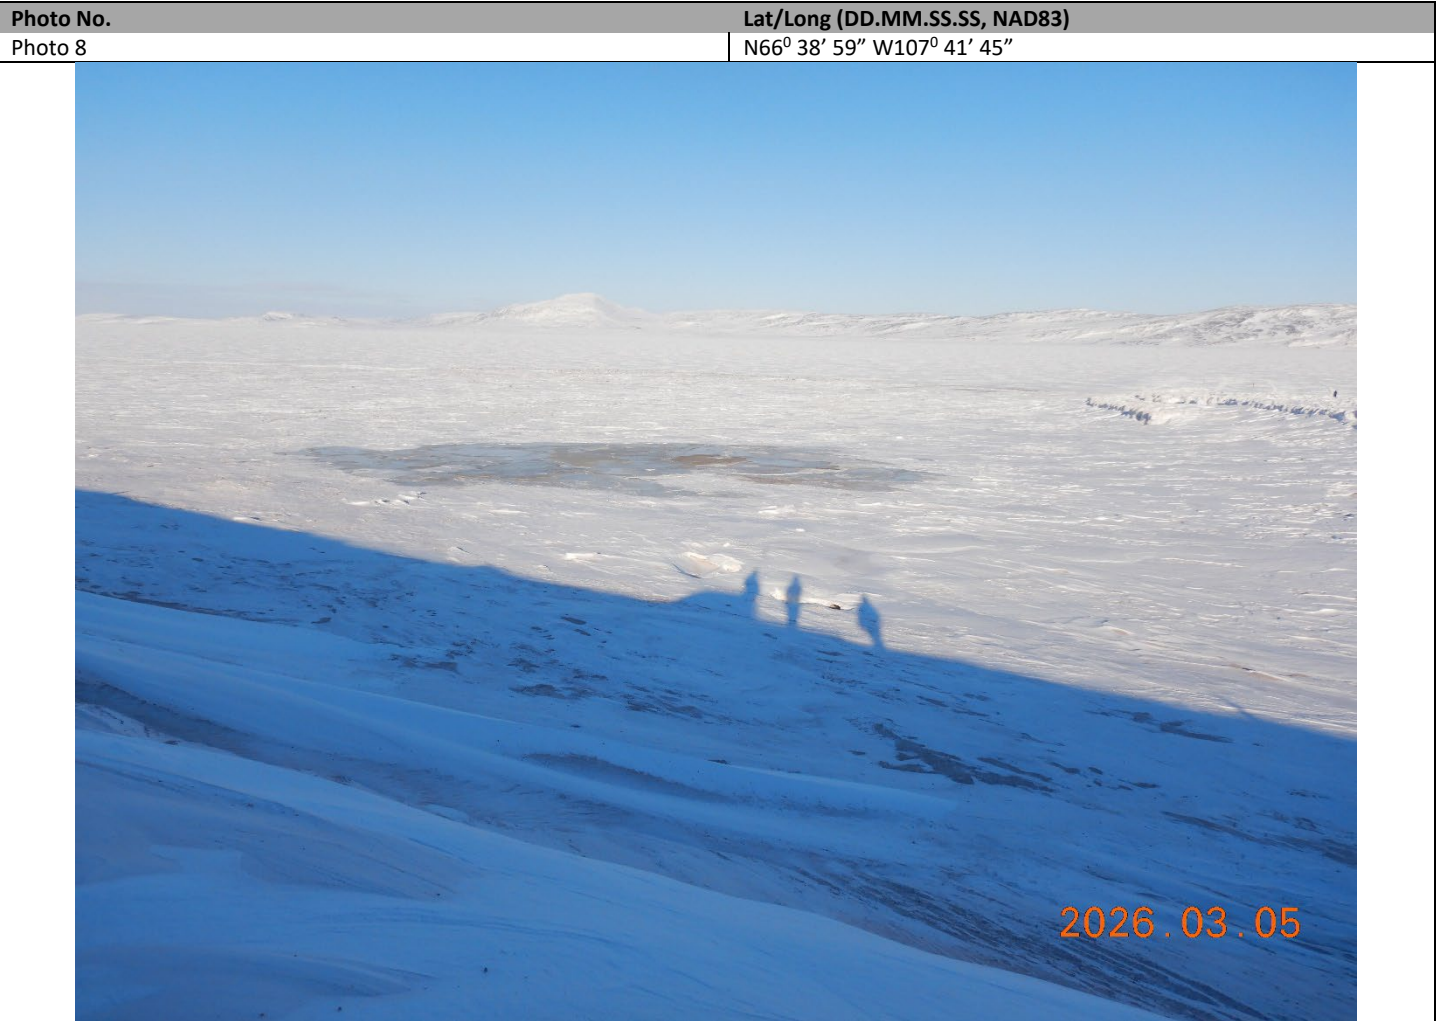
- 3) Waste Management
 - a) The MLA uses pacto toilettes and an incinerator for sewage management.
 - b) A grey water discharge line is located near the airstrip at N66° 38' 59.9" W107° 41' 45.7" for BRP-42. (Photo 8). Representatives note no samples of been taken to ensure compliance under Part F Item 6. A review of the licence indicates that sampling will take place when effluent reaches the marine environment which does not appear to be occurring.

Description:
Grey water discharge line at MLA. Photo taken from airstrip, discharge is the dark area in center with Bathurst Inlet in background.

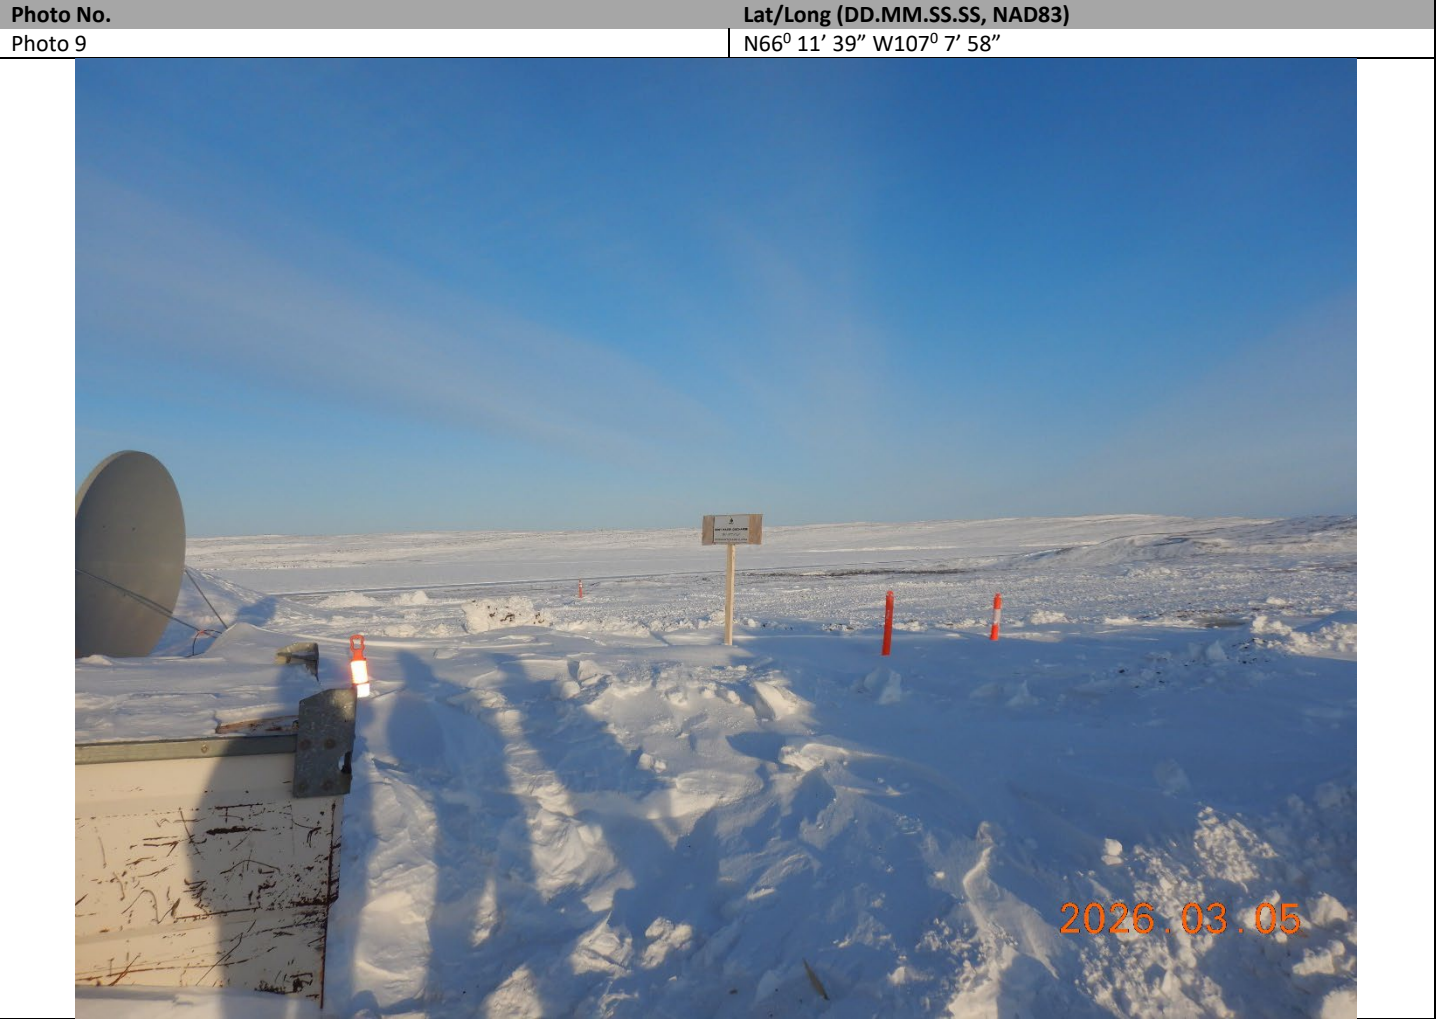
- 1) Water for this camp is obtained from various sources by water trucks generally used for ice road construction. Water use for this purpose is covered under Part E Item 5 of the licence. Water usage for the camp as of March 10 is 420m³ for the year.
- 2) Grey water is discharged in a natural depression at the rear of the camp (Photo 9) at N65° 33' 15" W106° 30' 36". The inspector notes the selected location is not optimal for the volume of waste produced by the camp and will result in off site impacts. Improvements to this infrastructure should be made to better comply with Part F Item 23 of the Licence. Signs indicating this is a waste disposal area are

present to comply with Part B Item 17 of the Licence. (Photo 9)

Description:
Grey water discharge line at MLA forward camp.

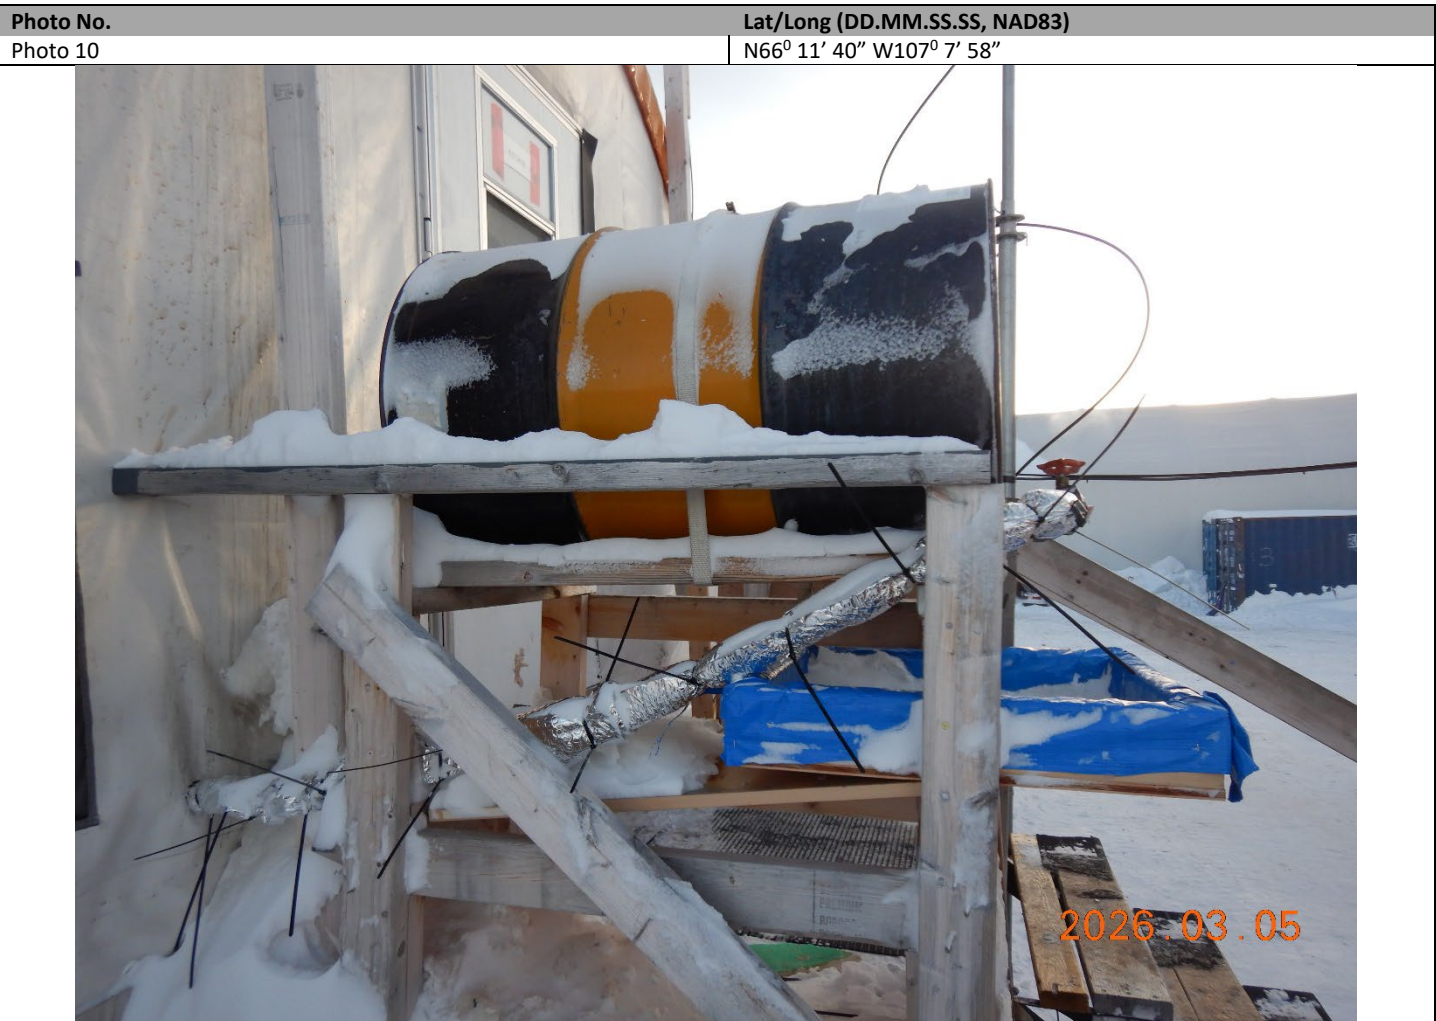
- a) Photo 10. The Inspector notes the secondary containment only covers a small area under the spigot from the fuel drum. Secondary containment must provide containment for the entire fuel carrying vessel.

Failure to comply with Licence
-Part H item 3, failure to provide secondary containment

Description:
Insufficient secondary containment.

- The Licensee shall immediately place and use adequate secondary containment for vehicles, hazardous material storage areas, and refueling areas.

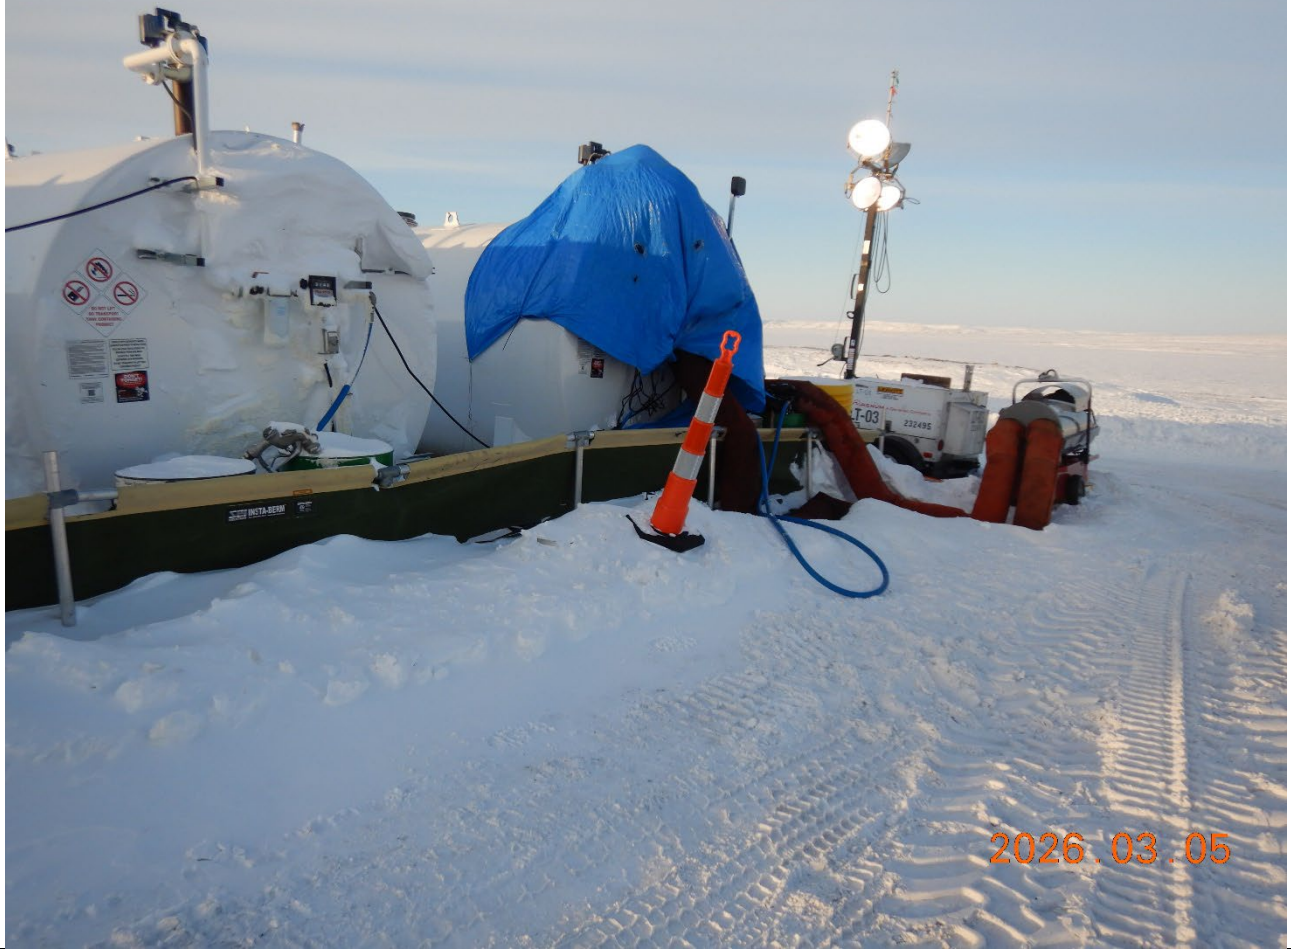
Photo No. Photo 11	Lat/Long (DD.MM.SS.SS, NAD83) N66° 11' 42" W107° 7' 59"
------------------------------	---

- b) The truck and equipment refueling area does not have a drip tray available to use during refueling activities. (Photo 11)
 - c) Secondary pads placed under bulk material totes behind shop are improperly placed and are not of a sufficient capacity if the containers fail. (Photo 12)

Description:
Equipment refueling area at MLA forward camp. Not no drip tray is available for use at this location.

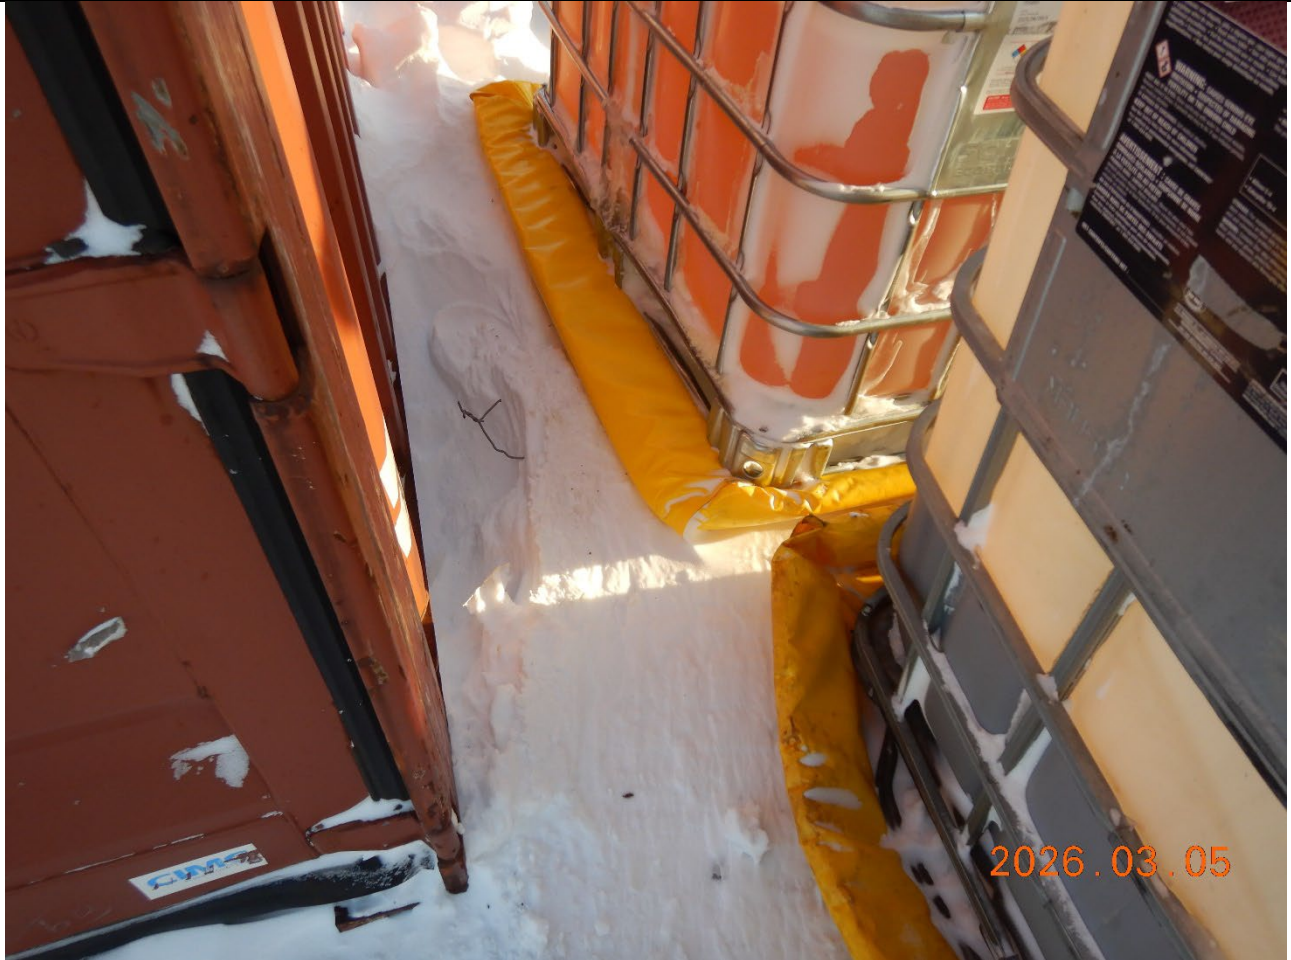
Photo No. Photo 12	Lat/Long (DD.MM.SS.SS, NAD83) N66° 11' 39" W107° 8' 2"
------------------------------	--

Description:
Poor use of drip tray underneath bulk totes. Also trays used are insufficient for capacity of containers.

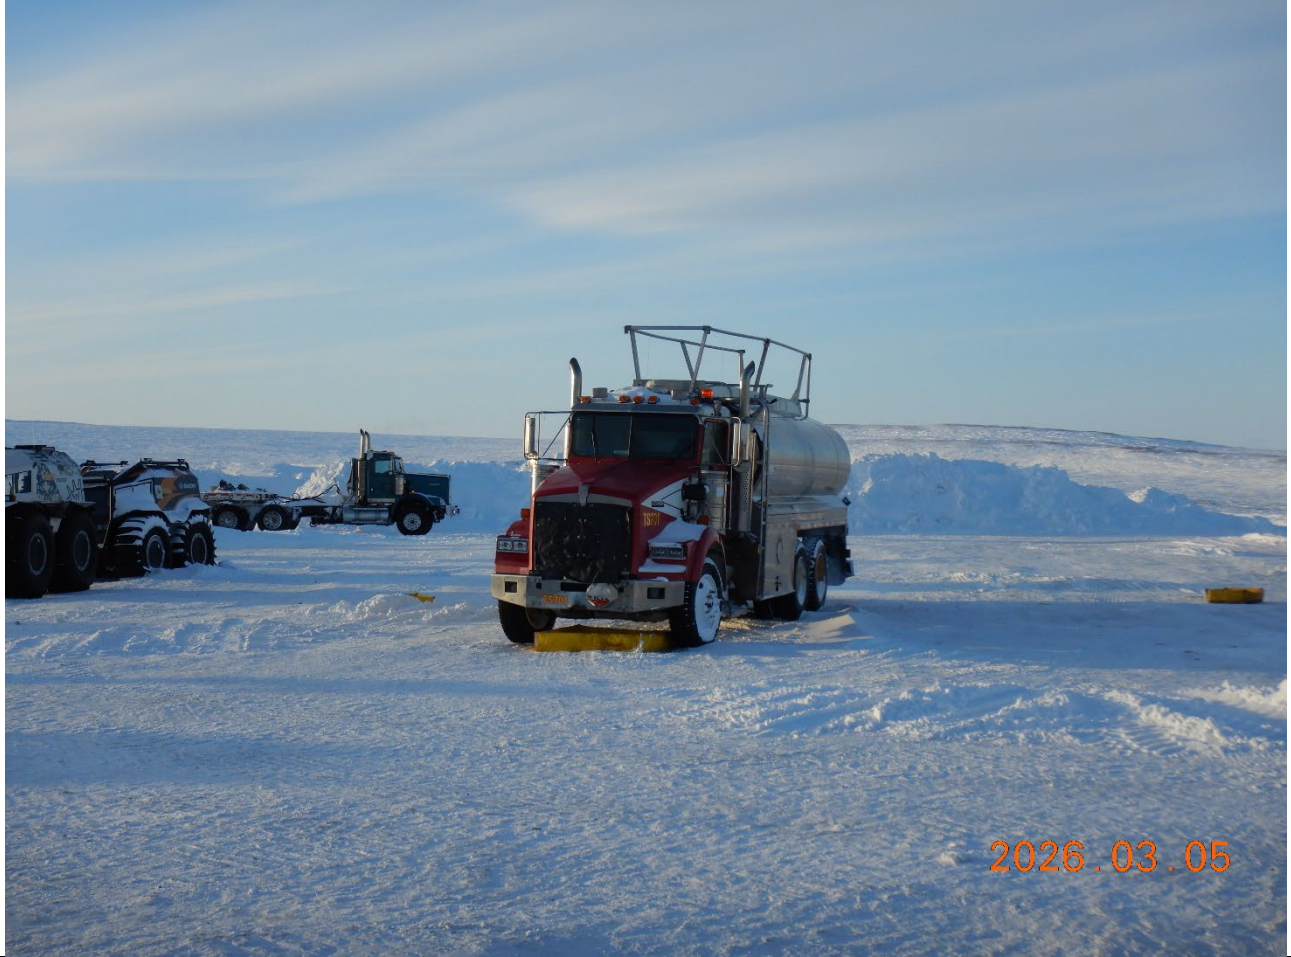
Photo No.
Photo 13

- d) Properly placed drip pan under truck (Photo 13)
- 4) Maintenance shop
 - a) The maintenance shop used at this site does not have an impermeable floor. Secondary containment is provided for a number of fluid containers. The Inspector notes in Photo 14 the tray under the tote is not of a sufficient capacity to contain a failure of the container.

Description:
Appropriate use of drip tray under equipment.

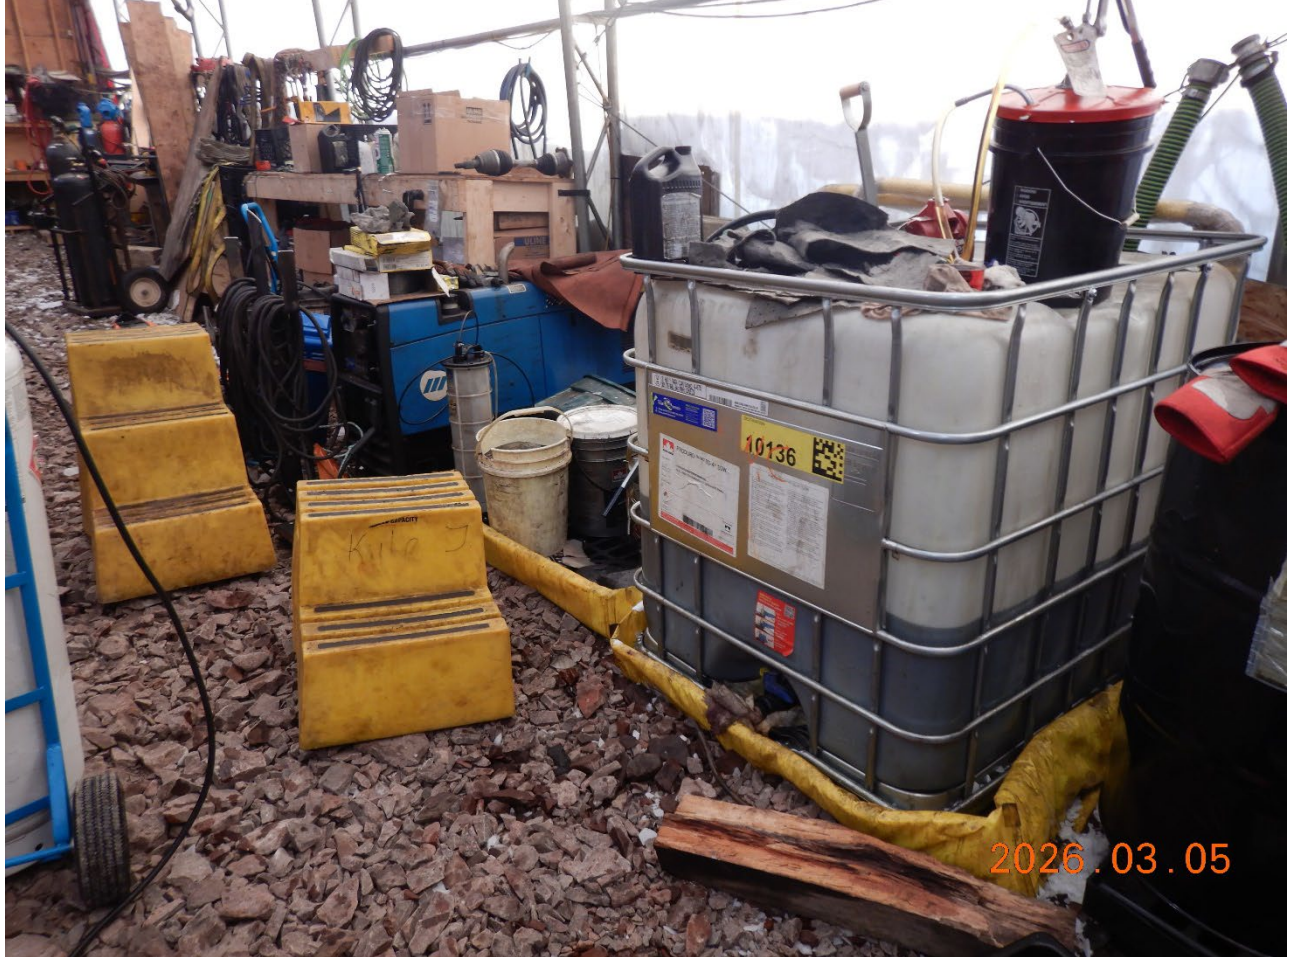
Photo No.
Photo 14

- b) Due to this shop not having an impermeable floor (like concrete) the inspector is concerned that maintenance activities inside the shop are not being conducted in such a way to prevent release into the environment.

Description:
Drip trays in mechanic shop.
