# Water Licence Inspection Report

Original  
 Follow-Up Report

On March 03, 2026 Resource Management Officer Isaiah James Bolt (Inspector) for Crown Indigenous Relations and Northern Affairs Canada (CIRNAC), conducted an inspection of 2AM-BRP1831 (License) issued to B2Gold (Proponent) to ensure compliance against their license.  
 Accompanying the Inspector was Chris LeGoffe, Environmental Superintendent of B2Gold and Kyle Amsel, Inspector for CIRNAC.

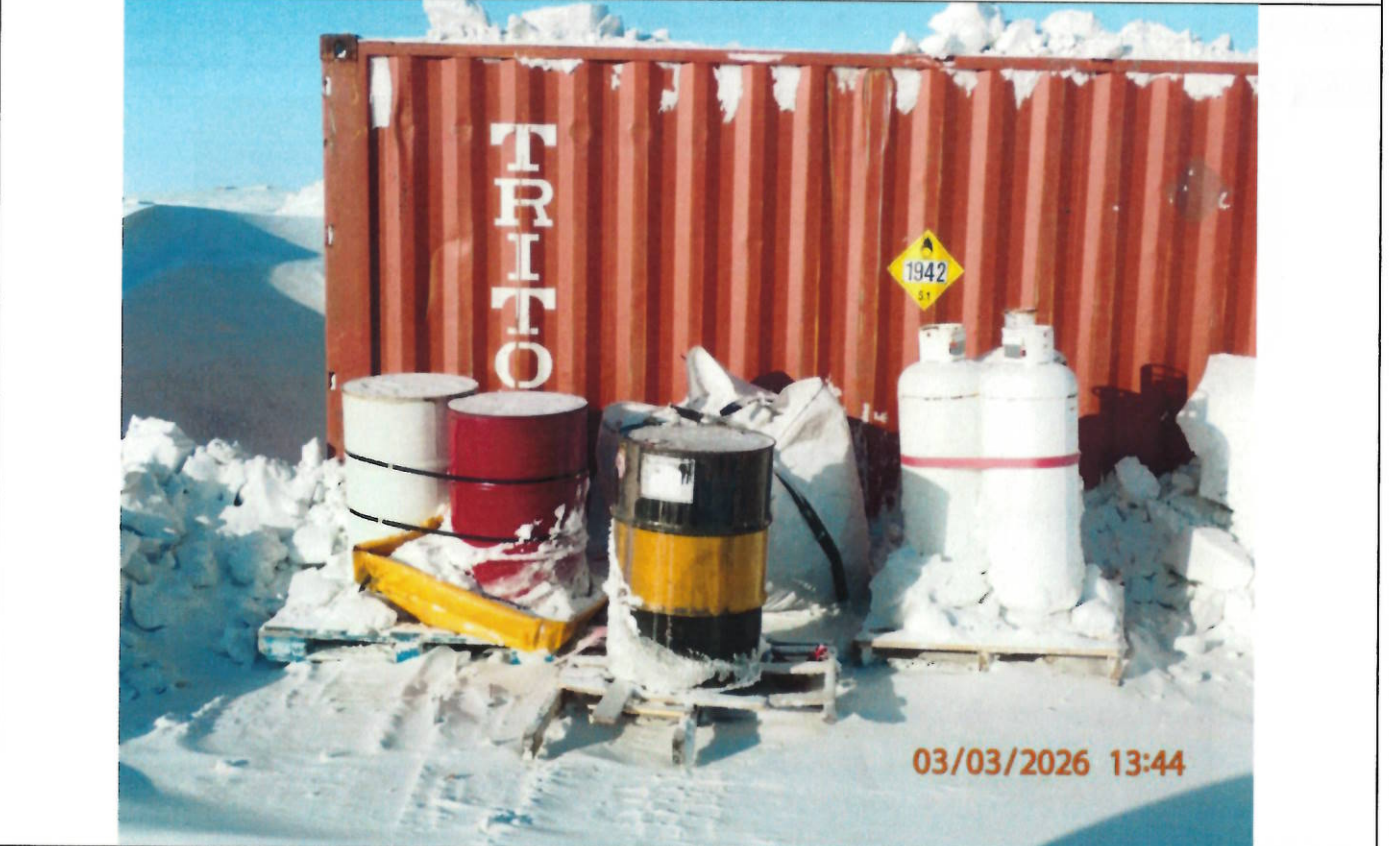
<b>Photo #</b>	2	<b>Coordinates:</b>	
----------------	---	---------------------	--

1. A copy of the water logs for goose lake main camp is shown on (Photo #1). Number of people on site is also provided.
2. Fuel drums were observed outside of containment near the airstrip (Photo #2).

**Description:**  
2 out of 3 drums placed outside of containment.

1. Ensure secondary containment of all fuels and chemicals on site.
2. Install and maintain flow meters or other such devices, or implement suitable methods required to measure Water use and effluent discharge at Goose Forward.

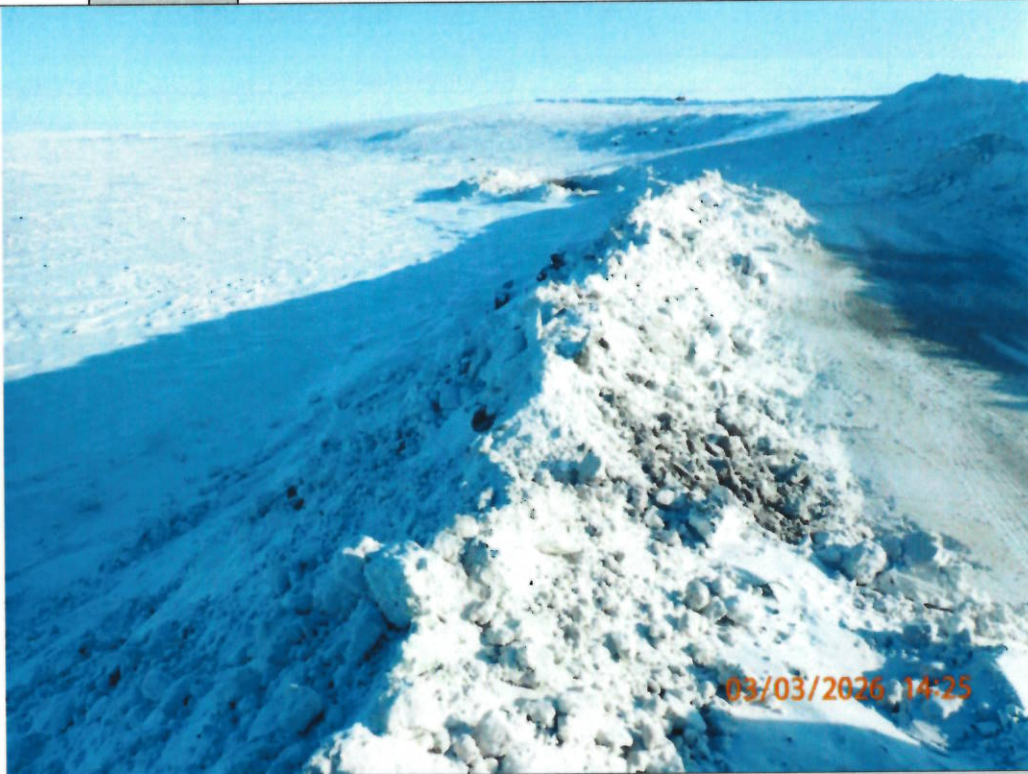
Photo # 3

3. At the goose lake water intake for 2AM-BRP1831, inspectors observed a snow bank filled with gravel and dirt (Photo #3). Once the snow melts, this dirt will run off into goose lake as there is no way of introducing sedimentation mitigation.

**Gravel/sediment laden snow bank right on the edge of goose lake (Main water supply area)** - Part D #7 of the Amended License states "The Licensee shall implement sediment and erosion control measures prior to and during Construction, and Operations where necessary, to prevent entry of sediment into Water." Part E #9 of the amended water license states "The Licensee shall undertake appropriate corrective measures to prevent and/or mitigate impacts to surface Water resulting from the Undertaking."

Snow bank on the north side of the access road to the main water supply for goose lake camp.

3. Remove gravel/dirt laden snow used as a snow bank berm on the edge of Goose Lake at the main water supply at goose lake.
4. Ensure grey water discharge location at goose forward camp is moved to ensure it is in a sump located at a distance of at least thirty one (31) metres above the ordinary High Water Mark of any Water body at a site where direct flow into a Water body is not possible and no additional impacts are created, or discharge it to a wetland area located at a distance of at least thirty one (31) metres above the ordinary High Water Mark of any Water body at a location where direct flow into a Water body is not possible and no additional impacts are created. Having the discharge onto the pad will result in erosion of the pad and sedimentation onto the land.

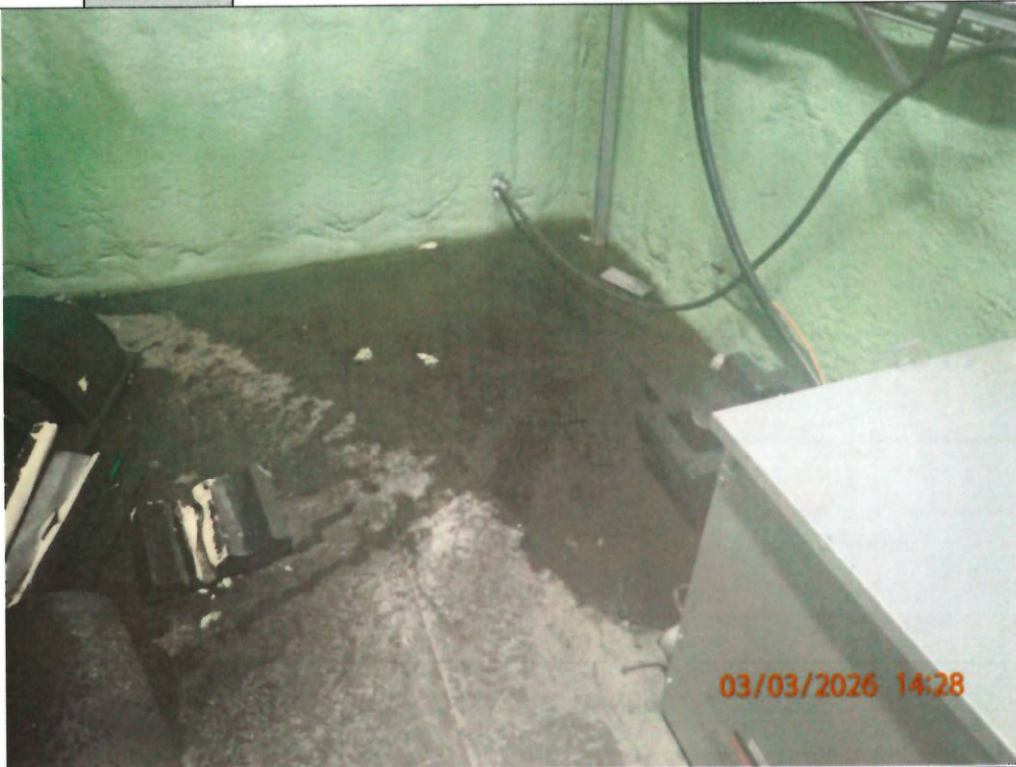
Photo # 4

4. At the "camp water supply" seacan for 2AM-BRP1831, a leak was observed on the main water line. A pool of water was observed in the corner of the seacan. (Photo #4) shows the standing water inside the seacan and (Photo #5) shows where the leak is coming from.

Water spill inside the main water supply seacan.

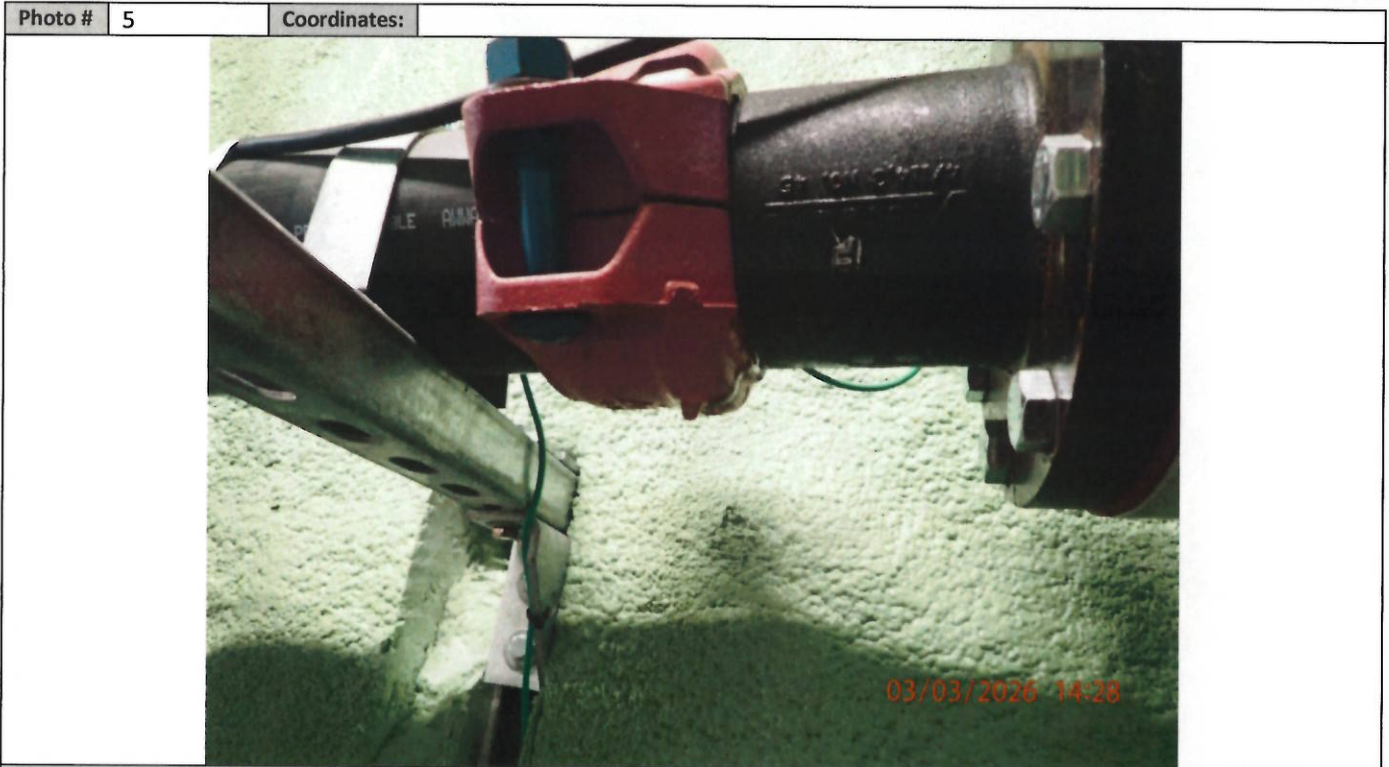
**Description:**  
Water leak from the main water line in the main water supply seacan.

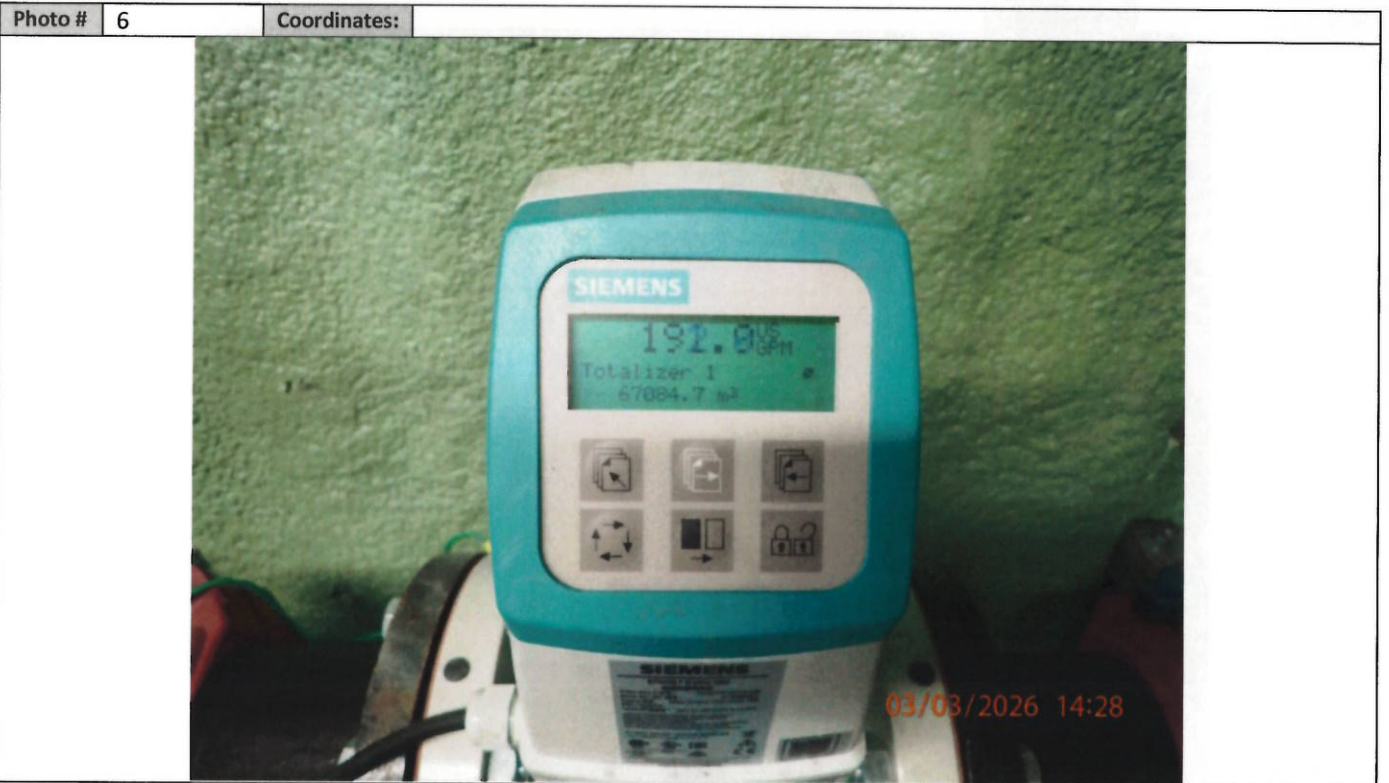
**Description:**  
Water meter inside the main water supply seacan.

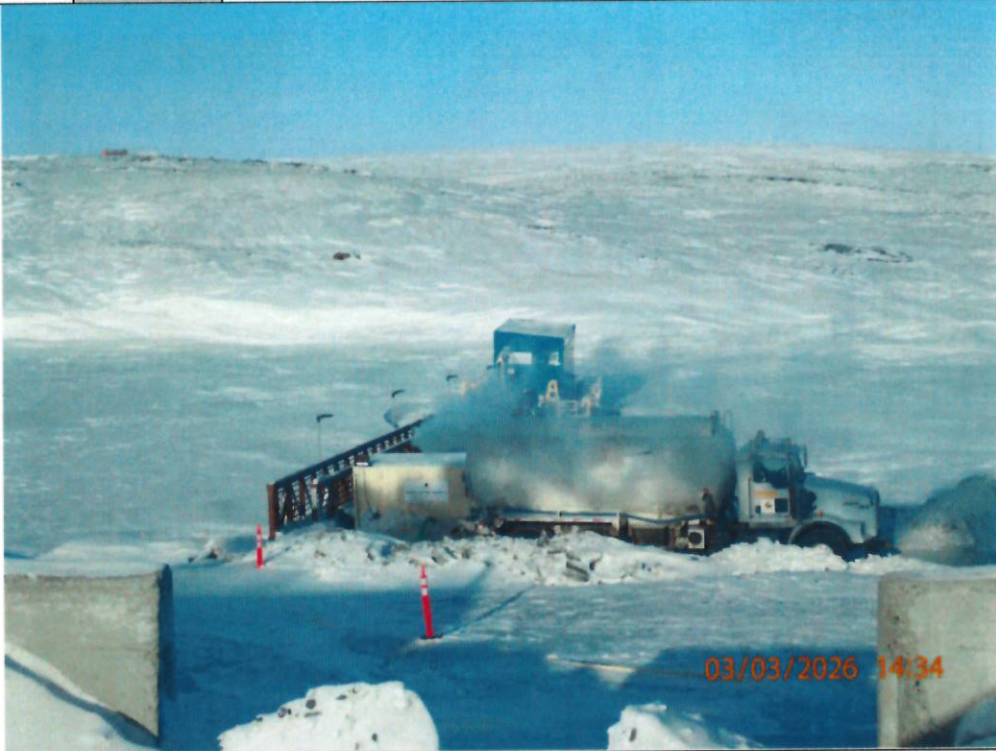
Photo # 7

5. A photo of the water meter inside the seacan was taken (Photo #6).
6. The water truck used to supply goose lake main camp was observed refilling at the time of inspection (Photo #7). Water trucks are refilled at the main water supply seacan and are used to supply camp 24 hours per day.

Water truck refilling.

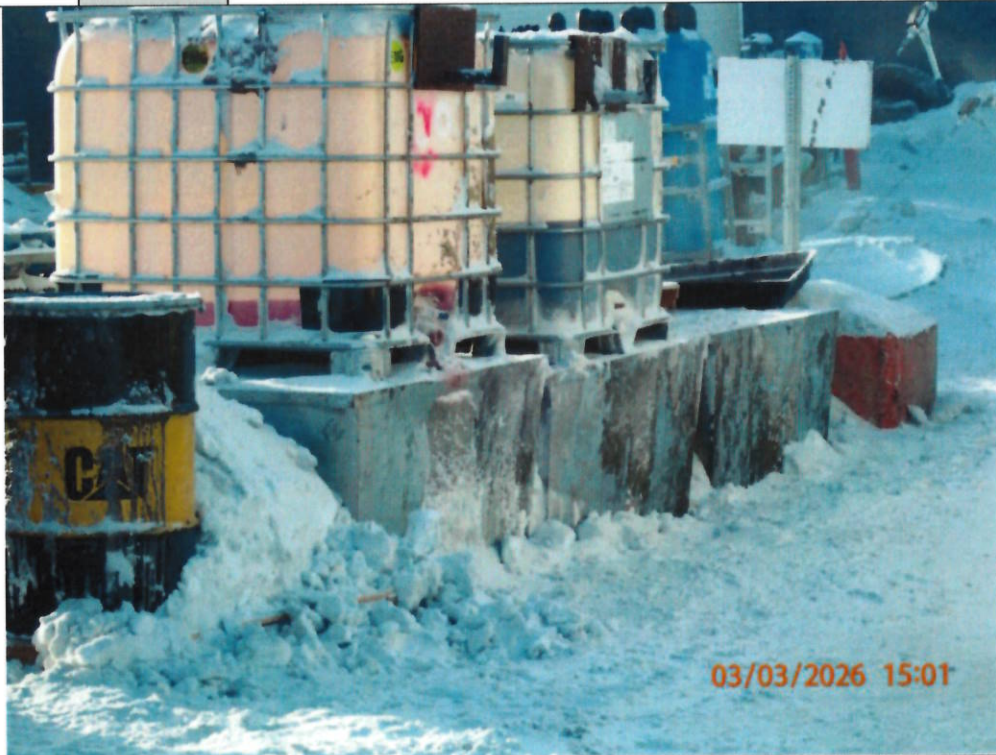
Photo # 8

7. Totes were observed leaking over their secondary containment at the Mechanic shop at goose main (Photo #8).
8. Totes and drums were observed outside secondary containment outside of the mechanic shop (Photo #9).

**Totes/drums out of secondary containment, Leaks on snow and staining on the ground.** Part H #3 of the amended water license states: "The Licensee shall provide secondary containment for fuel and chemical storage as required by applicable standards and acceptable industry practice."

Oil totes leaking over their containment onto the ground. A drum placed on a pallet, no secondary containment.

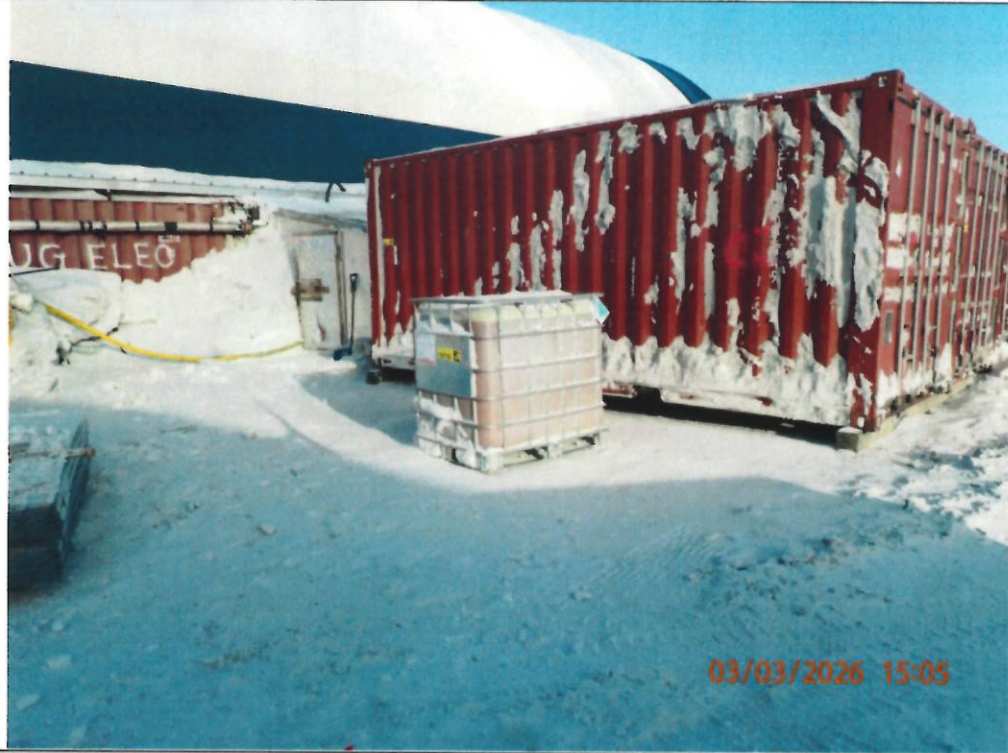
Photo #	9	Coordinates:	
---------	---	--------------	--

Description:  
1000L Tote out of containment.

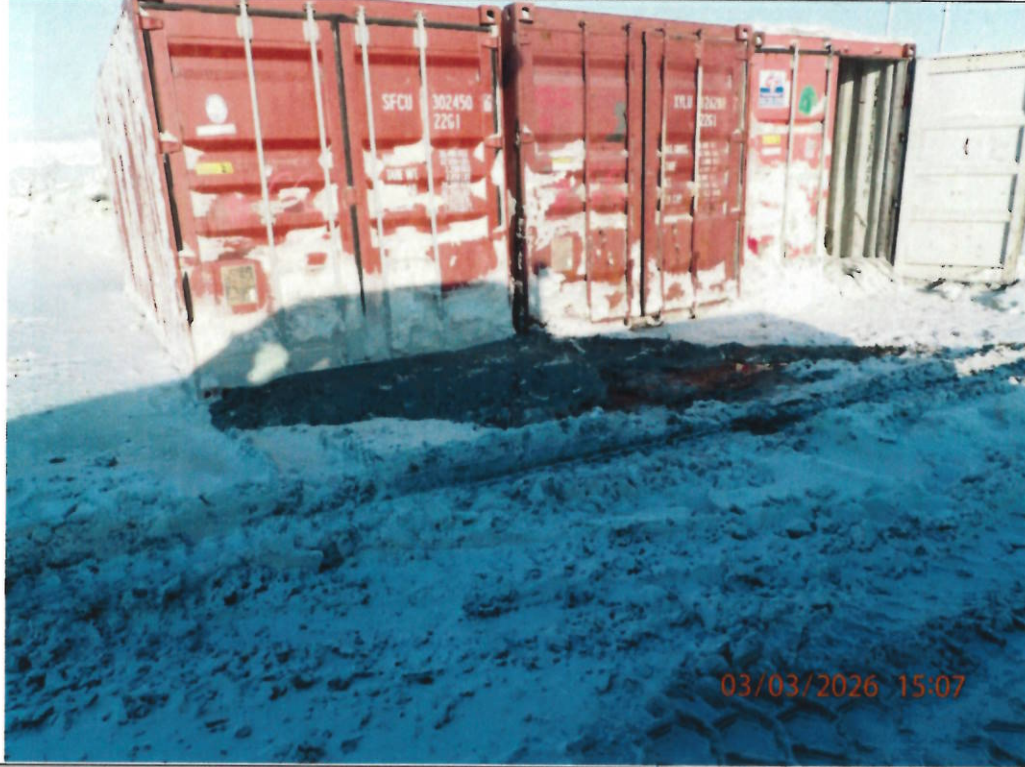
Photo #	10	Coordinates:	
---------	----	--------------	--

9. A spill was observed outside of the portal to underground, near some seacans (Photo #10). The spill was reported to the spill line. The spill consisted of dirty brine water.

Description:  
Brine spill on the ground near the underground portal.

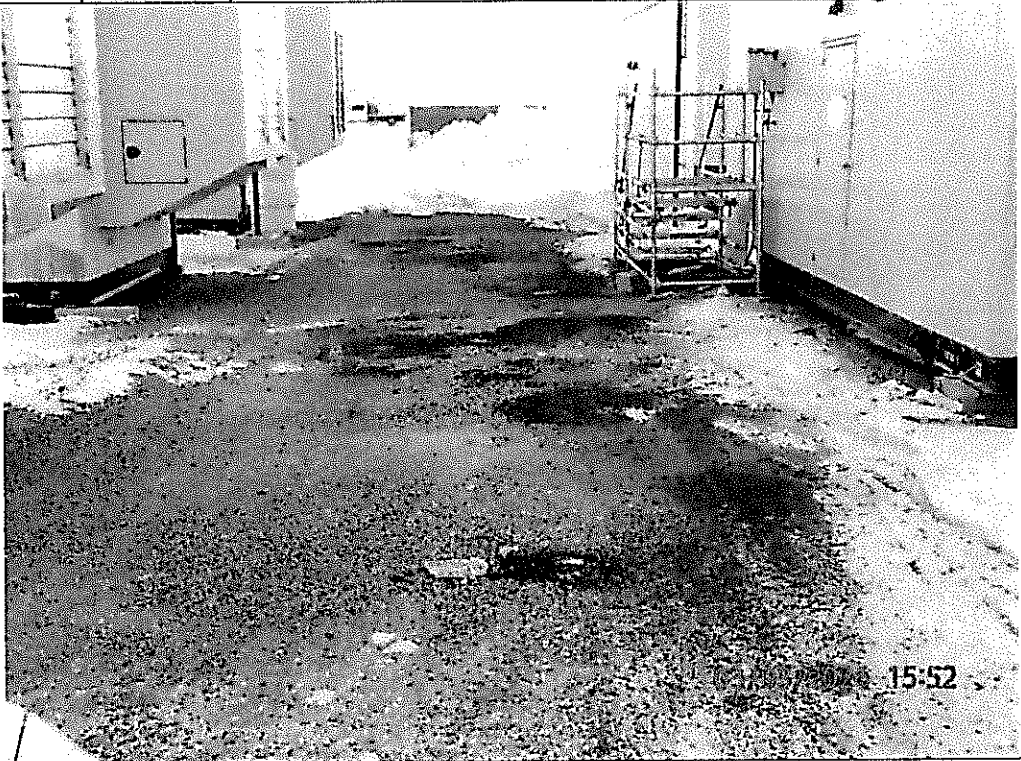
Photo # 11

10. Staining was observed on the ground between the camp power generators at goose main (Photo #11). No spill reported.

Description:  
Staining on the ground between the generators.

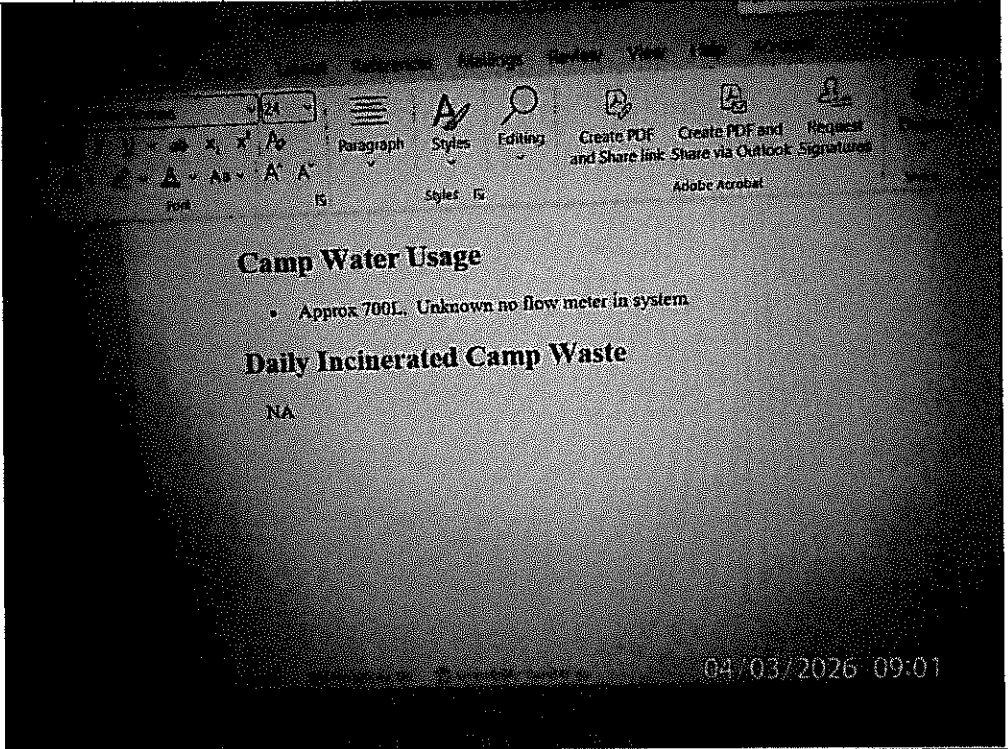
Photo # 12

11. (Photo #12) shows a picture of the laptop at Goose Forward stating "Camp Water Usage: Approx 700L, Unknown no meter in system"
12. Inside the building at Goose Forward, 16, 5 gallon water jugs were observed (Photo #13). Water is delivered from main camp to goose forward in these jugs. This water is treated at main camp and is part of main camp water logs.
13. (Photo #14) shows the grey water discharge location at Goose forward. This grey water is flowing back onto the constructed pad that the camp sits on and not into a natural depression on the tundra or a sump.
14. A copy of the water logs for Goose forward camp is provided on (Photo #15).

**No water meter at goose forward, no proper water logs provided.** Part I #3 of the amended water license states: "The Licensee shall install and maintain flow meters or other such devices, or implement suitable methods required to measure Water use and Effluent discharge volumes, to be operated and maintained to the satisfaction of an Inspector."

Description:  
Goose forward water log showing "approx. 700L. unknown no flow meter in system."

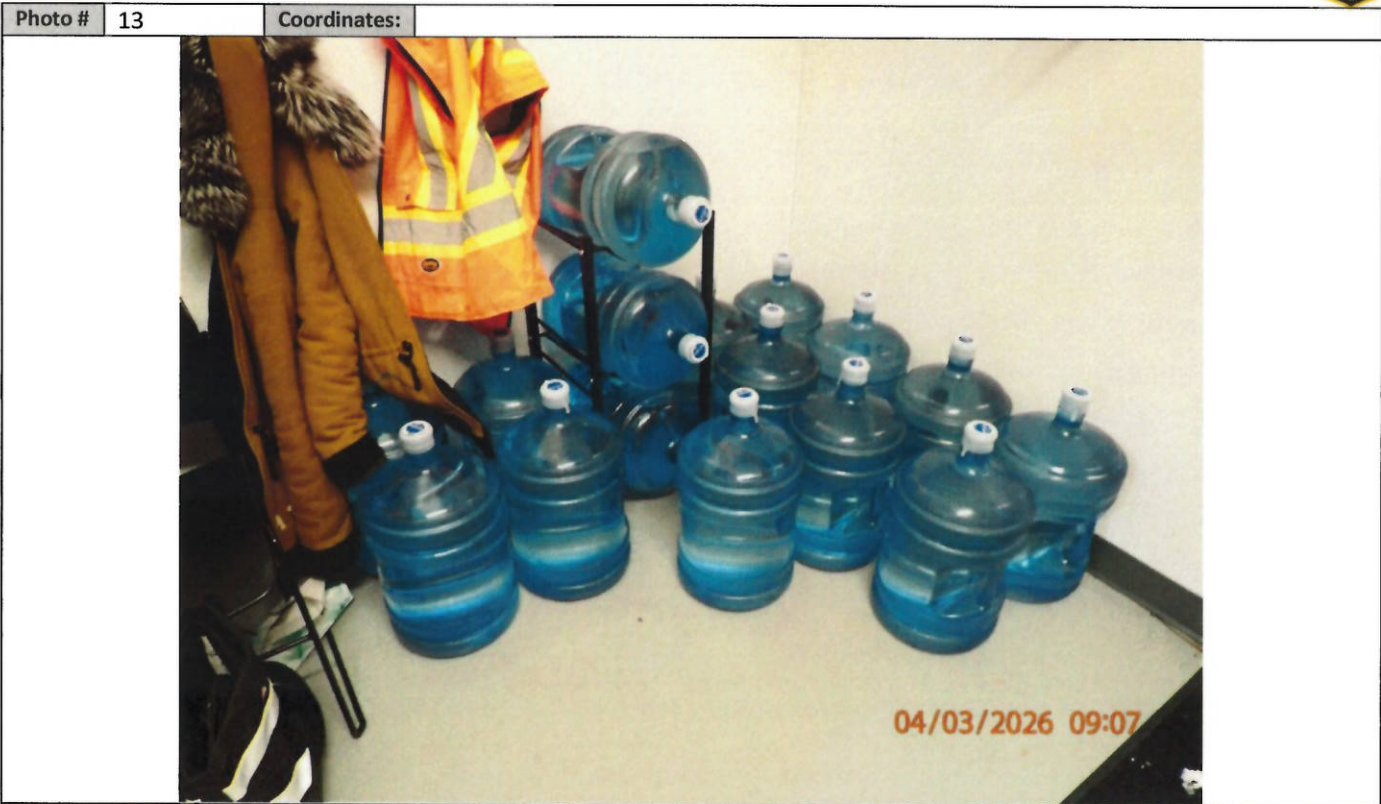
**Description:**  
Water jugs from main camp at goose forward. They are counted under goose lake main water logs.

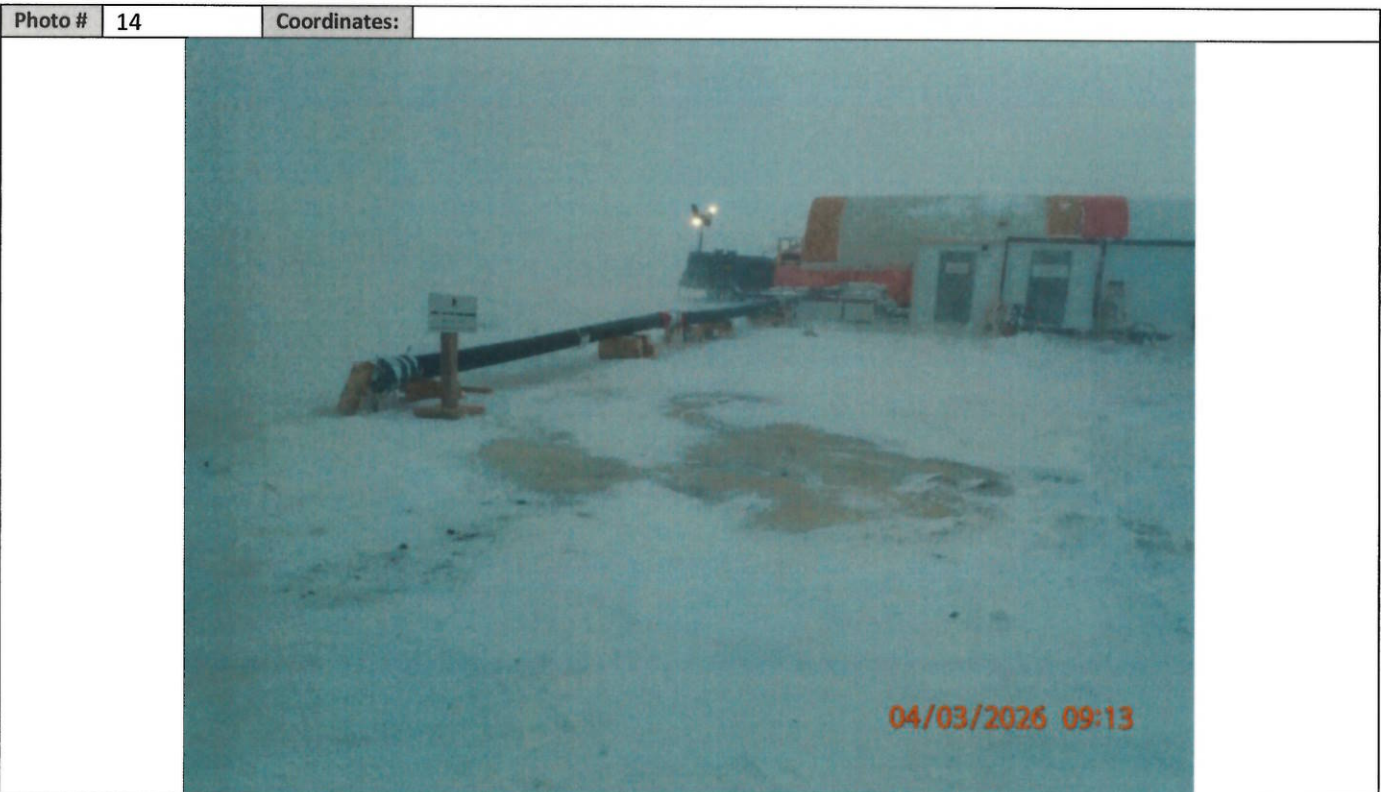
**Grey water not being deposited into a sump or natural depression.** Part F #23 of the amended water license states: "The Licensee shall contain all Greywater from WIR Service/Emergency Camps in a sump located at a distance of at least thirty one (31) metres above the ordinary High Water Mark of any Water body at a site where direct flow into a Water body is not possible and no additional impacts are created, or discharge it to a wetland area located at a distance of at least thirty one (31) metres above the ordinary High Water Mark of any Water body at a location where direct flow into a Water body is not possible and no additional impacts are created, unless otherwise approved by the Board in writing."

**Description:**  
Grey water discharge location at goose forward. The release flows right onto the PAD of the camp.
