WATER LICENCE INSPECTION FORM

Licensee	Licensee Representative
Sabina Gold and Silver Corp.	Rob Davidson
Licence No. / Expiry	Representative's Title
2AM-BRP1831	Operations Manager
Land / Other Authorizations	Land / Other Authorizations
Not applicable	Not applicable
Date of Inspection	Inspector
September 4, 2021	Omer Pasalic
Activities Inspected	
<div><div><input checked="" type="checkbox"/> Camp</div><div><input type="checkbox"/> Drilling</div><div><input checked="" type="checkbox"/> Mining</div><div><input checked="" type="checkbox"/> Construction</div><div><input type="checkbox"/> Reclamation</div><div><input checked="" type="checkbox"/> Fuel Storage</div></div> <div><div><input checked="" type="checkbox"/> Roads/Hauling</div><div><input checked="" type="checkbox"/> Other: Potable Water Source, Waste Water Treatment Facility, Solid Waste Facility</div><div><input type="checkbox"/> Other:</div></div>	
SECTION 1 <div><input checked="" type="checkbox"/> Comments (s. __)<div><input type="checkbox"/> Non-Compliance with Act or Licence (s. __)<div><input type="checkbox"/> Action Required (s. __)</div></div></div>

Photo Log

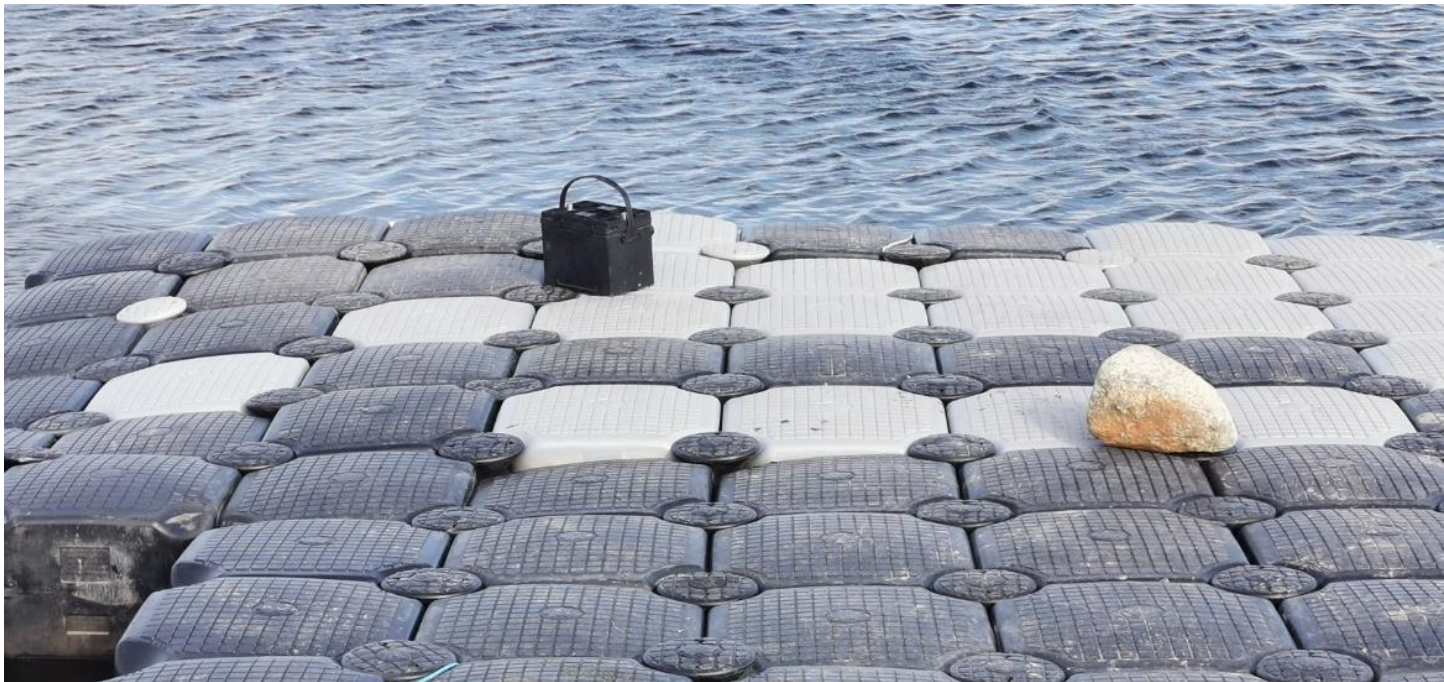
Jetty area of the Goose Bay site, appeared to have debris laying around, a car battery left unattended on the dock of the lake, gas cans next to the water were also observed. Photographs of the jetty are included with this report.

Fuel cans at the edge of the nearby water intake – Goose Lake

- If not already done so, please provide Board’s approval to burn materials named above in Section 2.
- If no approval, stop burning the material as described above in Section 2, until such time the approval has been granted.
- Remove items near jetty area to prevent contamination of water.
- Install and maintain secondary fuel spill containment to prevent fuel seeping onto the ground. (Maintenance garage).
- Immediately report any an all spills, regardless of quantity, to the NWT/NU Spill line at the numbers provided above in Section 2.
- Provide quantity of spill identified in the report above. Diesel fuel/tank number 7, plan for remediation and future preventable measures put in place.
- Instruct employees to use provided cigarette butts containers to dispose used cigarettes as opposed to dispose same directly onto the ground.

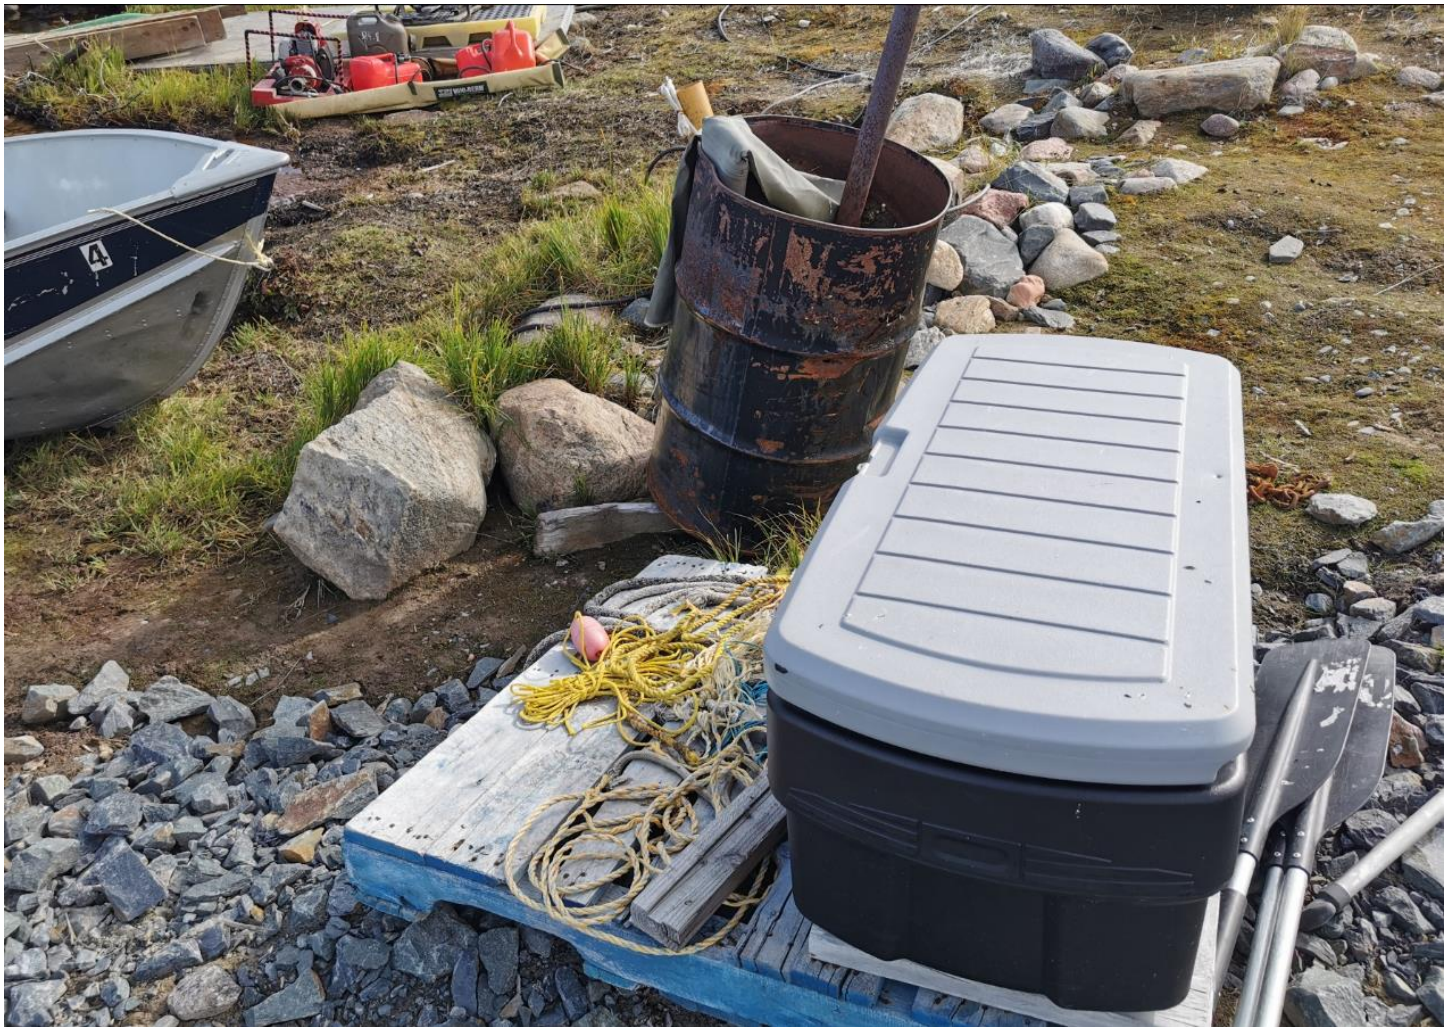
Unattended car battery left at the edge of the dock. Goose Lake.

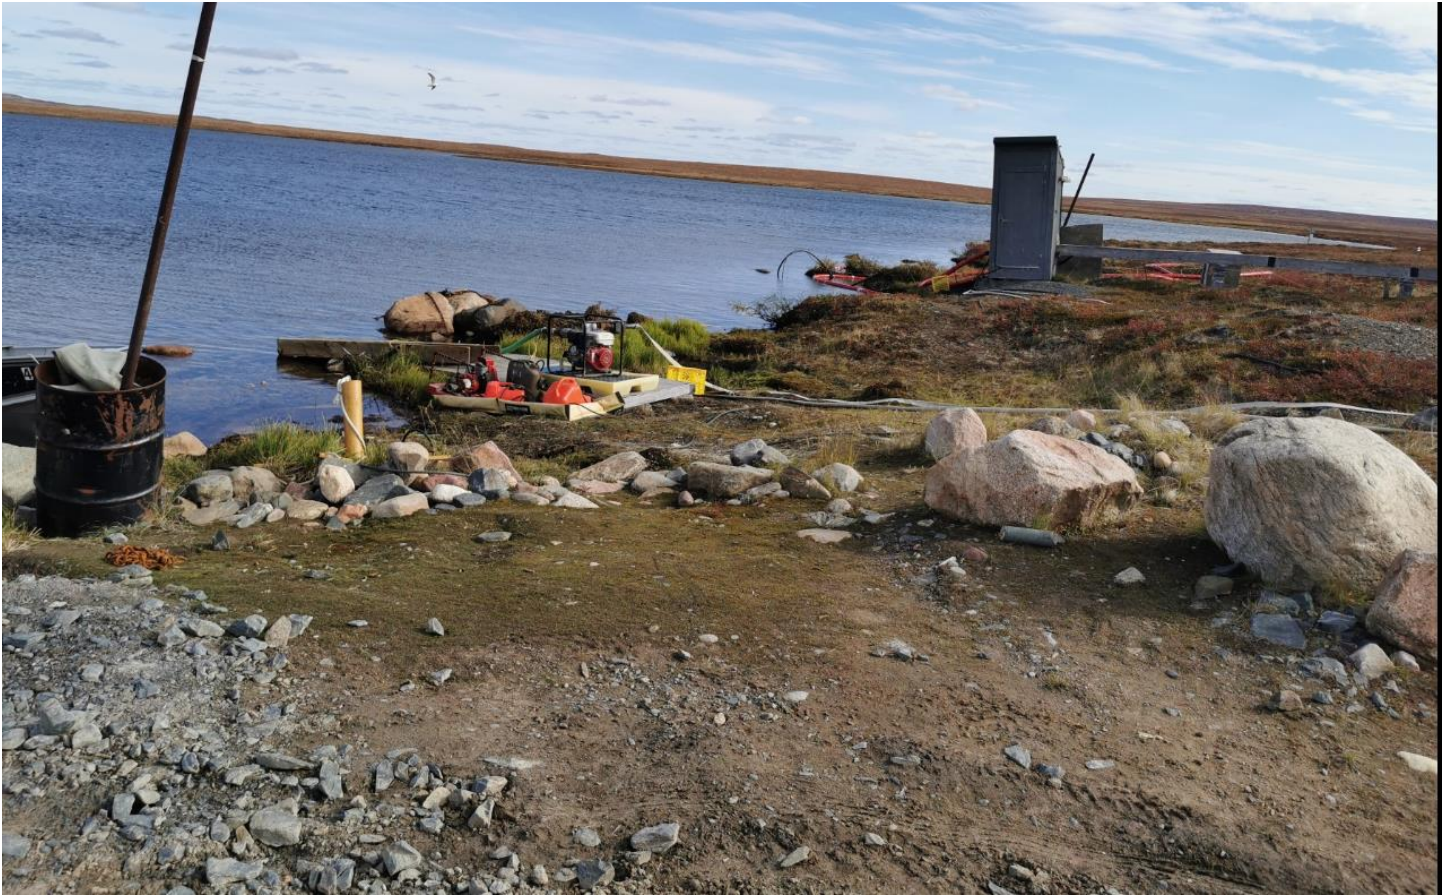
Loose unauthorized items observed within the 31 meters of the high water mark. Goose Lake.

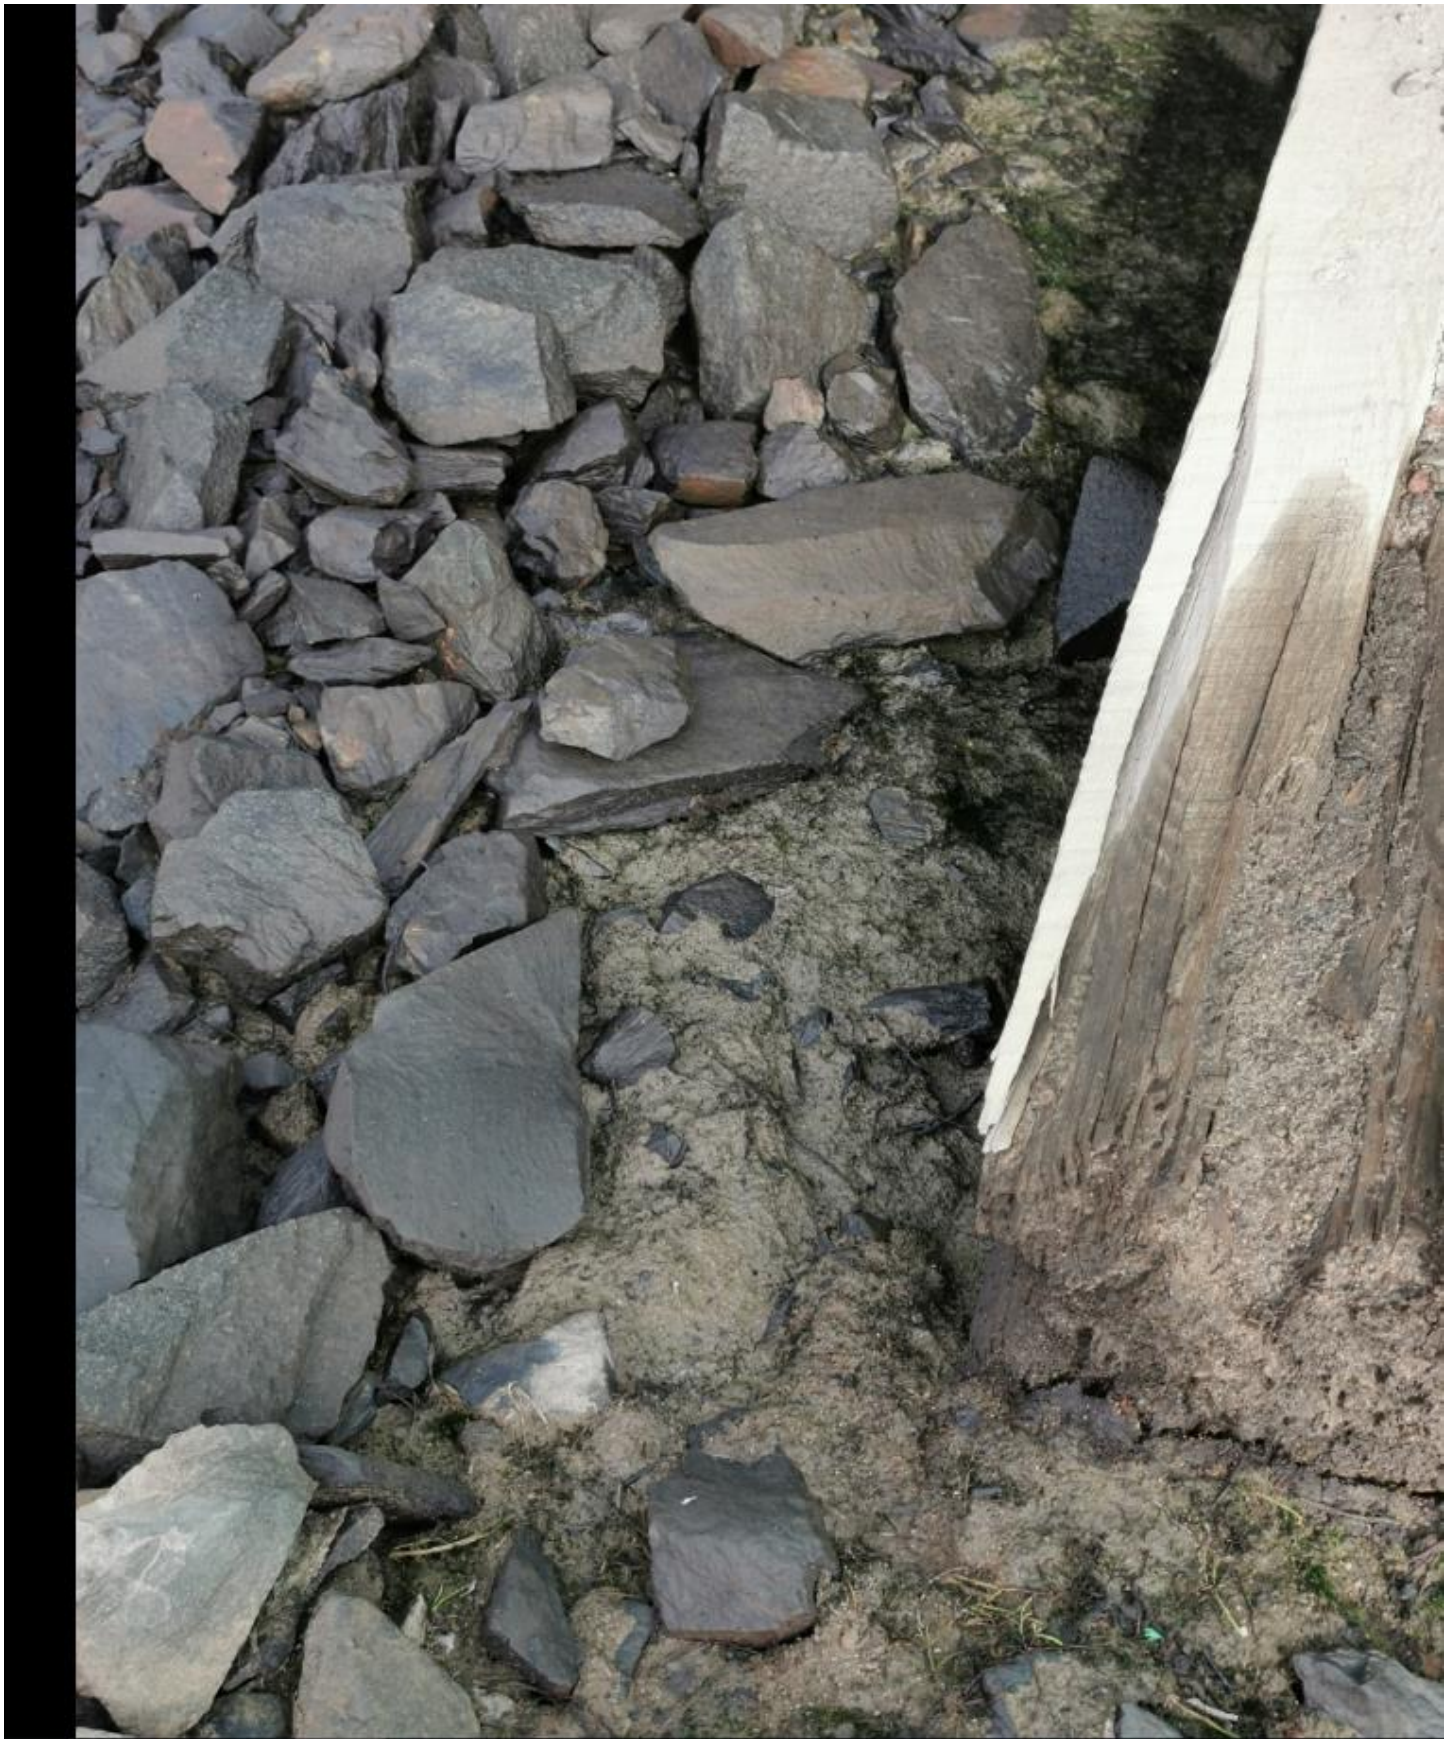
At approximately 1050 hours on the date mentioned above, the inspector was met by Rob Davidson, Operations Manager for the Goose Bay site. Throughout the inspection, a numerous items of the Goose Bay property, identified within issued permits, were inspected including a large diesel fuel spill next to the tank number 7 at the diesel storage facility. The fuel spill observed appeared to have escaped from the holding tank through the connecting outside pipe and onto the adjacent ground directly below the tank. Photographs of the spill are attached to this report.

Diesel fuel spill. Tank number 7.

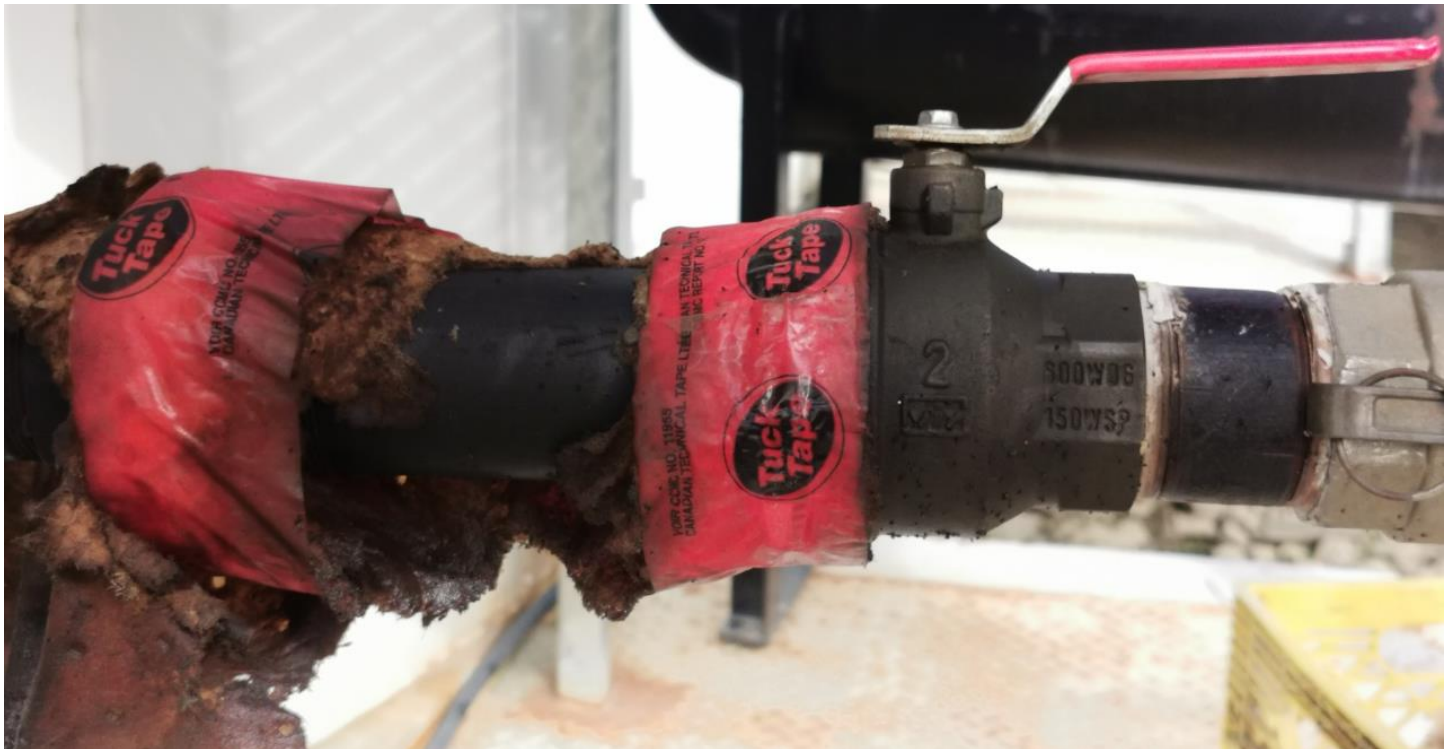
Tank number 7. Seepage detected into the ground/soil.

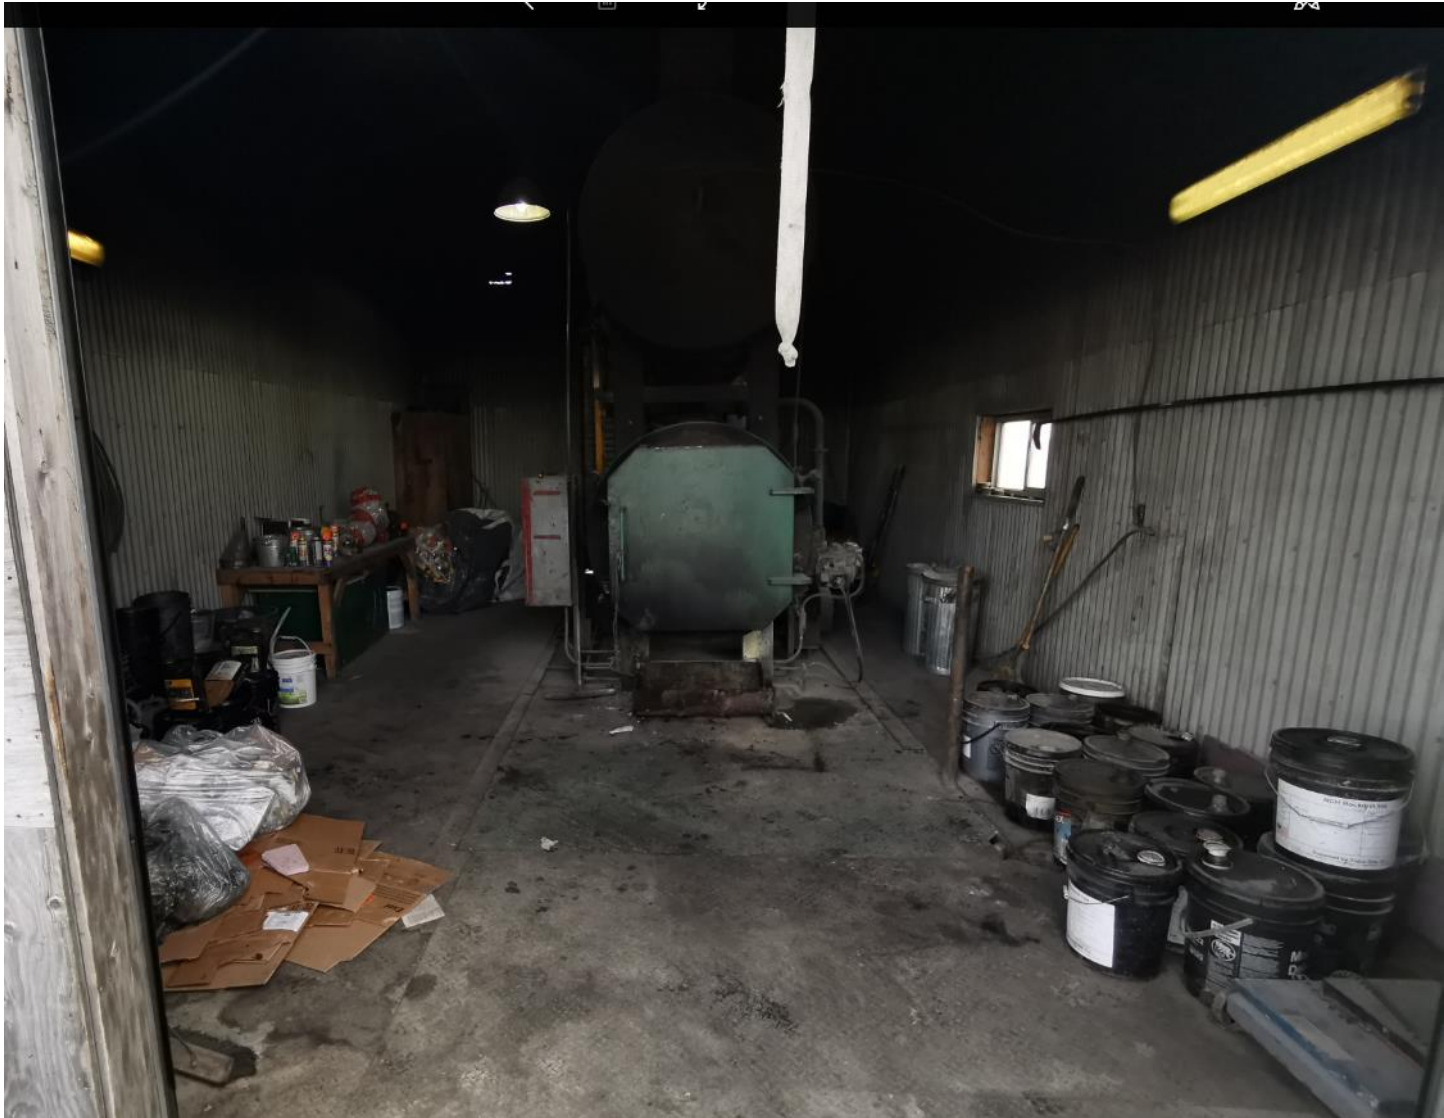
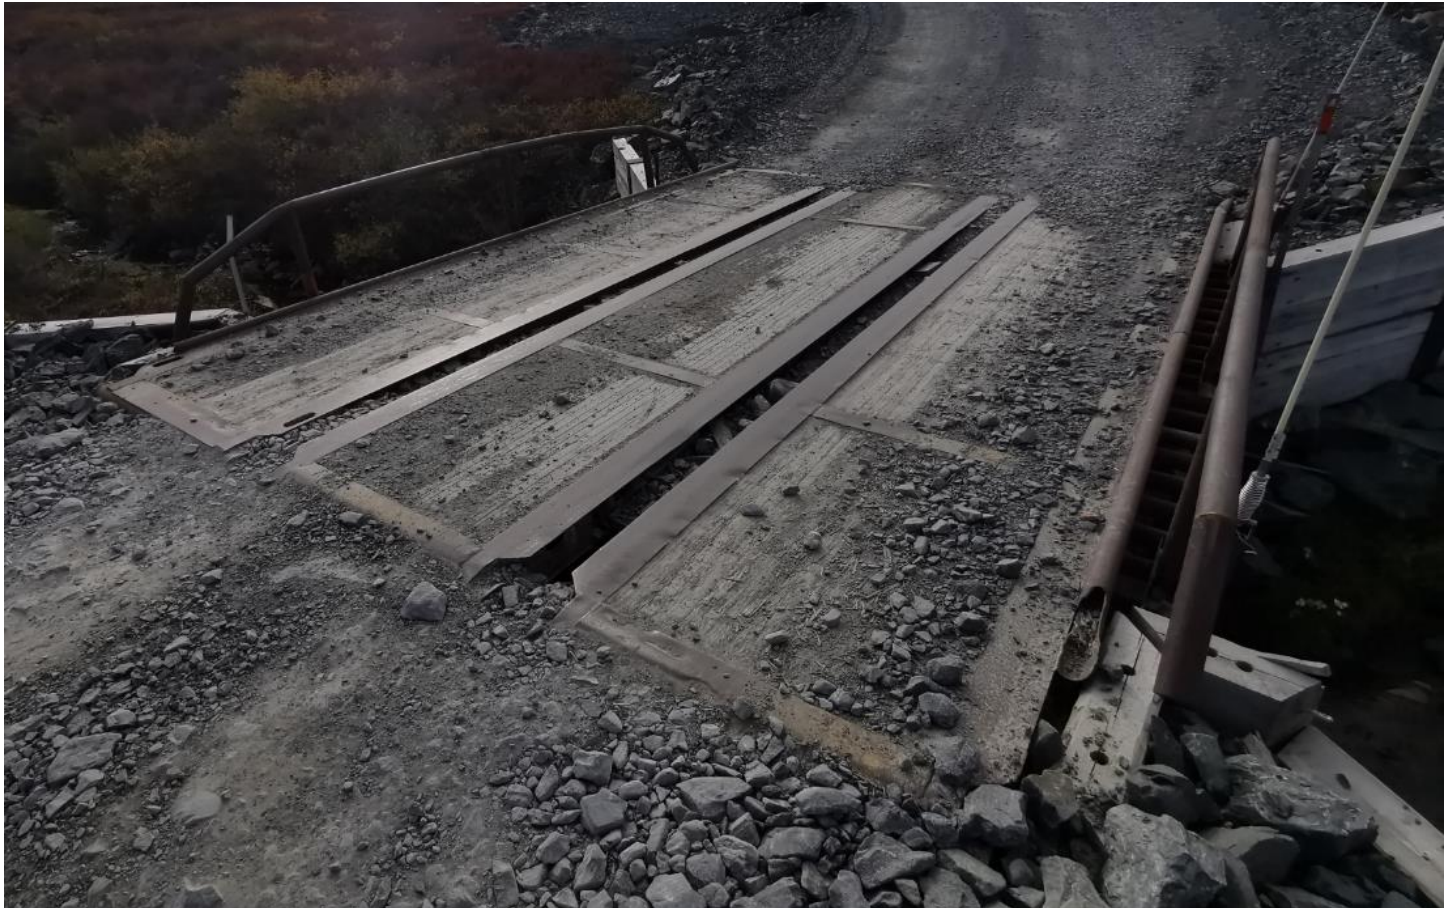
For disposal of sewage, the licensee is using a two-tank incinerator located at the main camp of Goose Bay site. No visible items not authorized by the license have been observed at or near the incinerator facility. Photographs of incinerator are included with this report.

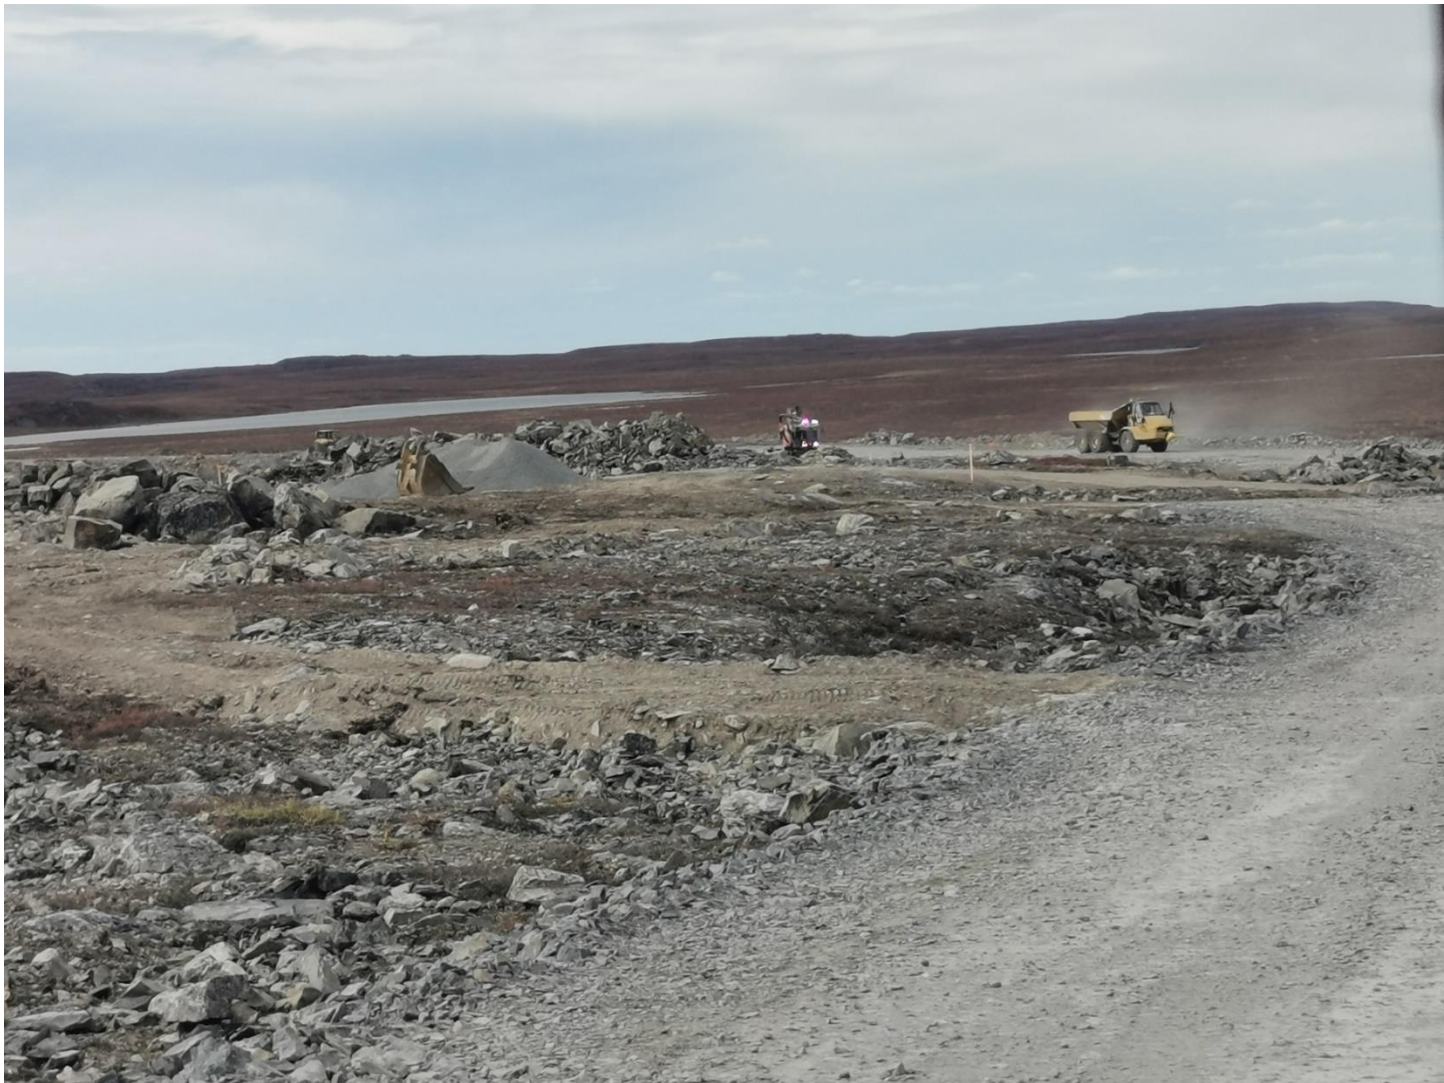
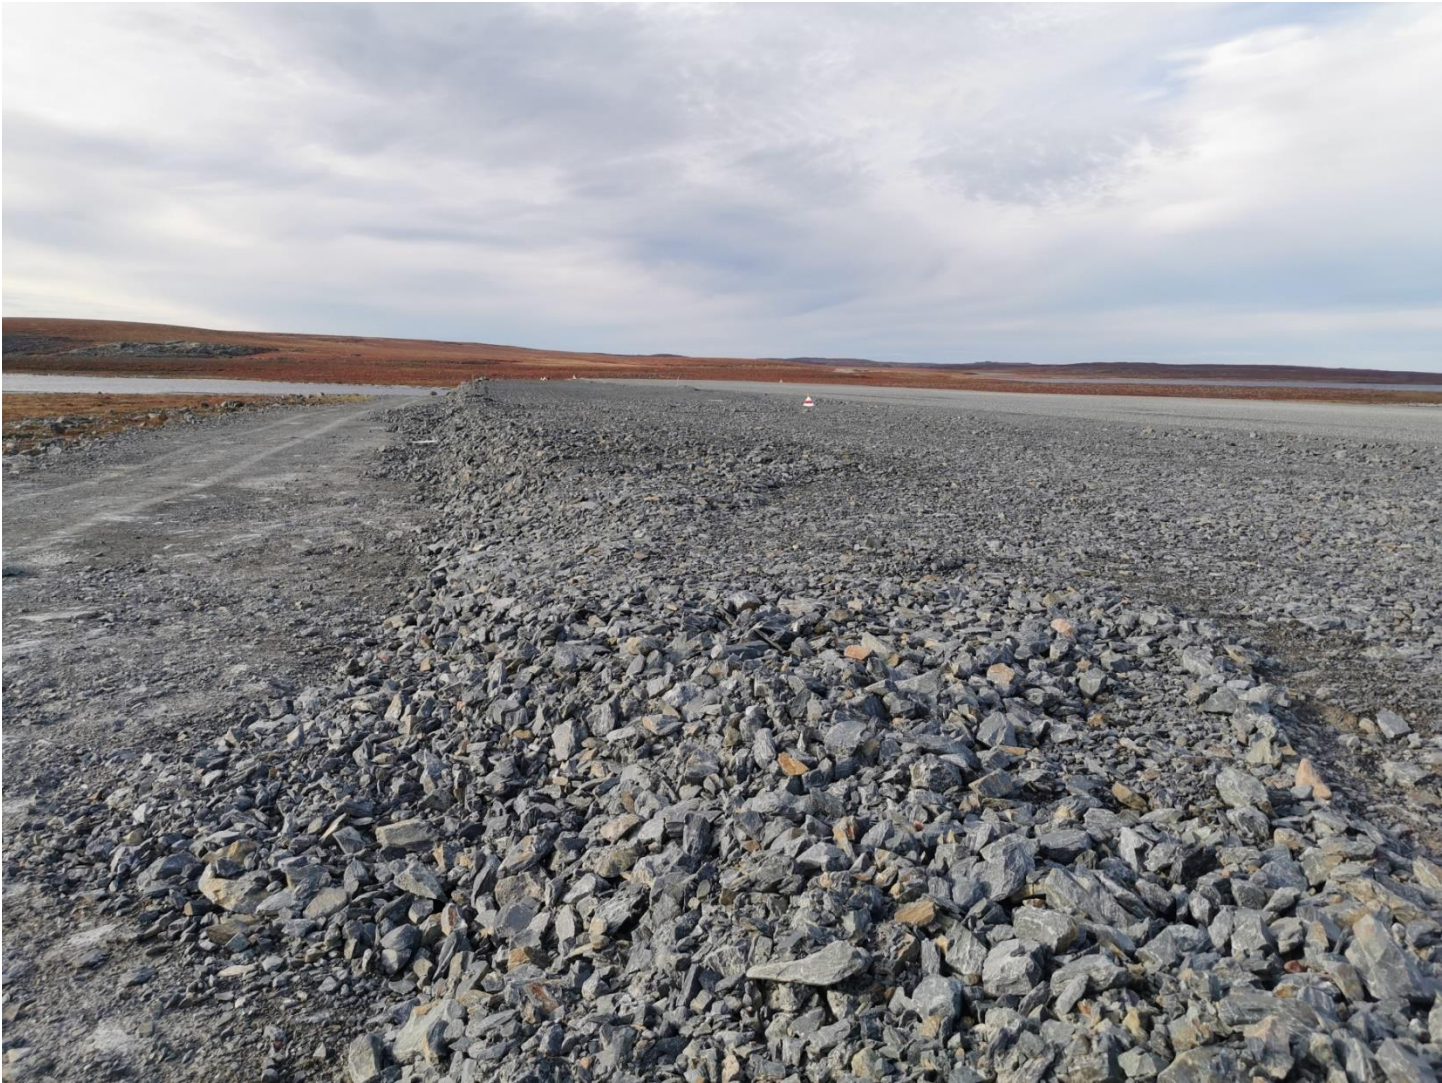
New constructions on the site were also observed. In addition to the construction of the new camp and fuel storage facility located about 4 kilometers south from the existing Goose Bay site’s location, a two new bridges connecting the two sites were built within the last two years. Photographs of the new construction and built bridges are attached to this report.

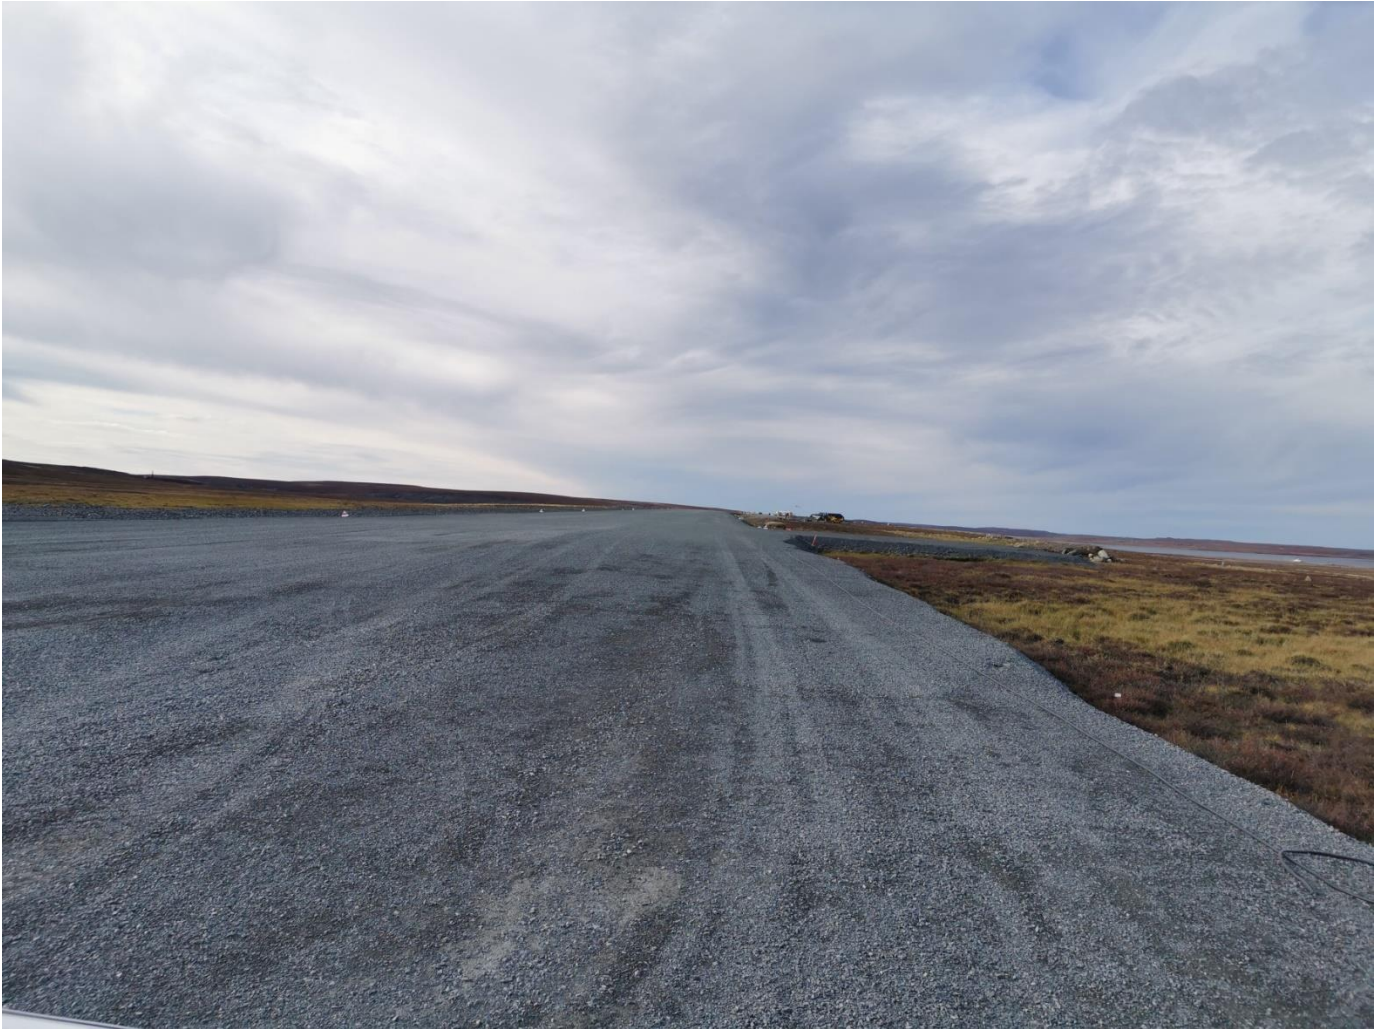
Air strip widening.

Currently, the licensee is expanding the air strip to allow for larger and heavier airplanes to operate to and from the site. The expansion currently under way is 50 feet widening of the air strip. Photographs of the air strip are attached to this report.
