WATER LICENCE INSPECTION FORM

| Sabina Gold and Silver | Merle Keefe |
| 2AM-BRP1831 | Environmental permitting Manager |
| June 19, 2022 | Jonathan MESHER |

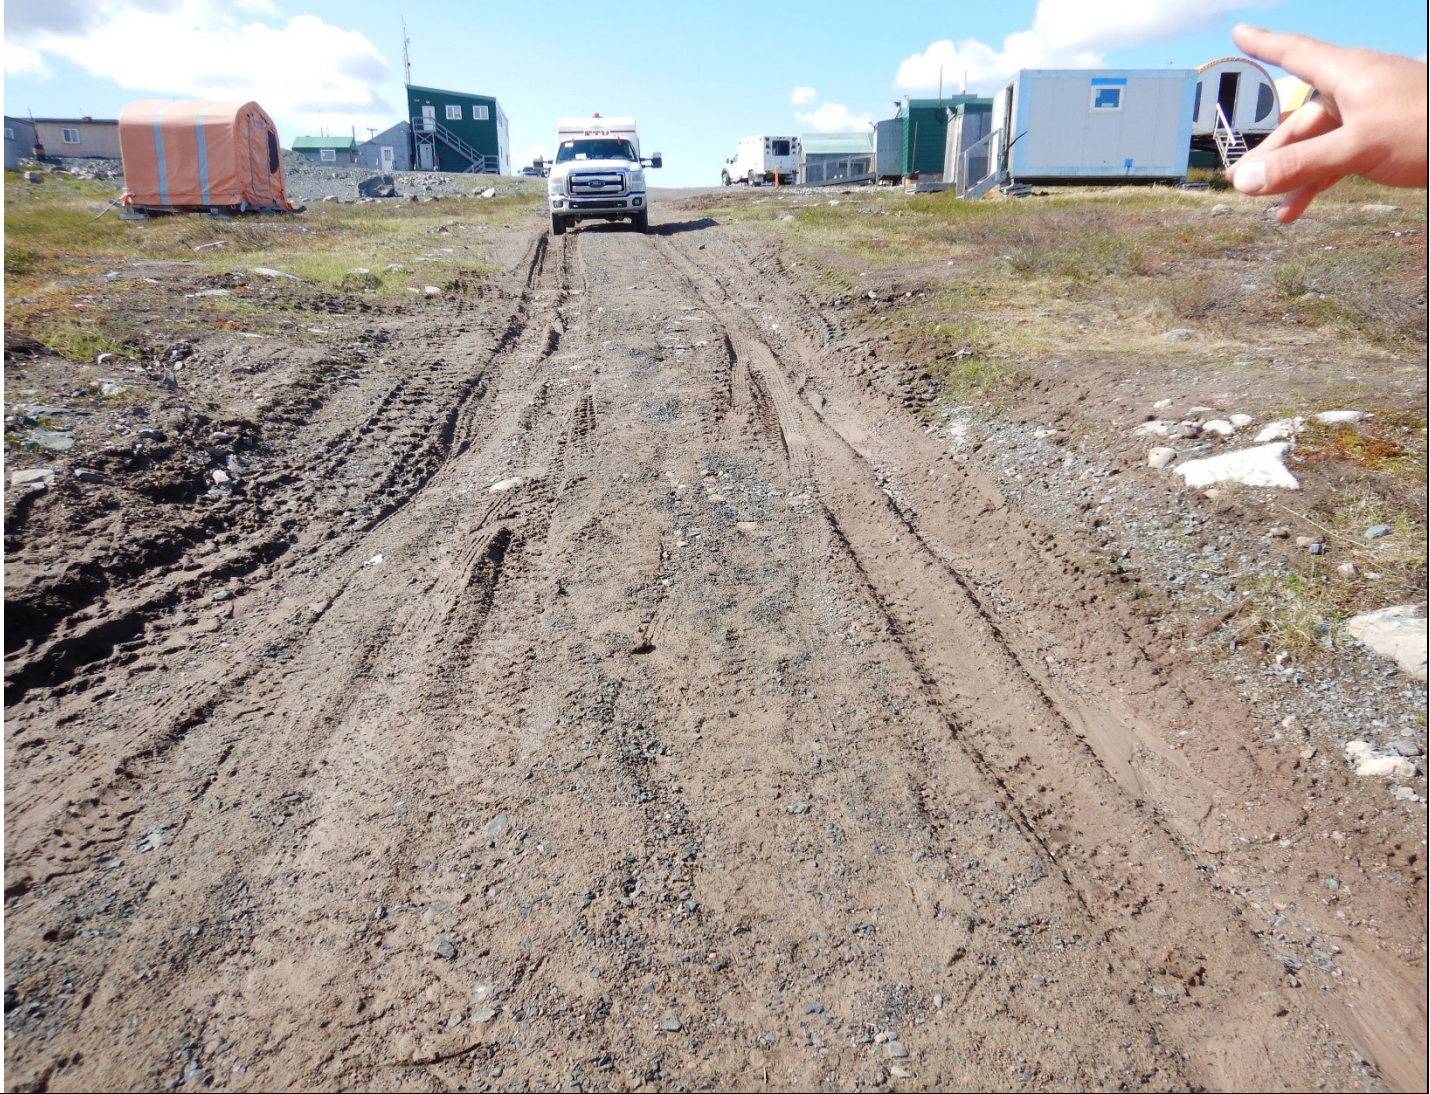
Photo 1

Goose Camp:
a. **Water Intake**
I. Water records appear up to date.
II. The road leading to the water intake appears to have signs of erosion, rutting and consists mostly of mud. Part D, item 7 of the licence 2AM-BRP states; “The Licensee shall implement sediment and erosion control measures prior to and during Construction, and Operations where necessary, to prevent entry of sediment into Water.”, therefore the inspector is requesting that the licensee install erosion control measures on both roads to prevent sediment from enter Goose lake. See photo 1 for one of the water intake roads.

Description: Rutting leading to water intake.

- 1) The licensee is to implement erosion control measures at the water intake roads to prevent the entry of sediment into Goose Lake.
- 2) The licensee is to remove all Hazardous waste and food waste from the Waste Storage Area and store it in an approved manner.
- 3) The license is to provide a plan to ensure the “sump” is operating as a sump as defined in the licence and no longer over flowing into the surrounding water bodies.
- 4) The licensee is to provide an inventory of the historic waste pile, remove all waste from the ponding water and ensure all Hazardous waste is stored in secondary containment.
- 5) The licensee is to ensure all hazardous waste and hazardous materials is stored in a way to prevent waste from entering water and is consistent with the approved licence/Management plans.

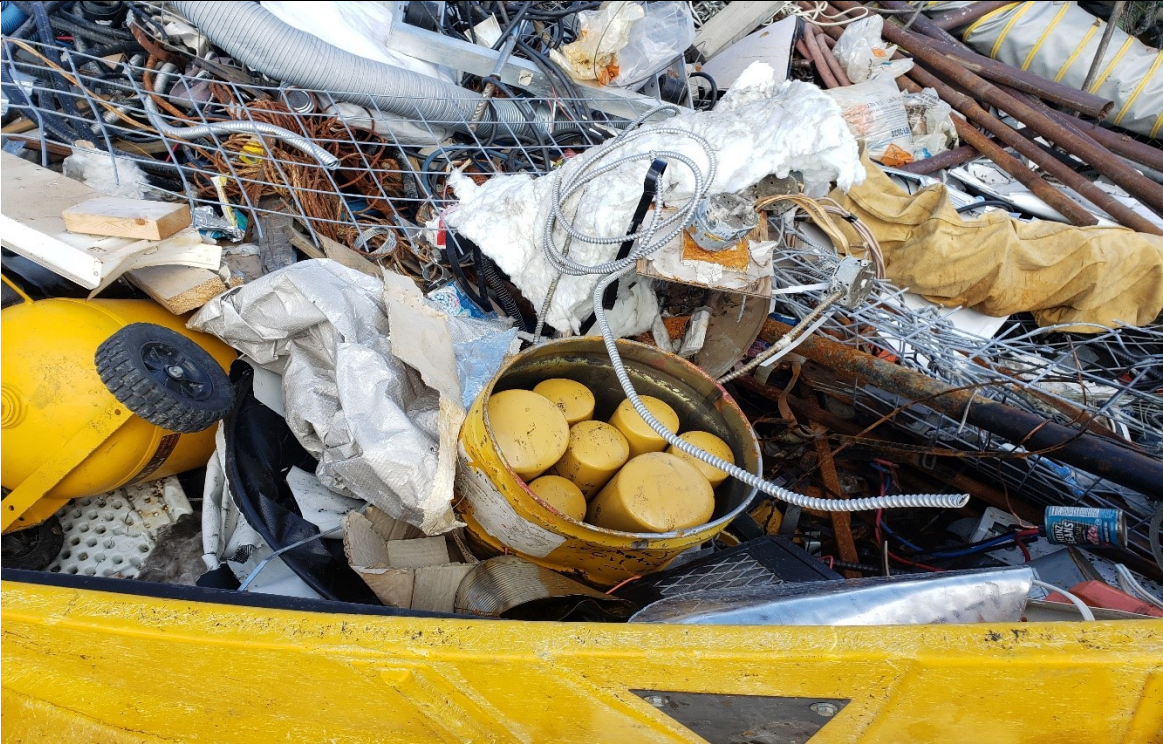
Photo 2

b. **Waste Storage**
I. Temporary Waste Storage Facility- This facility had the following concerning items; Food waste, Oil filters and a fuel tank on a welder, The BACK RIVER PROJECT Landfill and Waste Management Plan, section 6.4.1 states the following; “Recyclable non-hazardous, non-combustible waste will be stored in dedicated waste storage facilities located at each of the Project sites” and “Indoor storage for beverage containers will be used to avoid attracting wildlife.”. Furthermore section 6.4.2 states that; “Hazardous waste will be stored inside or within lined containment facilities at the Goose Property and MLA to minimize potential leaching to the environment.” With the presence of the noted food waste and hazardous waste it appears the licensee is not adhering to the approved Landfill and waste management plan. See photos 2-4 for items noted.

Description: Oil filters.

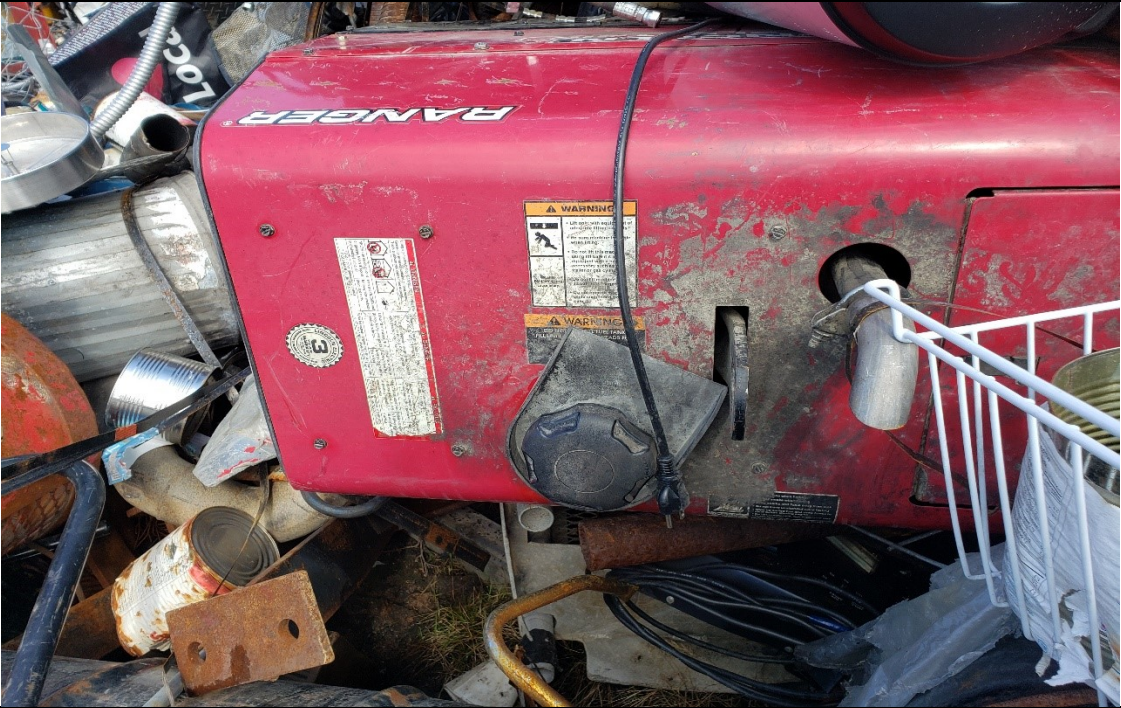
| Date | Camera | Inspector | Authorization |
|---|---|---|---|
| Photo 3 | | | |

| Date | Camera | Inspector | Authorization |
|---|---|---|---|
| Description: fuel container. | | | |

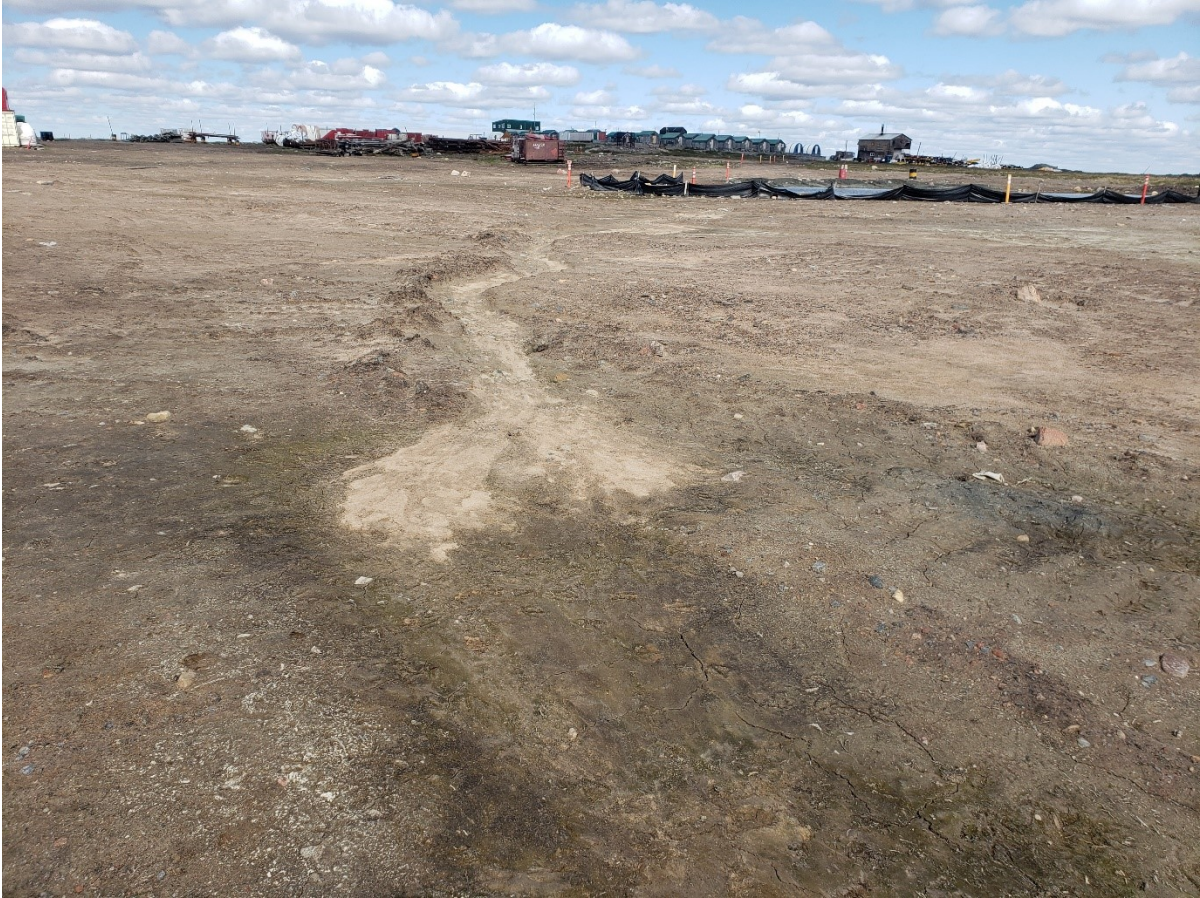
| Date | Camera | Inspector | Authorization |
|--|---|---|---|
| Photo 6 | | | |

- II. The licensee is depositing drill waste into a “sump” to the south of the main camp, in the licence a sump is defined as the following; “ means a structure or depression that collects, controls, and filters liquid waste before it is released to the environment. This structure should be designed to prevent erosion while allowing percolation of liquid waste;”. While on site the “sump” had limited freeboard, signs of erosion down gradient leading to ponding water and there appeared to be discoloration of the flora where the erosion lead to. See photos 5-8 for photos of the sump, overflow and potential discolorations from overflow.

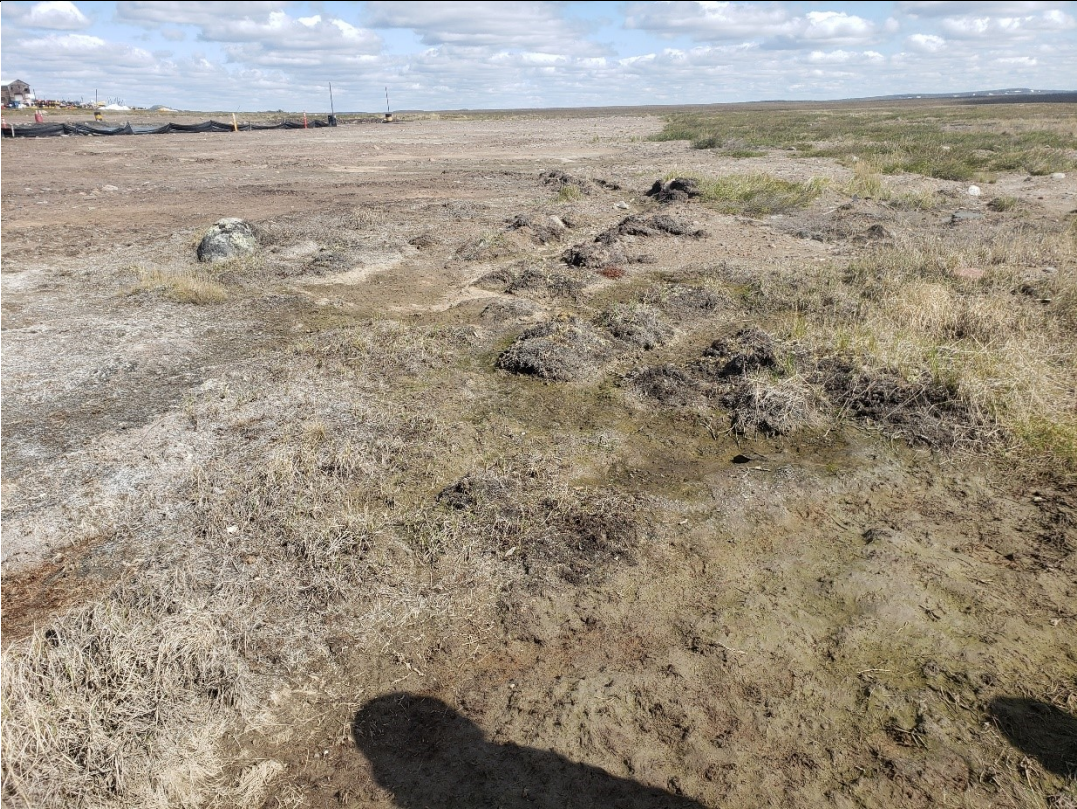
Photo 7

Description: Potentially discolored flora from the sump overflow. (looking towards the sump)

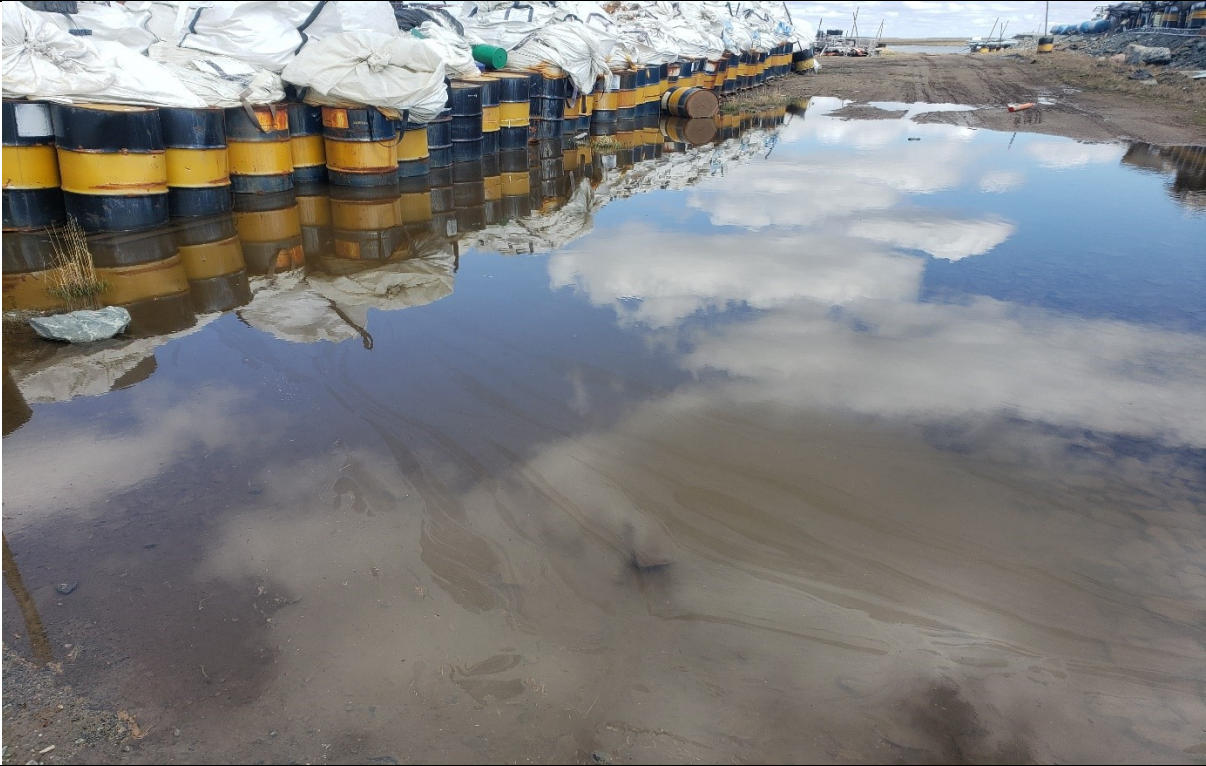
Photo 9

- III. Historical waste pile- During the inspection the historical waste pile was sitting in ponding water and there appeared to be a visible sheen indicating hydrocarbon contamination, the inspector requested the licensee collect samples. The BACK RIVER PROJECT Landfill and Waste Management Plan, section 6.4.2 states that; “Hazardous waste will be stored inside or within lined containment facilities at the Goose Property and MLA to minimize potential leaching to the environment.” And section 12(1) of the Nunavut Waters and Nunavut Surface Rights Tribunal Act states that; 12 (1) Subject to subsection (2) and except in accordance with the conditions of a licence, no person shall deposit or permit the deposit of waste (a) in waters in Nunavut; or (b) in any other place in Nunavut under conditions in which the waste, or any other waste that results from the deposit of that waste, may enter waters in Nunavut. See photo 9 for the potential hydrocarbon contamination.

Description: Historical waste pile and potential hydrocarbon contamination.

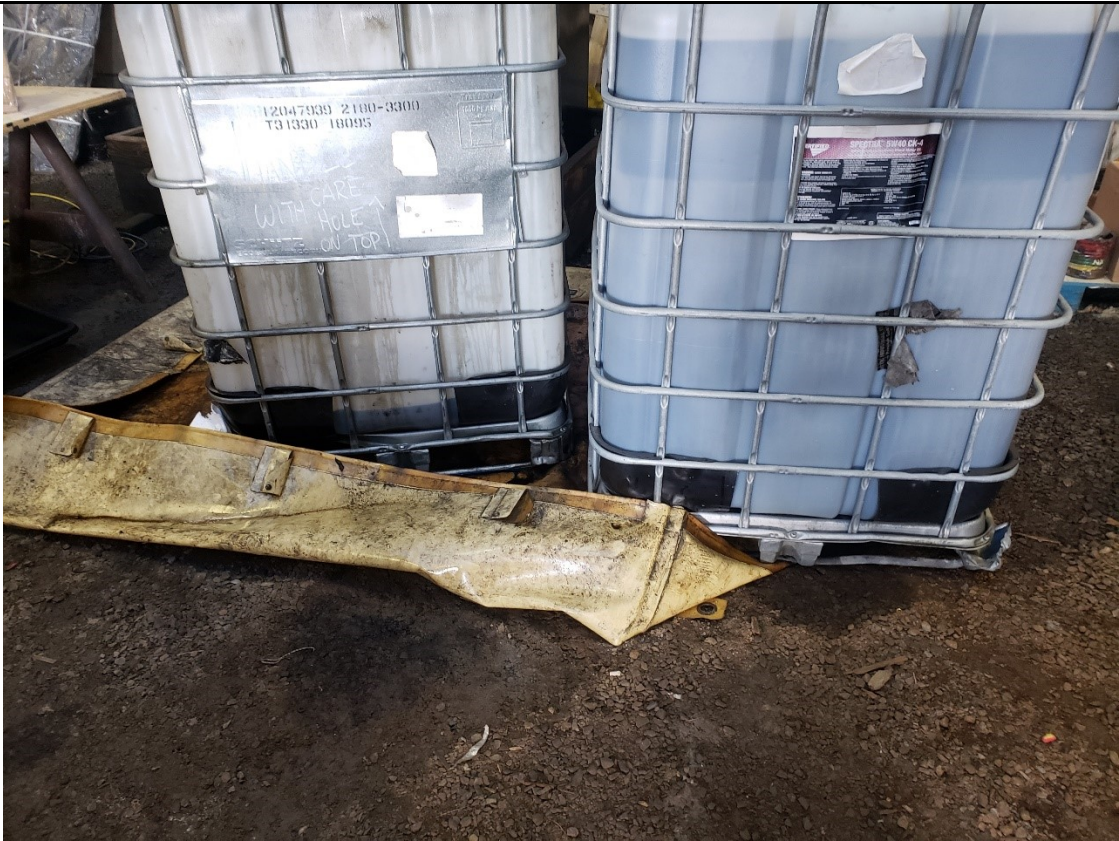
Photo 10

- IV. Hazardous materials outside of containment- See photo 10 for a tote of 0W40 (motor oil) outside of containment in the maintenance shop, See photo 11 for contaminated soil sitting on a liner, not contained, near the under ground shop area, see photo 12 for 5 totes outside of containment near the portal.

Description: Motor oil not in secondary containment.

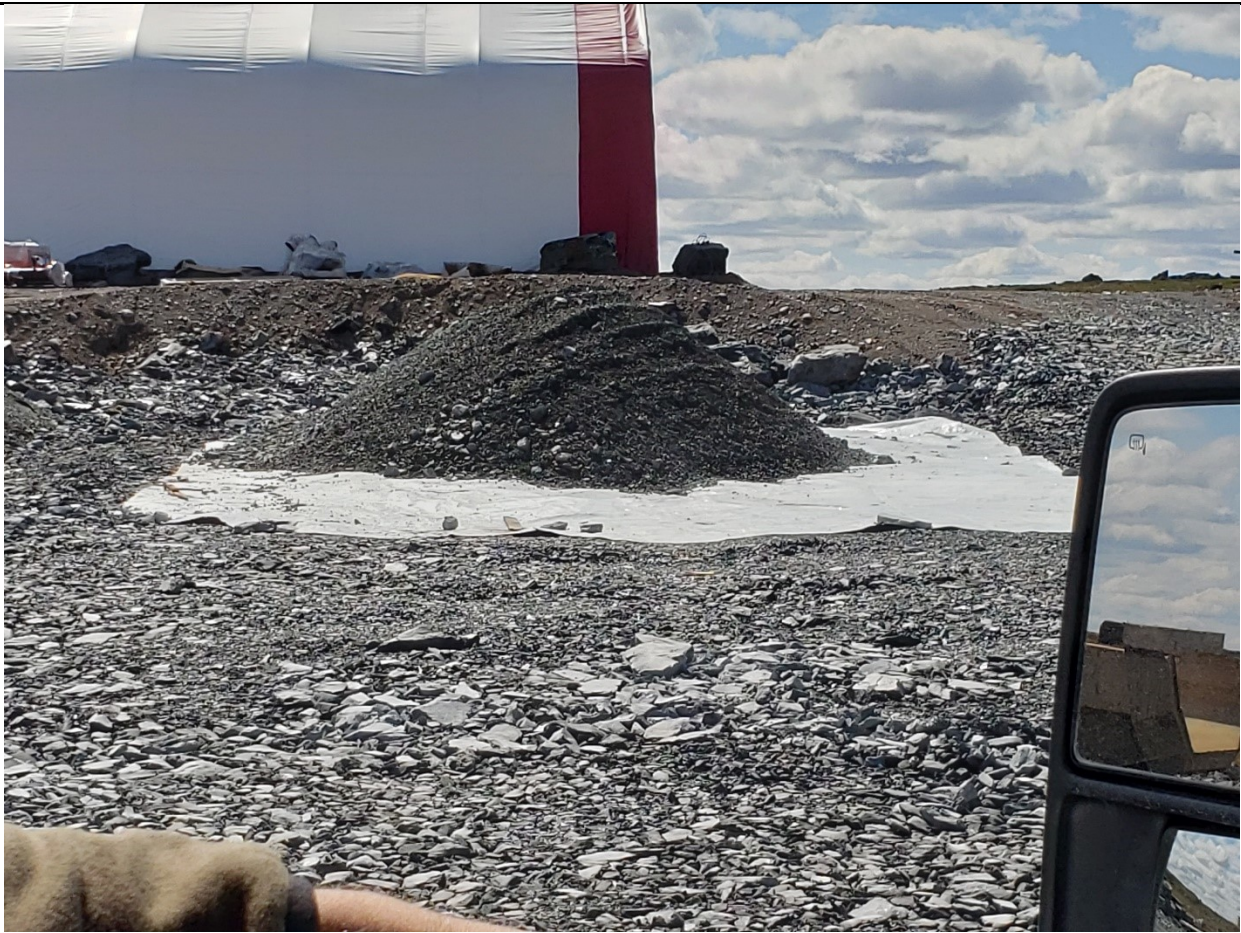
Photo Log
Photo 11

Description: contaminated Soil outside of containment.

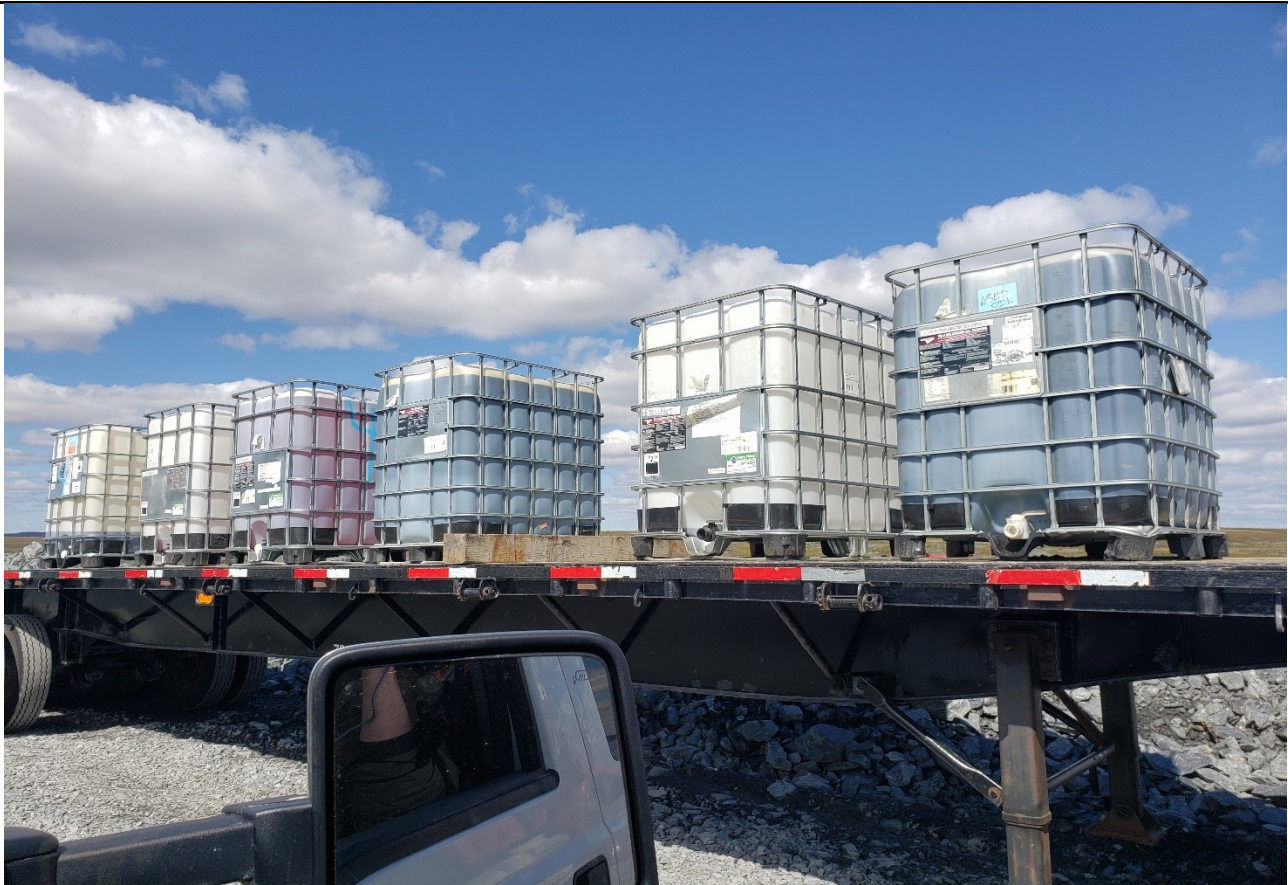
Photo Log
Photo 12

Description: Totes outside of containment.
