Goose & MLA Project Sites – 2023 Annual Geotechnical Inspection

Back River Project, Nunavut, Canada
B2Gold Corp.

SRK Consulting (Canada) Inc. ■ CAPR003105 ■ April 2024

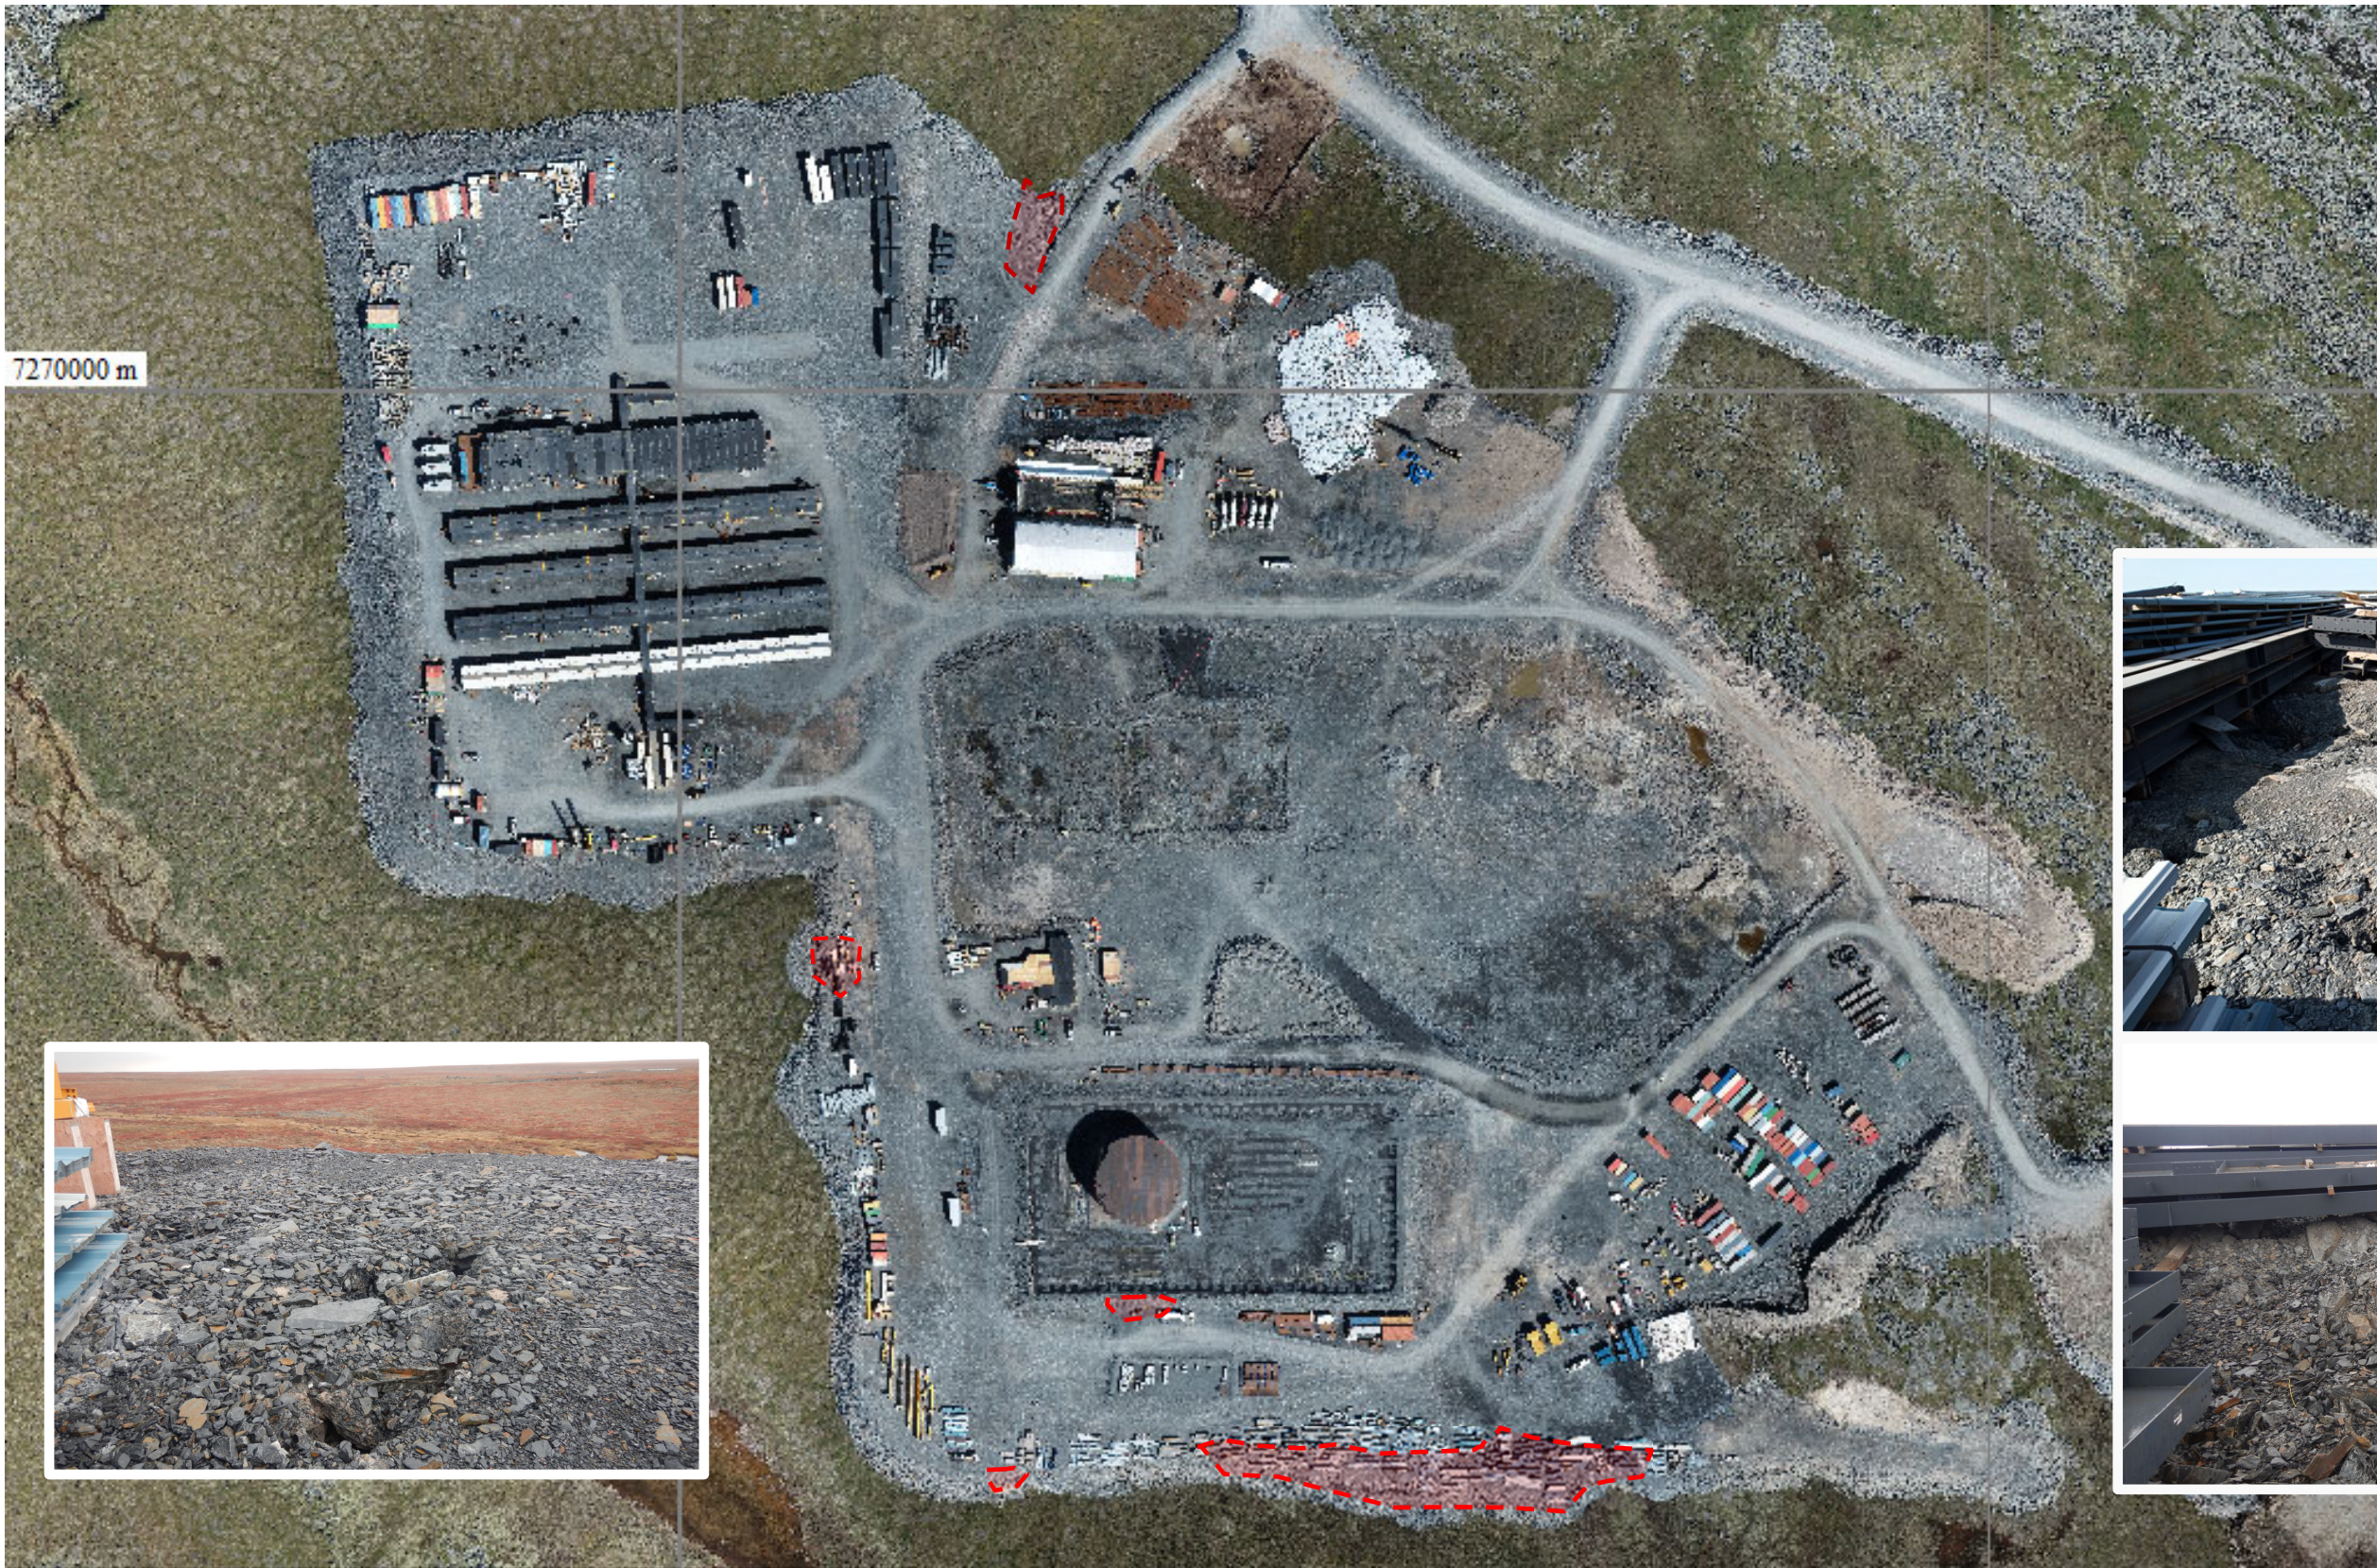
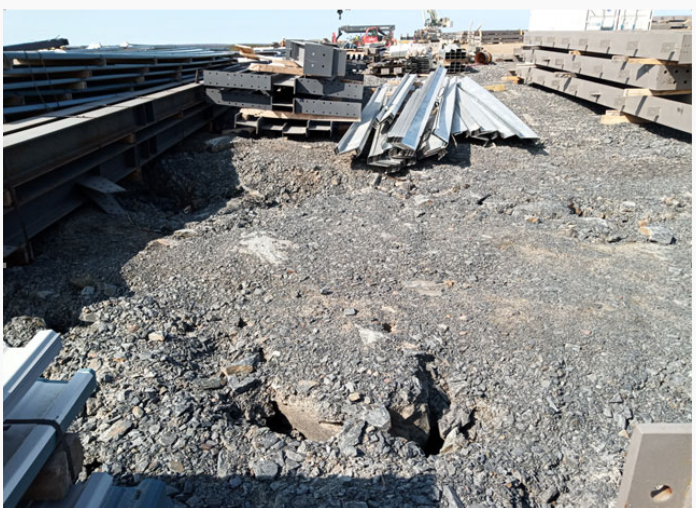
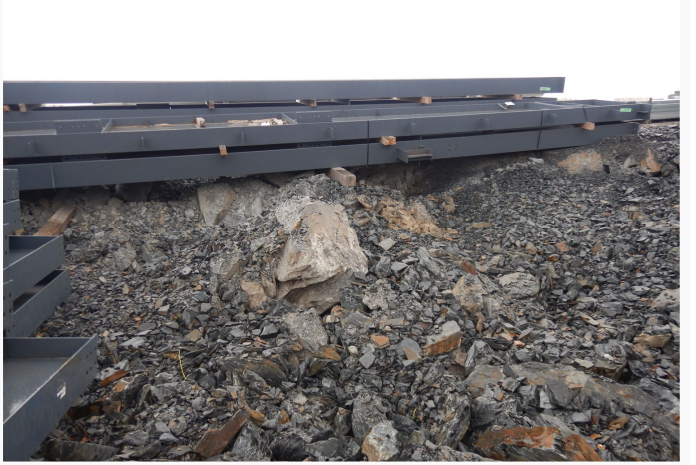
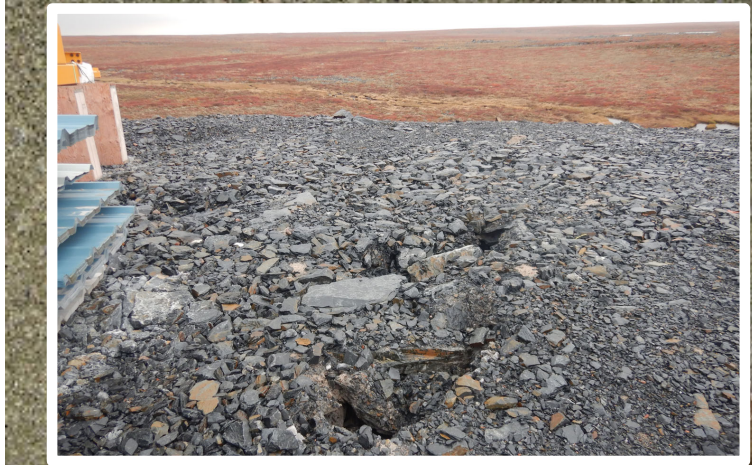
2023 Annual Geotechnical Inspection	
Job No: CAPR003105 Filename: BackRiver_2023AGI_Figures..pdf		Back River Project		Voids in the Camp Pad	
				Date: 2024-02-28	Approved: JBK
				Figure:	4

Voids and cracks in the pad due to the excessive amount of overburden material in the pad fill.

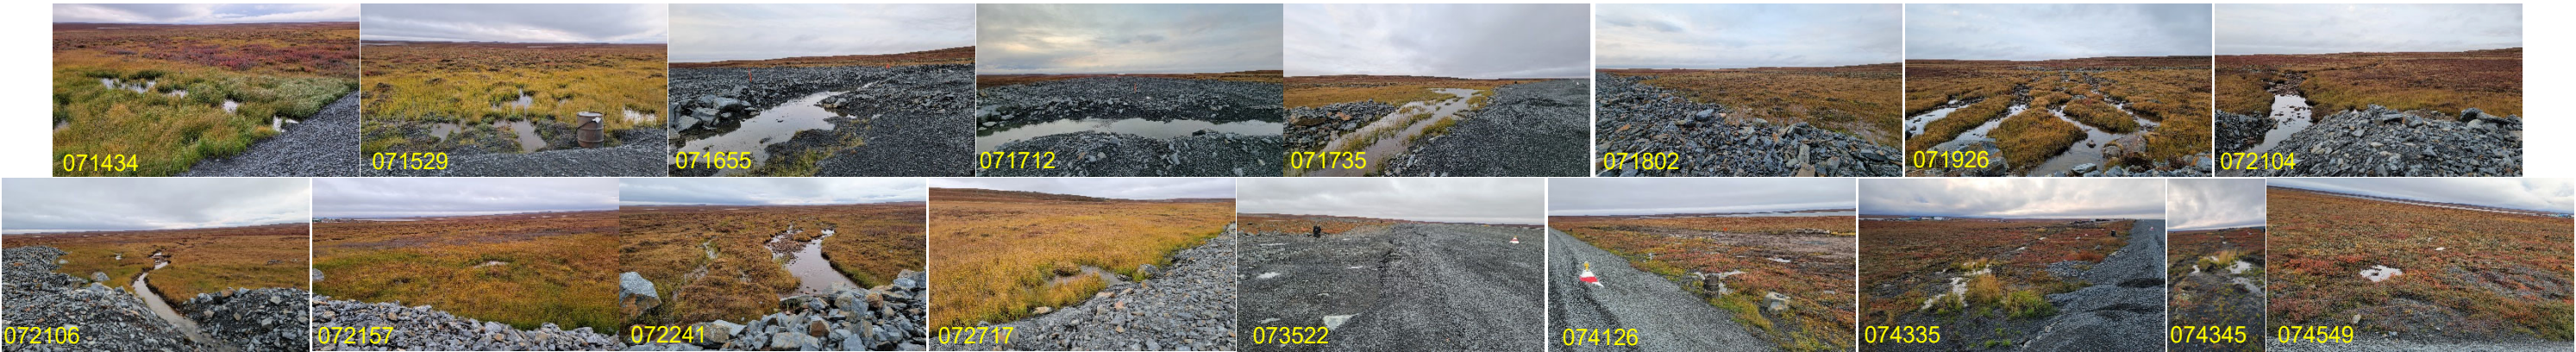
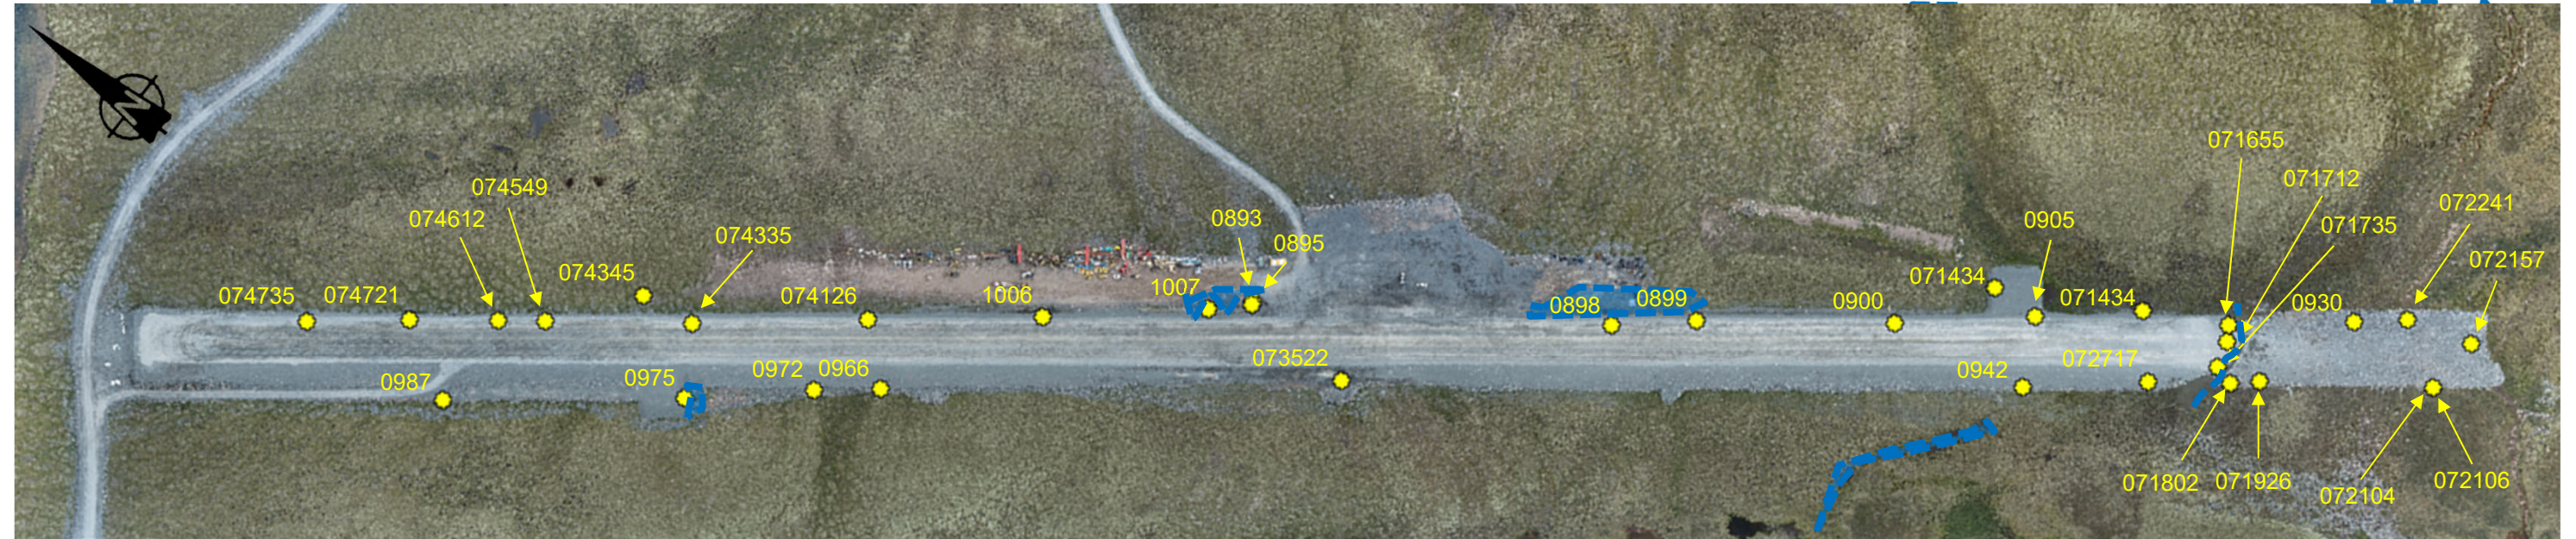
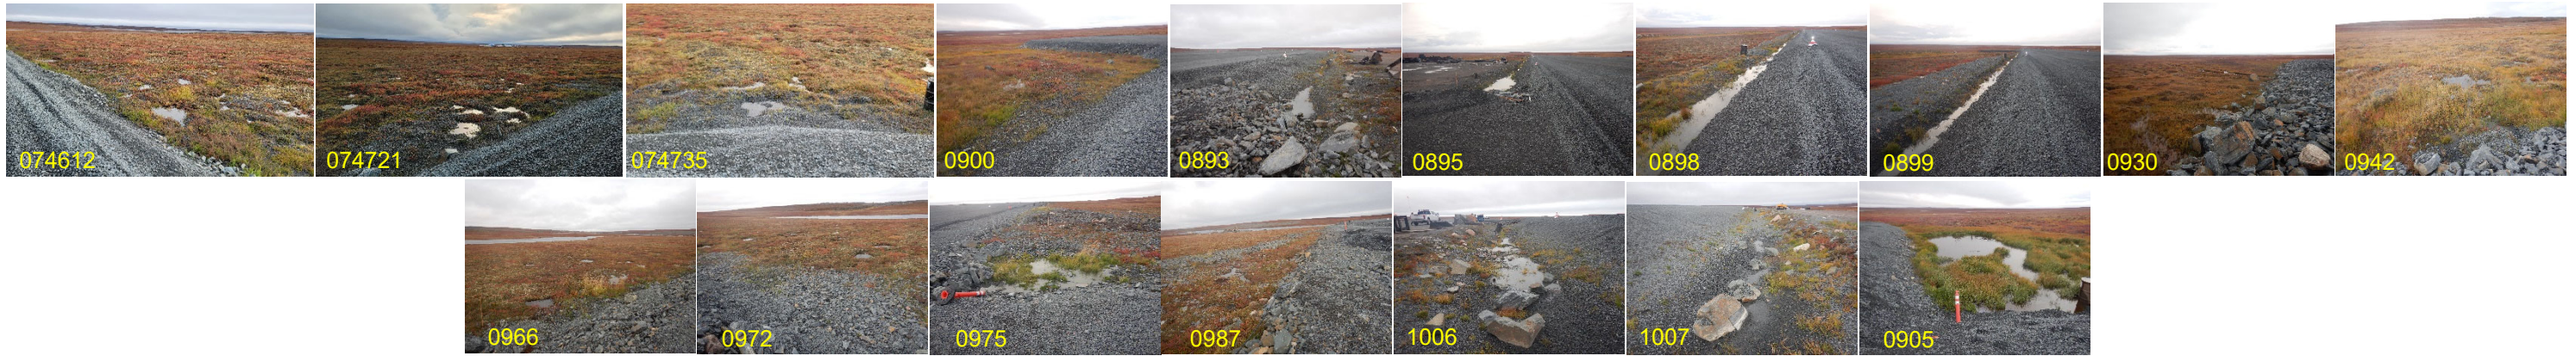
Date: 2024-02-28	Approved: JBK	Figure: 5
---------------------	------------------	---------------------

Ponding water and bodies of water near pads.

**Ponding Water
Goose Airstrip**

- Specifically, the airstrip(s) shoulders (both Goose and the MLA) should continue to be closely monitored to ensure that any additional maintenance is able to be conducted as required. Routine airstrip inspections should occur year-round by site staff but would be suggested to be increased in frequency over the spring to fall months (around June to November). In addition to any observations at the airstrip shoulder, any areas of larger undulations or settlements that require ongoing maintenance should be noted and records kept to assist with long term performance monitoring.

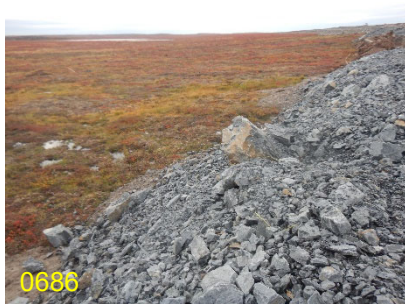
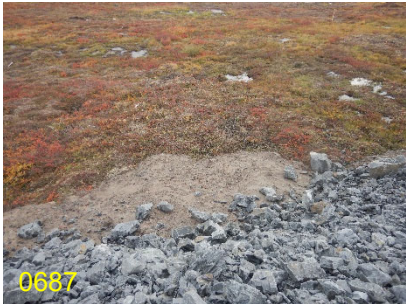
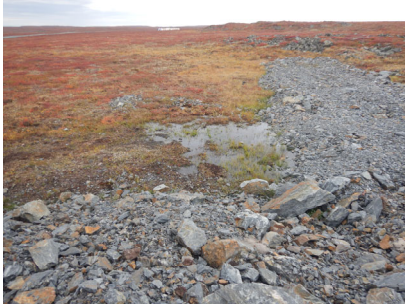
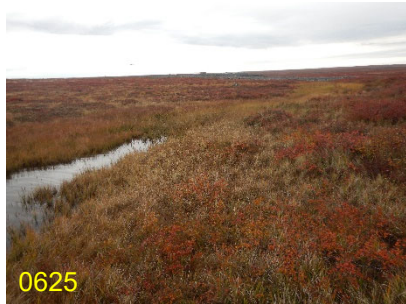
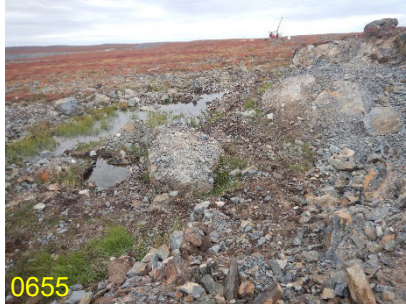
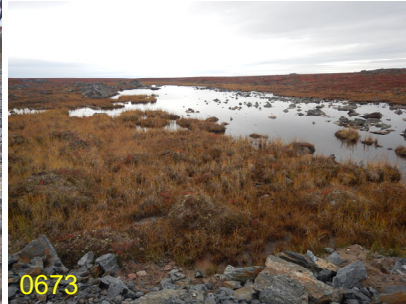
Date: 2024-02-28	Approved: JBK	Figure: 6
---------------------	------------------	---------------------

- Ponding water was observed along the upstream side of the key trench.
- The ephemeral stream flow around approx. Sta 0+325 was impeded in part from the upstream access road fill that was placed as part of the winter 2023 construction activities.

**Ponding Water
Goose Primary Pond**

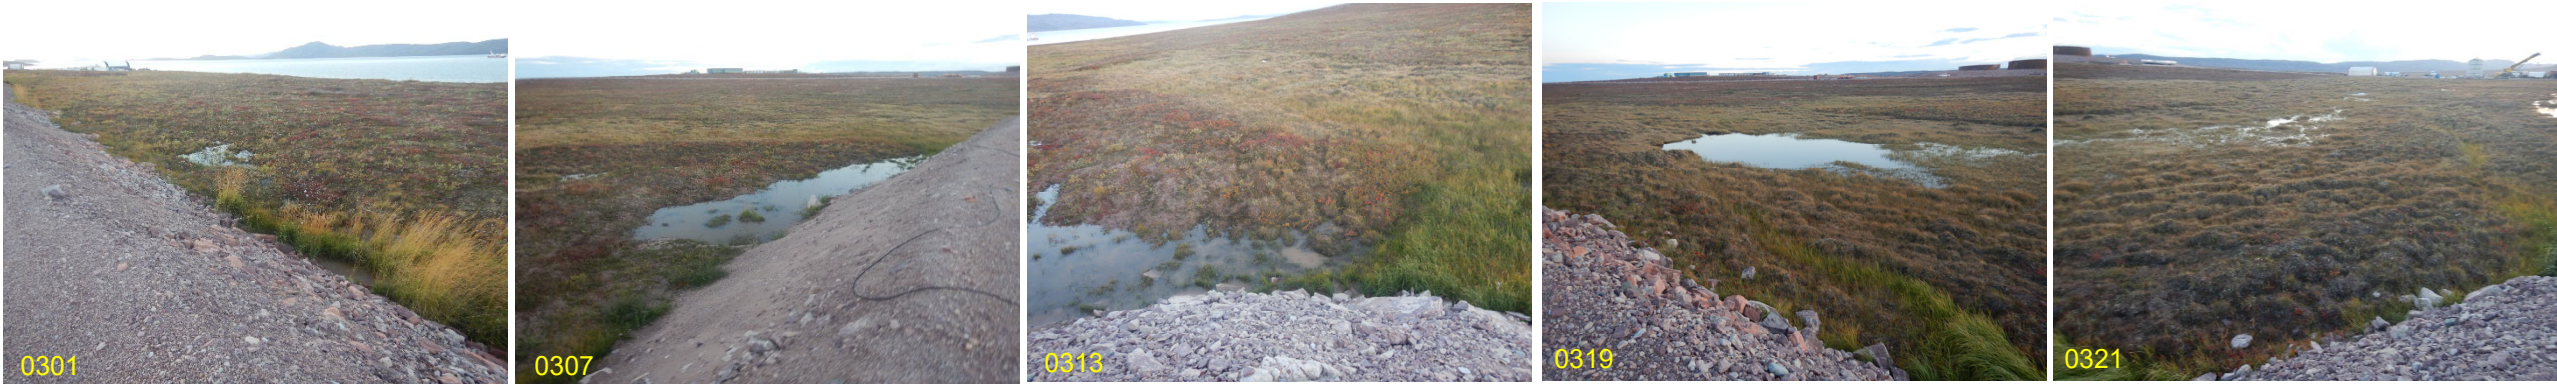
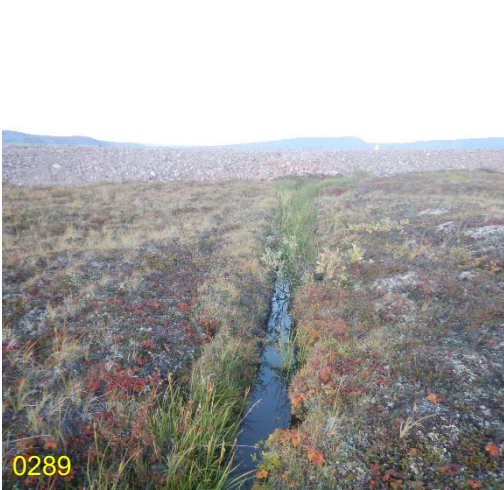
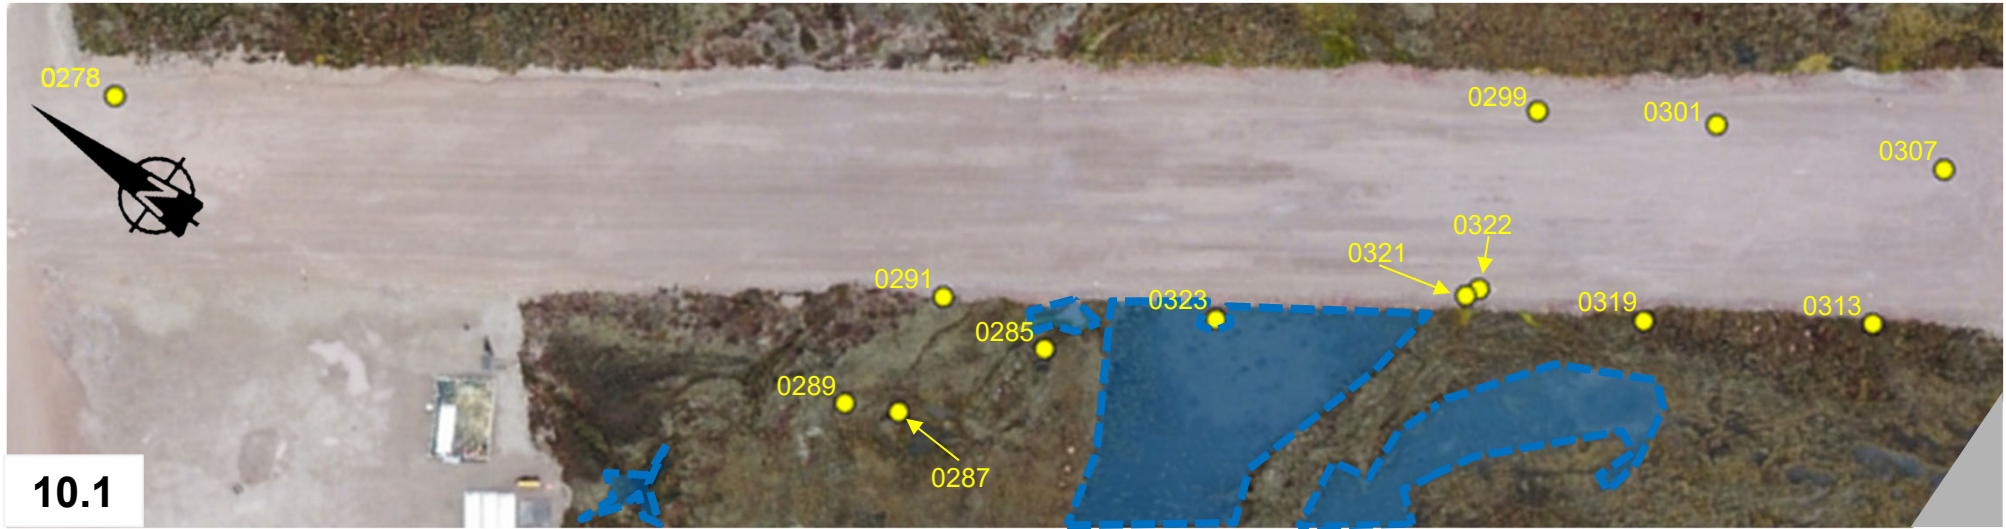
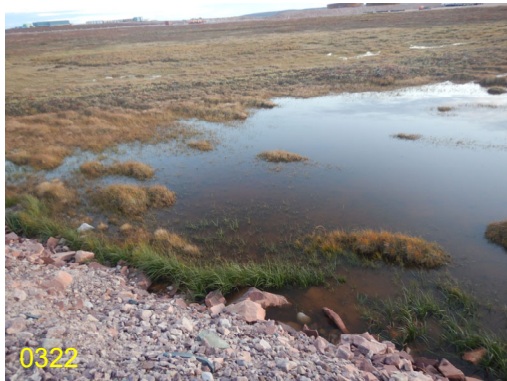
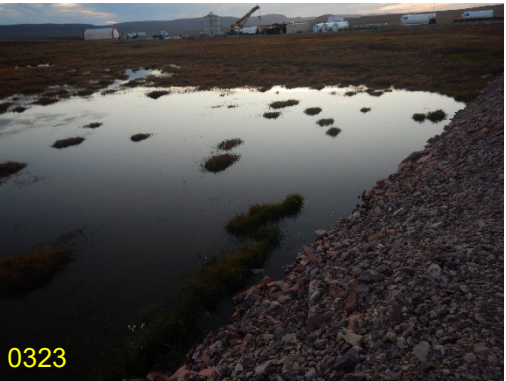
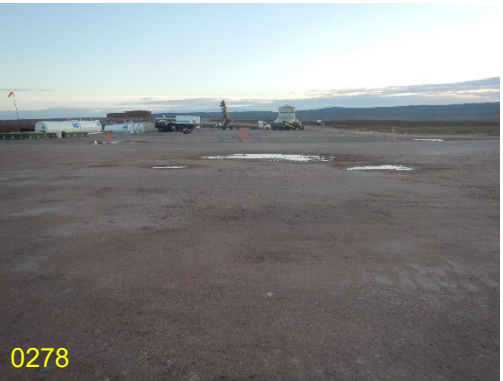
2023 Annual Geotechnical Inspection		
		Ponding Water MLA Airstrip		
Job No: CAPR003105 Filename: BackRiver_2023AGI_Figures..pdf	Back River Project	Date: 2024-02-28	Approved: JBK	Figure: 11

- At the MLA there is ponding water against the southern-to-southern western edges of the airstrip (Figure 11). B2Gold should monitor these areas (specifically as temperatures annually warm on site from winter to spring to summer conditions). Some consideration should be given to redirecting or trying to push any ponding water further away from the toes of the existing MLA airstrip. This could be done in an attempt to push any thermal degradation further away from the main airstrip fill. Pumping down / removal of any ponded water at the toes of the airstrip in the fall (before winter freeze-up) would increase the cold ambient air and ground heat transfer to help slow down permafrost degradation (reduce thawing rates and slow deepening of the active layer). This increased water management may help to reduce overall maintenance activities at this airstrip.

Ponding water and bodies of water near pads.

8. **Goose and MLA – Airstrips - Monitor and consider longer term water management measures for the impediment of flow at the airstrips.** Ponding water and expected ice rich ground was noted to be adjacent to, or intersecting, both site airstrips. These locations should be carefully monitored, and ongoing maintenance should be expected.

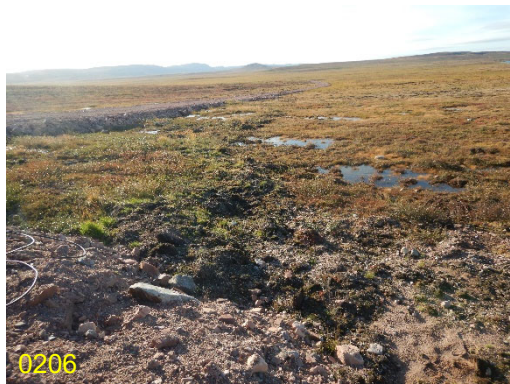
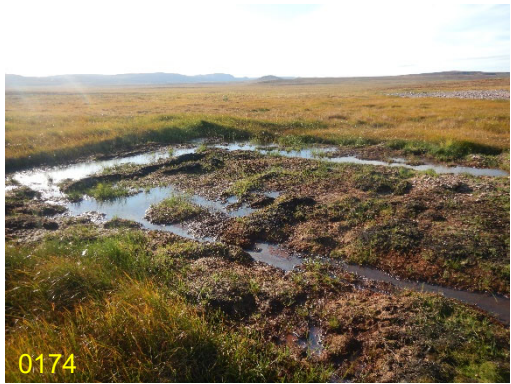
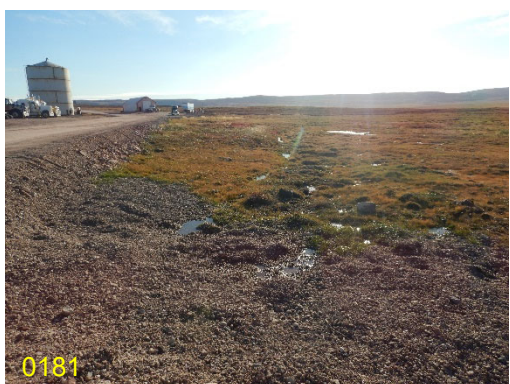
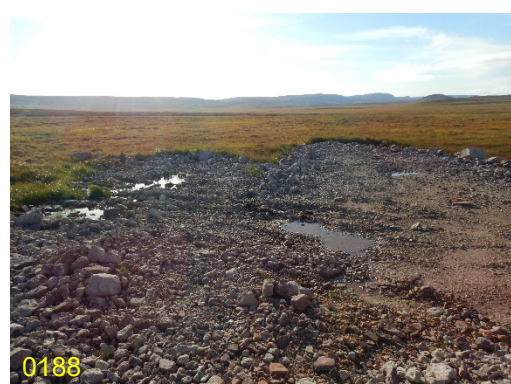
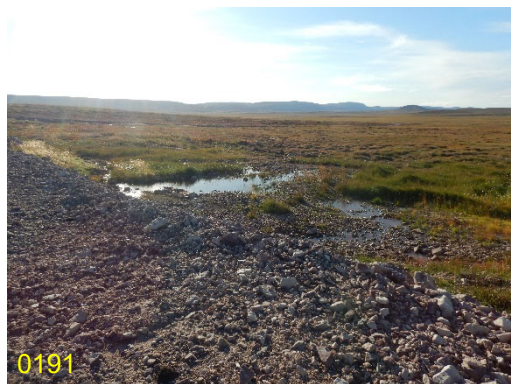
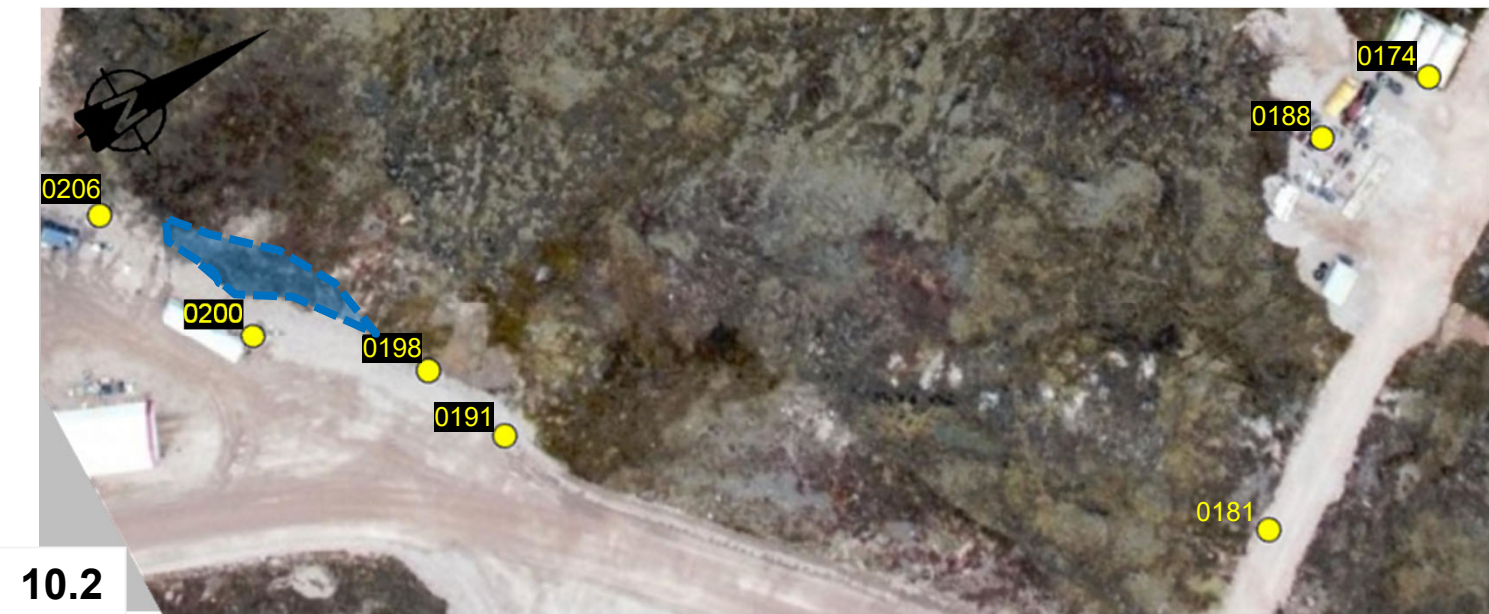
2023 Annual Geotechnical Inspection		
		Ponding Water MLA Lower Laydown Pad and Temporary Fuel Storage		
Job No: CAPR003105 Filename: BackRiver_2023AGI_Figures..pdf	Back River Project	Date: 2024-02-28	Approved: JBK	Figure: 12

Ponding water and bodies of water near pads.

- *This has now been completed onsite.*
2. **MLA – General - Develop a remediation plan for the historic temporary fuel storage area.** Area in the low point where tundra has been damaged and degraded. Comment first noted in the 2022 AGI. Develop a remediation plan for this area. Note that the remaining fuel tanks in this area were empty at the time of the 2023 AGI summer site visit.
