## **Appendix A      Photolog from 2023 Visit – Goose**

Back River Project

2023 Annual Geotechnical Inspection

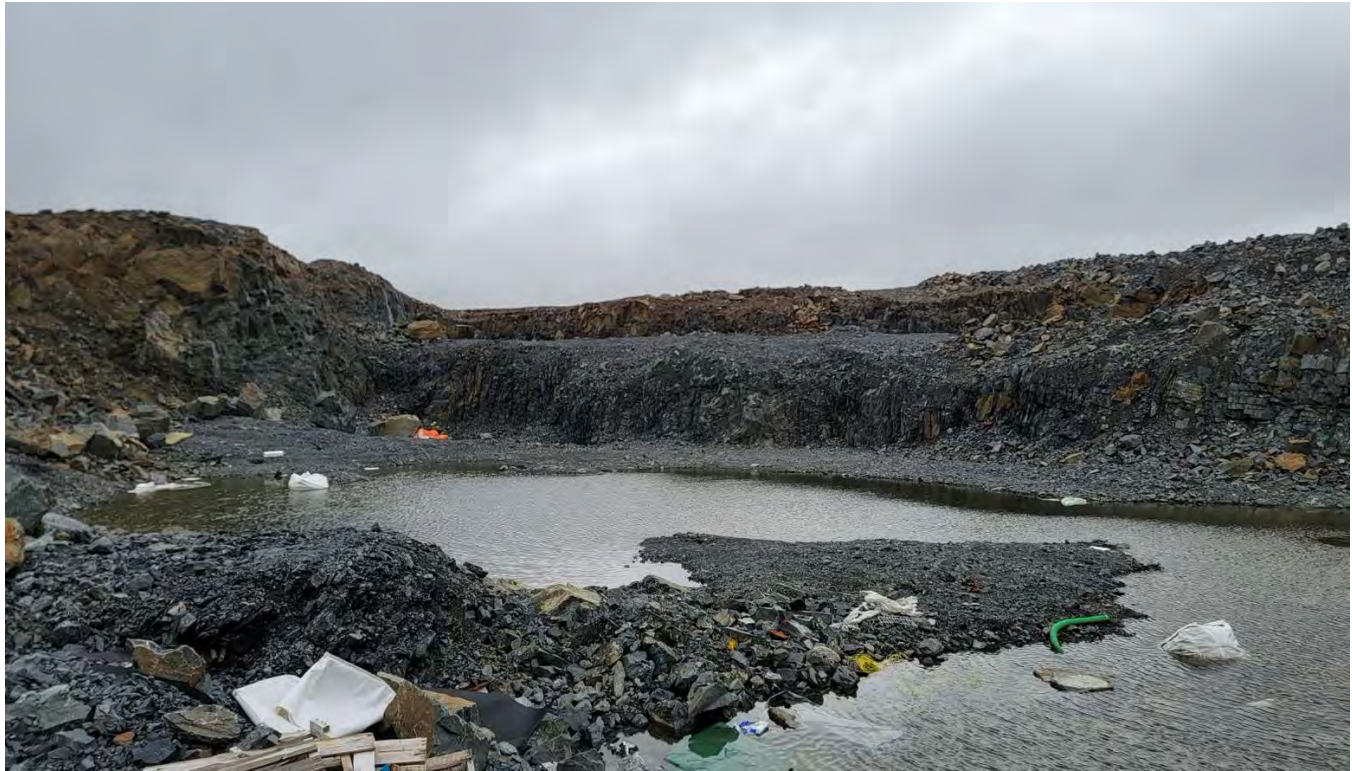
G-5. - Ponding waters at the bottom of Goose Quarry looking east

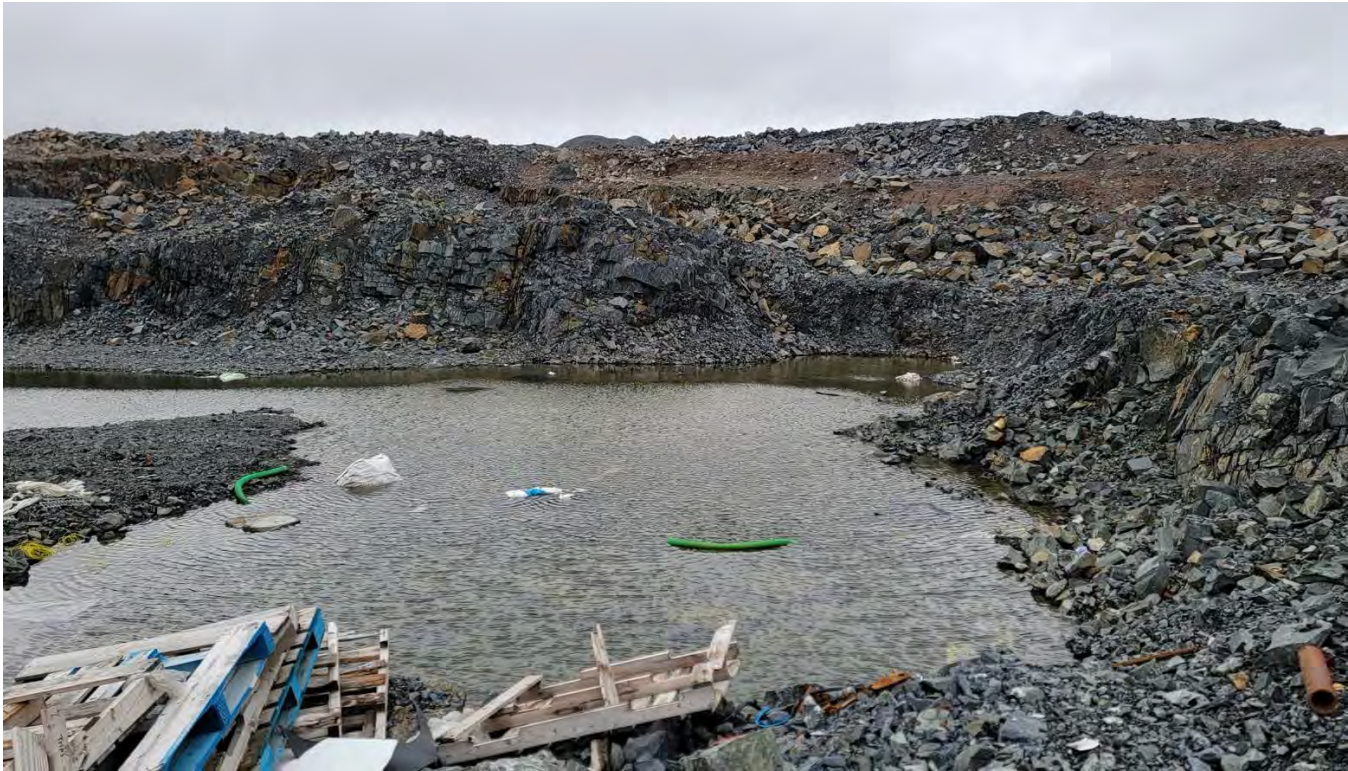
G-6. - Ponding waters at the bottom of Goose Quarry looking south

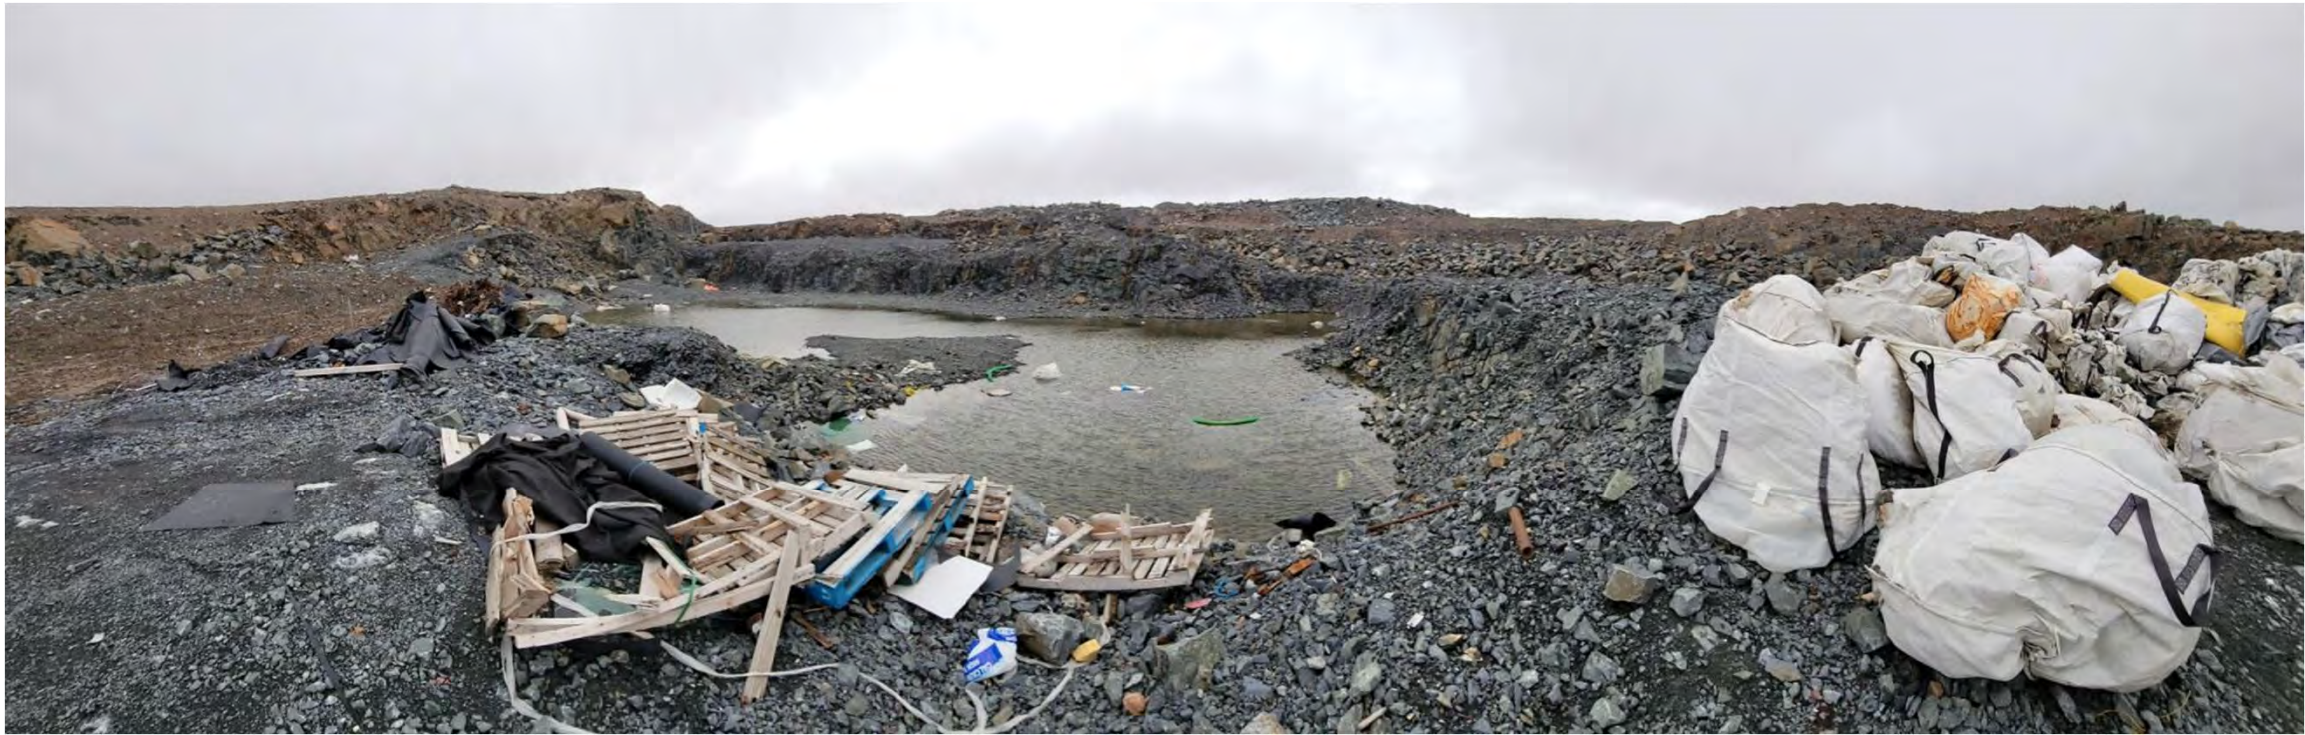
G-7. - Overview at the bottom of the Goose Quarry looking south

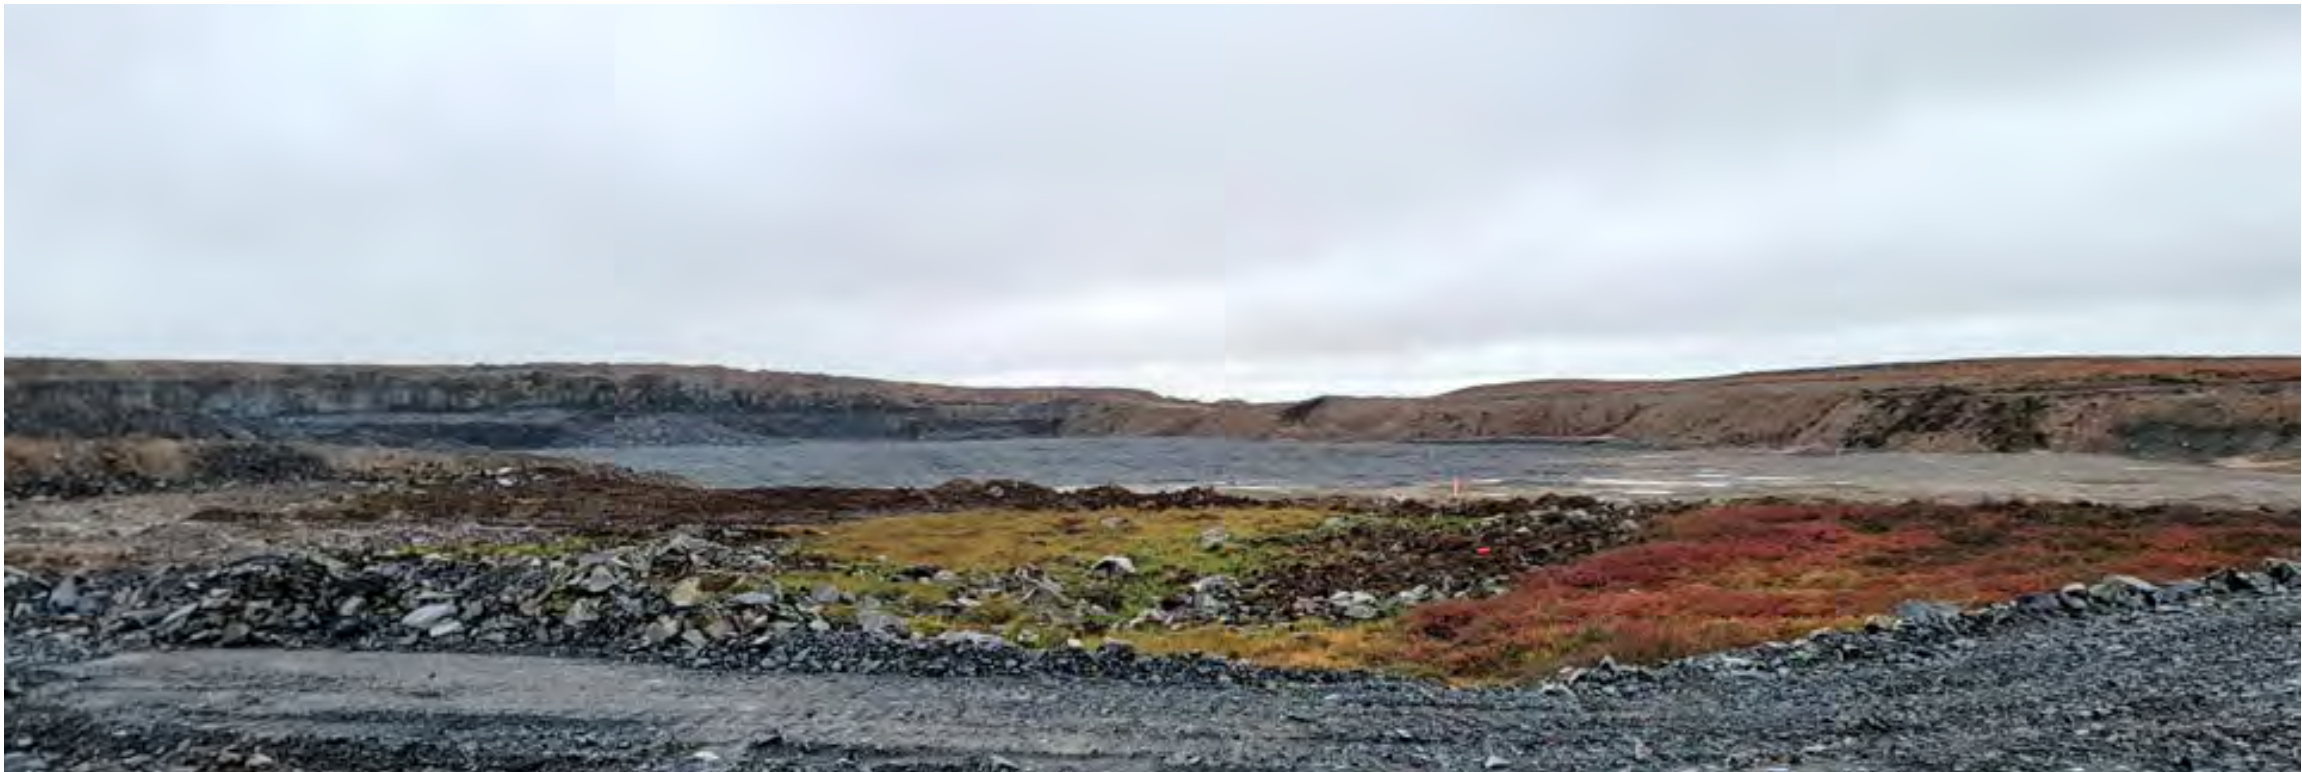
G-12 – General view, looking south

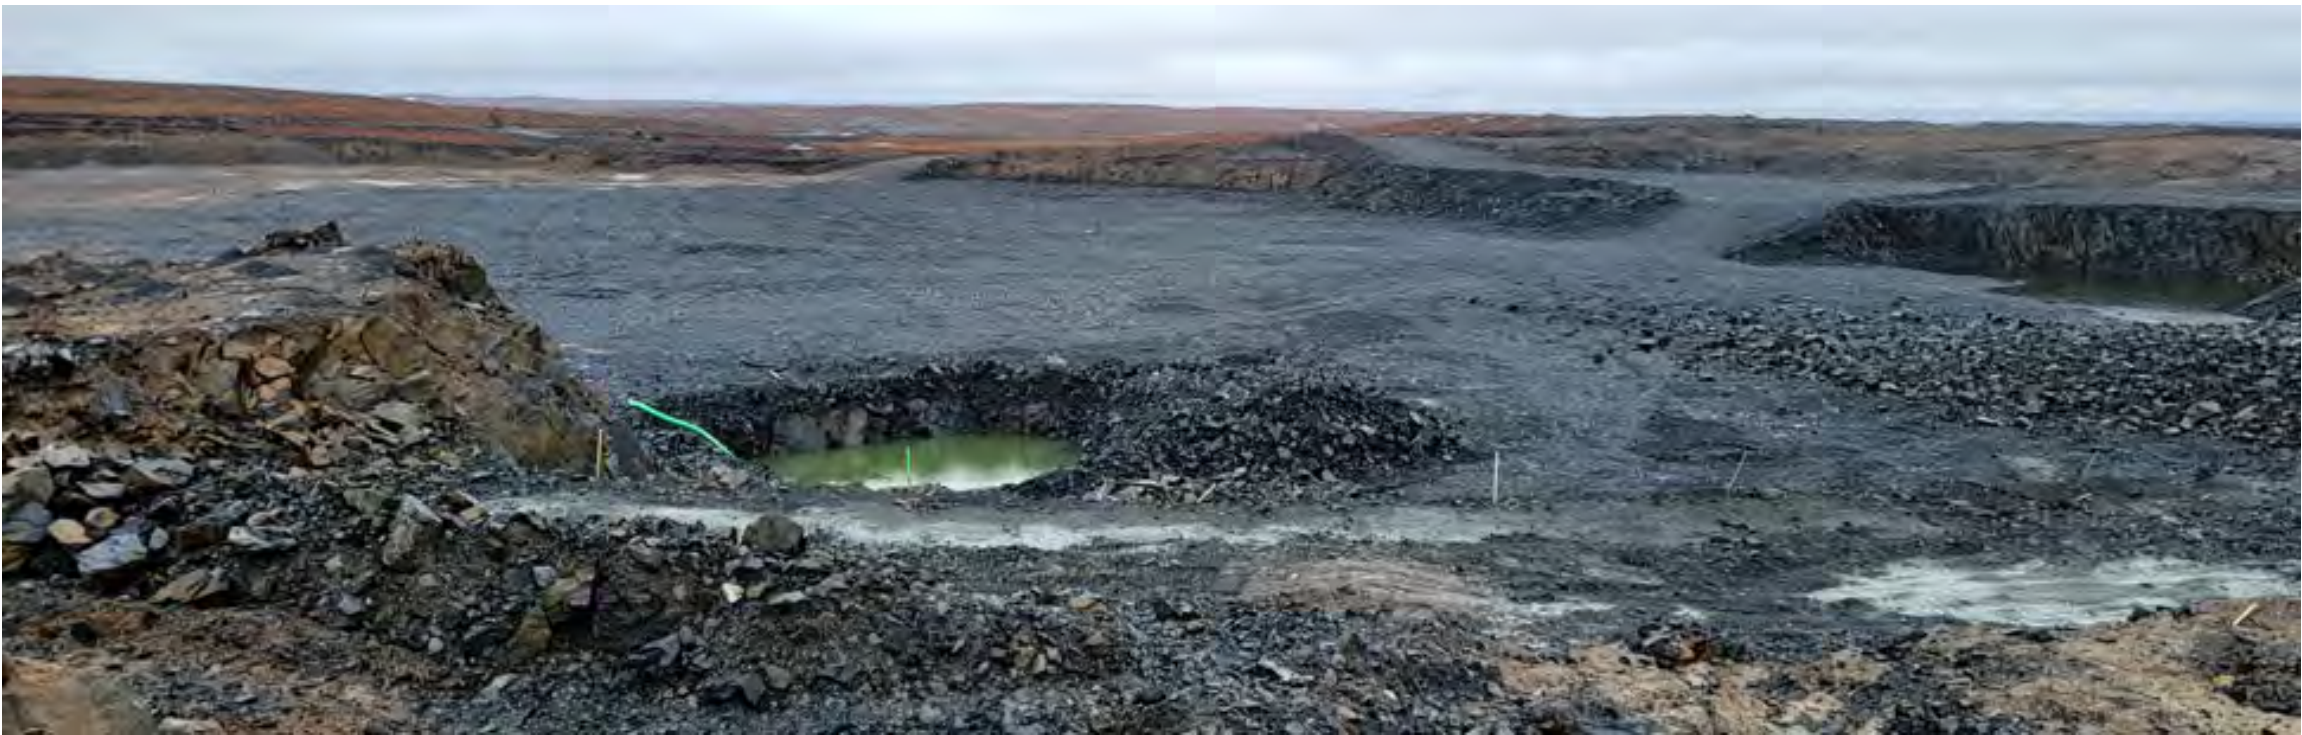
G-13 – Base of the pit, looking north

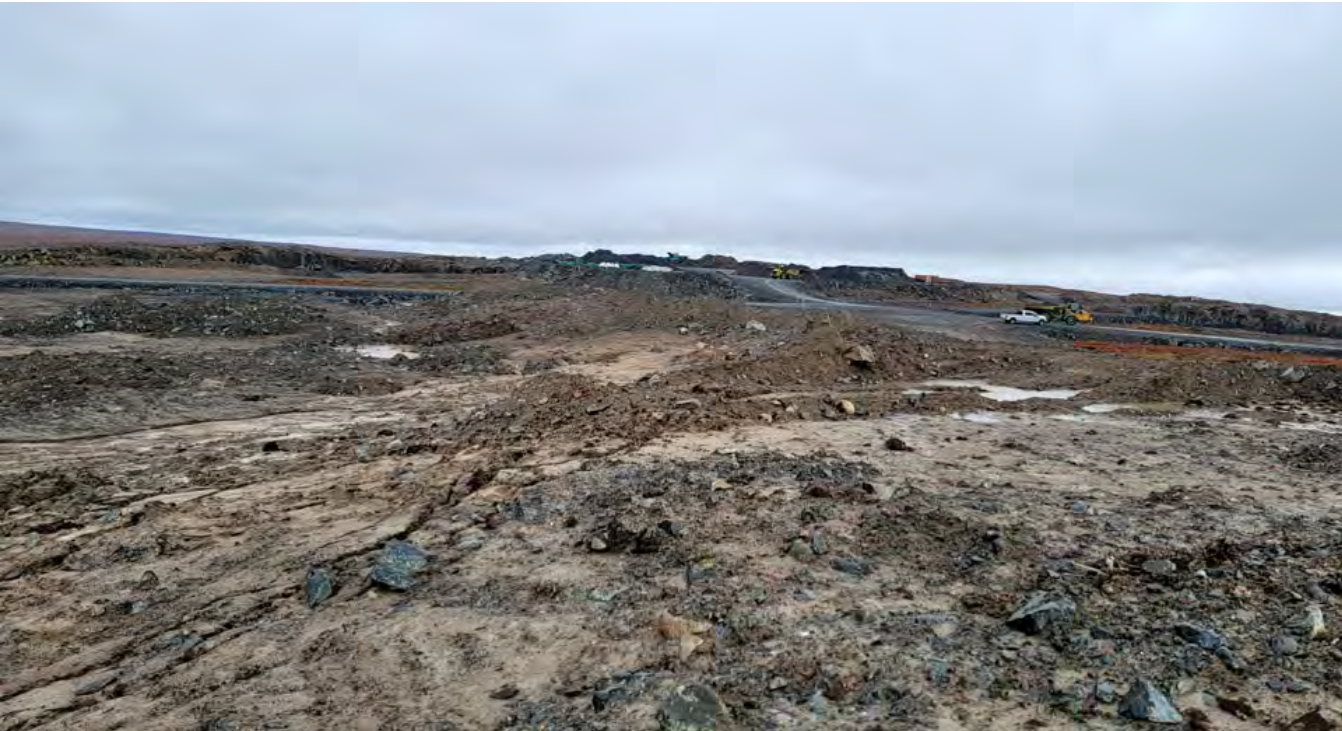
G-15. Tension cracks at the crest of the SSE

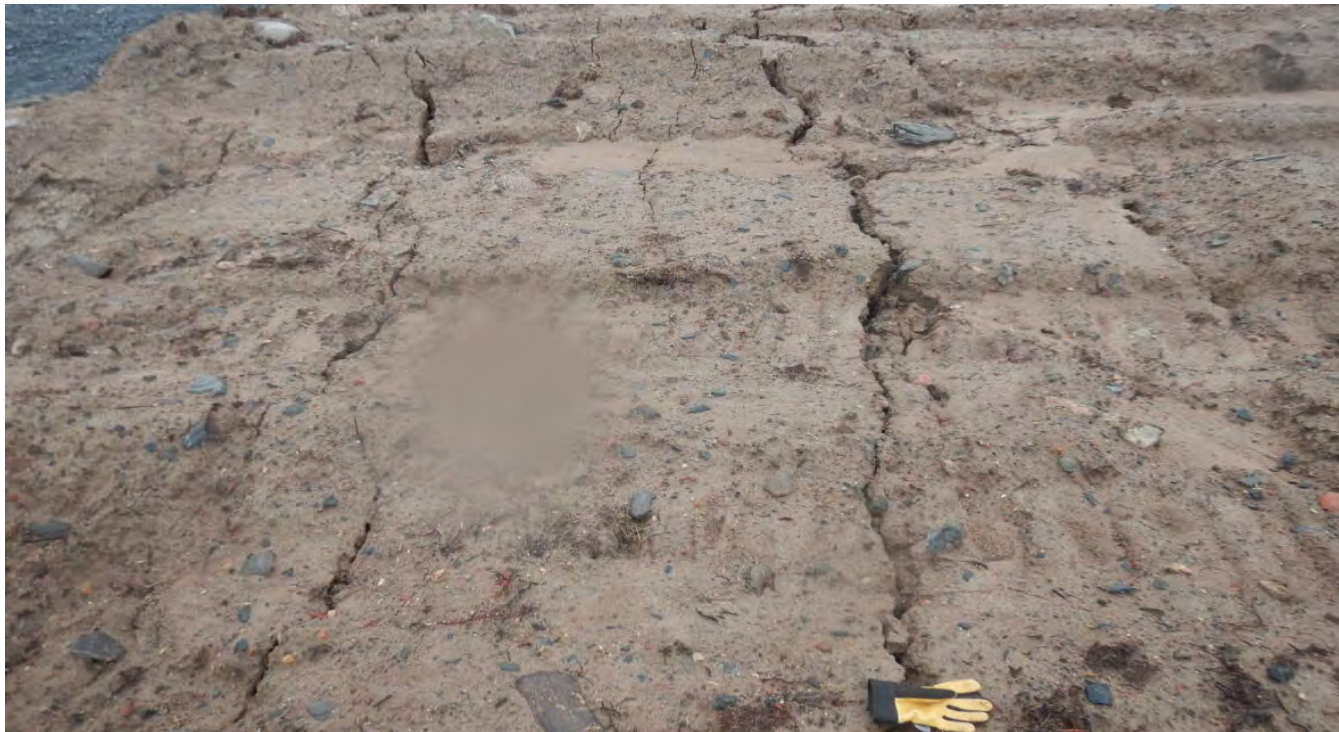
G-16. Tension cracks at the crest of the SSE

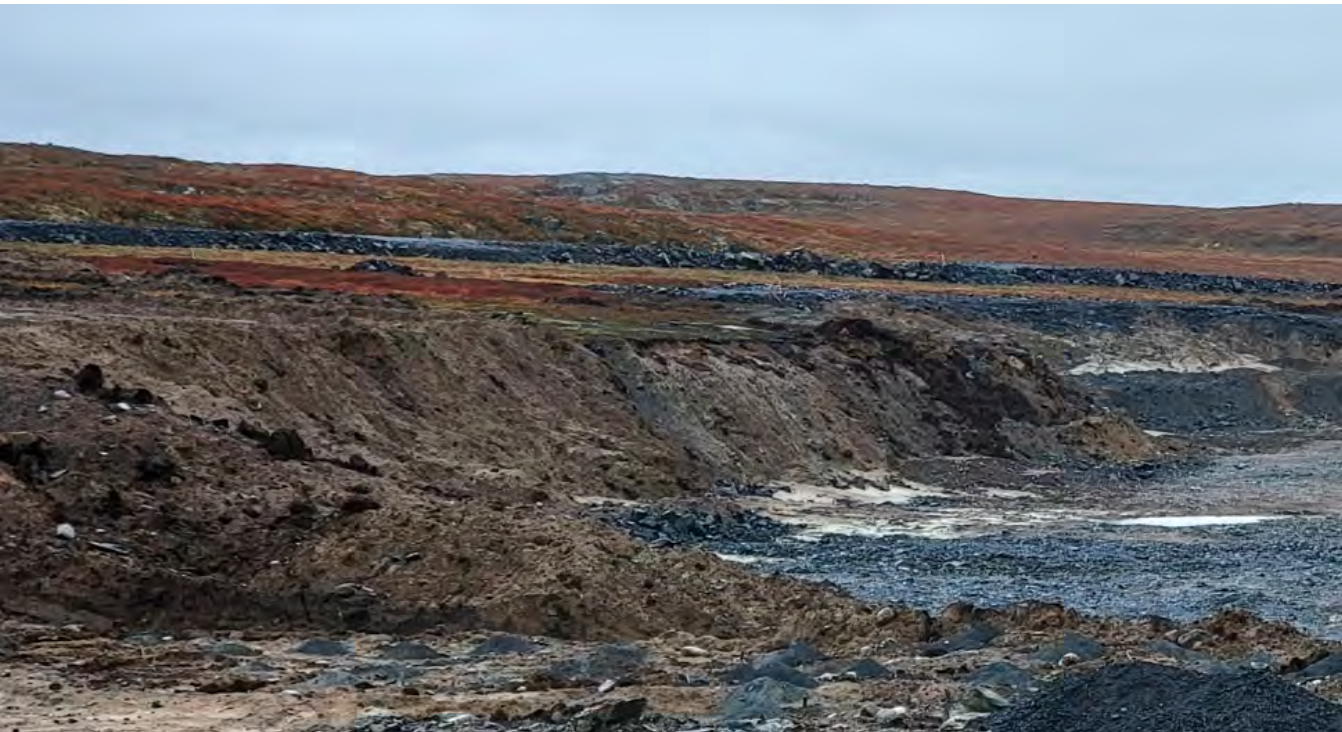
G-17 – SSW slope of Echo Pit

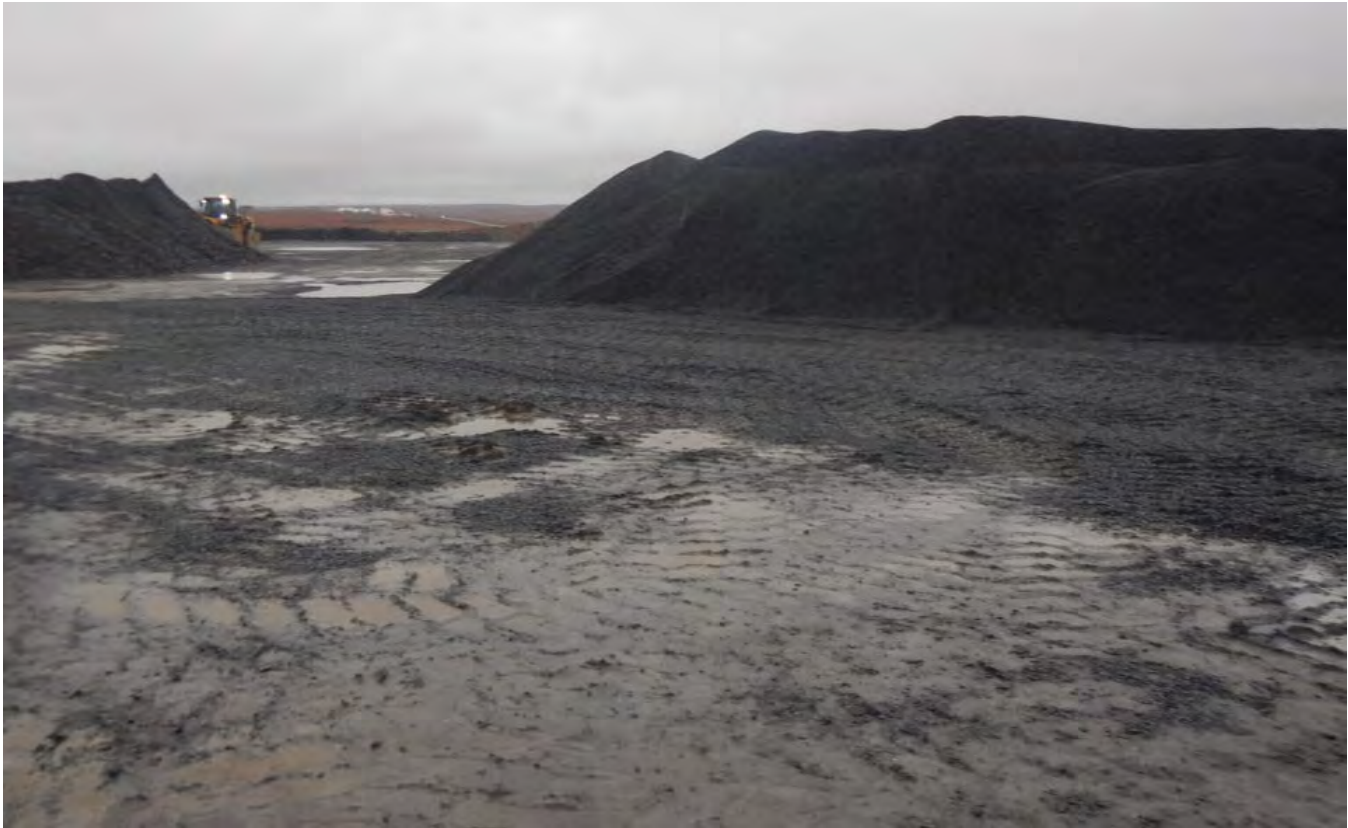
G-26. - Crusher stockpile pad. Two piles of 1” crush

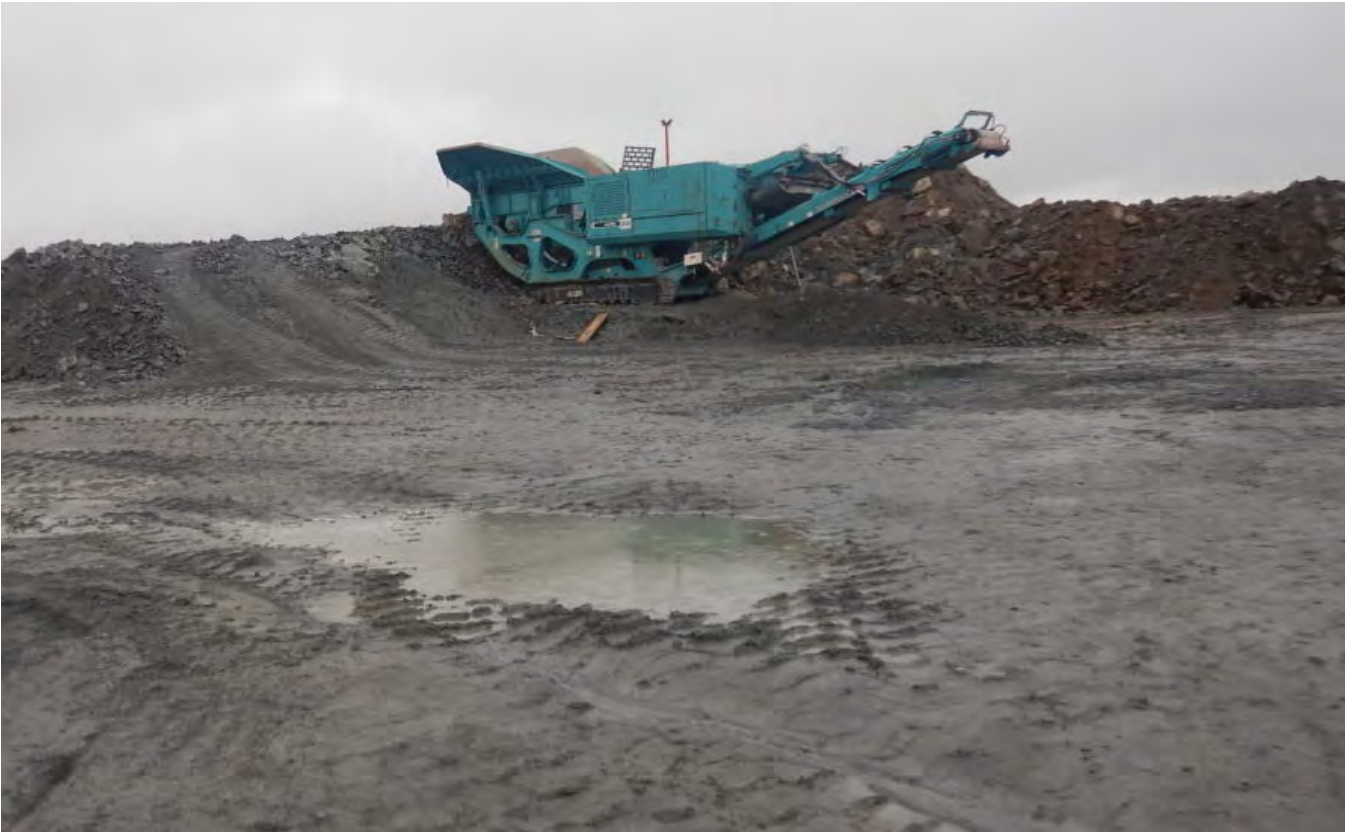
G-27. - Surface undulation of the crusher pad

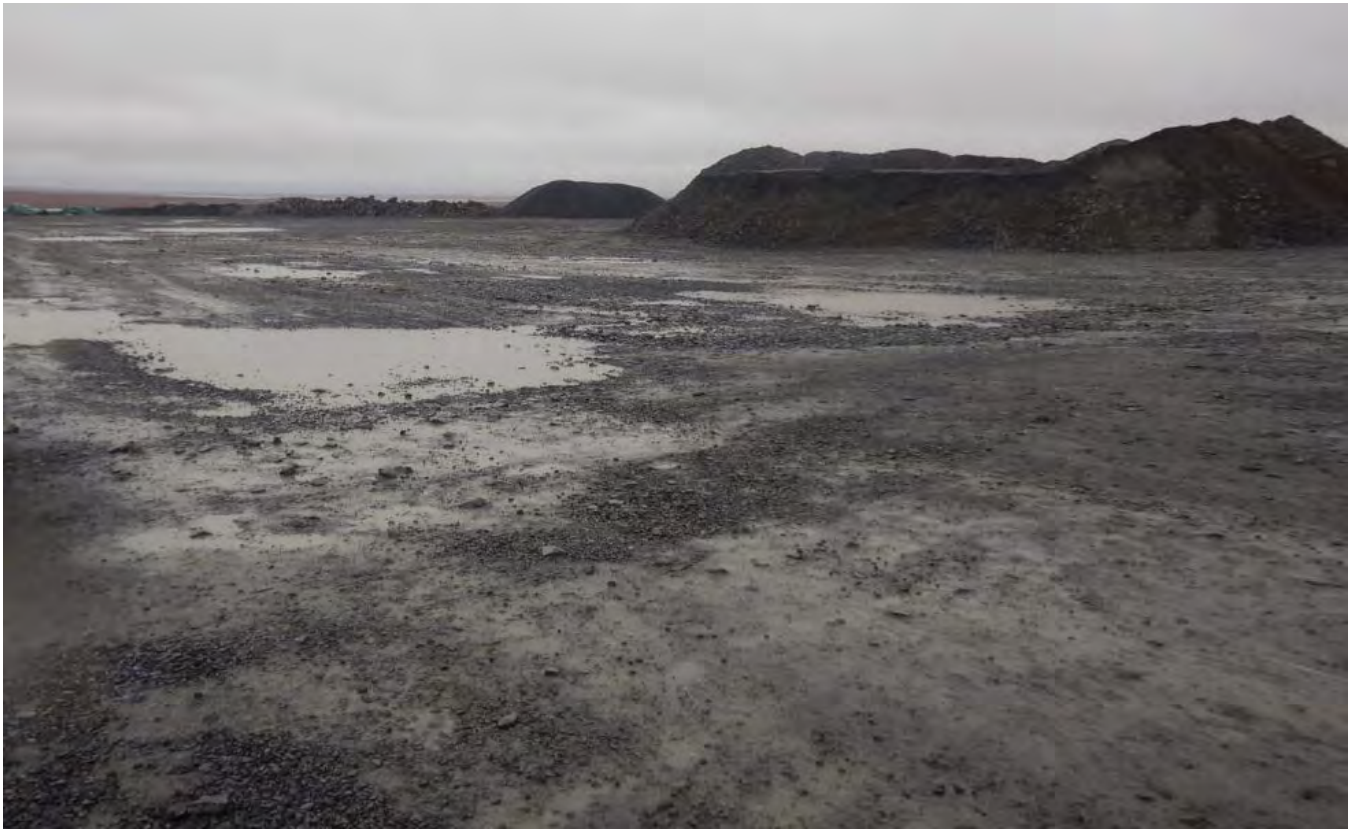
G-28. - Crusher stockpile pad. Surface undulation

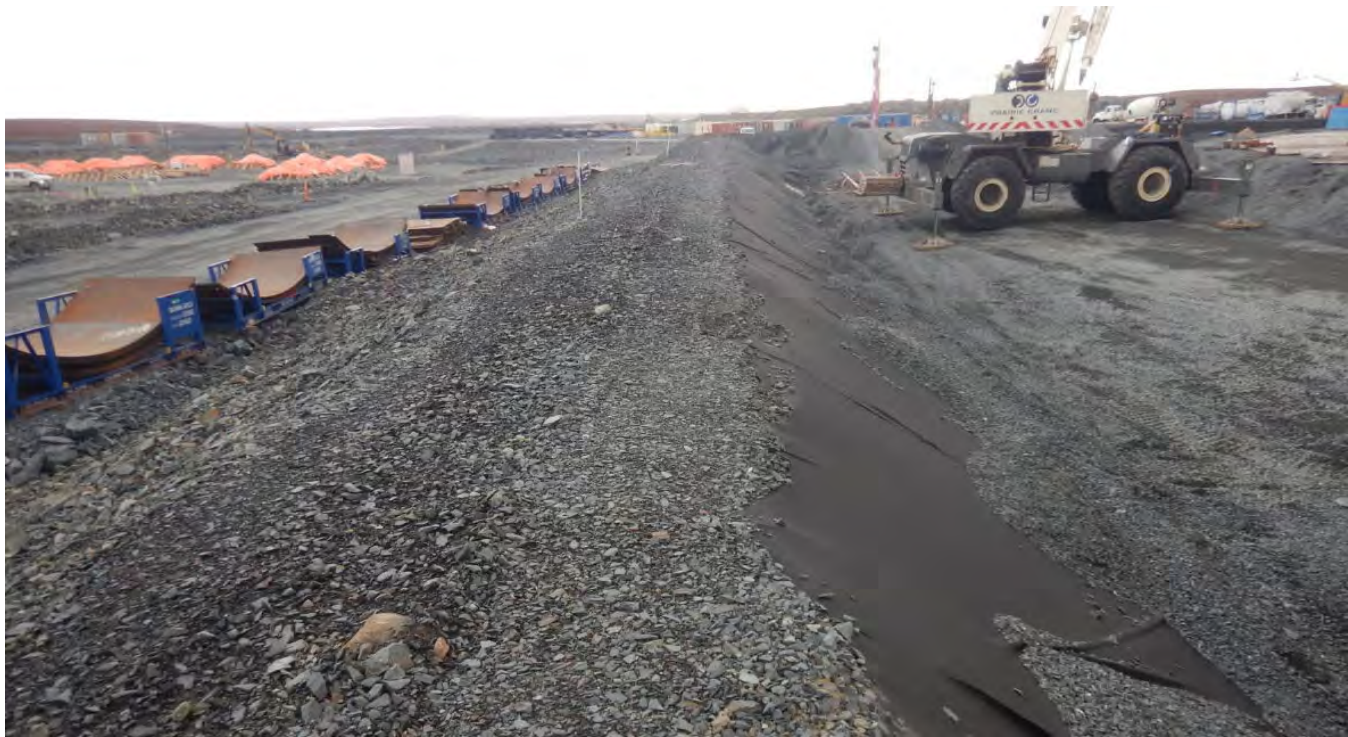
G-29. – Northern berm of the containment area (inner and outer slopes), looking west

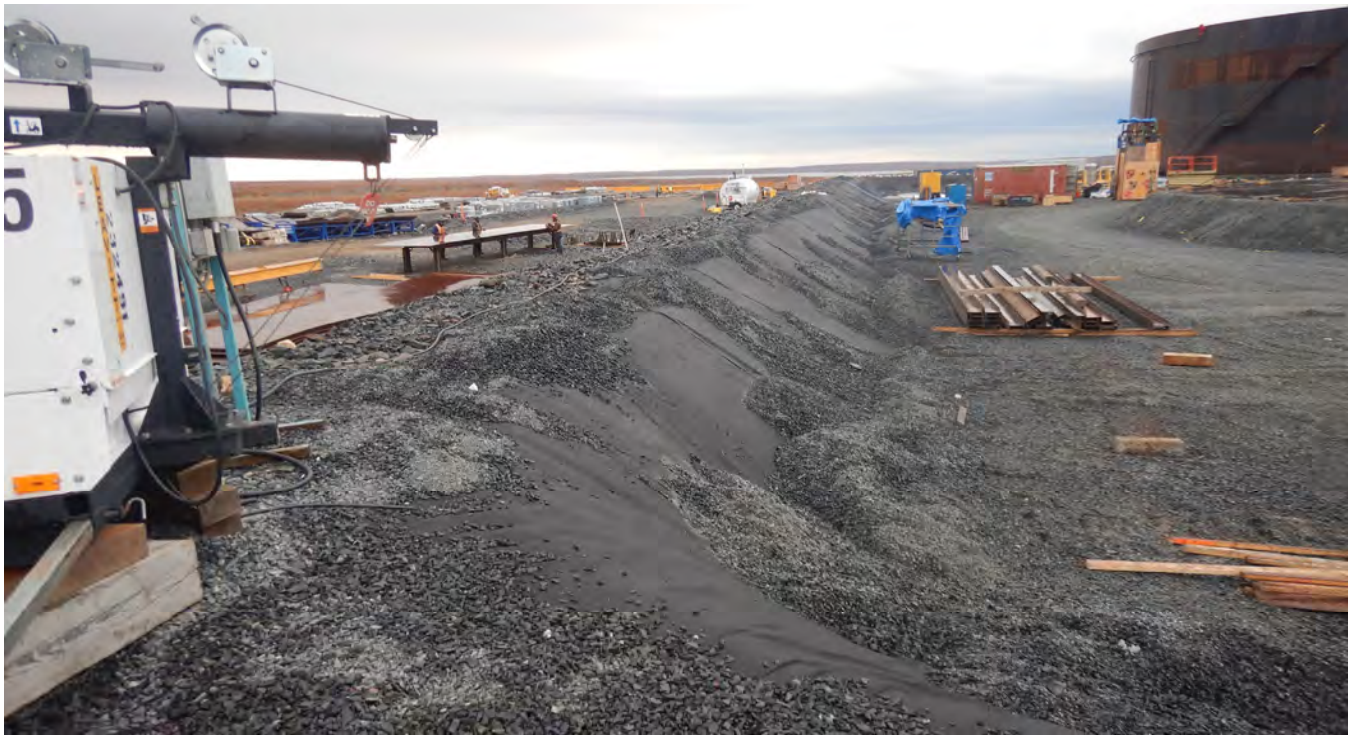
G-31. – Southern berm, looking west.

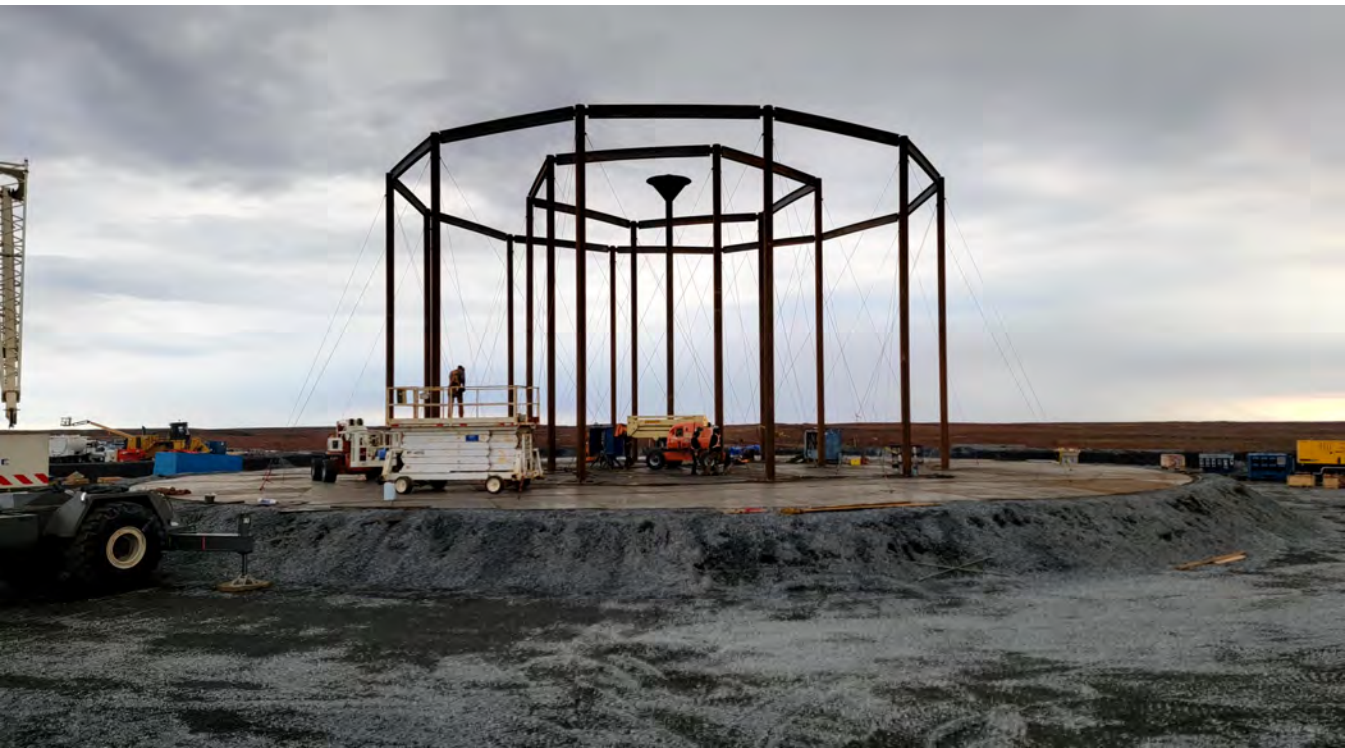
G-32. – Pedestal of Tank #2 (northern side), looking south

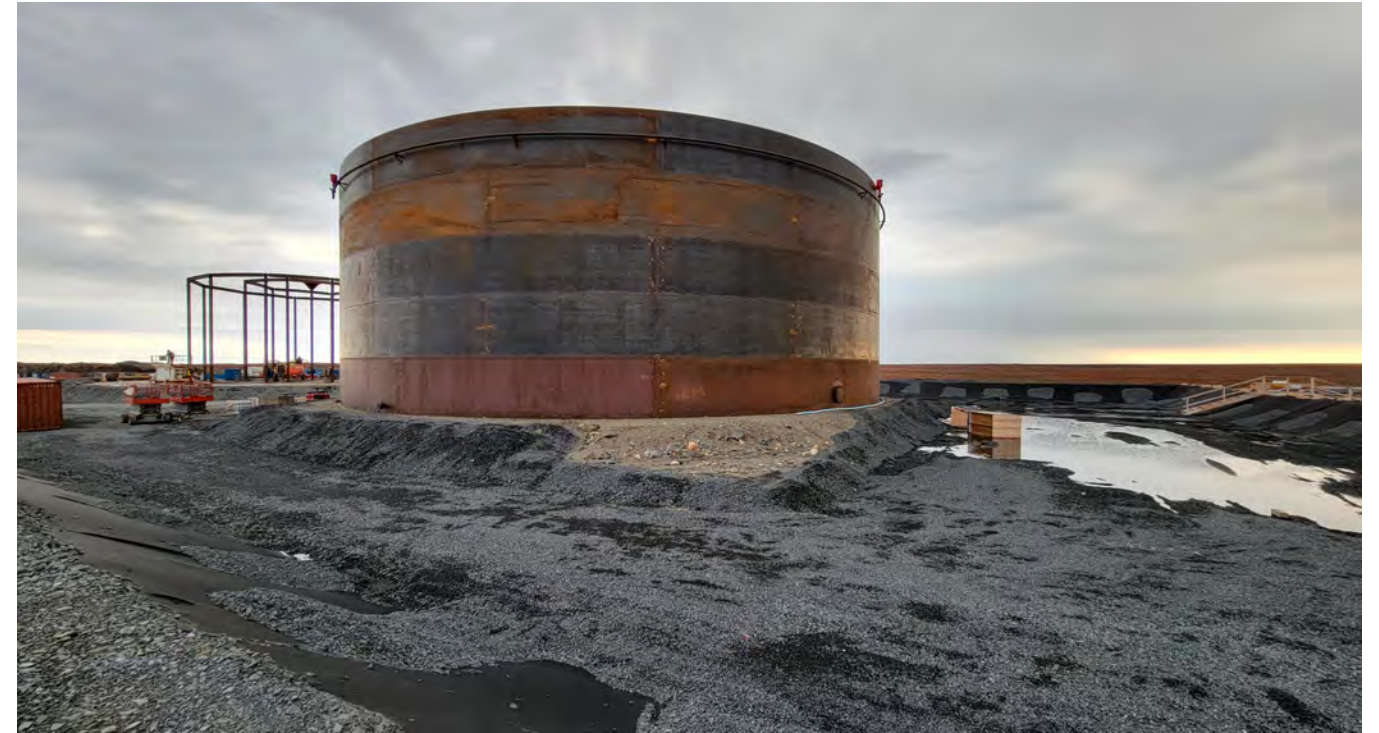
G-34. - NW corner of the containment area and pedestal for Tank #1, looking SE.

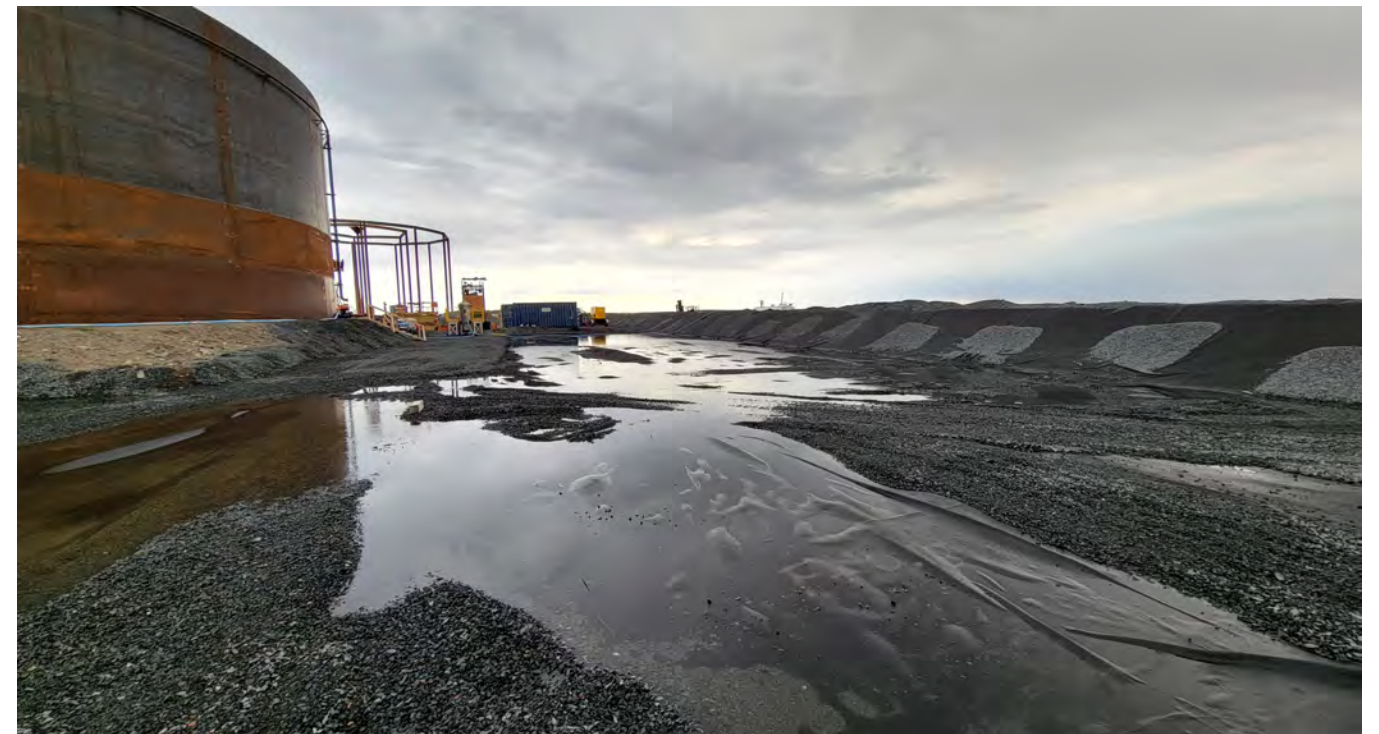
G-36. – Southern side of the containment area, looking east. Note that the ponding water and exposed liner at the base and slopes of the containment area

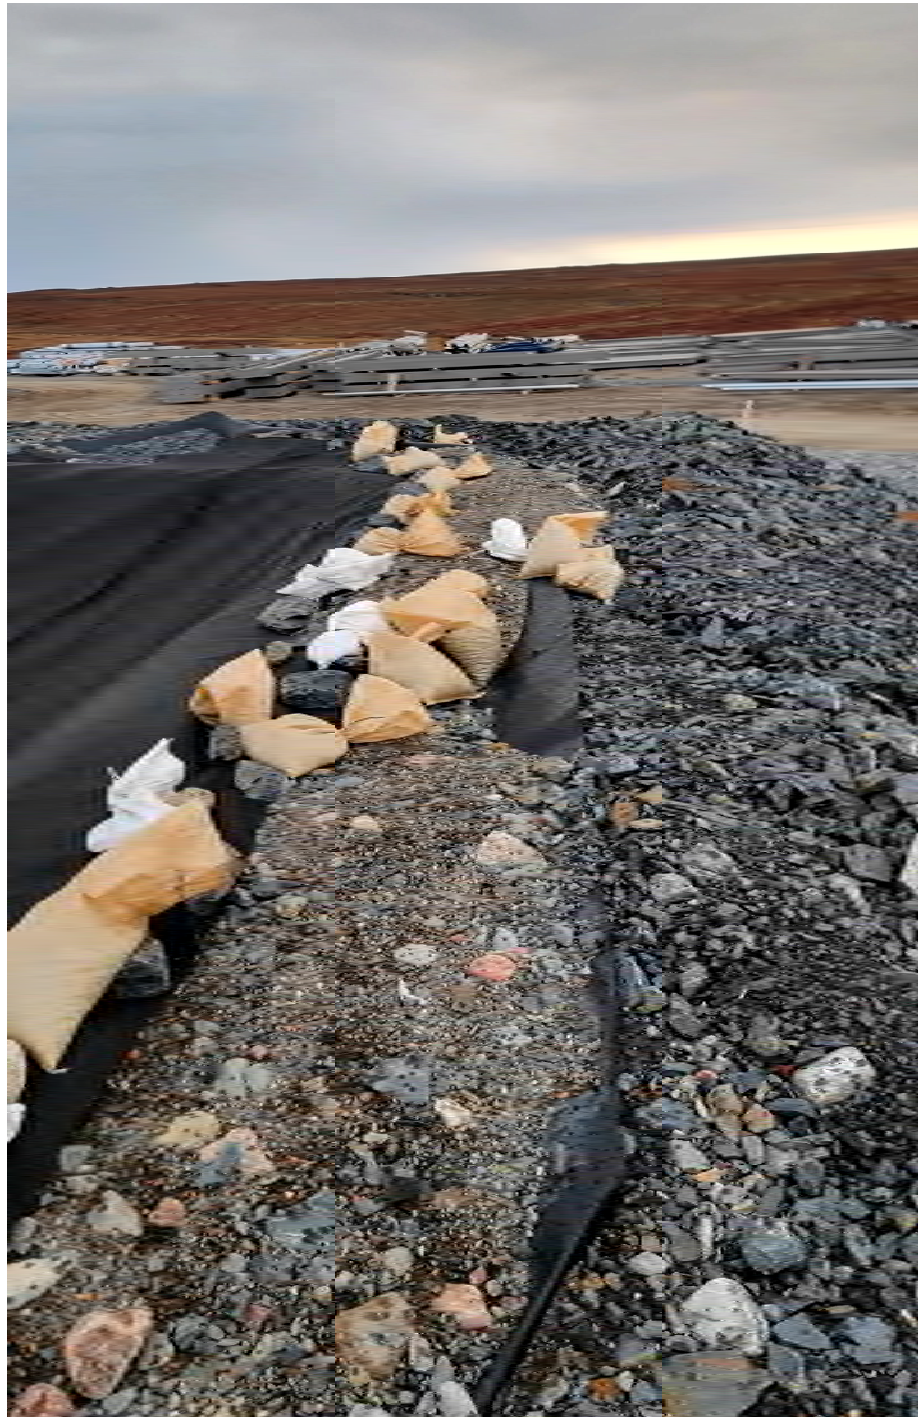
G-37 . – Edge of the HDPE liner is exposed on top of the SW corner of the berm, looking south

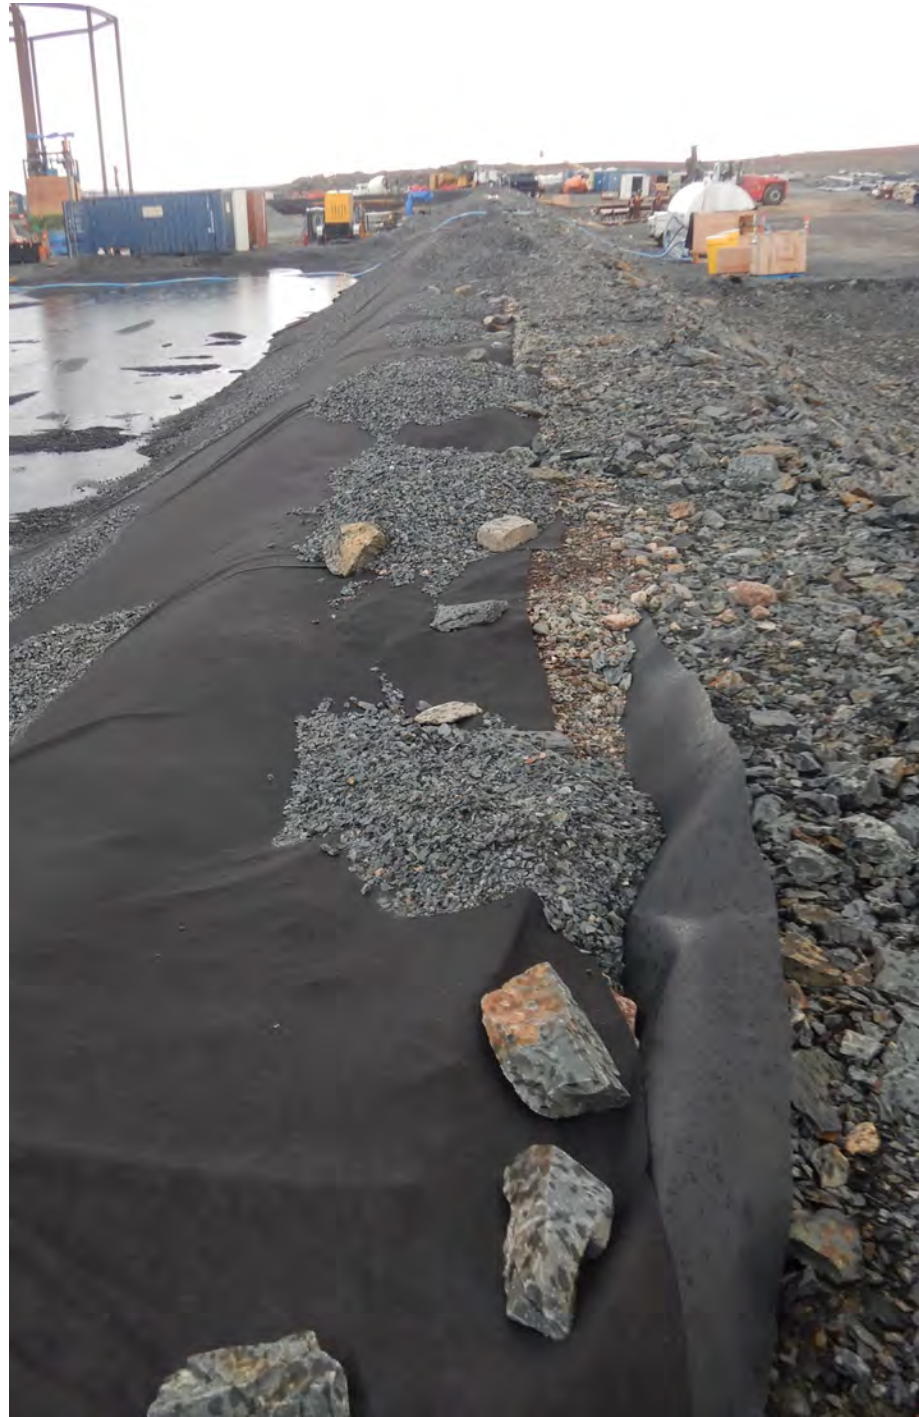
G-38. – Edge of the HDPE liner is exposed on top of the southern berm, looking east

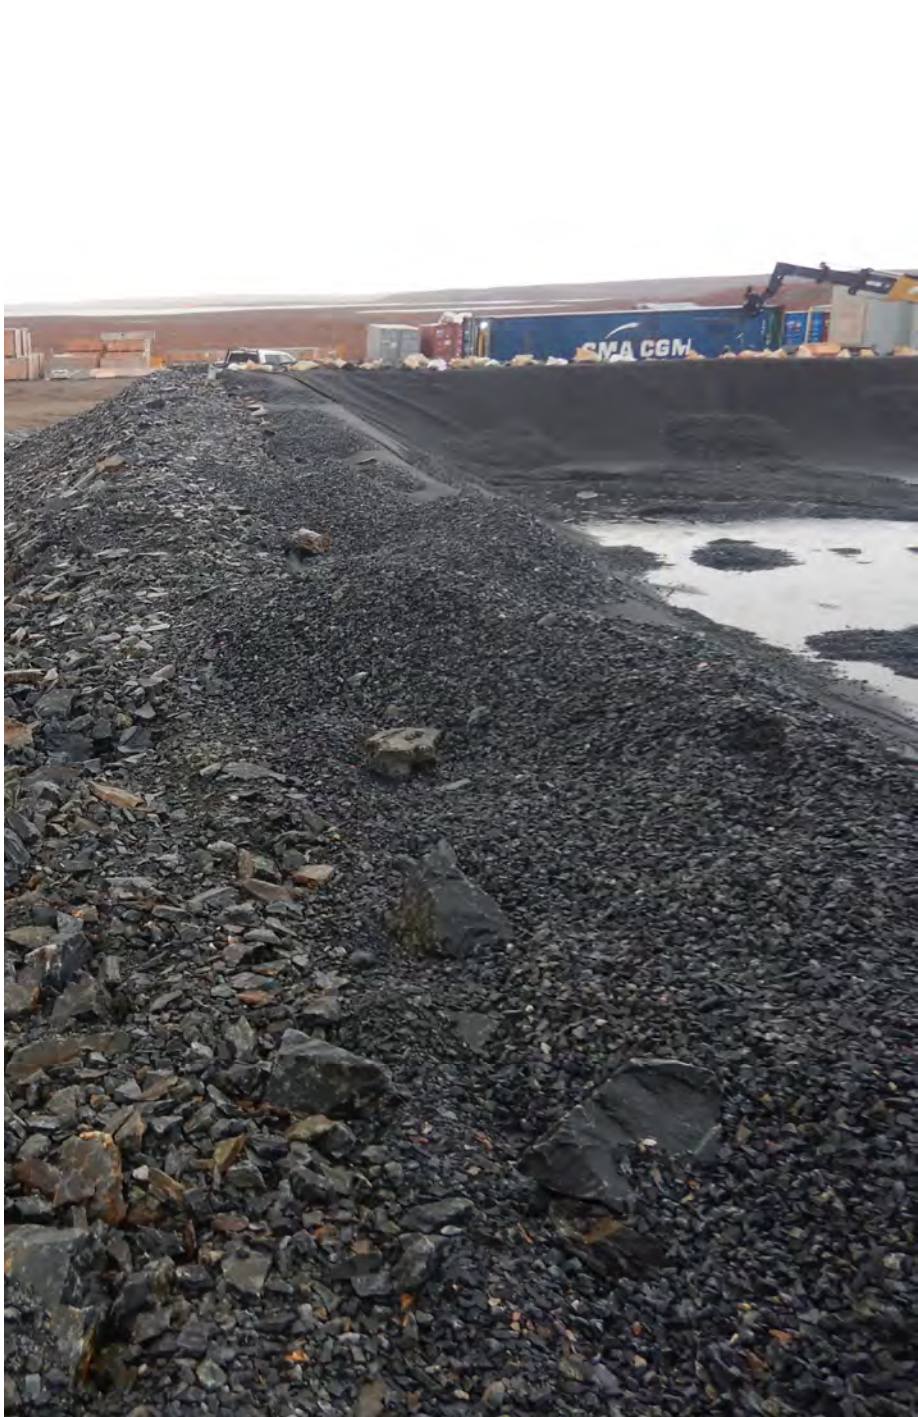
G-39. – Southern berm of the containment area
