## **Appendix A      Photolog from 2023 Visit – Goose**

Back River Project

2023 Annual Geotechnical Inspection

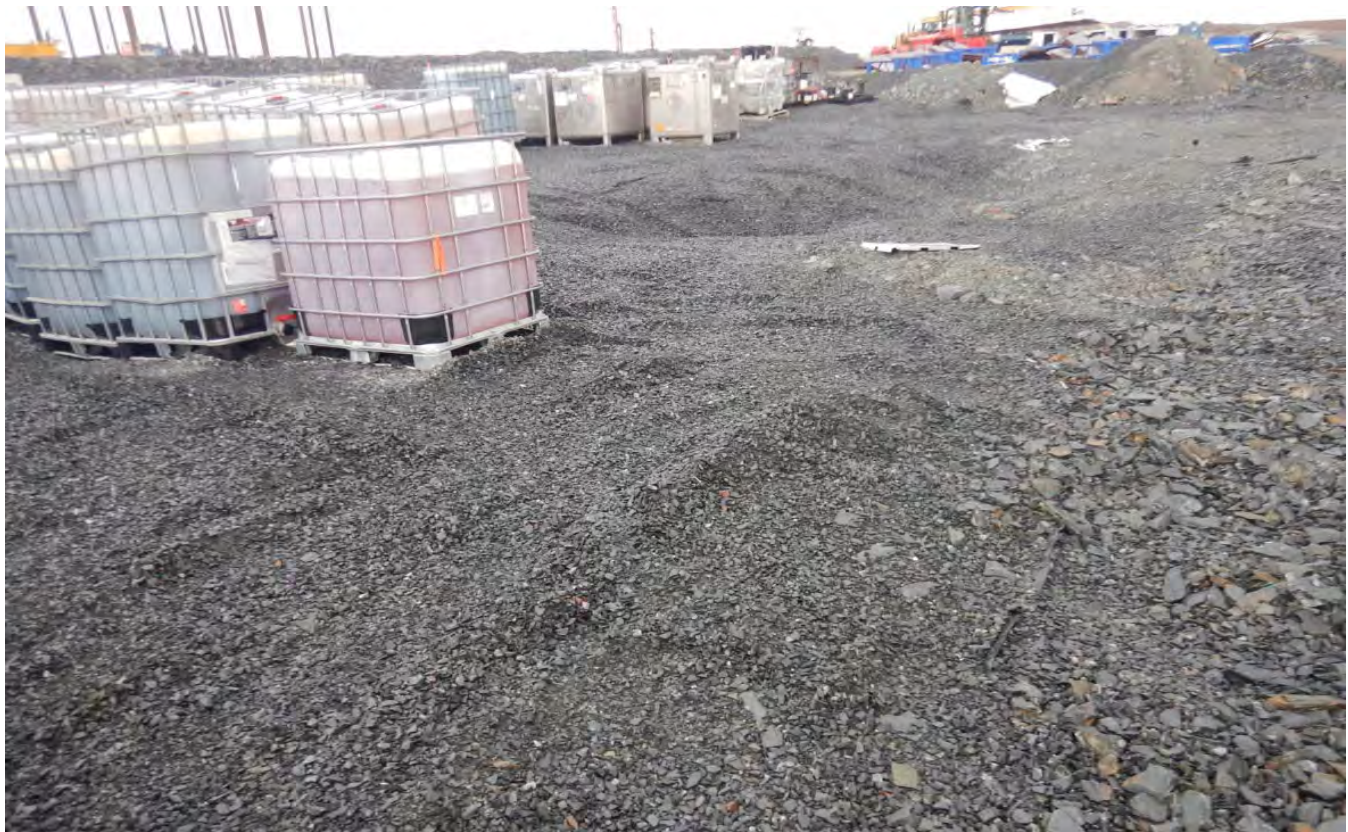
G-40. – Base of the secondary containment storage area.

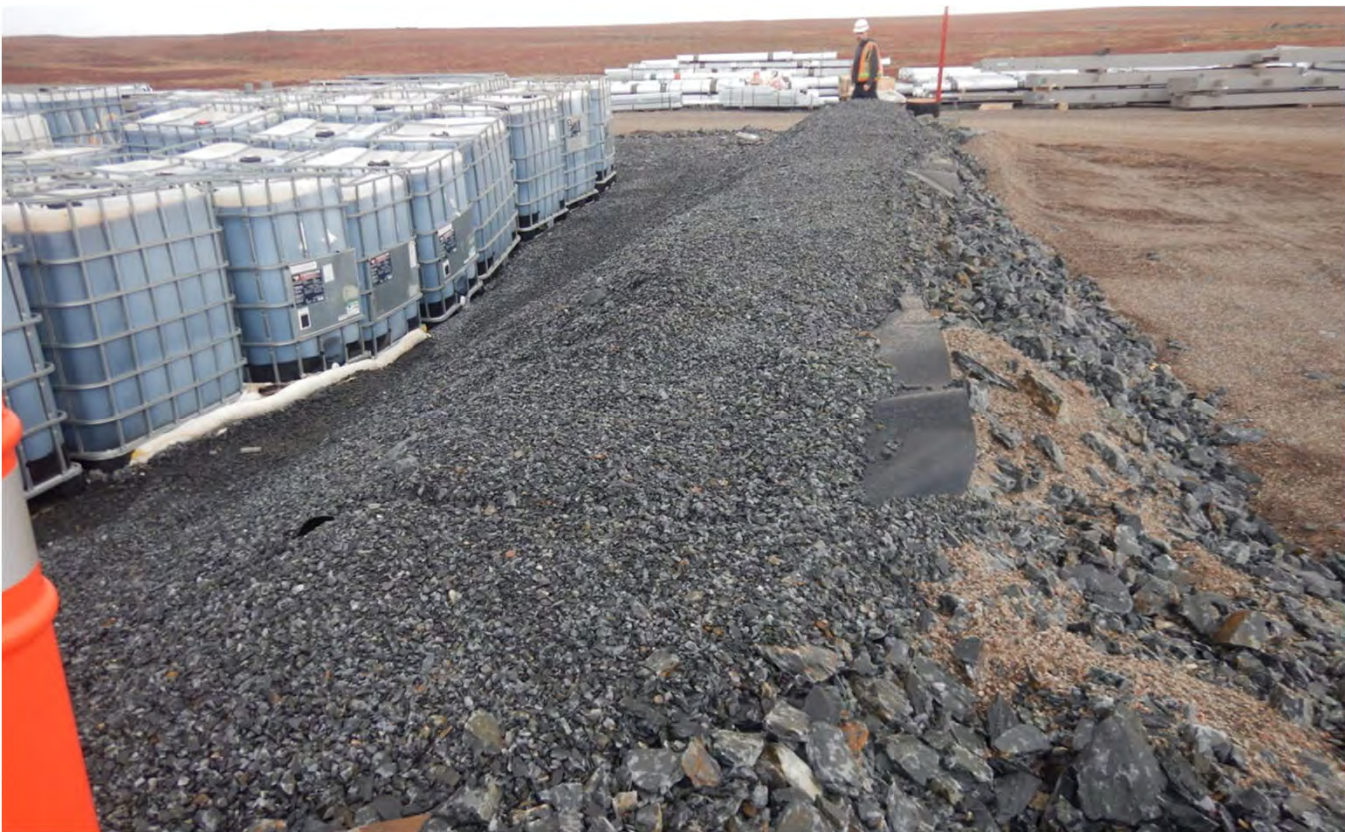
G-41. – Western berm of the secondary containment storage area, looking south. Note exposed HDPE liner

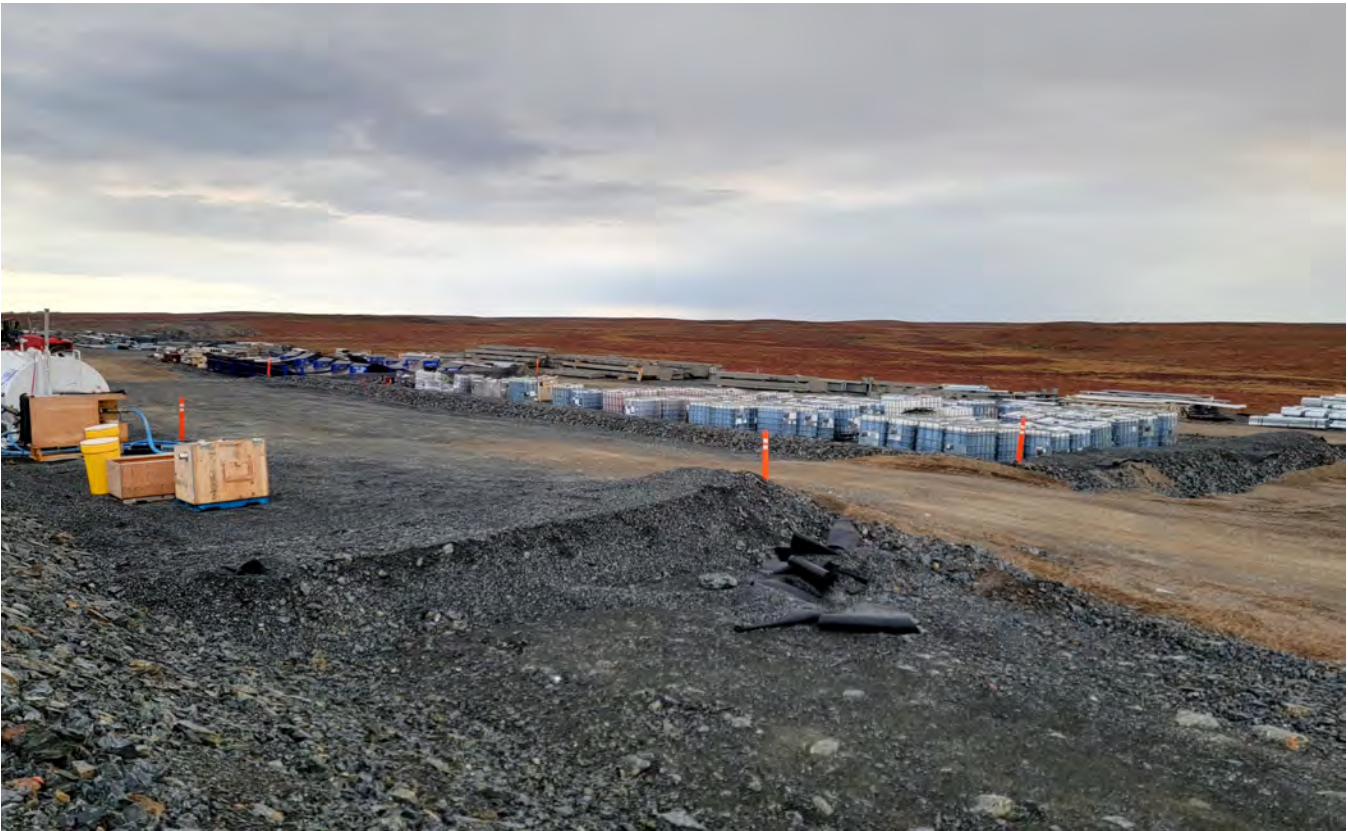
G-42. – Panoramic view of the secondary containment storage area, looking SE

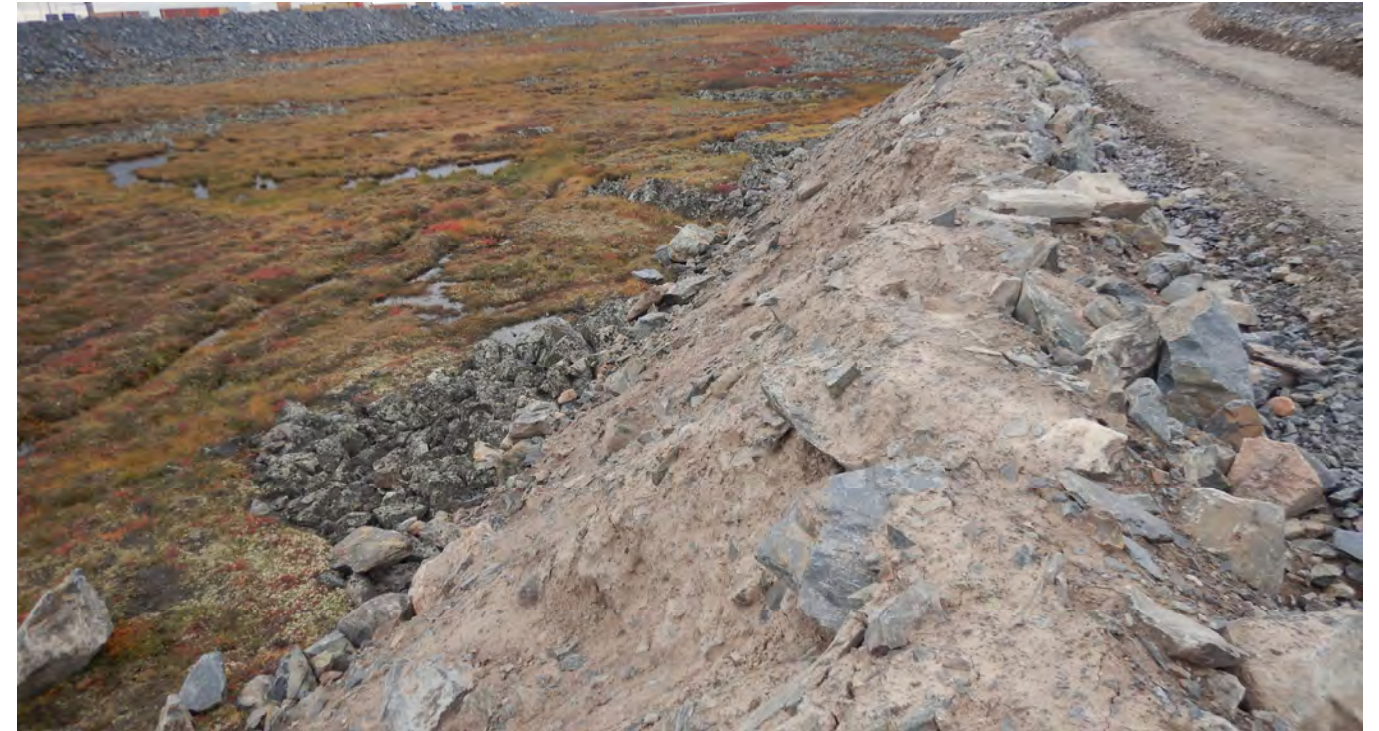
G-44. - Berm of the CWP. Western slope. Photo was taken looking S

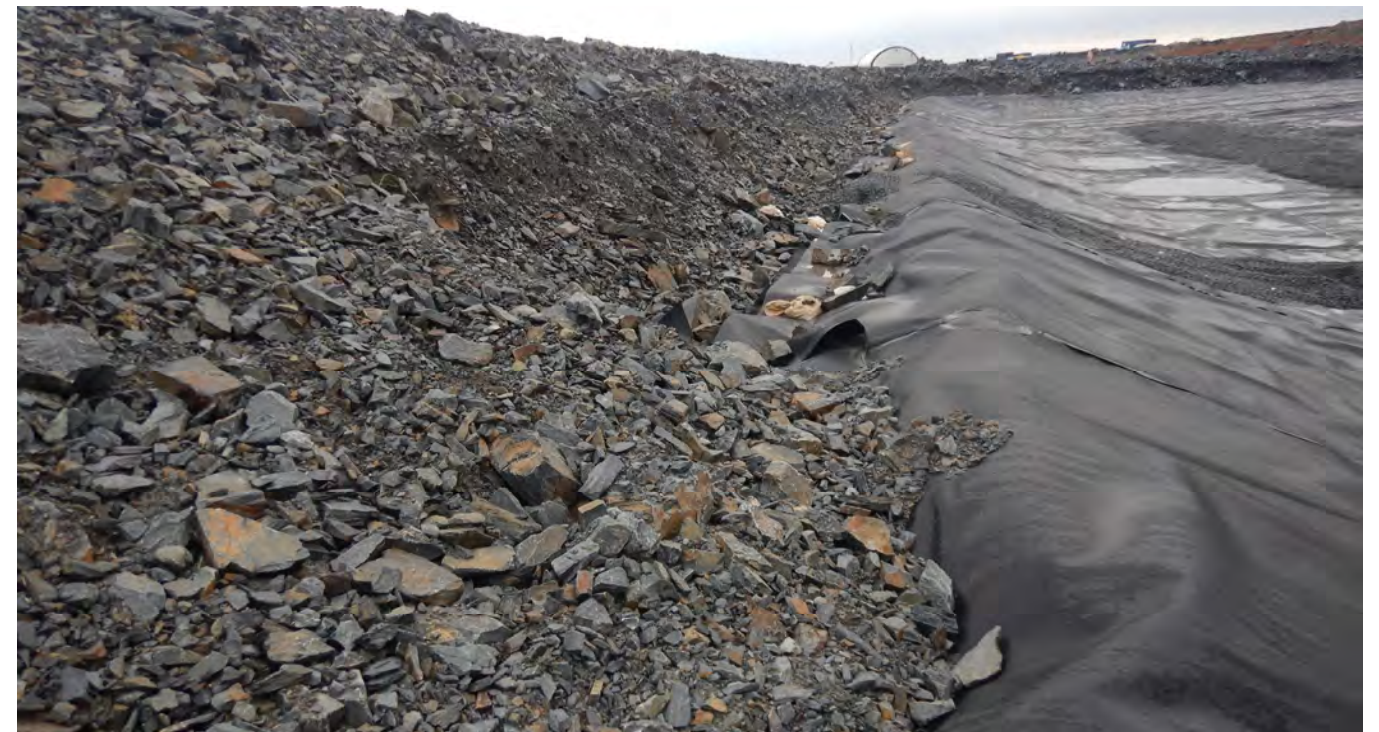
G-46. - Berm of the CWP. Inner slope. Photo was taken looking SE.

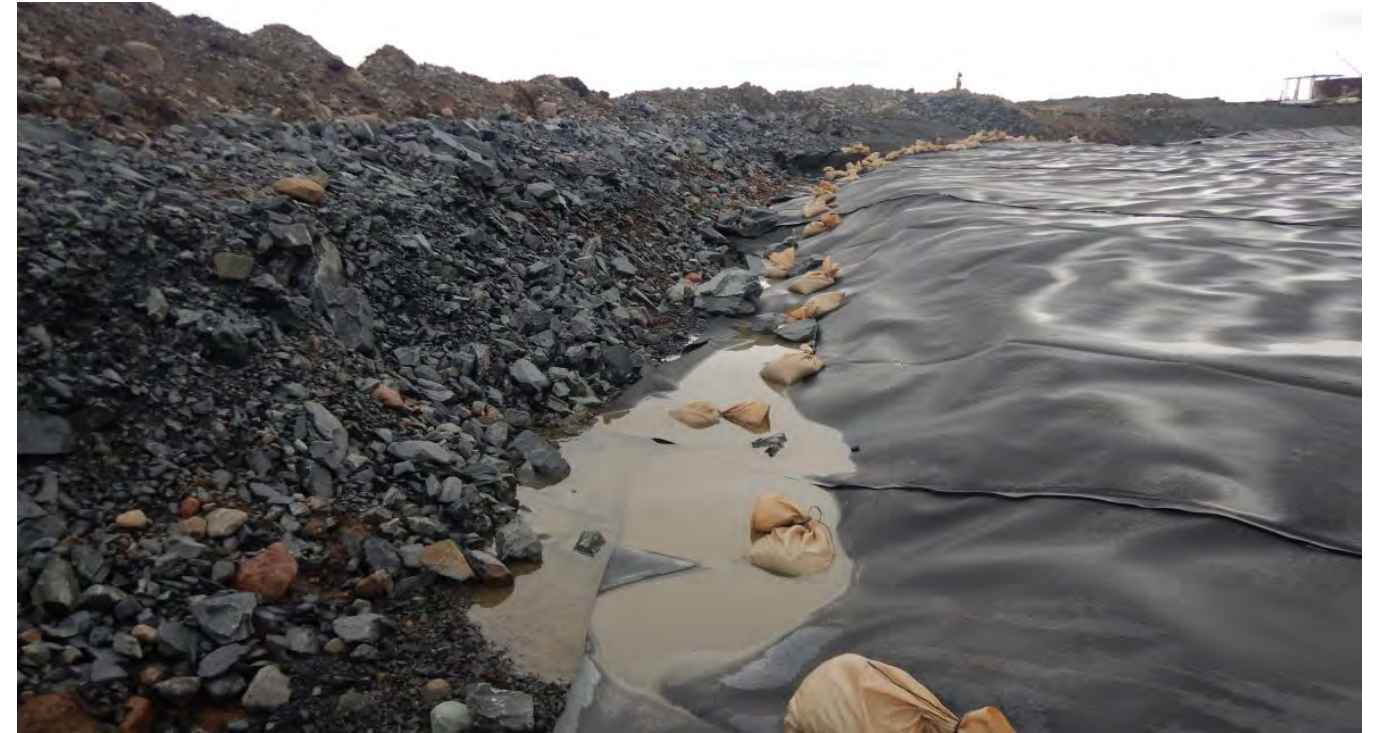
G-48. – Southern berm of Camp Pas CWP, looking SW

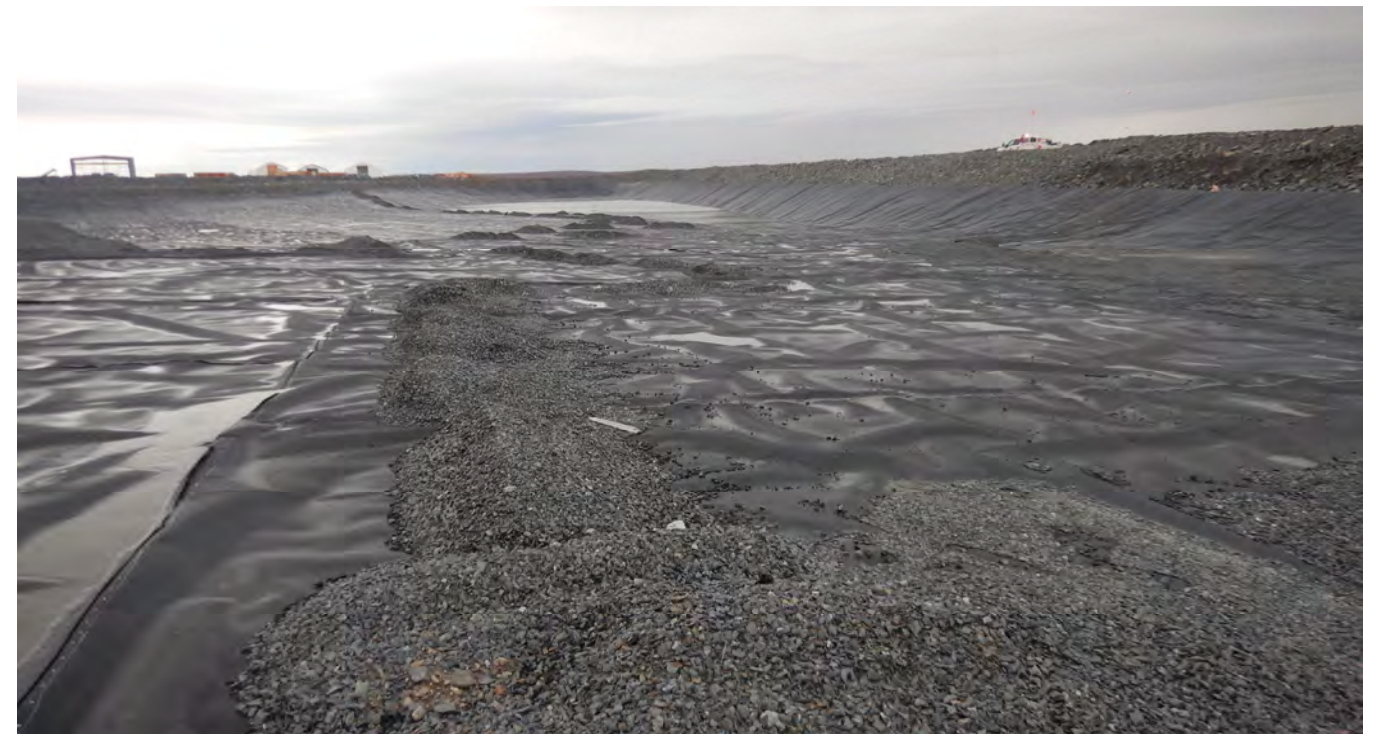
G-50. - Base of Camp Pas CWP, looking NW

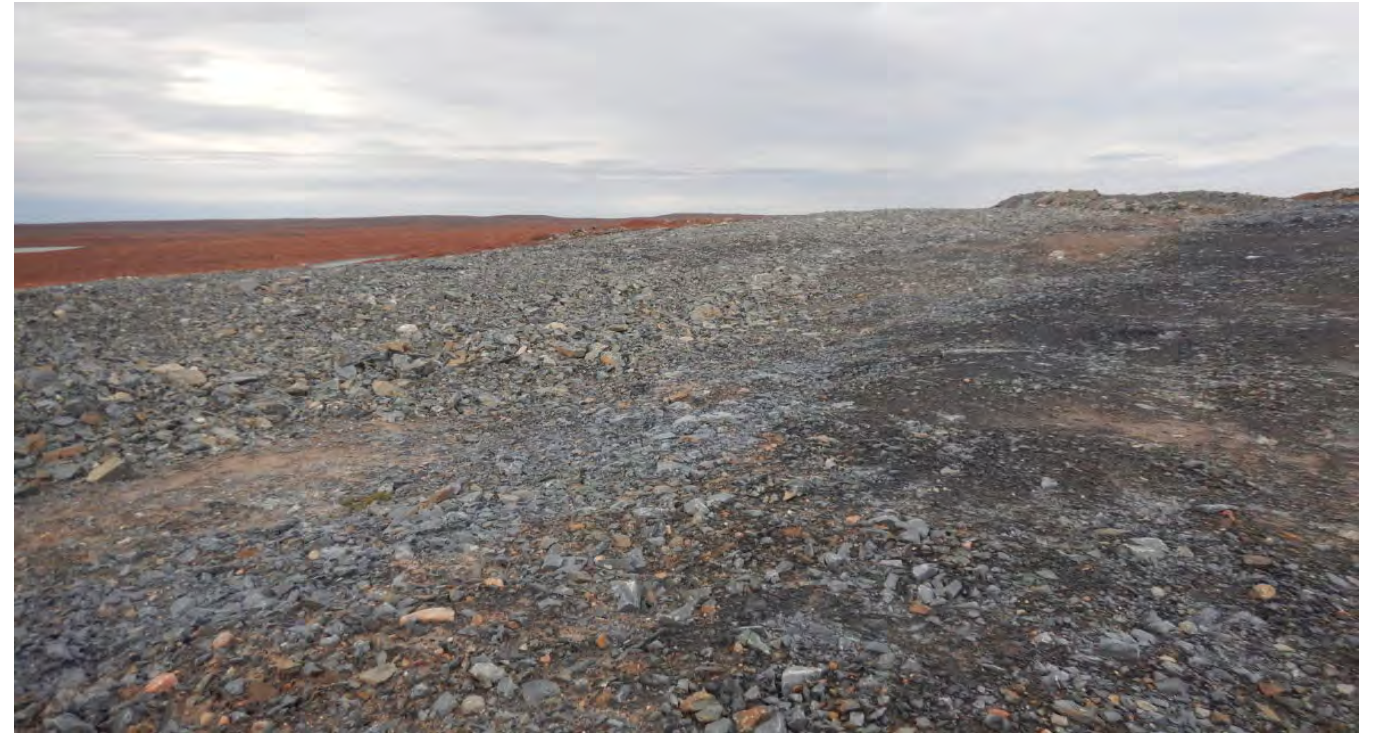
G-52. –Key trench winter protection approx. between Sta 0+70 and Sta+150

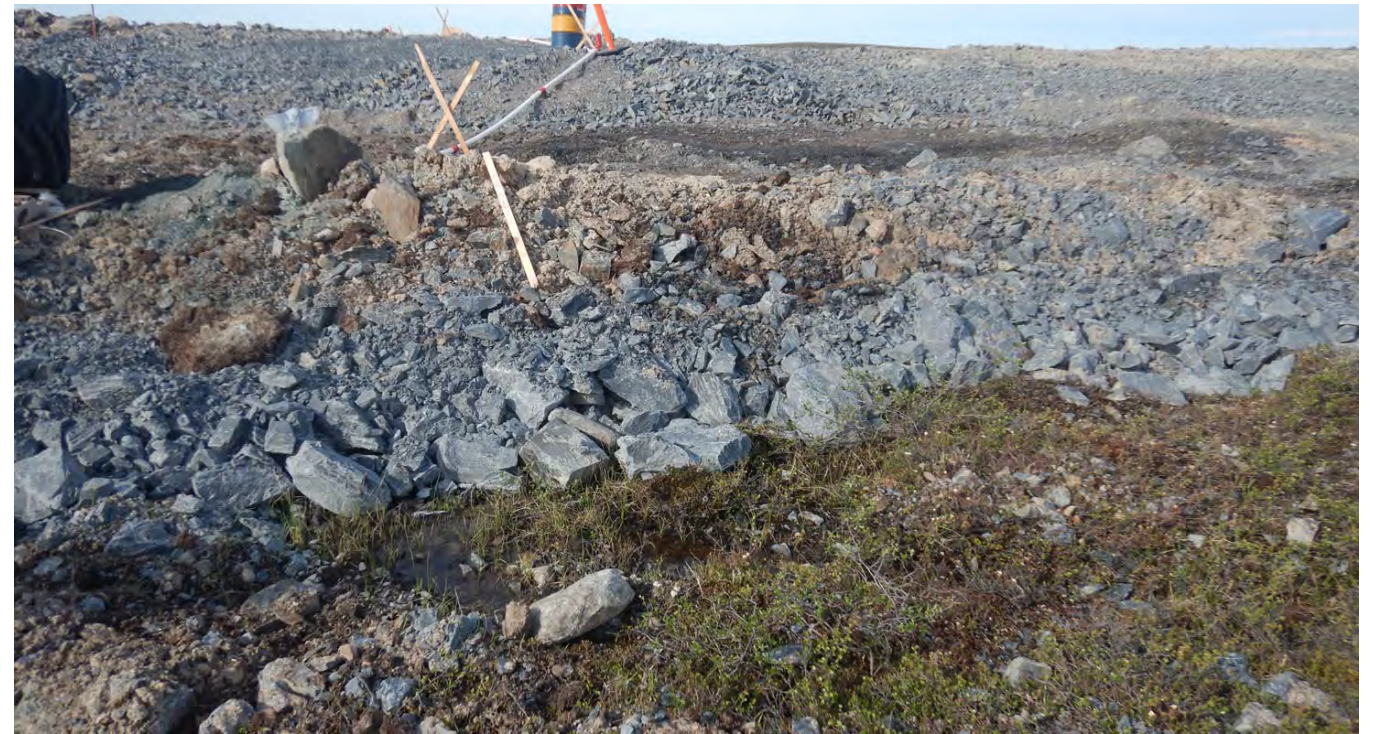
G-54. – Ponding water at the downstream side of the key trench approx. at Sta 0+550

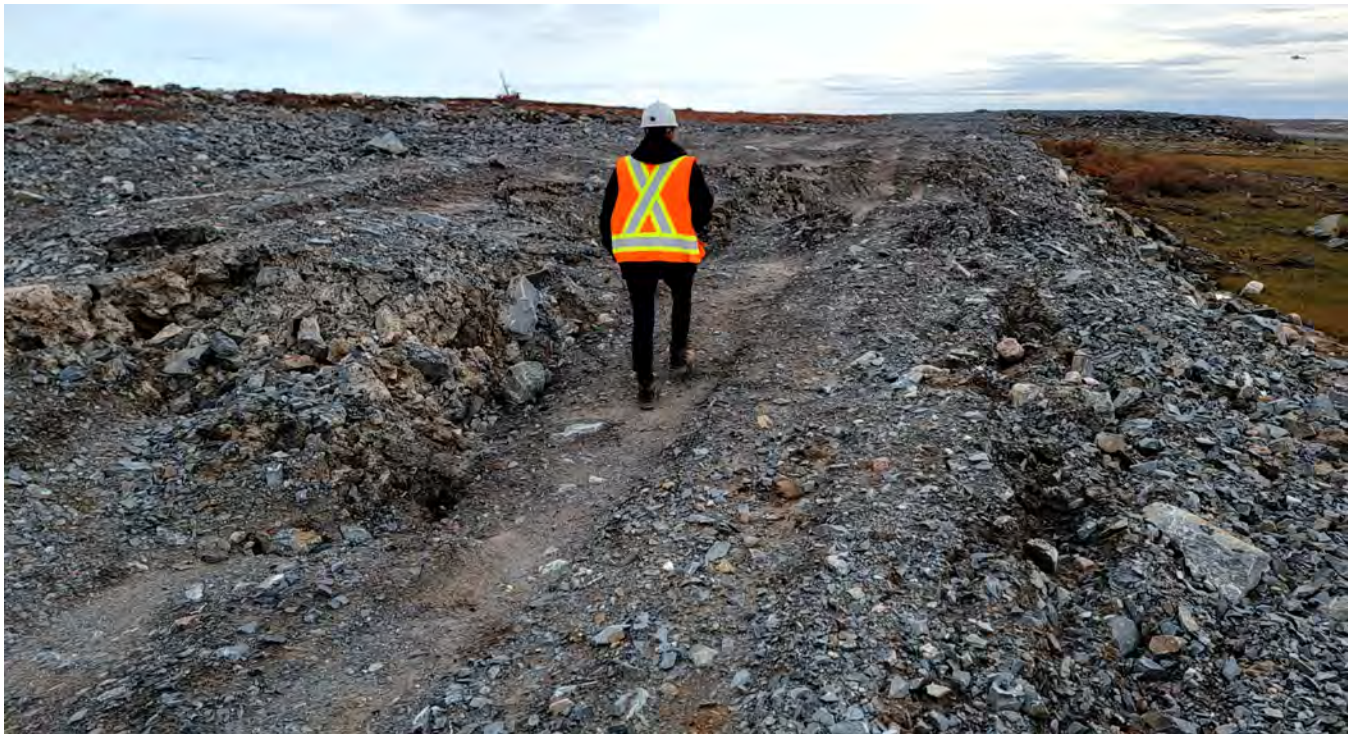
G-57. – Temporary Road along the upstream side of the key trench approx. at Sta 0+260. Note embankment degradation

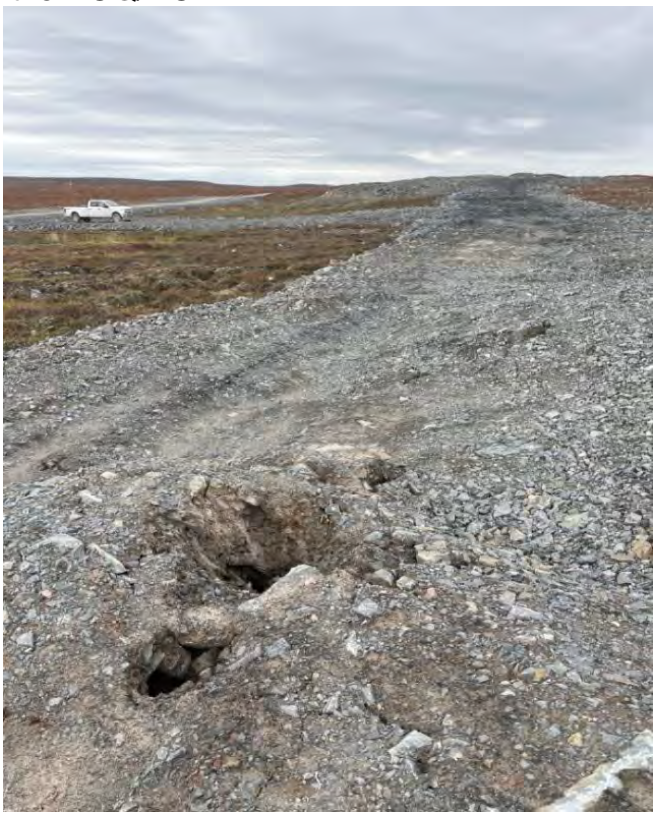
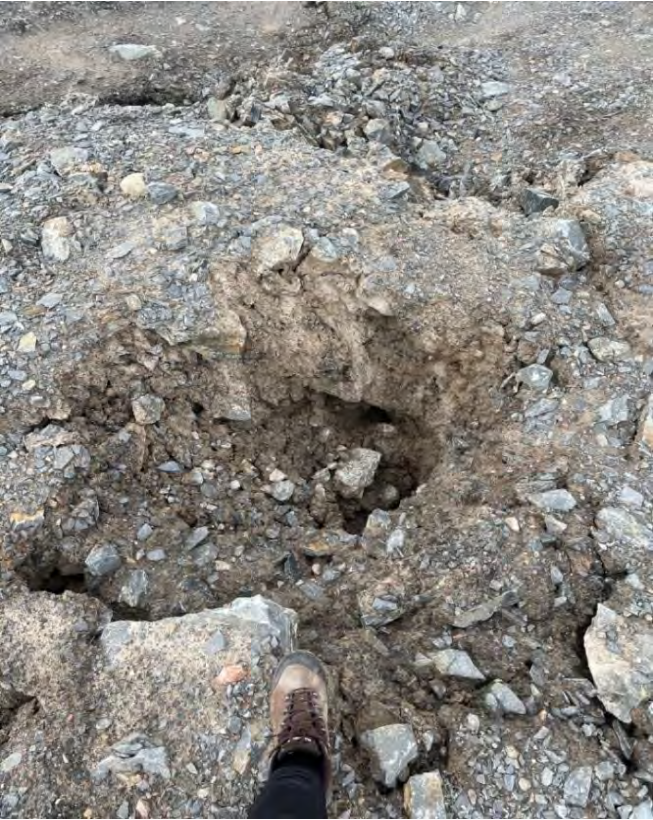
G-58 and G-59. - Embankment degradation approx. at Sta 0+260.

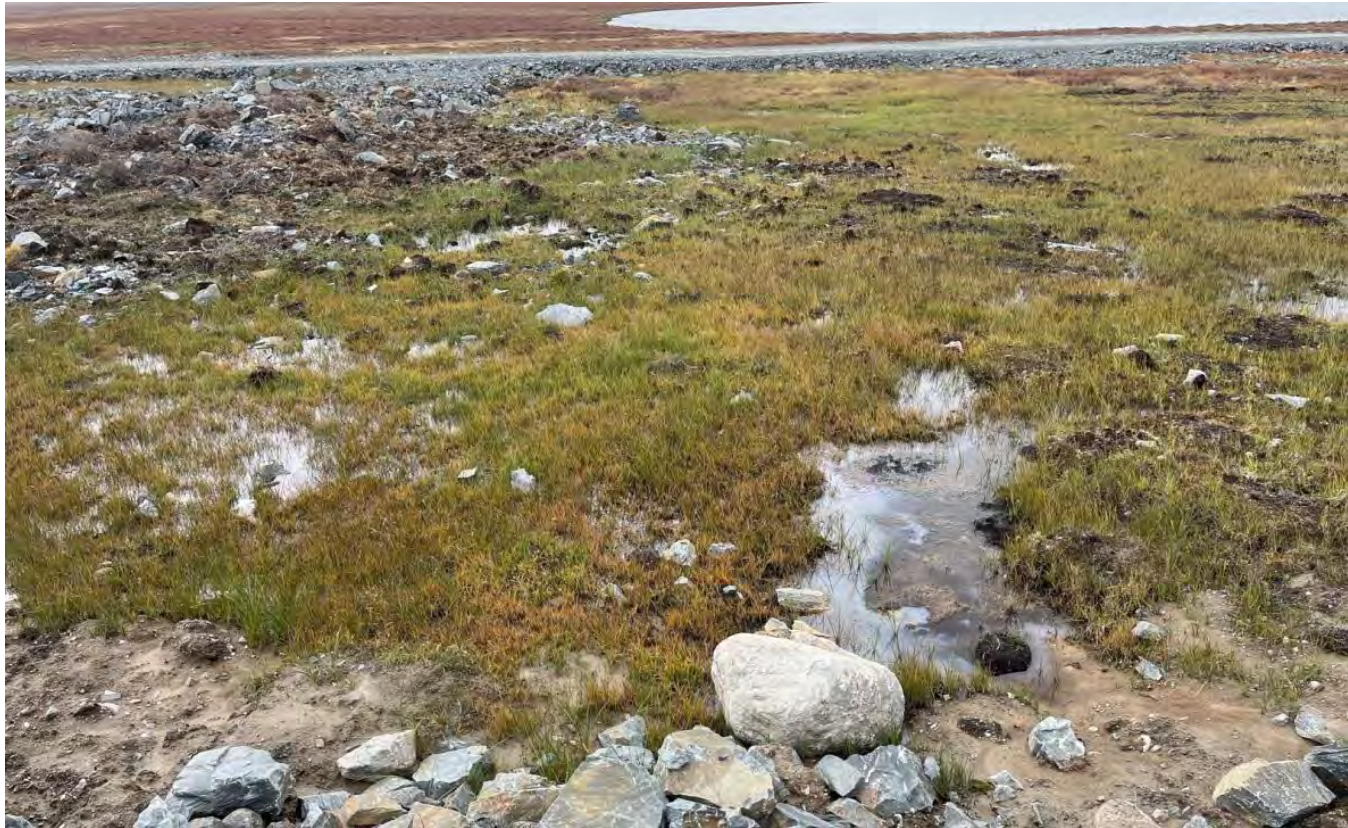
G-60. – Ponding water at the downstream side of the key trench approx. at Sta 0+270

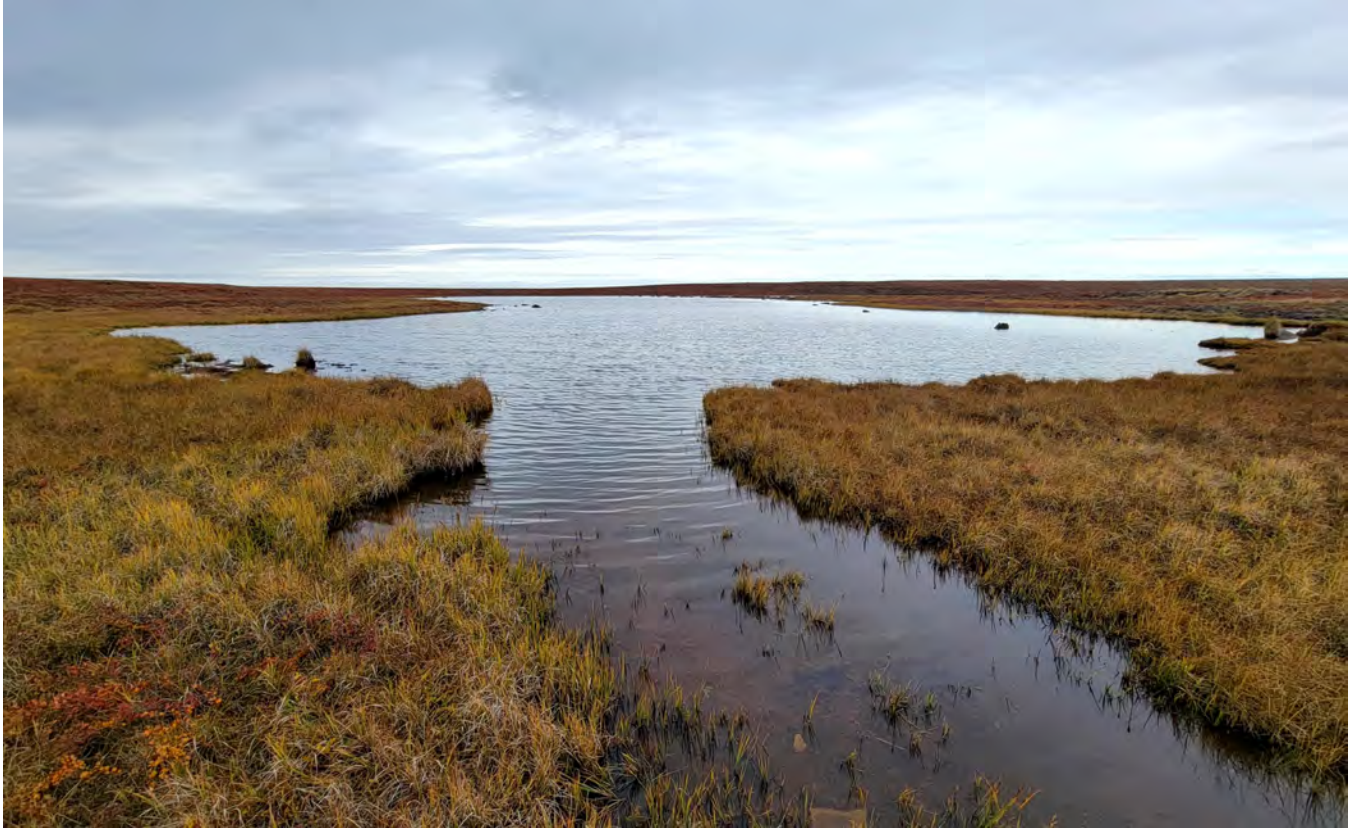
G-61. – A lake and a creek at the upstream side of the dam approx. at Sta 0+330, 35 m away from the dam alignment

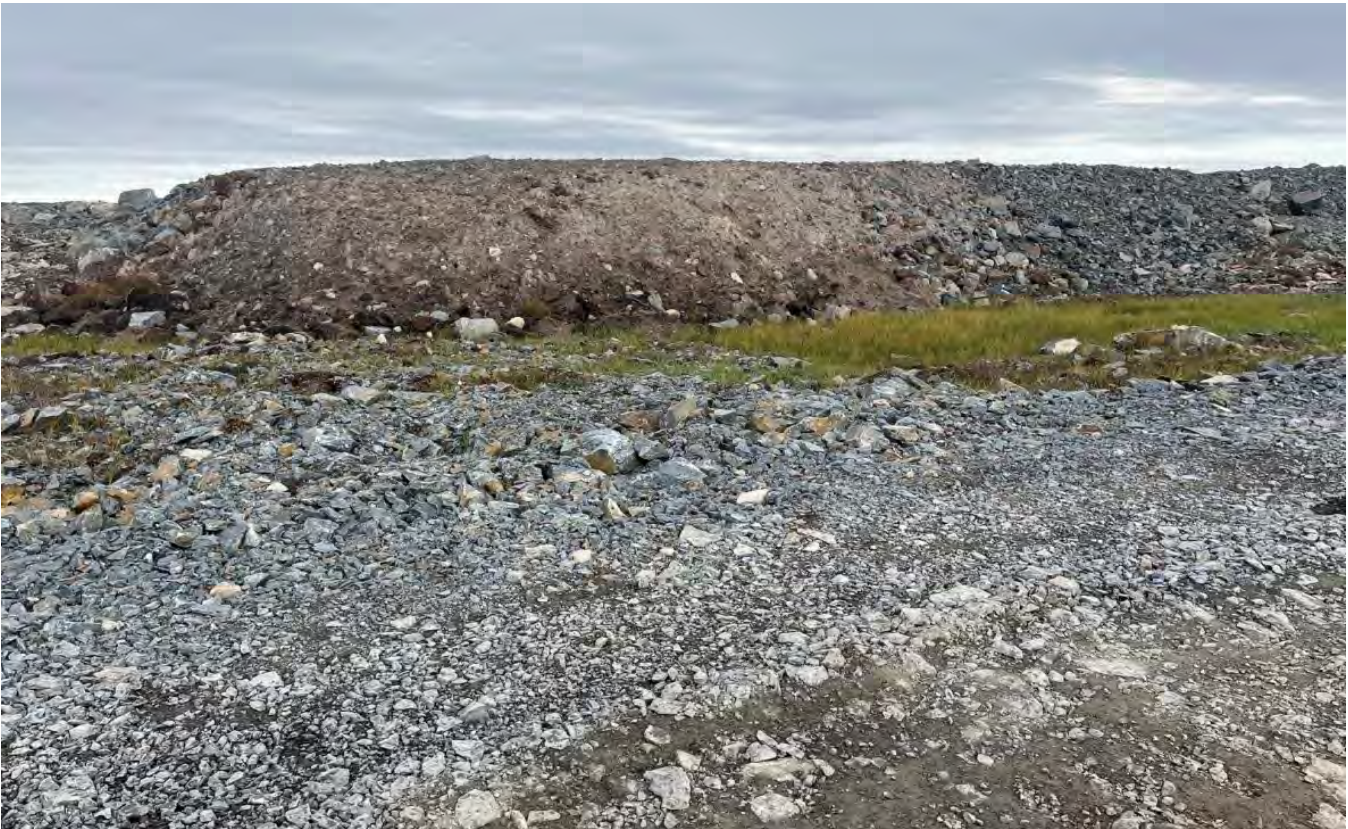
G-62. – Minimum winter cover (bulk material placed approx. at Sta 0+430)

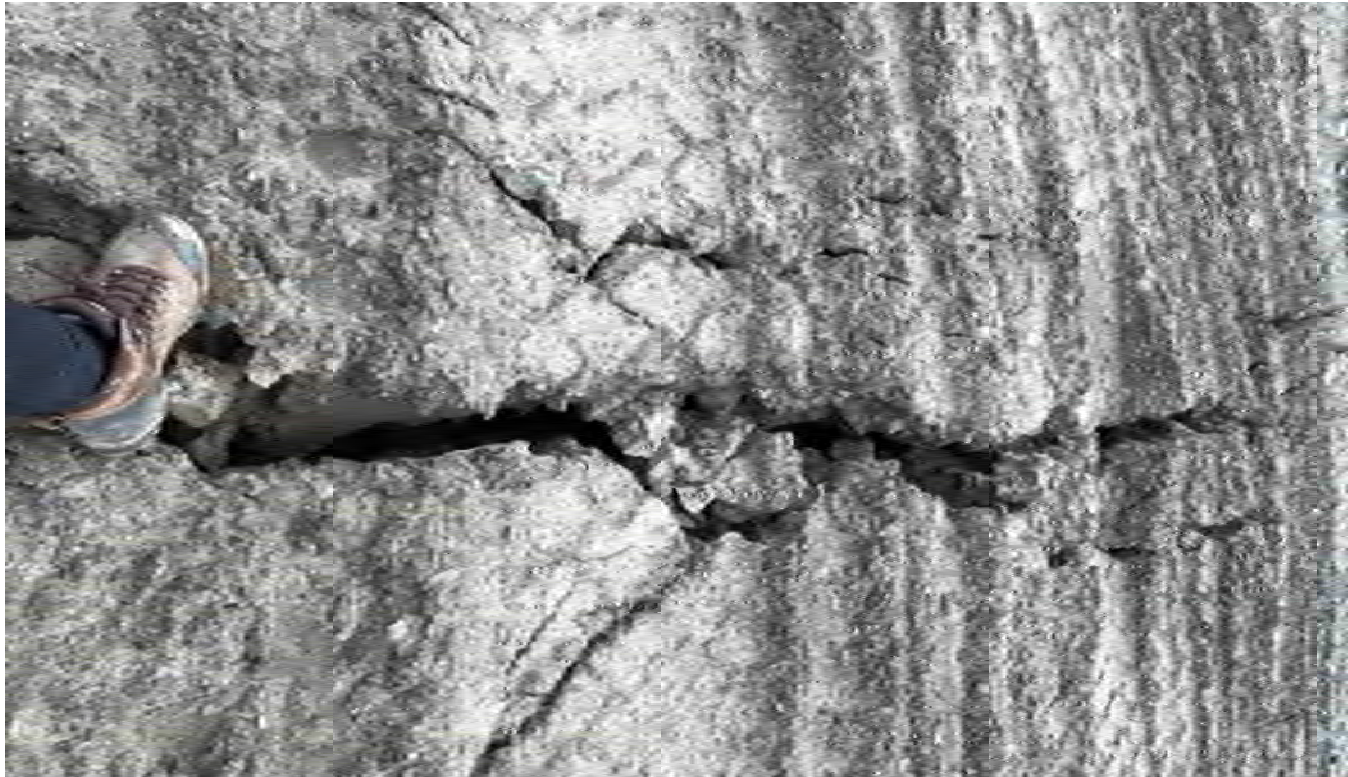
G-63. - A set of elongated cracks approx. at Sta 0+450

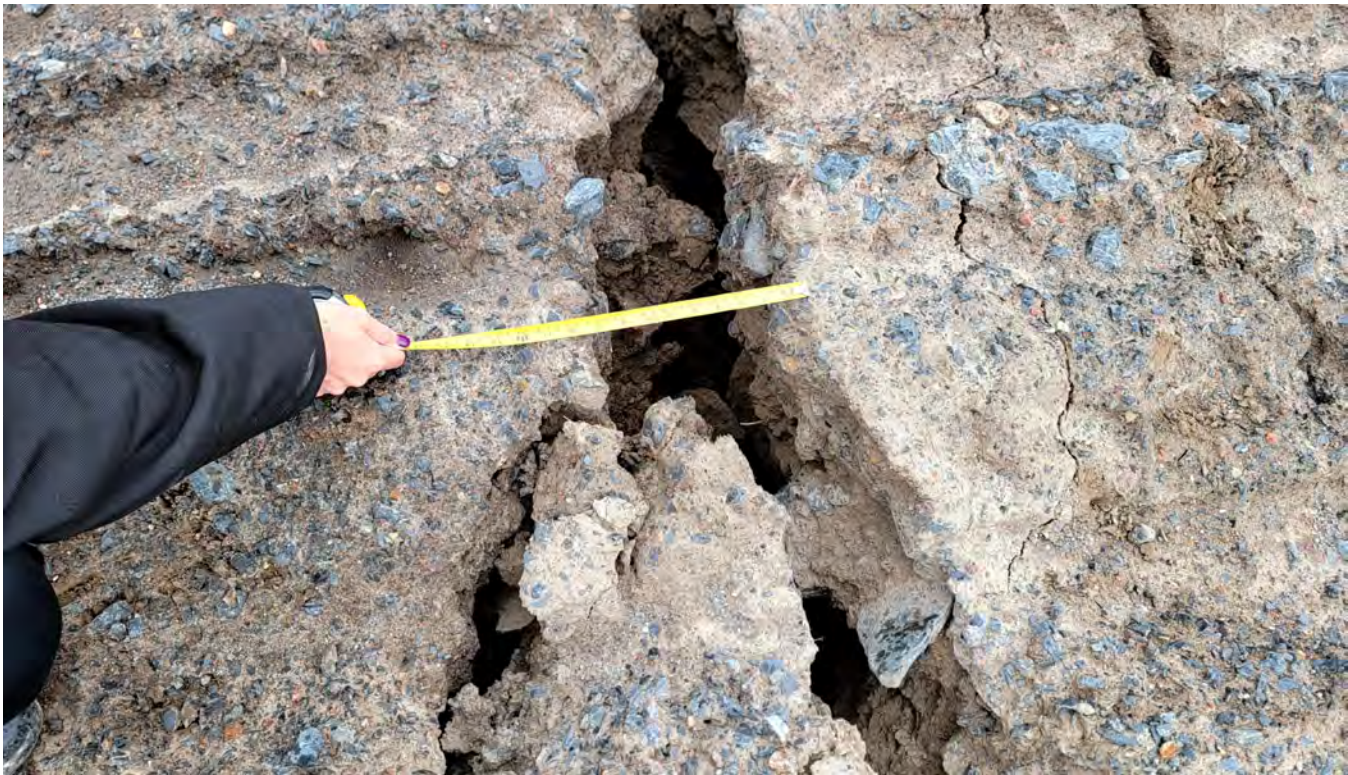
G-64. - A set of elongated cracks approx. at Sta 0+450

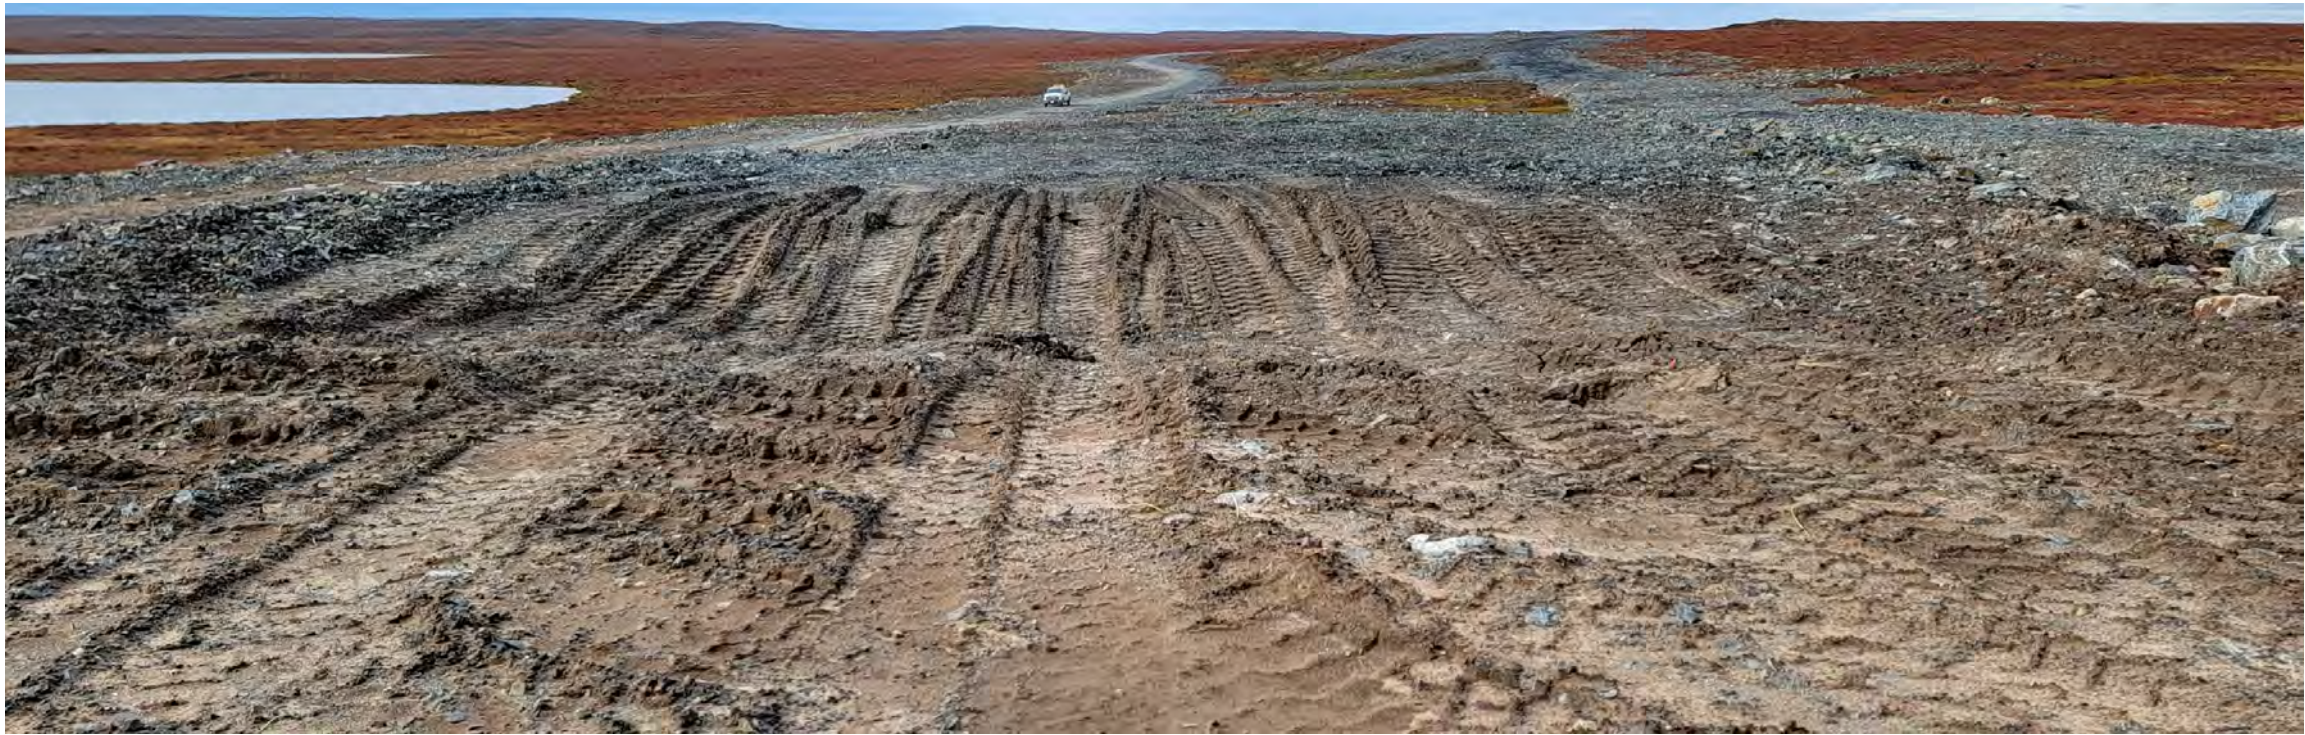
G-65. - Depression 0.5-0,7 m deep approx. at Sta 0+450.

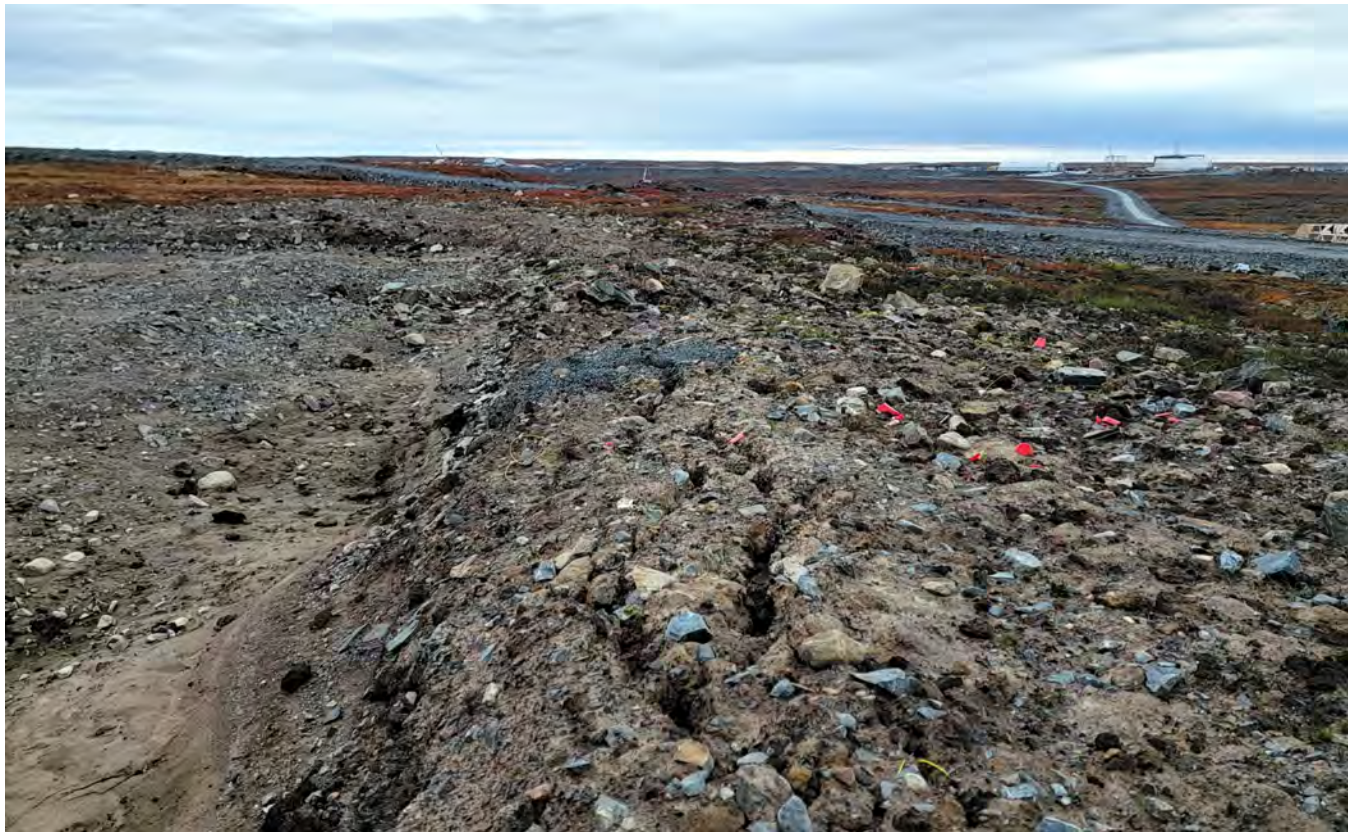
G-66. – Base and southern wall of the SE end of the spillway, looking SE

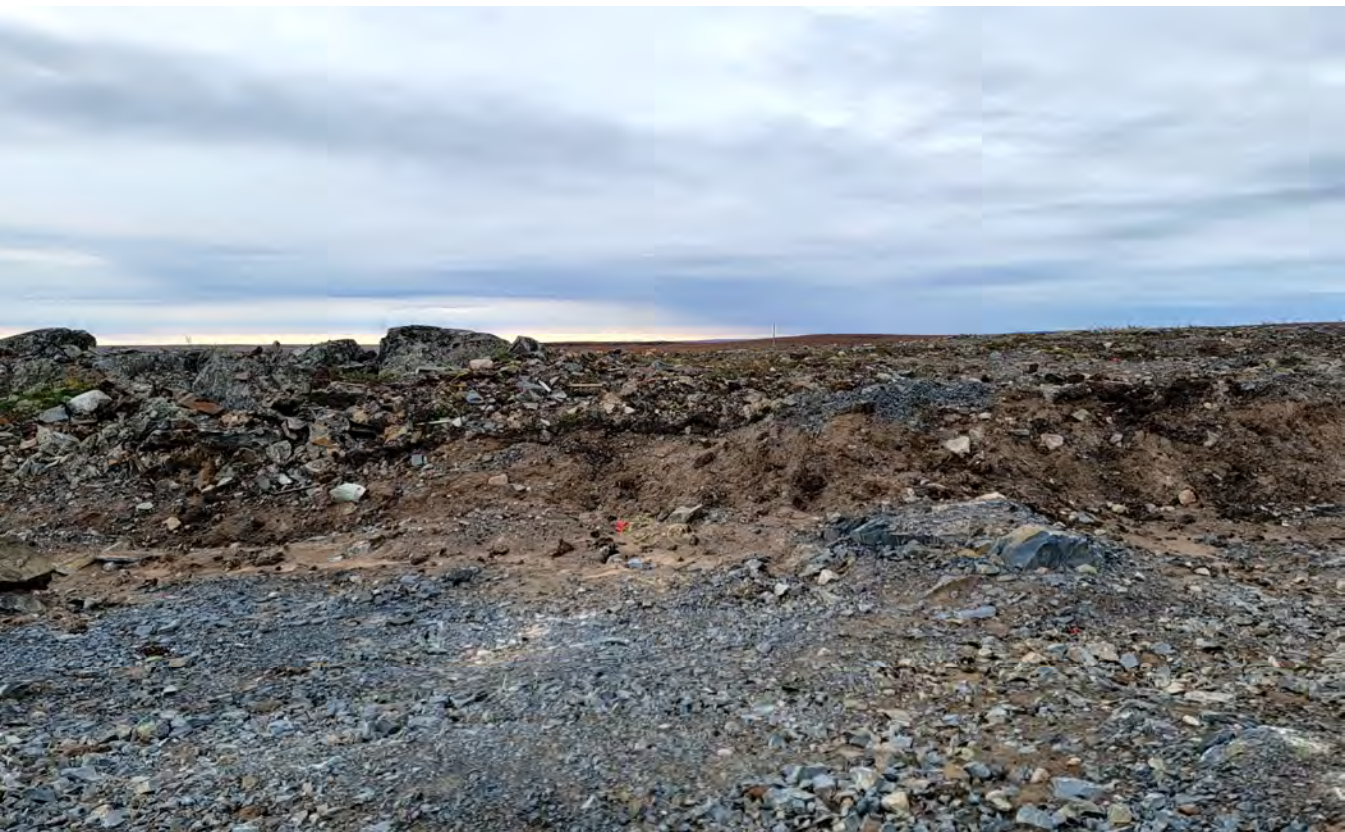
G-67. – Northern wall of the spillway

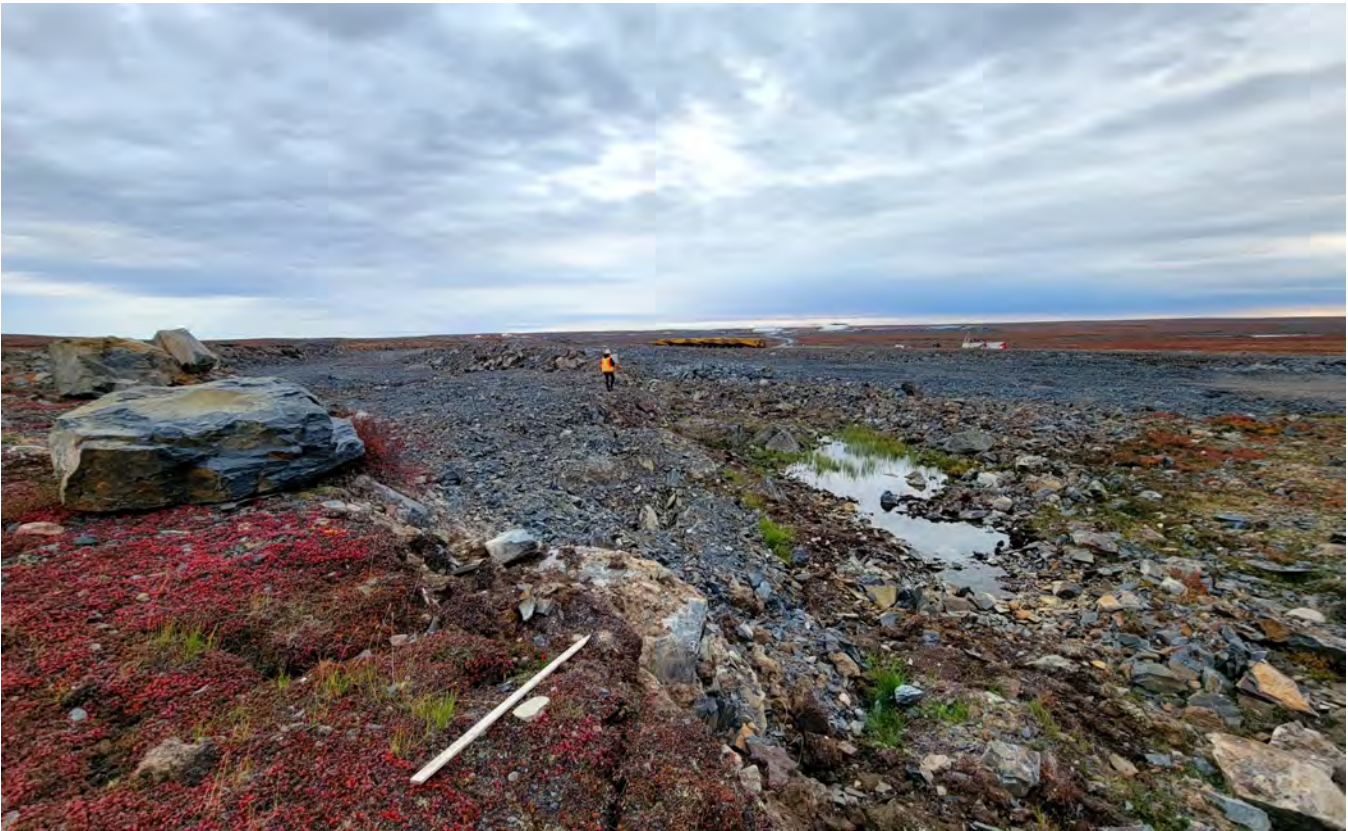
G-68. – Northern end Spillway, looking S
