## **Appendix A      Photolog from 2023 Visit – Goose**

Back River Project

2023 Annual Geotechnical Inspection

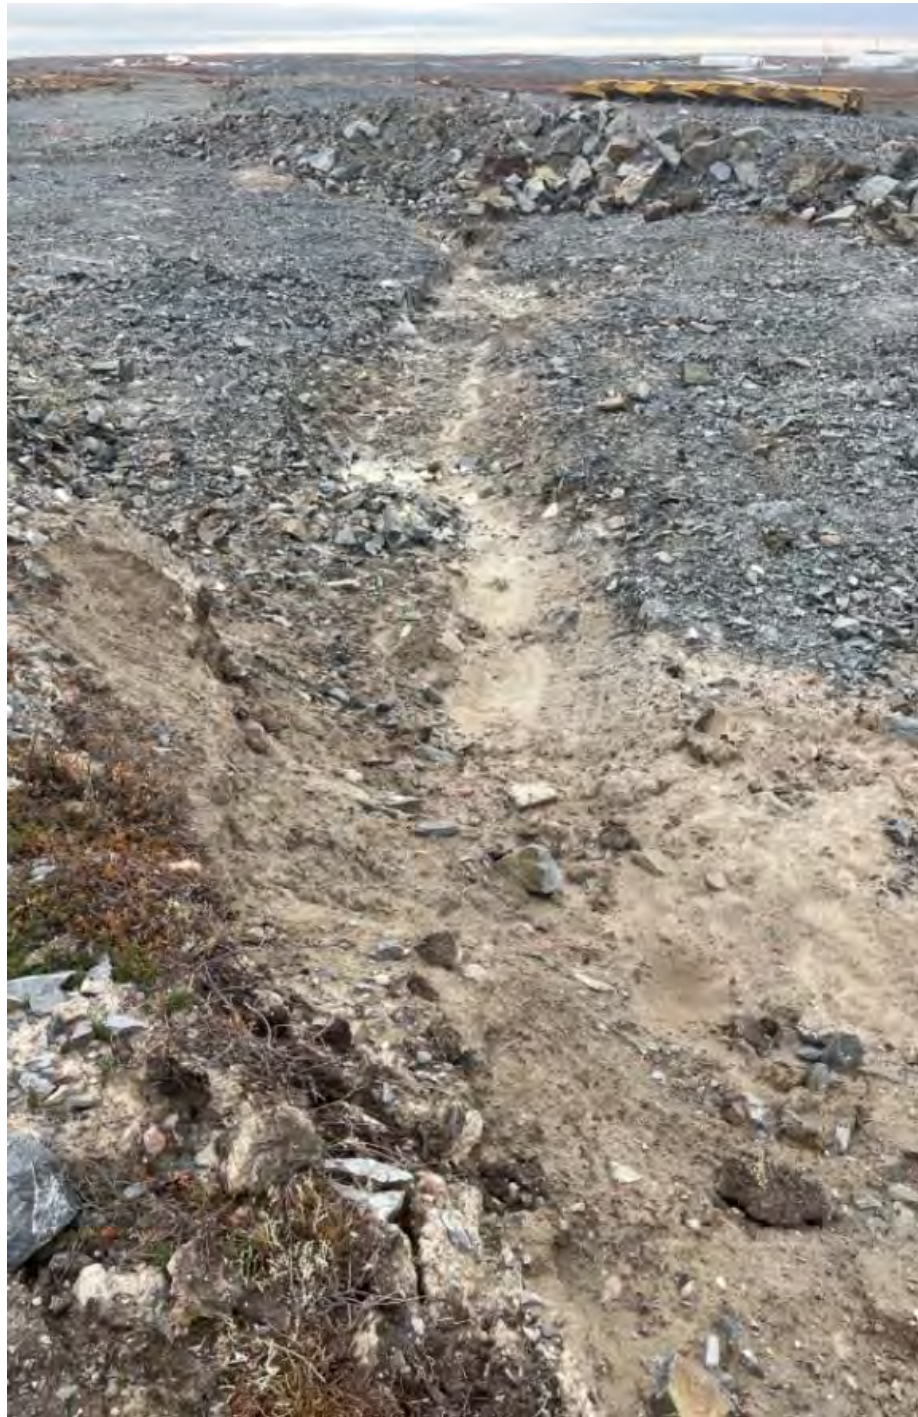
G-69. - Erosion channel at the base of the spillway close to the northern end

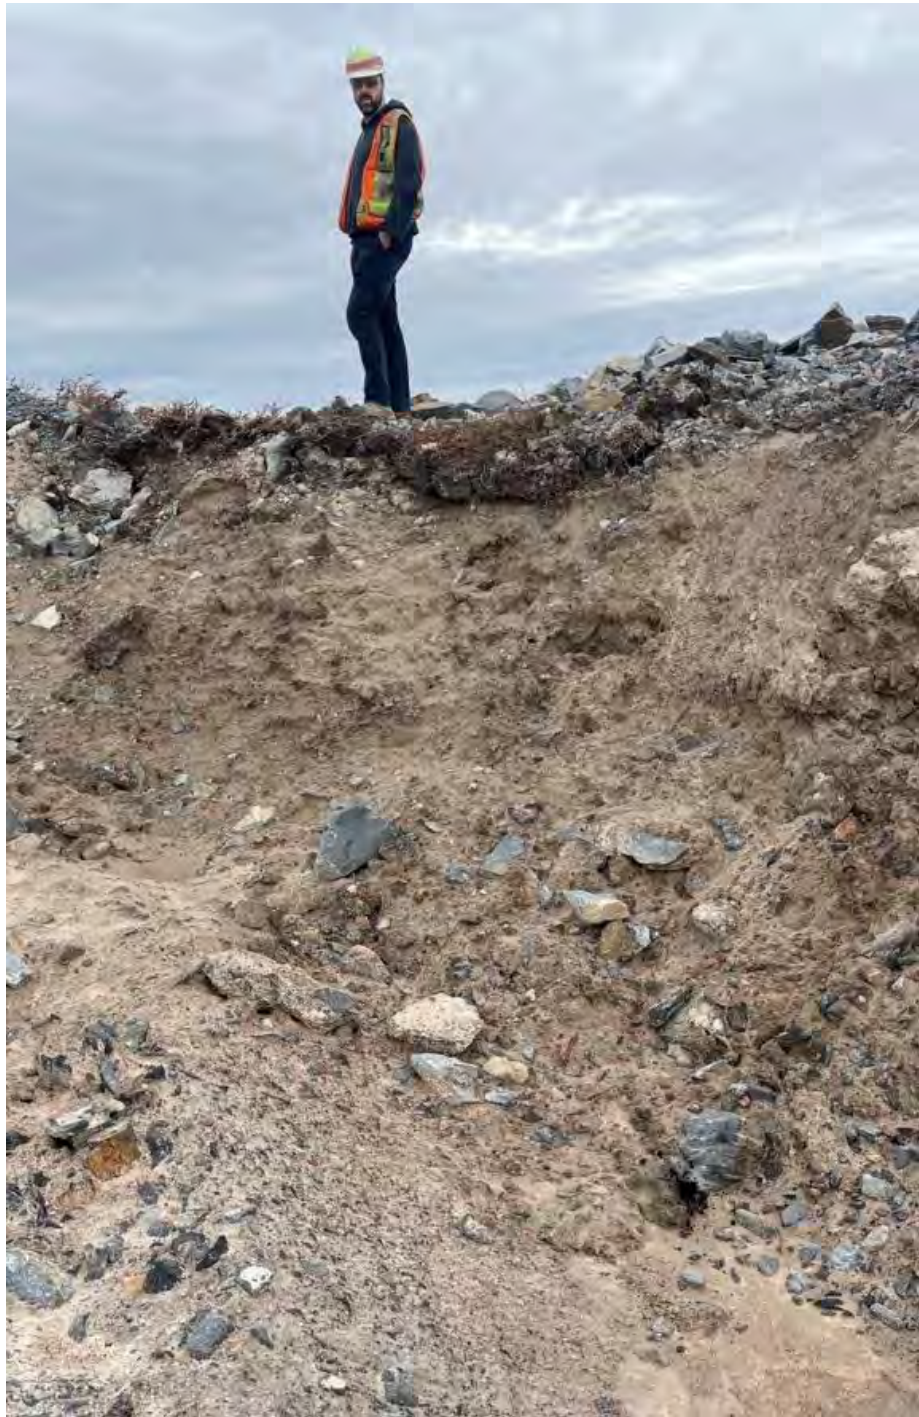
G-70. - Overburden material at the northern wall of the spillway

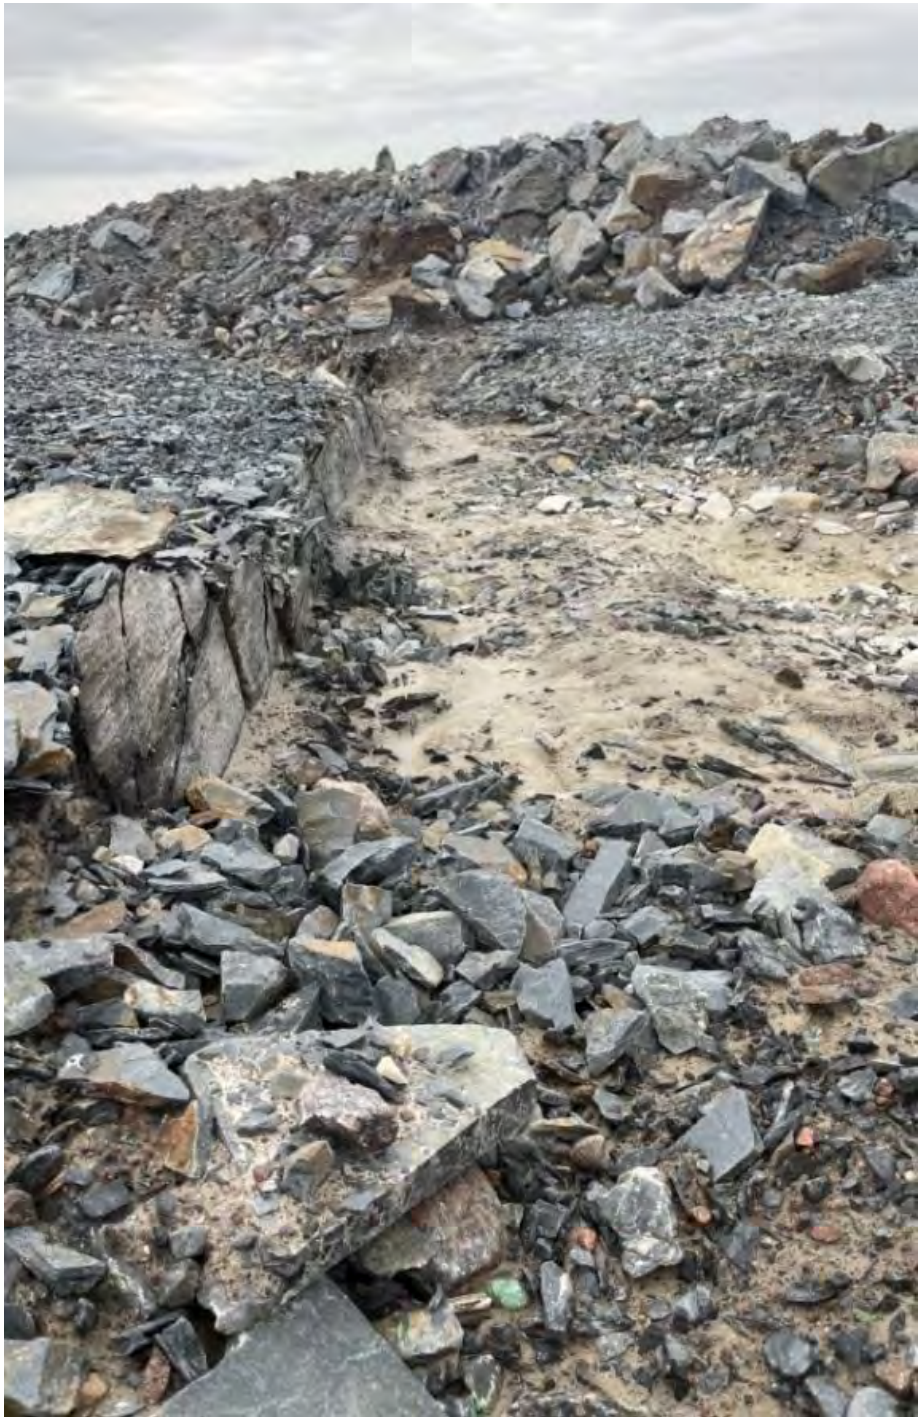
G-71. - Bedrock – overburden contact at the base of the spillway

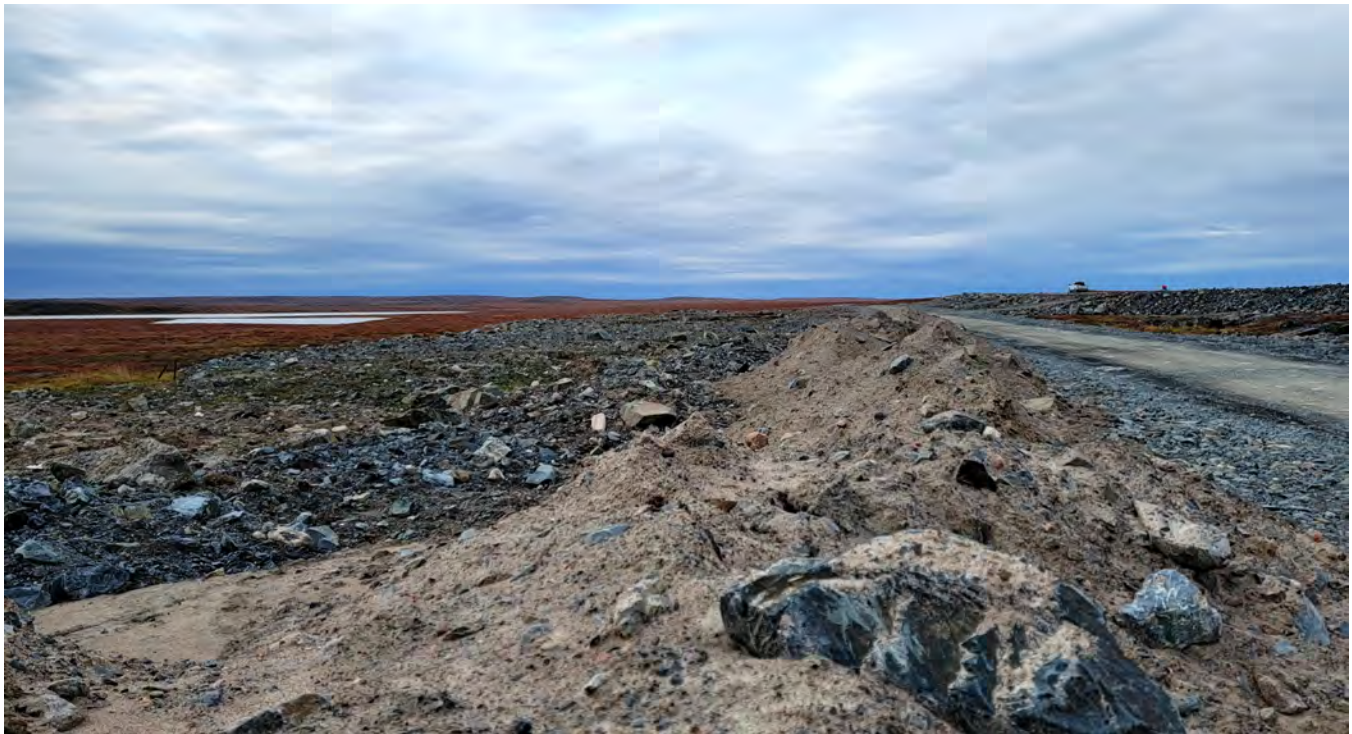
G-74. - Downstream side of the runway. Piles of the overburden material

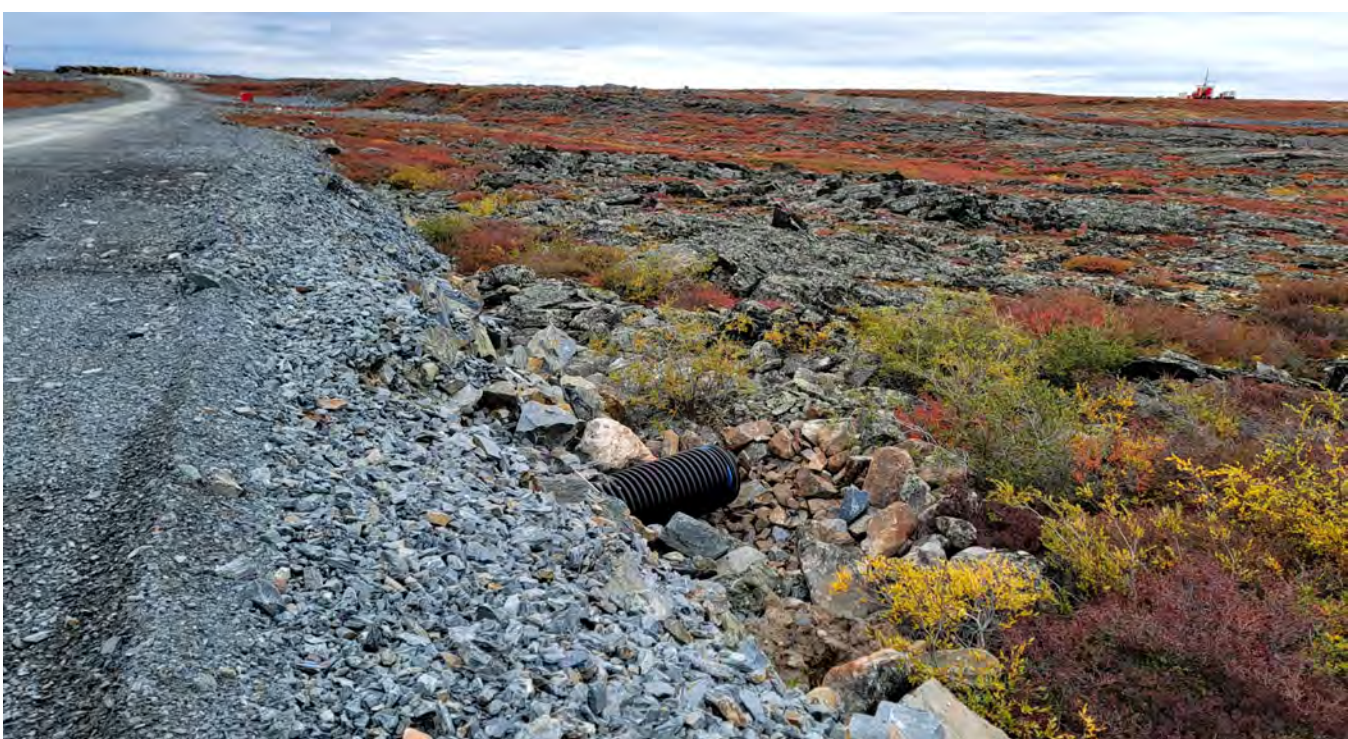
G-77. – Culver. Outlet

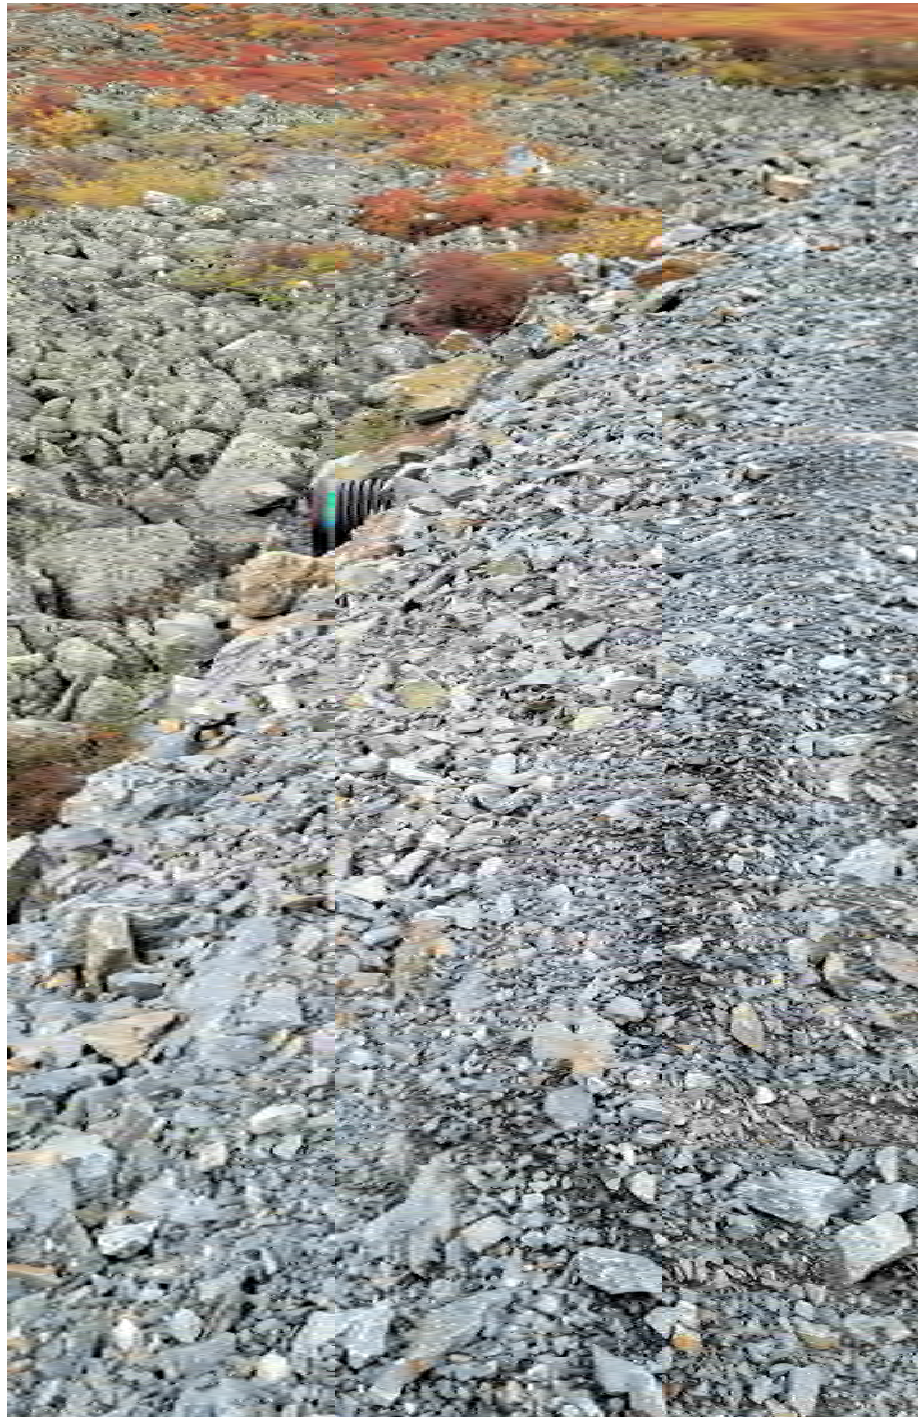
G-80. - Culvert. Inlet

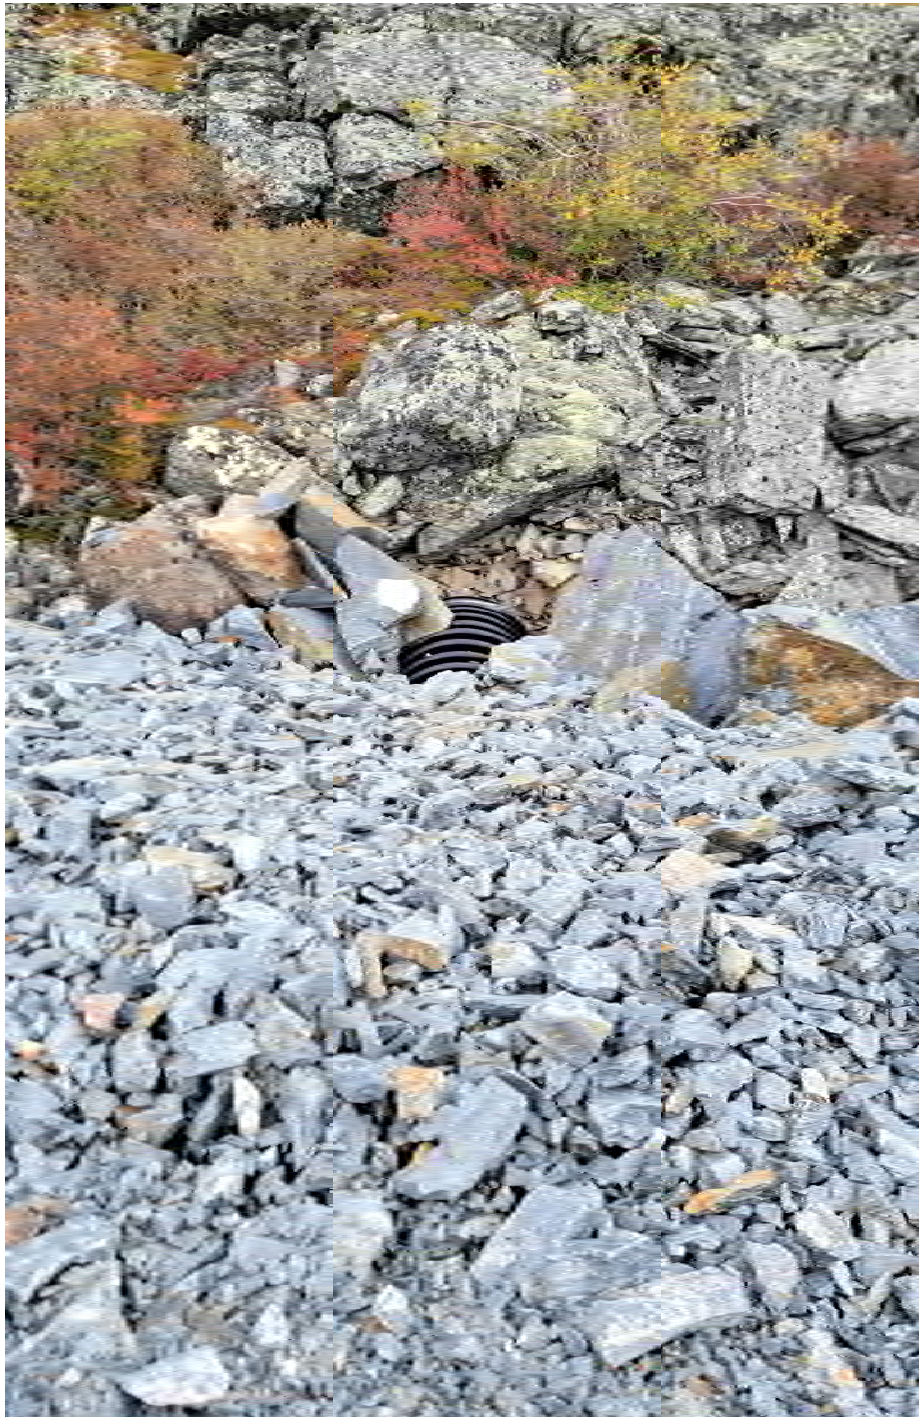
G-81. - The outlet is covered with large boulders.

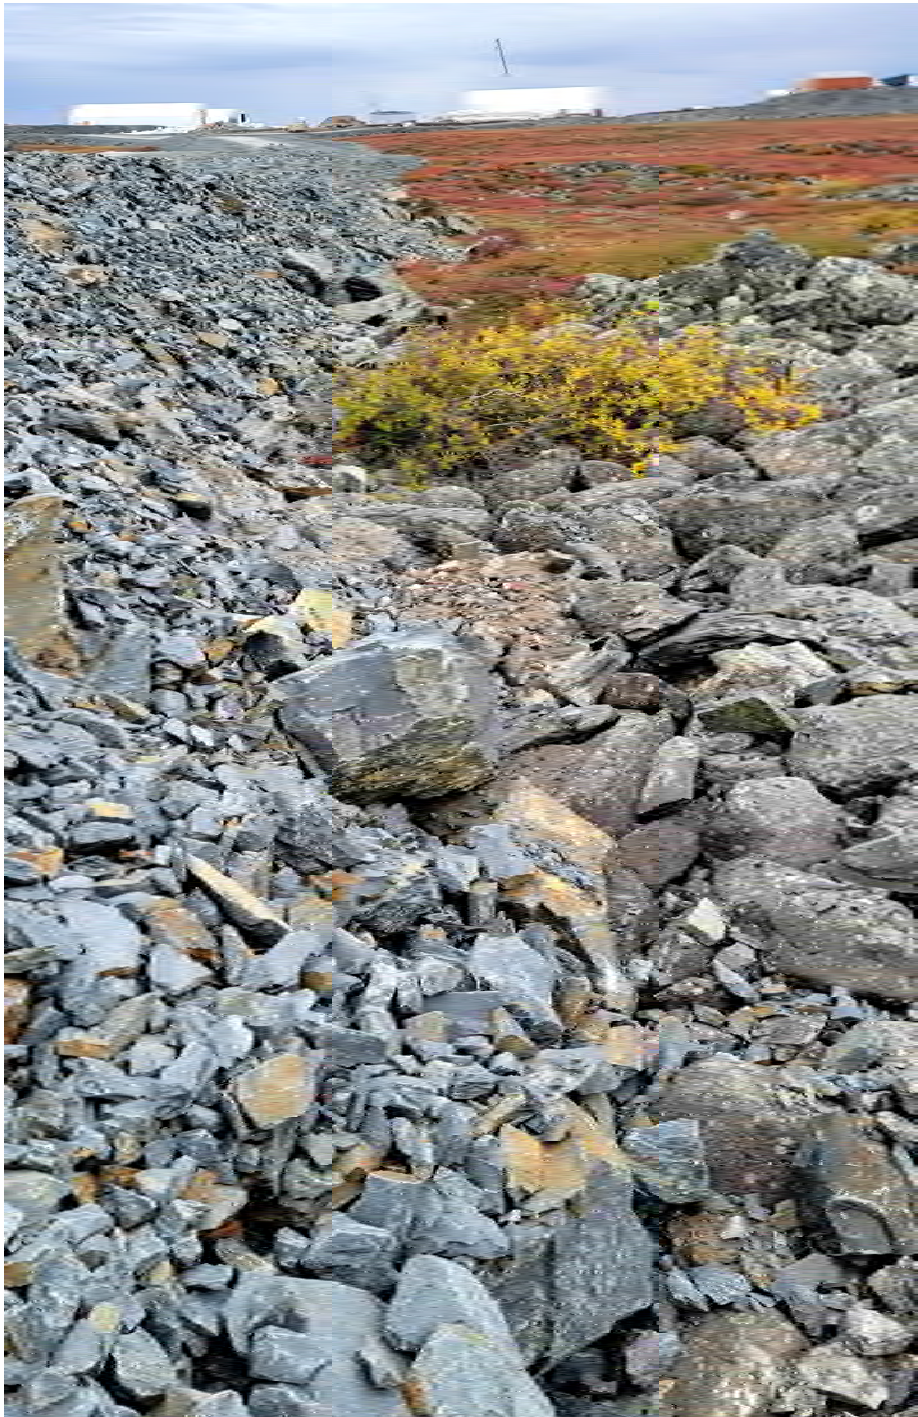
Photo G-82. - Example of the fill material used for the all-weather road construction. Some boulders greater than 0.8m in diameter are found at the toe of the embankment. Note the thickness and slope angle of the embankment. The photo was taken looking south.

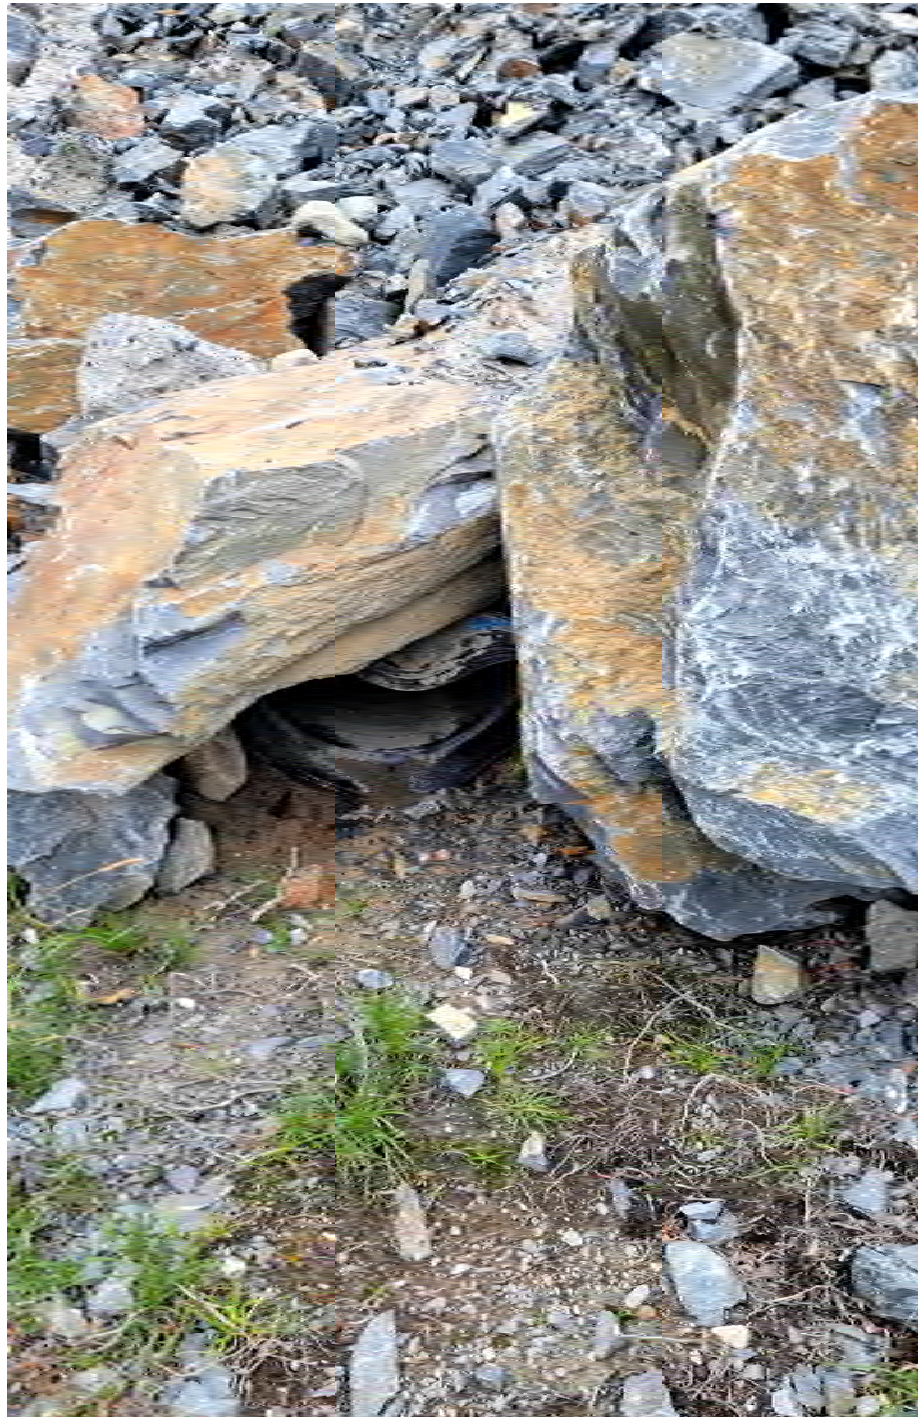
Photo G-83. – Damaged culvert

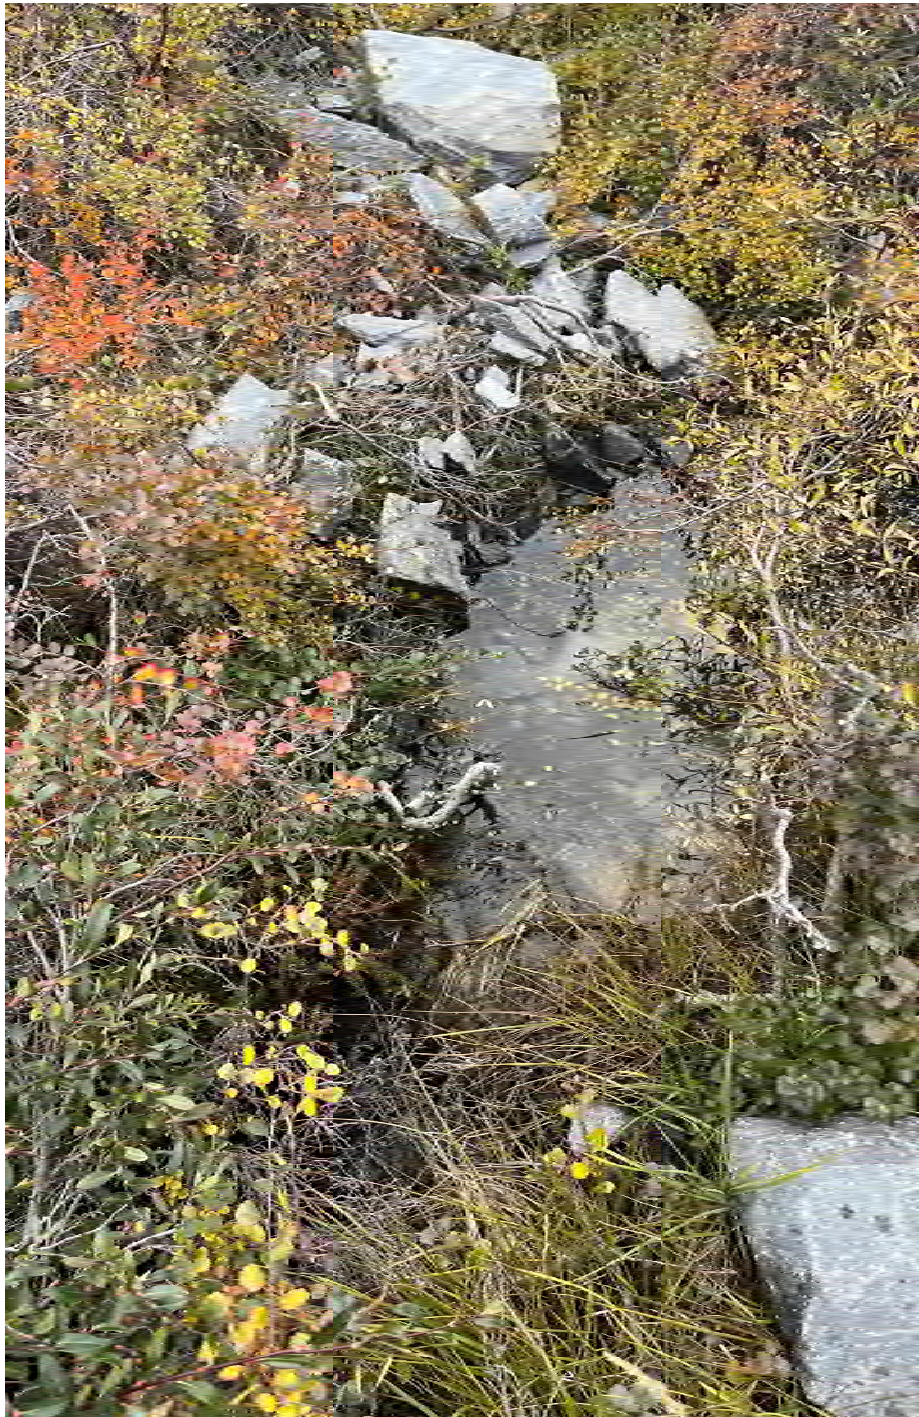
Photo G-84. – A creek at the western side of the road.

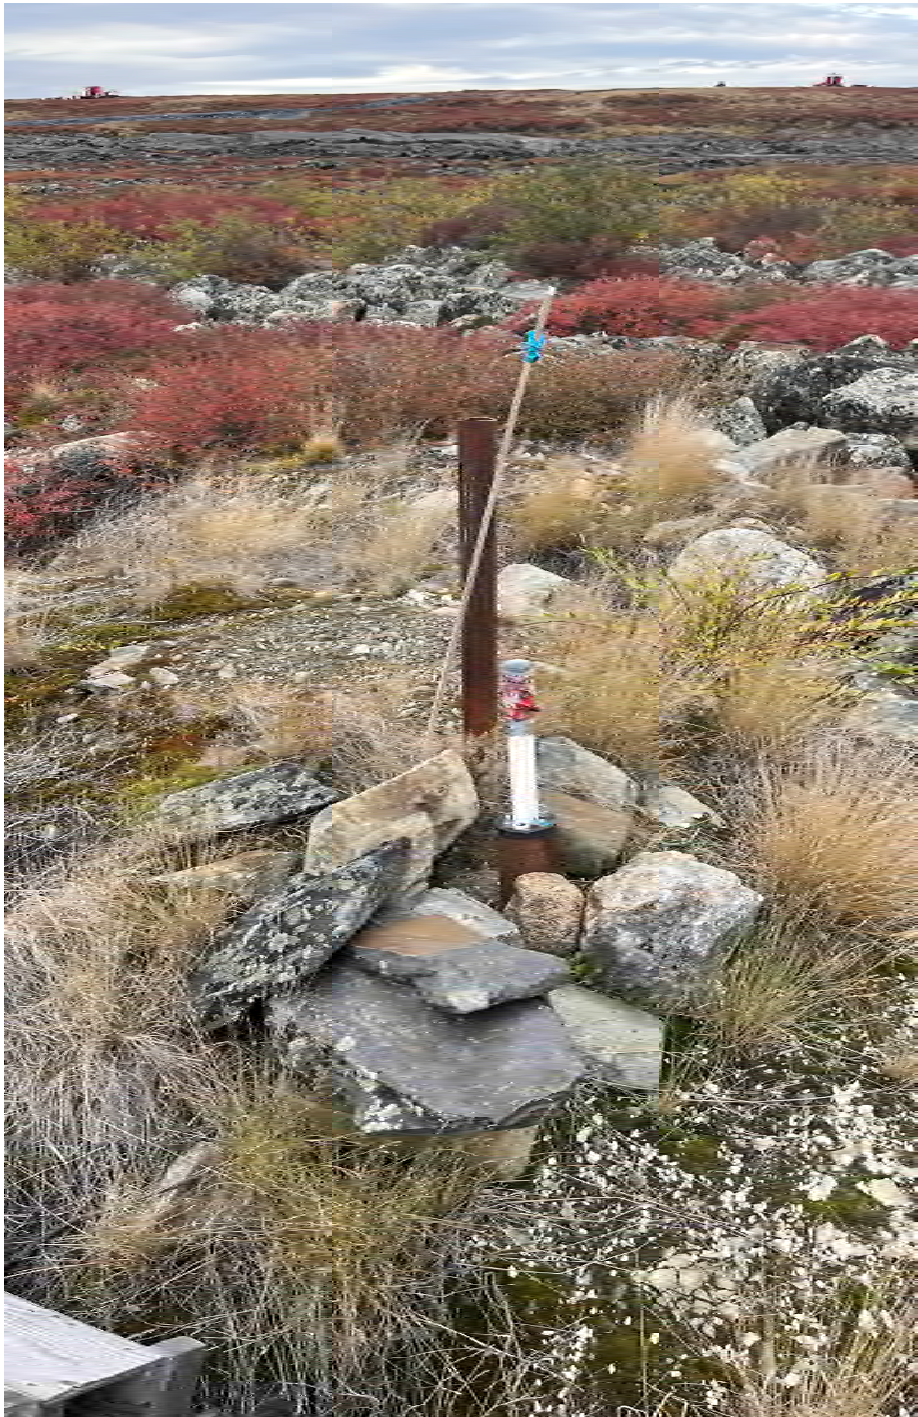
G-85. – An old borehole was found on the eastern side of the road

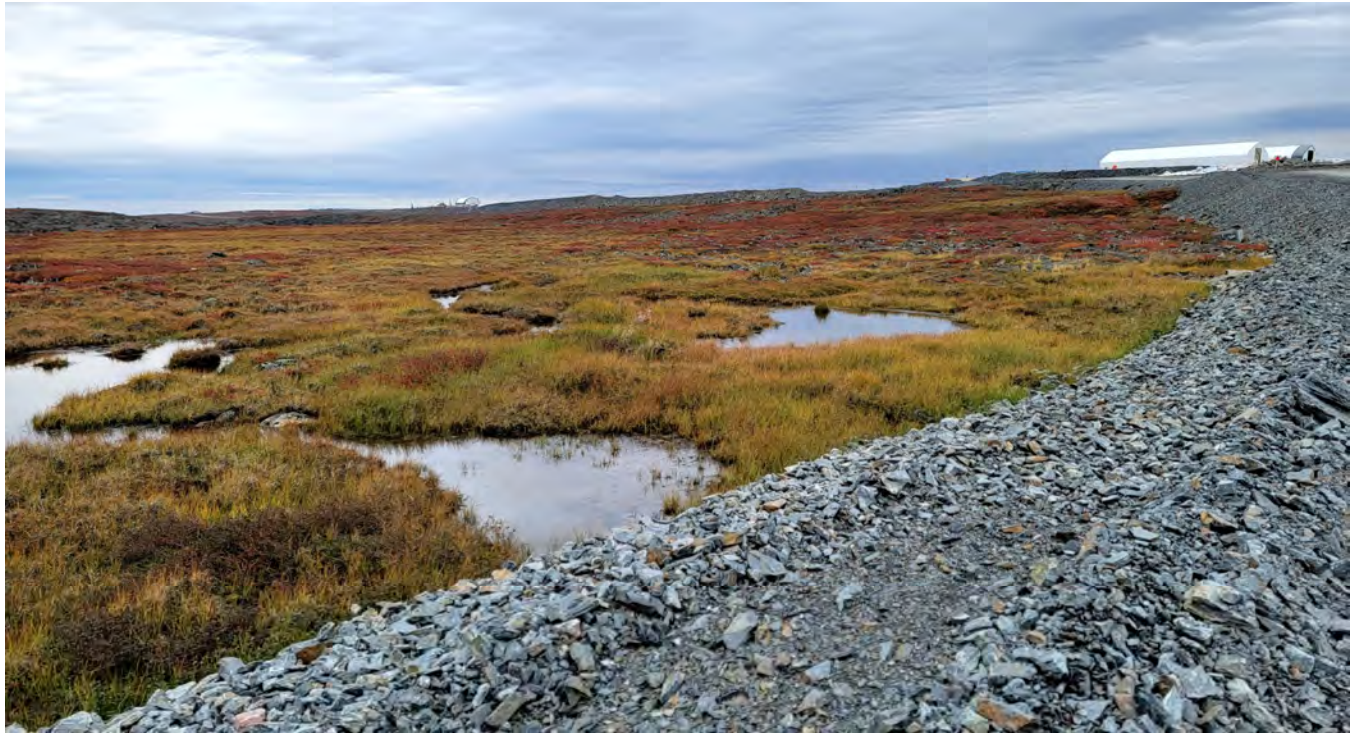
G-86. – Ponding waters at the eastern side of the road

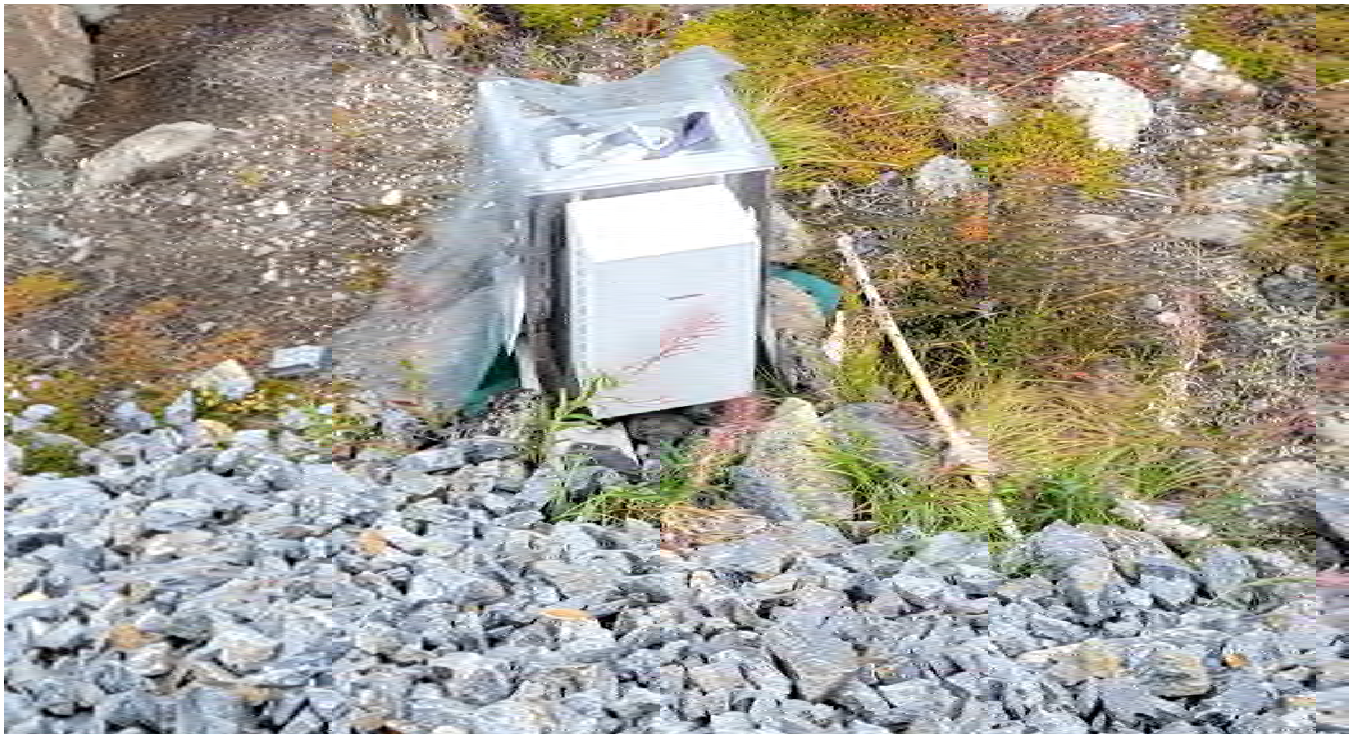
G-88. – Ground temperature monitoring station at the western toe of the Neck Crossing road

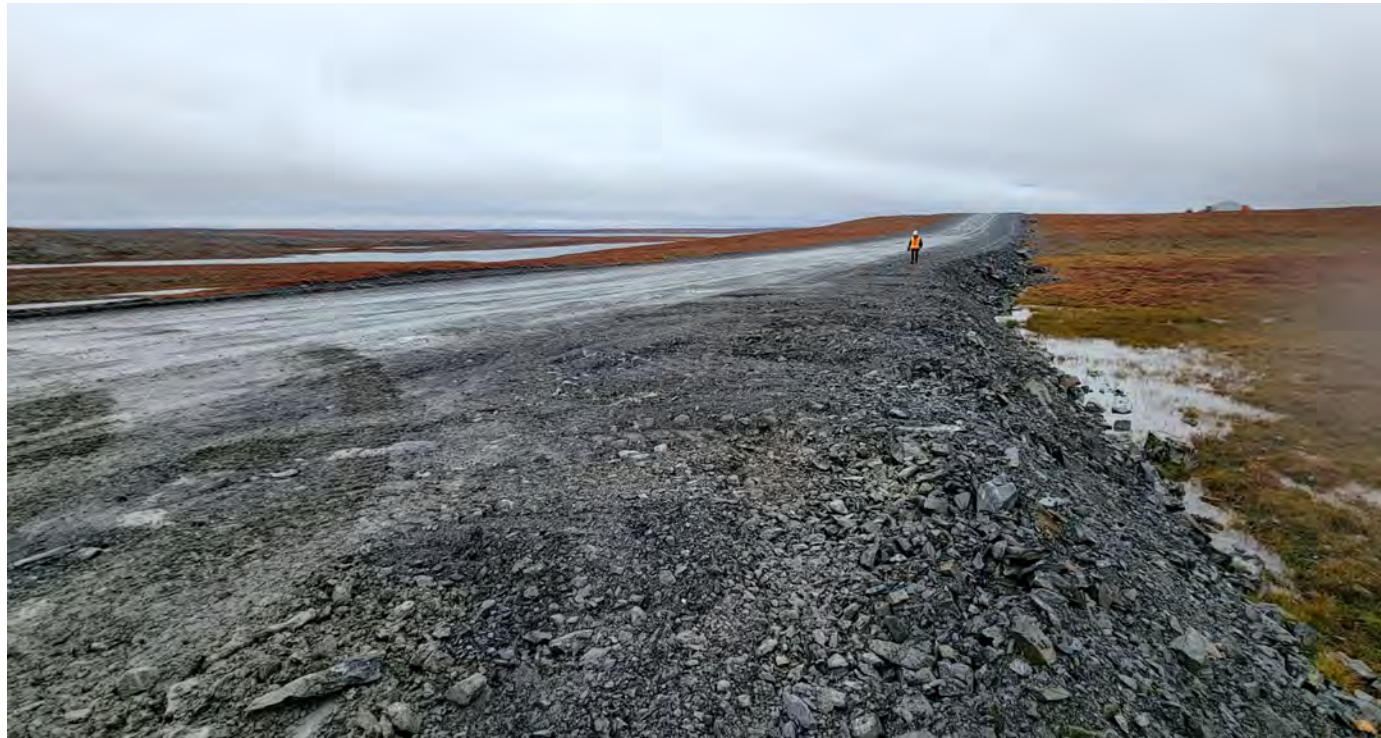
G-92. – Outlet location. An outlet was buried under the engineering fill. Note the thickness of the fill material

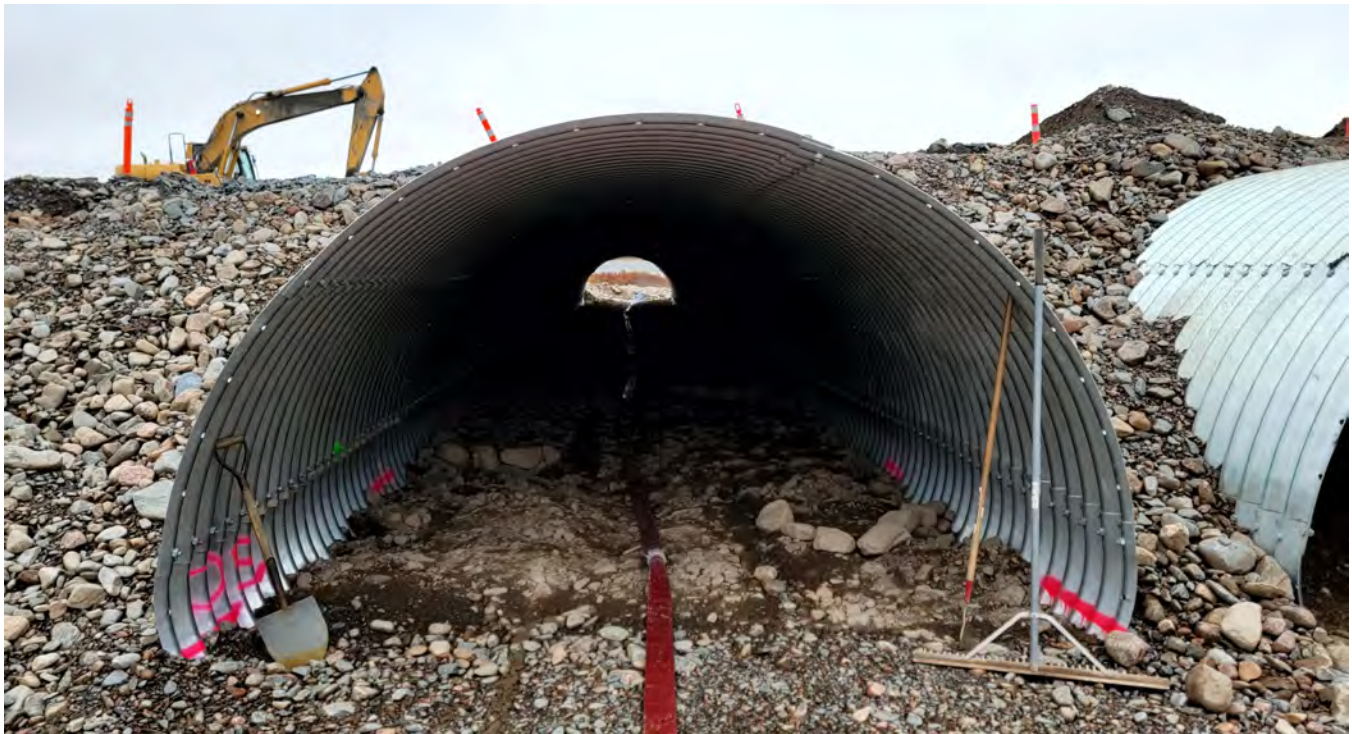
G-95. Base of the culver #1

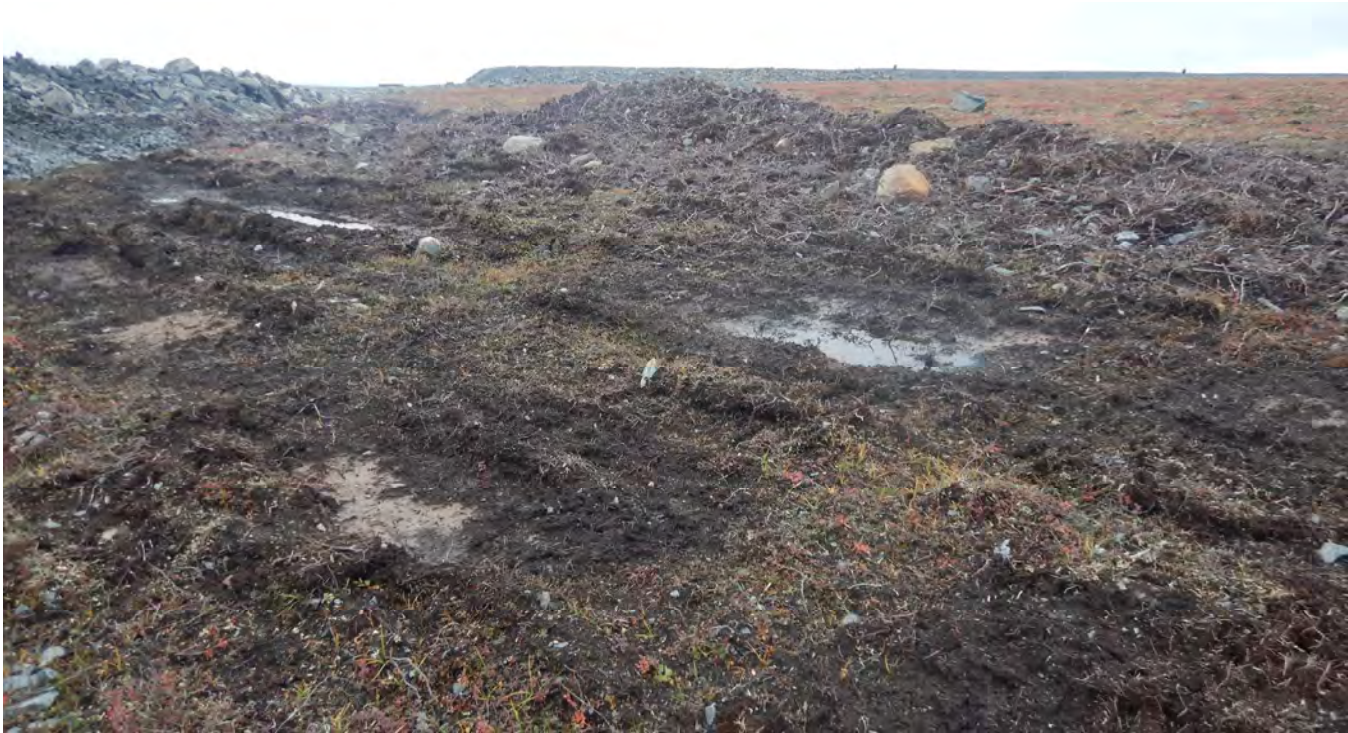
G-98. - Damaged tundra around the construction site looking east towards the airstrip

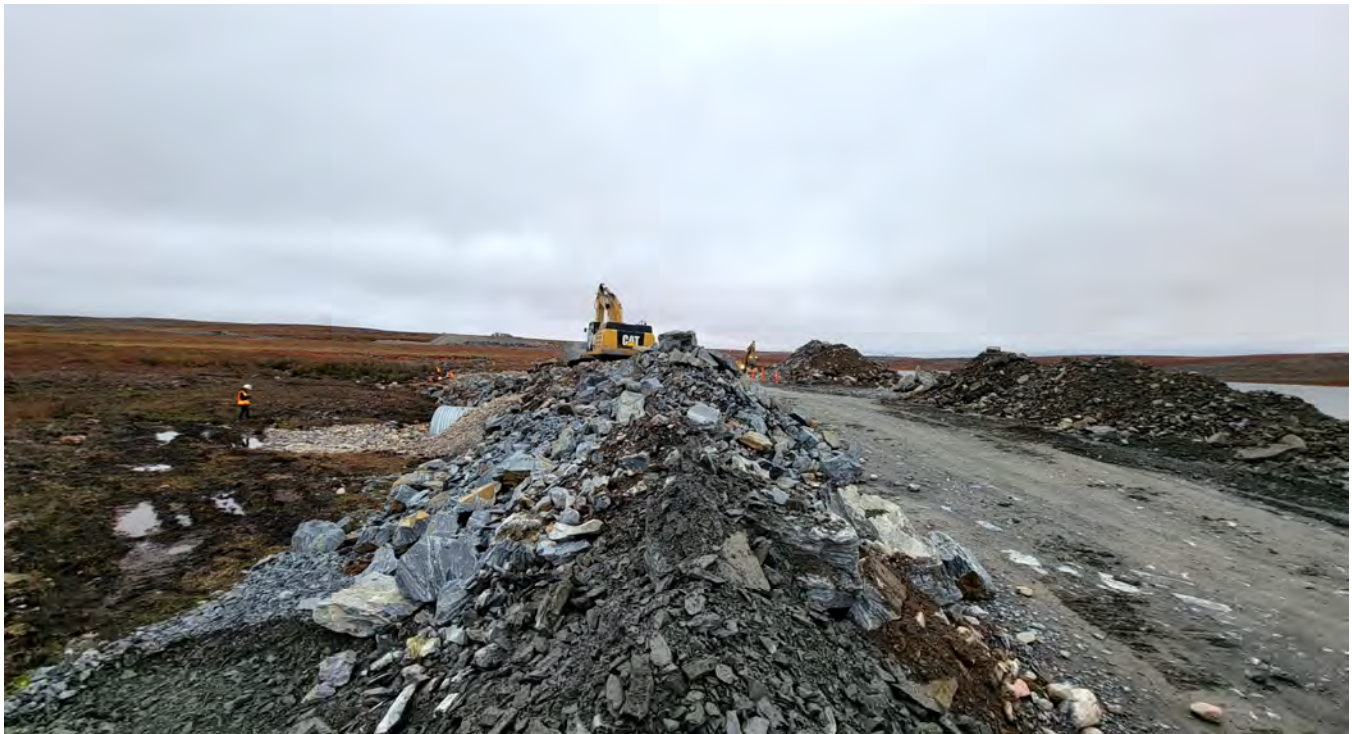
G-99. - Overculvert fill material.

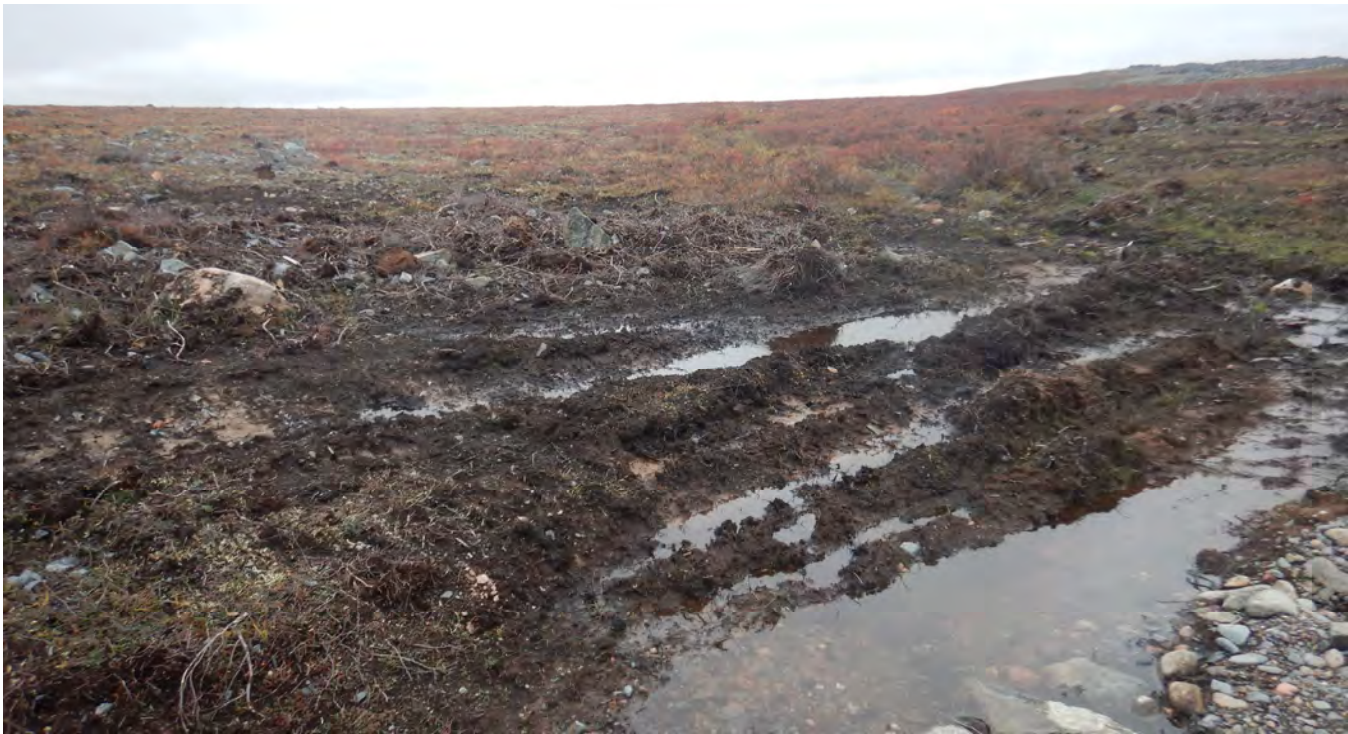
G-100. - Damaged tundra around the construction site looking southeast
