Goose & MLA Project Sites – 2024 Annual Geotechnical Inspection

Back River Project, Nunavut, Canada
B2Gold Corp.

SRK Consulting (Canada) Inc. ■ CAPR003105 ■ April 2025

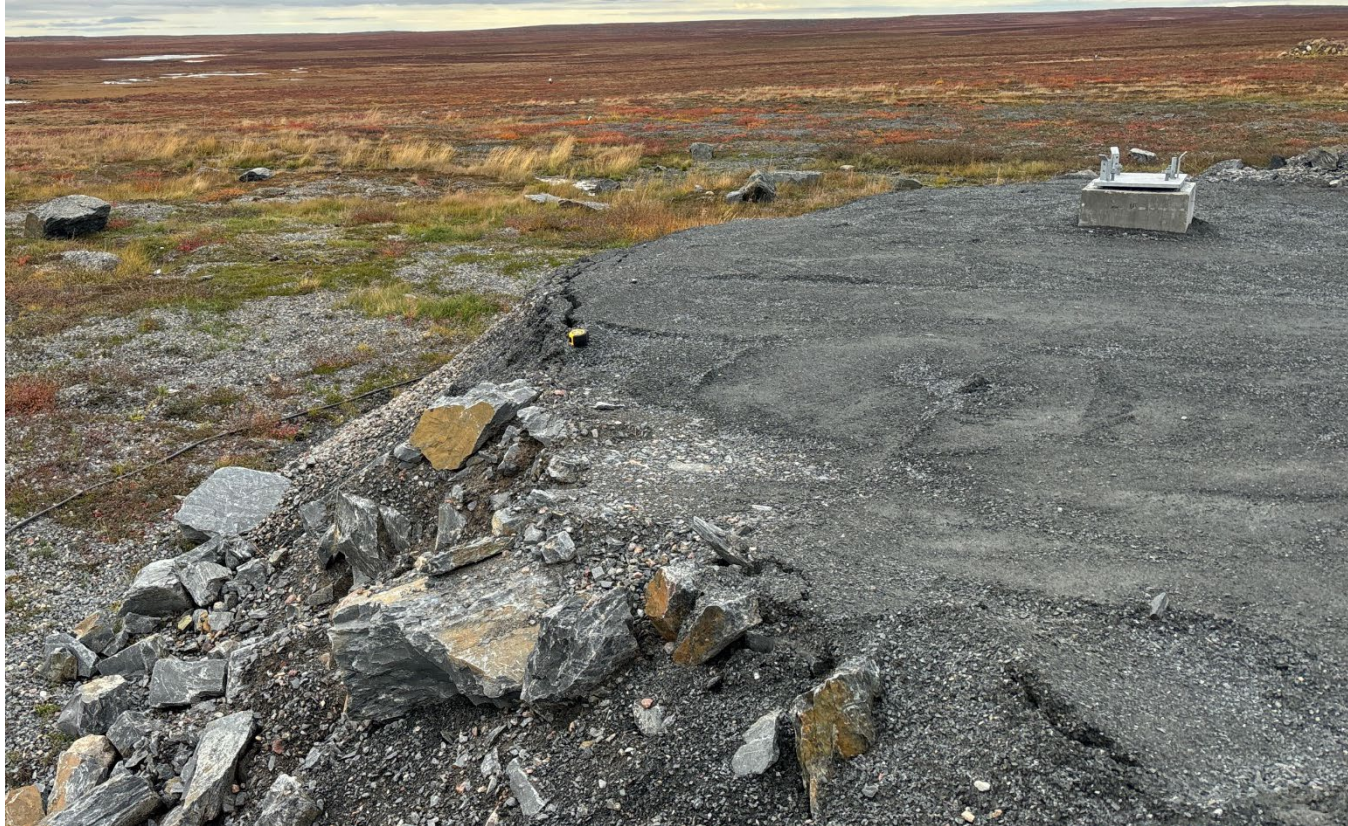
G-49: Eastern side apron, facing NW – Note tension cracking

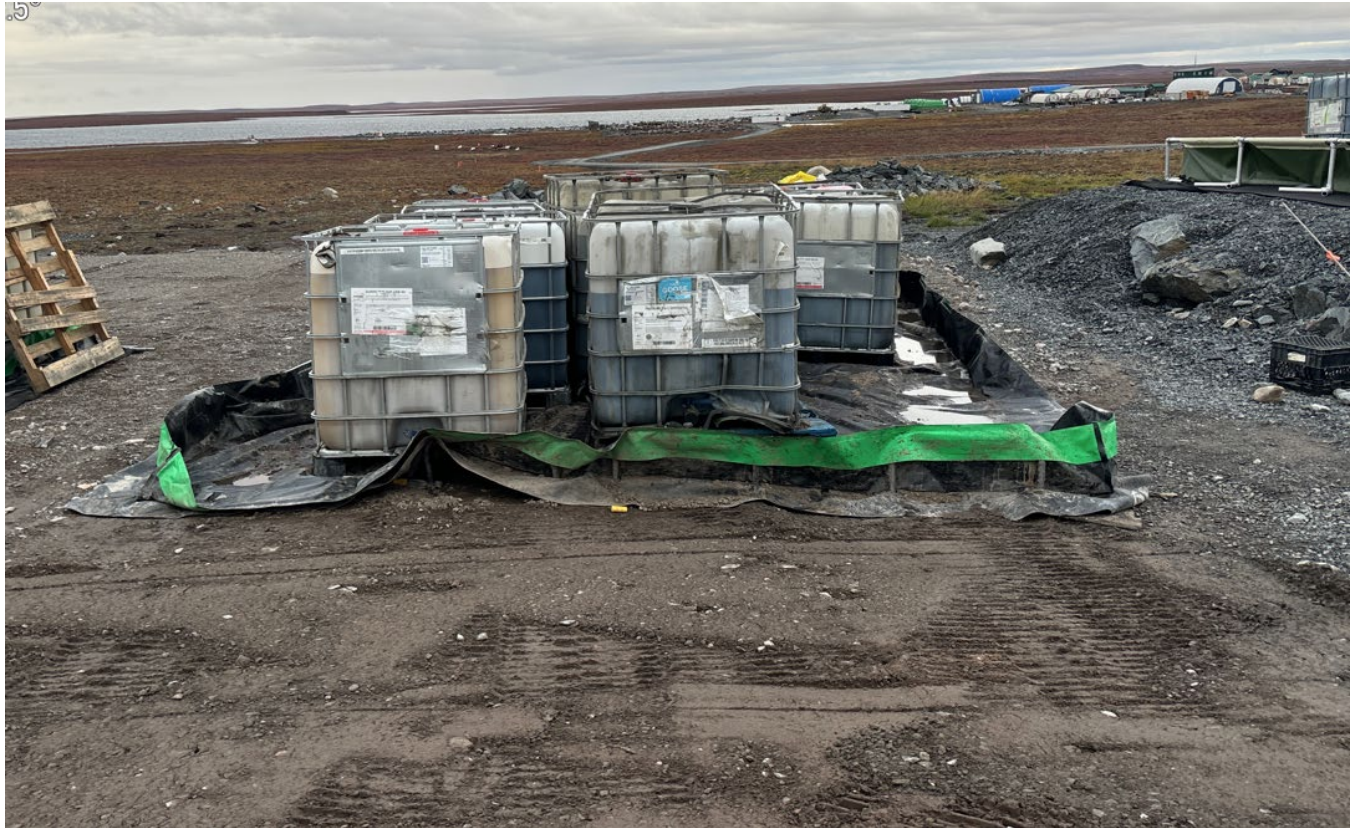
G-56: Containment berm is damaged

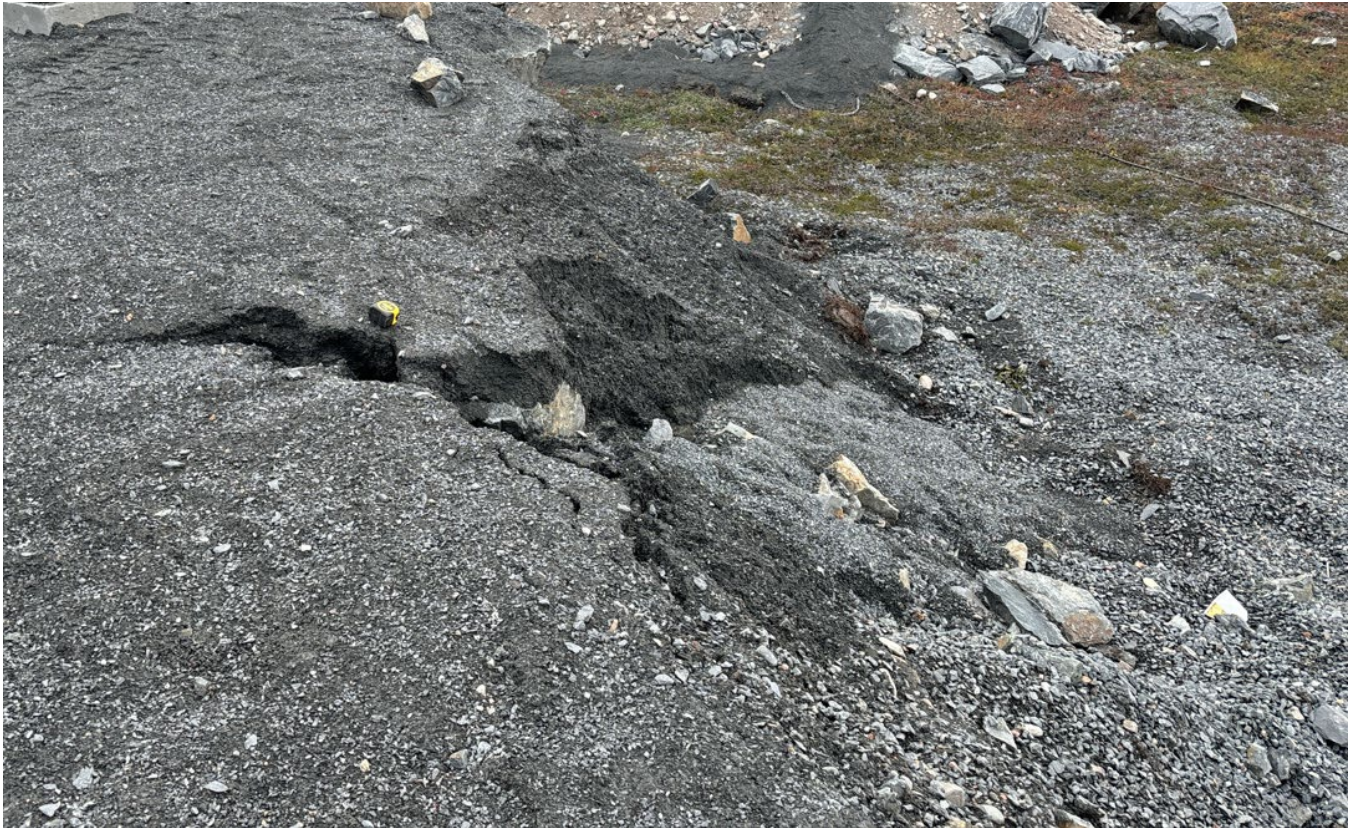
G-57: Laydown area erosion gullies

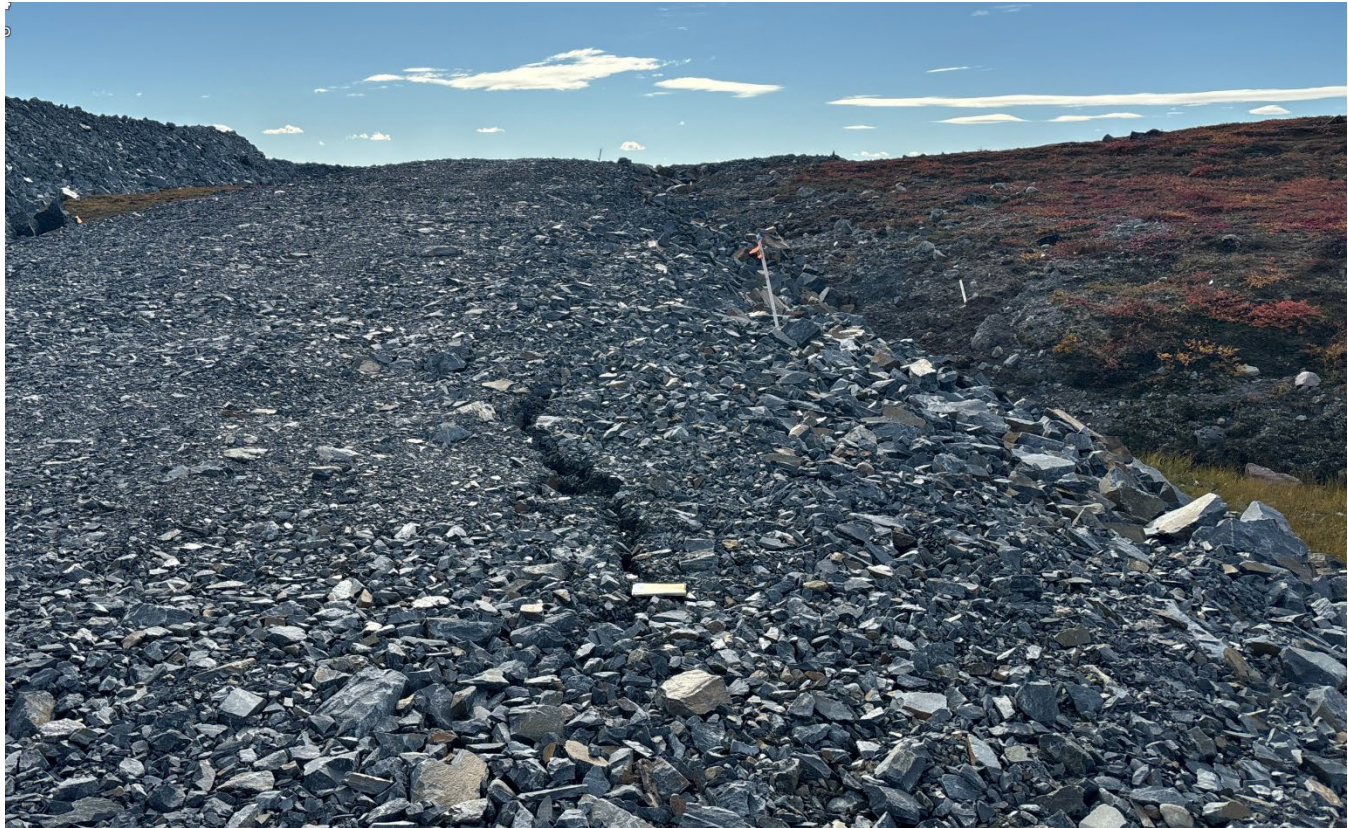
G-75: Diversion, facing SW – Note tension cracks

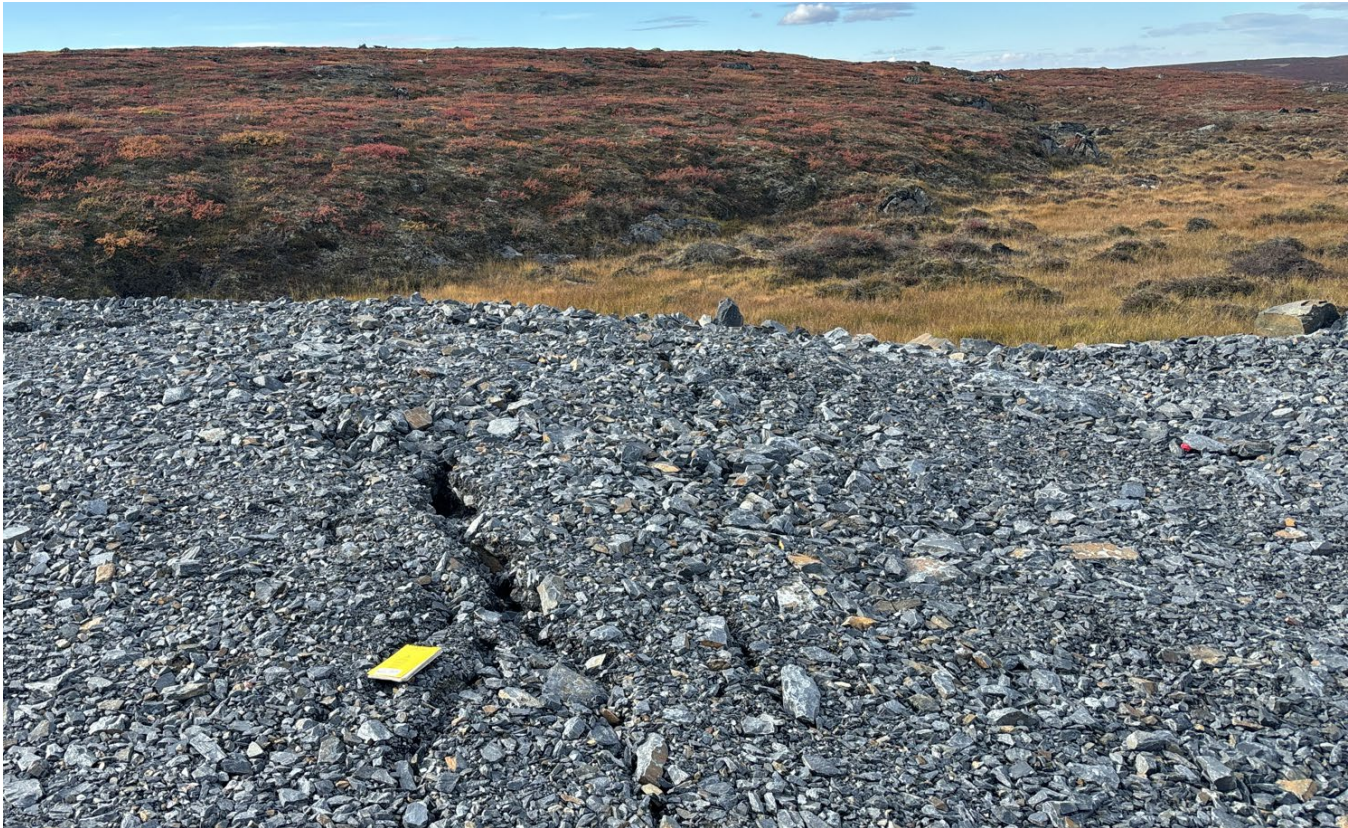
G-76: Diversion, facing north – Note tension crack

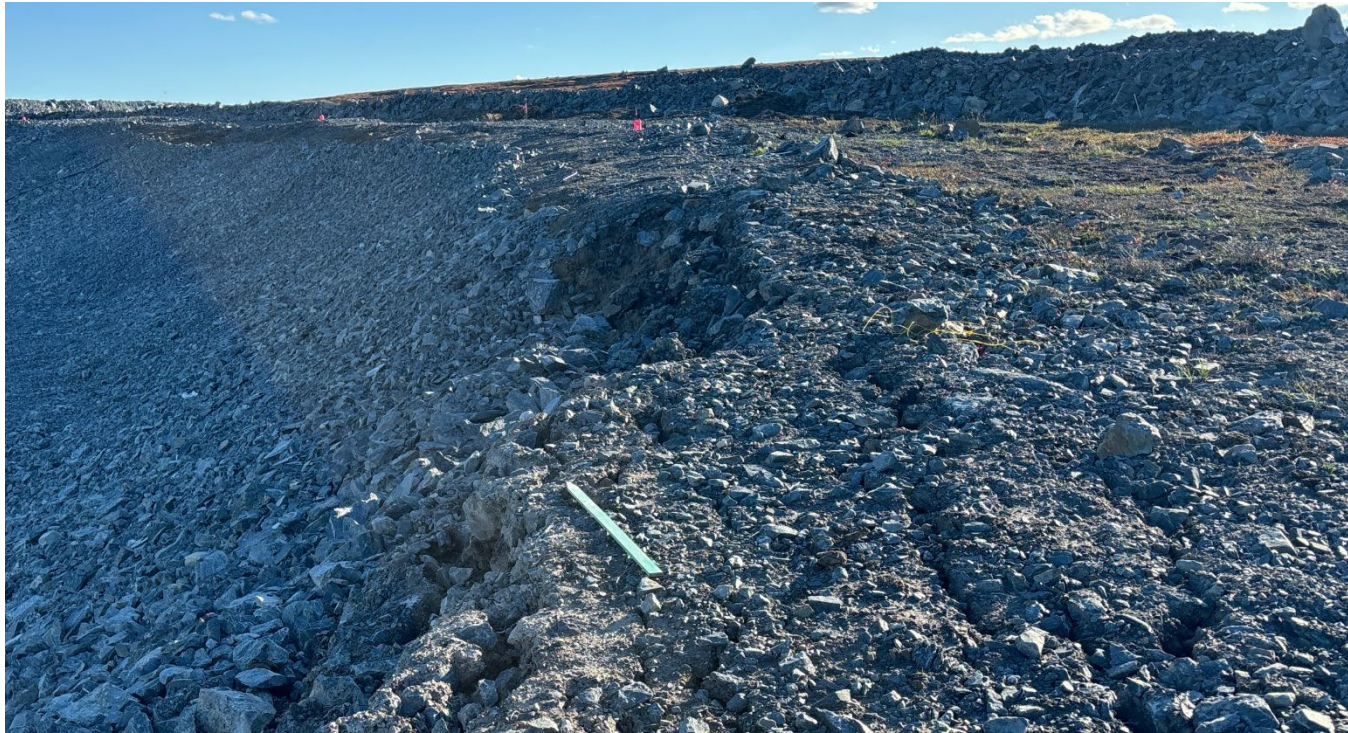
G-85: Crest of western wall, facing south – Note tension cracks

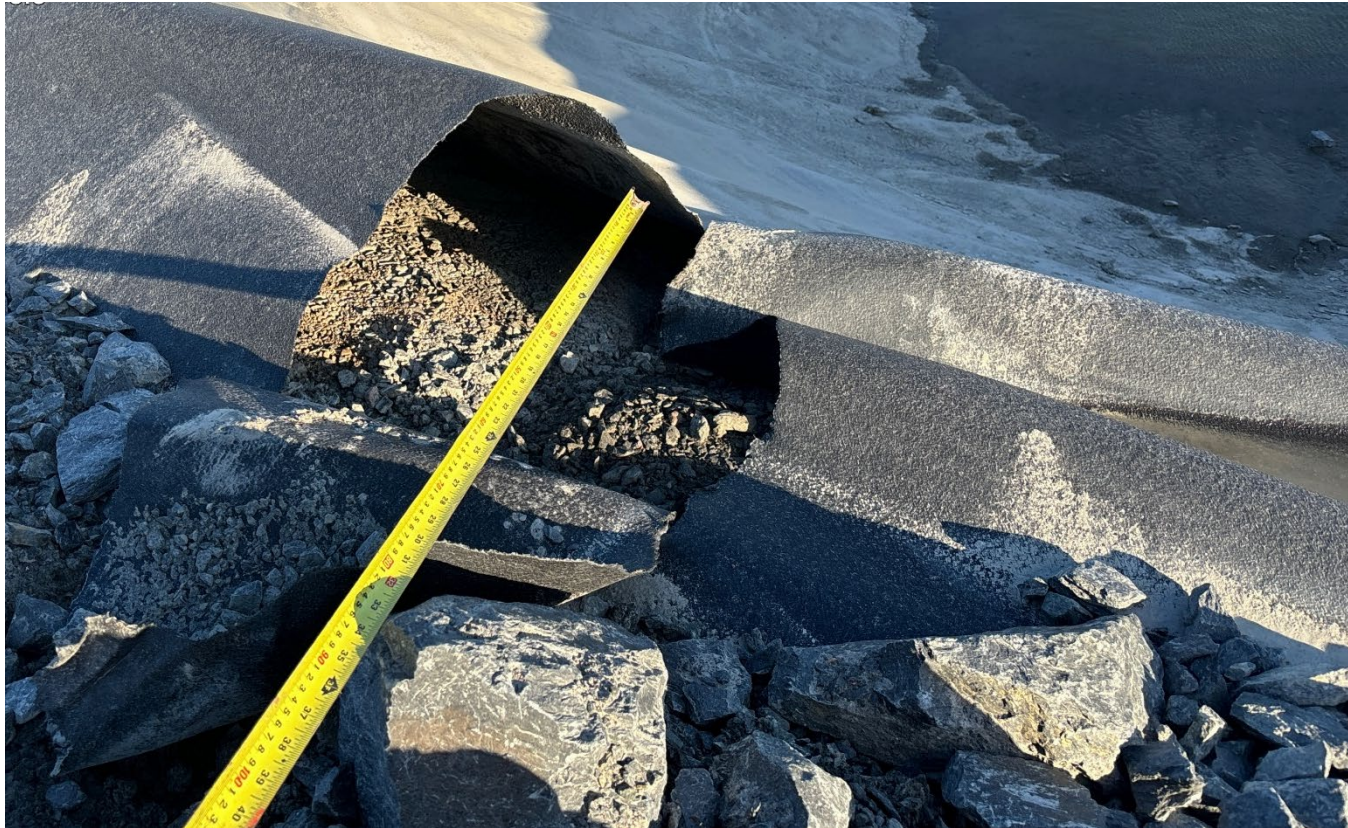
G-93: Liner tie-in damage

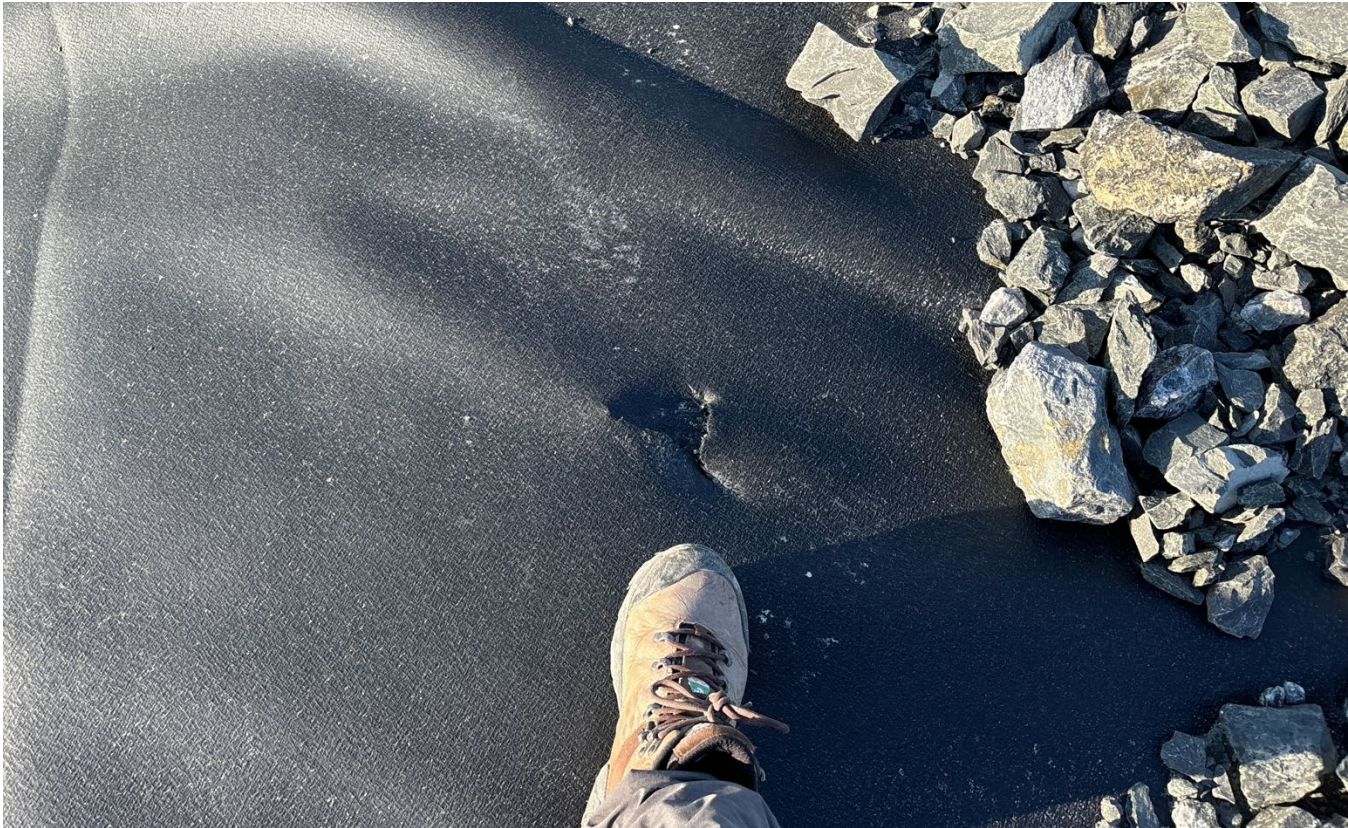
G-94: Liner damage

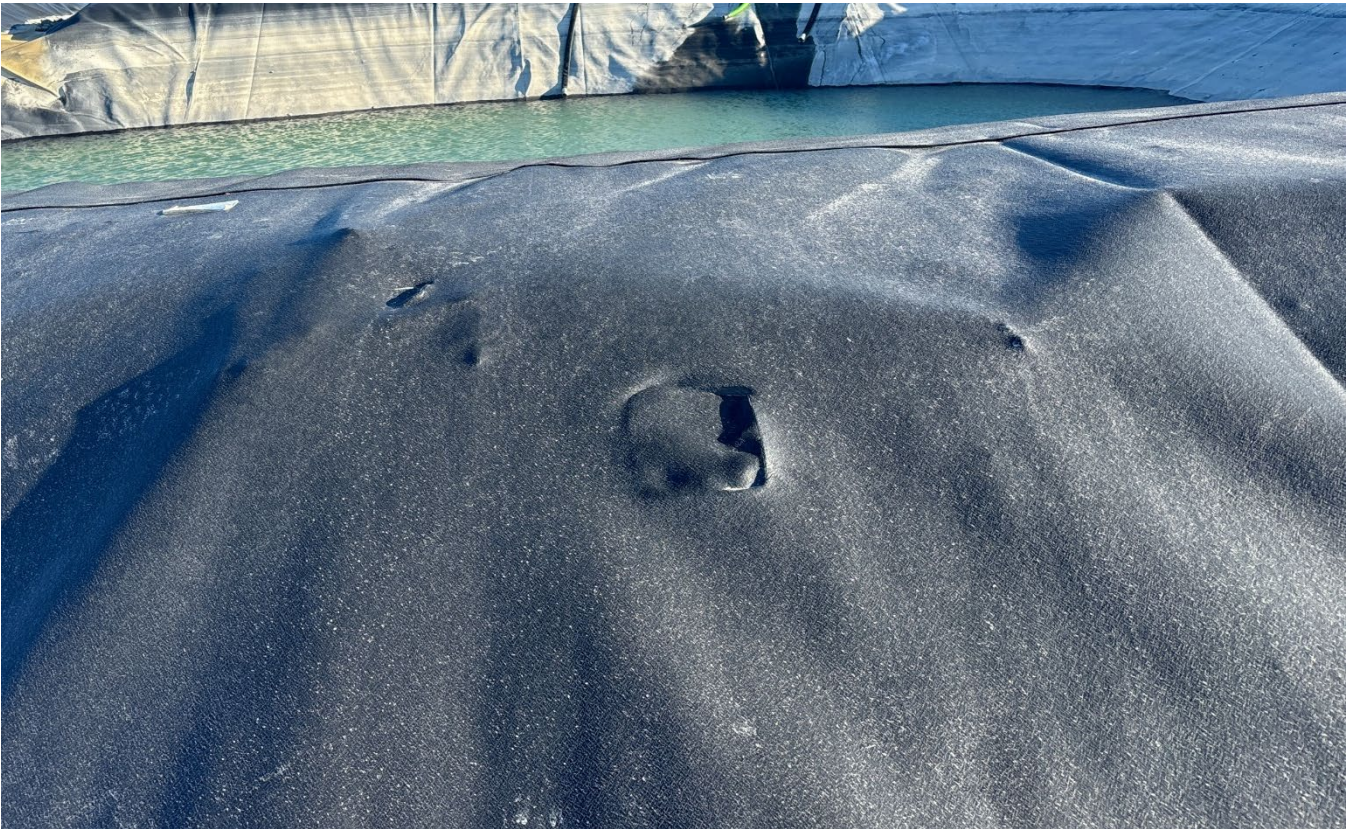
G-95: Liner damage

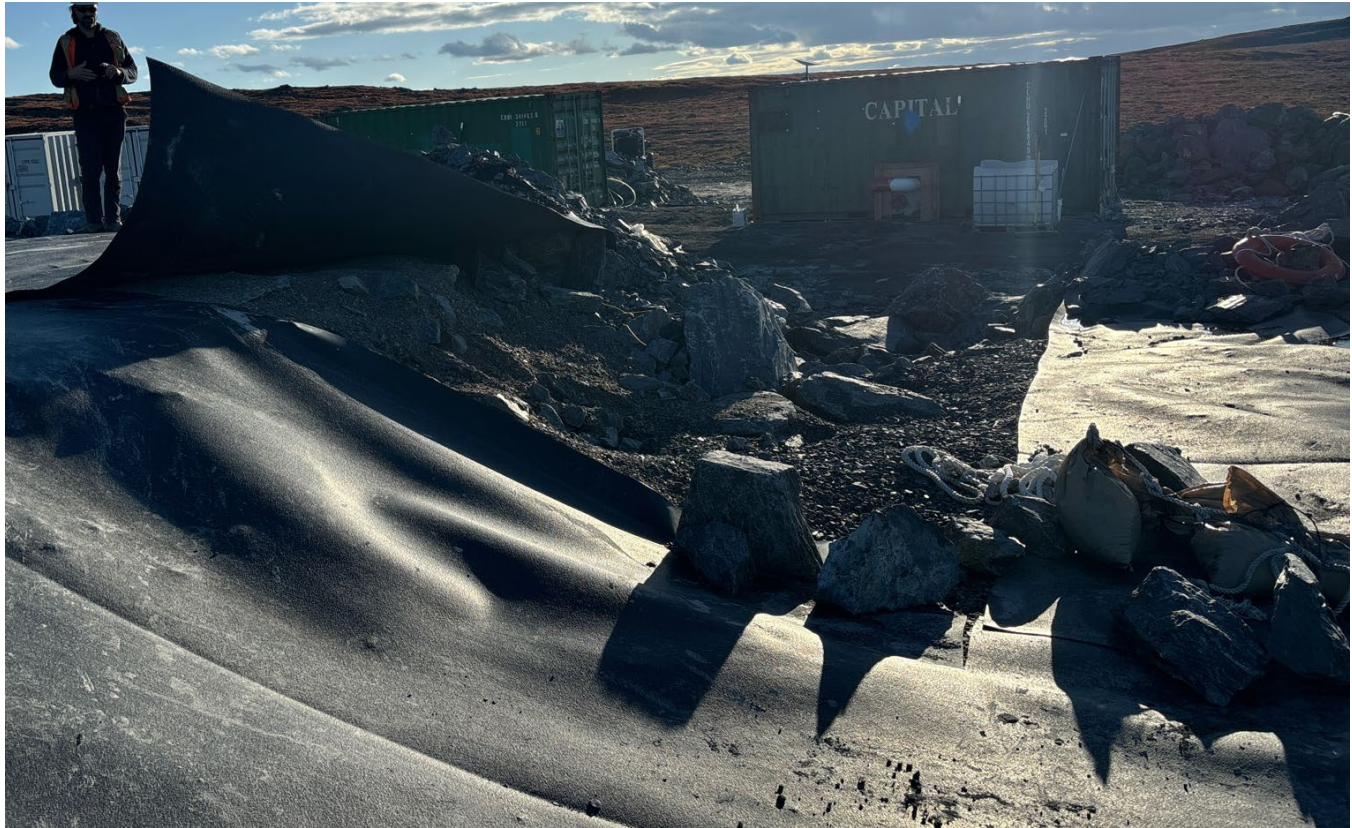
G-96: Pond slope – Note inappropriate material on liner

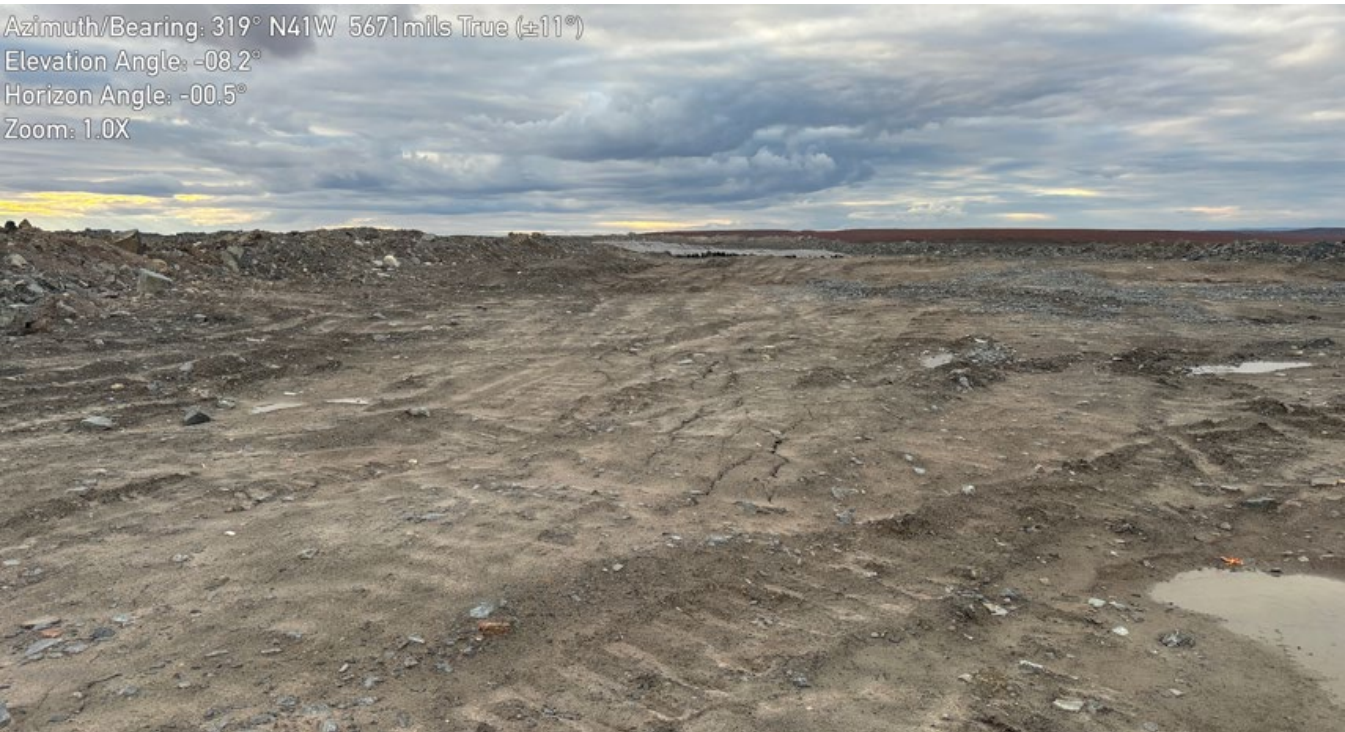
G-113: General Stockpile surface condition, facing NW – Note tension cracks

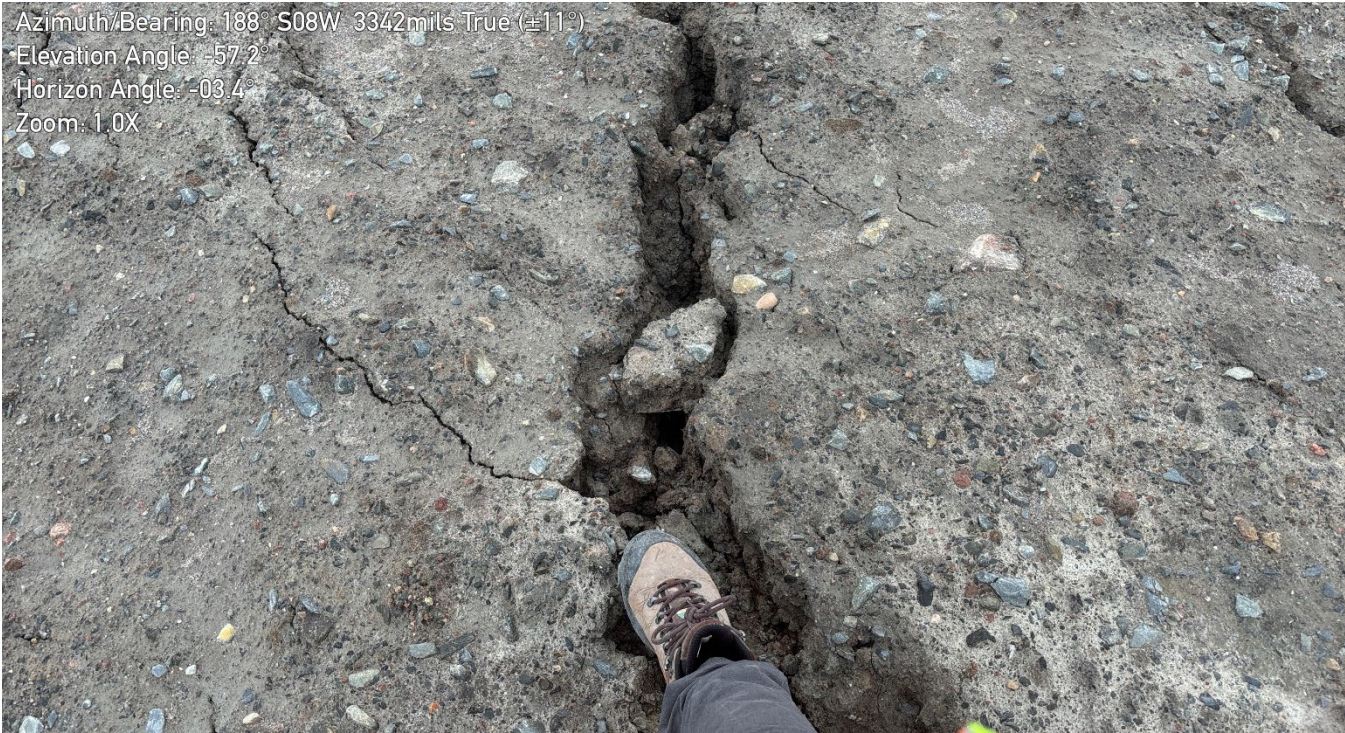
G-114: Tension cracks

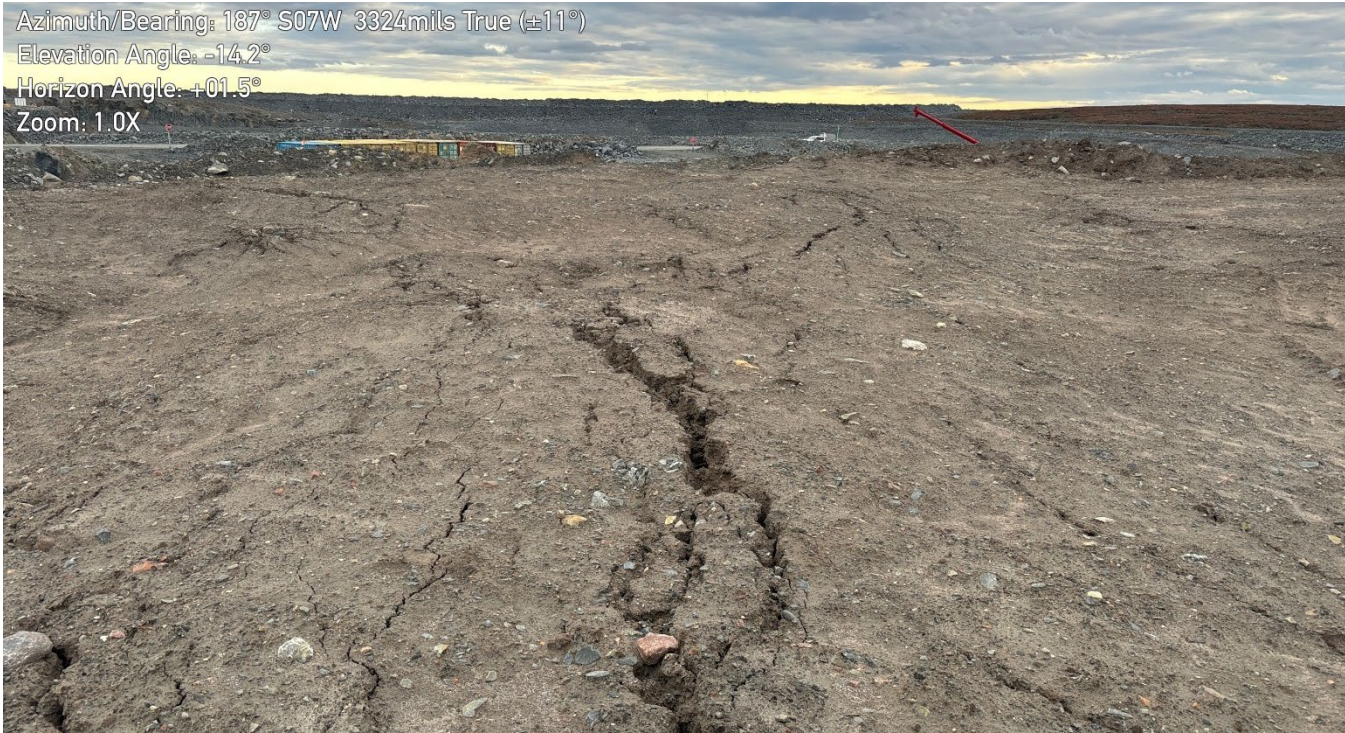
G-115: Stockpile, facing south – Note tension cracks

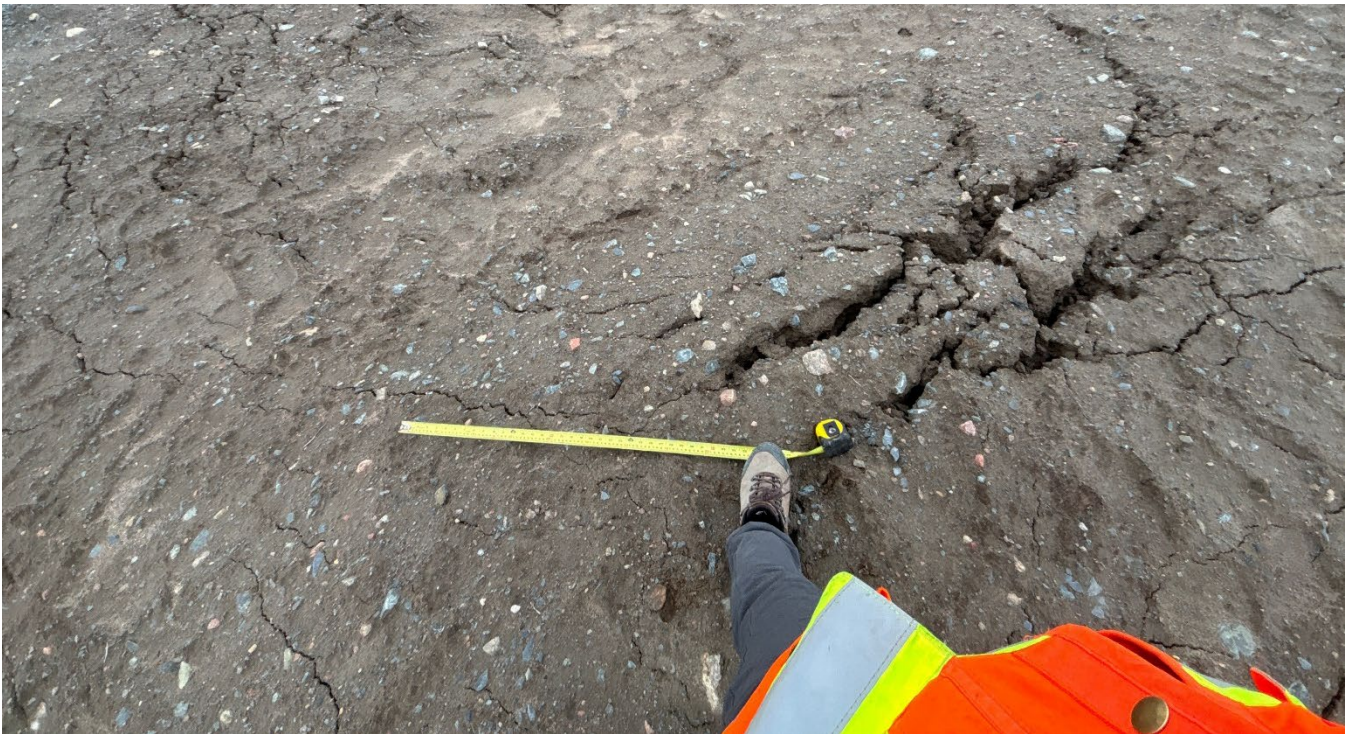
G-116: Tension cracks

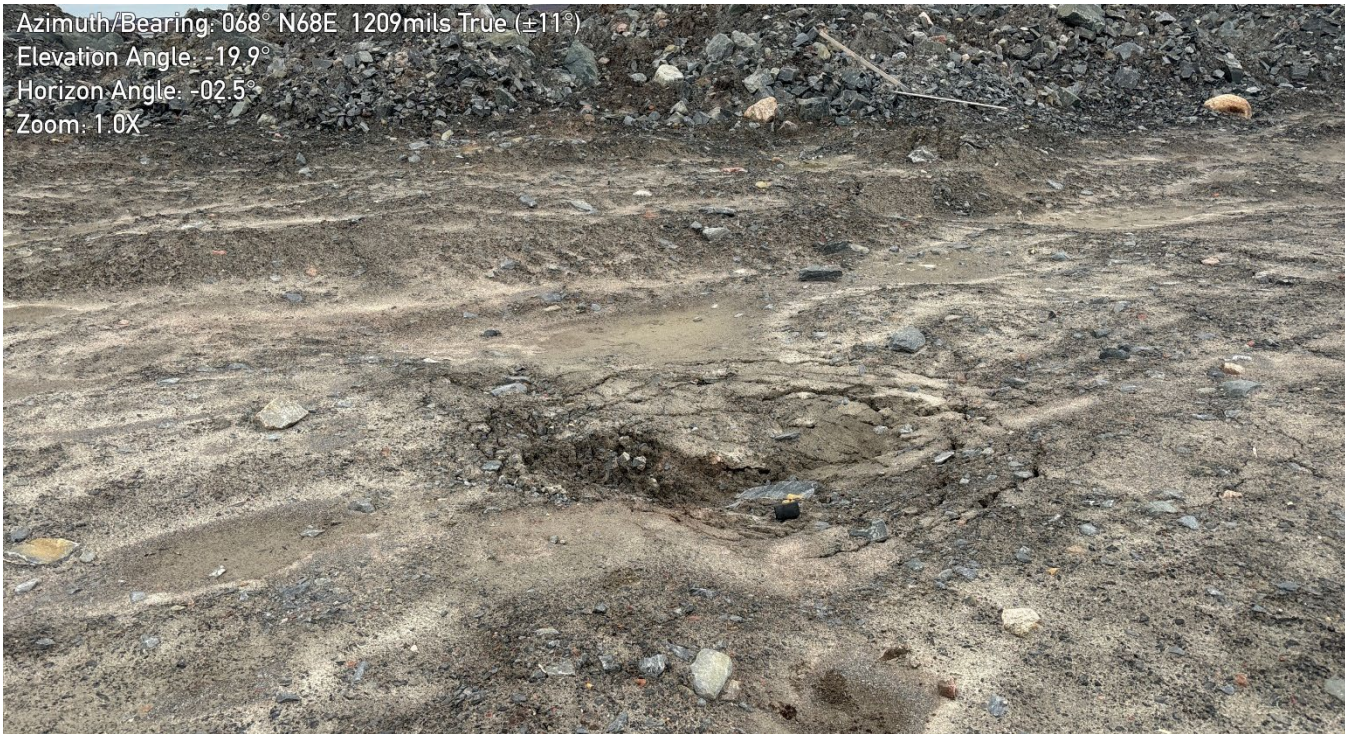
G-117: Tension cracks

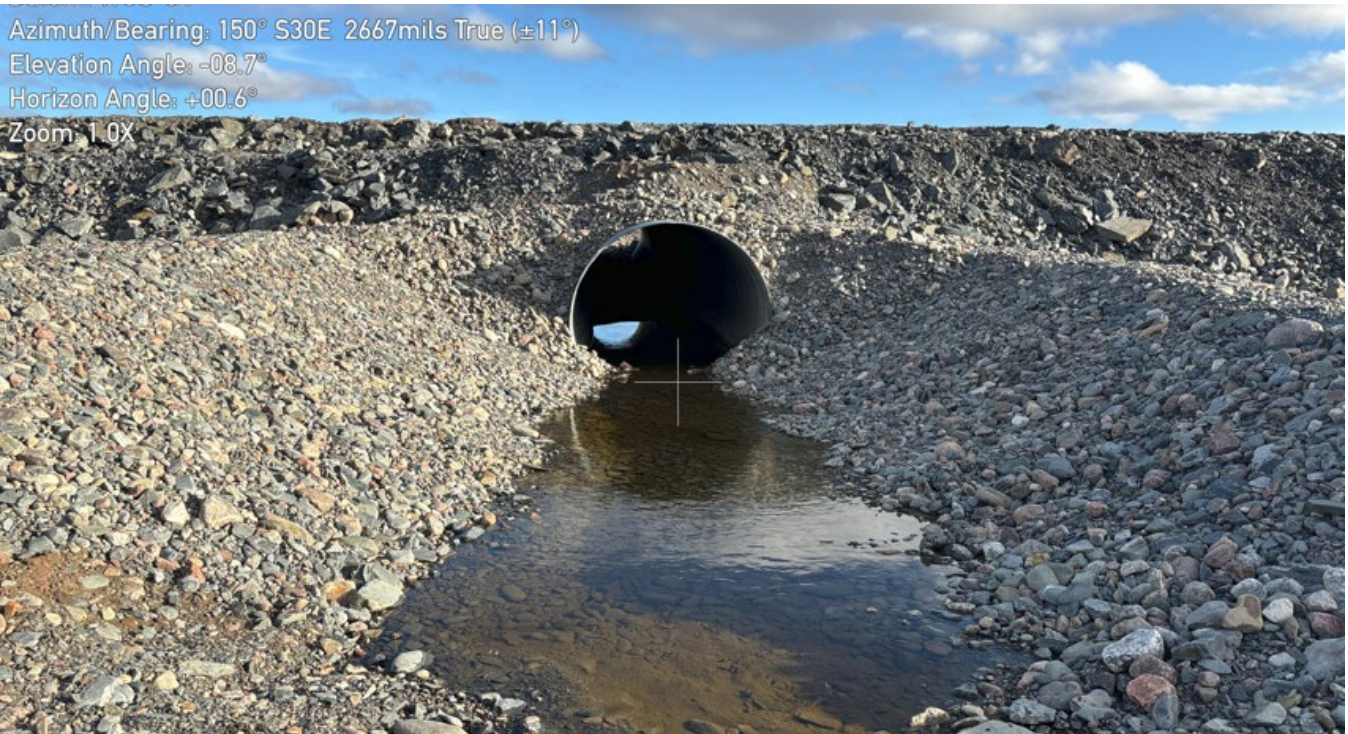
G-121: Gander Crossing Small Culvert, facing south– Note circular damage from installation. Ponding Water

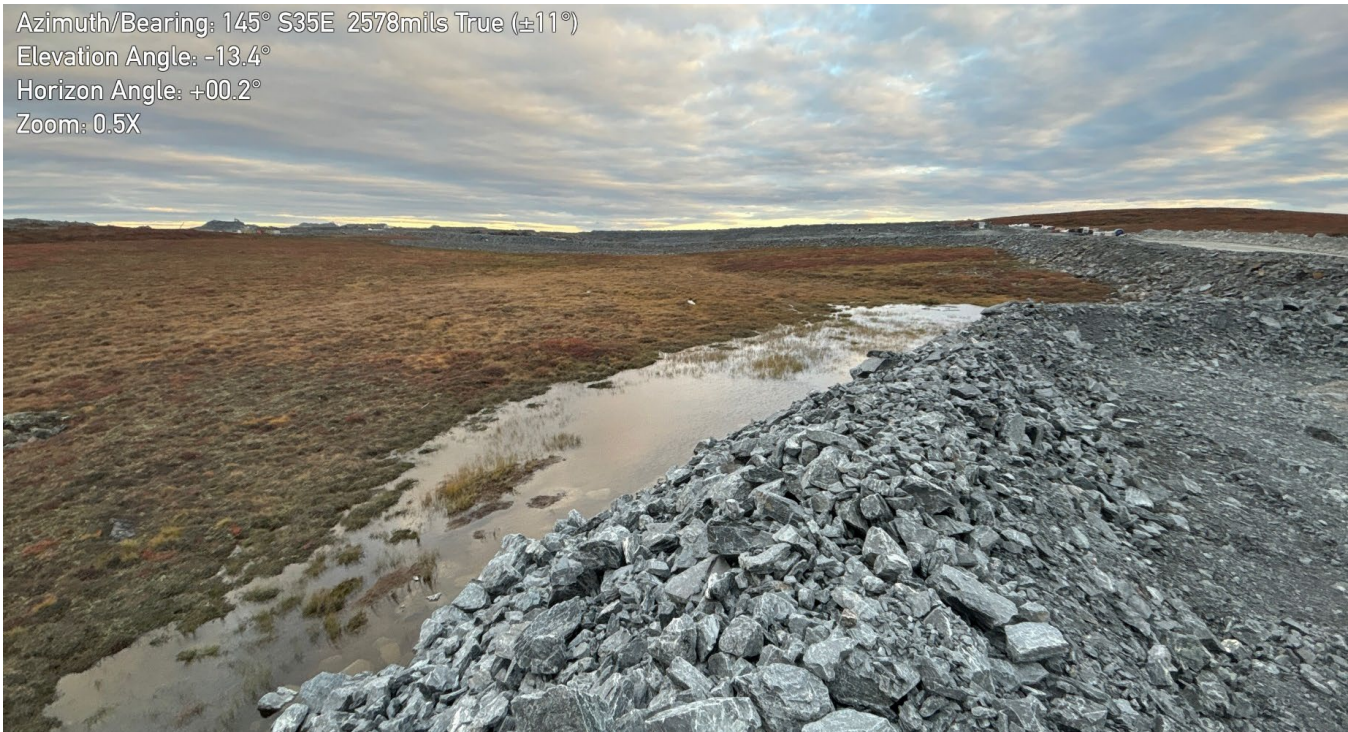
G-144: Laydown area ground conditions – Note Tension cracks

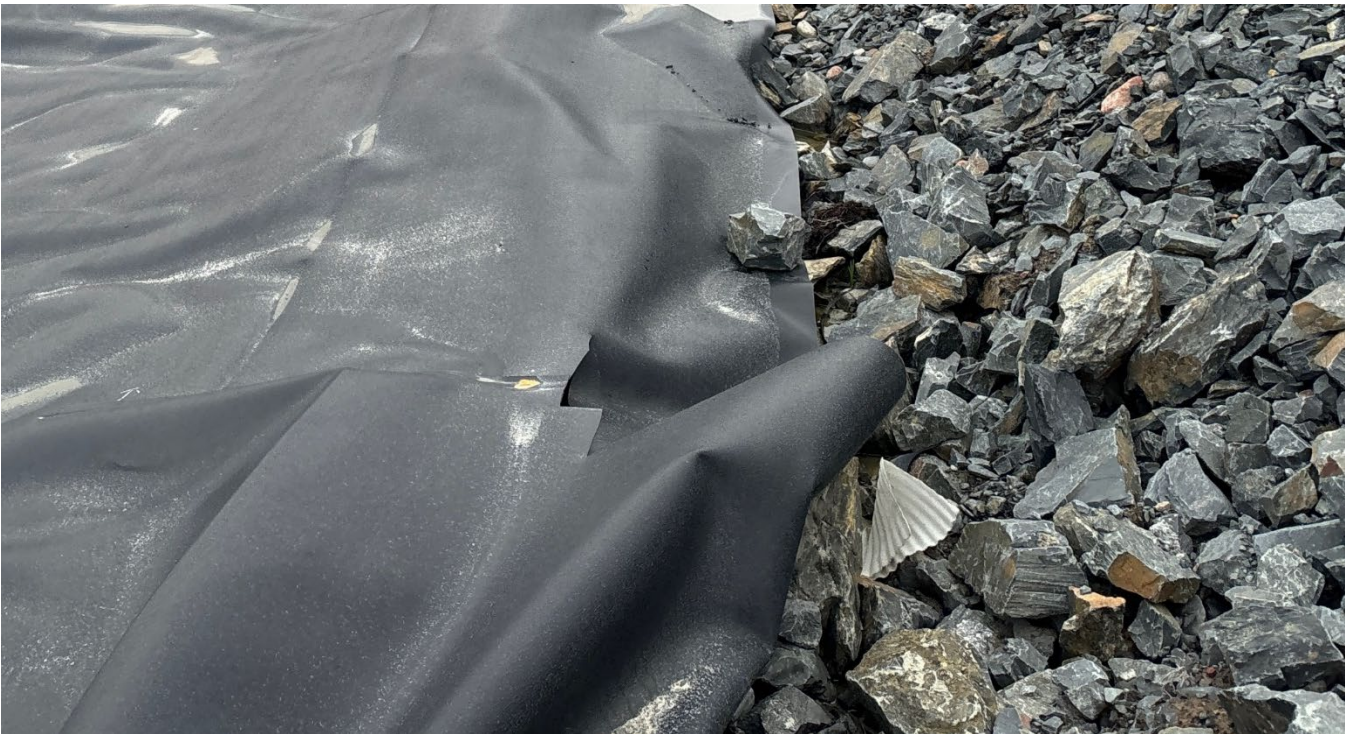
G-153: Zoomed in, No tie in and liner damage

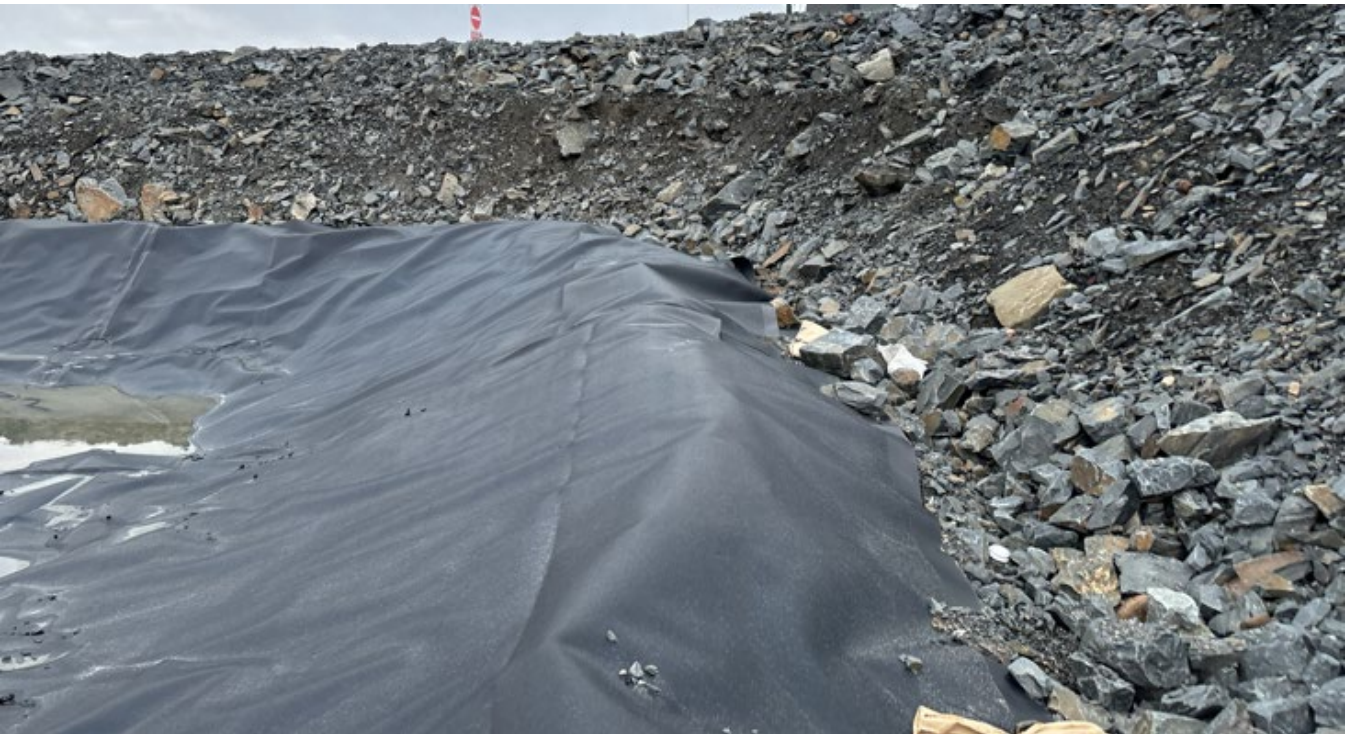
G-154: NE edge – No tie-in

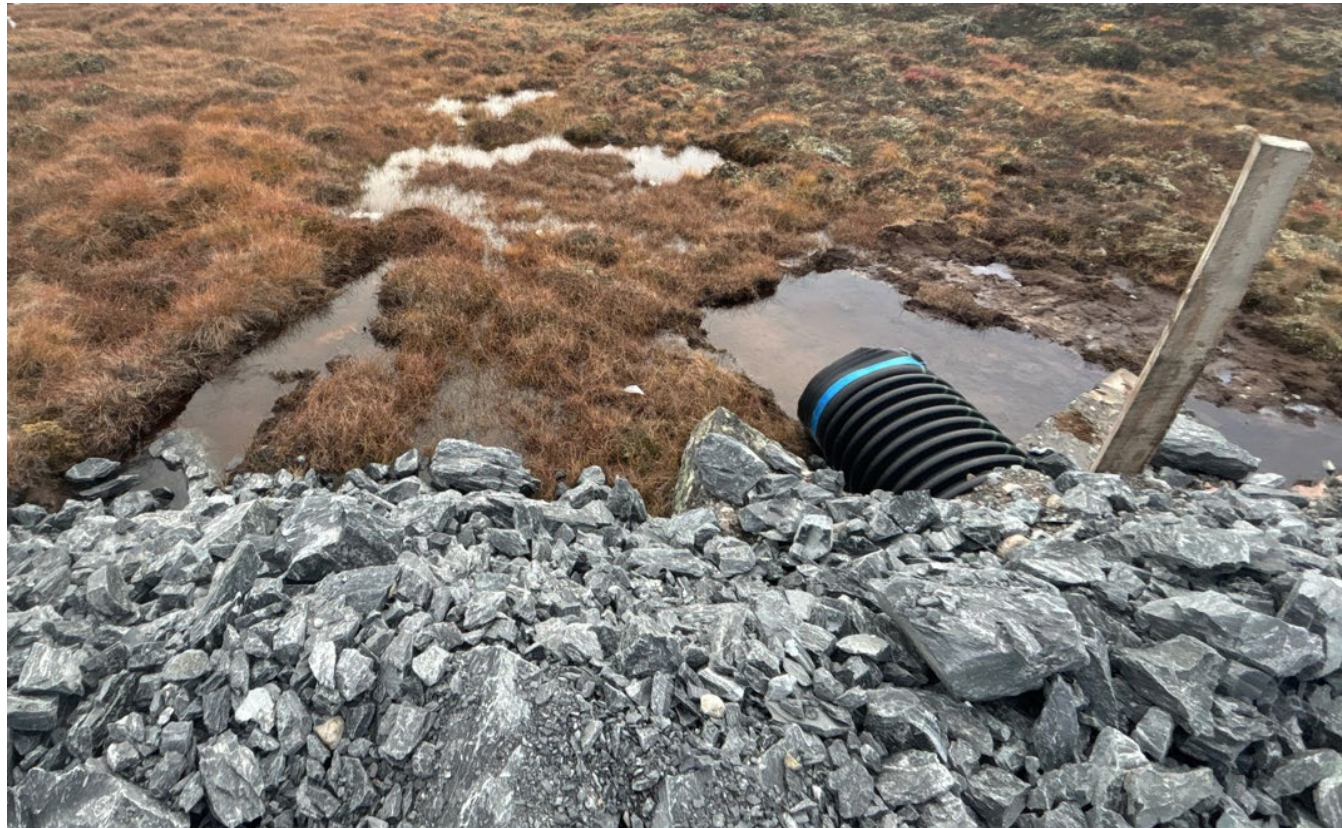
G-172: Damaged culvert causing water ponding at inlet

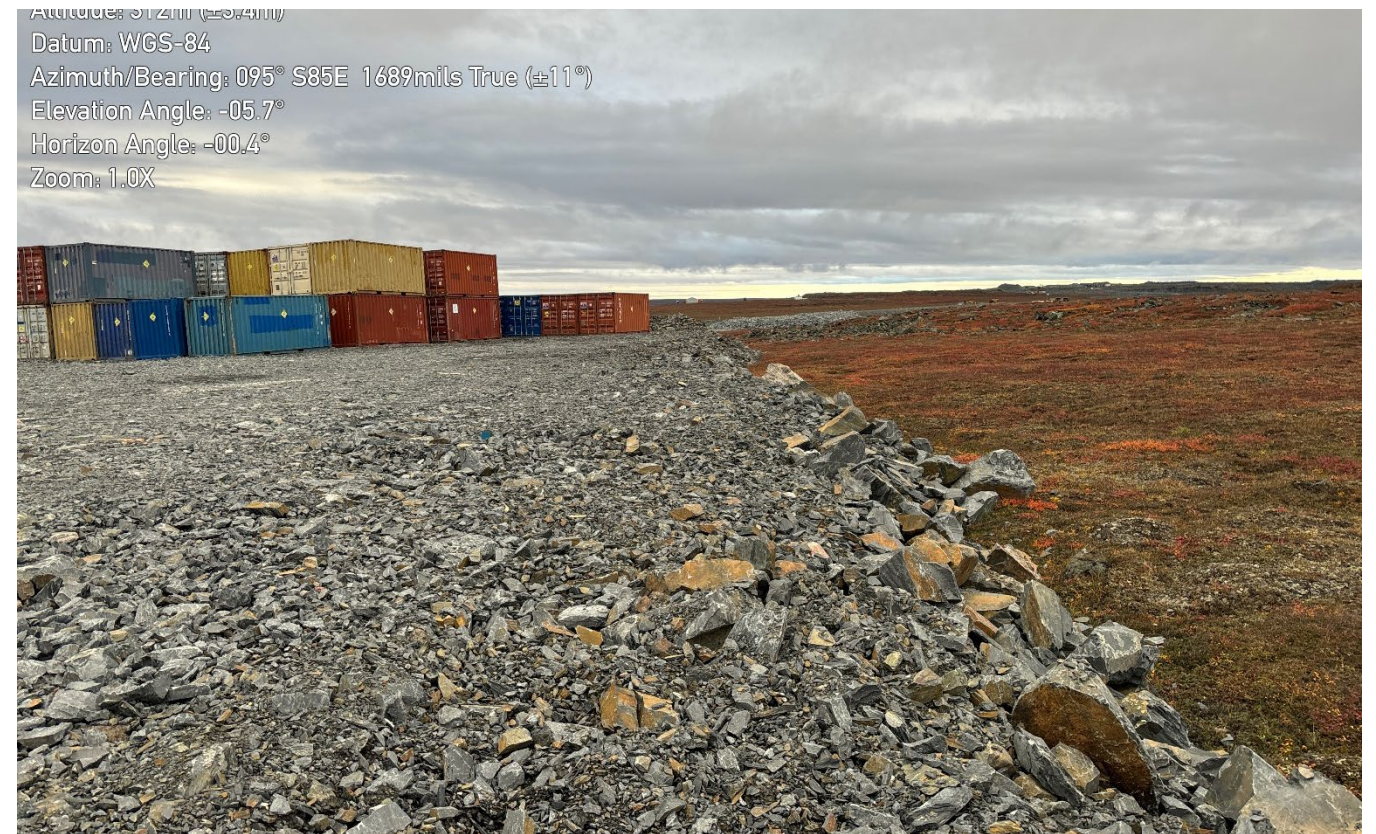
G-173: Laydown area at the northern side of the all-weather road – Note oversteepend slopes
