Goose & MLA Project Sites – 2024 Annual Geotechnical Inspection

Back River Project, Nunavut, Canada
B2Gold Corp.

SRK Consulting (Canada) Inc. ■ CAPR003105 ■ April 2025

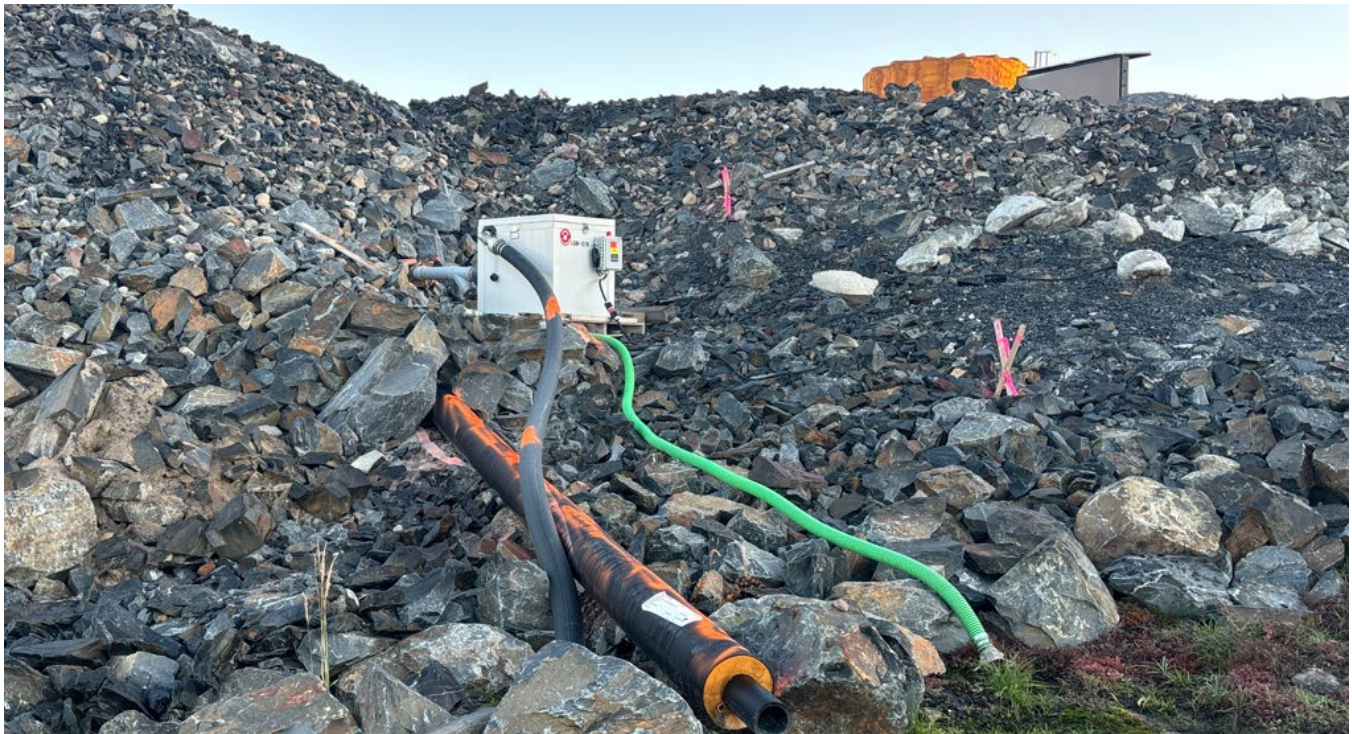
G-181: Discharge area – Note Oversteepened slope, equipment can be damaged by falling rocks

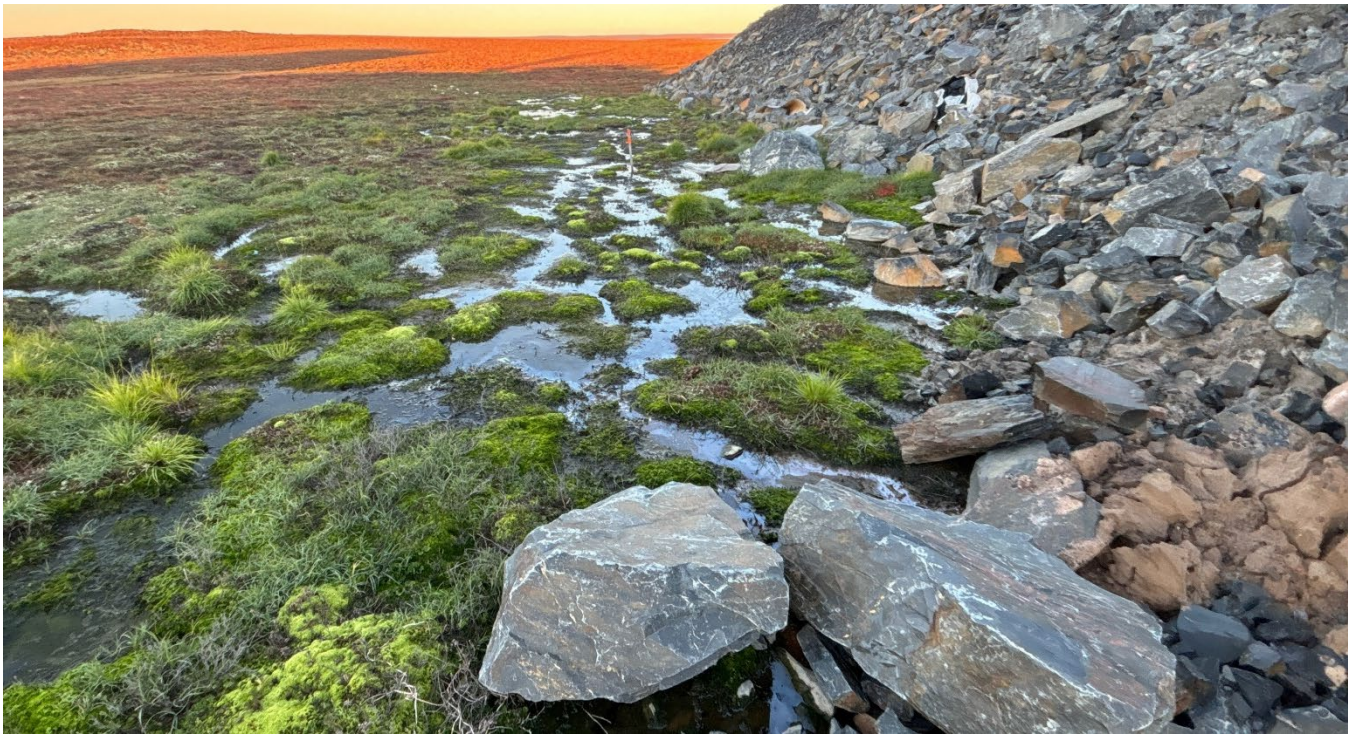
G-182: Ponding water at toe of south slope, facing west

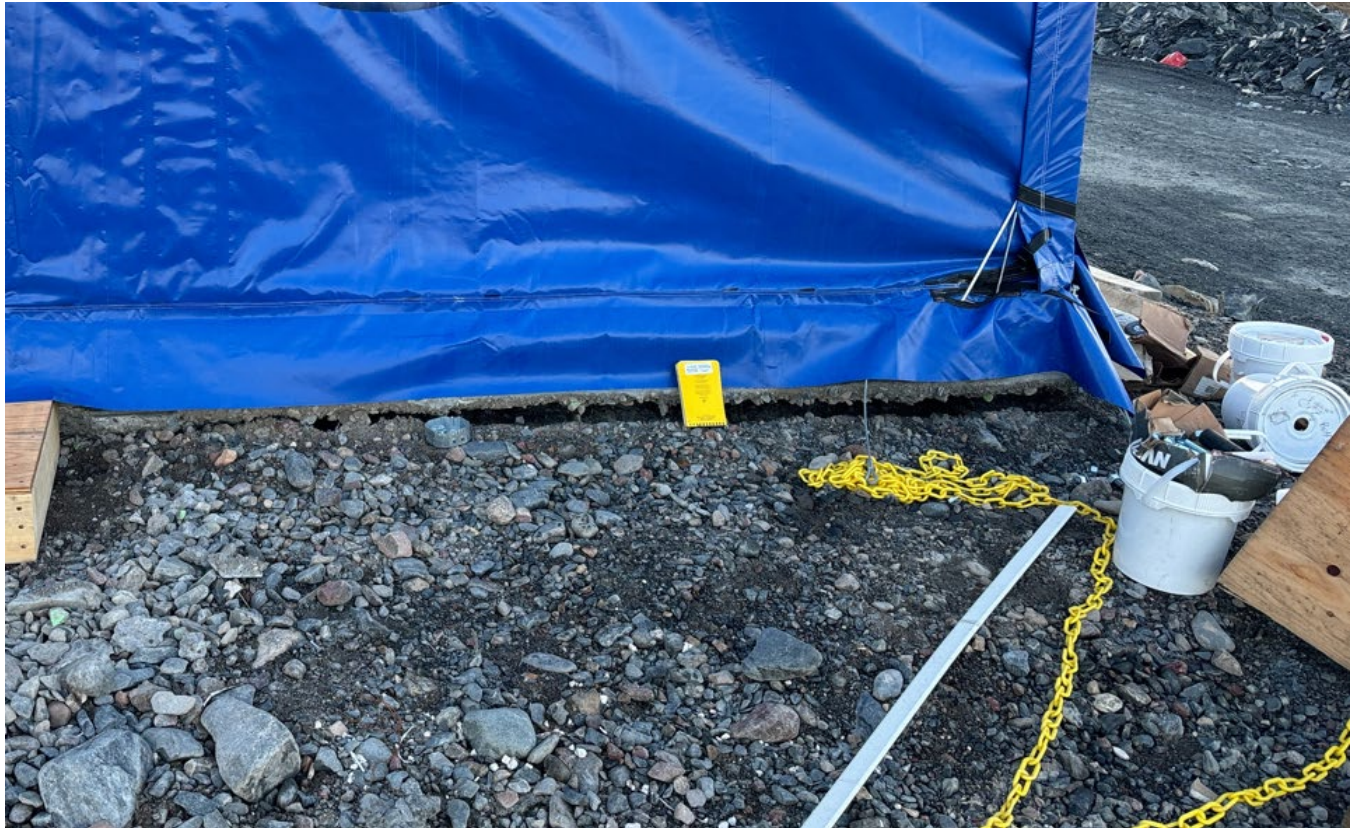
G-186: Tent foundation – Note 7cm gap between tent and foundation

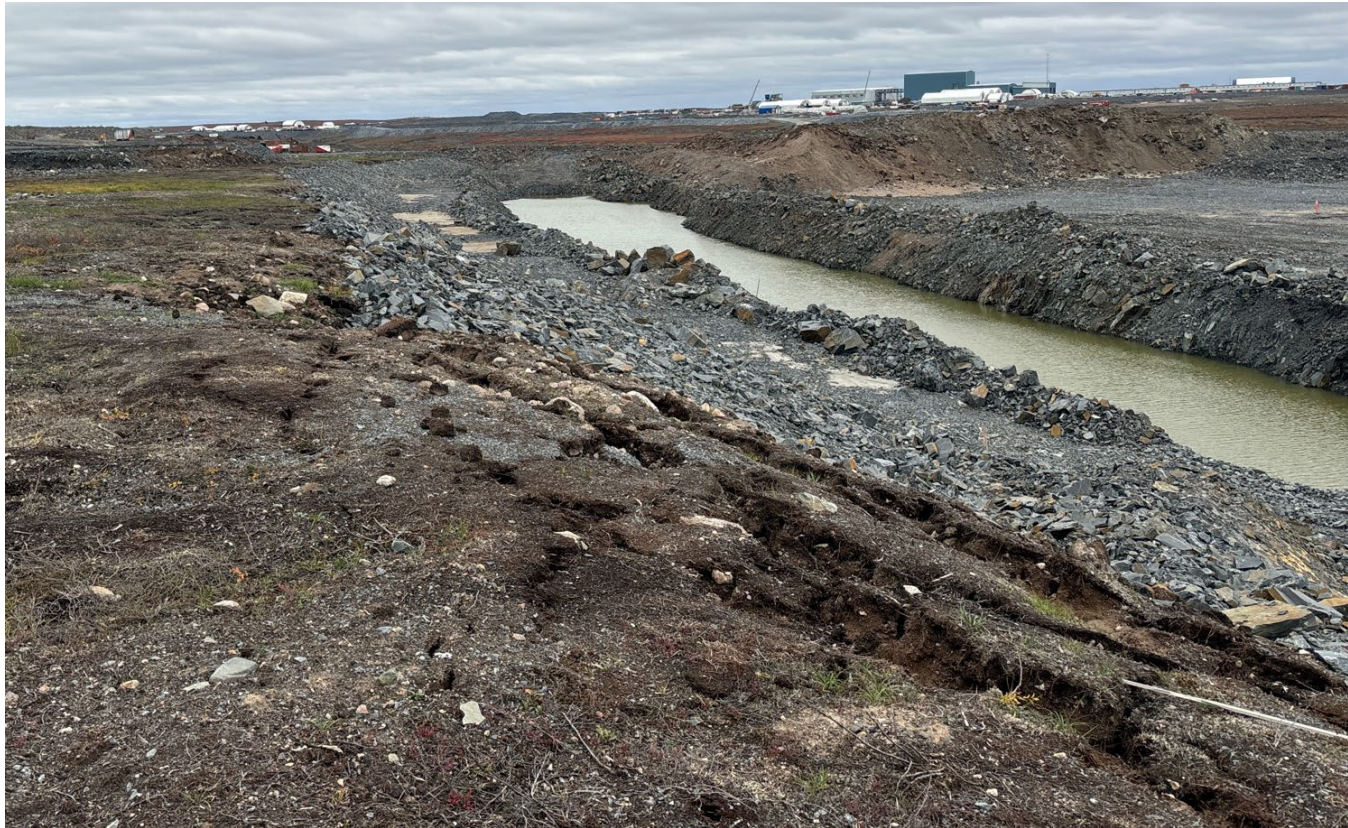
G-207: NE slope, facing south – Note thermal erosion and tension cracking due to lack of rockfill layer

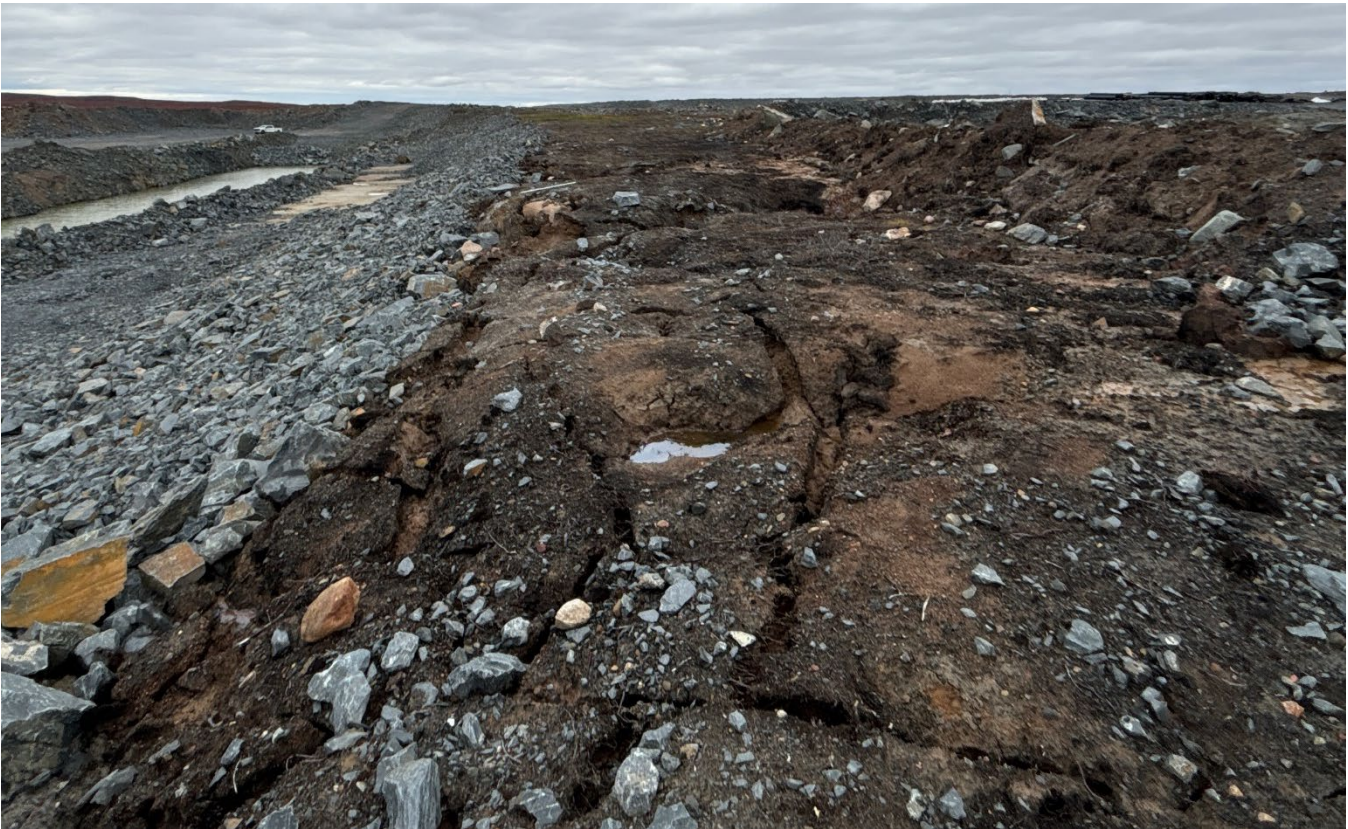
G-209: NE slope, facing NW – Note tension cracking

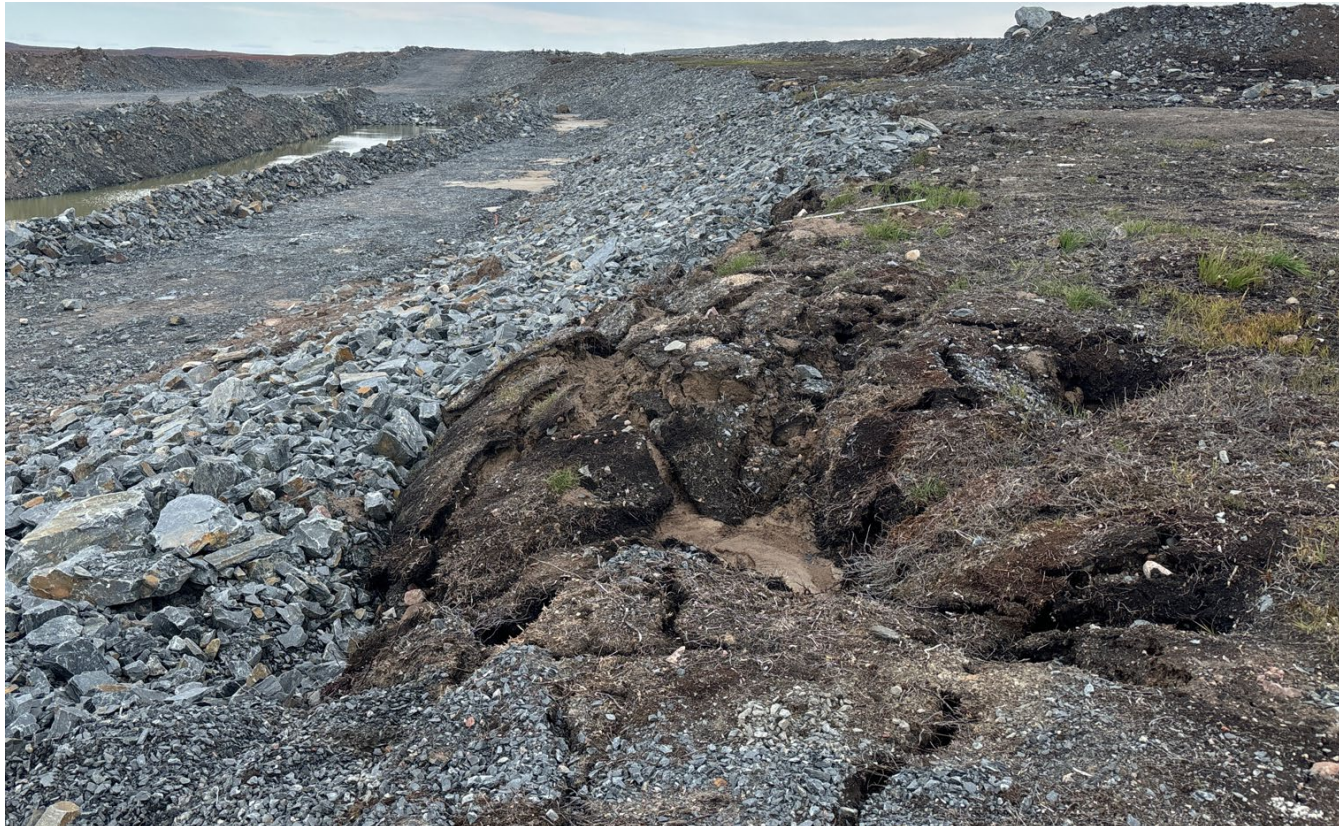
G-210: South end of slope, facing NW – Note thermal erosion due to lack of rockfill layer

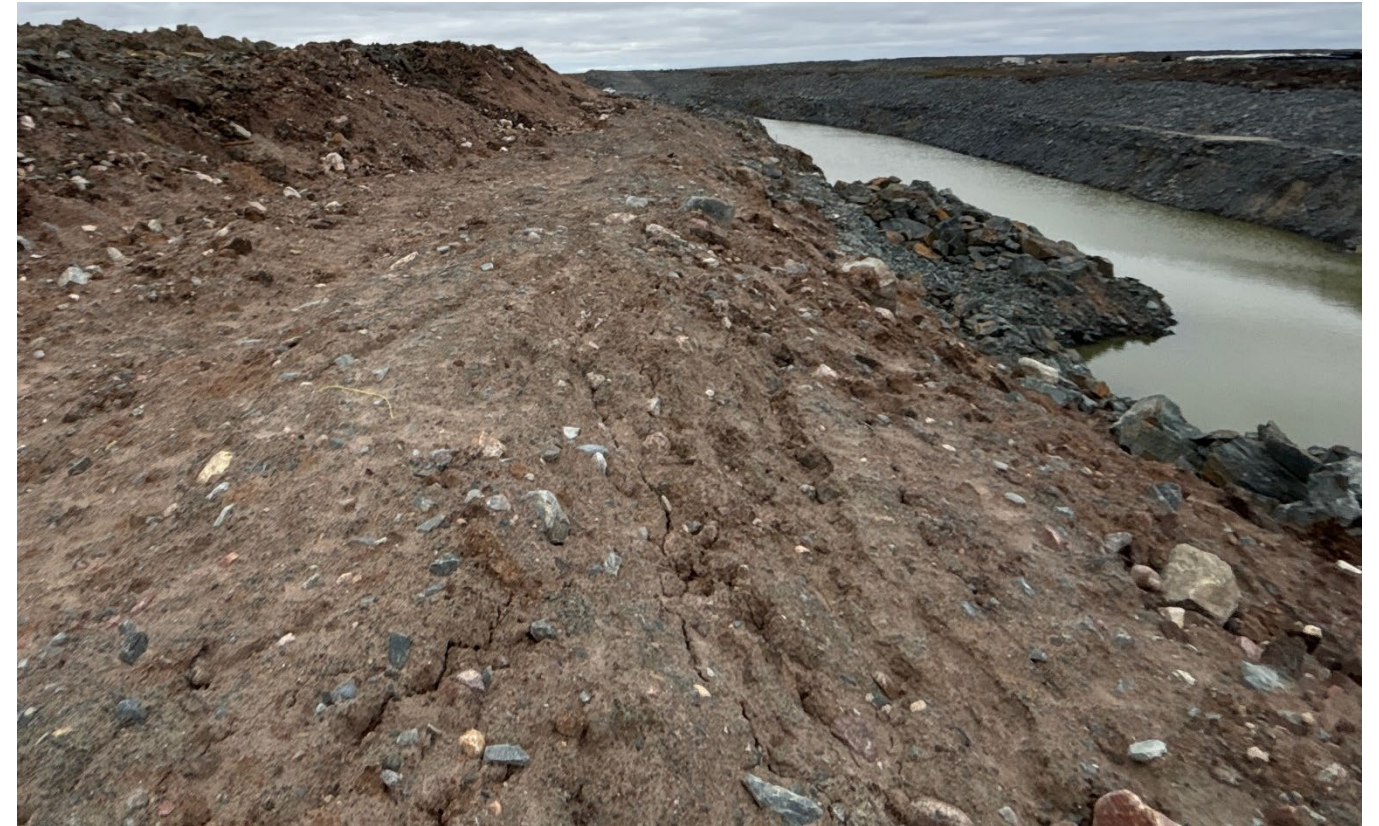
G-211: Southern end of SW slope – Note tension cracking

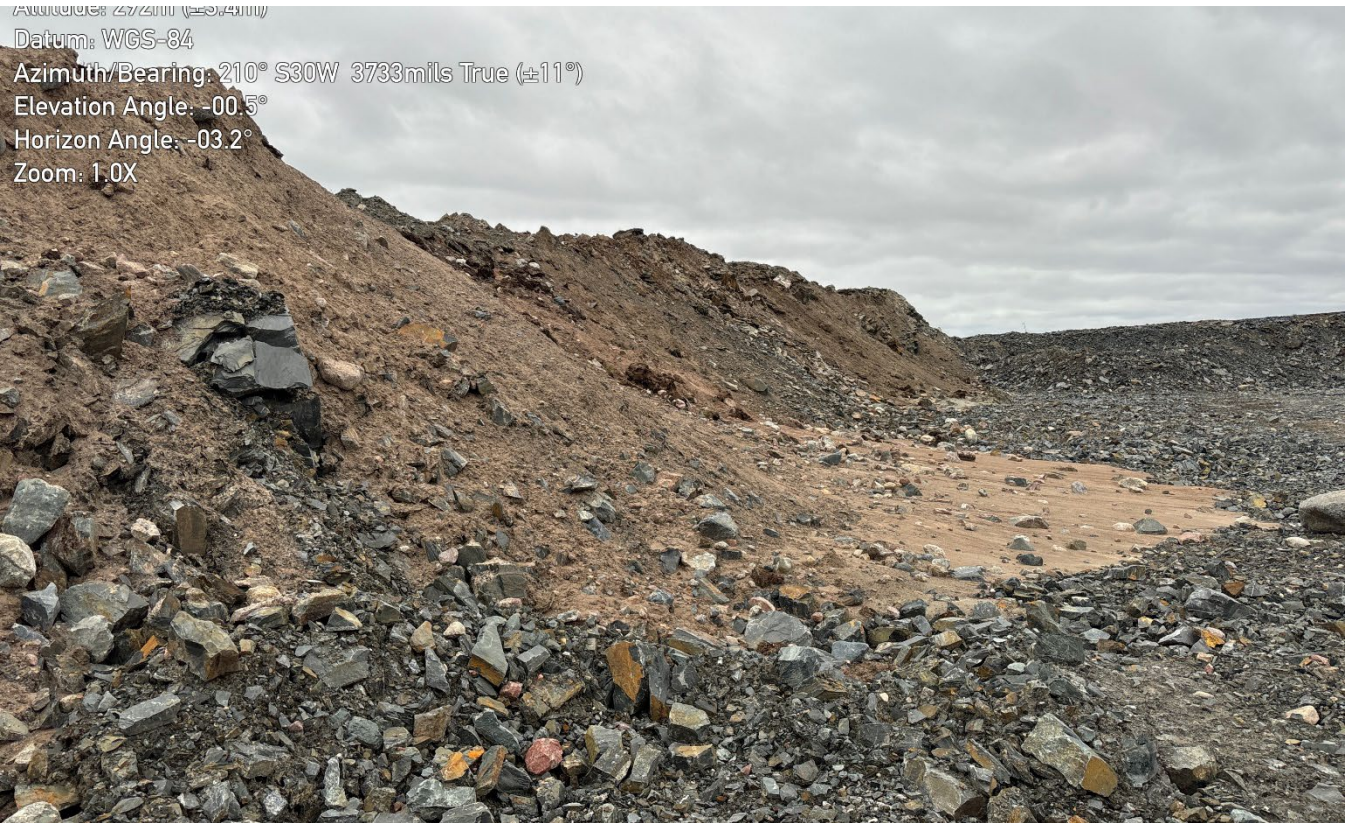
G-213: Umwelt slope. First bench on SW side, facing north – Note thermal erosion

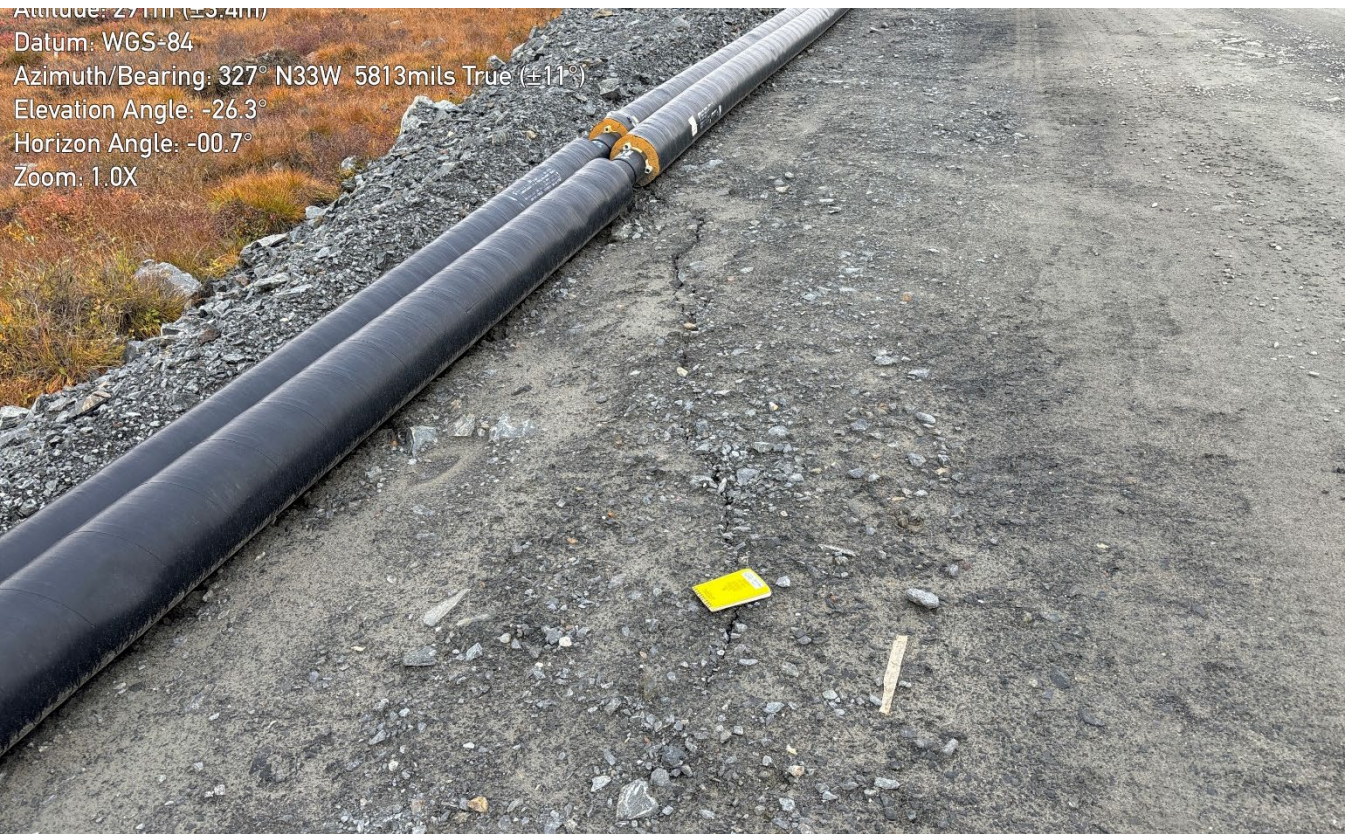
G-234: Tension crack through pipeline

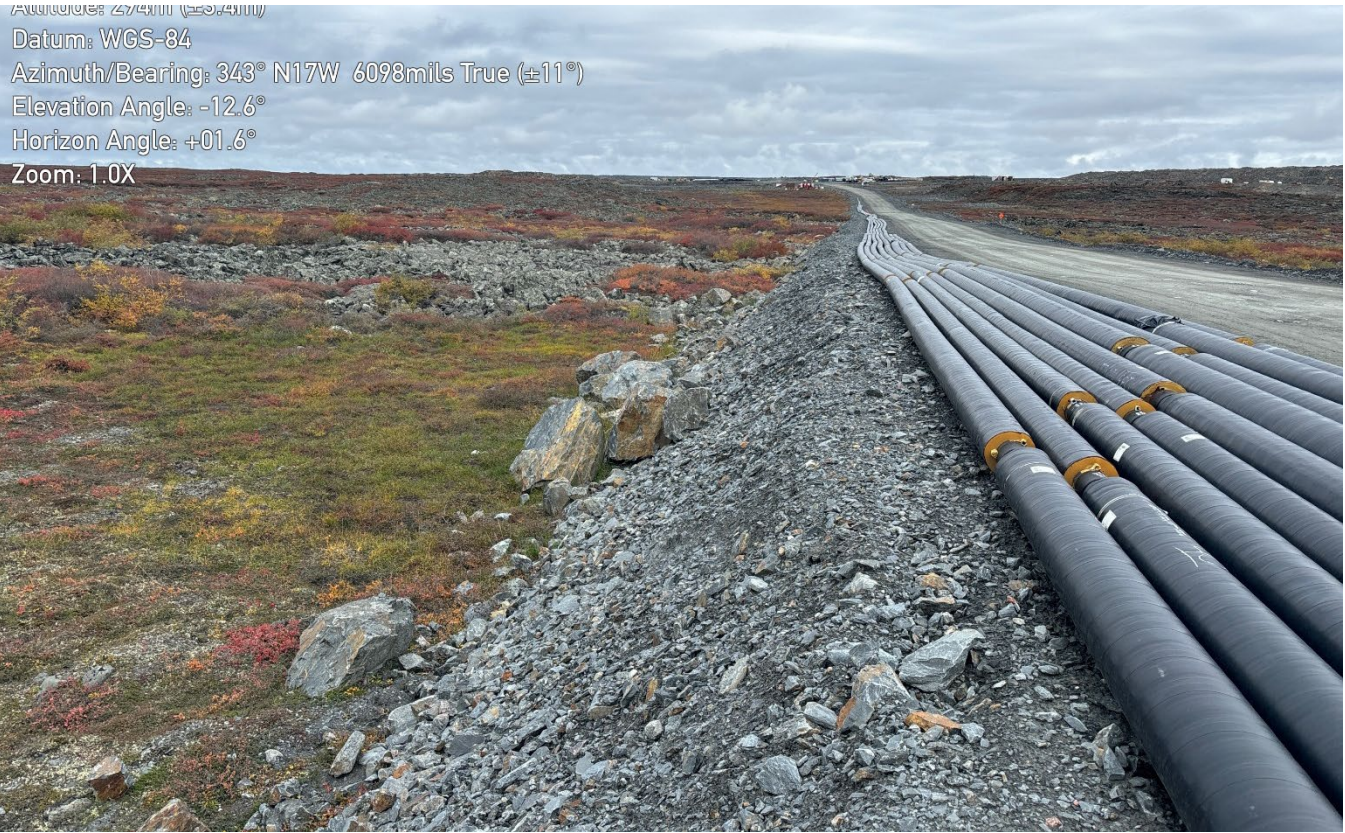
G-235: General pipe layout – Note large blast rock at toe

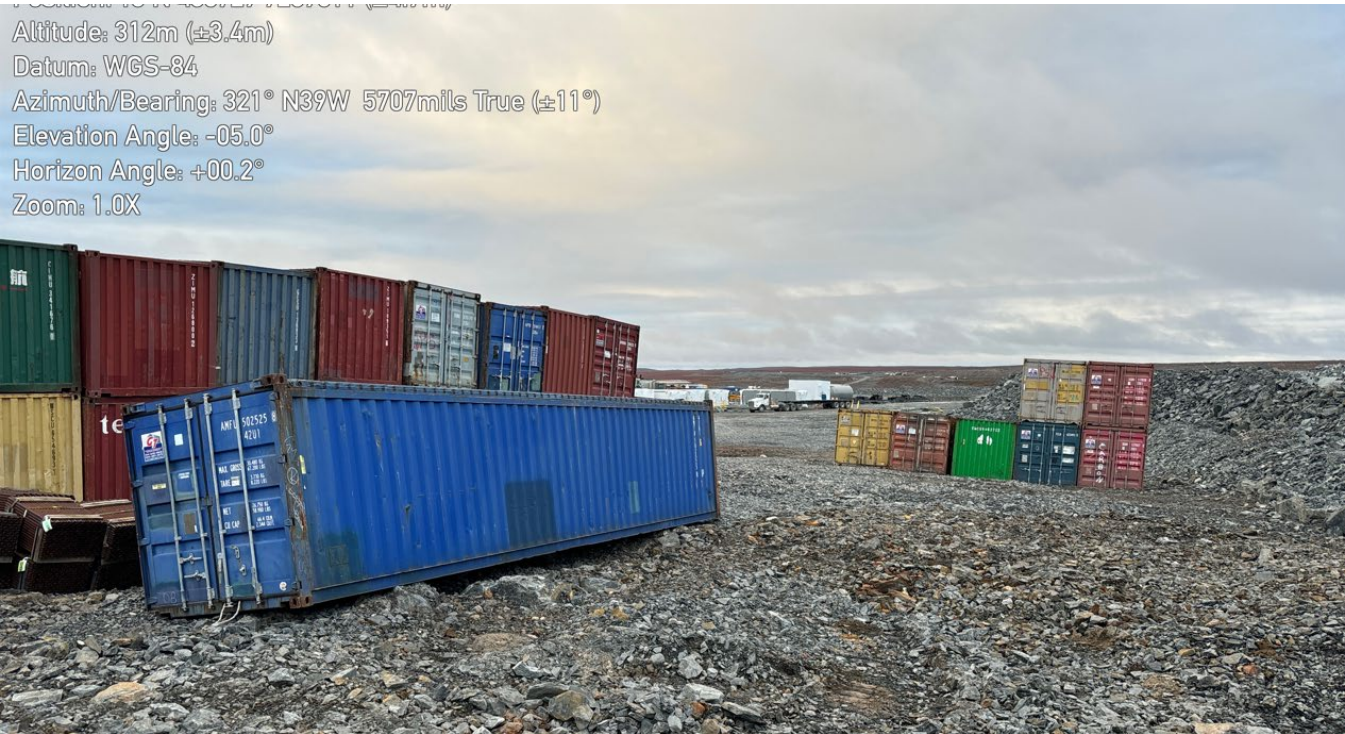
G-249: Large settlement present – Potential for seacans toppling (Hazardous & Toxic)

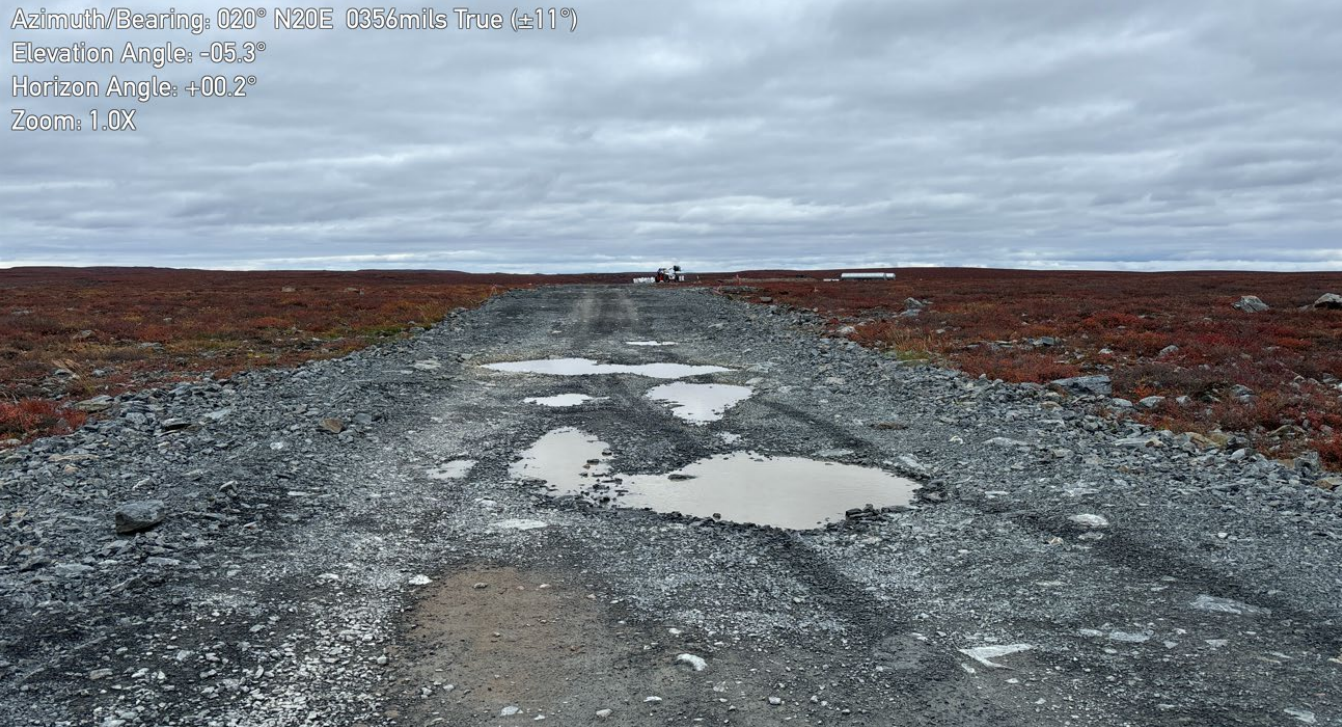
G-253: Access road, facing NE – Note road is underbuilt, and foundation is degraded

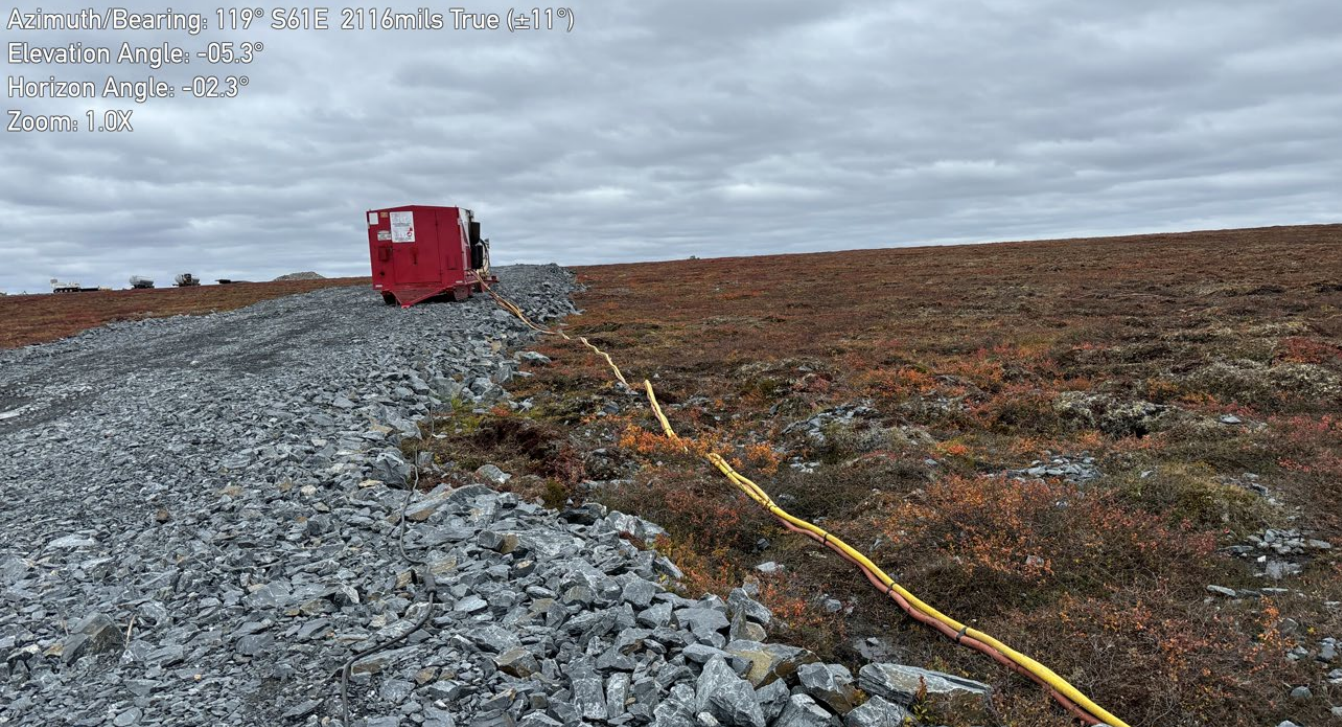
G-254: Pond access road, facing east – Note road is underbuilt

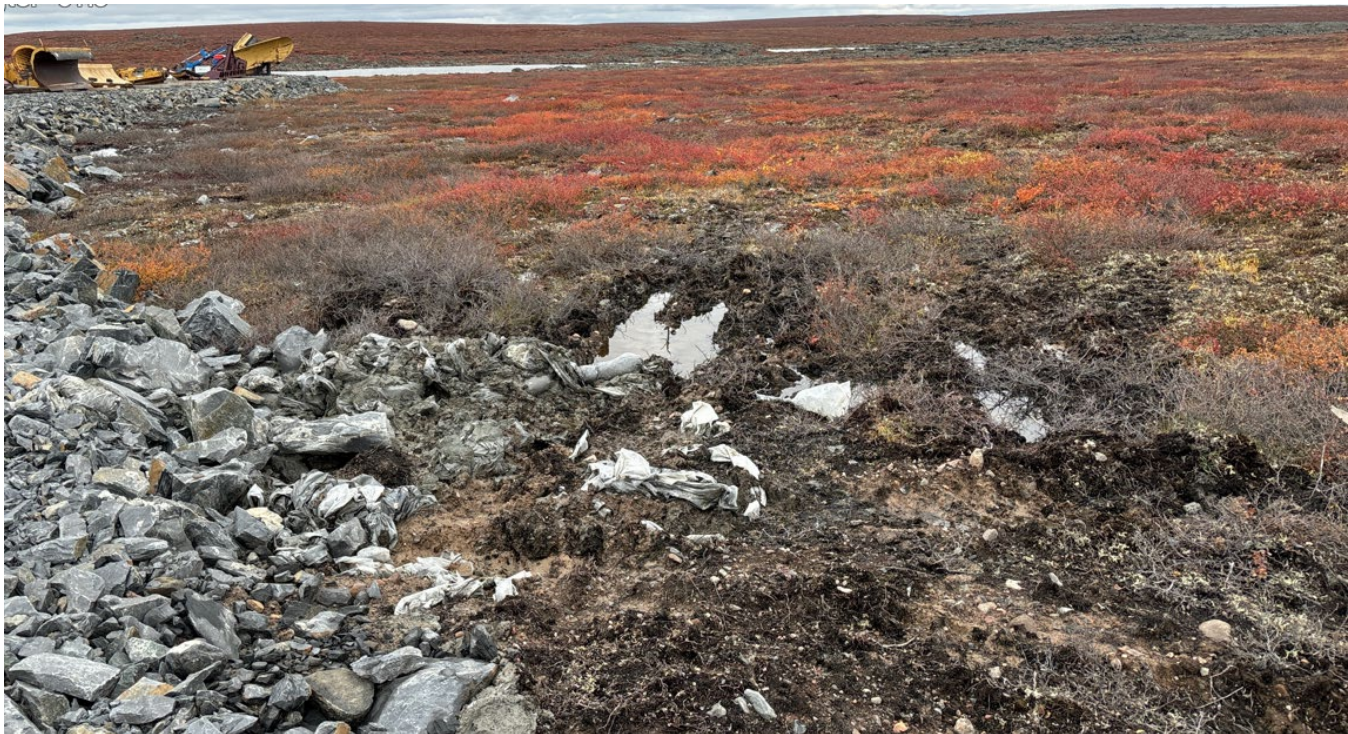
G-259: Camp pad edge, facing east – Note tundra around the pad is disturbed and degraded

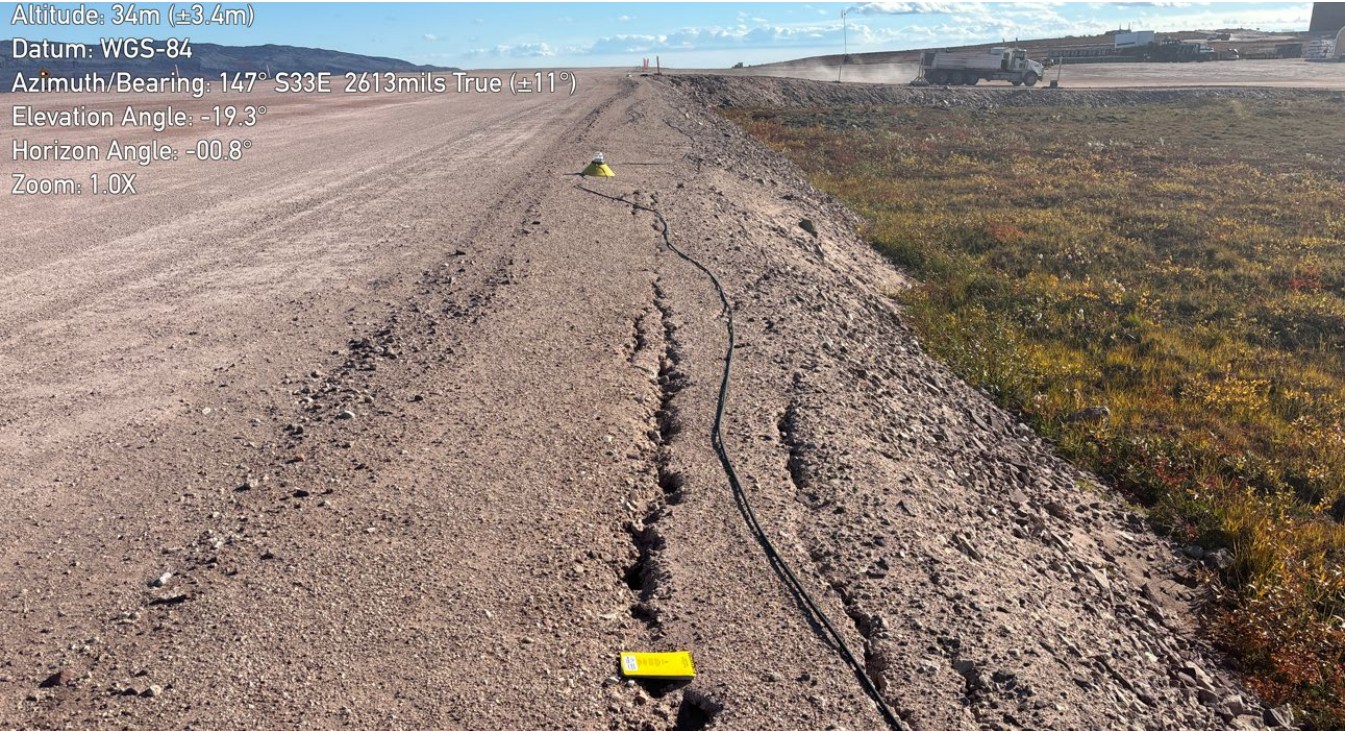
M-13: Airstrip, western side, facing SW – Cracks at the embankment crest – offset the lightening system off the crest

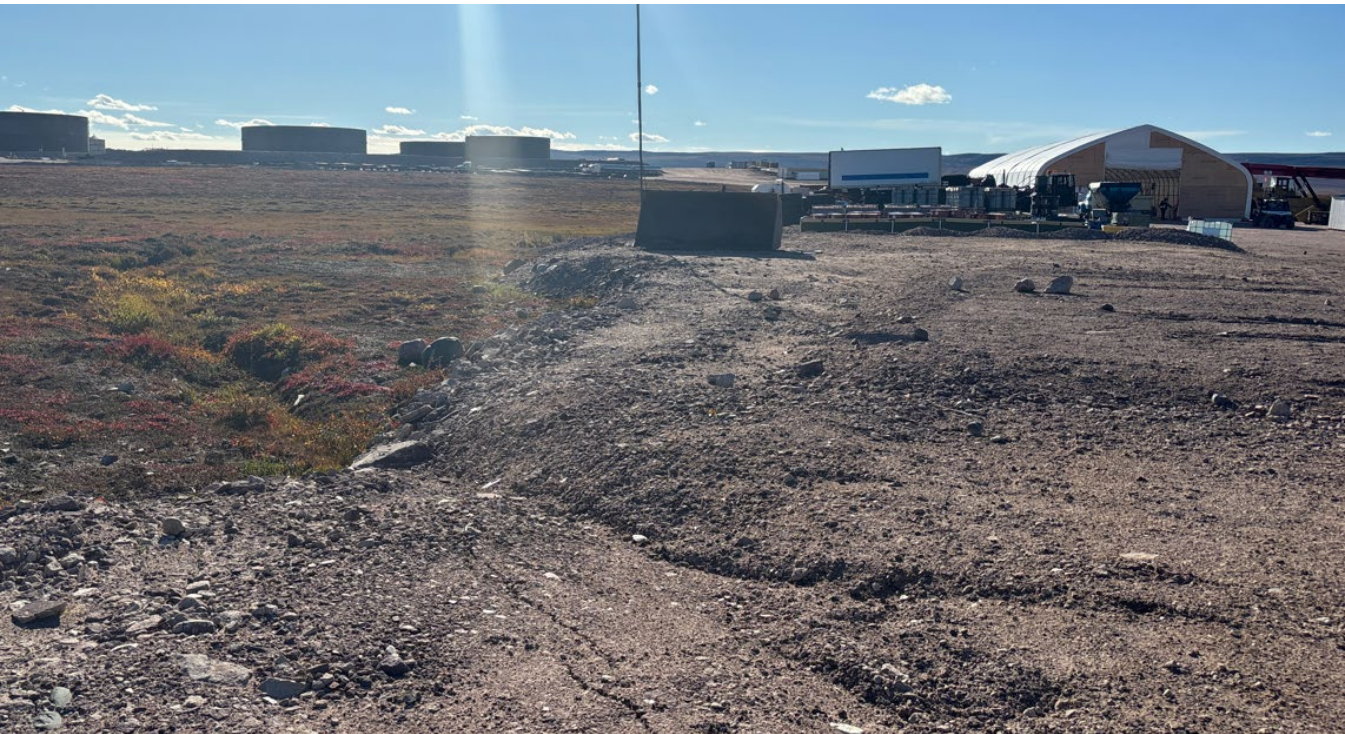
M-15: Airstrip, western side – Note erosion gullies

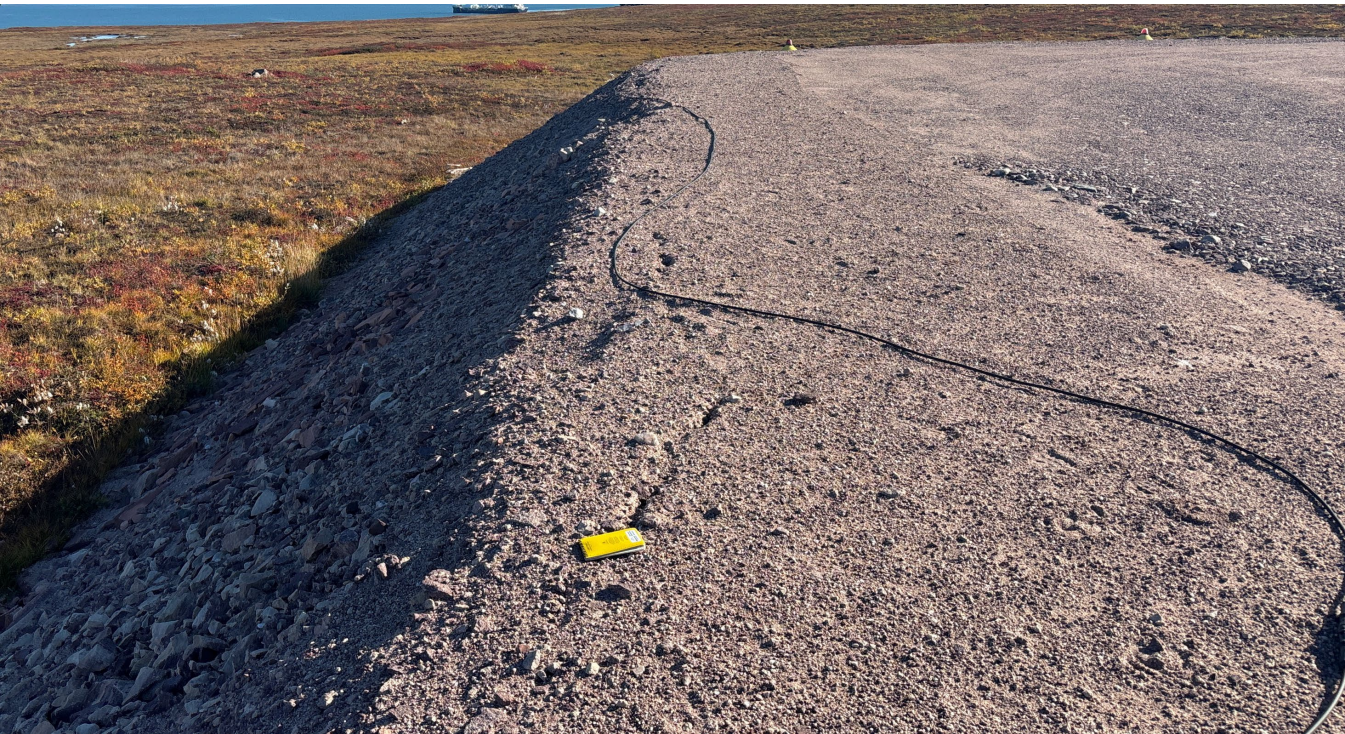
M-23: Southern end, facing SE – Note tension cracks

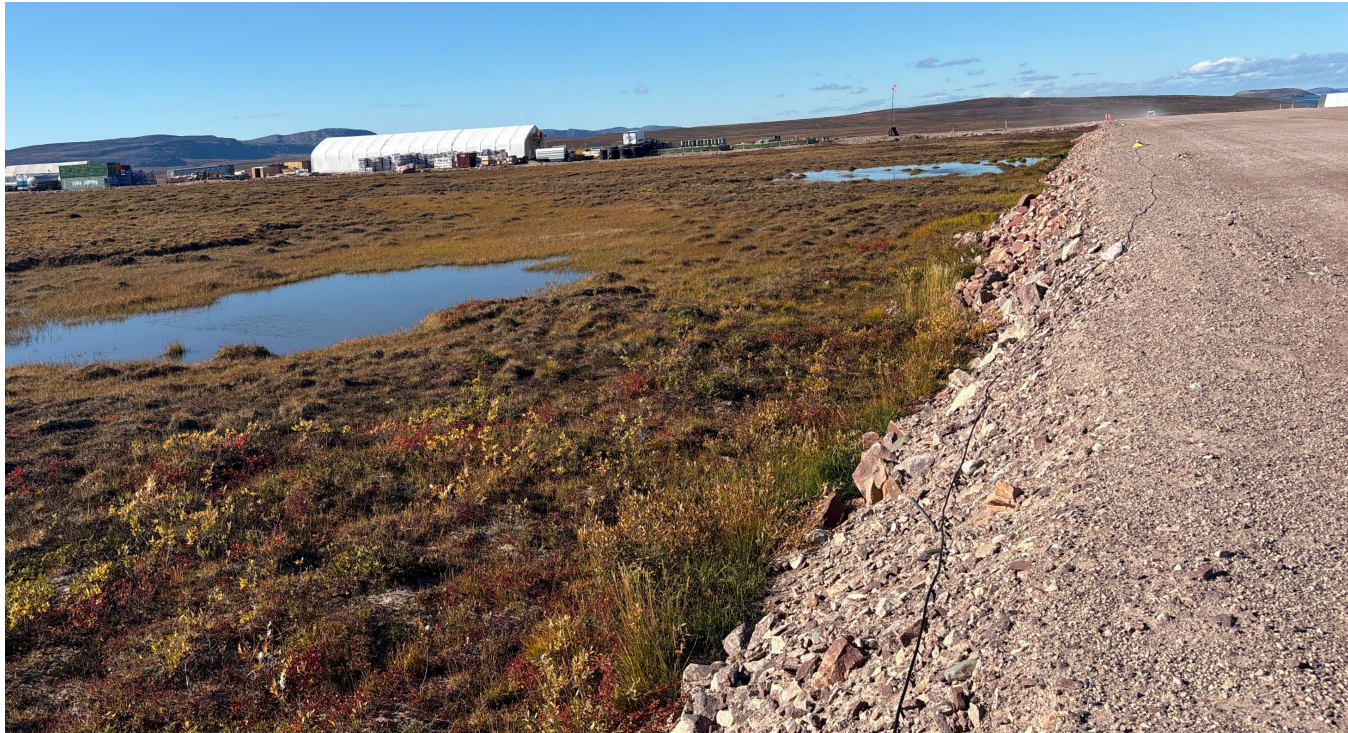
M-24: South end – Note ponding water at the toe of the embankment

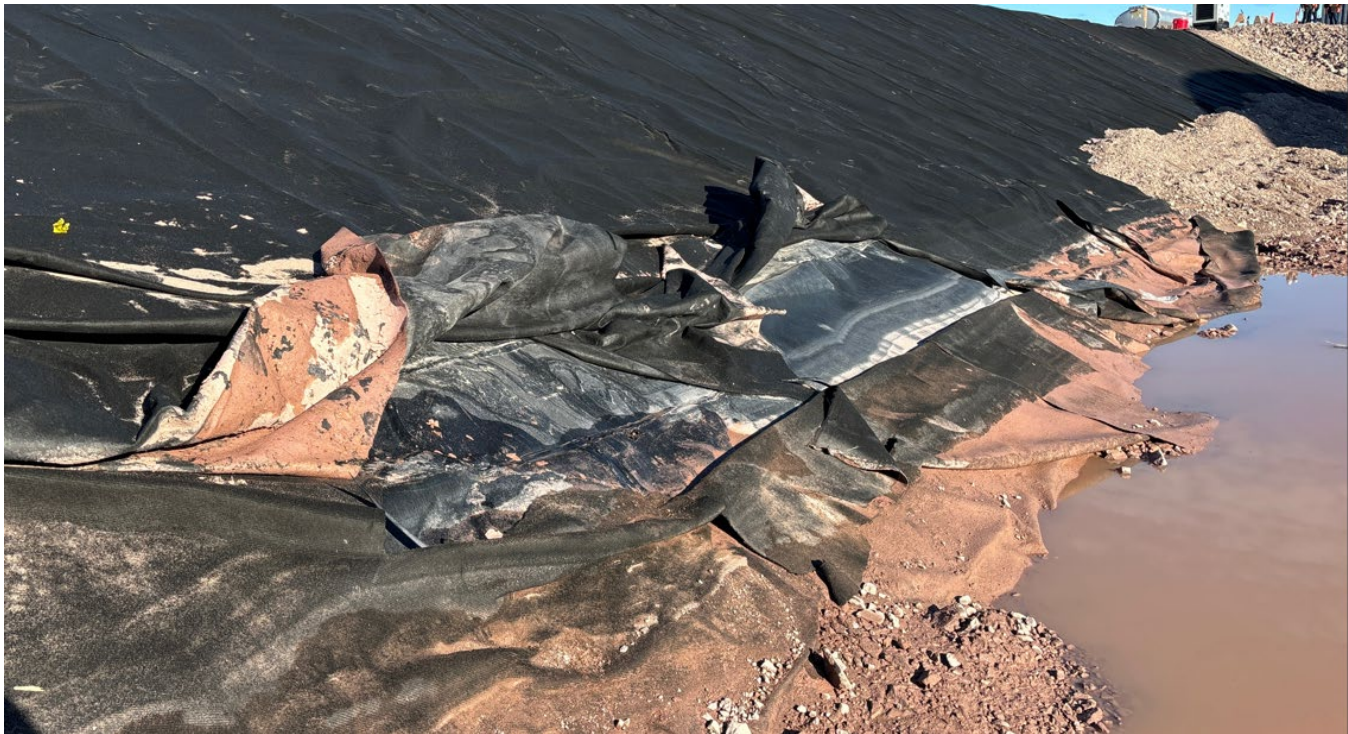
M-34: Liner damage
