Rascal Stream West Crossing Construction Summary Report

Back River Project (B2Gold Back River Corp.)

22567626-163-R-Rev0-8000

10 July 2024

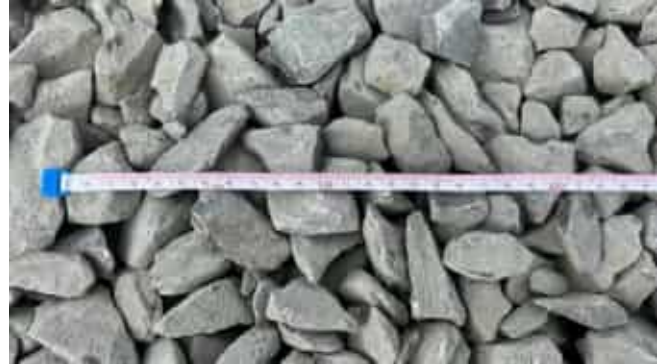
Photo 4: Measurement of The Bedding Material

- Provide sieve analysis data for both the bedding material and the esker material to approve use of these materials.
- Allowance for deviation between natural channel material obtained in the upstream and proposed embankment material should be confirmed with the design engineer, alternative material may be required.
- Final placed culvert slope to be provided to WSP to confirm acceptable conveyance capacity of the design event. The deviation between design and surveyed slopes should be confirmed with the design engineer.
- Culvert assembly of plates is recommended to be completed in-place, to avoid lifting segments of the culvert.

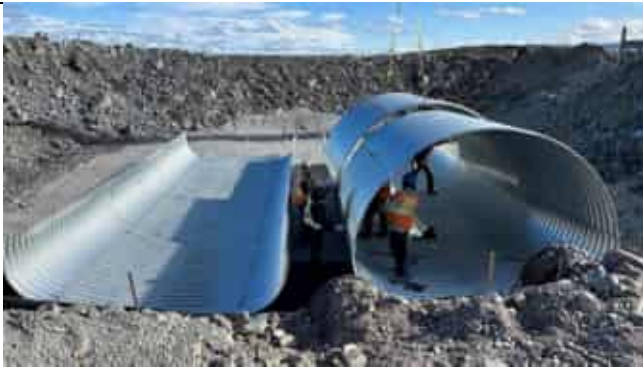
Photo 3: Top plate assembly began prior to placement of embankment material and boulder cluster

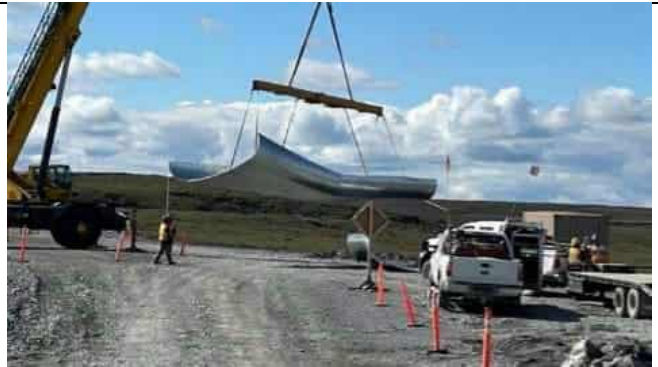
Photo 4: Culvert bottom plate of the downstream segment on the east side (right downstream) was deformed when being lifted

- Armtec's designer, S.J. Macrae, who provided the culvert structural design (Armtec drawing reference:19-463-B) should be notified about the culvert bottom plate deformation when being lifted to confirm structural integrity of the arch culverts under the haul road. Assessment, recommendations and potential remedial actions to be completed by Armtec.

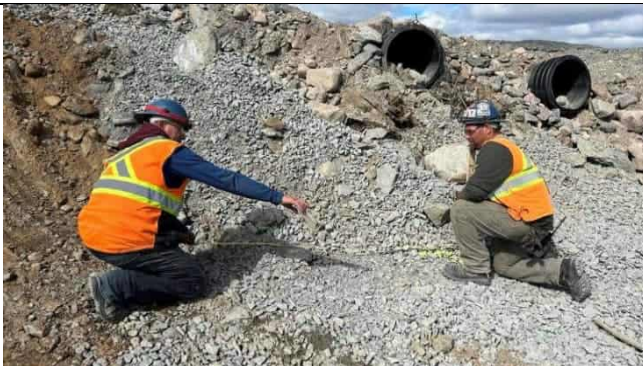
Photo 5: The excavated area extends 2.7 m from edge of the culvert on the west side

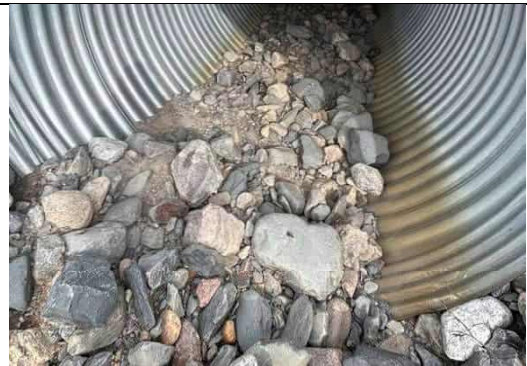
- No channel substrate was identified inside the secondary culvert.
- No geotextile was identified underneath riprap apron of the secondary culvert.
- Outlet of the secondary culvert was partially submerged under low flows with backwater effects observed at the outlet.

Photo 6: Minimal channel substrate was identified inside the secondary culvert

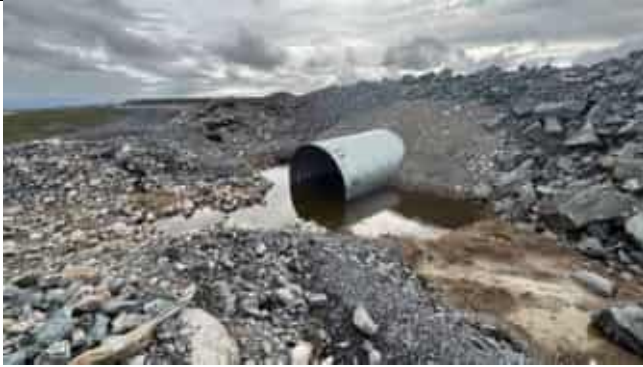
Photo 7: Outlet of the secondary culvert was partially submerged under low-flow condition

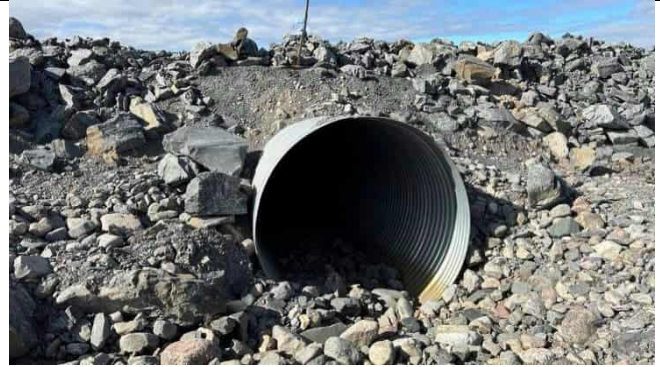
WSP did not observe or document the placement of the geotextile for the secondary channel culvert during the installation of the secondary culvert and B2Gold Nunavut did not provide documentation supporting the installation of the geotextile. Therefore, the geotextile installation was not confirmed and is considered a potential deficiency. WSP recommends monitoring the secondary channel culvert inlet, outlet, and aprons for channel migration and erosion and completing repairs as required with material that meets the design specifications or has been approved by WSP.

Photo 8: No non-woven geotextile was identified at the inlet and the outlet secondary culvert

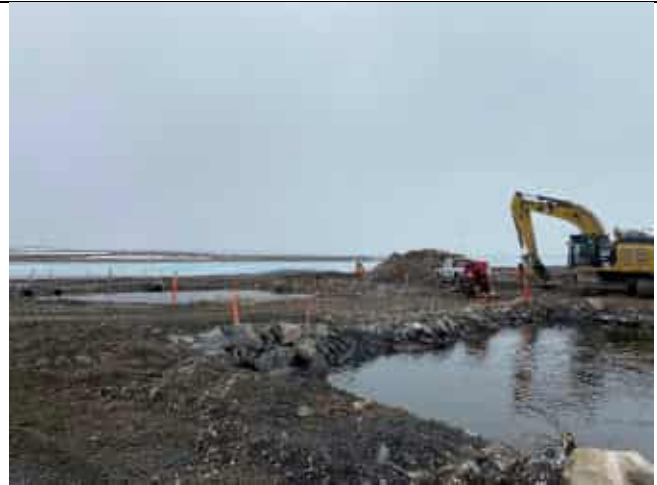
Photo 2: Lower pond seeping into twin multiplate excavation through temporary road.

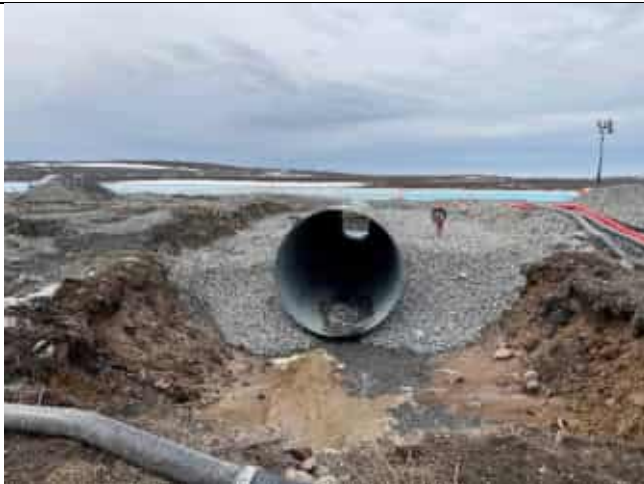
Photo 3: Secondary culvert inlet section raised without bedding underneath looking downstream at 16:52.

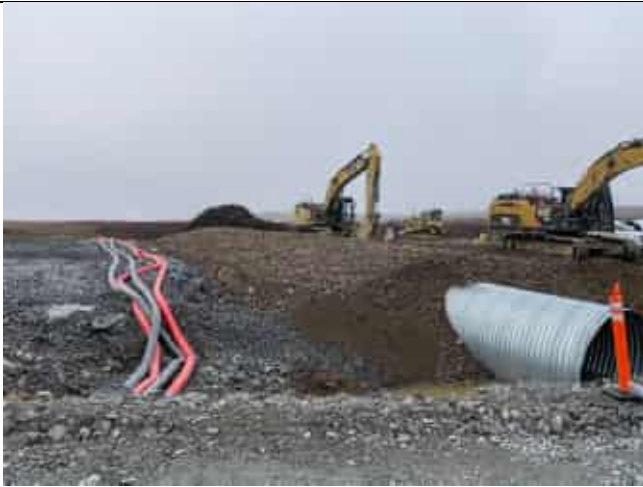
Photo 1: Secondary culvert raw esker backfill 0.3 m above culvert crest looking upstream at 8:59.

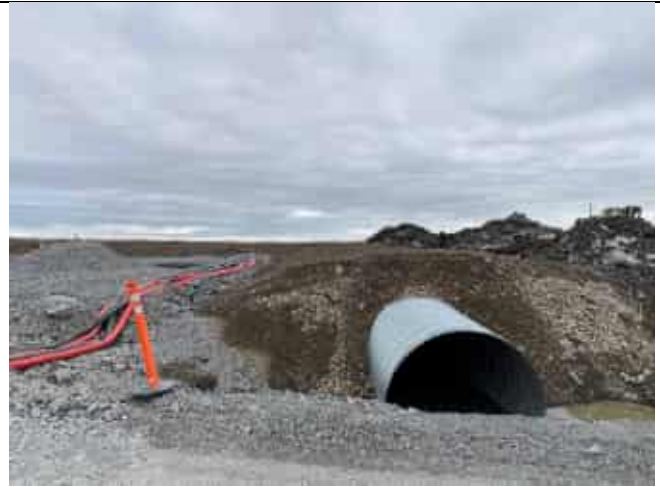
Photo 2: Secondary culvert raw esker backfill 0.6 m above culvert crest looking upstream at 14:38.

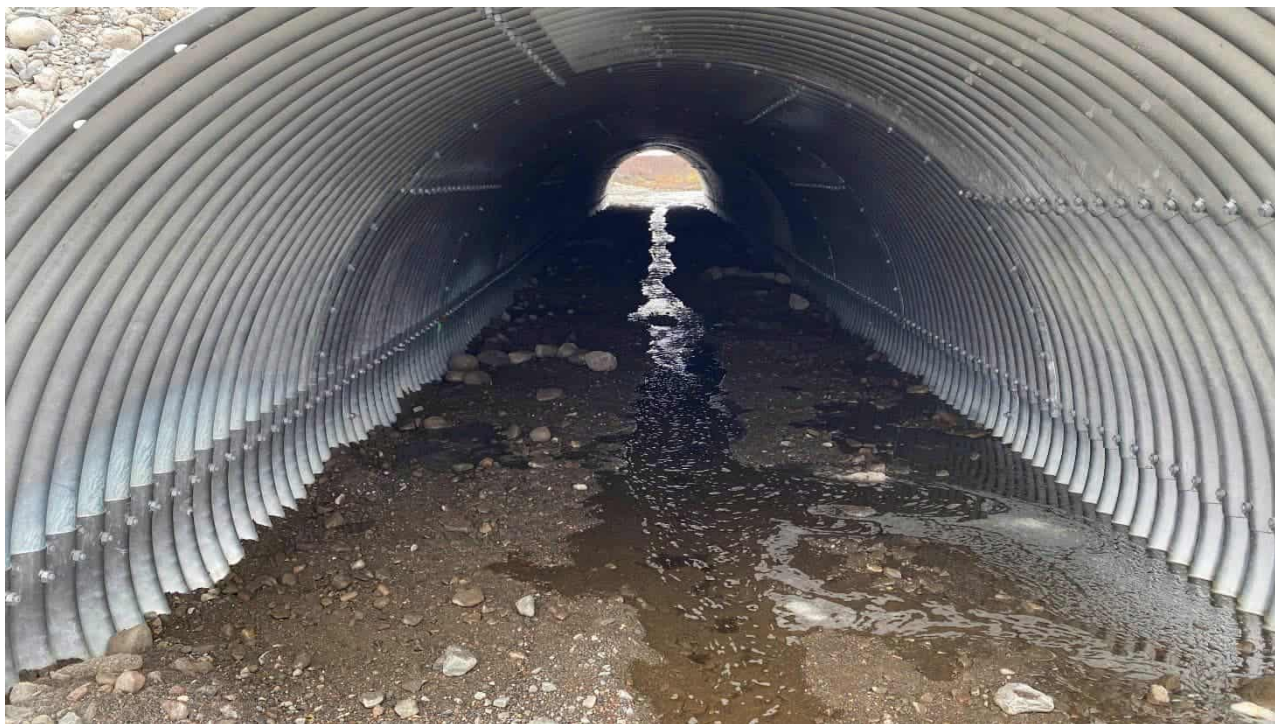
The channel embedment depth for the main channel culverts was specified to be 890 mm with shallow V-swale depth of 250 mm. The constructed embedment depth was observed to be approximately 500 mm with V-swale depth less than specified on September 17, 2023, and is a modification from the design specifications. This is not anticipated to adversely affect the conveyance capacity of the main channel culverts and concentrated flow was observed along the centerline. However, the shallow V-swale depth may adversely affect fish migration through the culverts during low-flow conditions. WSP recommends fisheries monitoring and monitoring the channel substrate for channel migration and erosion within the culverts and completing repairs as required.

Photograph 15: Main Channel East Barrel Channel Substrate Looking Upstream from Culvert Outlet, Taken September 17, 2023

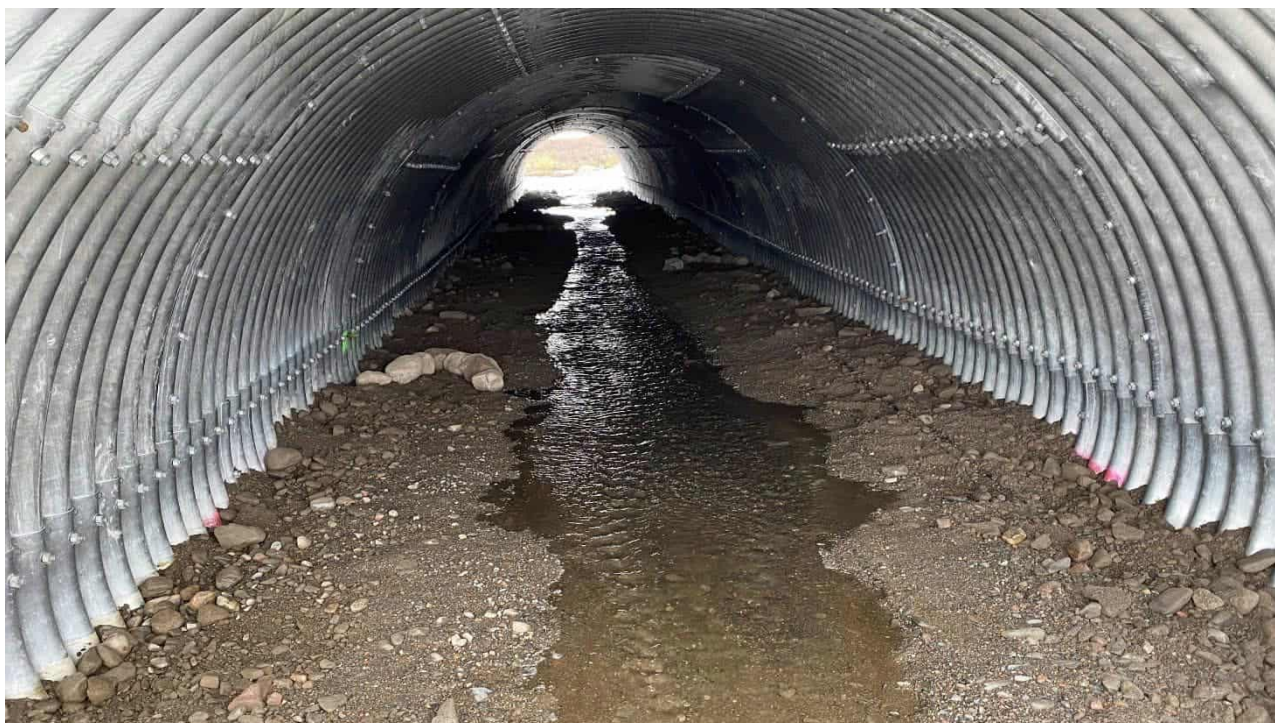
Photograph 16: Main Channel West Barrel Channel Substrate Looking Upstream from Culvert Outlet, Taken September 17, 2023

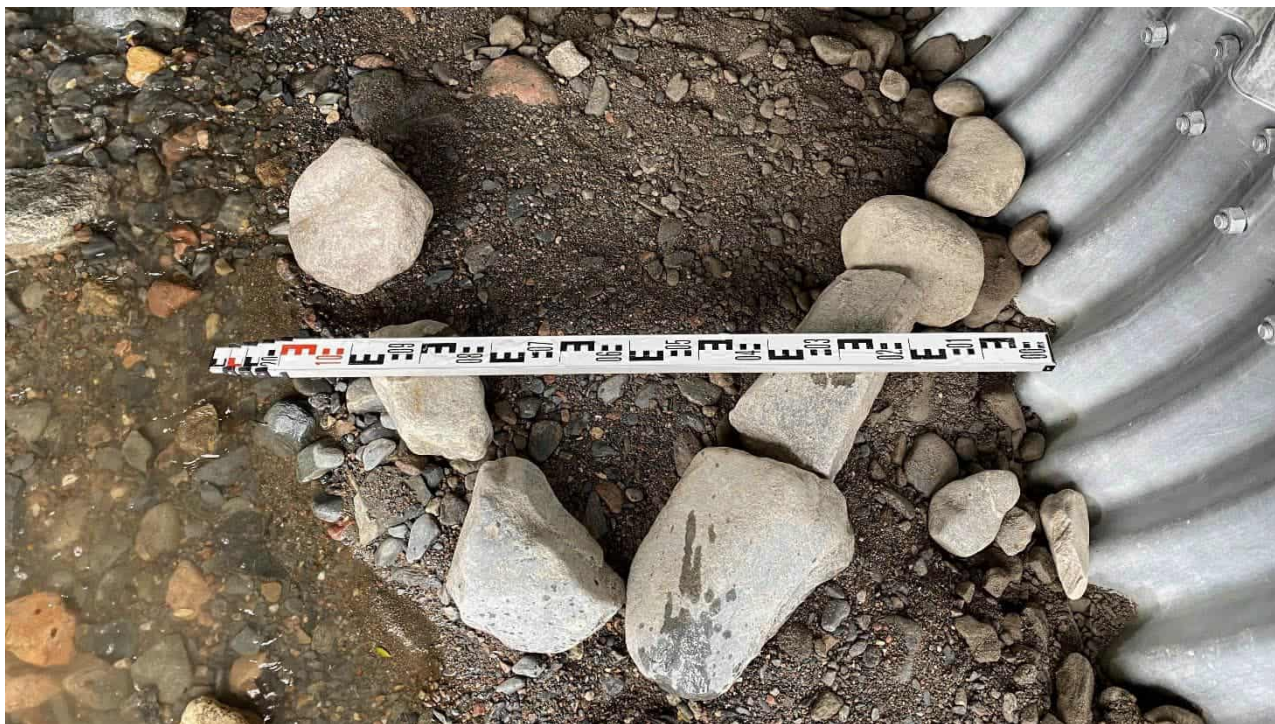
The boulder clusters for the main channel culverts were specified to be composed of rock sizes from 250 mm to 300 mm. The boulder clusters placed were observed to be undersized with an approximate D_{50} of 150 mm and is a modification from the design specifications. WSP recommends monitoring the boulder clusters for particle migration and completing repairs as required with rock sizes of 250 to 300 mm.

Photograph 17: Main Channel Culverts Typical Boulder Cluster and 1 m Scale Bar, Taken September 17, 2023

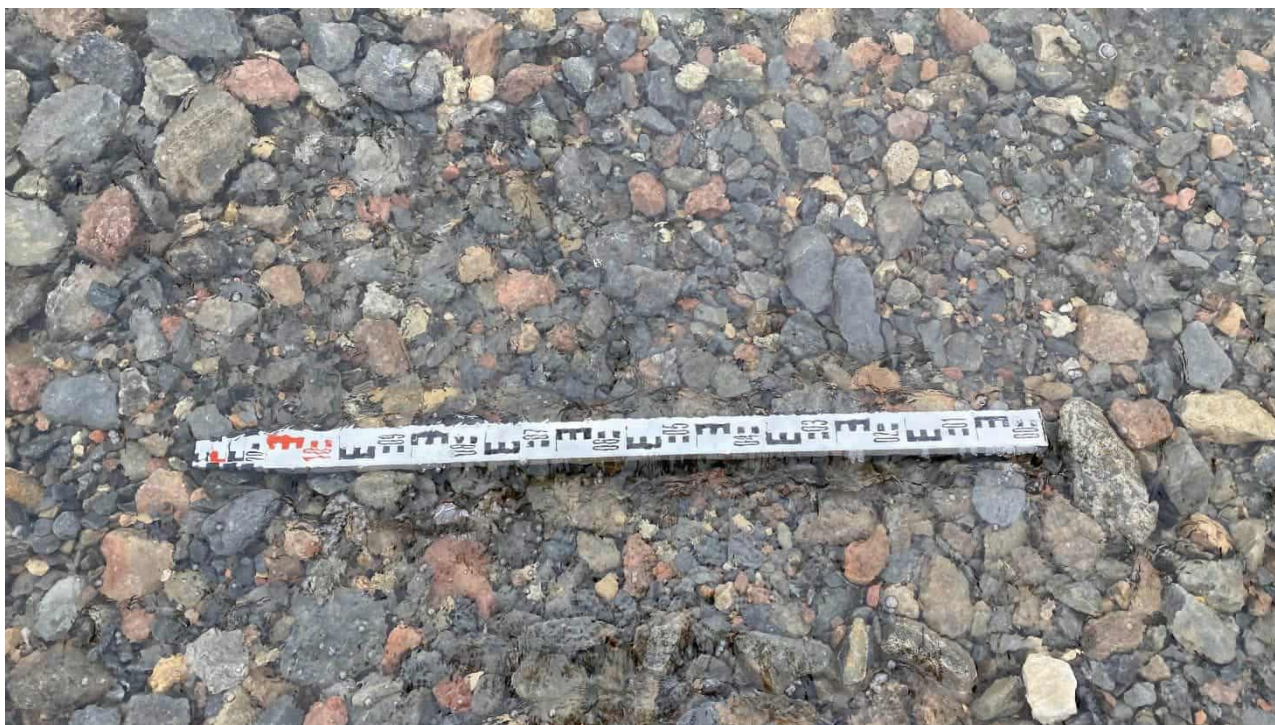
The material used for the construction of the main channel culverts and secondary channel culvert riprap aprons was esker material and is a modification from the design specifications. Based on visual observations, the esker material placed for the culvert aprons is undersized gravelly cobbles with an approximate D_{50} of 75 mm. Gradation of the esker material placed within the culvert aprons was not provided. There is potential for erosion of the embankments and at the culverts inlet and outlet due to undersized riprap material. WSP recommends riprap aprons be included in a monitoring program.

Photograph 18: Main Channel Apron Material and 1 m Scale Bar, Taken September 17, 2023

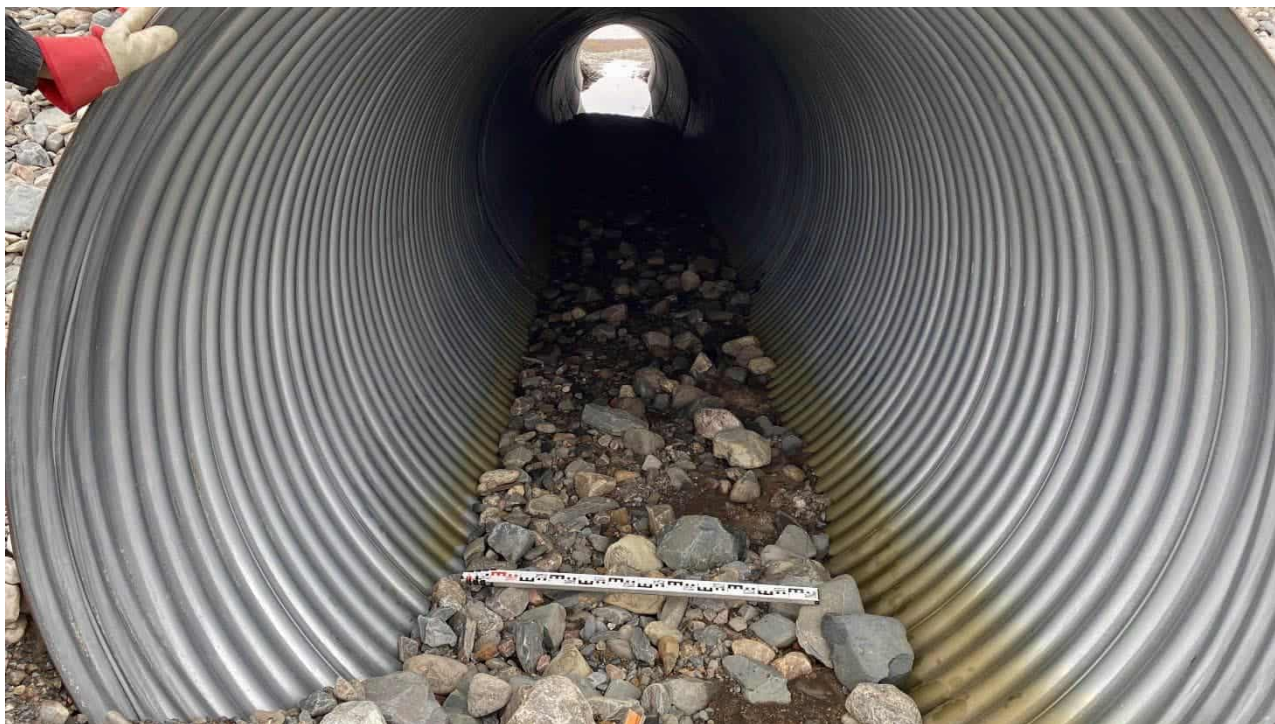
The channel embedment depth for the secondary channel culvert was specified to be 960 mm. The constructed embedment depth was observed to be approximately 310 mm on September 17, 2023 and is a modification from the design specifications. This is not anticipated to adversely affect the conveyance capacity of the secondary channel culvert. However, WSP recommends including the secondary channel culvert in future fish monitoring programs.

Photograph 25: Secondary Channel Culvert Substrate and Embedment Material Looking Downstream from Culvert Inlet, Taken September 17, 2023

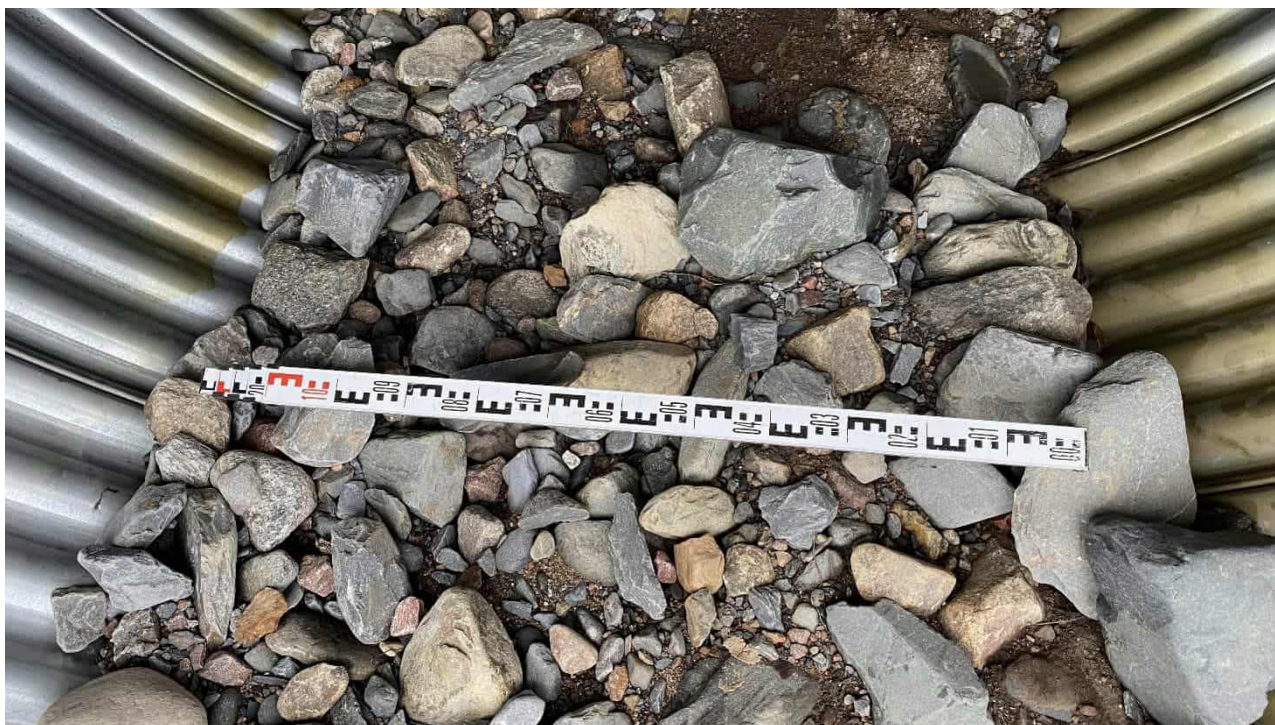
Photograph 26: Secondary Channel Culvert Substrate and 1 m Scale Bar at Inlet, Taken September 17, 2023
