Rascal Stream West Crossing Construction Summary Report

Back River Project (B2Gold Back River Corp.)

22567626-163-R-Rev0-8000

10 July 2024

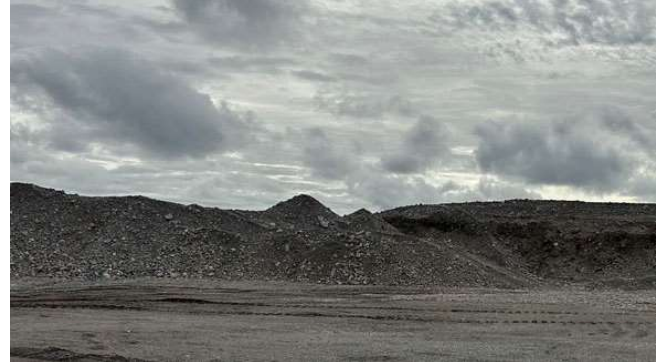
Photo 2: Proposed Substitute Material for Channel Substrate 09:30.

- Provide sieve analysis data for both the bedding material and the esker material to approve use of these materials.
- Allowance for deviation between natural channel material obtained in the upstream and proposed embankment material should be confirmed with the design engineer, alternative material may be required.
- Final placed culvert slope to be provided to WSP to confirm acceptable conveyance capacity of the design event. The deviation between design and surveyed slopes should be confirmed with the design engineer.
- Culvert assembly of plates is recommended to be completed in-place, to avoid lifting segments of the culvert.

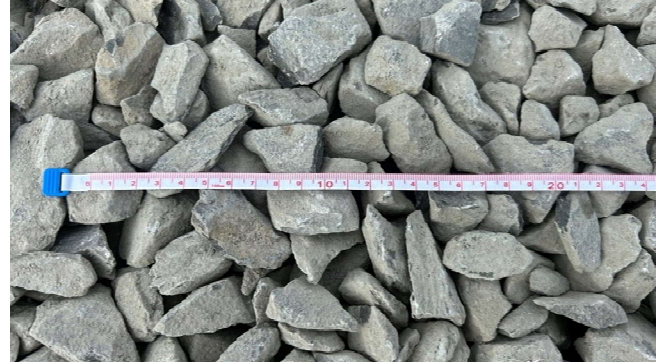
Photo 4: Measurement of The Bedding Material

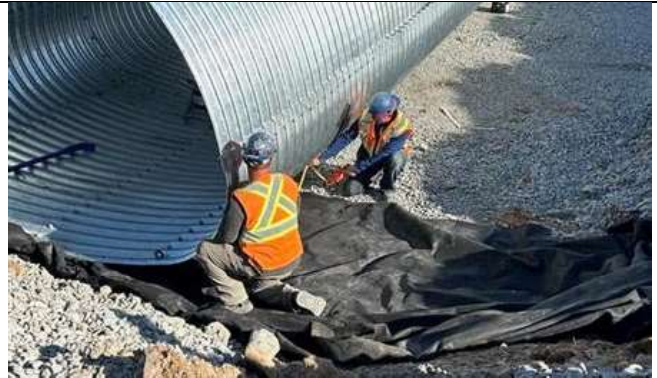
Photo 2: Non-woven geotextile extends 2 m beneath culvert

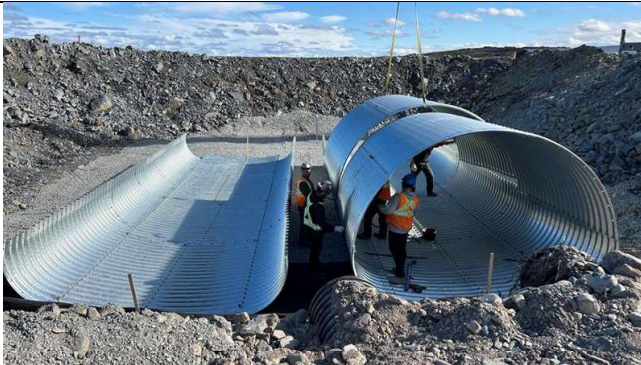
Photo 3: Top plate assembly began prior to placement of embankment material and boulder cluster

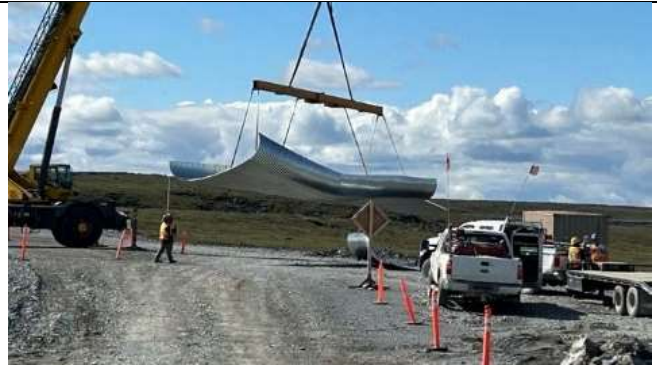
Photo 4: Culvert bottom plate of the downstream segment on the east side (right downstream) was deformed when being lifted

- Armtec's designer, S.J. Macrae, who provided the culvert structural design (Armtec drawing reference:19-463-B) should be notified about the culvert bottom plate deformation when being lifted to confirm structural integrity of the arch culverts under the haul road. Assessment, recommendations and potential remedial actions to be completed by Armtec.

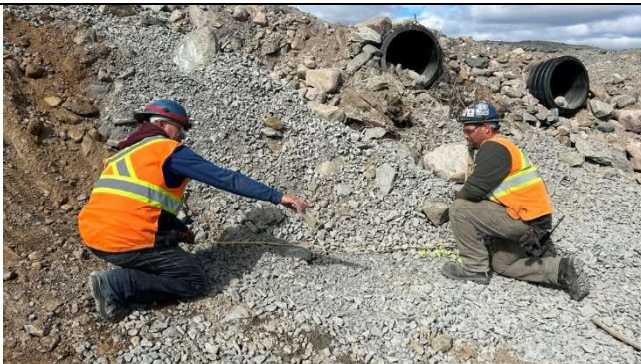
Photo 5: The excavated area extends 2.7 m from edge of the culvert on the west side

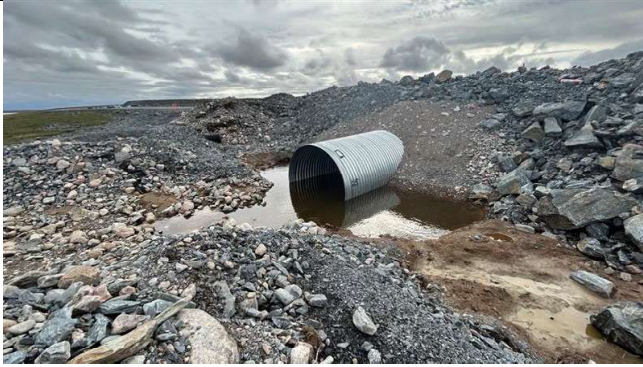
- No channel substrate was identified inside the secondary culvert.
- No geotextile was identified underneath riprap apron of the secondary culvert.
- Outlet of the secondary culvert was partially submerged under low flows with backwater effects observed at the outlet.

Photo 7: Outlet of the secondary culvert was partially submerged under low-flow condition

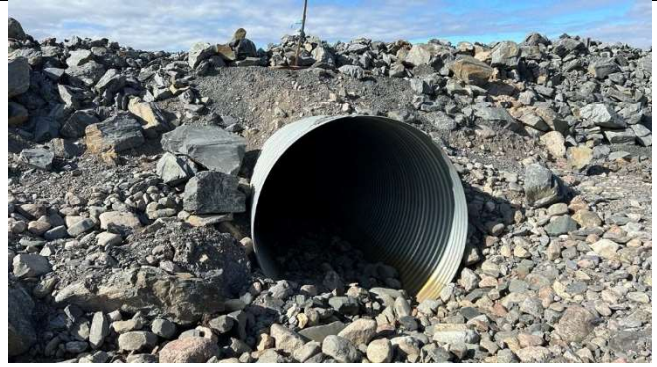
WSP did not observe or document the placement of the geotextile for the secondary channel culvert during the installation of the secondary culvert and B2Gold Nunavut did not provide documentation supporting the installation of the geotextile. Therefore, the geotextile installation was not confirmed and is considered a potential deficiency. WSP recommends monitoring the secondary channel culvert inlet, outlet, and aprons for channel migration and erosion and completing repairs as required with material that meets the design specifications or has been approved by WSP.

Photo 8: No non-woven geotextile was identified at the inlet and the outlet secondary culvert

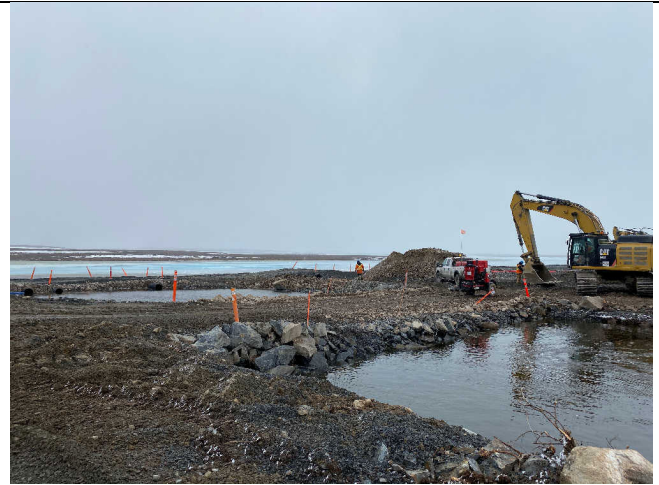
Photo 2: Lower pond seeping into twin multiplate excavation through temporary road.

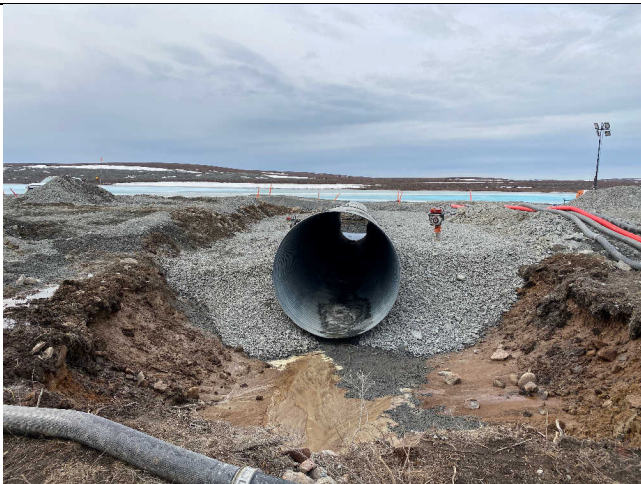
Photo 3: Secondary culvert inlet section raised without bedding underneath looking downstream at 16:52.

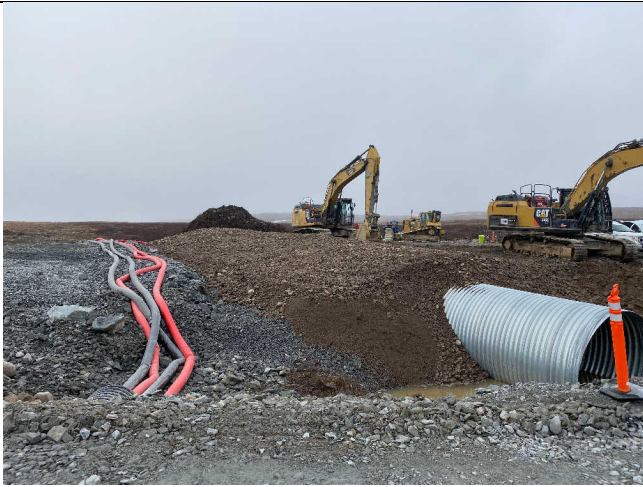
Photo 1: Secondary culvert raw esker backfill 0.3 m above culvert crest looking upstream at 8:59.

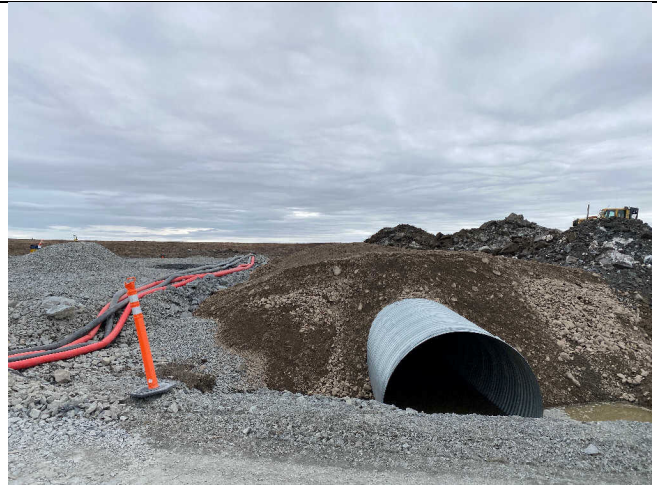
Photo 2: Secondary culvert raw esker backfill 0.6 m above culvert crest looking upstream at 14:38.

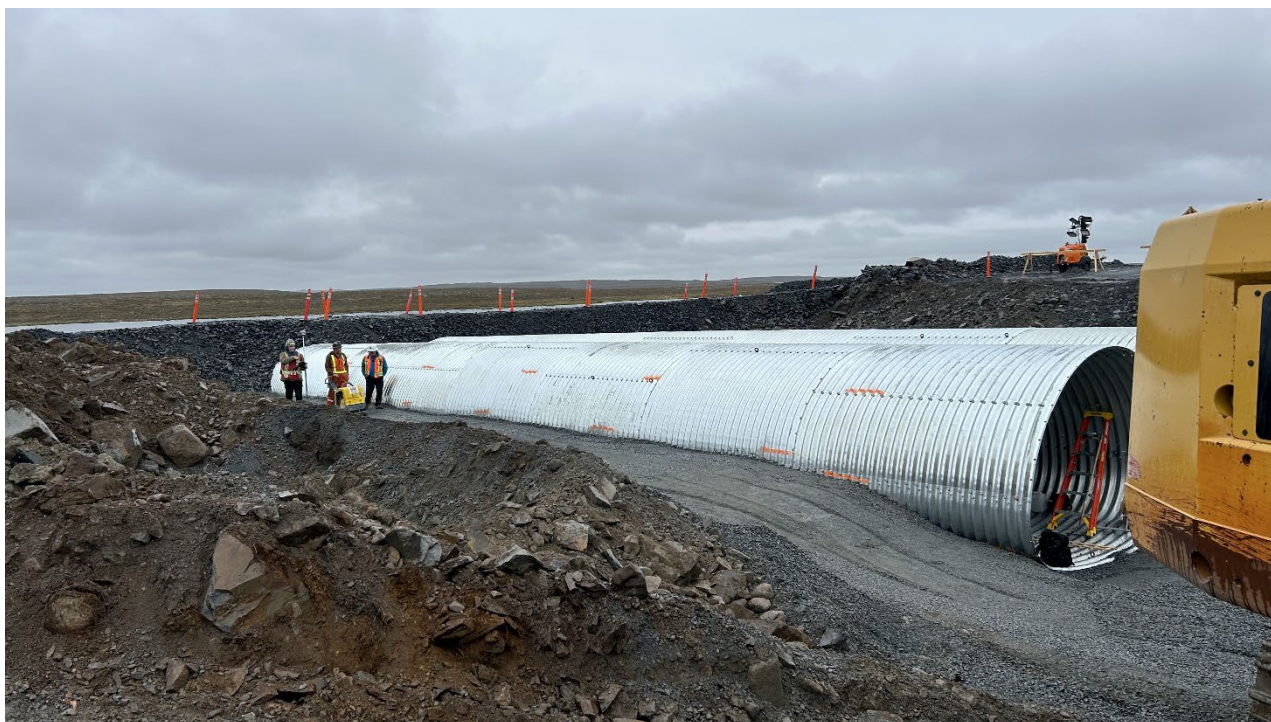
According to Armtec's design drawing package (Armtec Project #19-463-B), backfill for the culvert construction was specified to be compacted to 95% standard proctor. No backfill compaction testing was completed during the construction of the culverts. WSP acknowledges that 95% standard proctor compaction of the backfill may have been achieved, however, because there was no compaction testing and documentation, the actual compaction achieved is unknown and deemed a potential deficiency. The potential for unsatisfactory compaction of the backfill material may result in culvert deformation and road subsidence of the culverts, which WSP recommends be included in a monitoring program.

Photograph 7: Main Channel Culverts Backfill Placement and Compaction to Approximately 900 mm Above Culvert Invert. Taken August 22, 2023 (Provided by B2Gold)

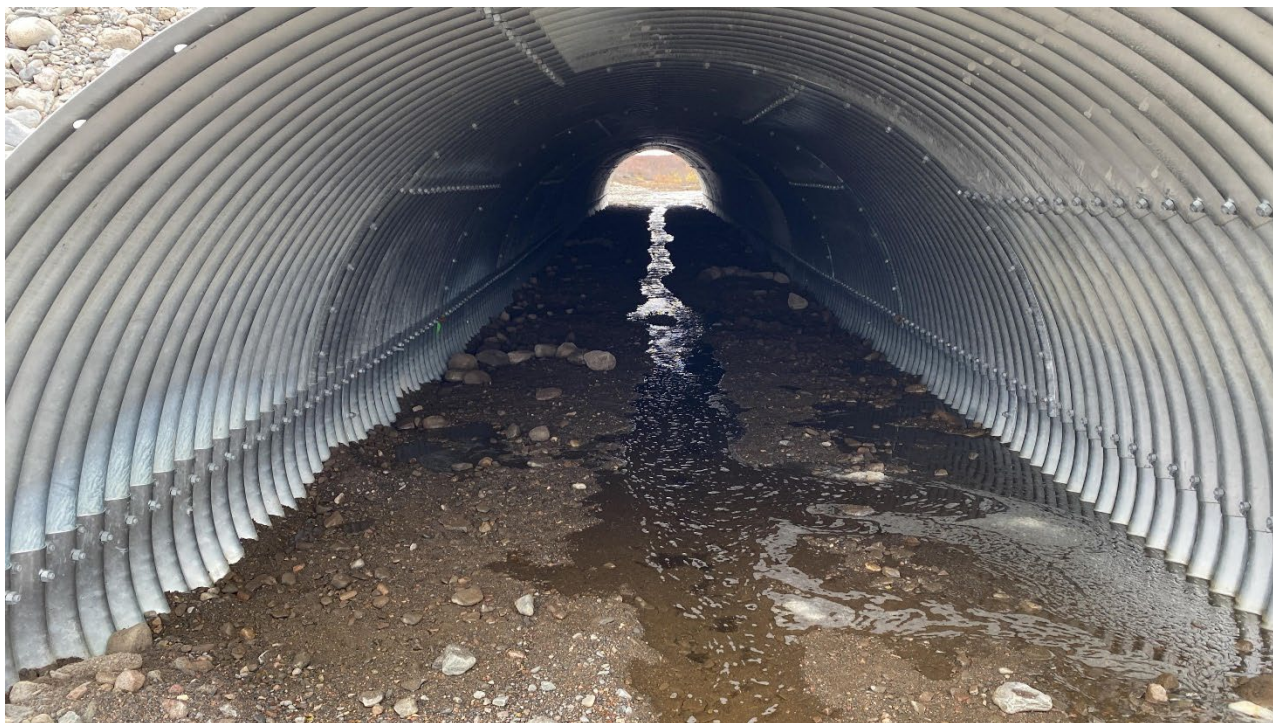
The channel embedment depth for the main channel culverts was specified to be 890 mm with shallow V-swale depth of 250 mm. The constructed embedment depth was observed to be approximately 500 mm with V-swale depth less than specified on September 17, 2023, and is a modification from the design specifications. This is not anticipated to adversely affect the conveyance capacity of the main channel culverts and concentrated flow was observed along the centerline. However, the shallow V-swale depth may adversely affect fish migration through the culverts during low-flow conditions. WSP recommends fisheries monitoring and monitoring the channel substrate for channel migration and erosion within the culverts and completing repairs as required.

Photograph 15: Main Channel East Barrel Channel Substrate Looking Upstream from Culvert Outlet, Taken September 17, 2023

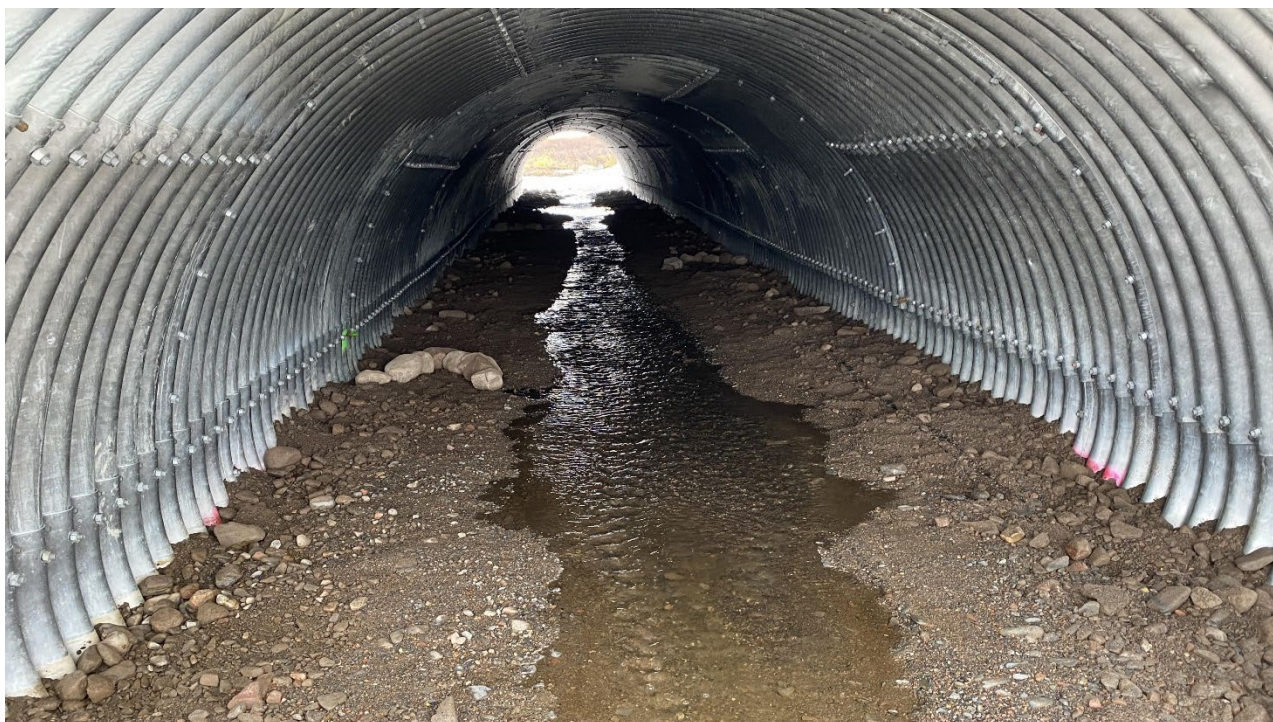
Photograph 16: Main Channel West Barrel Channel Substrate Looking Upstream from Culvert Outlet, Taken September 17, 2023

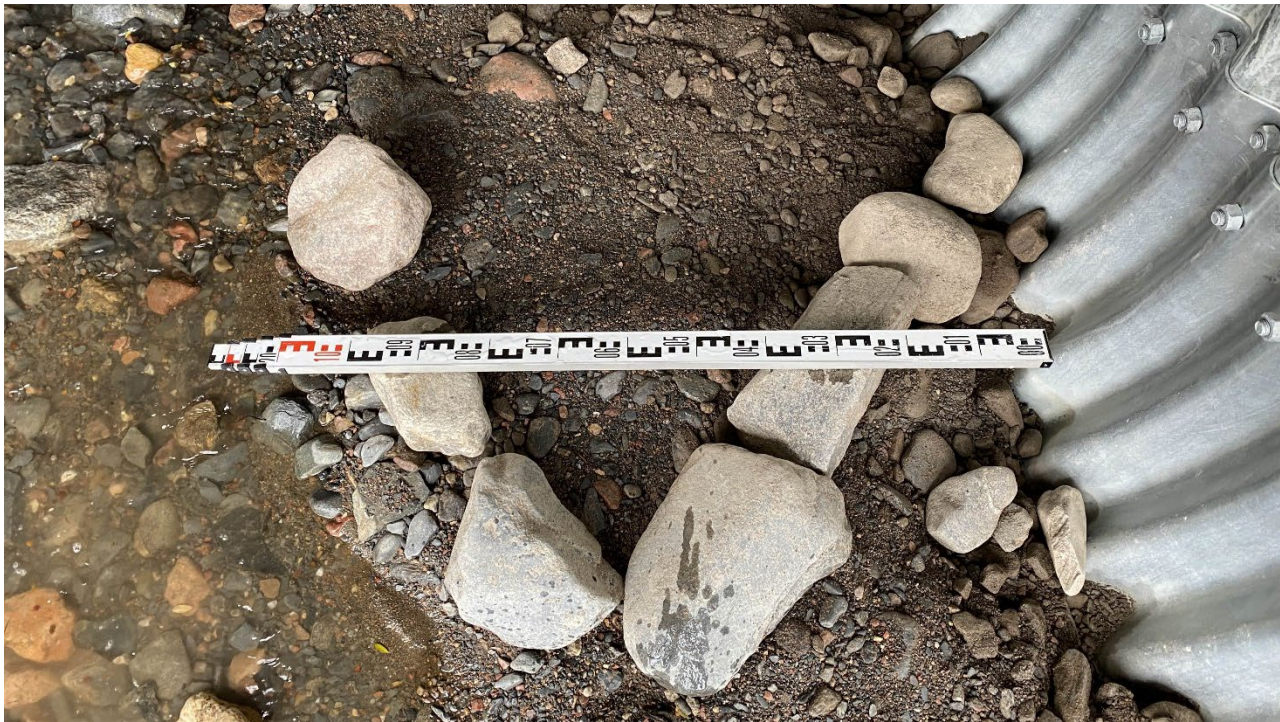
The boulder clusters for the main channel culverts were specified to be composed of rock sizes from 250 mm to 300 mm. The boulder clusters placed were observed to be undersized with an approximate D_{50} of 150 mm and is a modification from the design specifications. WSP recommends monitoring the boulder clusters for particle migration and completing repairs as required with rock sizes of 250 to 300 mm.

Photograph 17: Main Channel Culverts Typical Boulder Cluster and 1 m Scale Bar, Taken September 17, 2023

- Shallow V-swale cross-sectional shape for main channel culverts remains for improved fish passage under low-flow conditions.
- Inspect boulder clusters after freshet and replace displaced boulders as required.
- Embankment, inlet and outlet riprap erosion, as well as bed and banks erosion near the culverts.
- Debris accumulation:
 - Remove debris as required to maintain designed culvert capacity.
- Structural monitoring of the culverts (deformation) and haul road subsidence inspection.

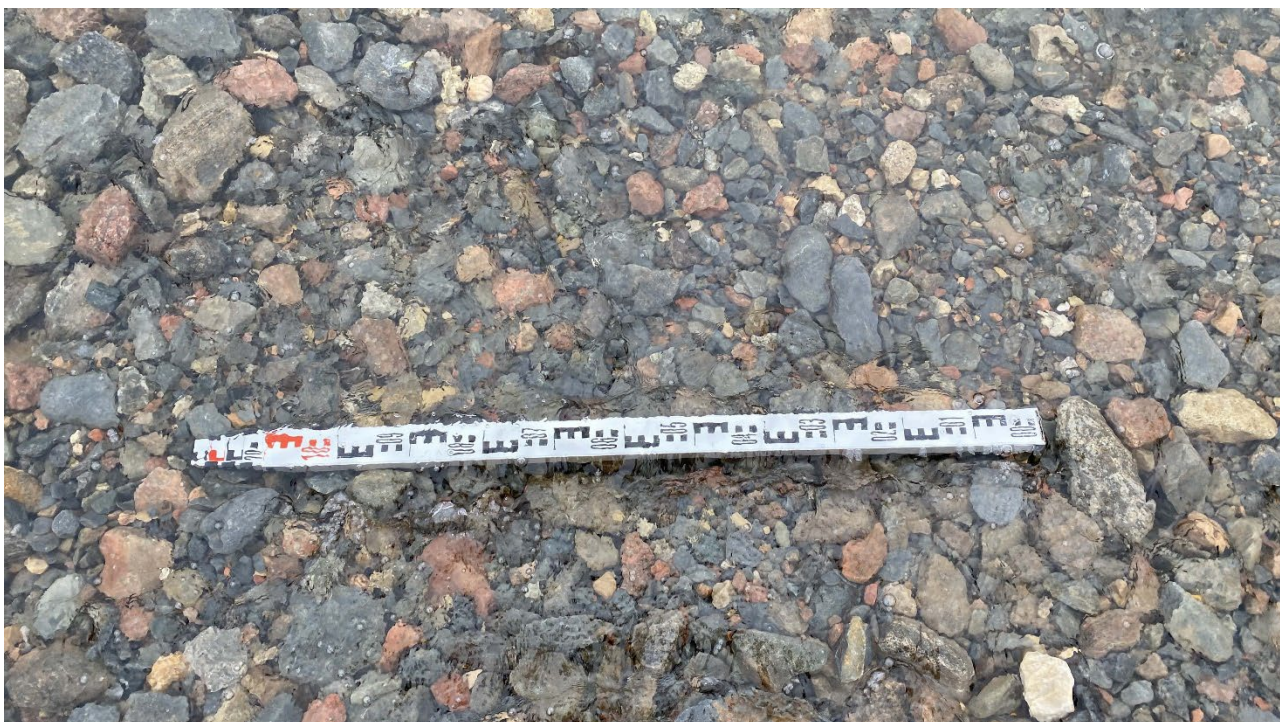
The material used for the construction of the main channel culverts and secondary channel culvert riprap aprons was esker material and is a modification from the design specifications. Based on visual observations, the esker material placed for the culvert aprons is undersized gravelly cobbles with an approximate D_{50} of 75 mm. Gradation of the esker material placed within the culvert aprons was not provided. There is potential for erosion of the embankments and at the culverts inlet and outlet due to undersized riprap material. WSP recommends riprap aprons be included in a monitoring program.

Photograph 18: Main Channel Apron Material and 1 m Scale Bar, Taken September 17, 2023

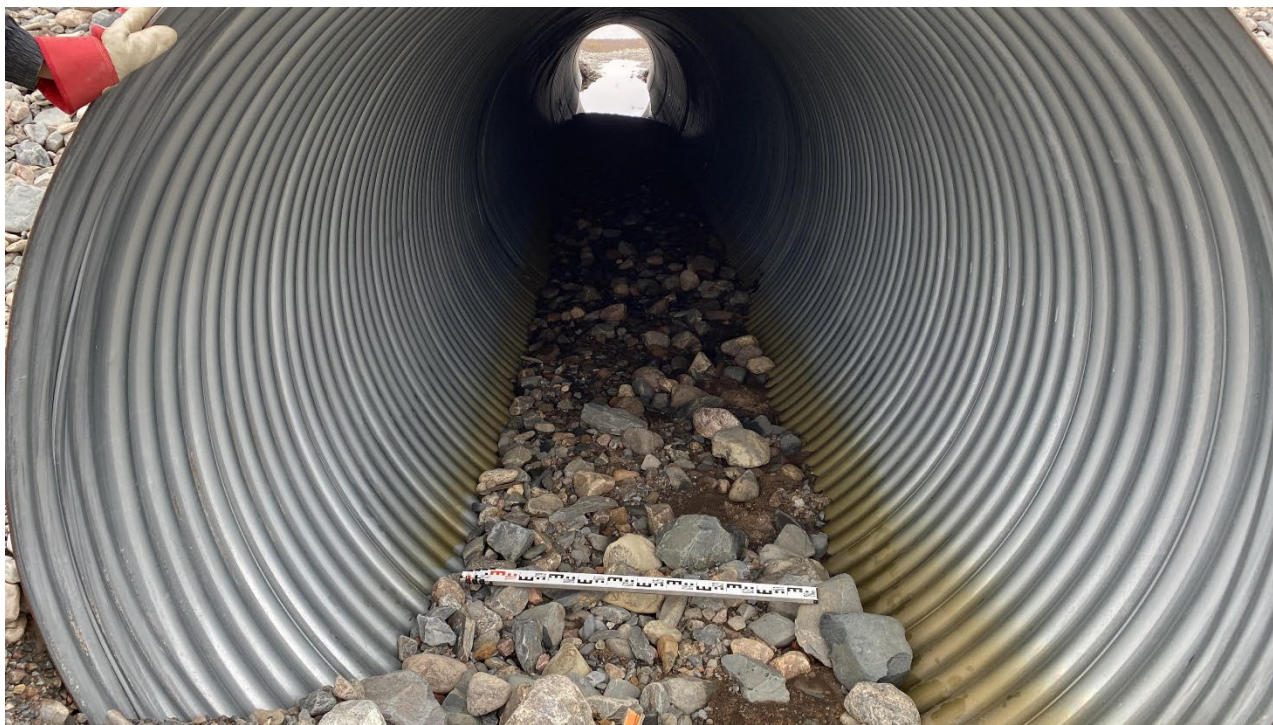
The channel embedment depth for the secondary channel culvert was specified to be 960 mm. The constructed embedment depth was observed to be approximately 310 mm on September 17, 2023 and is a modification from the design specifications. This is not anticipated to adversely affect the conveyance capacity of the secondary channel culvert. However, WSP recommends including the secondary channel culvert in future fish monitoring programs.

Photograph 25: Secondary Channel Culvert Substrate and Embedment Material Looking Downstream from Culvert Inlet, Taken September 17, 2023

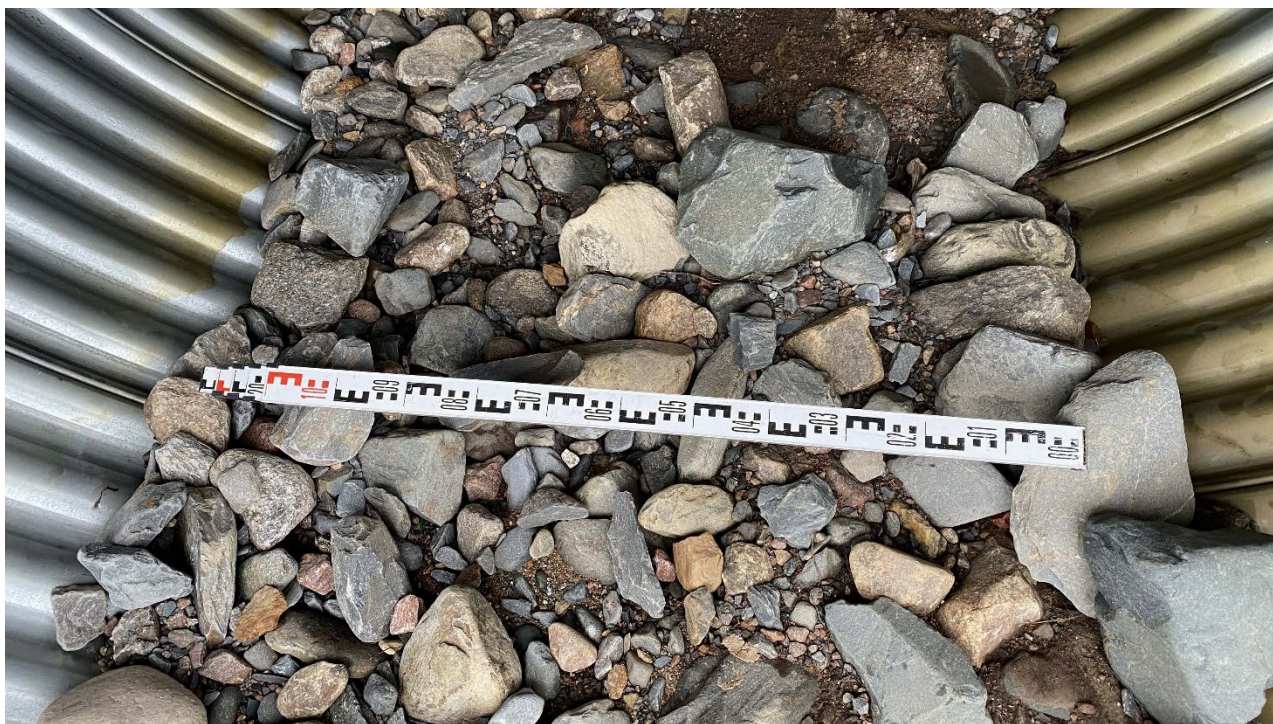
Channel substrate for the main channel culverts and secondary channel culvert was specified to be excavated native channel substrate. The excavated channel substrate was deemed unsuitable for the culvert channel substrate due to high saturation and esker material was substituted. The esker material placed was observed to be undersized gravelly cobbles with an approximate D_{50} of 75 mm and is a modification from the design specifications. WSP recommends monitoring the channel substrate for channel migration and erosion within the main channel culverts and secondary channel culvert and completing repairs as required.

Photograph 26: Secondary Channel Culvert Substrate and 1 m Scale Bar at Inlet, Taken September 17, 2023
