Attention **Merle Keefe, Environmental Permitting Manager for Sabina Gold and Silver**
Subject **Goose Project Site – 2021 Annual Geotechnical Inspection**
Project 1CS020.021

The 2021 AGI for the Goose site is the subject of this memorandum.

Attachment 3 Photolog from July 2021 Site Visit

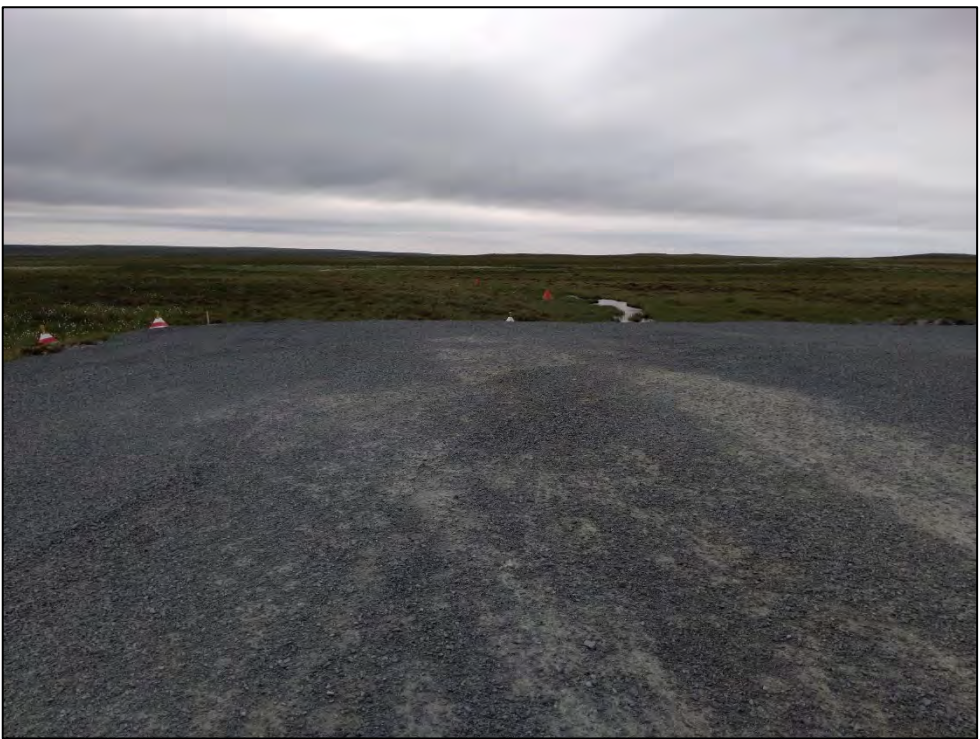
Photo 26 – Southern end of airstrip where thick fill note, no cracking or undulation observed

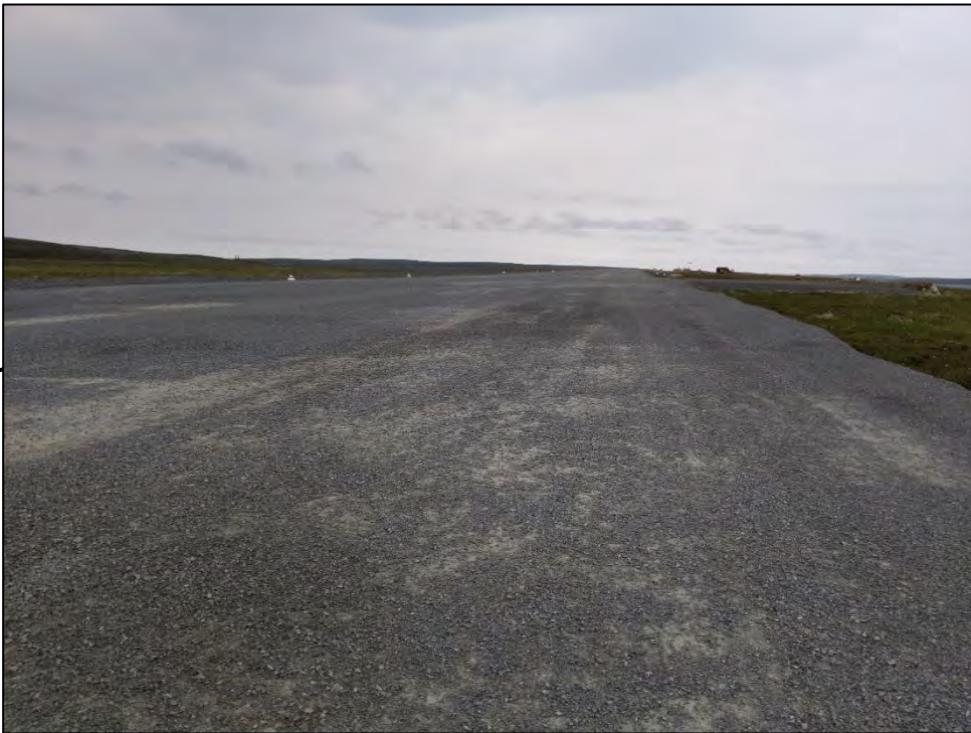
Photo 27 – View northerly direction of airstrip surface, no cracking observed despite lower fill thickness

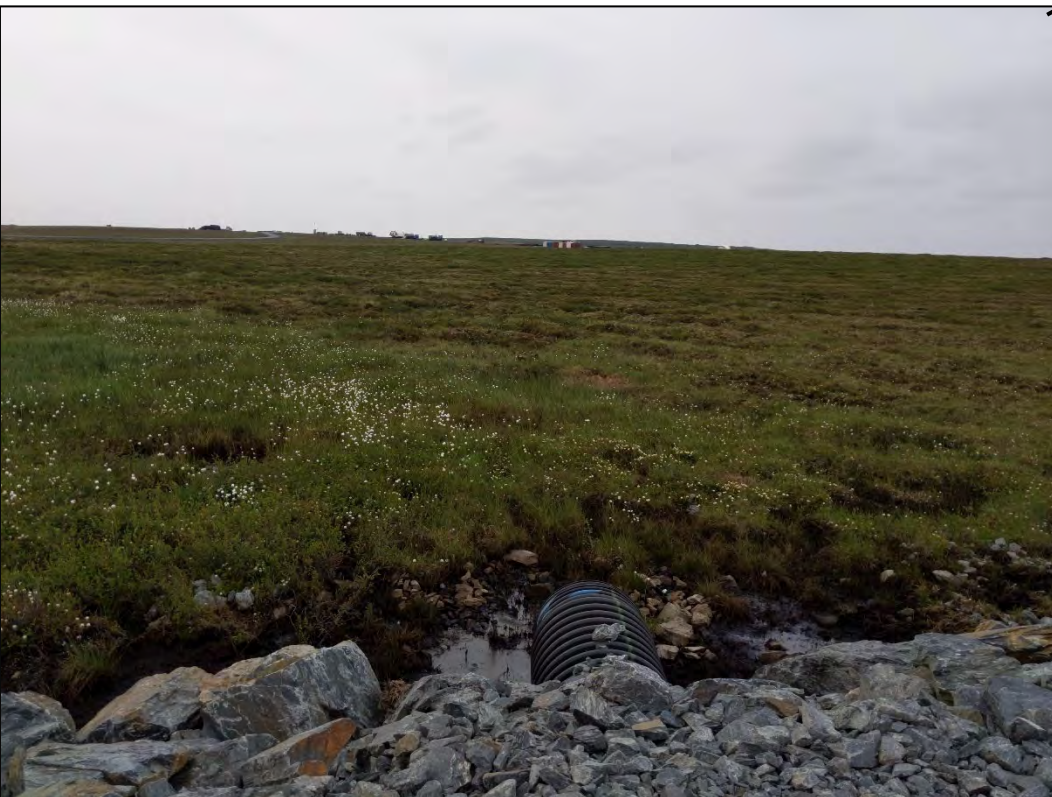
Photo 2 – Inlet, no ponding observed

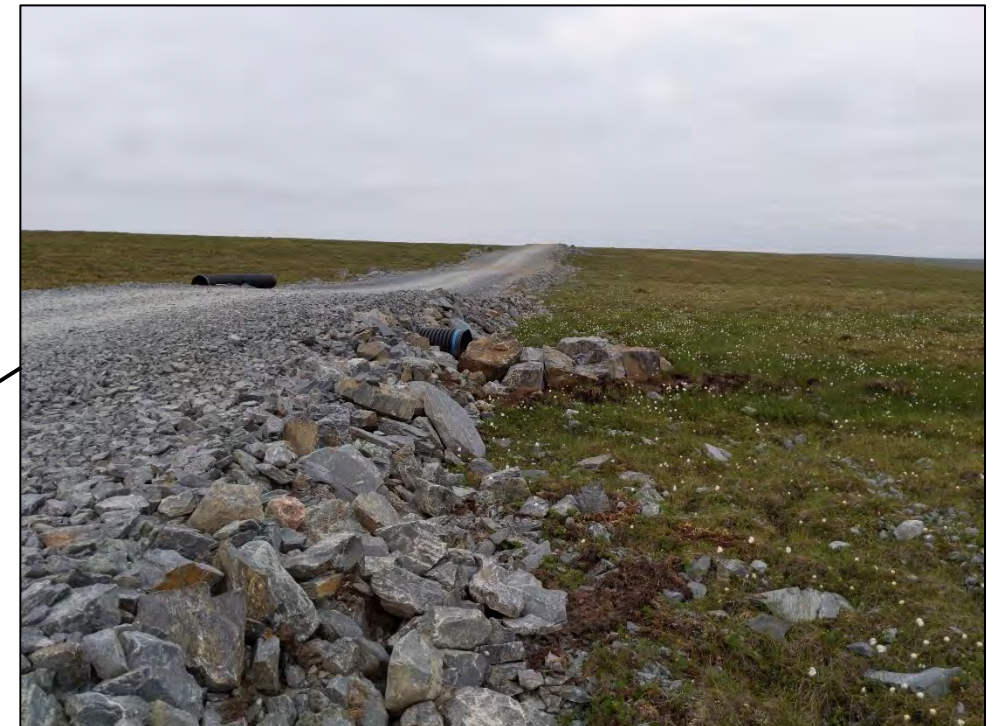
Photo 3 - Outlet, note rocks placed to dissipate water energy at culvert outlet. Cover above pipe may be insufficient/problematic when traversed by larger vehicles.

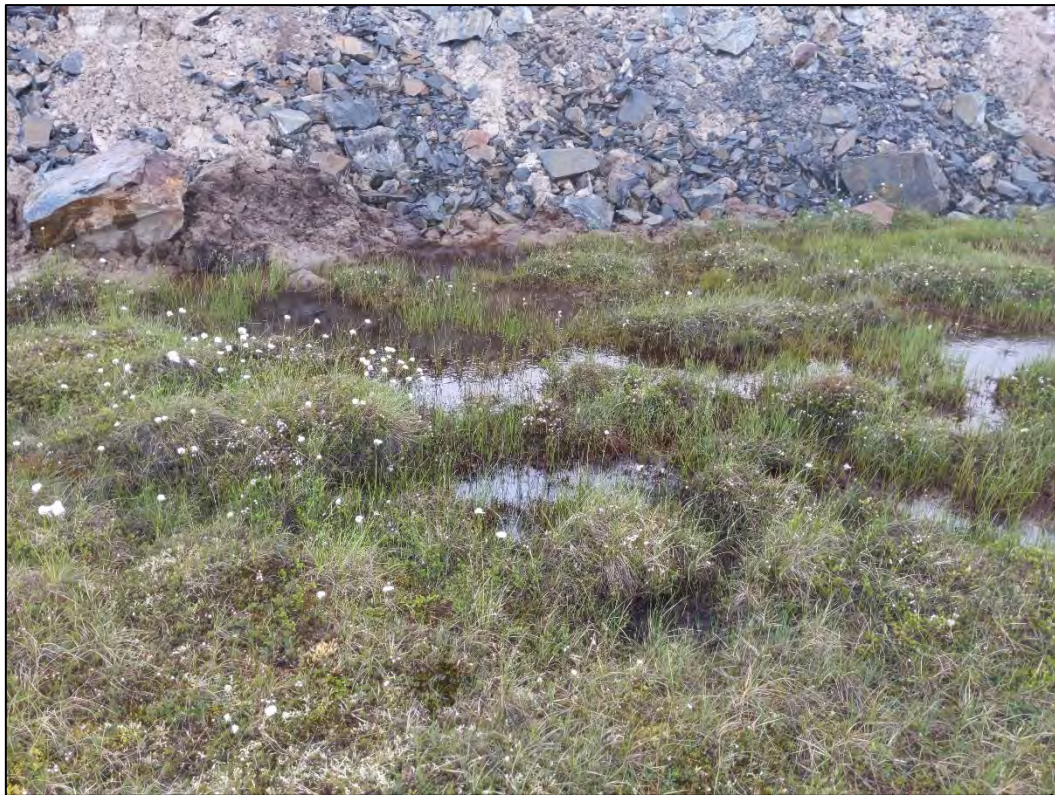
Photo 9 – Some ponded water observed within footprint

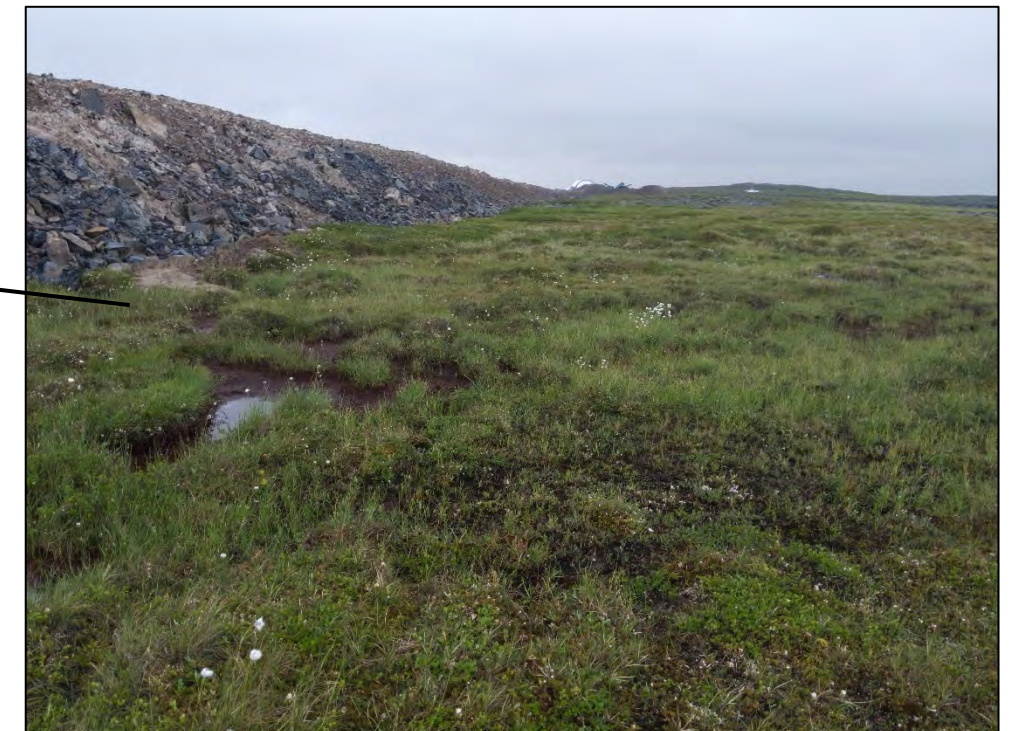
Photo 12 – Some ponded water observed within footprint

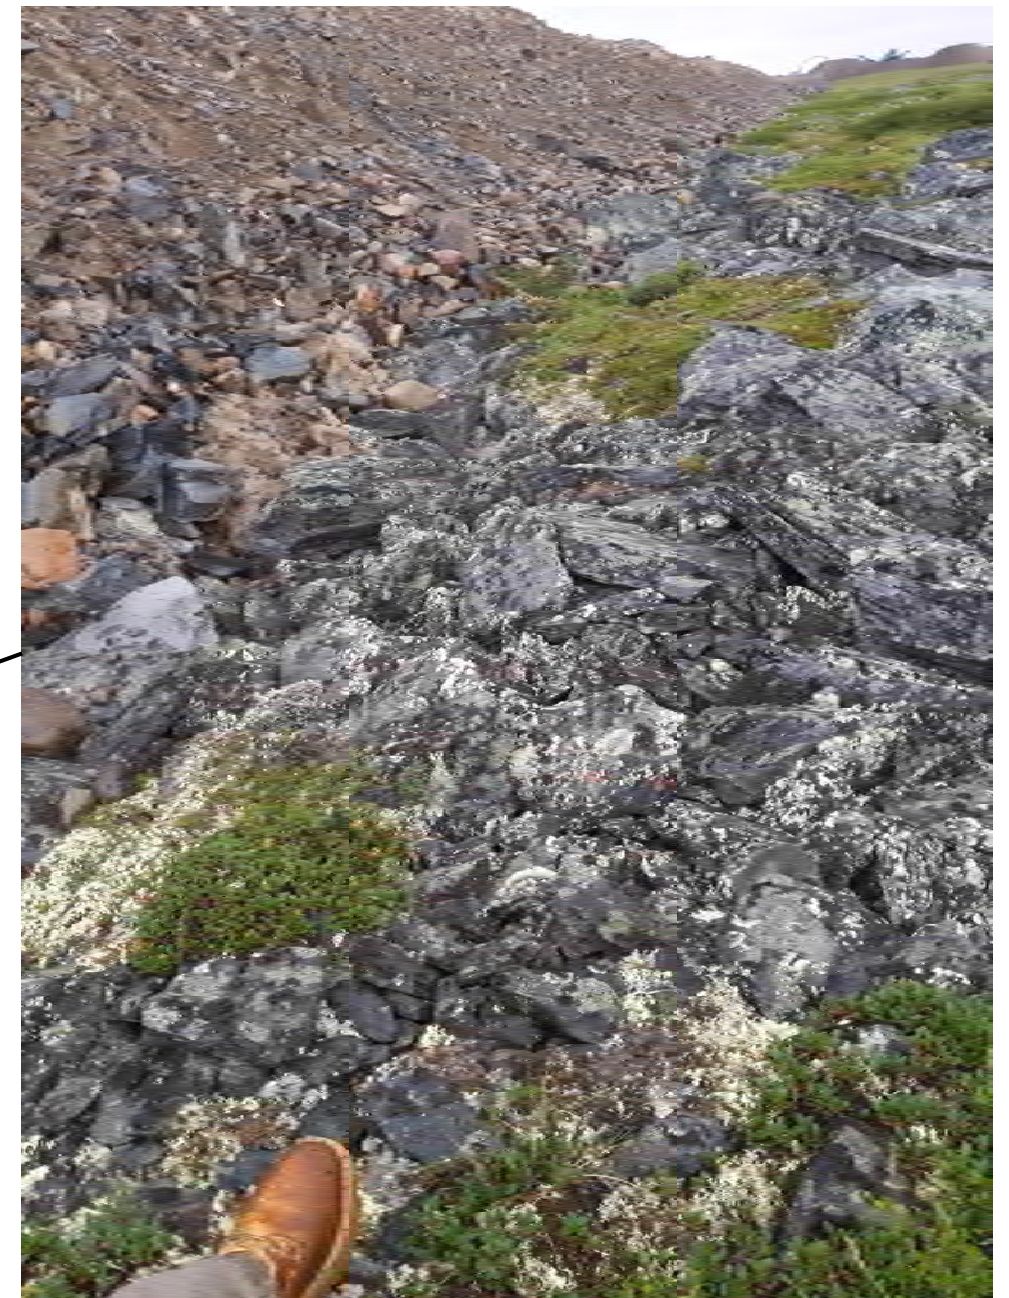
Photo 16 – Fractured rock extending under CWO embankment area

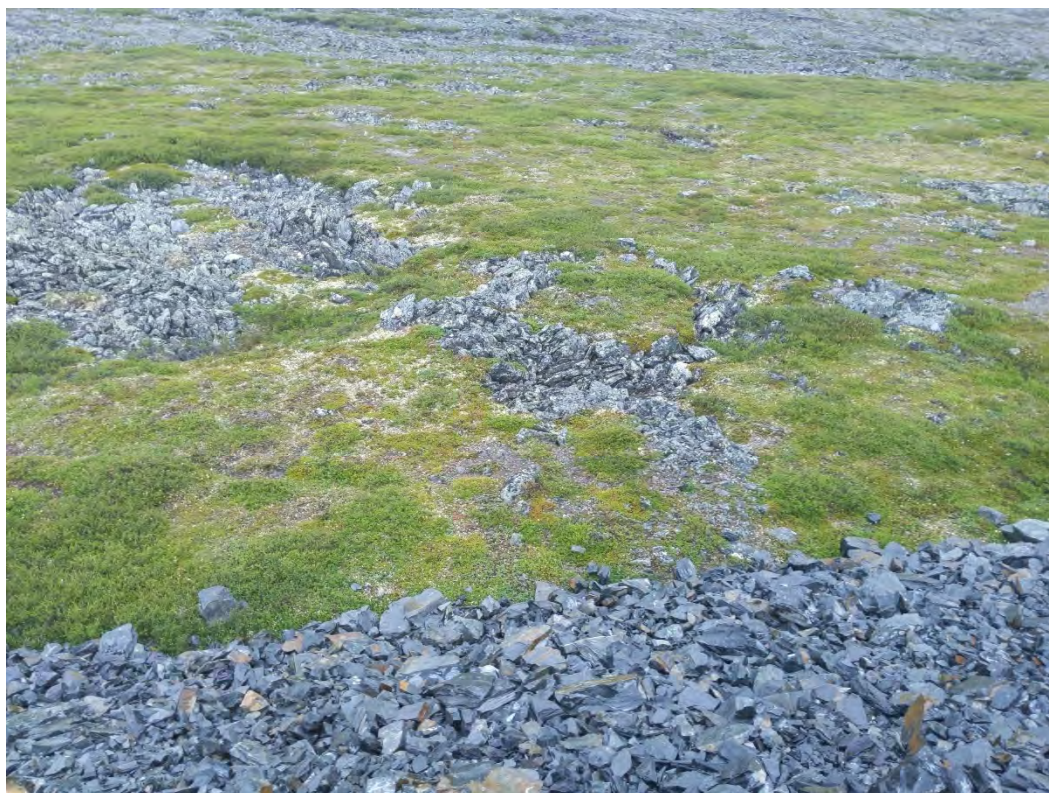
Photo 14 – Fracture rock extending beyond CWP embankment area

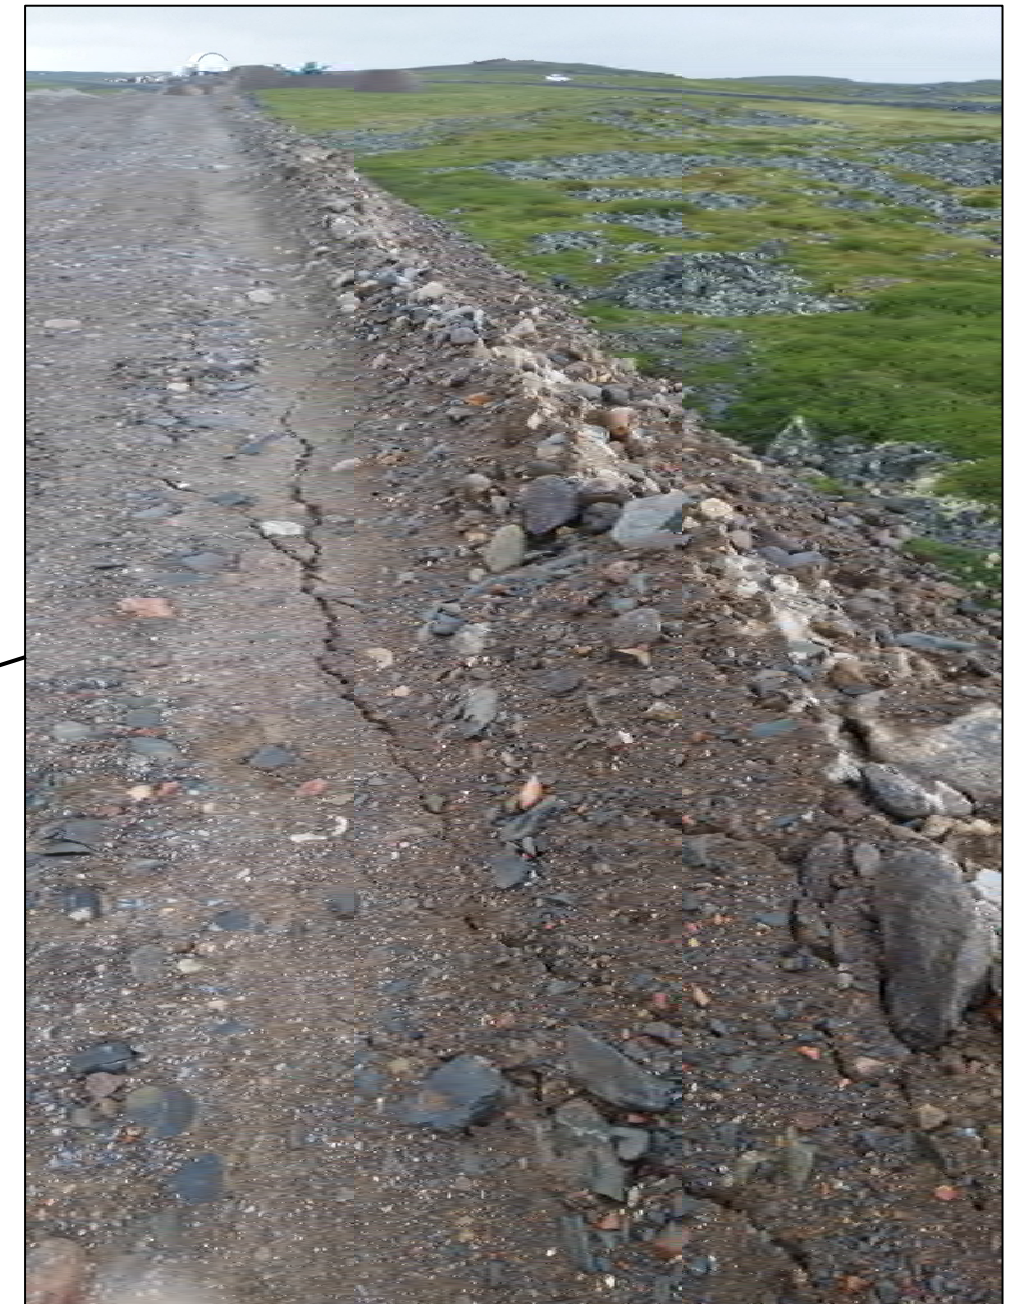
Photo 23 – Note cracks on roadway, road fill ~4 m above tundra

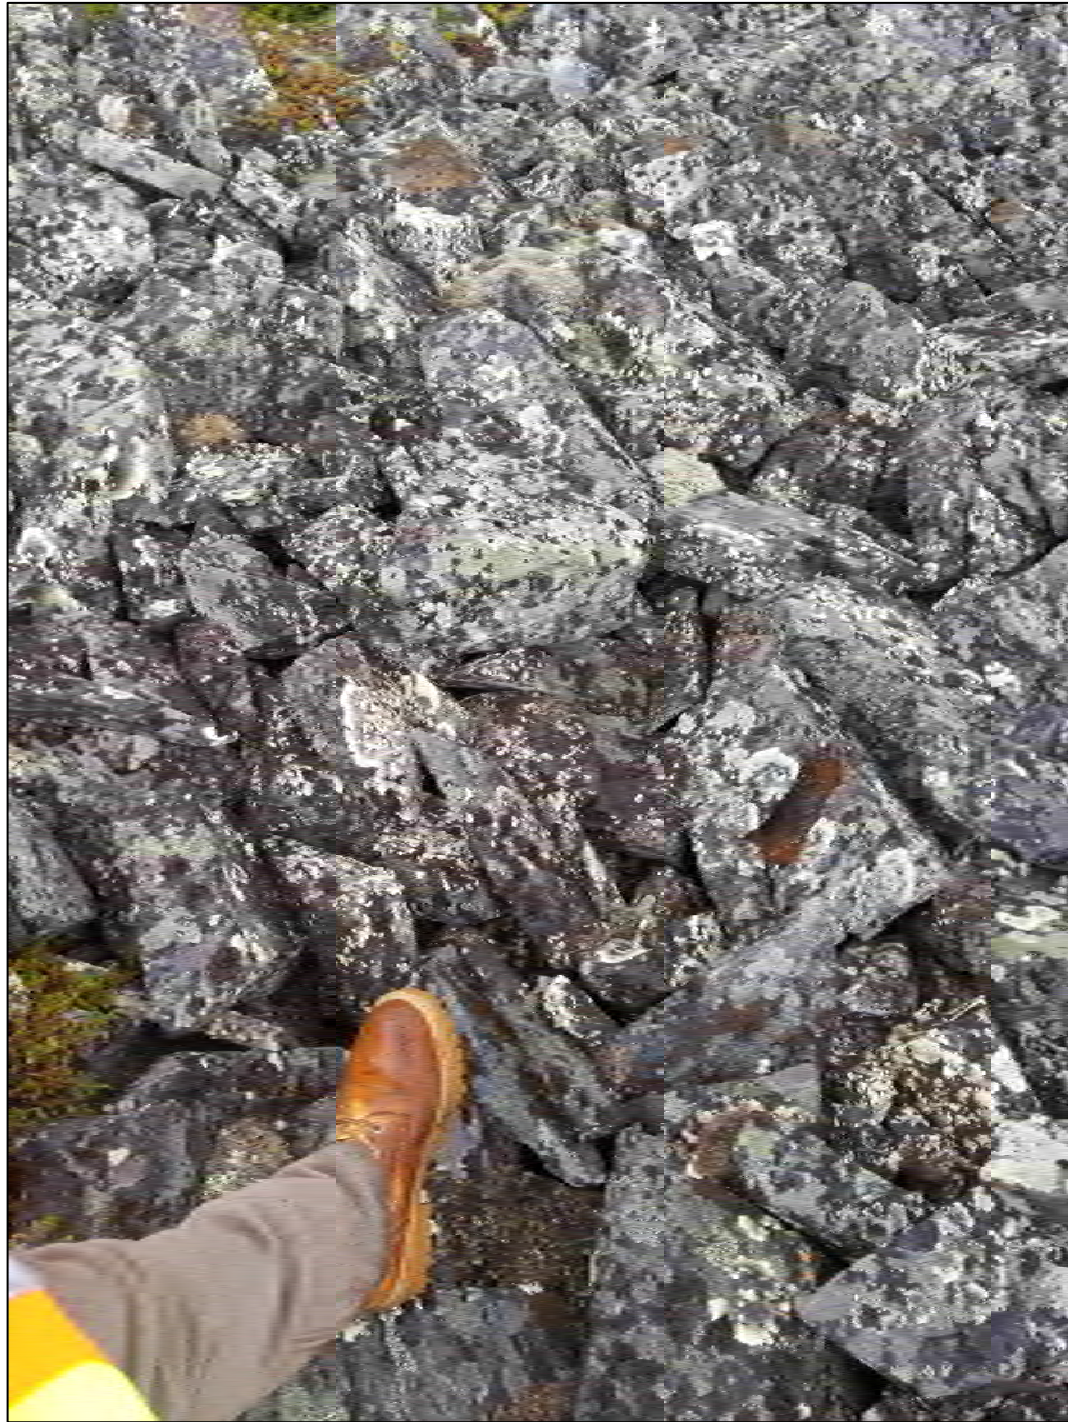
Photo 26 – Highly fracture rock outcrop

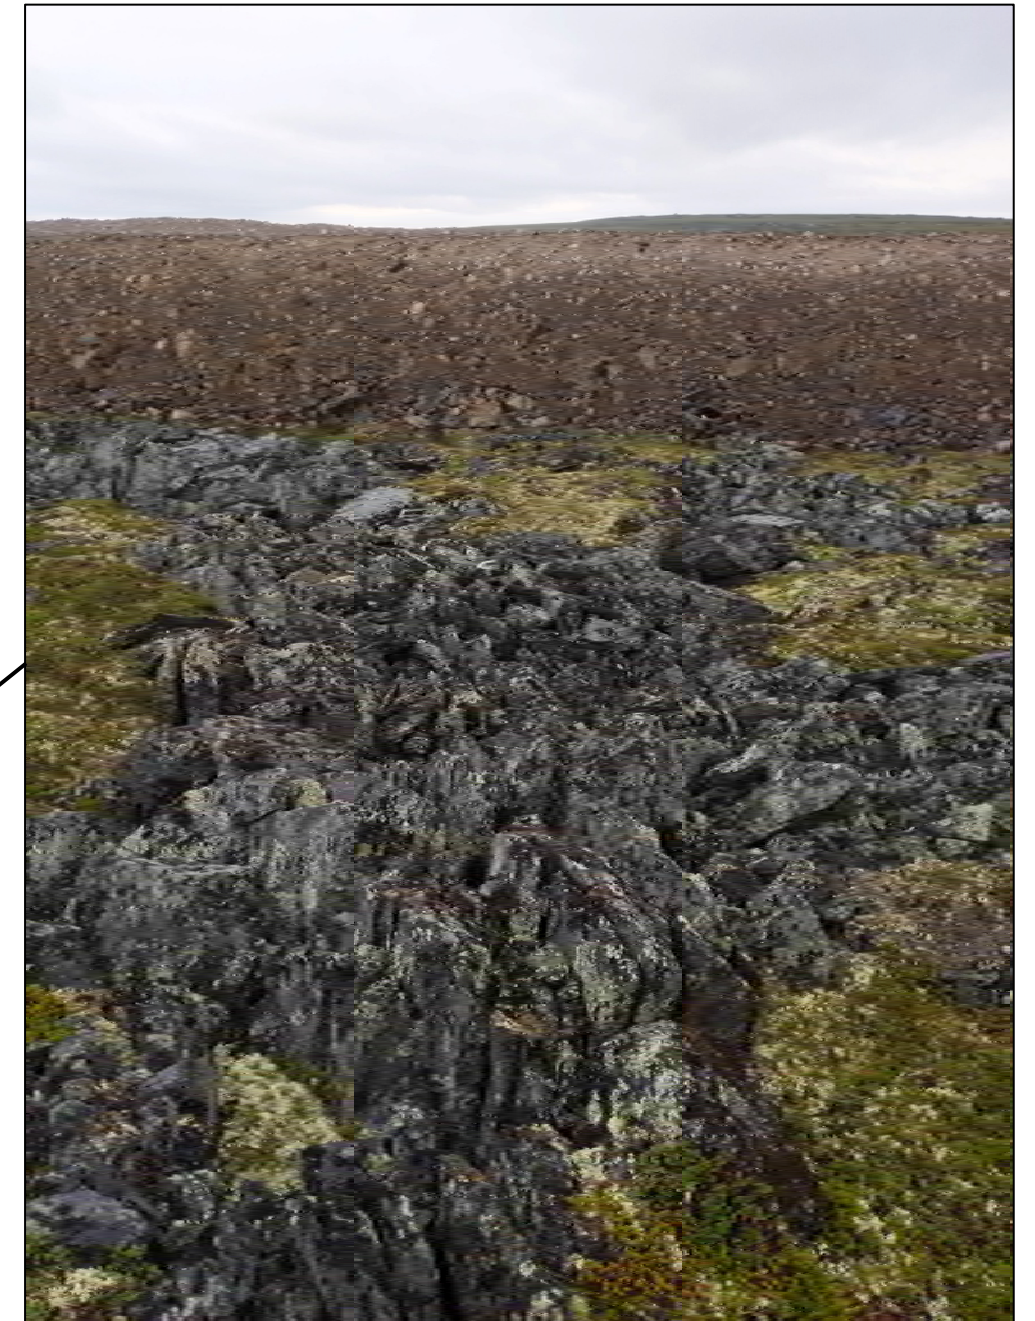
Photo 27 – Highly fractured rock outcrop extending through planned embankment area

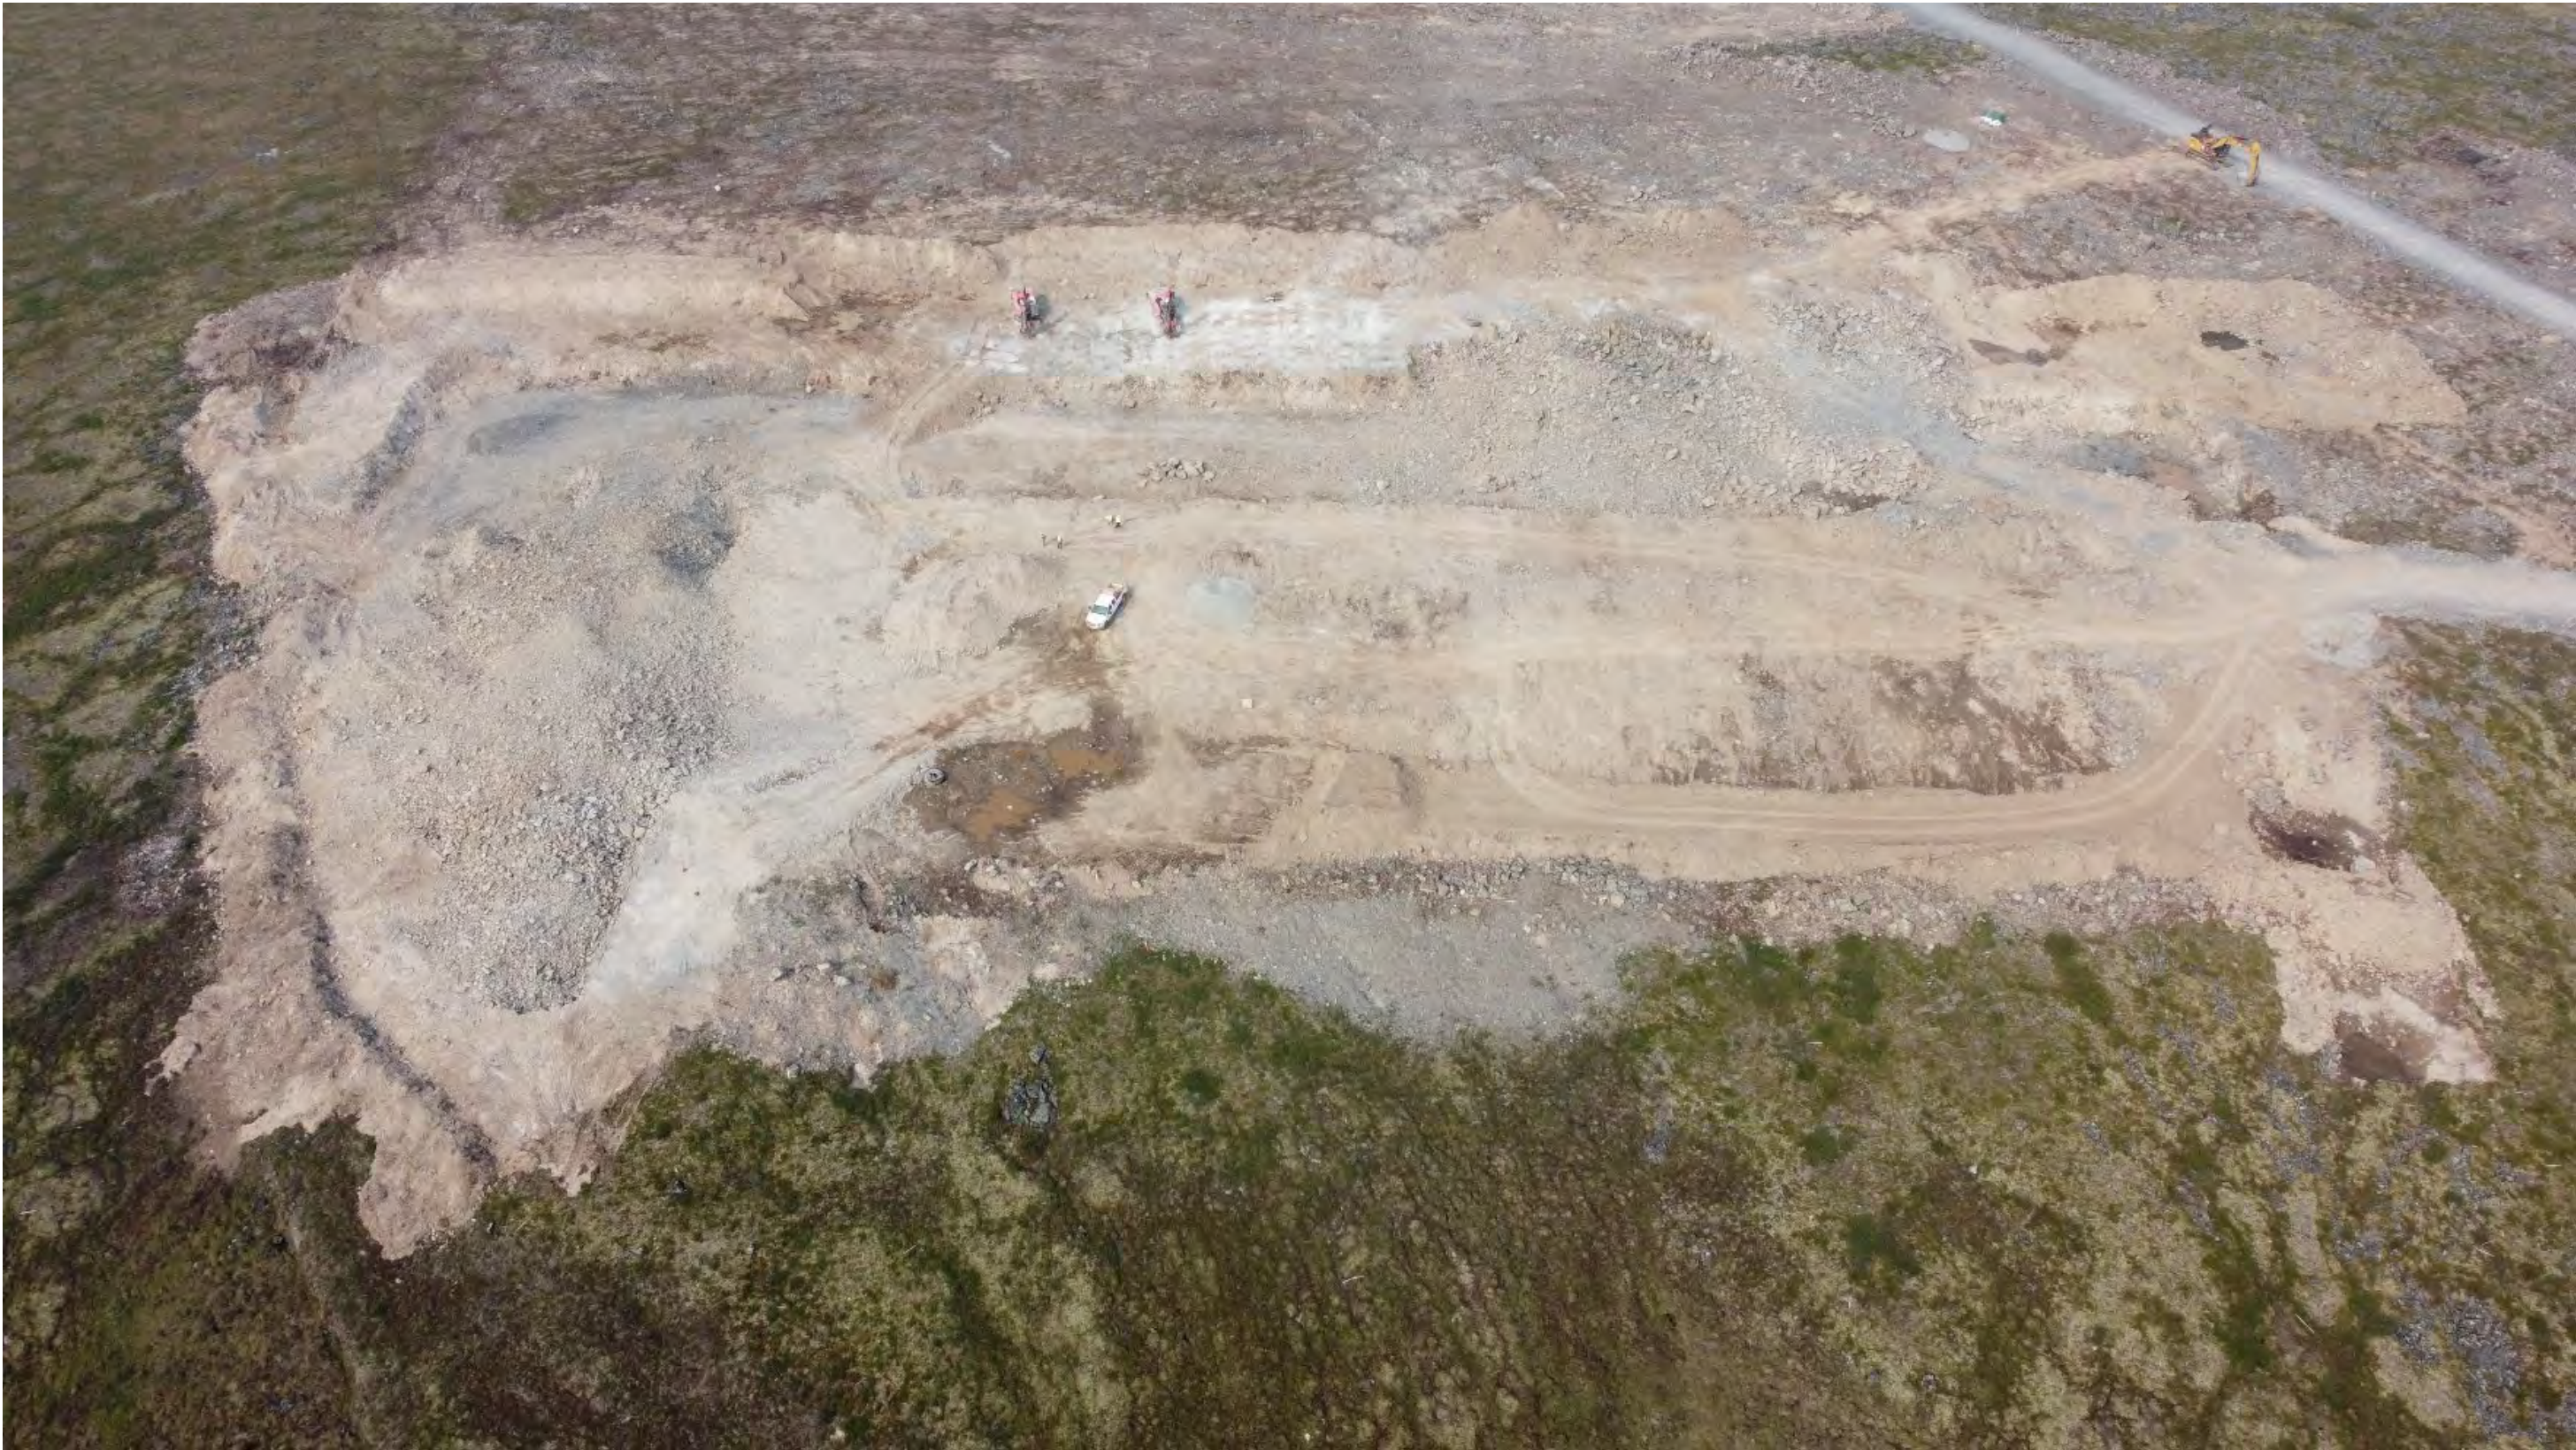
Note: At the time of the summer SRK inspection there were no tanks installed on site at the plant site pad. This photo shows an overview of the site development activities at the plant site pad area at the time of the summer 2021 inspection. This location was in a state of active development

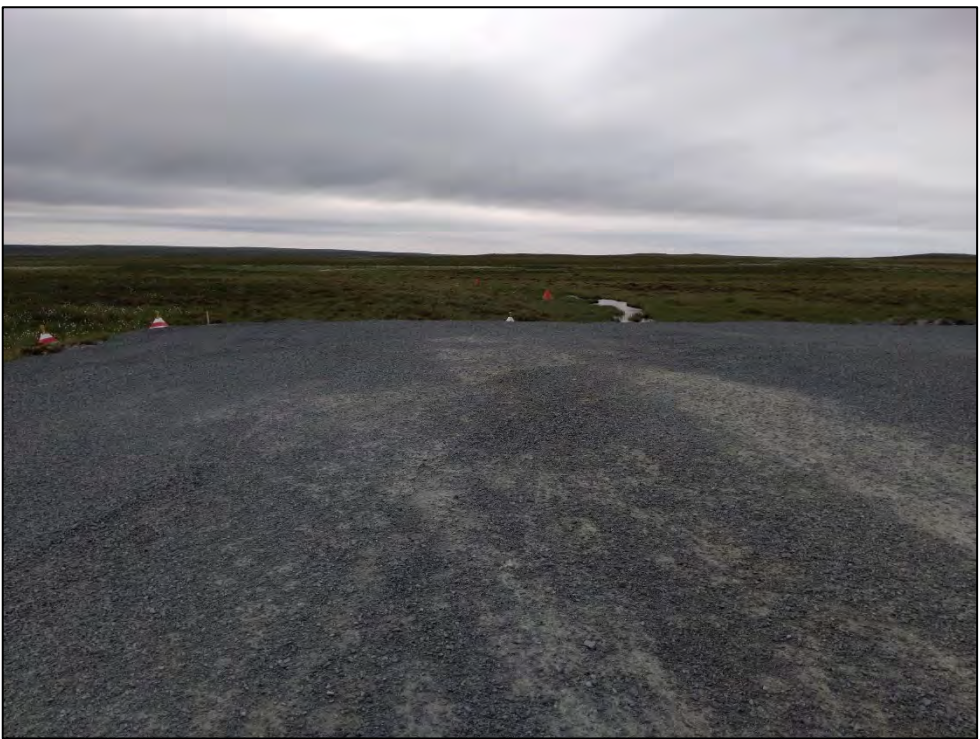
Photo 26 – Southern end of airstrip where thick fill note, no cracking or undulation observed

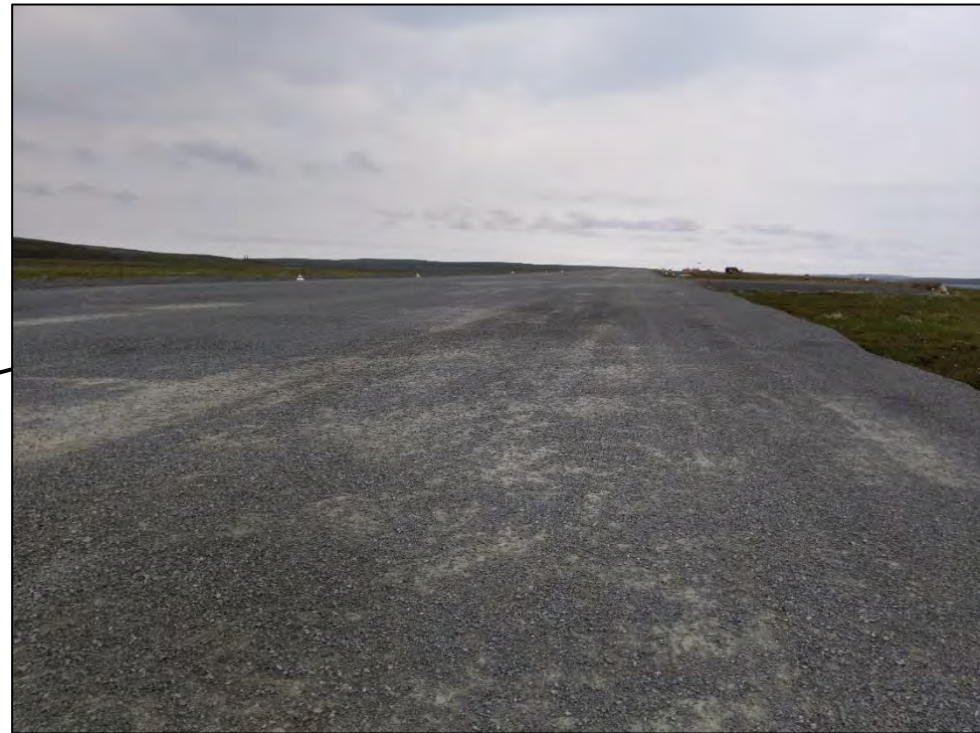
Photo 27 – View northerly direction of airstrip surface, no cracking observed despite lower fill thickness

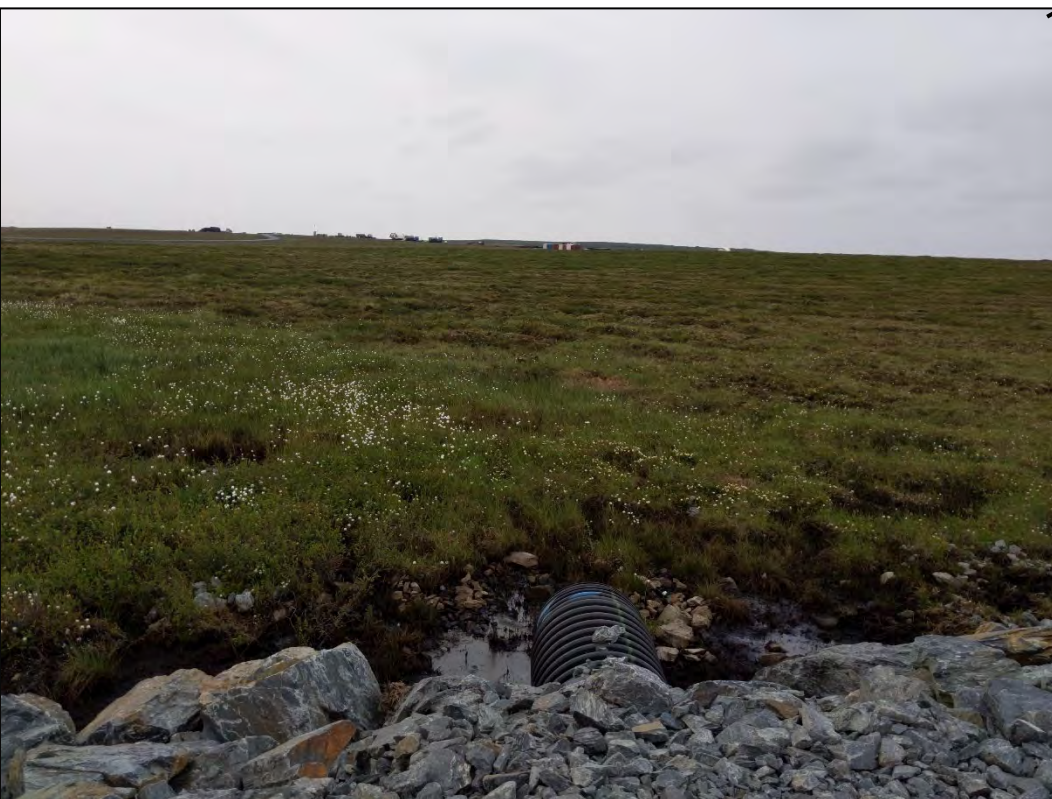
Photo 2 – Inlet, no ponding observed

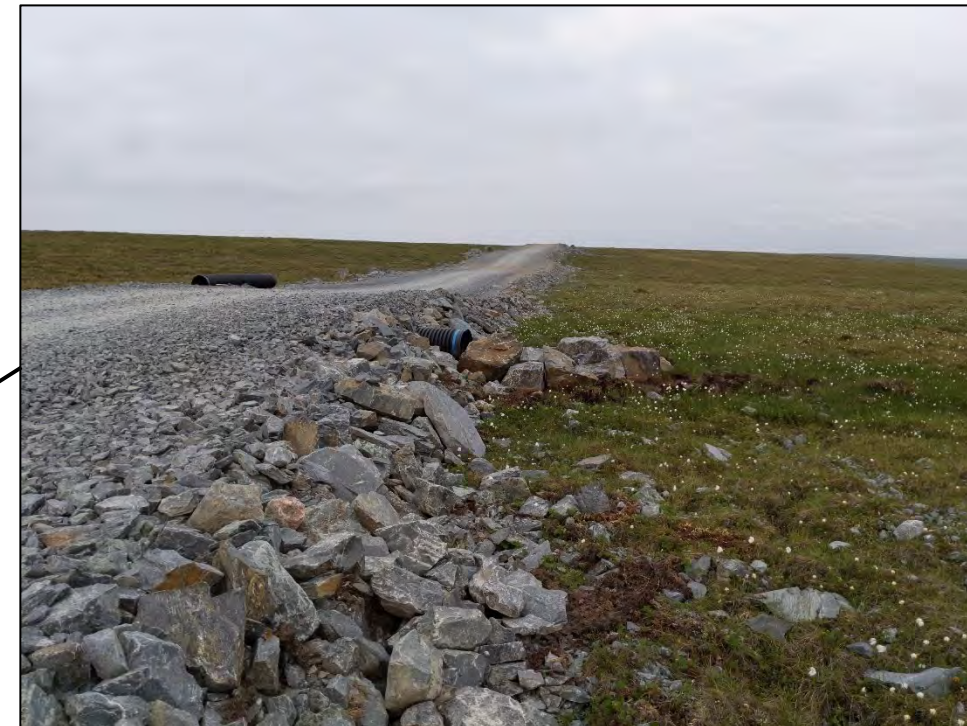
Photo 3 - Outlet, note rocks placed to dissipate water energy at culvert outlet. Cover above pipe may be insufficient/problematic when traversed by larger vehicles.

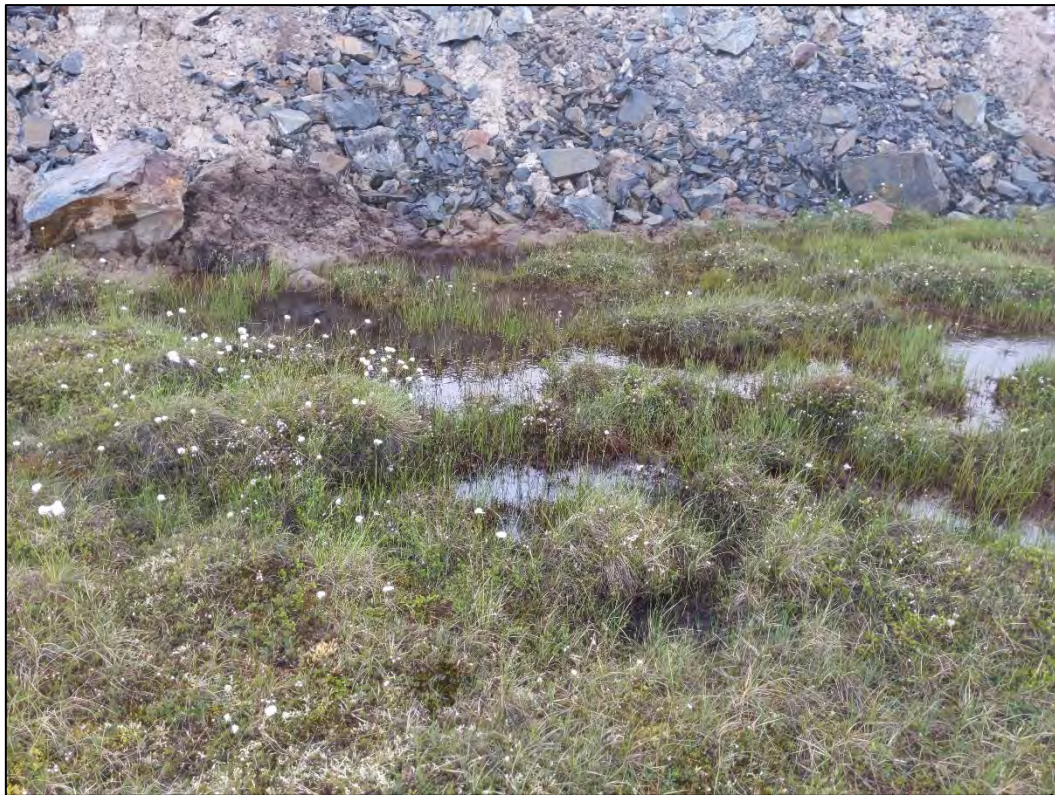
Photo 9 – Some ponded water observed within footprint

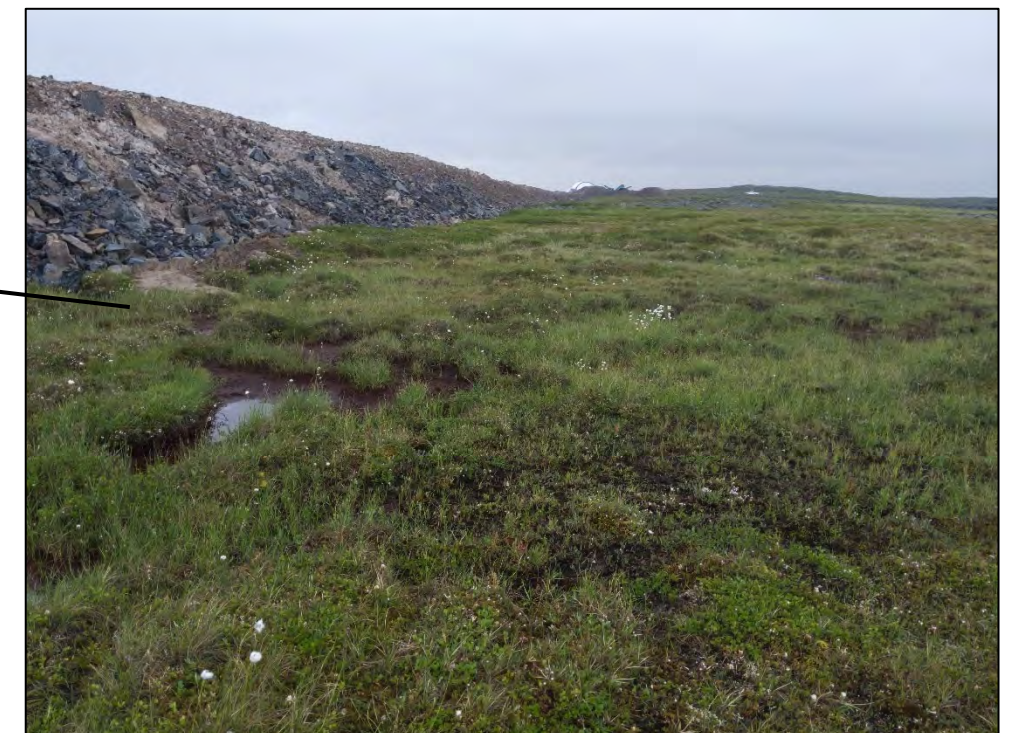
Photo 12 – Some ponded water observed within footprint

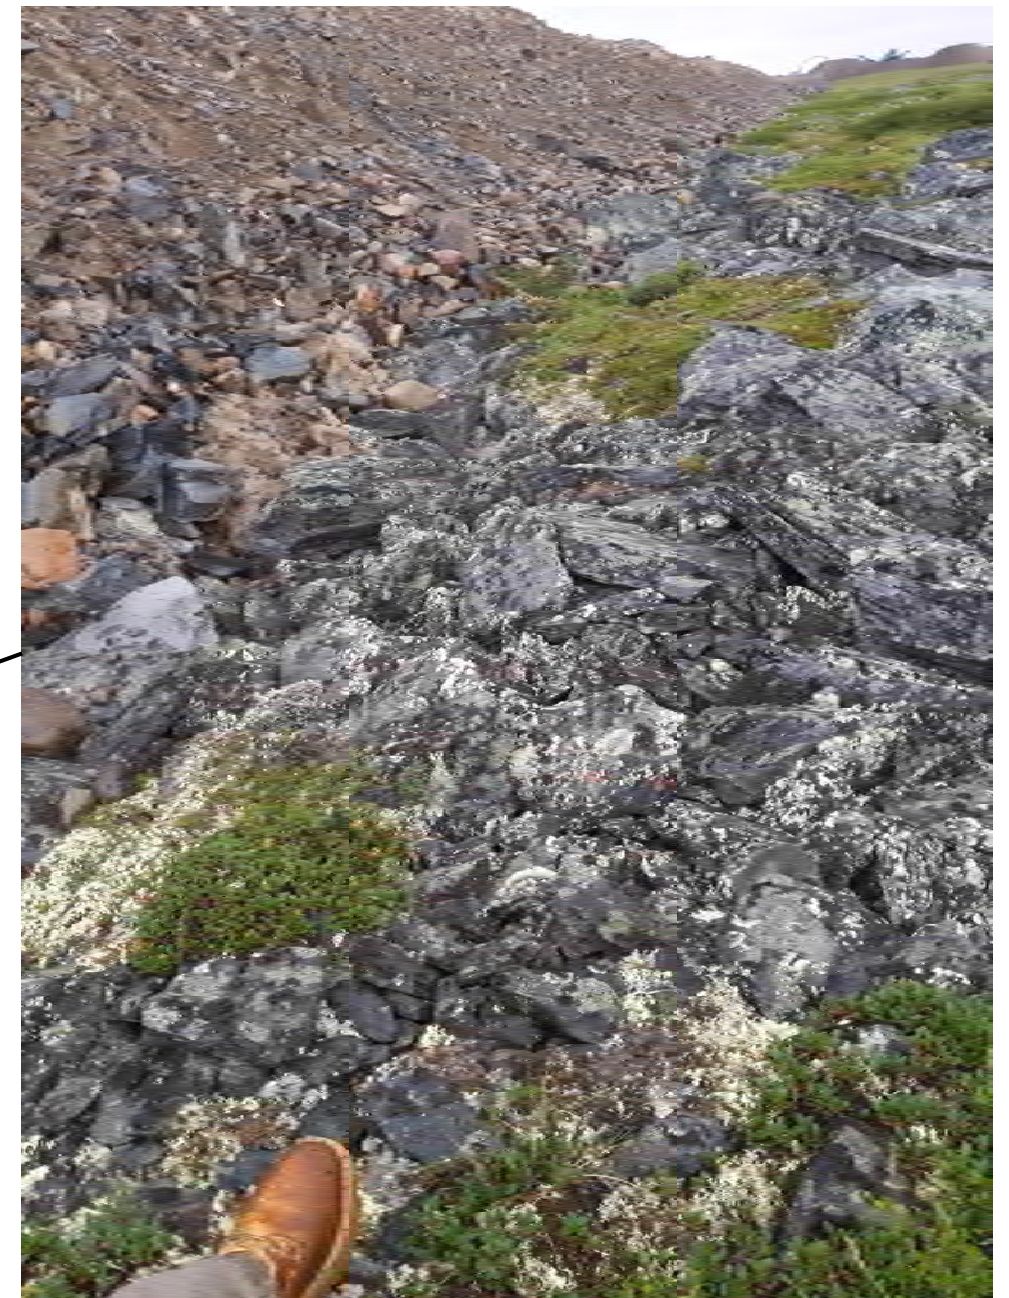
Photo 16 – Fractured rock extending under CWO embankment area

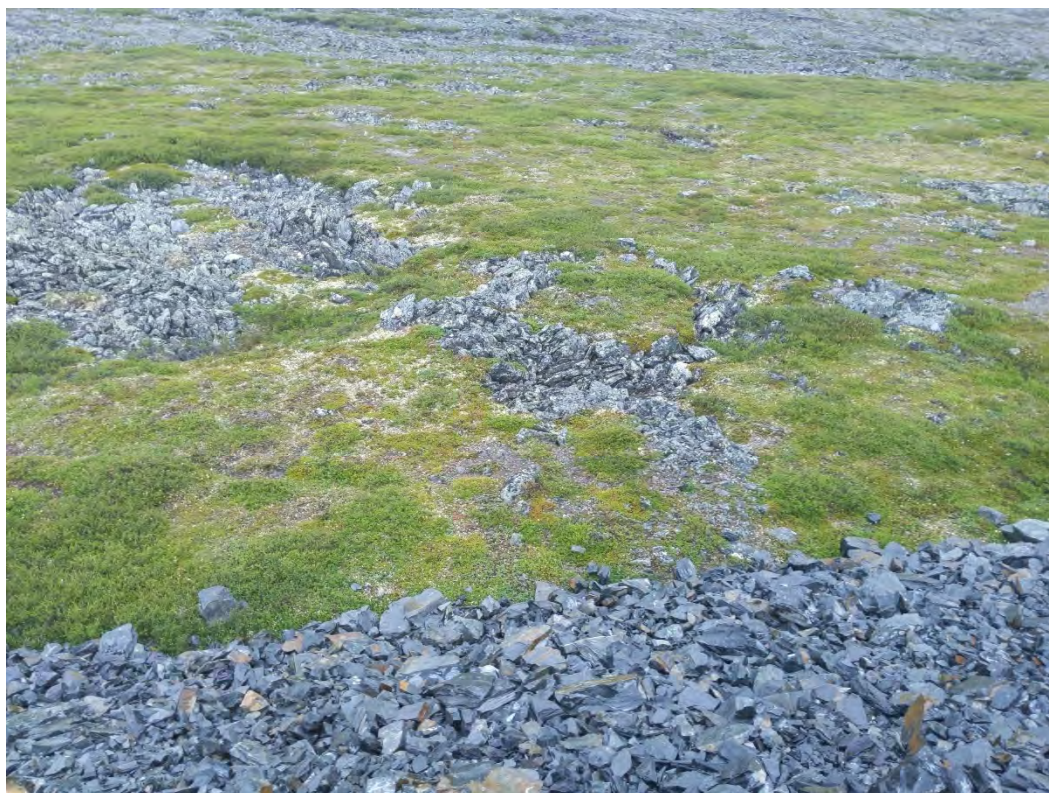
Photo 14 – Fracture rock extending beyond CWP embankment area

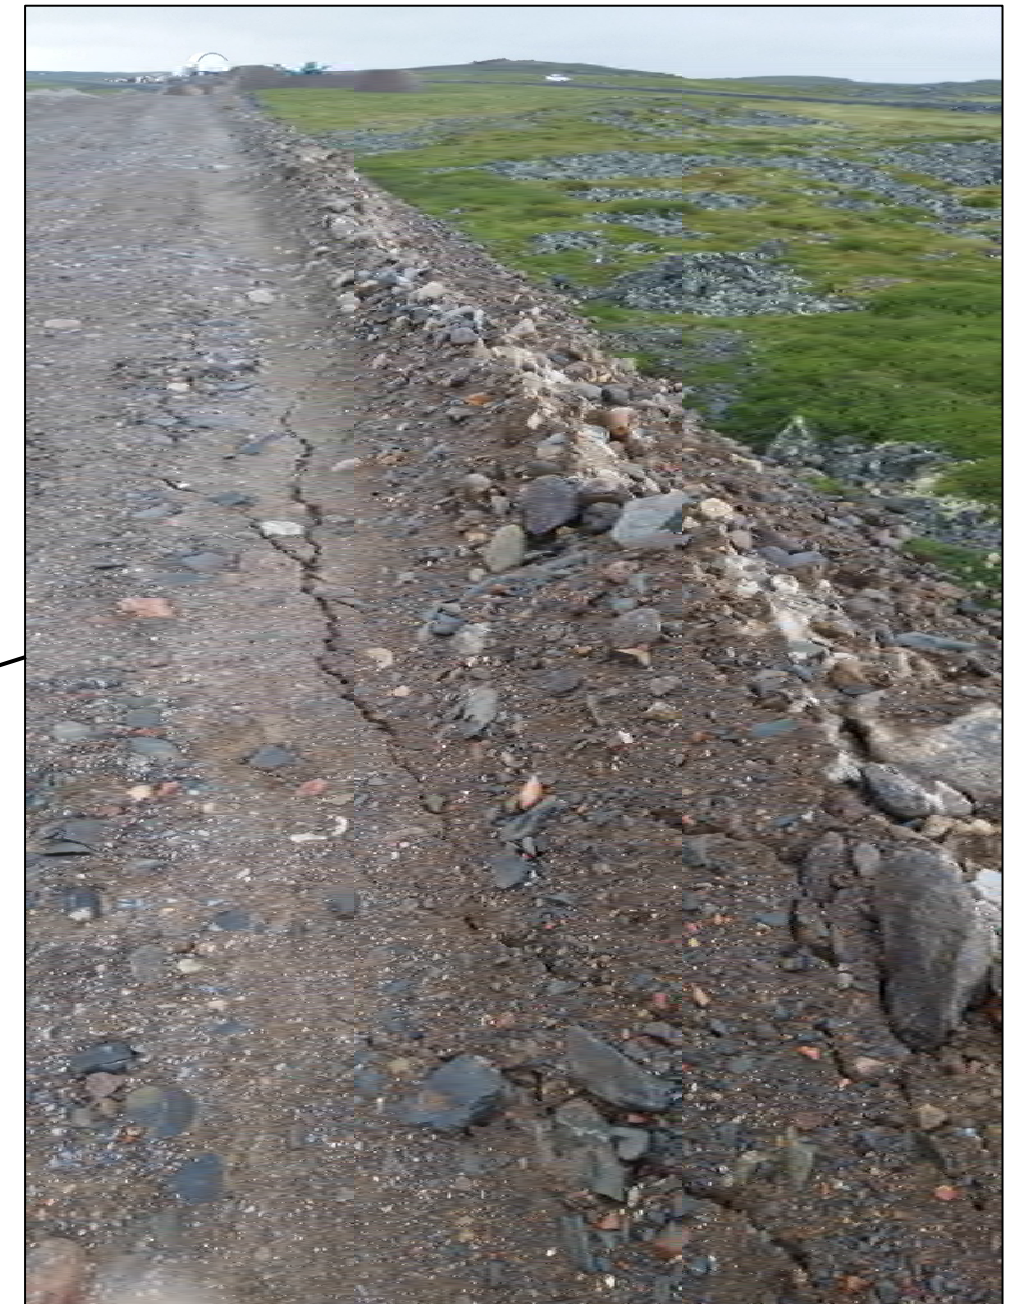
Photo 23 – Note cracks on roadway, road fill ~4 m above tundra
