Attention **Merle Keefe, Environmental Permitting Manager for Sabina Gold and Silver**
Subject **Goose Project Site – 2021 Annual Geotechnical Inspection**
Project 1CS020.021

The 2021 AGI for the Goose site is the subject of this memorandum.

Attachment 3 Photolog from July 2021 Site Visit

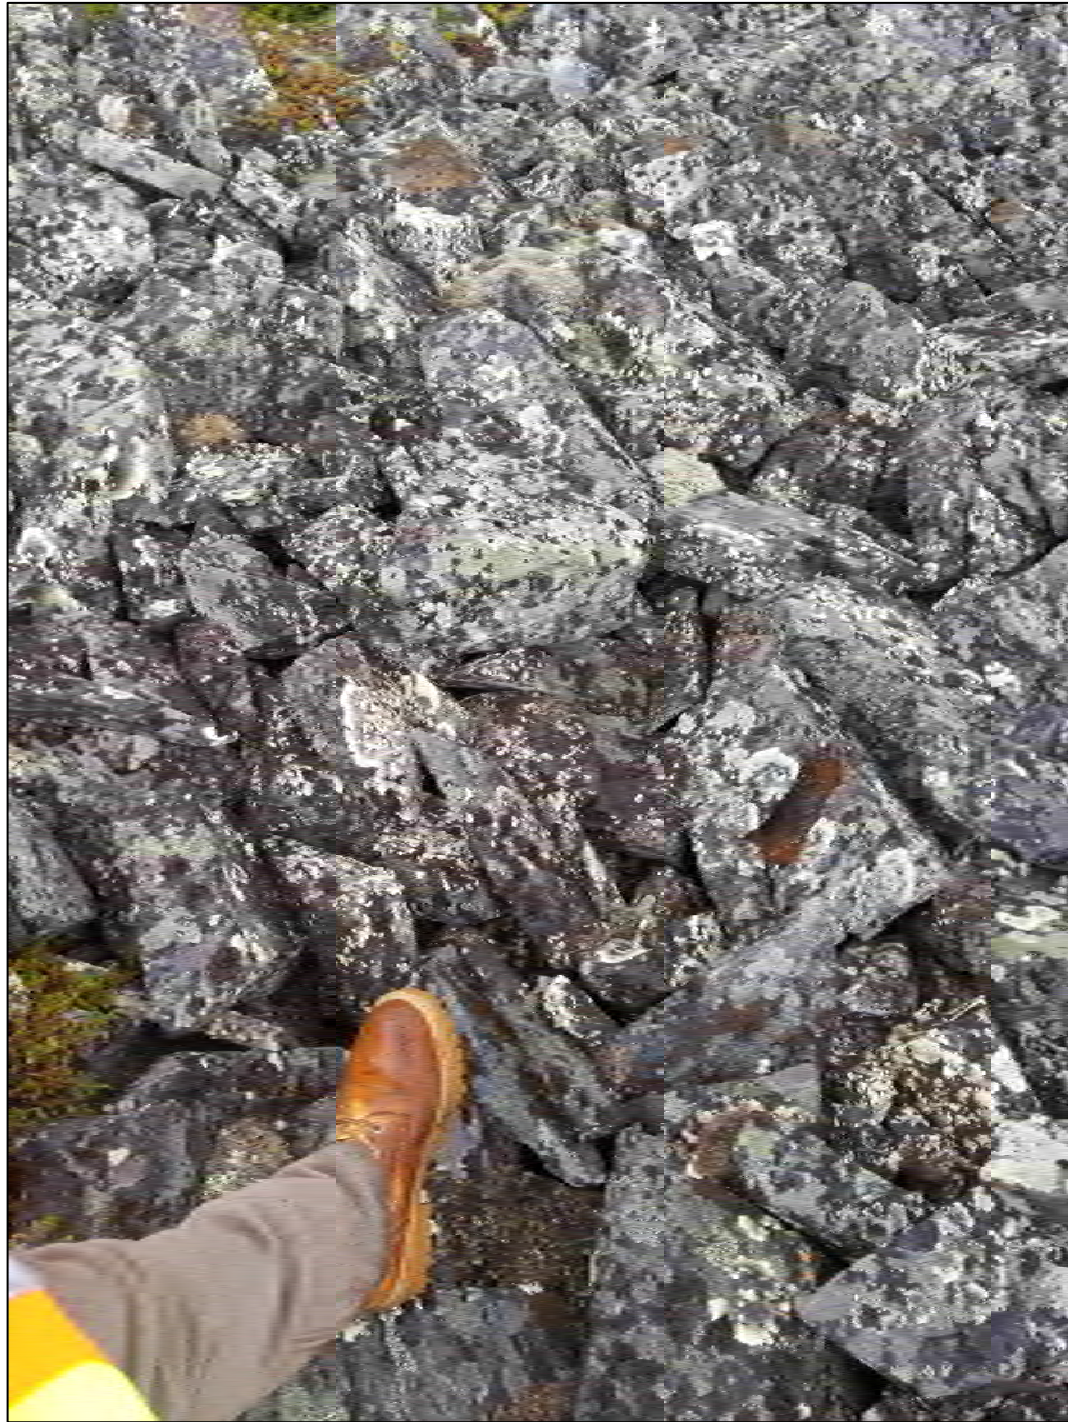
Photo 26 – Highly fracture rock outcrop

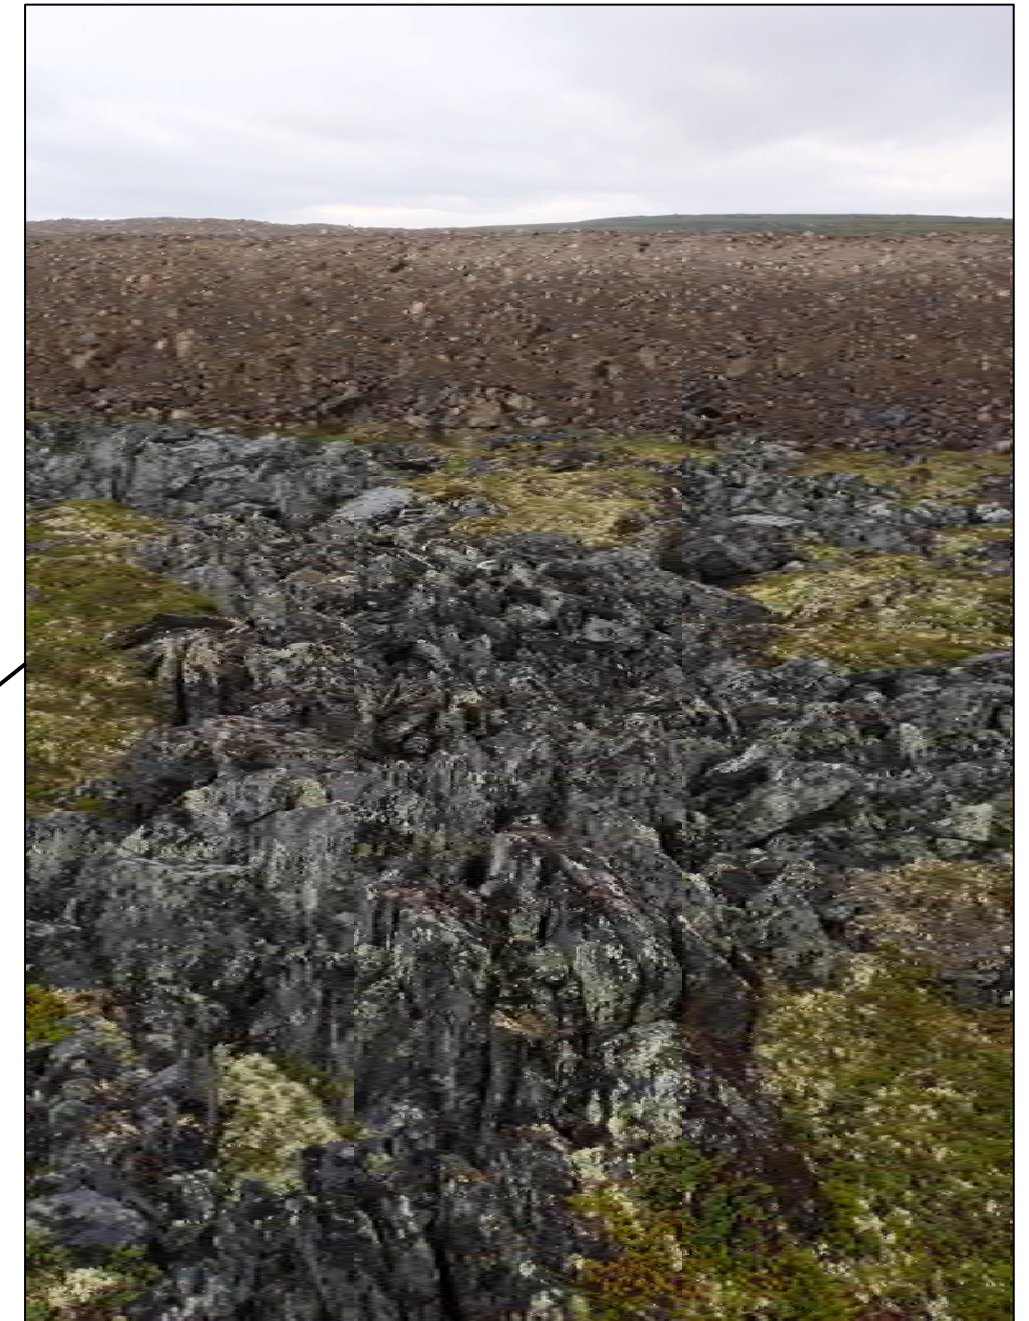
Photo 27 – Highly fractured rock outcrop extending through planned embankment area

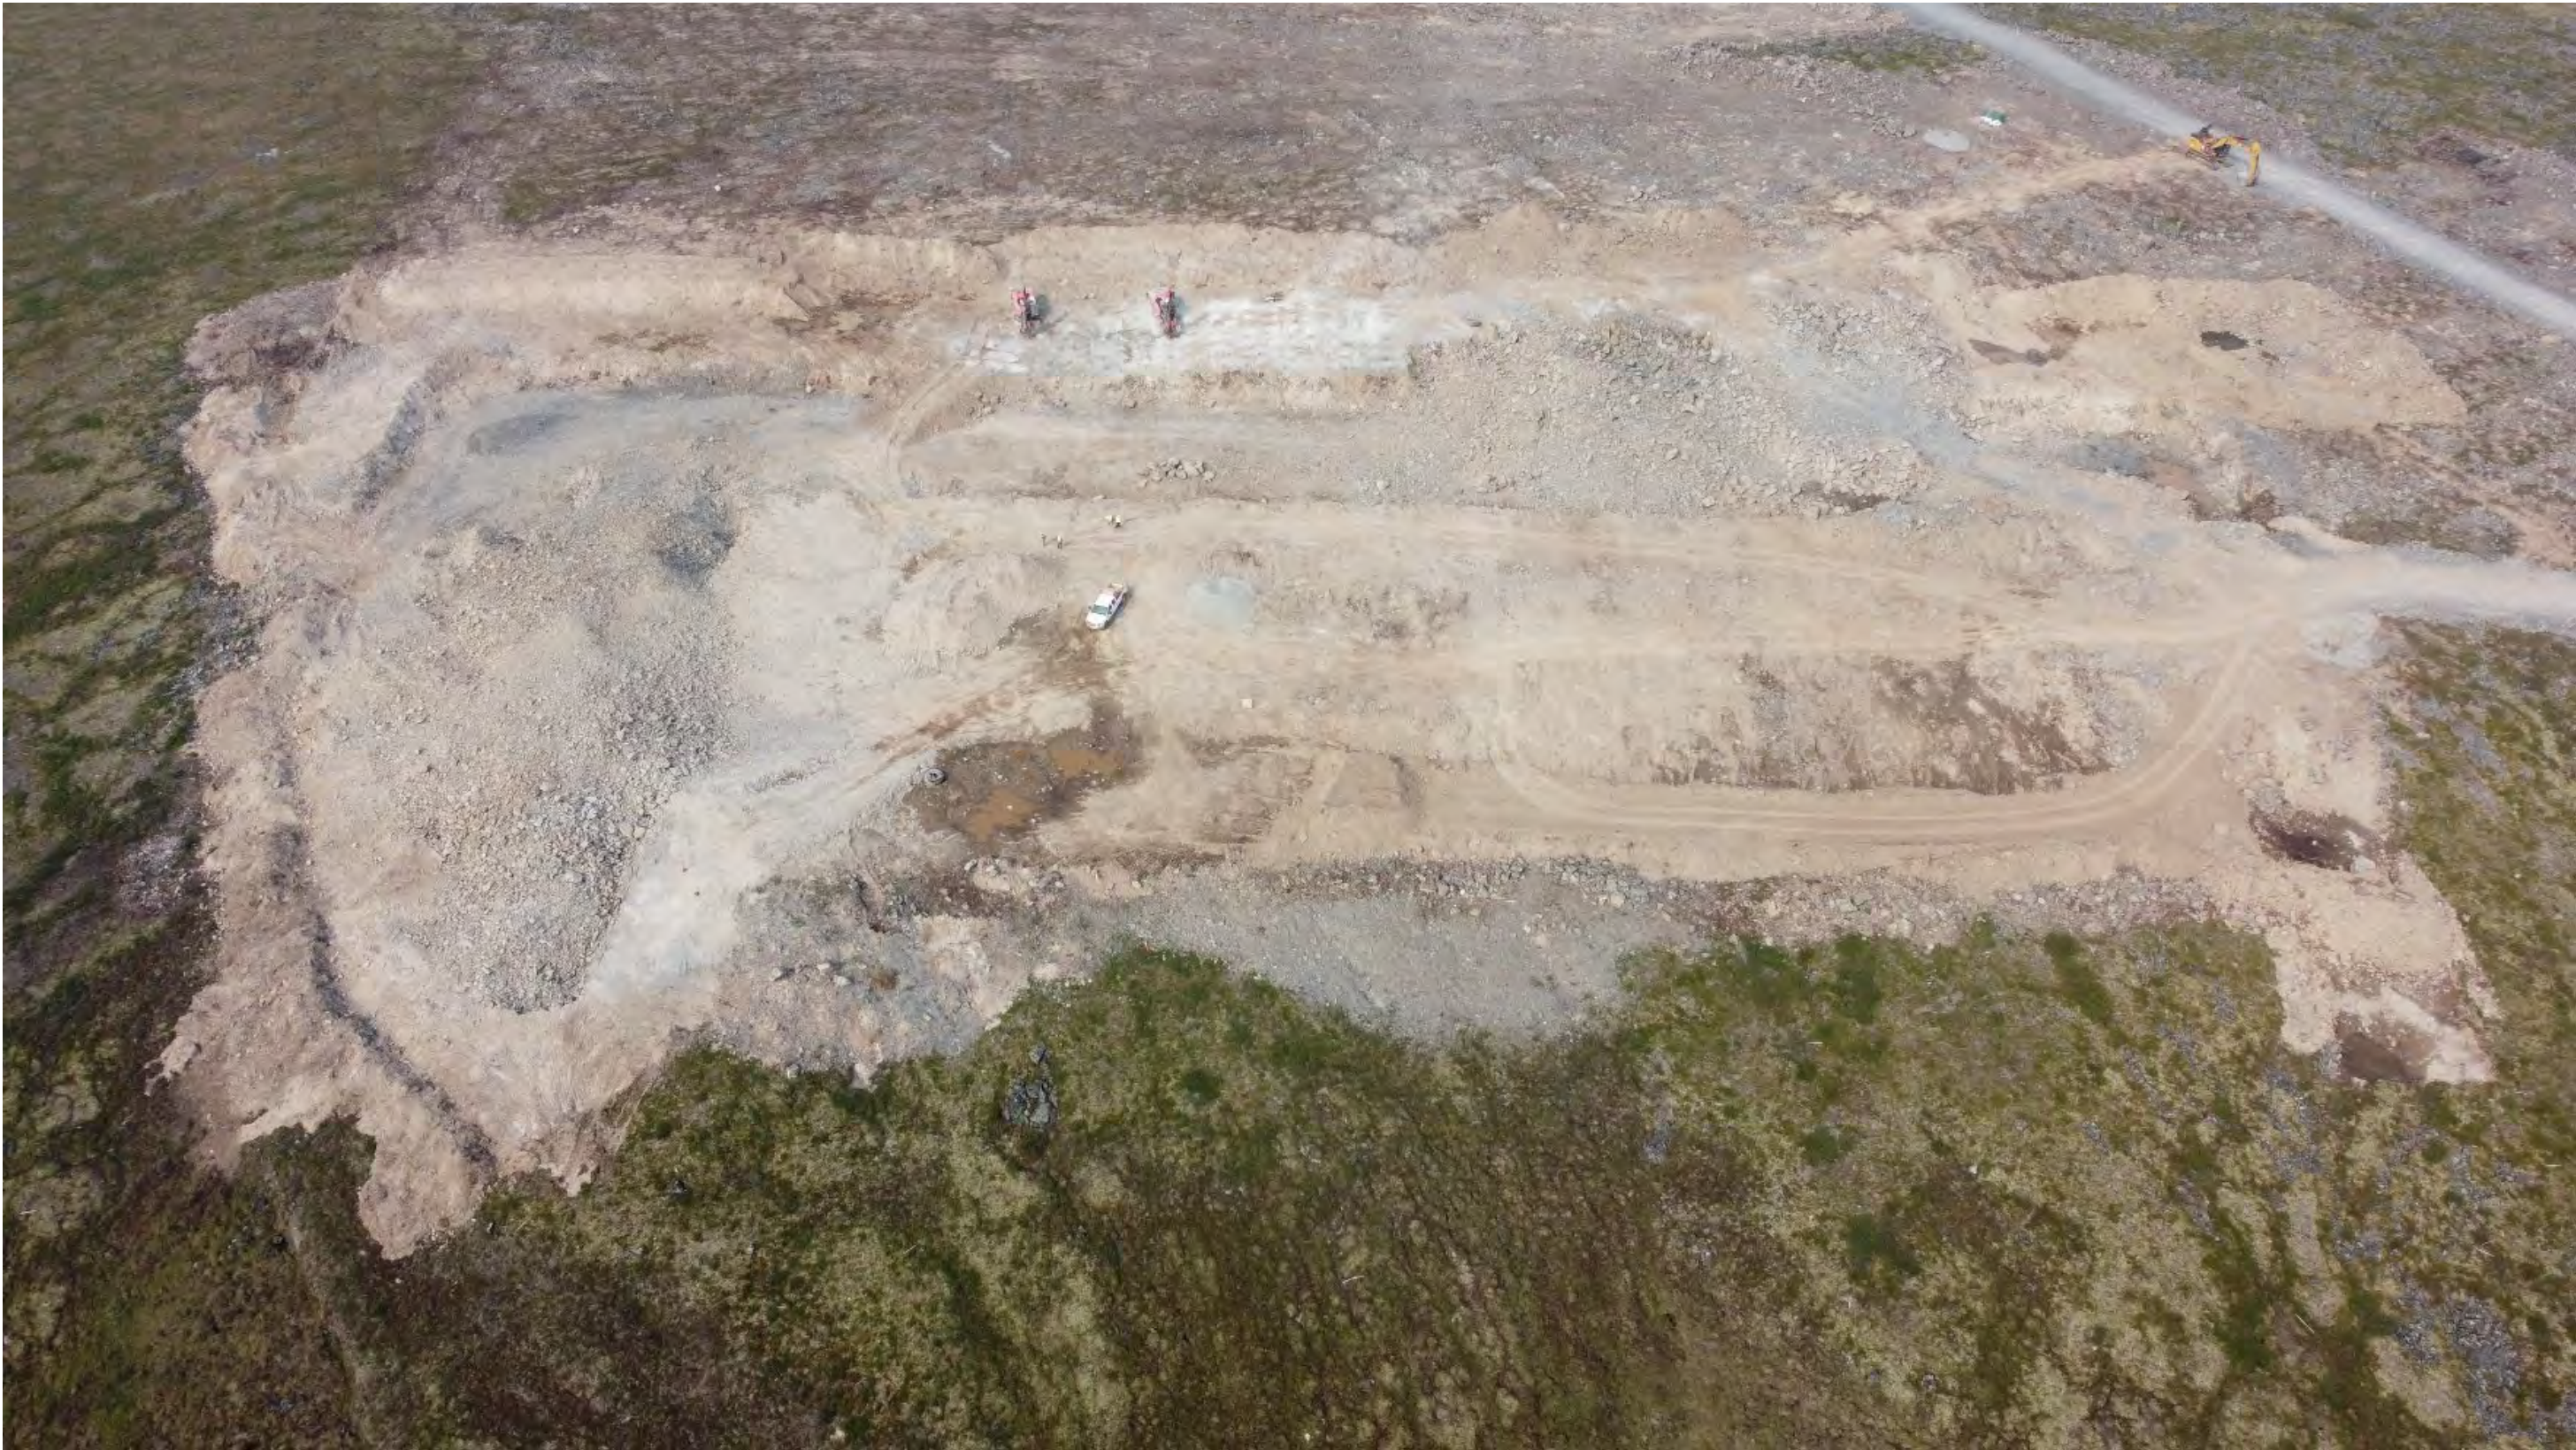
Note: At the time of the summer SRK inspection there were no tanks installed on site at the plant site pad. This photo shows an overview of the site development activities at the plant site pad area at the time of the summer 2021 inspection. This location was in a state of active development
