**2014 2AM-DOH1323 Type A Water Licence
Annual Report
Supplemental Document**

Doris North Project

Prepared by
TMAC Resources Inc.
Toronto, ON

March 2015

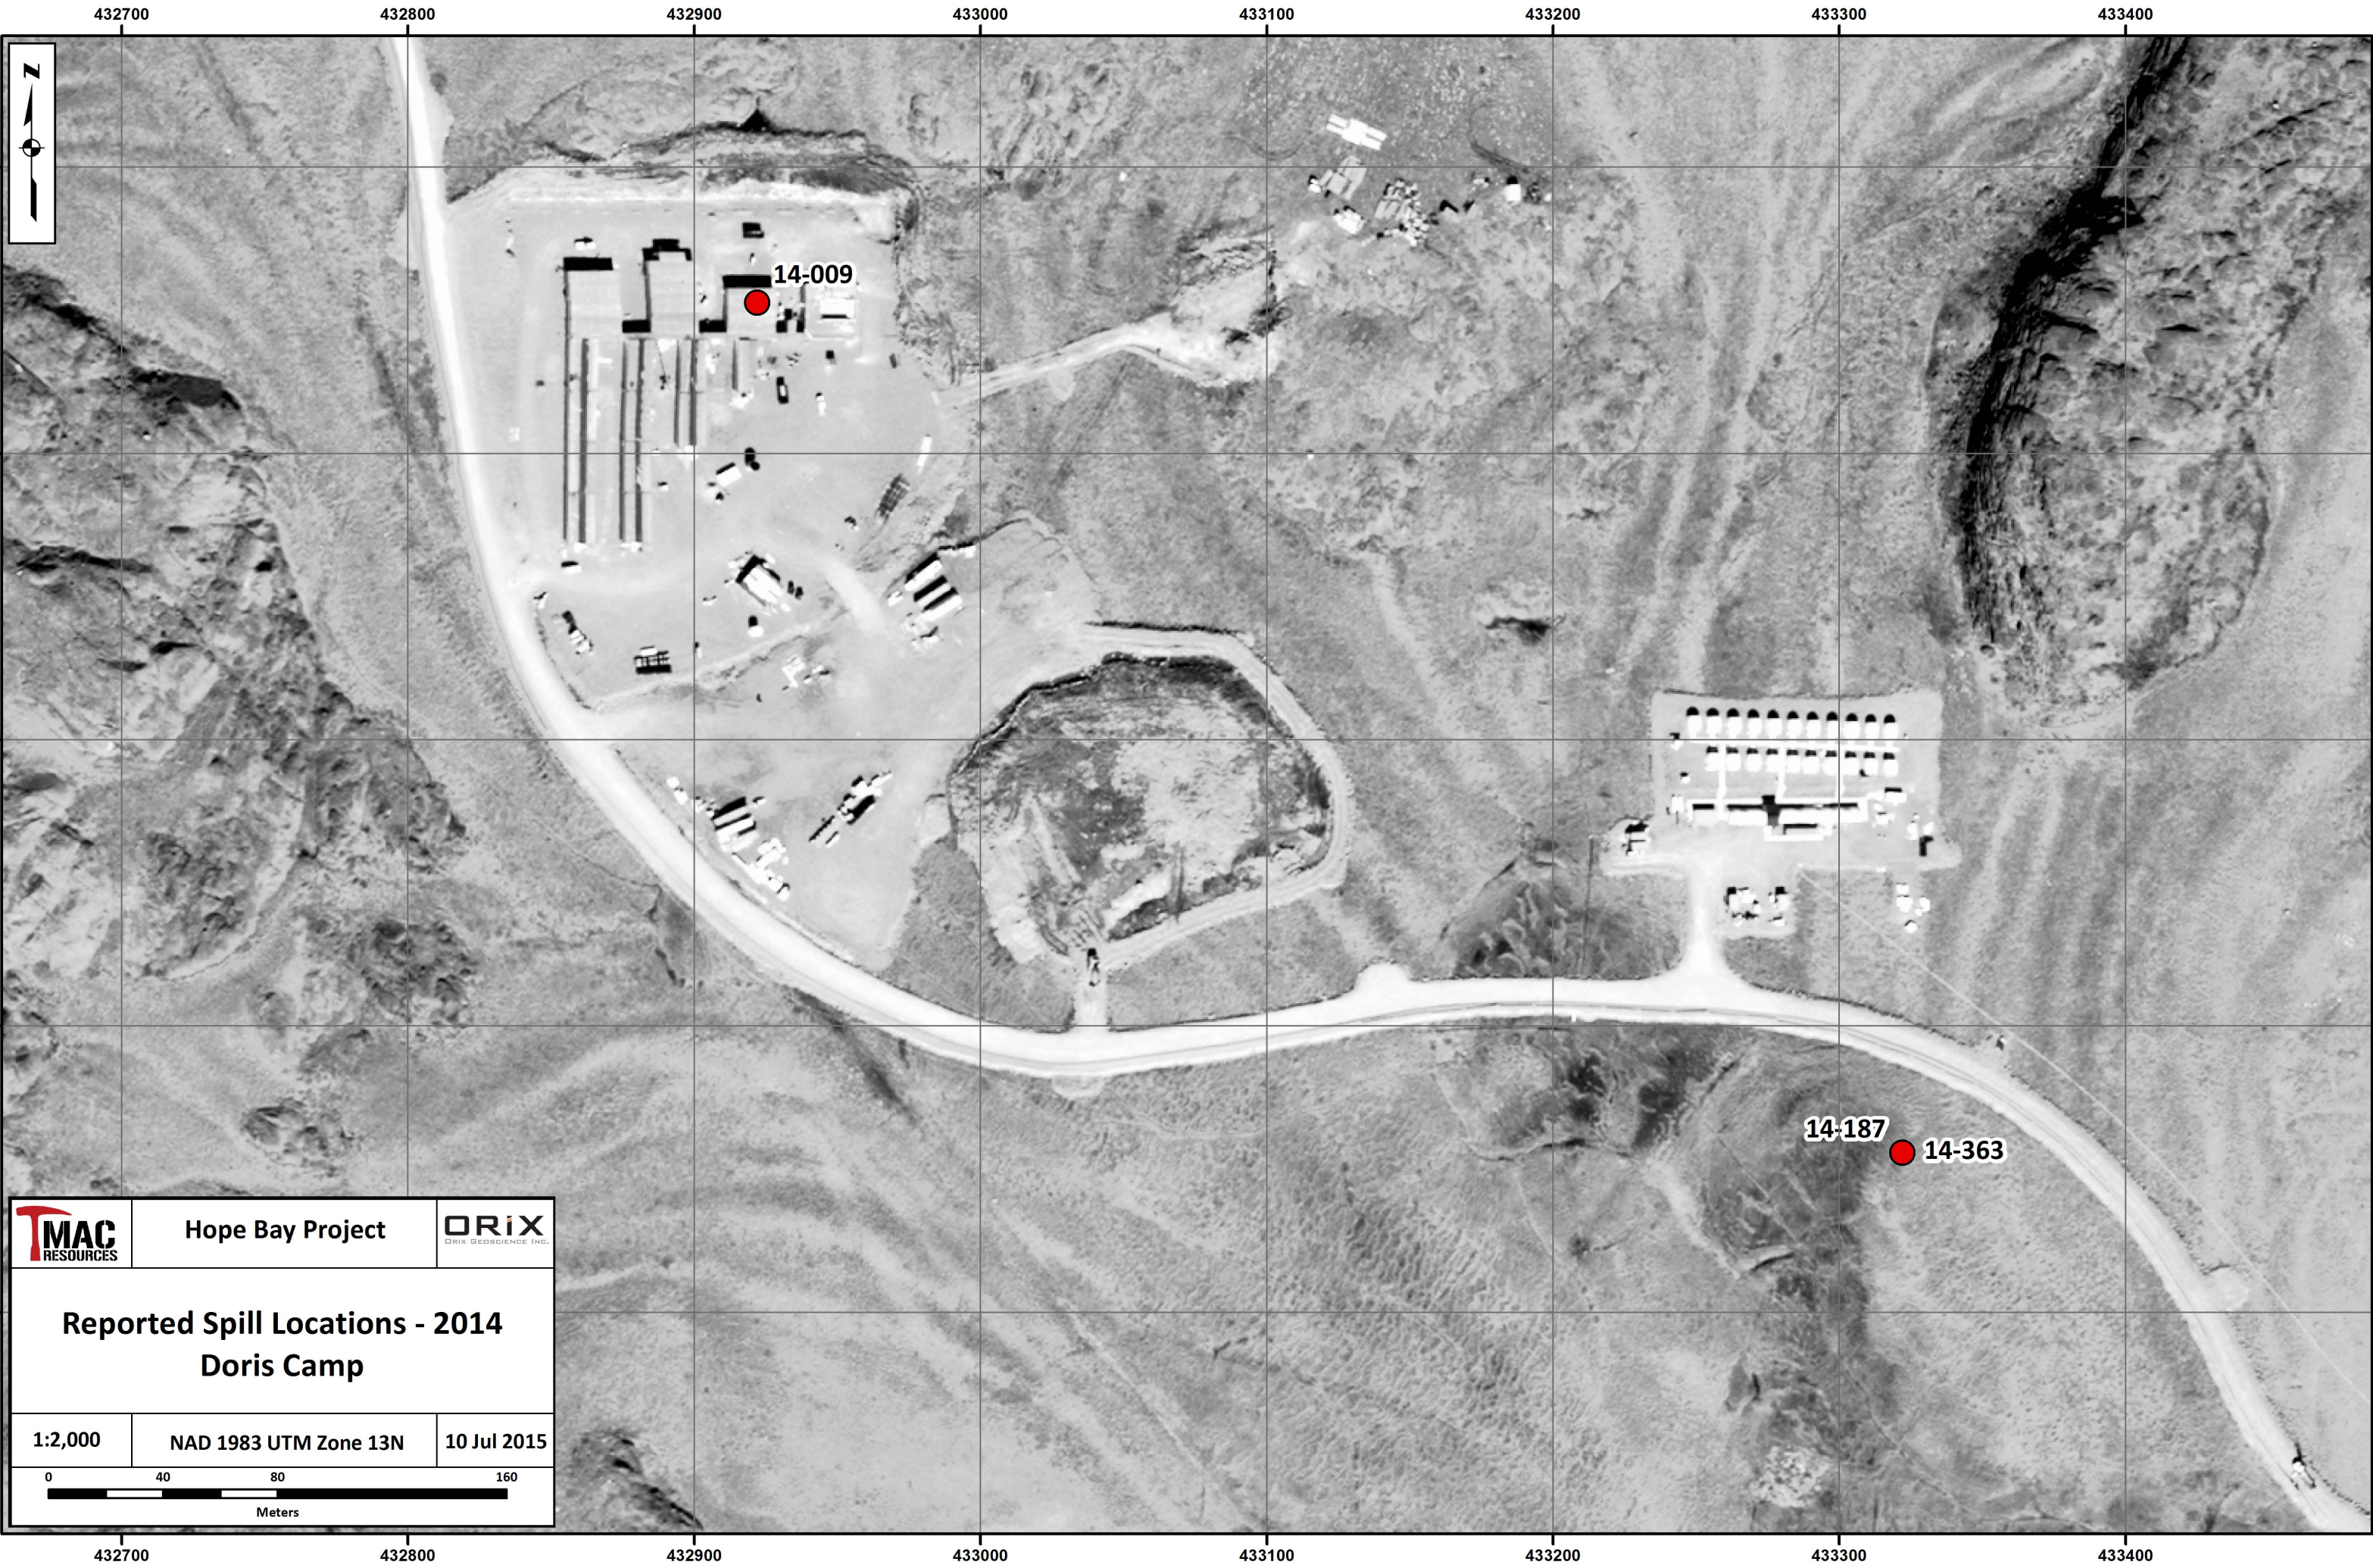
Reported Spill Locations - 2014 Doris Camp		
1:2,000	NAD 1983 UTM Zone 13N	10 Jul 2015

Details of Spill: A leak of an estimated 250L of greywater was detected beneath Doris Camp Kitchen (kitchen sink, steamer, dishwasher) from cracks in the PVC piping. The root cause was attributed to pipe expansion and contraction from freezing and/or possibly camp settlement. The spilled greywater was removed by heating the ice around the pipes and the electrical cables in the affected area and allowing the melted grey water to drip into buckets. The bulk of the ice removal was performed by chipping it away, placing it into buckets, and placing it in the Waste Water Treatment Plant for processing. Pipe repairs were effected, the area was reinsulated and a system of periodic checks beneath the camp instituted to prevent further occurrences.

Details of Spill: Approximately 10m³ of meltwater was pumped out onto the tundra adjacent to Sump #1. Sump #1, designed to catch runoff water, was plugged with ice and the automated pumping system was not operating. In order to commission the automated system approximately 10m³ of turbid water was pumped out on the tundra to allow for connections to be made on the automated pump system. This water should have been hauled with the vacuum truck to the TIA rather than being discharged to the environment. Pumping was ceased shortly after initiation and water management procedures were reviewed with the contractor.

Details of Spill: A sinkhole developed beneath a drill operating on Doris Camp Pad G. Drilling was halted due to concerns of ground stability issues of the camp pad and the drill was removed from this location. Conductivity measurements in surface water flow indicate that brine water may have migrated south from the drill hole under Doris Road and onto the surrounding tundra near Sump #1. The volume released is unknown. Water was pumped from the drill hole and Sump #1 and routed to the water management system. A snow berm was constructed between Sump #1 and Doris Lake to capture spring meltwater and monitoring of surface flow in the area will determine if further water management is required.
