WATER LICENCE INSPECTION FORM

Licensee		Licensee Representative	
TMAC Resources		Kyle Conway	
Licence No. / Expiry		Representative's Title	
2AM-DOH1335		Environment Supervisor	
Land / Other Authorizations		Land / Other Authorizations	
Date of Inspection		Inspector	
May 7-8 2019		Candice Pedersen	
Activities Inspected			
<input checked="" type="checkbox"/> Camp		<input type="checkbox"/> Mining	
<input type="checkbox"/> Roads/Hauling		<input type="checkbox"/> Drilling	
		<input type="checkbox"/> Other:	
		<input type="checkbox"/> Reclamation	
		<input checked="" type="checkbox"/> Fuel Storage

On May 7, 2019 a water licence inspection was conducted at the TMAC Doris camp (2AM-DOH1323) by Inspector Candice Pedersen accompanied by Kyle Conway of TMAC. Facilities inspected included, but were not limited to; Roberts Bay Facilities, Doris Main Camp, Waste Management Area, Bulk Fuel Storage at the Single Tank Farm, Lower Laydown Area by the Batch Plant, the Burn Pit by Quarry 2, the Mill Pad, the Detox Tailings Area, the Underground Laydown Area, Doris Crown Pillar, the Tailings Impoundment Area (TIA), Windy Lake Raw Water Intake, Doris Lake Raw Water Intake, Doris Camp Pad, Doris Camp Di

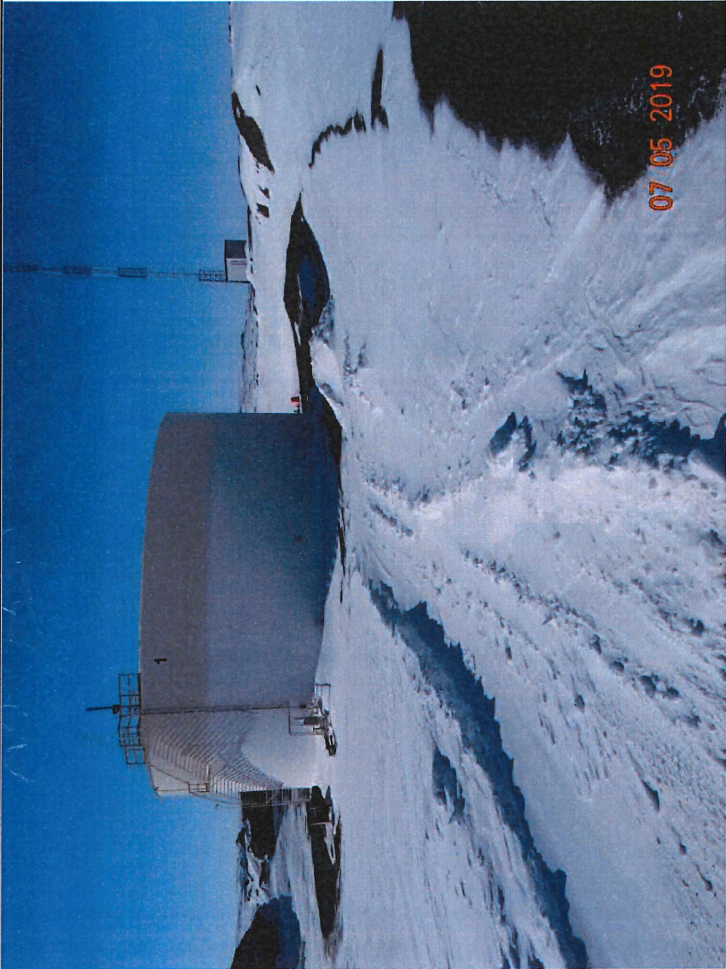
Date	Camera	Inspector	Authorization
07 05 2019	SONY Cybershot	Candice Pedersen	
Photo Log # 1	Location (NAD 83 DD MM SS.SS)		
Photo #1	N68 10 35.7           W106 36 57.7

**Bulk Fuel Storage at the Single Tank Farm:** The inspector noted there were three areas of snow piles within the berm. It appears the snow was cleared from places other than inside the tank farm (see *photo log #1 and #2*). It is evident from one trail that it appears to have been plowed by heavy equipment and deposited near the single tank. The inspector is concerned that the snow will reduce the available capacity of the secondary containment if a spill were to occur. Inspector is informing TMAC Resources to stop storing snow in the secondary containment.

Description: Snow plowed into bermed area by the Bulk Fuel Storage by Tank #1

Inspector wants TMAC Resources to stop pushing snow into the berm at the Bulk Fuel Storage at the Single Tank Farm.

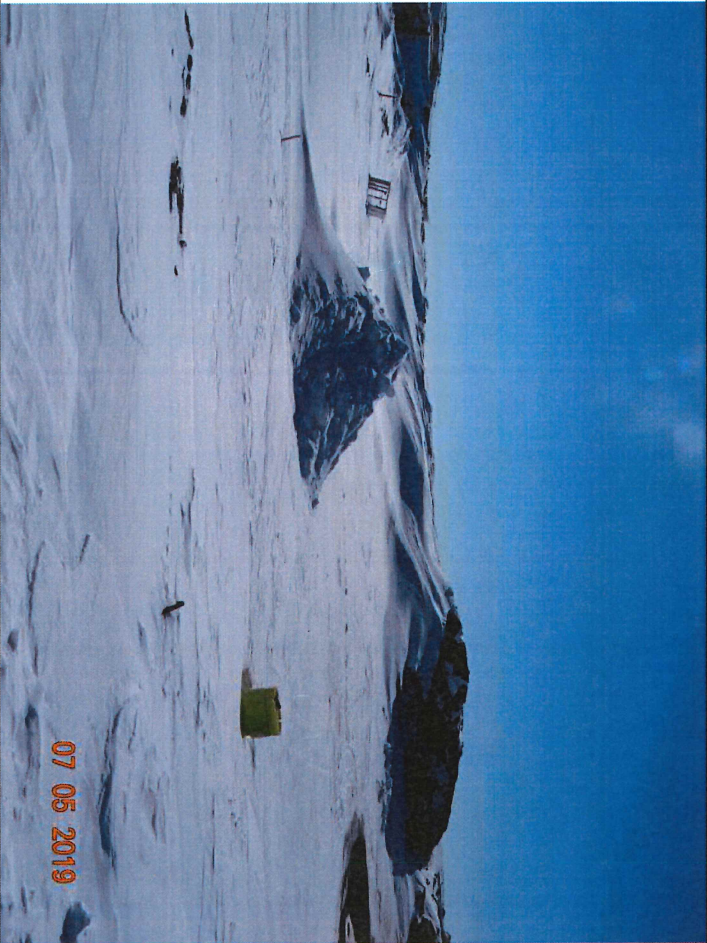
Photo Log # 2	Location (NAD 83 DD MM SS.SS)
Photo #2	N68 10 35.8           W106 36 57.6

Description: More snow plowed into bermed area by Bulk Fuel Storage by Tank #1

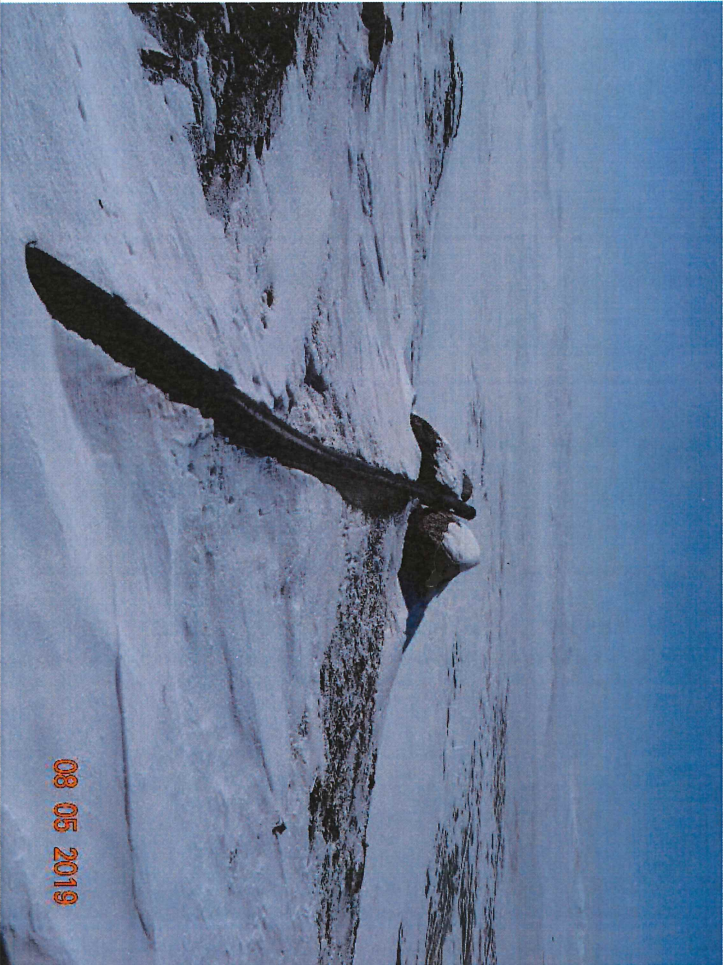
Photo Log # 3

**Tailings Discharge Line:** During the inspection, it was noted that some tailings have been deposited on the downward side of the hill (*see photo log #3*). The location was identified as a concern in the previous inspection. TMAC since then changed the location of discharge to the base of the hill with a longer pipe. There are no concerns at this time.

Description: Residue of tailings at old discharge location

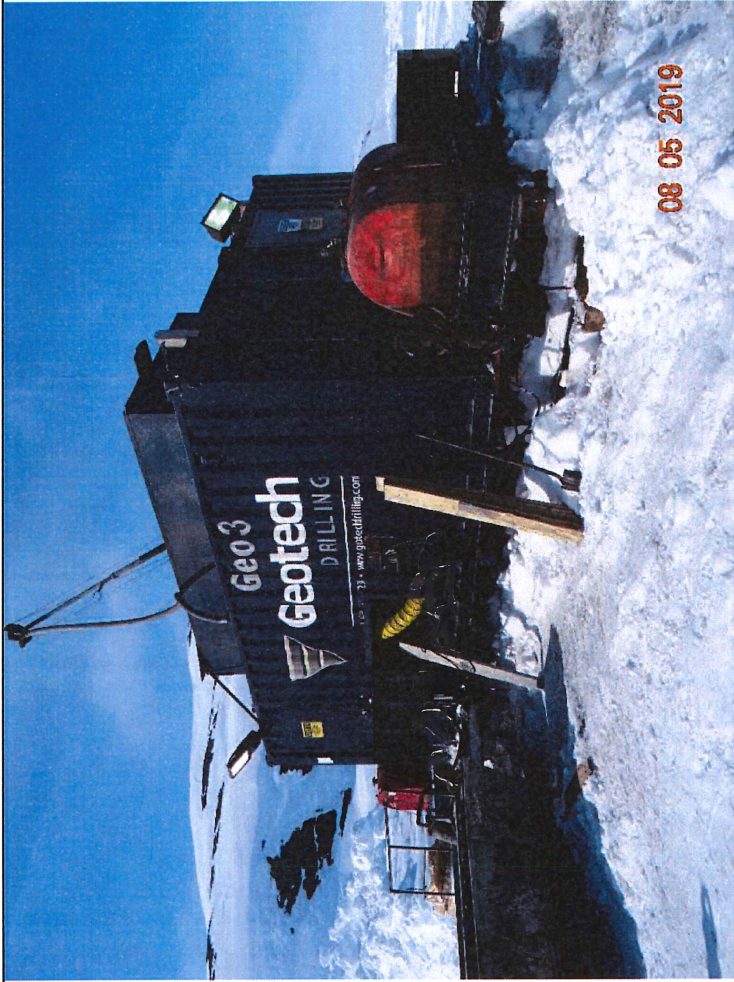
Photo Log # 4

**On-ice drilling:** The core shack at Patch Lake was very clean inside and outside (*see photo log #4*) from proper storing of sediment water and waste water. Completed drilling areas were left very clean because the management ensured nothing was left behind, inspector noted it was hard to see old drill spots other than the snow cleared to access the sites.

Description: Core shack on Patch Lake

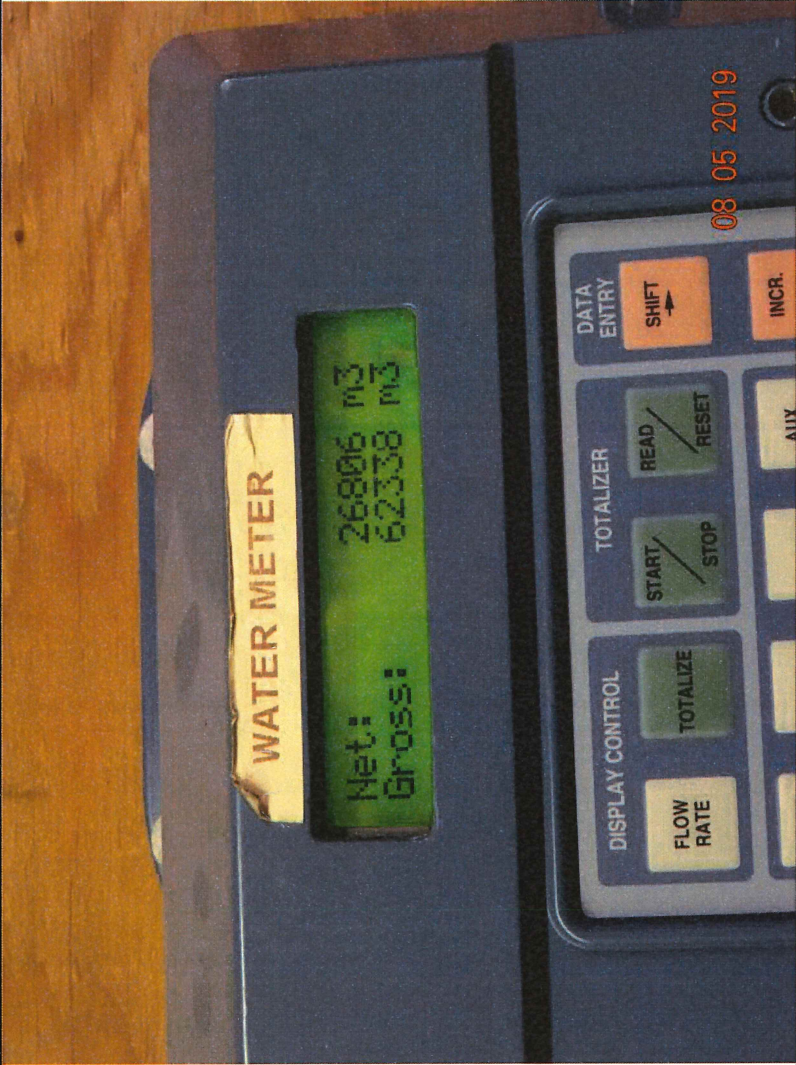
Photo Log # 5  
Photo #5

**Doris Lake Raw Water Intake:** No concerns were noted with this facility it appears to be operating as intended. Photo was taken of the flow meter installed (see *photo log #5*) and shows that 26,806 cubic meters has been used since the meter was installed. TMAC records water usage internally with the number shown on the flow meter.

Description: Flow meter at the Raw Water Intake Facility

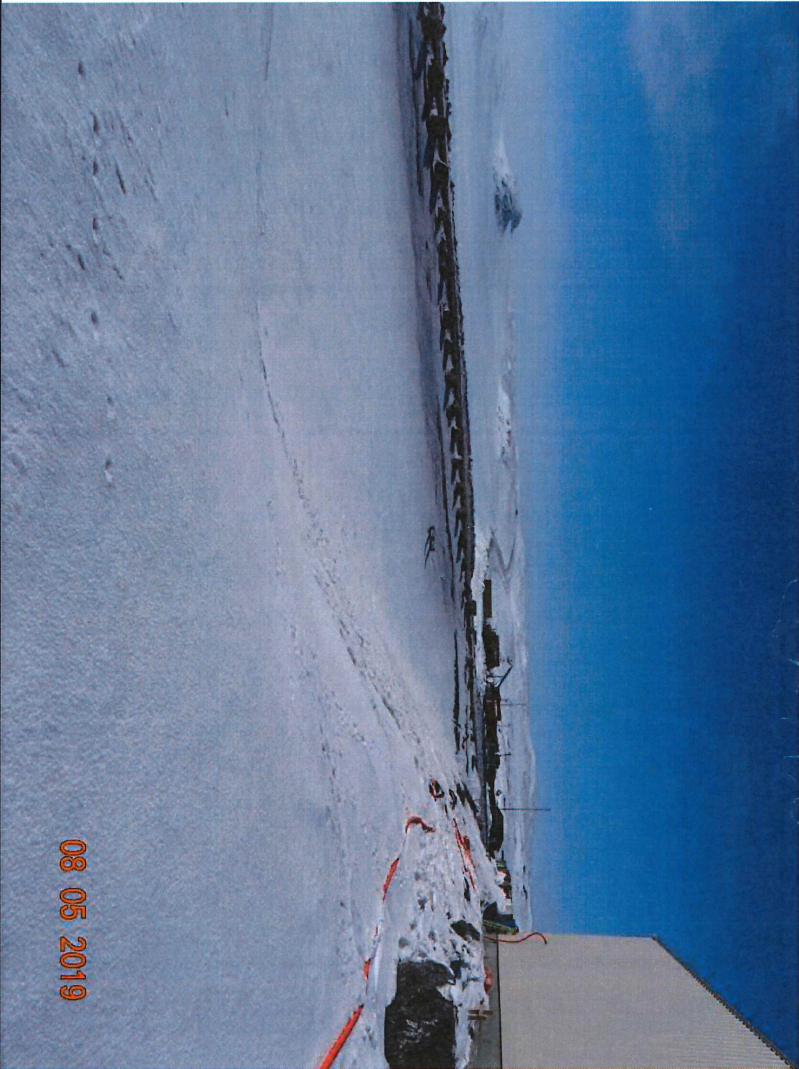
Photo Log # 6  
Photo #6

**Sediment Control Pond:** Inspector walked around facility and did not note anything different from last inspection other than snow cover, no concerns noted with this facility. (*see photo log #6*)

Description: Sediment Control Pond

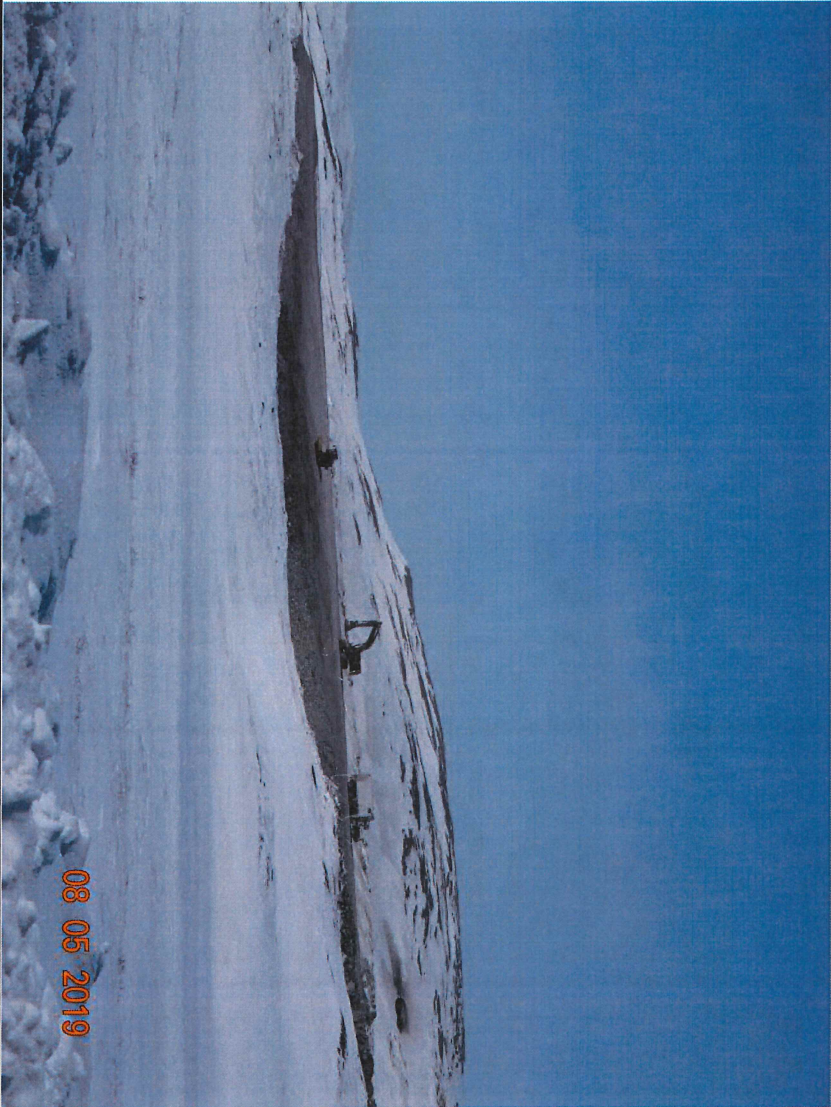
Photo Log # 7

**Doris Crown Pillar:** The Doris Crown Pillar is a piece of the greenstone belt that is at the surface of the earth, it is located 500 meters directly East of the main camp. The Crown Pillar started to be stripped of the overburden in October 2018 and mined over the winter. Reclamation started in March and once Inspector arrived it was at the back filling stage (*see photo log #7*). A culvert was placed on the East corner to ensure proper drainage in the area. No concerns were noted.

Description: Reclamation of the Doris Crown Pillar
