3.4 Shoreline Laydown Area

3.5 20 ML Roberts Bay Tank Farm Secondary Containment

3.6 5 ML Roberts Bay Tank Farm Secondary Containment

3.7 Roberts Bay Waste Management Area

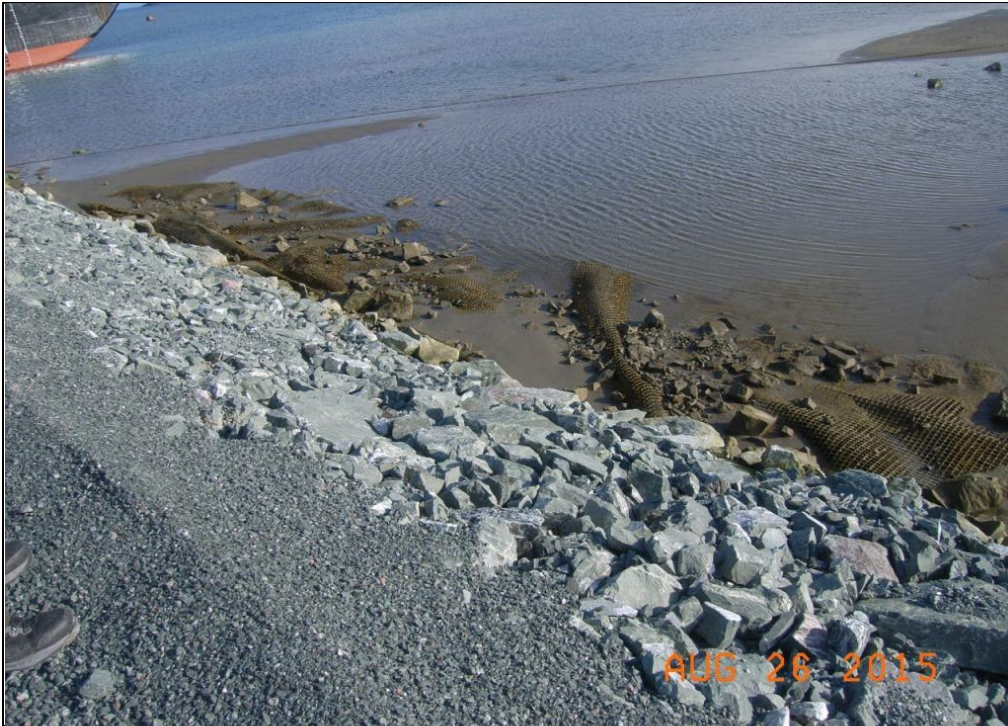
Photo: 3.3-3

Roberts Bay Jetty –
exposed geogrid at
east toe.

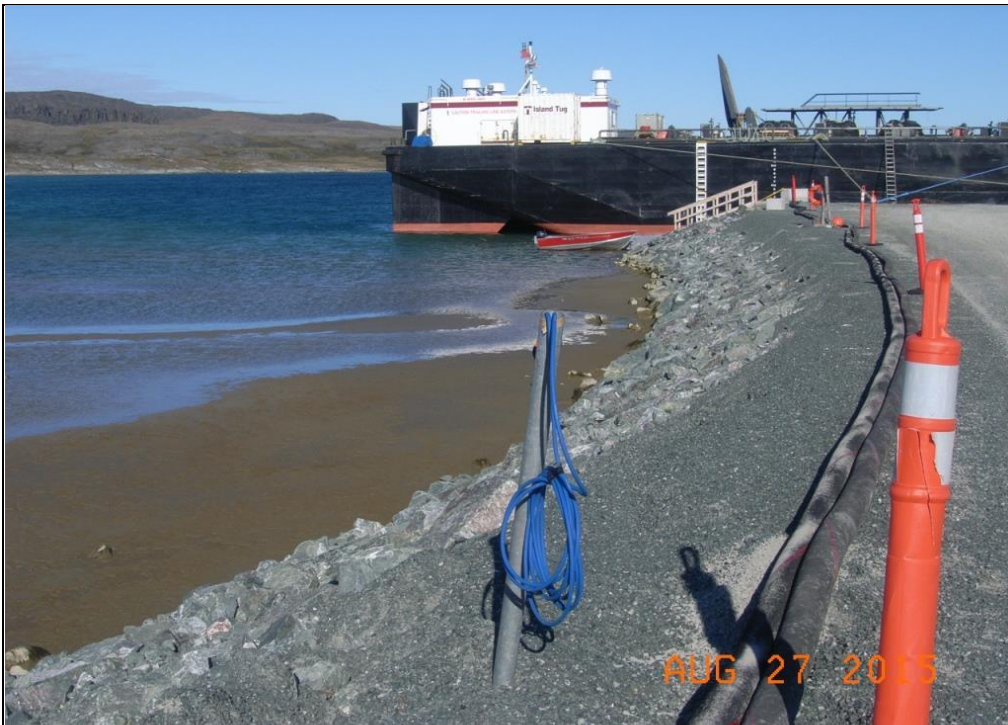
Photo 3.3-4

Roberts bay Jetty –
west toe

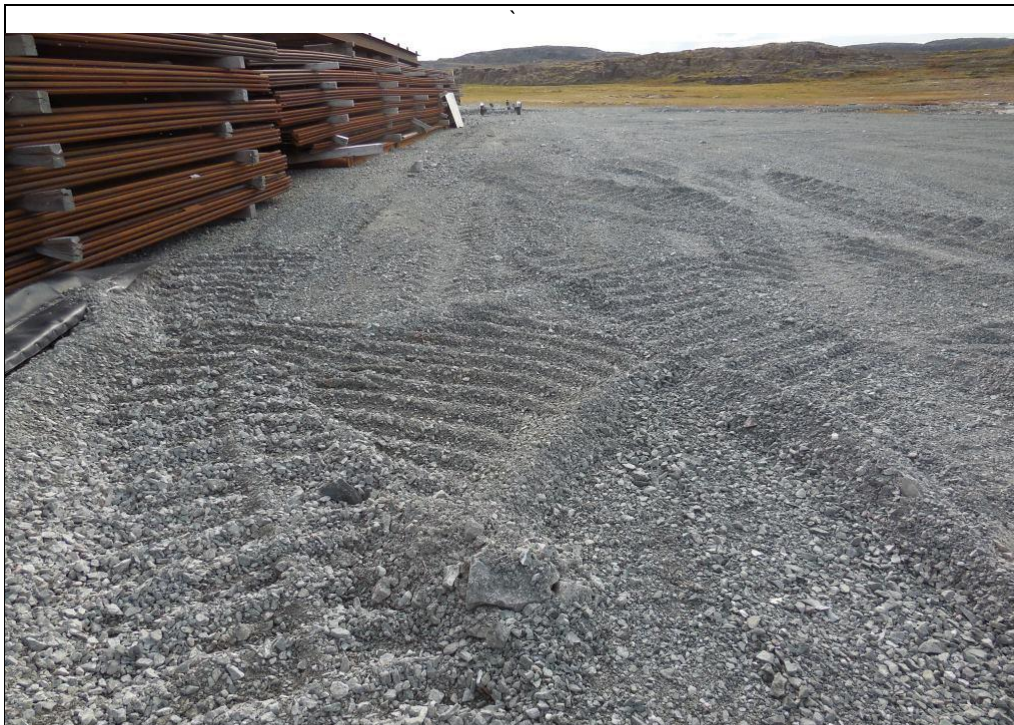
There were no obvious signs of thermal settlement across the surface of the pads or roads. There was some water ponded against the south (upstream) side of the main laydown area, and there were tension cracks through the south end of the main laydown pad (behind the stockpiled sheet piling) and slumping of the edge of the pad, suggesting some degradation of permafrost below the edge of the pad.

Photo: 3.4-1
 Roberts Bay
 Laydown Area, north
 edge of stockpiled
 sheet piling

It is recommended that the area along the south edge of the main laydown pad be monitored to determine whether water regularly ponds against the main laydown pad. If so, accumulated water should be pumped out during freshet and after significant or prolonged rainfall events.

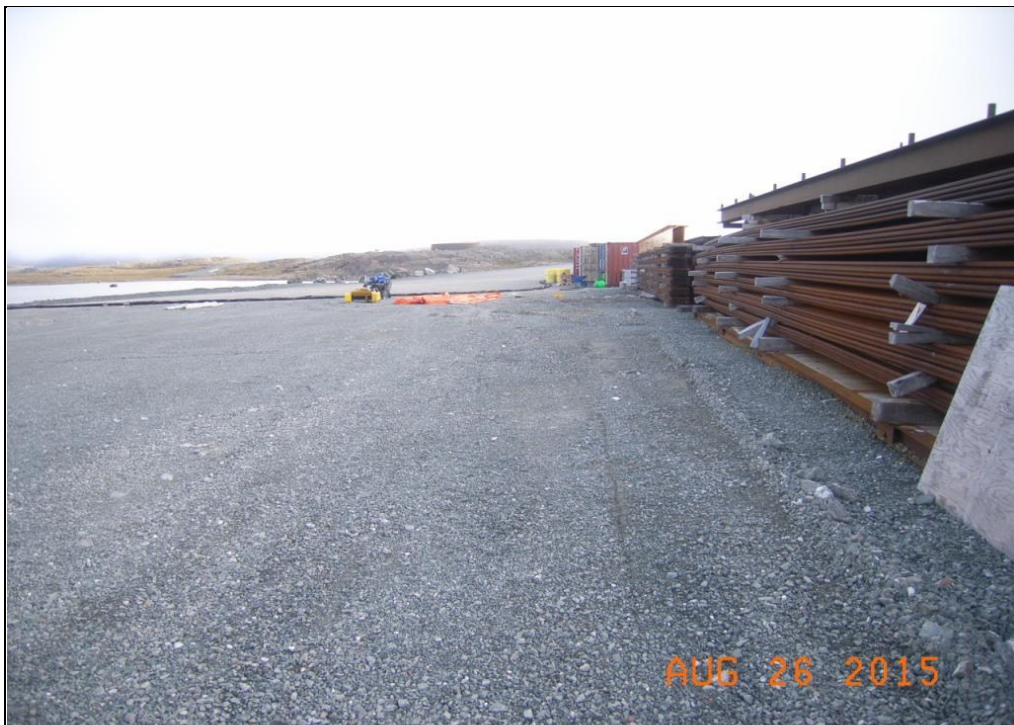
Photo: 3.4-2
 Roberts Bay
 Laydown Area, north
 edge of stockpiled
 sheet piling

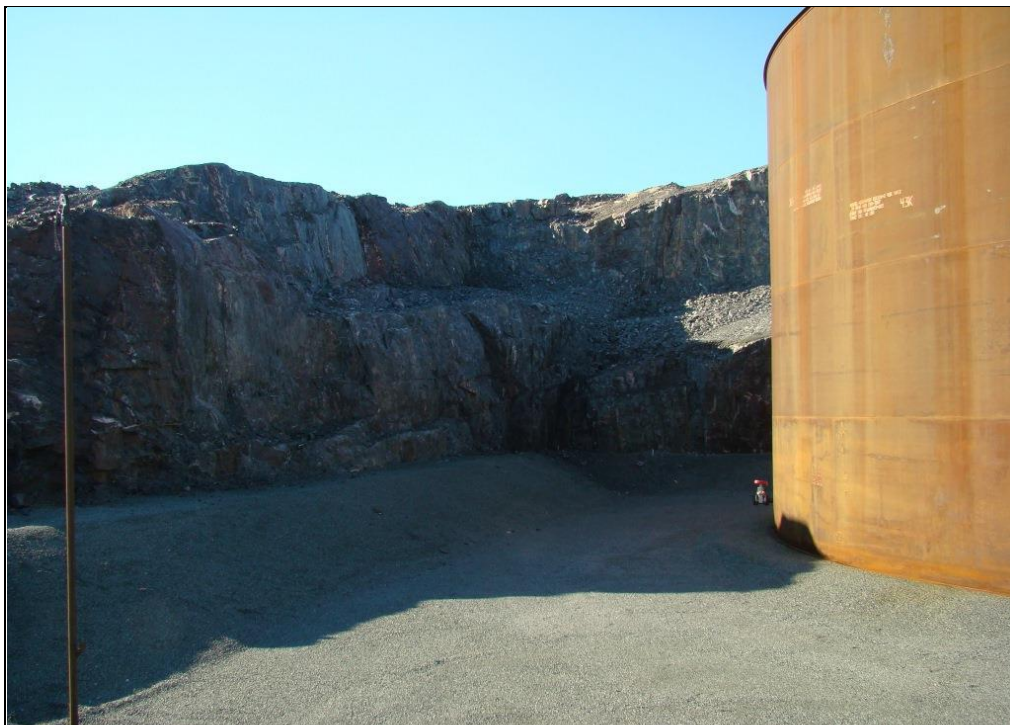
Photo: 3.5-2
 Roberts bay Tank
 Farm; rock cut

Recommendations from inspections carried out by specialists examining the stability of the rock face and rockfall protection system should be implemented

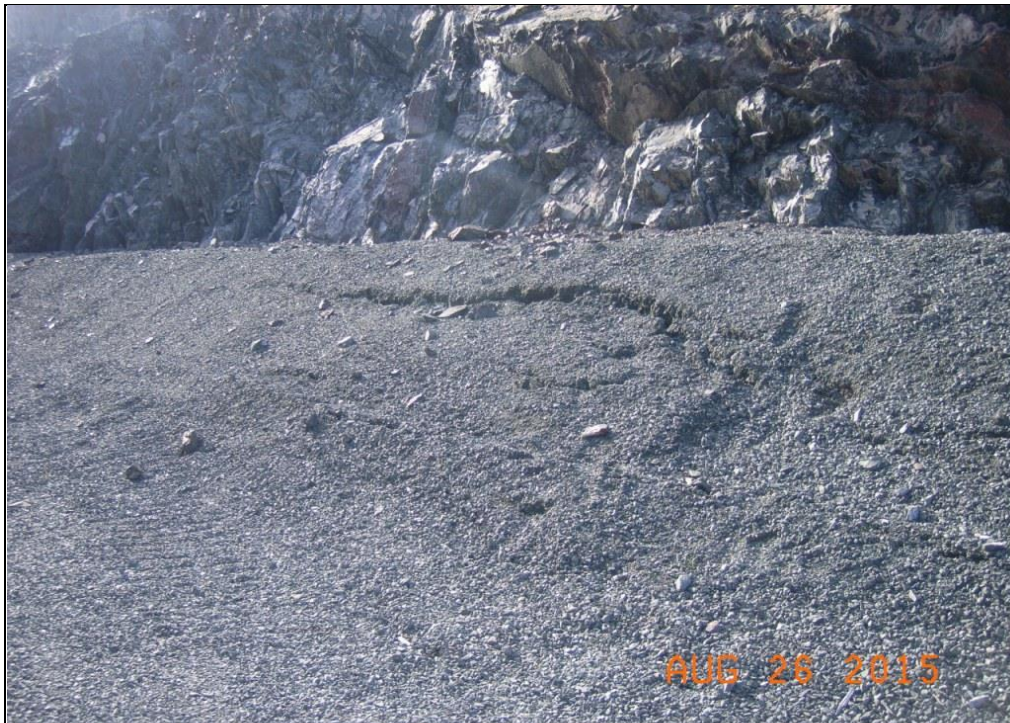
There are a number of areas where the gravel cover has slipped and exposed portions of the HDPE liner along the bund slopes. There are also some wheel / track marks in the cover gravel from equipment moving fuel lines and snow removal.

Photo: 3.5-4
Roberts Bay Tank
Farm; cover material
slippage

Sections of exposed liner should be documented and inspected for damage. The gravel cover at wheel and track marks should be measured. Where the gravel is less than the design thickness, the gravel should be scraped back to expose the liner for inspection. The liner should be repaired if required by qualified personnel, and the cover gravel replaced.

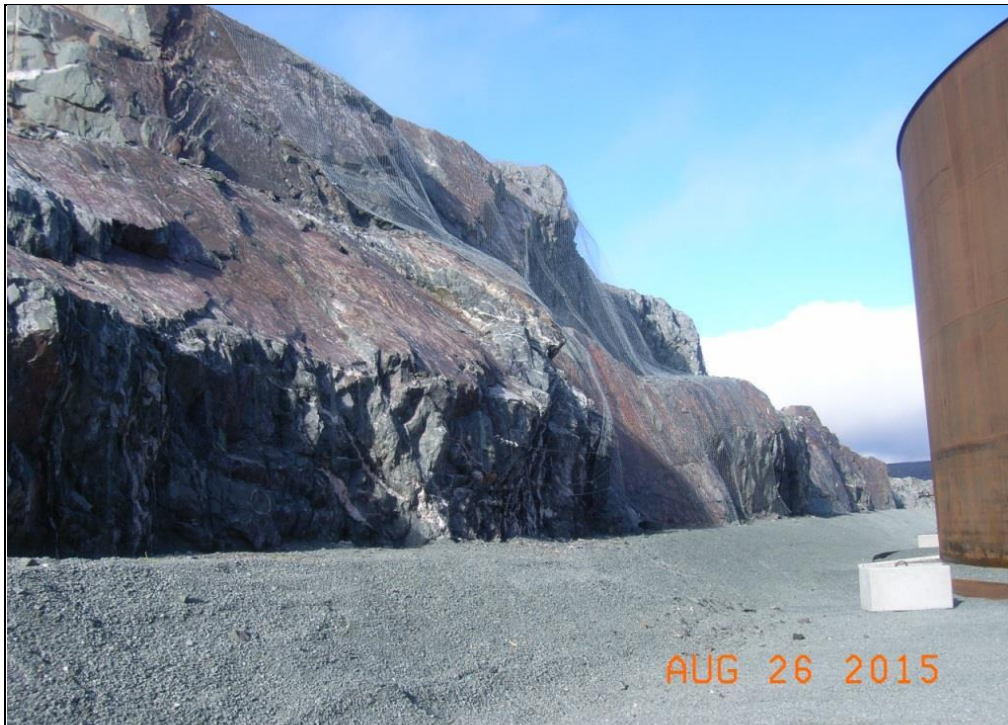
Photo: 3.5-5
Roberts Bay Tank
Farm; rock cut

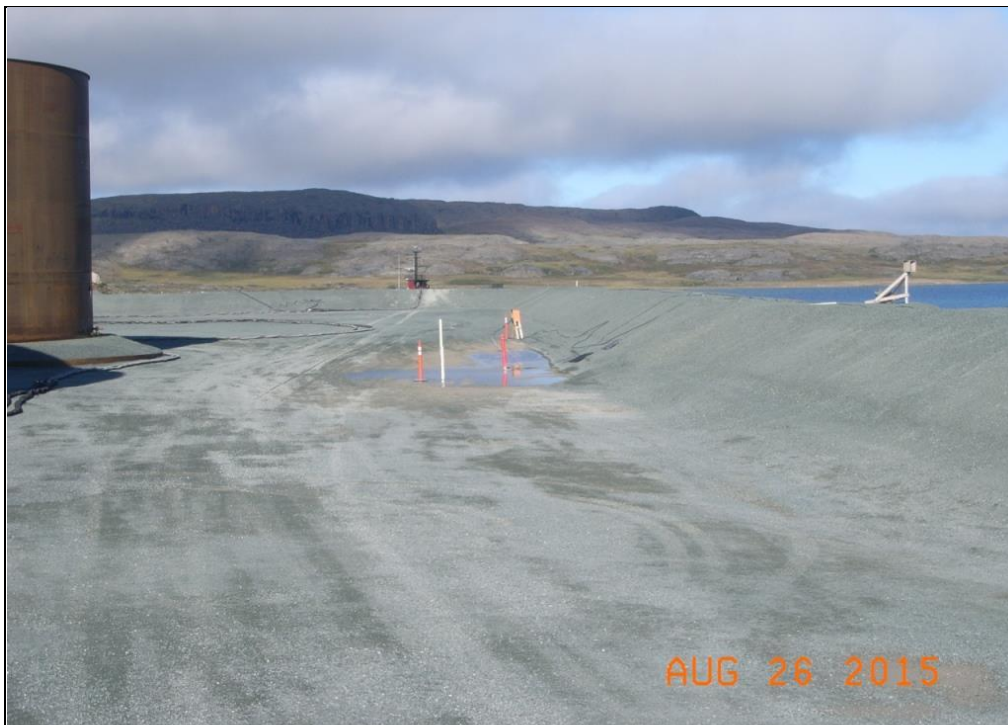
At the time of the inspection, the sump was full of water. There is a buildup of sediment on top of (and likely within) the gravel cover surrounding the sump.

Photo: 3.5-6
Roberts Bay Tank
Farm; east
containment bund
and sump

The construction of the sump should be checked to see if it was designed to allow water to enter from the sides. If so, the sump should be pumped out and monitored to see if water is entering from the sides. The concentration of sediment may be blinding the gravel cover in the immediate vicinity of the sump, and the gravel may need to be replaced with cleaner material at some time.

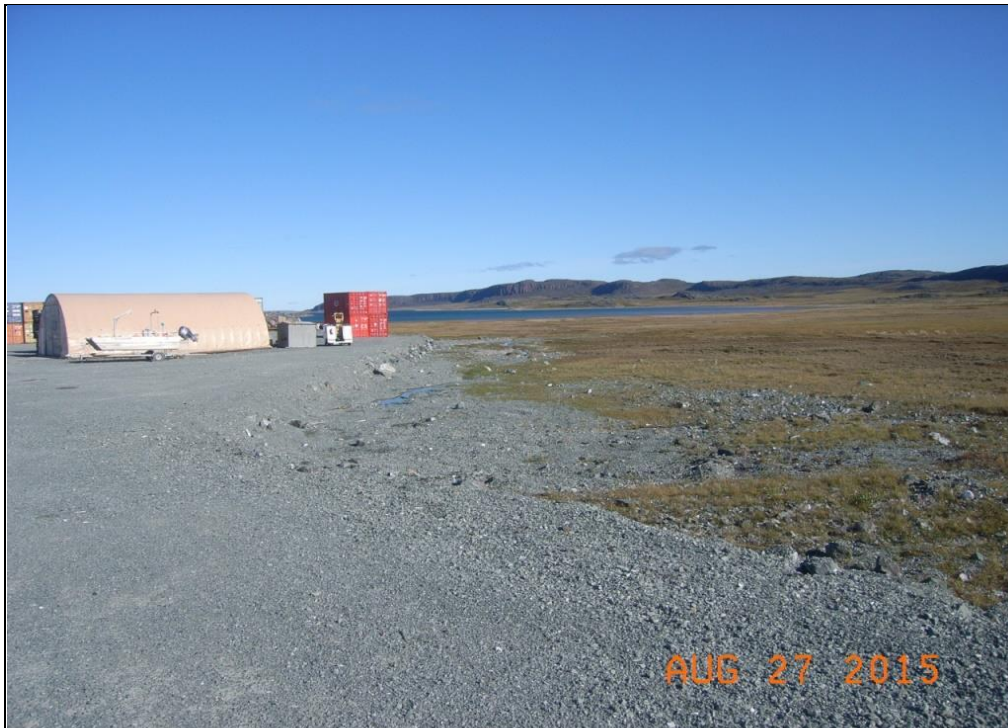
No standing water was observed against the toe of the perimeter of the rock fill pad or along the driveway, and no signs of thermal settlement. There was no standing water on top of the pad or areas of significant settlement. Significant tension cracks were noted on the north, east, and south sides of the pad.

Photo :3.7-3
Roberts Bay Waste
Management Area;
east edge of pad

Continue monitoring areas where rock was relocated from the tundra for signs of thermal settlement, and for ponded water along the edges of the thermal pad.

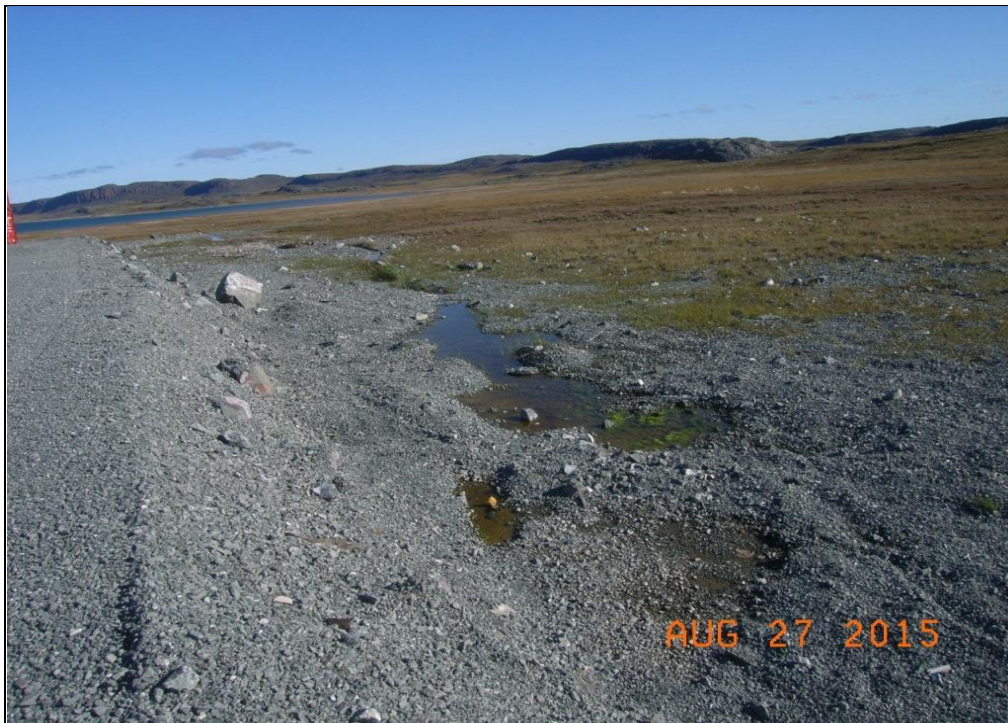
Photo :3.7-4
Roberts Bay Waste
Management Area;
east edge of pad

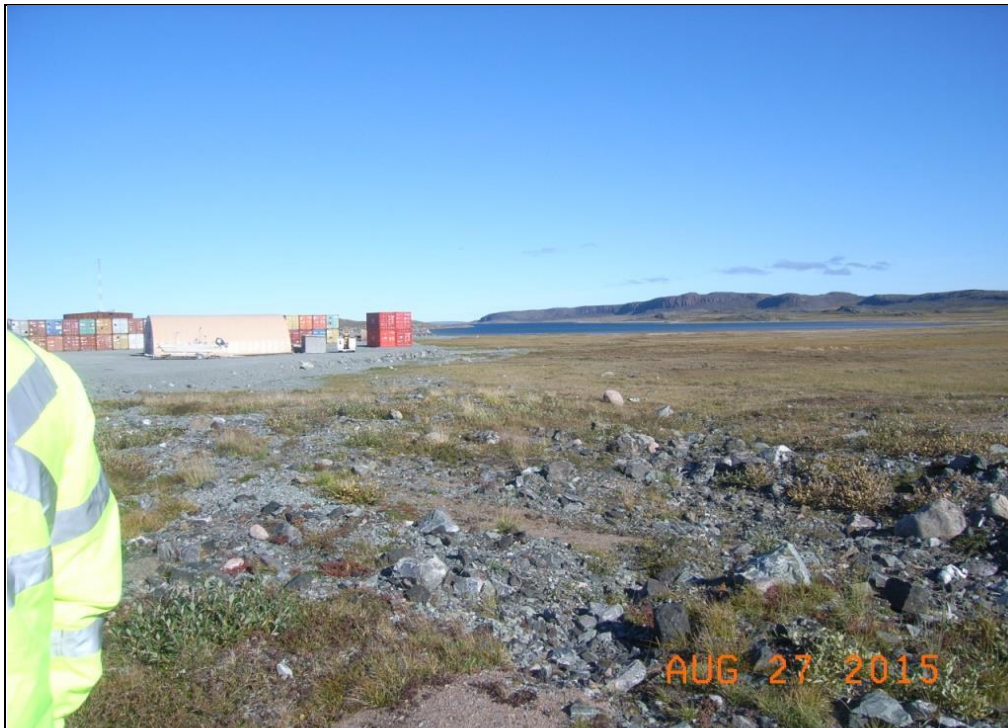
Photo :3.7-5
Roberts Bay Waste
Management Area;
east edge of pad
