3.9 Airstrip

3.10 Former Wash Bay/Explosives Mixing Plant

3.11 Upper and Lower Reagent Pads

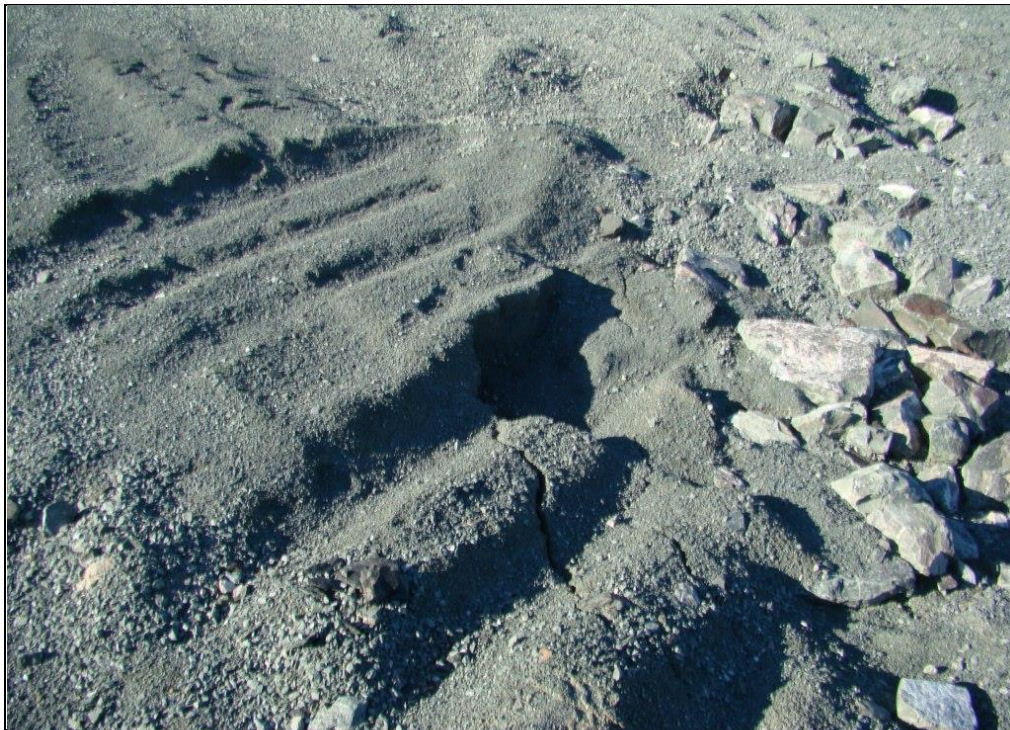
Photo: 3.8-1
 Quarry #1
 Overburden Dump;
 area of subsidence

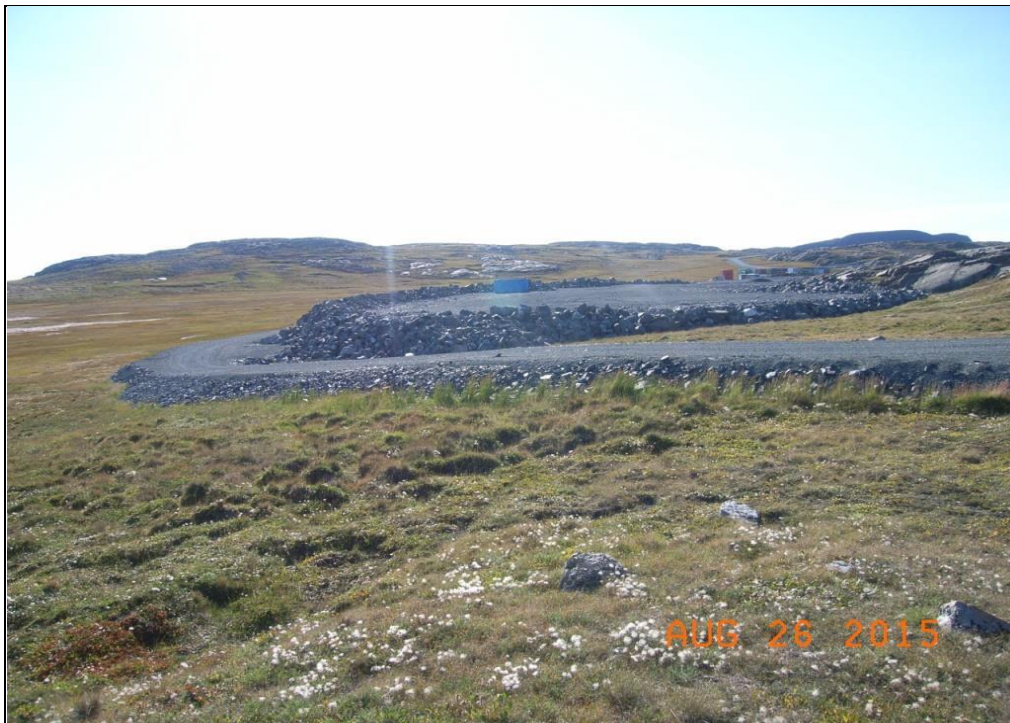
Photo: 3.8-2
 Quarry #1
 Overburden Dump;
 surrounding
 sediment control
 berm

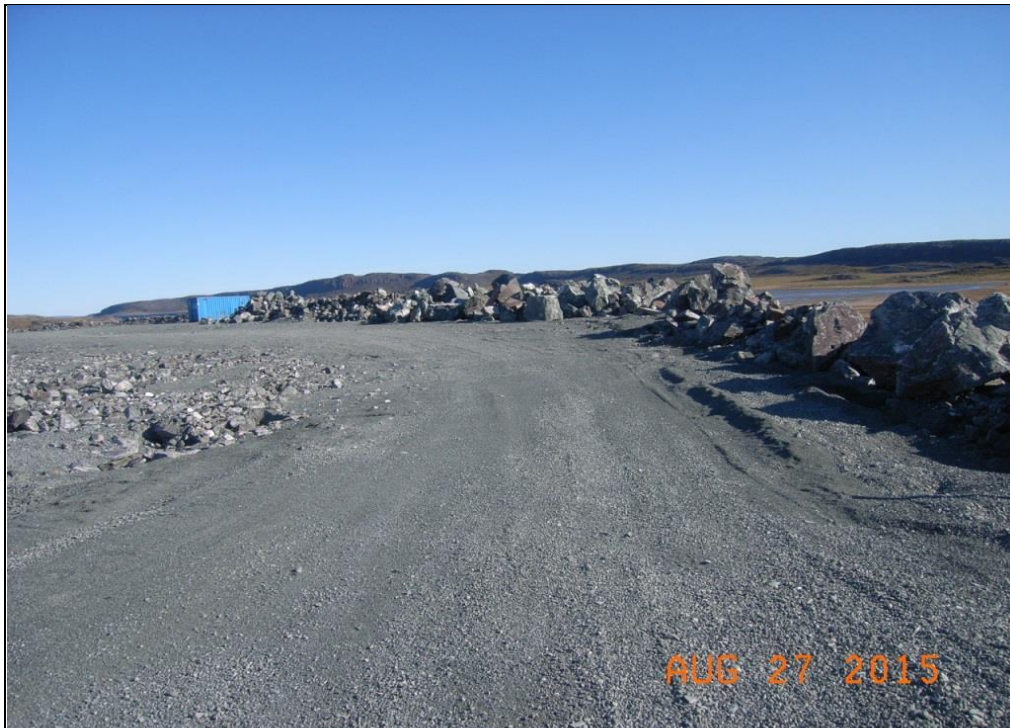
Photo: 3.8-3
Entrance to Quarry
#1 Overburden
Dump

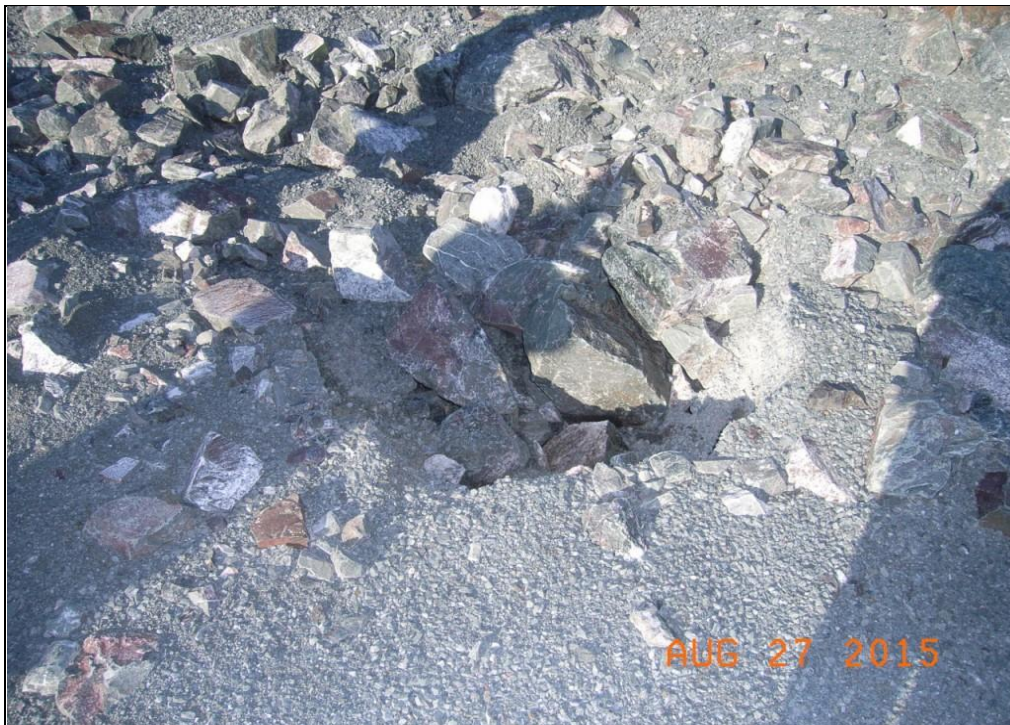
Photo: 3.8-4
Quarry #1
Overburden Dump;
area of subsidence

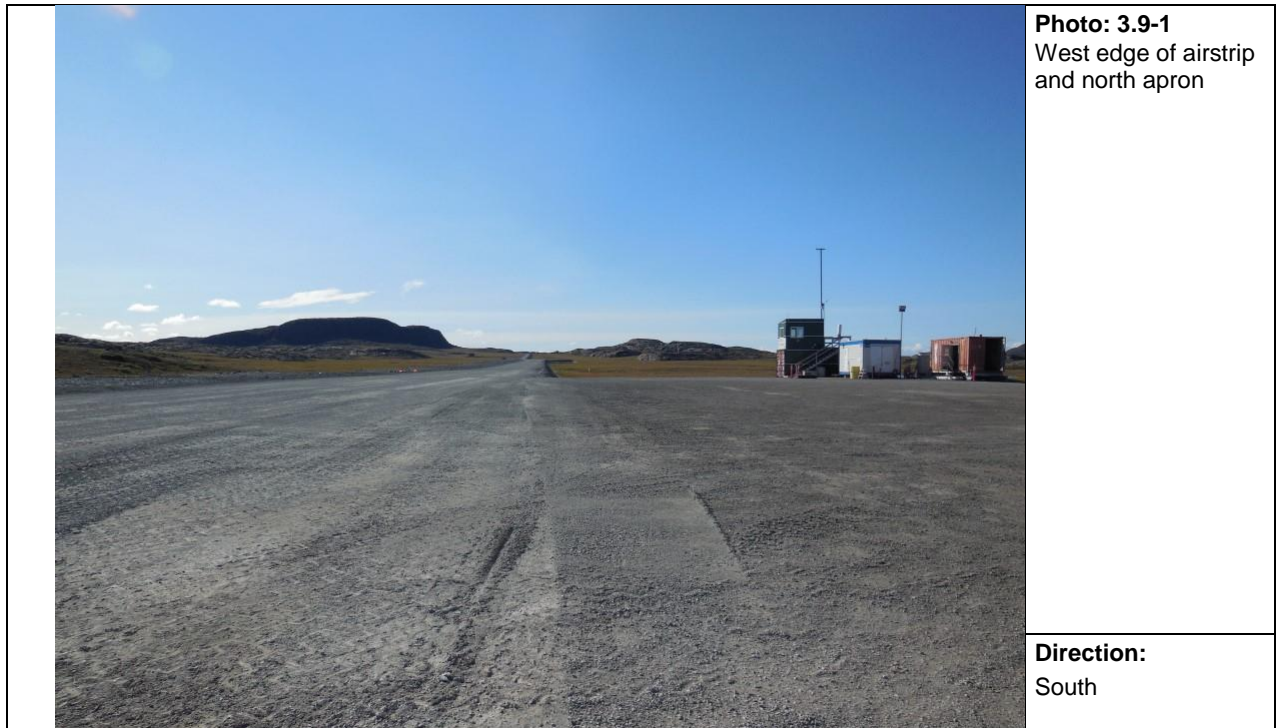
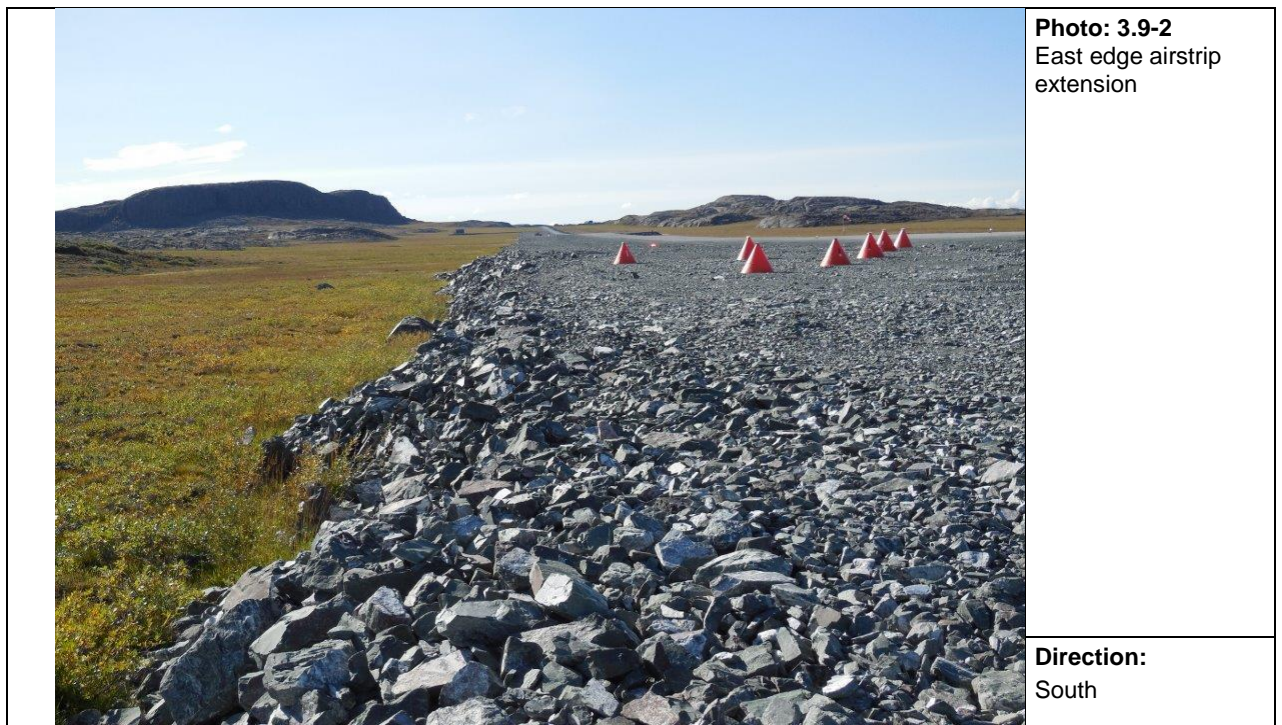
Generally, no standing water was observed against the toe of the airstrip thermal pad. There were some significant tension cracks observed along the crest of the pad, particularly along the apron areas and near the control tower. This may be due to some thermal settlement along the edges or just due to the step angle of the pad slopes. There are also some areas where finer surface material have fallen into the void spaces in the underlying coarser material.

<p>Photo: 3.9-3 North end of airstrip; east edge</p> <p>Direction: North / East</p>
--	---	--

<p>Photo: 3.9-4 West edge of airstrip; south of north apron</p> <p>Direction: South</p>
--	--	--

The tension cracks observed near the control tower and other nearby structures should be repaired. Generally, these structures lie close to the edge of the pad and, if the cracks widen, there may be some movement or damage to the pad.

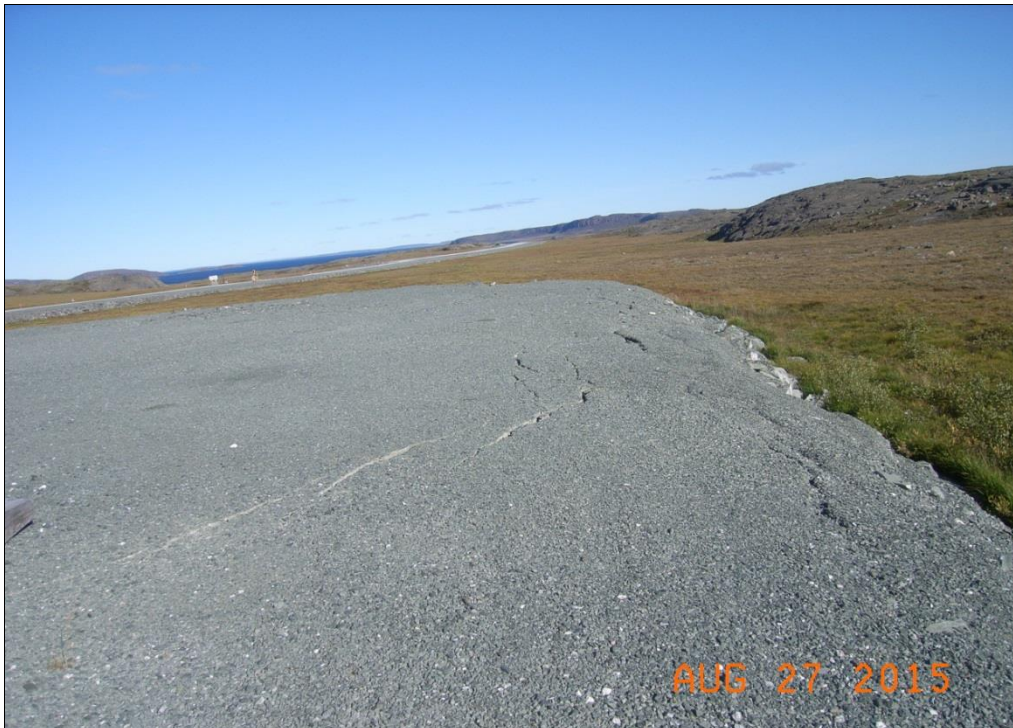
No standing water was observed against the toe of the perimeter of the rock fill pad or along the driveway, and there were no signs of thermal settlement. There was no standing water on top of the pad or areas of significant settlement. Significant tension cracks were noted on the north, east, and south sides of the pad.

Photo: 3.10-1
Former Wash
Bay/Explosives
Mixing Plant; east
edge of pad

If it is proposed to repurpose the building in the future, the tension cracks should be repaired. There is some potential for the cracking to propagate back into the pad and undermine the concrete building pad.

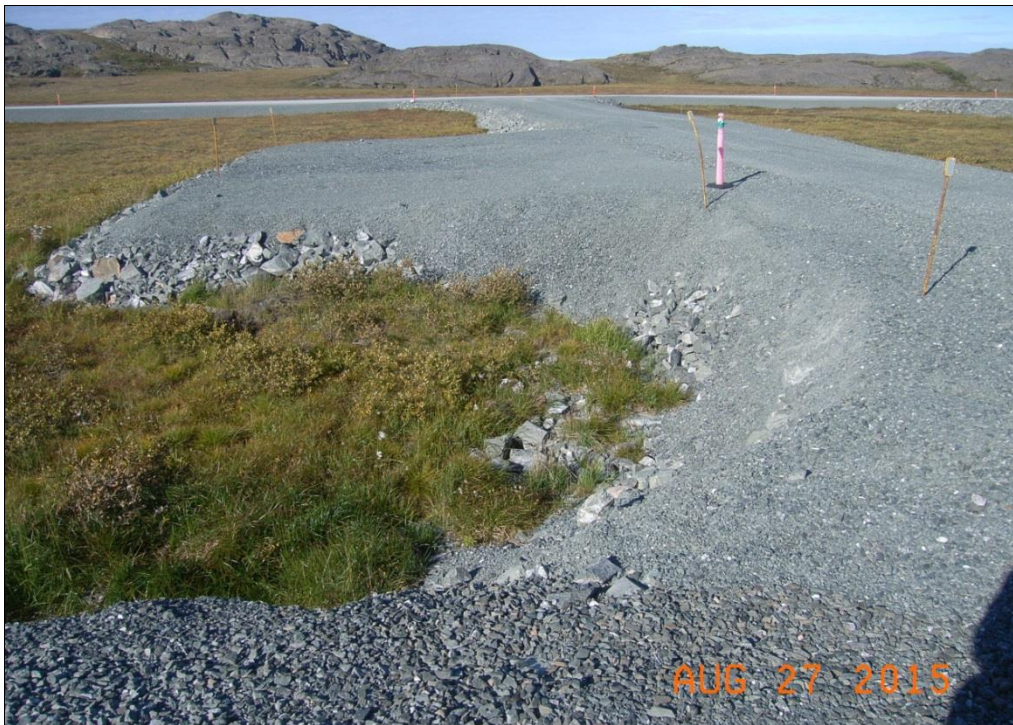
Photo: 3.10-2
Former Wash
Bay/Explosives
Mixing Plant; access
road and turning pad

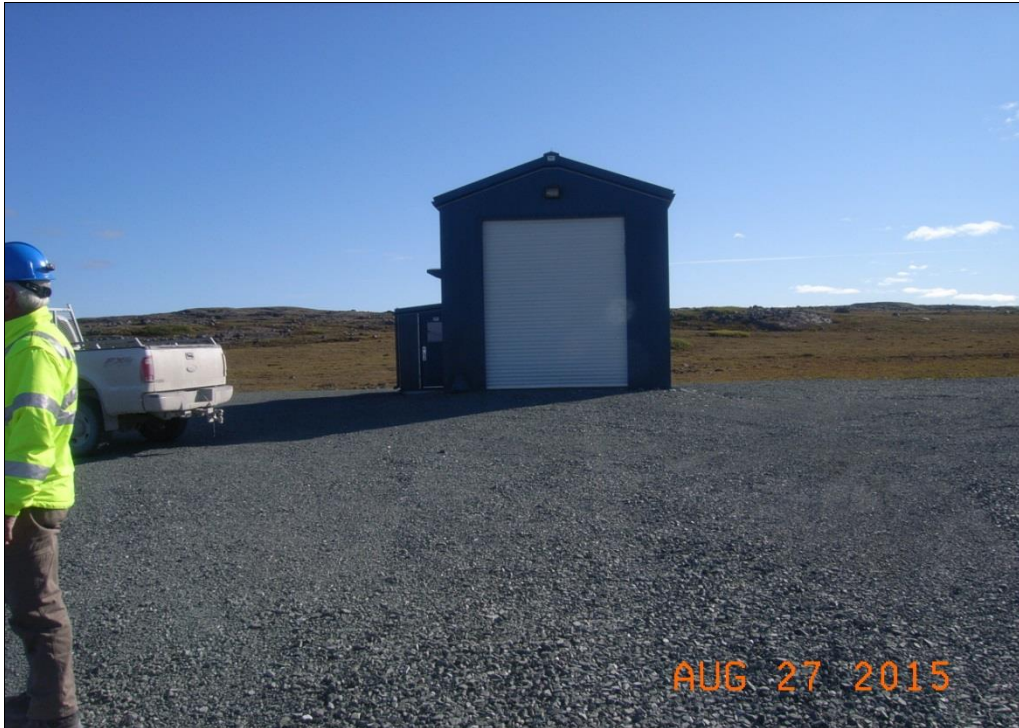
Photo: 3.10-3
Former Wash
Bay/Explosives
Mixing Plant

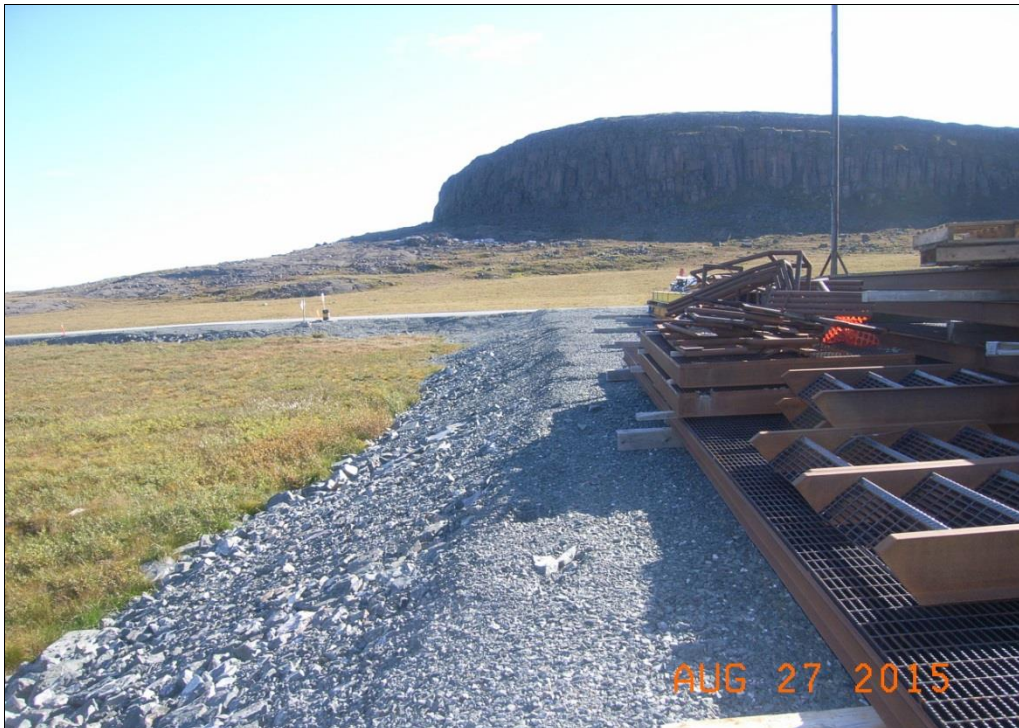
Photo: 3.11-1
 Upper Reagent Pad;
 north edge of pad

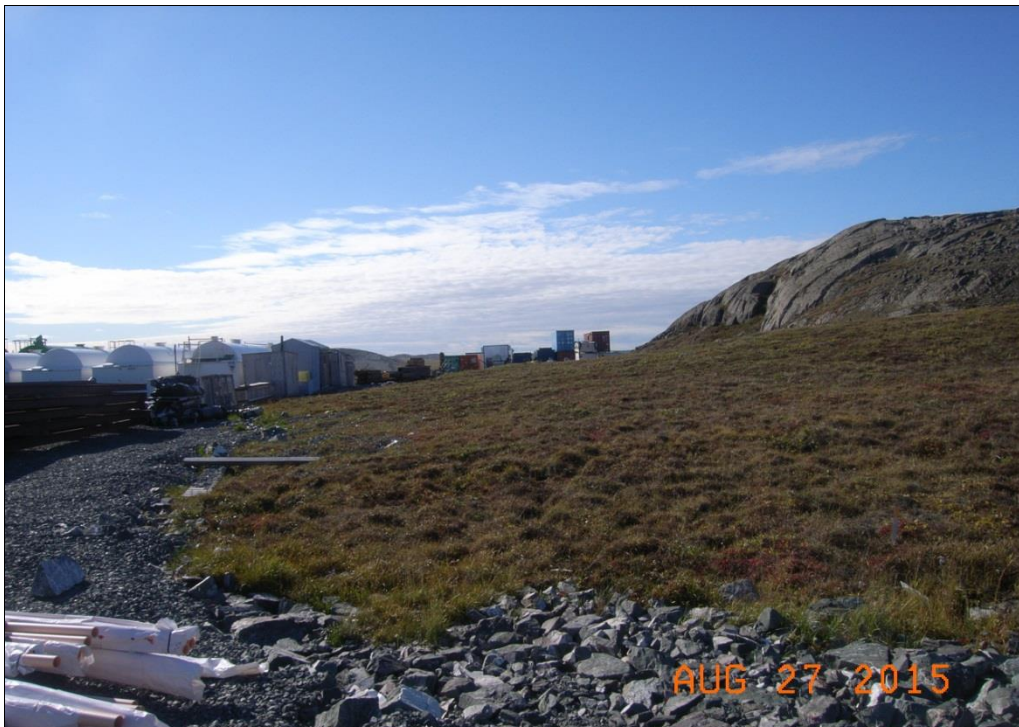
Photo: 3.11-2
 Upper Reagent Pad;
 east edge

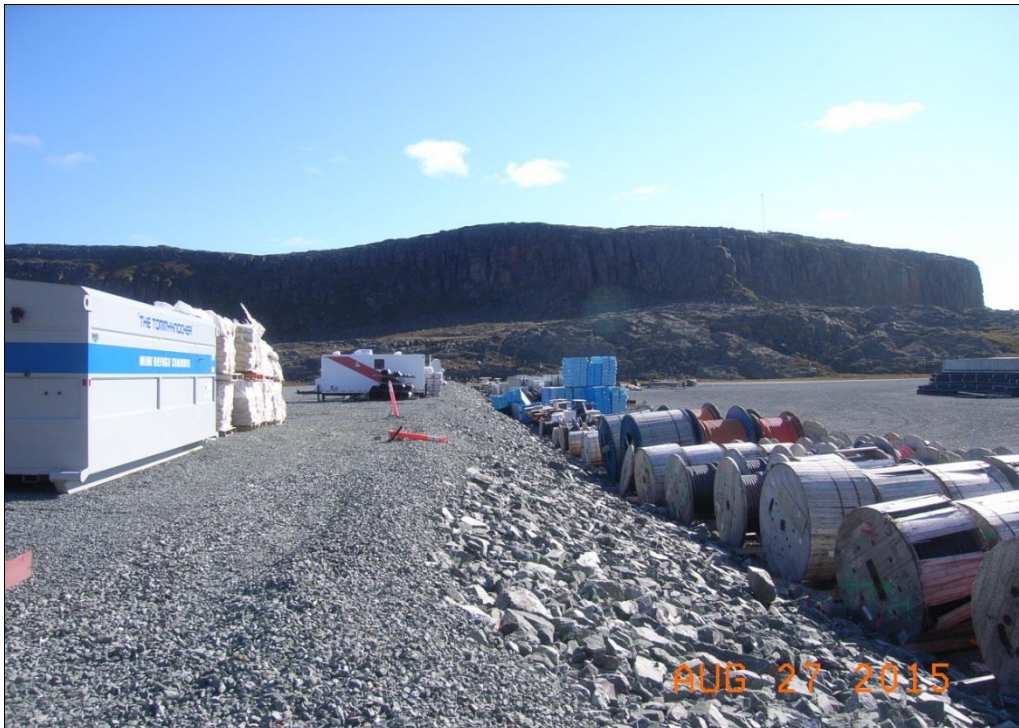
Photo: 3.11-3
 Slope between upper
 reagent and lower
 reagent pads

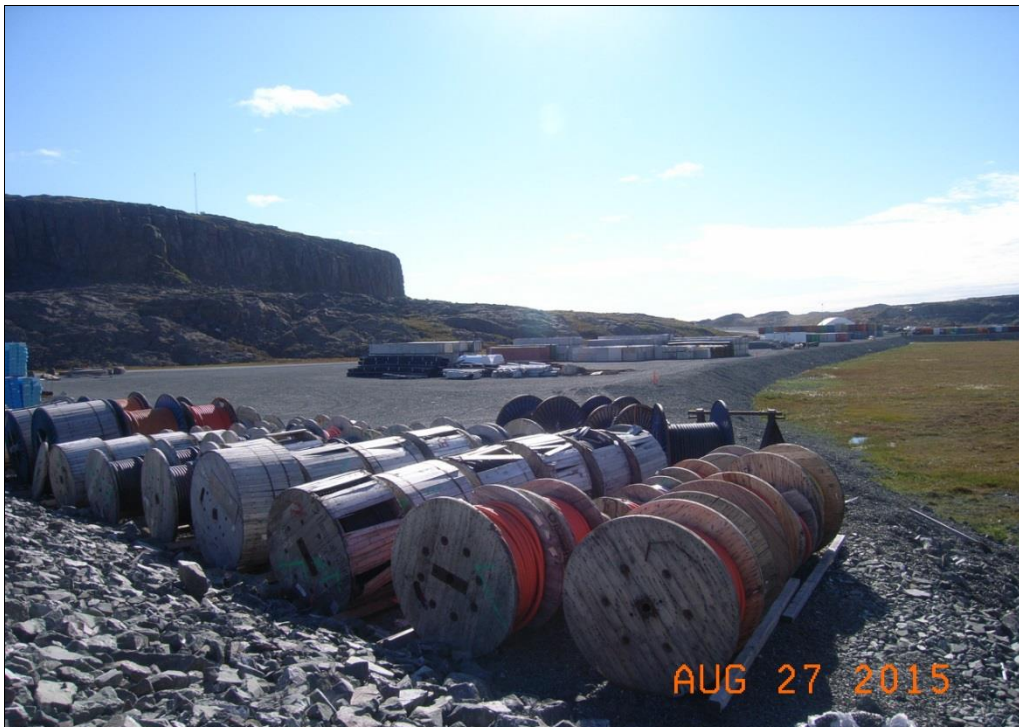
Photo: 3.11-4
 Lower reagent pad;
 east edge

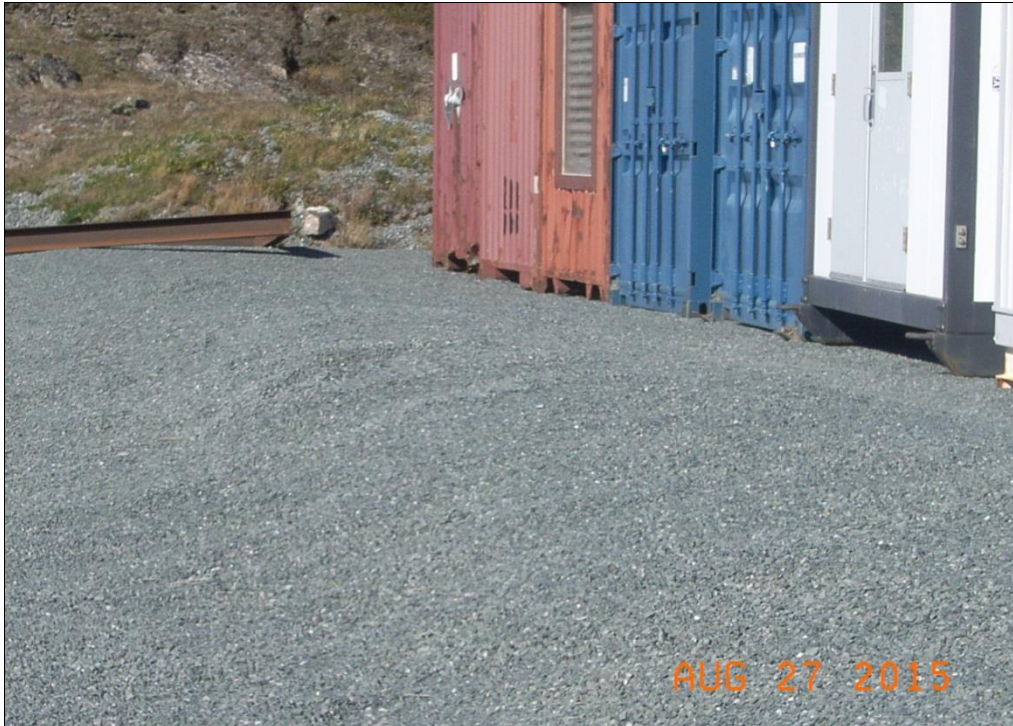
Nothing is presently stored inside the secondary containment area. The HDPE liner is exposed in a few areas.

Photo: 3.12-1
Upper reagent pad
AN secondary
containment bund

If it is proposed to use this area for secondary containment, the liner should be exposed to confirm that it is undamaged.

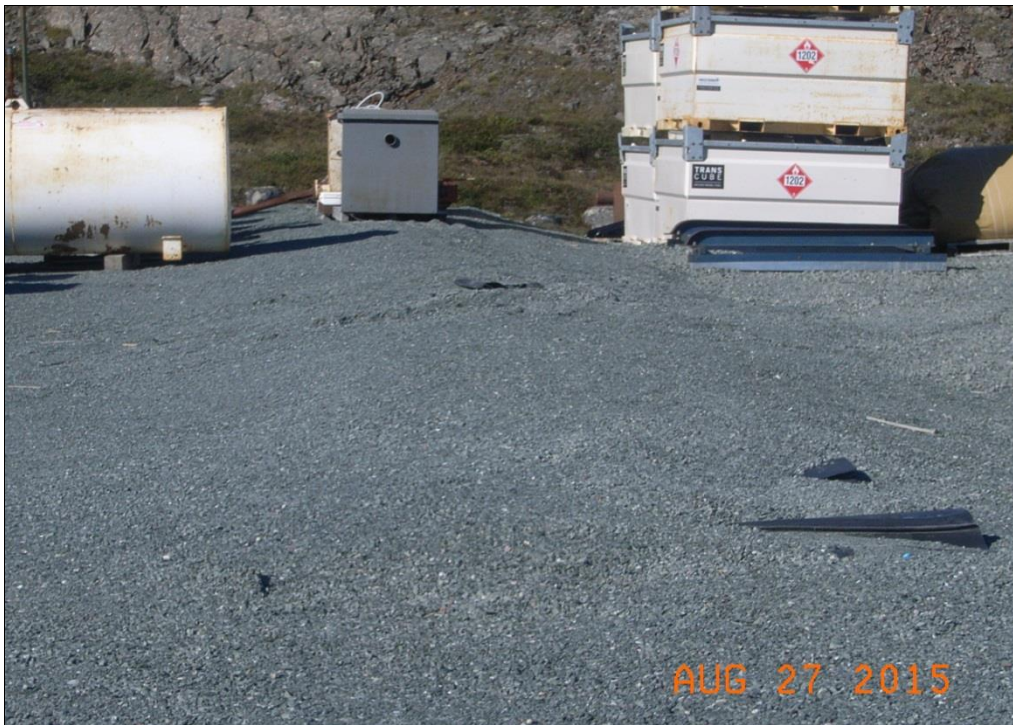
Photo: 3.12-2
Upper reagent pad
AN secondary
containment bund;
exposed HDPE liner

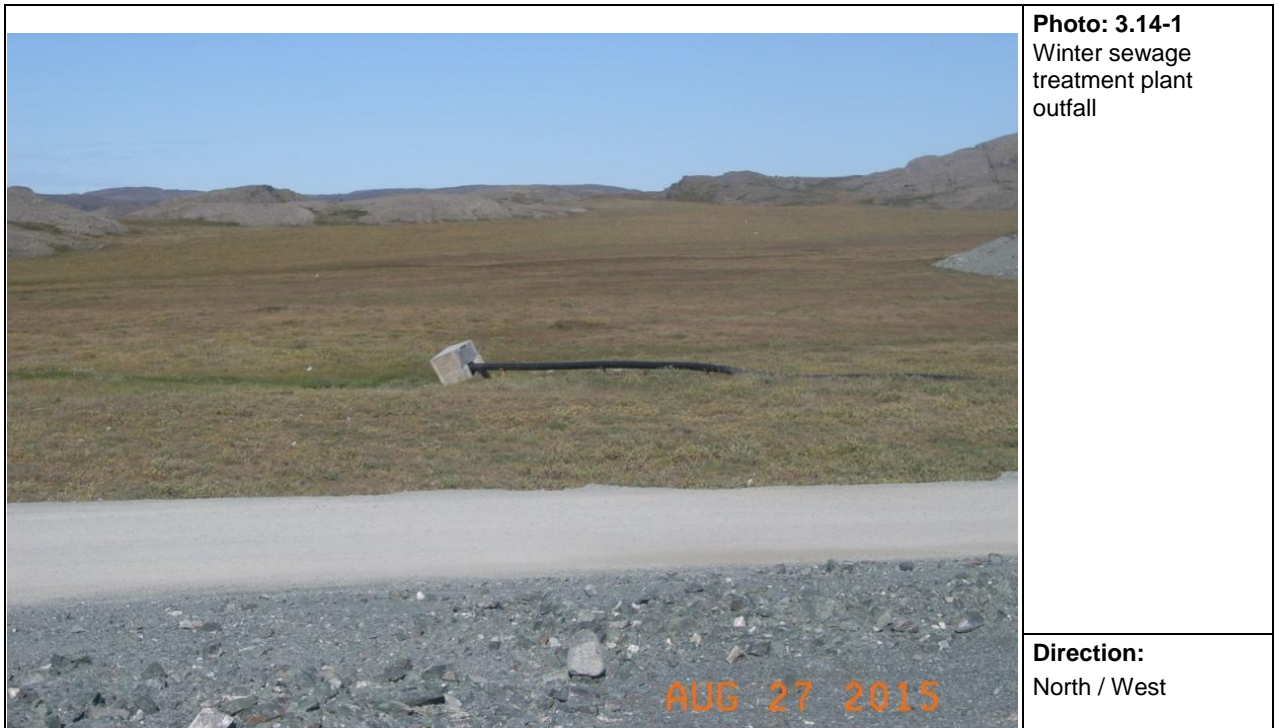
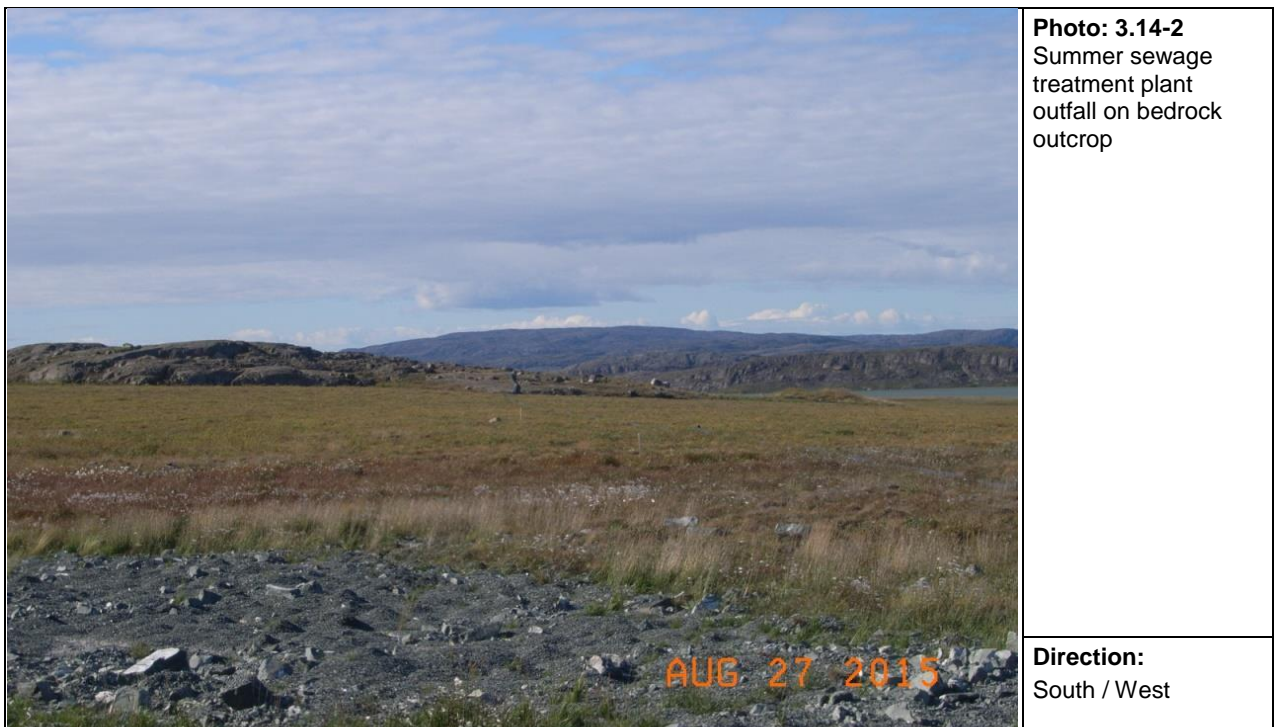
The sewage treatment plant outfall pipe is southwest of the Batch Plant Pad. It used to discharge treated effluent directly onto the tundra, but now only does so during the winter months (with a diffuser) as some thermal settlement and reduction in vegetation was noted in 2010 and 2011. The pipeline is extended and outflows onto a bedrock outcrop during the summer months. The extended pipeline is not used during winter months because of difficulties with keeping the pipeline unfrozen. (Photos 3.14-1 to 3.14-2)

The original pipeline outlet should be monitored in the spring for thermal settlement. The outlet should be switched to the bedrock outcrop as soon as possible in the spring.

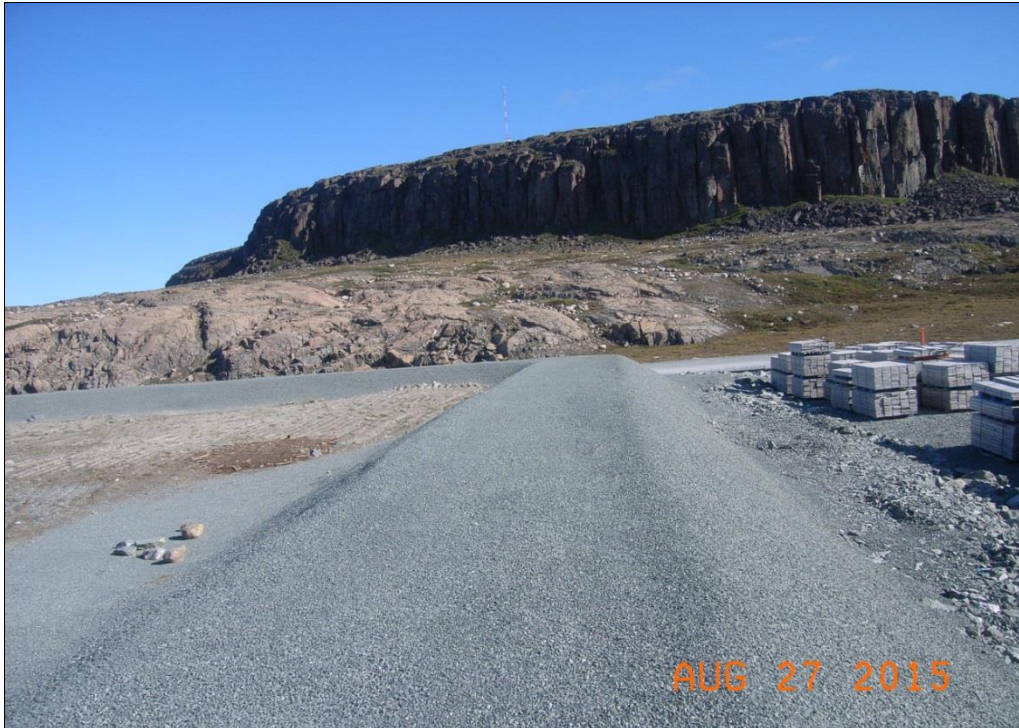
Photo: 3.15-1
Landfarm; south
containment bund

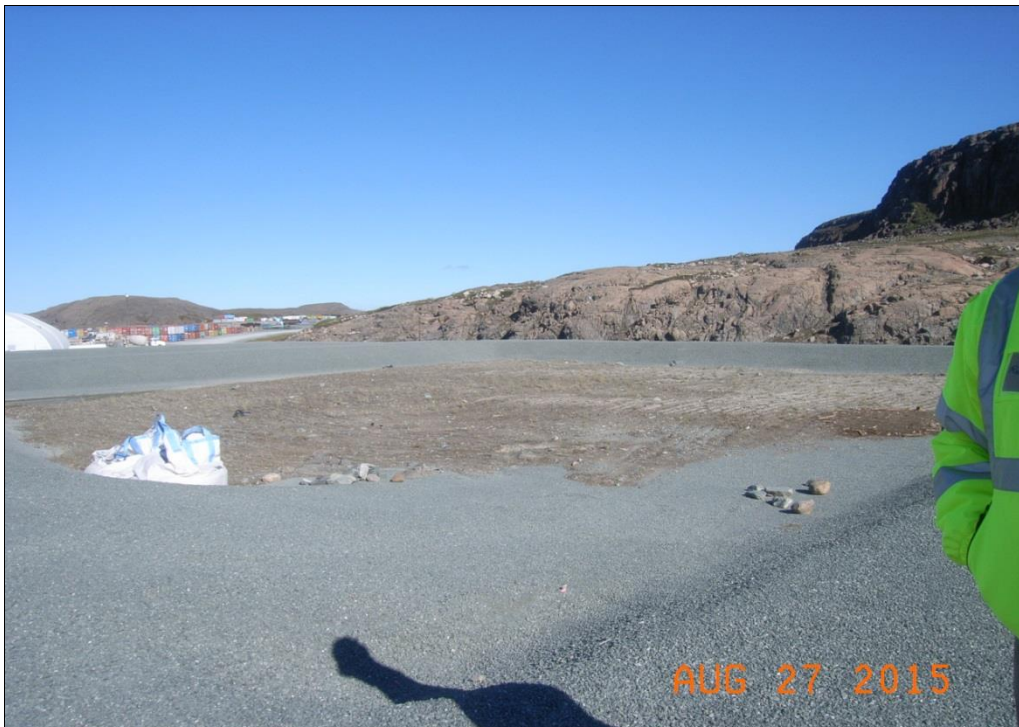
The soil cell was dry except in the corner by the sump. Some larger pieces of rock lay along the base of the pond with the soil.

Photo: 3.15-2
Landfarm; soil cell -

Large pieces of stone / rock should be removed from the cells to avoid damage to the HDPE liner. Areas where stone has been (partly) scuffed off the liner should be replaced to provide a full cover thickness. The pothole at the base of the snow pond ramp should be repaired and a diffuser should be used to reduce the impact of the inflow into the pond.
