### **3.16 Quarry #2 and Crusher Area**

### **3.18 Doris North Camp Pads (Pad X, Y, C, E/P, F, G, J/H, Q and Helipad)**

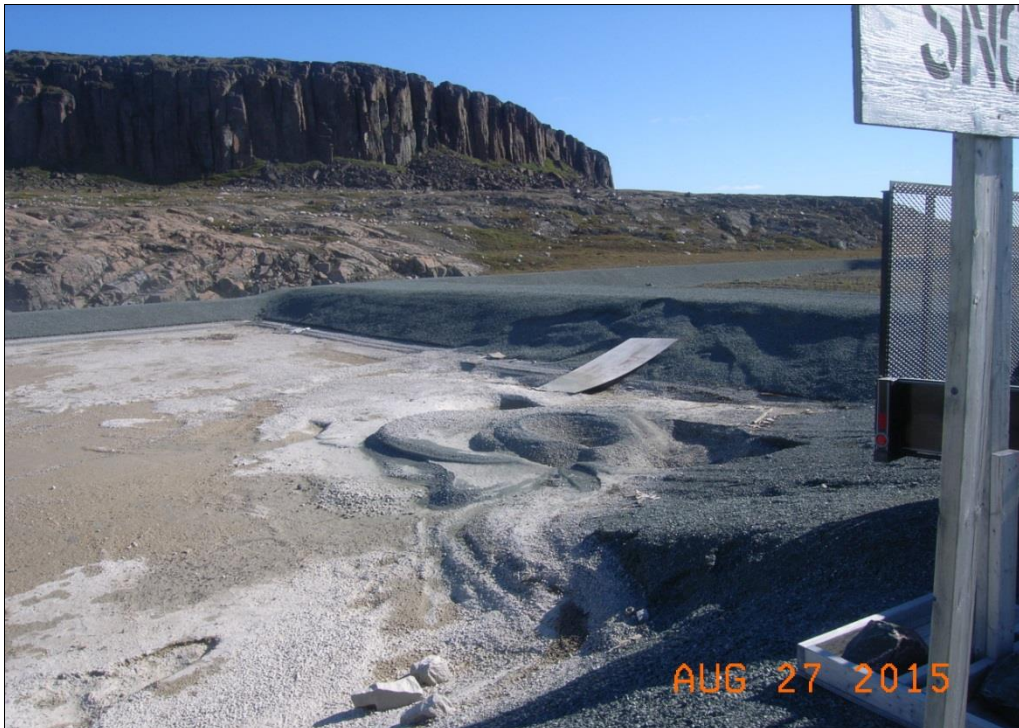
**Photo: 3.15-5**  
Landfarm; snow cell  
– damage to internal  
ramp

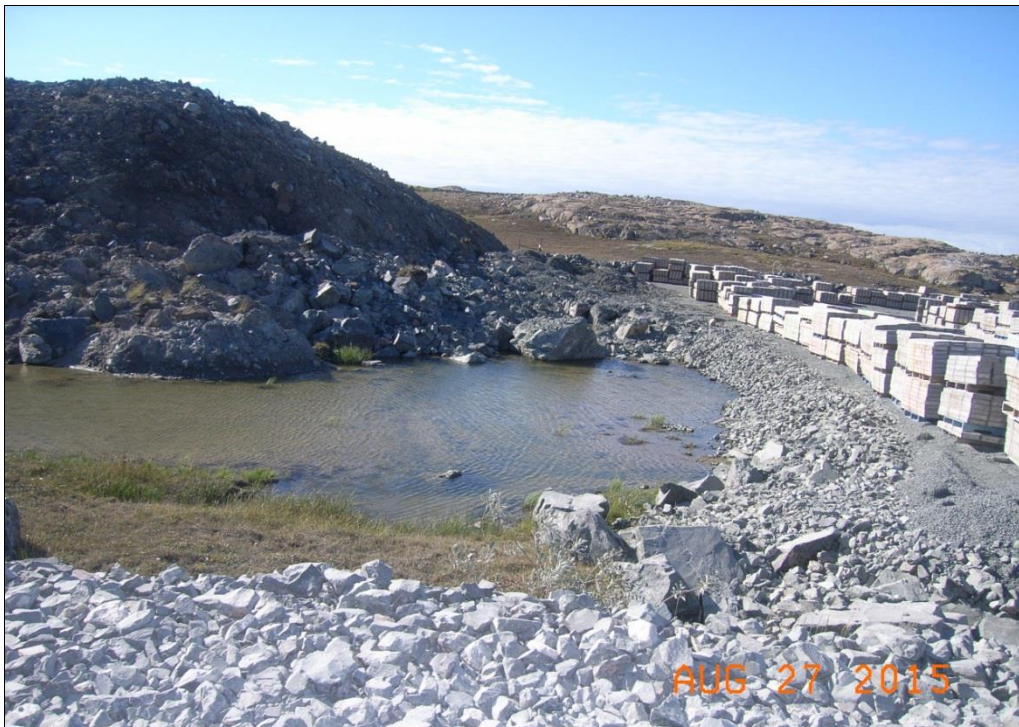
**Photo: 3.15-8**  
 Ponded water at south end of Land farm

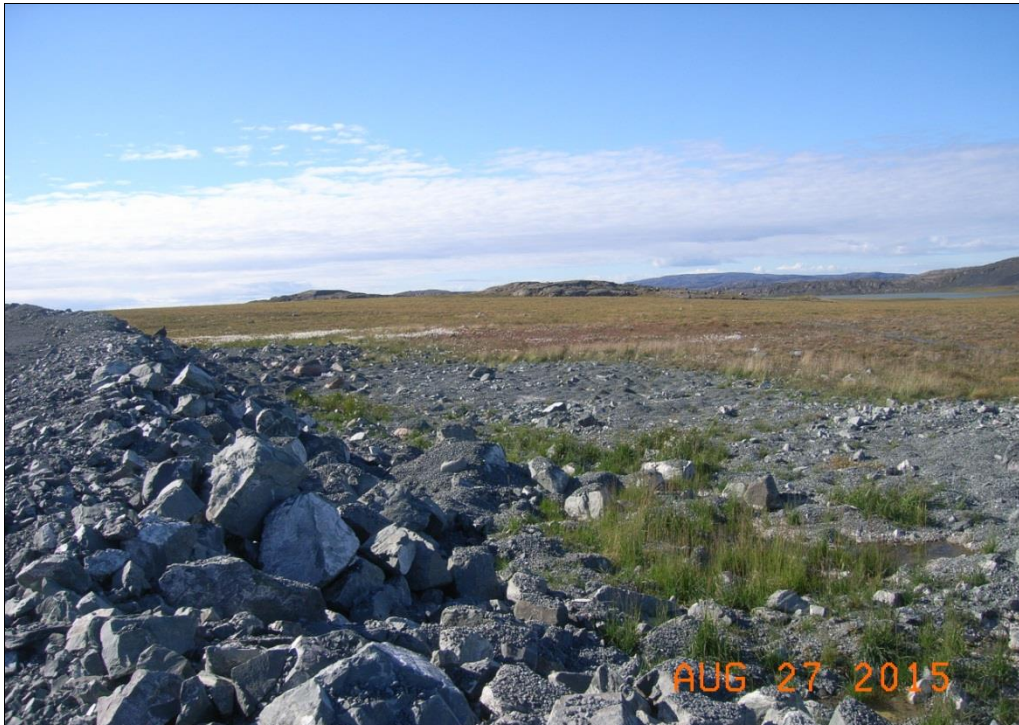
**Photo: 3.16-4**  
 Granular over Tundra  
 at edge of Quarry #2  
 area

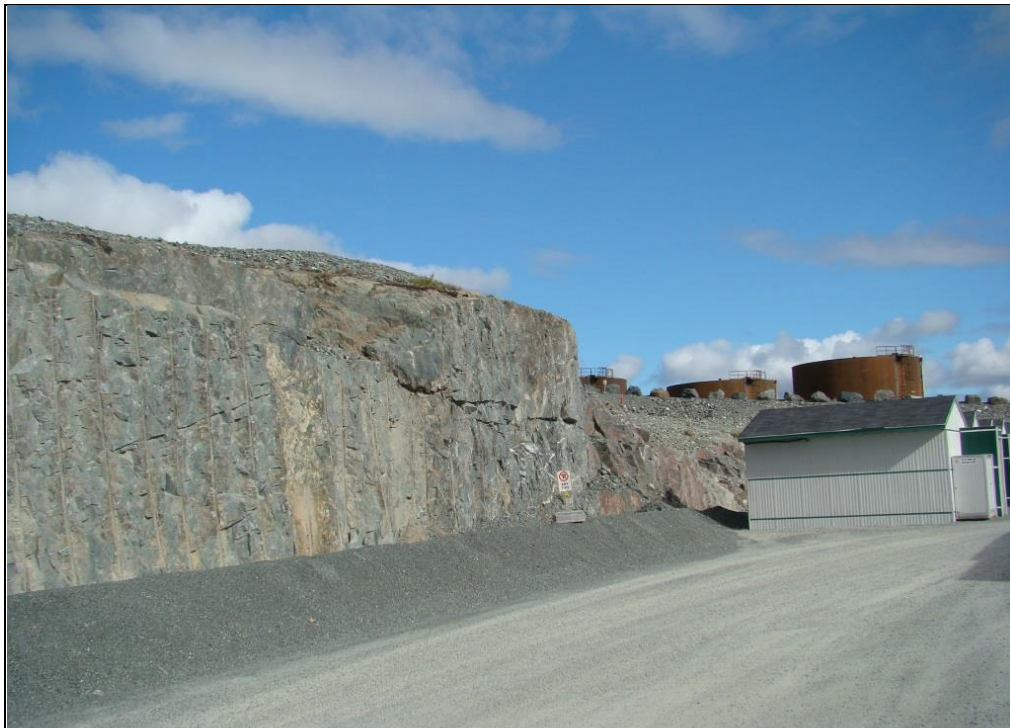
The rock cut along the north and west limit of Pad X is a vertical face. The face has been scaled and there was no loose or spalled pieces of rock below the wall.

**Photo: 3.18-1**  
 Pad X –  
 Accommodations –  
 rock cut

The vertical rock face should be inspected periodically particularly after periods of freeze thaw, and loose rock should be scaled. Alternatively, netting and rock bolts could be installed, or barricades installed to prevent access to the base of the wall.

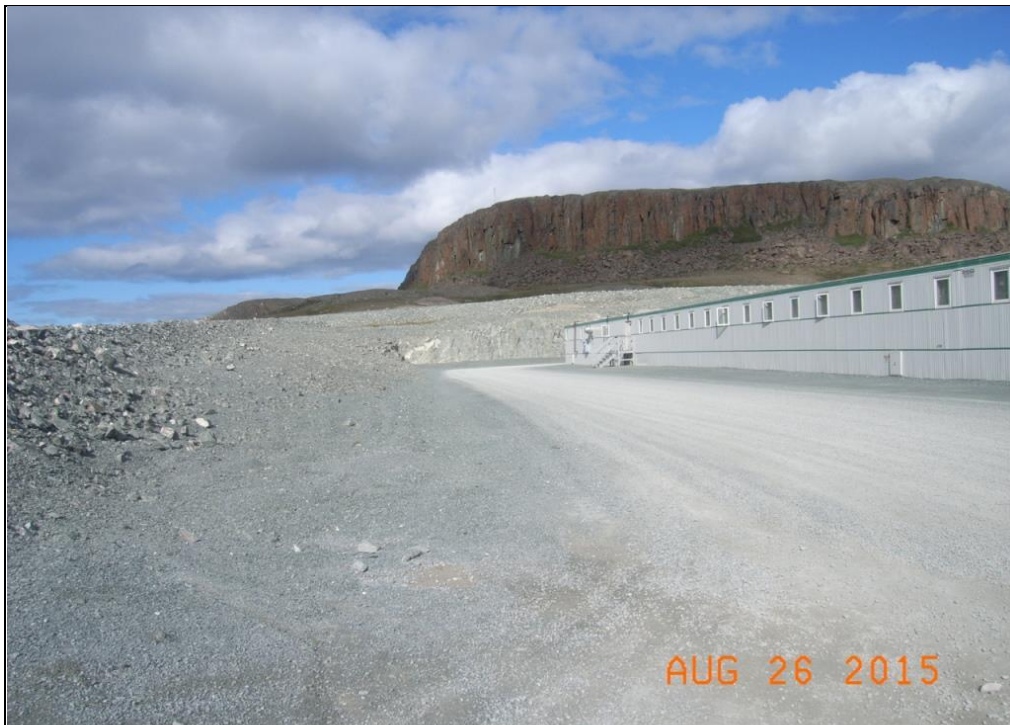
**Photo: 3.18-2**  
 Pad X –  
 Accommodations –  
 rock cut

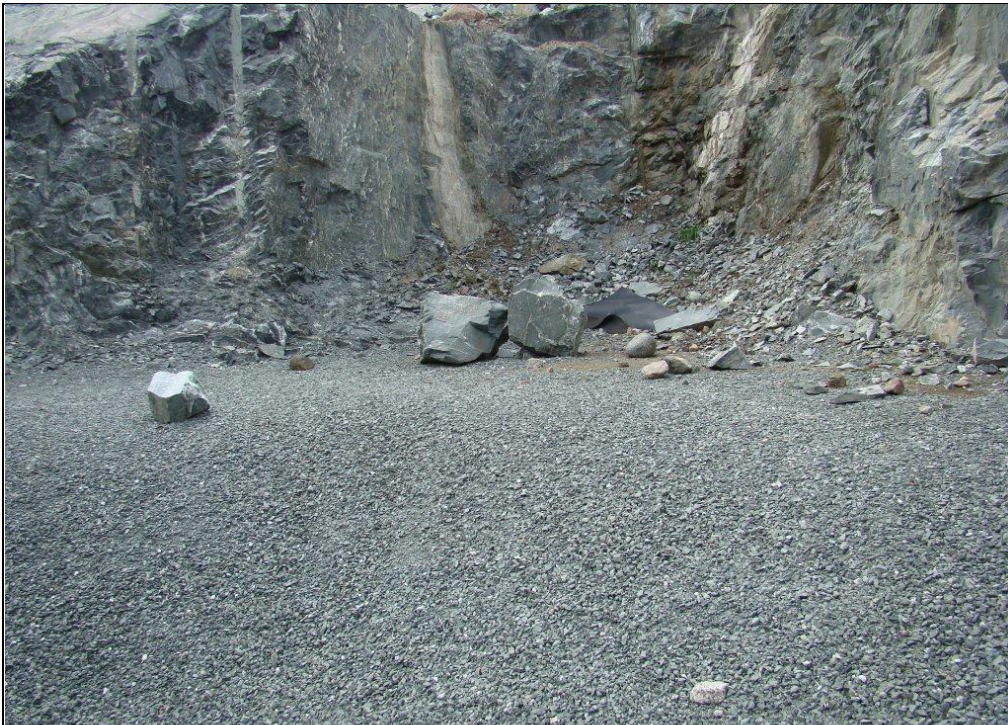
There were pieces of rock that had spalled off the rock face into the bunded area, although none of the pieces appears to have reached the tanks.

**Photo: 3.19-2**  
Doris North Tank  
Farm; containment  
bund; fallen rock  
pieces on top of  
containment bund

Long-term stabilization measures have been designed for the rock faces to prevent damage to the tanks and the HDPE liner. These should be implemented as the site moves out of Care and Maintenance.

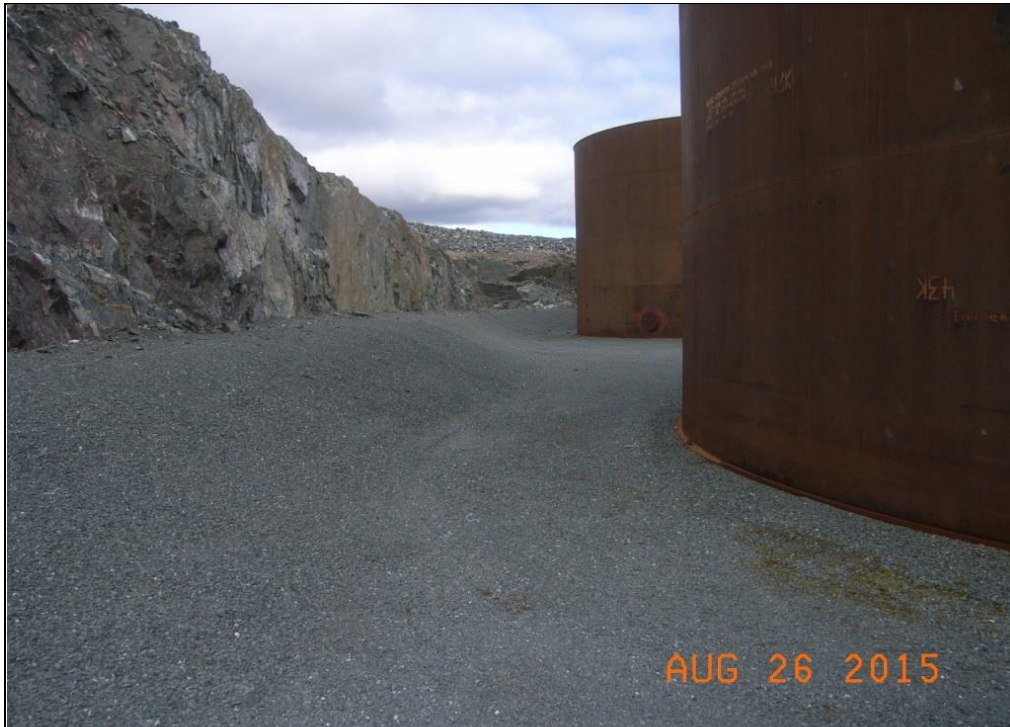
**Photo: 3.19-3**  
 Doris North Tank  
 Farm; containment  
 bund and rock cut

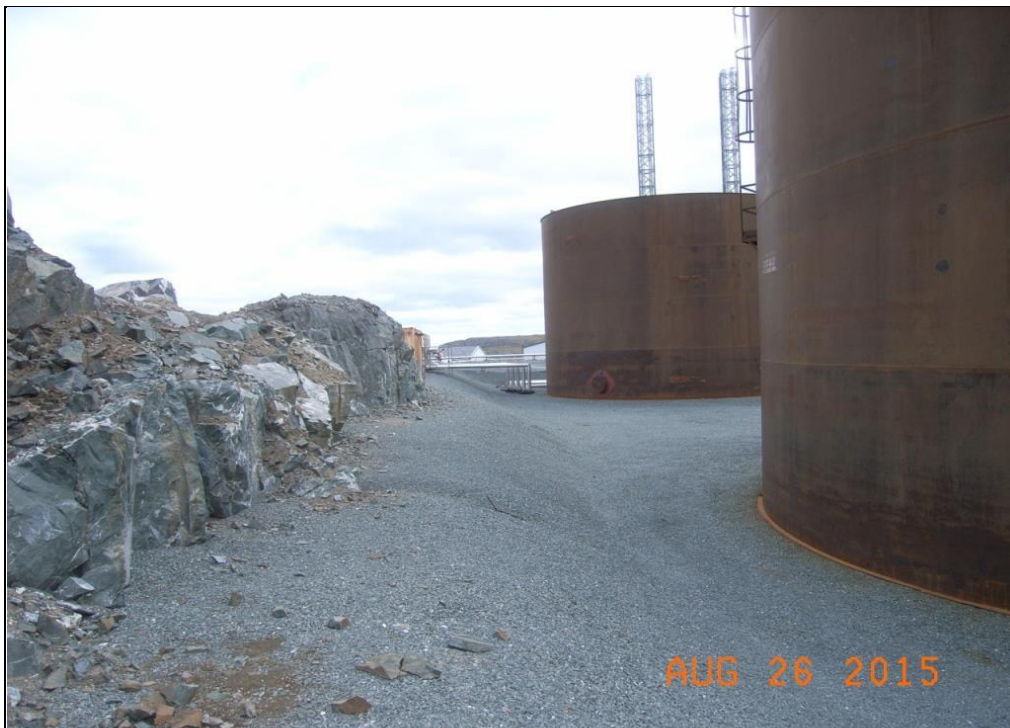
**Photo: 3.19-4**  
 Doris North Tank  
 Farm; containment  
 bund and rock cut
