### **3.21 Doris North Portal – Pad L**

### **3.22 Waste Rock Pile – Pad I**

### **3.24 Pollution Control and Sedimentation Ponds**

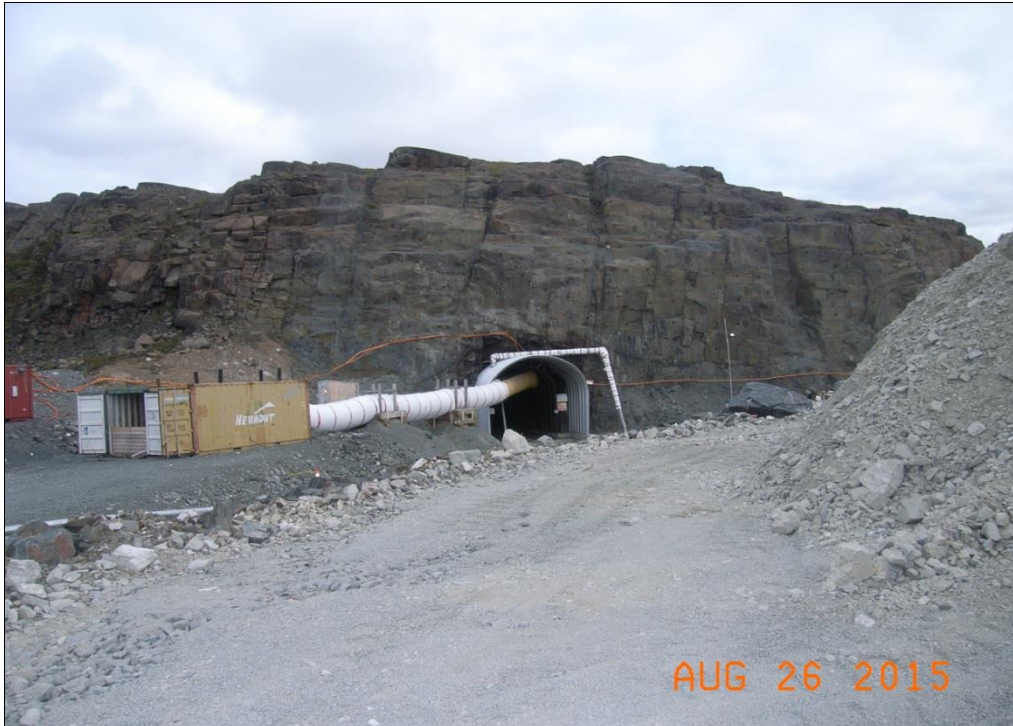
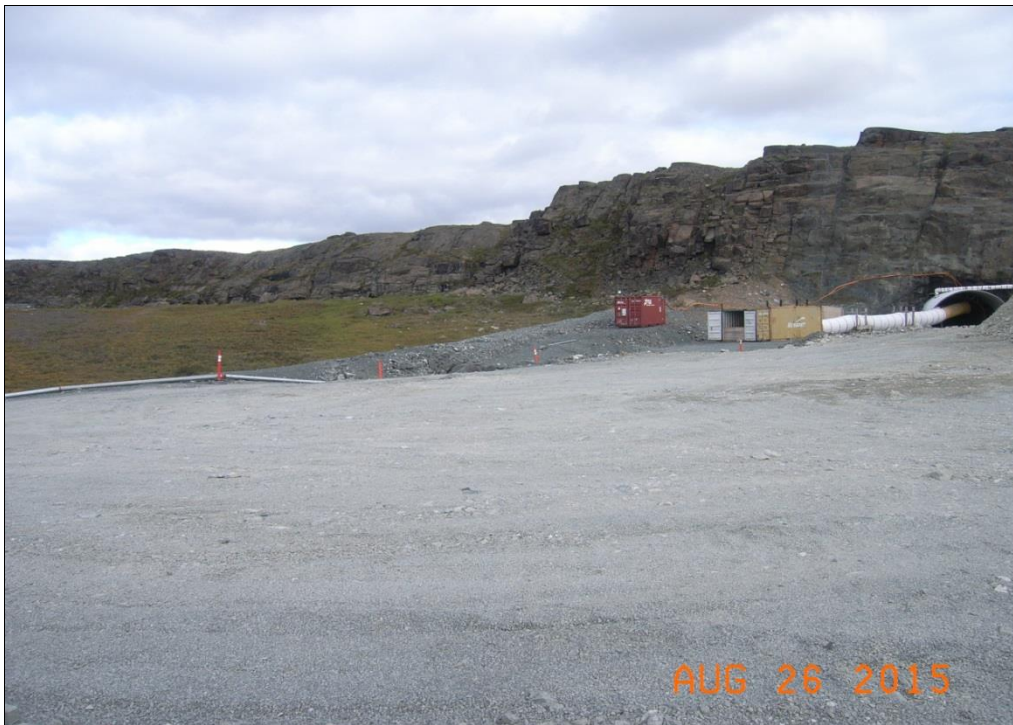
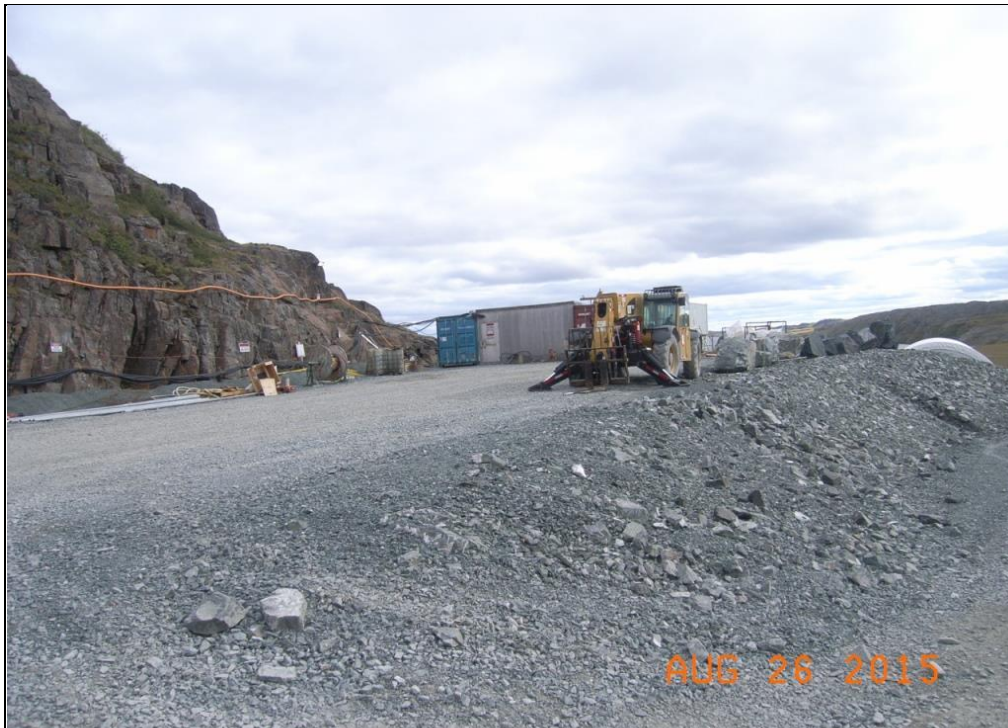
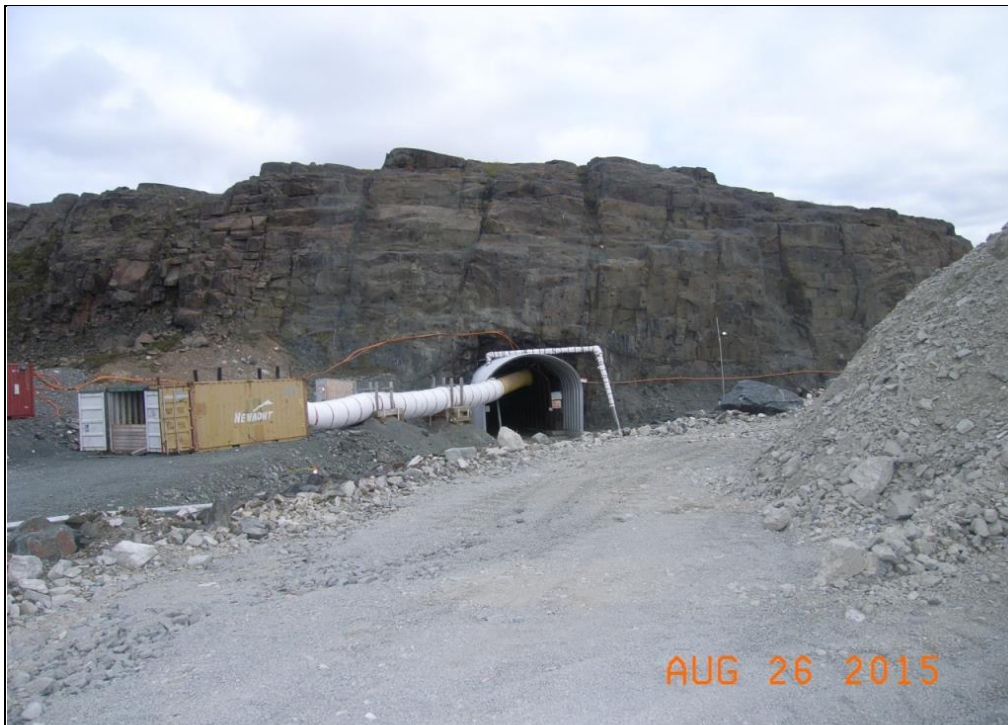
The rockfall protection appeared to be in good repair although a detailed inspection was not carried out.

There were no signs of standing water on the surface of the Pad and no areas of significant settlement. There was no standing water noted along the toe of the pad, and no tension cracks were observed along the crest of the pad.

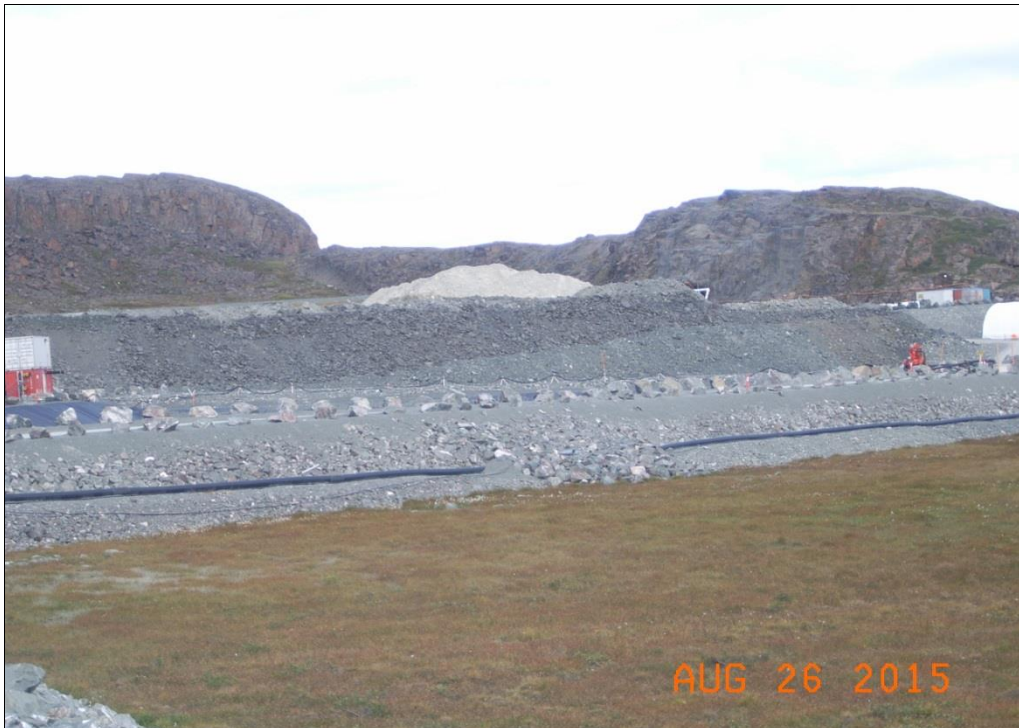
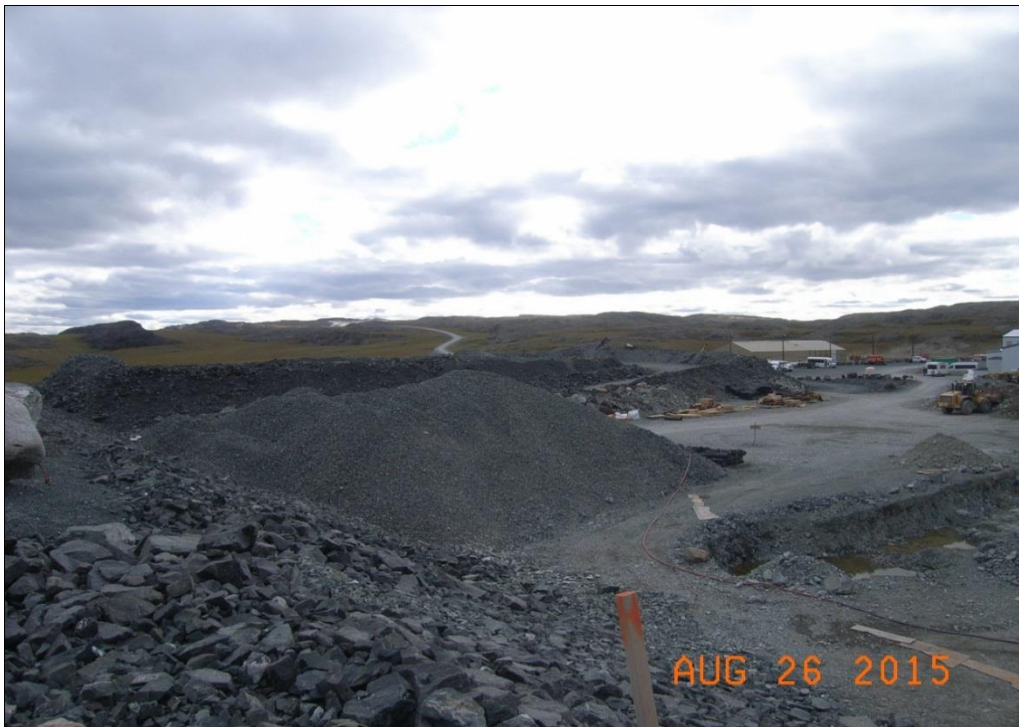
Tension cracks were observed along the edge of Pad I where it forms the north embankment of the Pollution Control Pond. Previous inspections have reported seepage from beneath the waste rock although no obvious seepage was seen at the time of the August 2015 inspection.

Once production resumes and if Pad I is used to store more waste rock, it will need to be managed in accordance with the Waste Rock Management Plan.

The stability of the waste rock pile along the south edge should be assessed, or the waste rock be removed from the edge of the pad. This area should be barricaded off until an assessment confirms that the pile is stable.

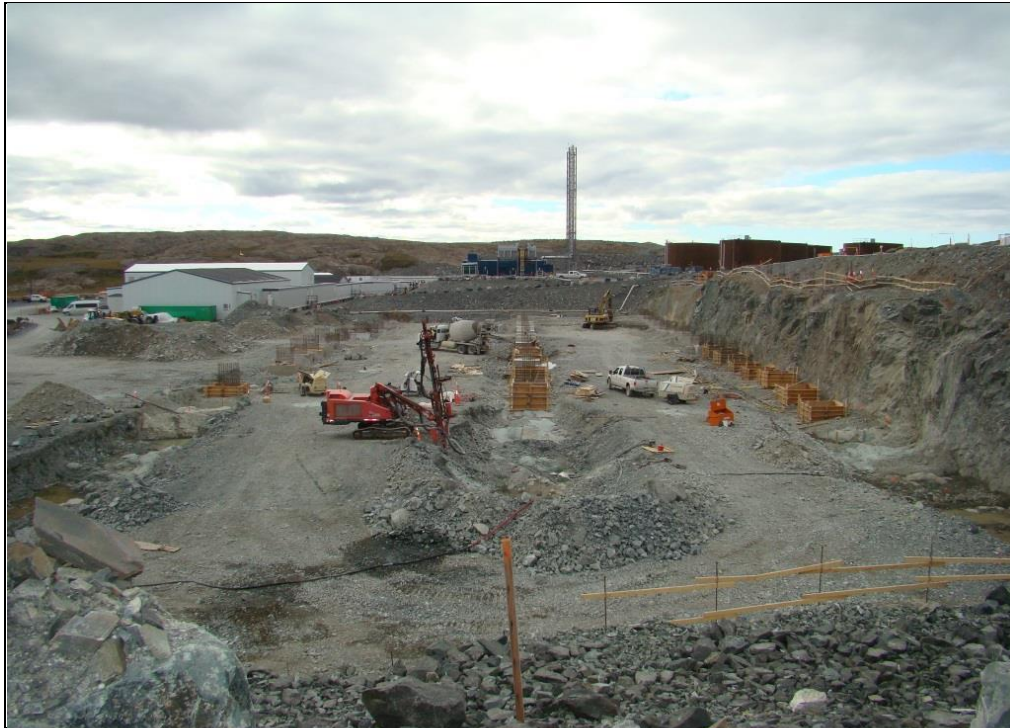
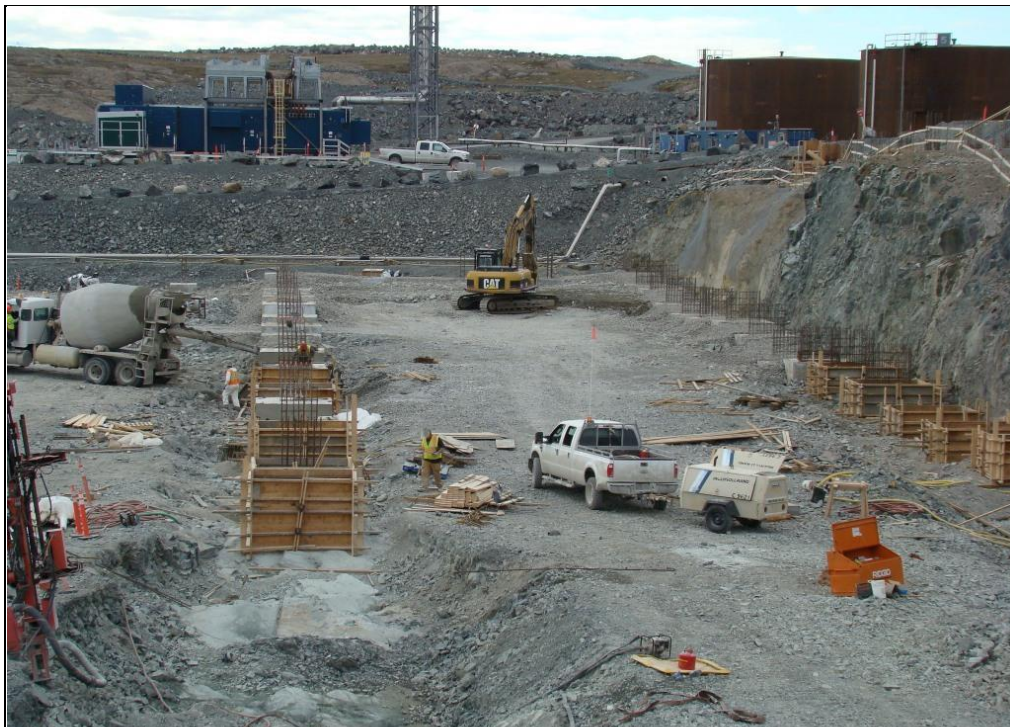
At the time of the geotechnical inspection spread footings were being poured for the modular mill complex building that was on its way to site. Foundations were also being poured on the top of the rock face at the north limit, as the mill complex will step up onto the upper bench.

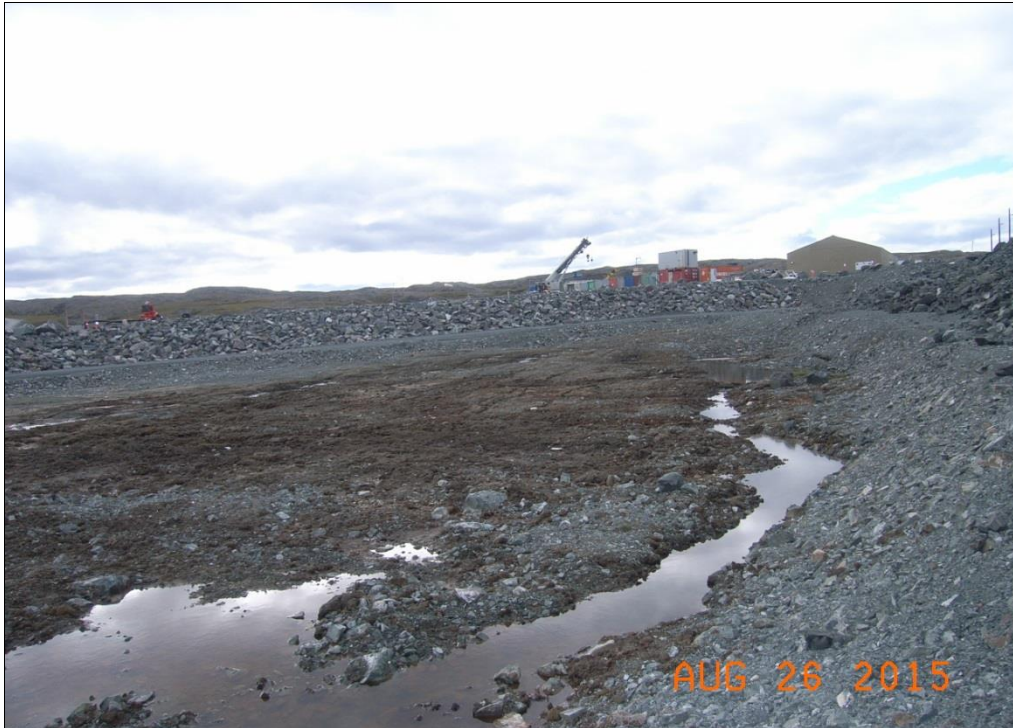
**Photo: 3.24-1**  
Pollution Control  
Pond

There was no water in the pond except for a small amount along the north limit.

The 2015 thermistor data along the south limit of the Pollution Control Pond indicates conditions around the key trench are comparable with previous years, and that it is performing as designed.

The stability of the south edge of the Pollution Control Pond and the waste rock stockpile should be assessed. The Proponent should continue regular monitoring of the temperature at the downstream side of the pond.

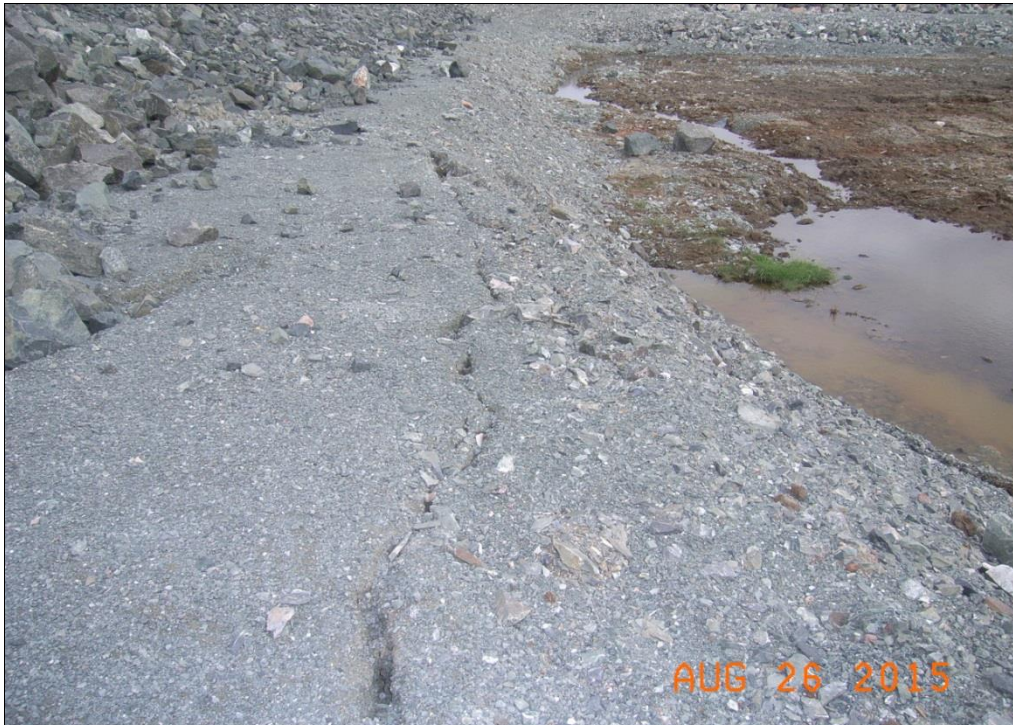
Tension cracks were observed on the upstream (north) berm of the Pollution Control Pond. These have been reported since 2012 and are attributed to degradation of the permafrost below the edge of the adjacent thermal pad (Pad I – Waste Rock Pad).

**Photo: 3.24-2**  
Pollution Control  
Pond – tension  
cracks

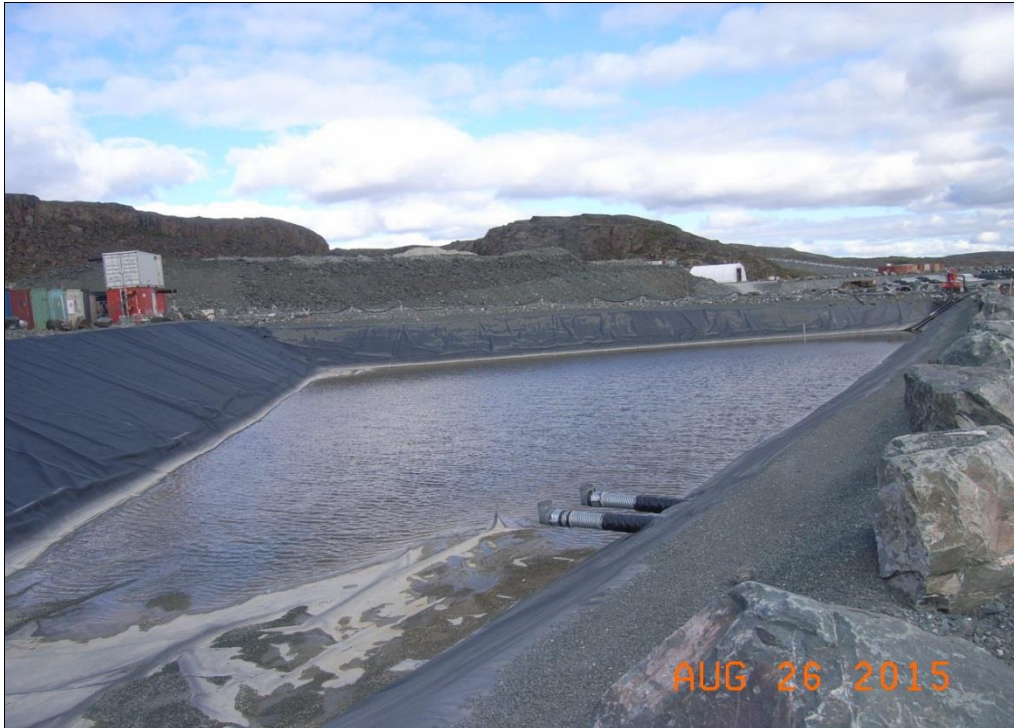
There was some water in the base of the pond at the time of the inspection, well below the overflow pipes.

**Photo: 3.24-3**  
 Sedimentation Pond;  
 HDPE liner and  
 overflow pipes

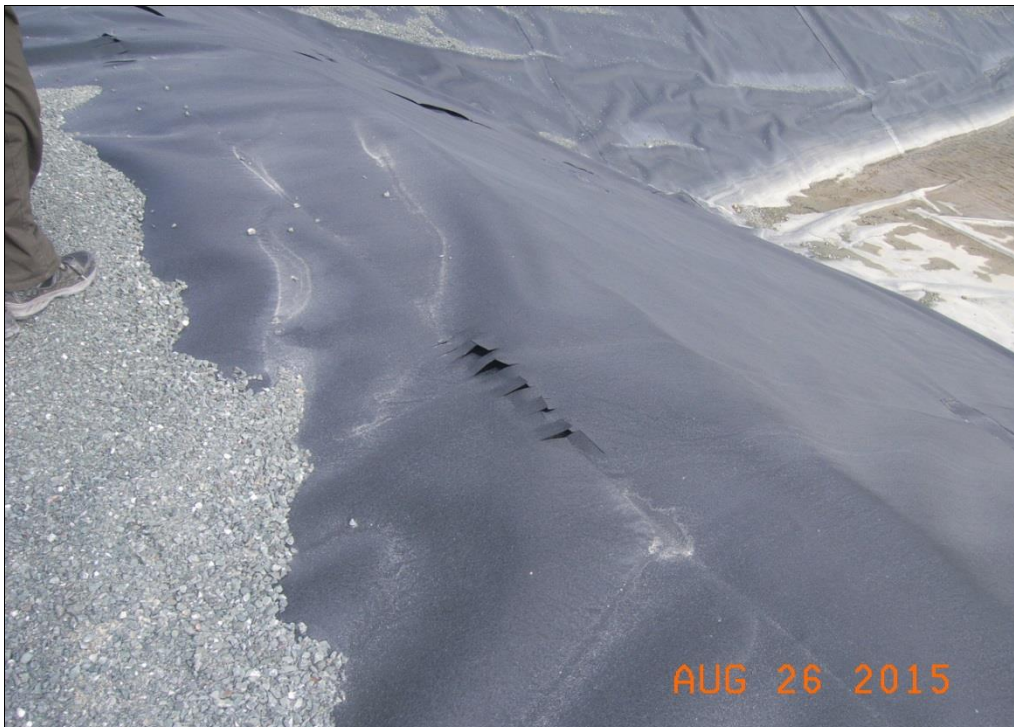
The HDPE liner in the northeast corner of the pond, along the upper portion of the pond slope, is cut at regular intervals, likely due to handling. These cuts appear to lie above the elevation of the two overflow pipes.

**Photo: 3.24-4**  
 Sedimentation Pond;  
 cuts in HDPE liner

It should be confirmed that the cuts in the HDPE liner lie above the elevation of the overflow pipelines. The overlap between the two sections of liner at the north end of the berm that separates the two ponds should be sealed.

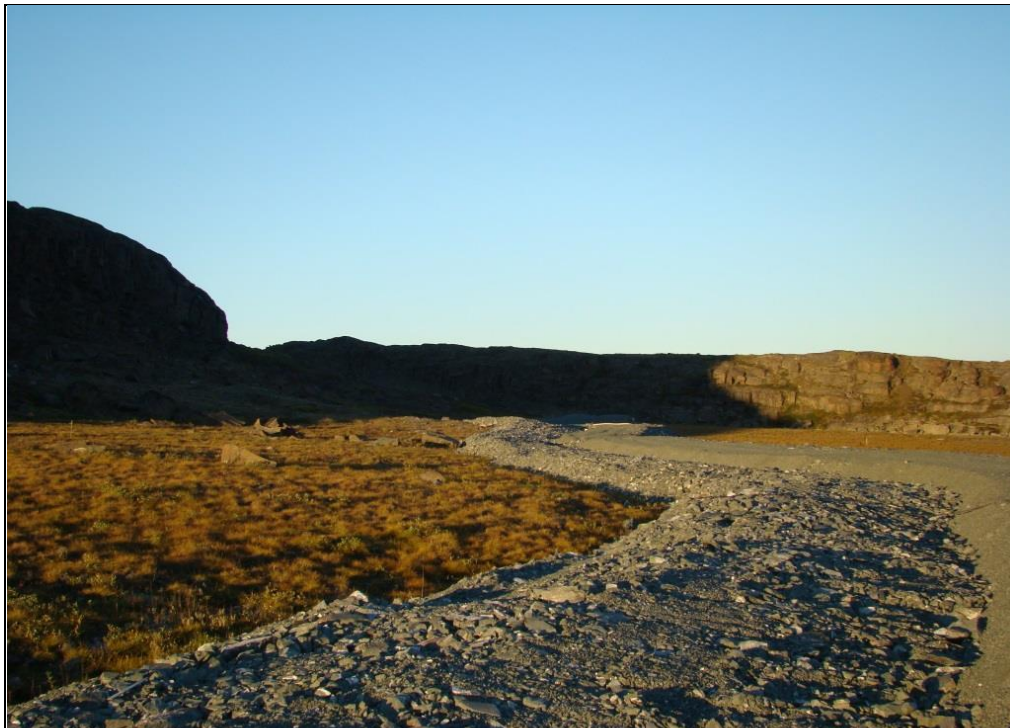
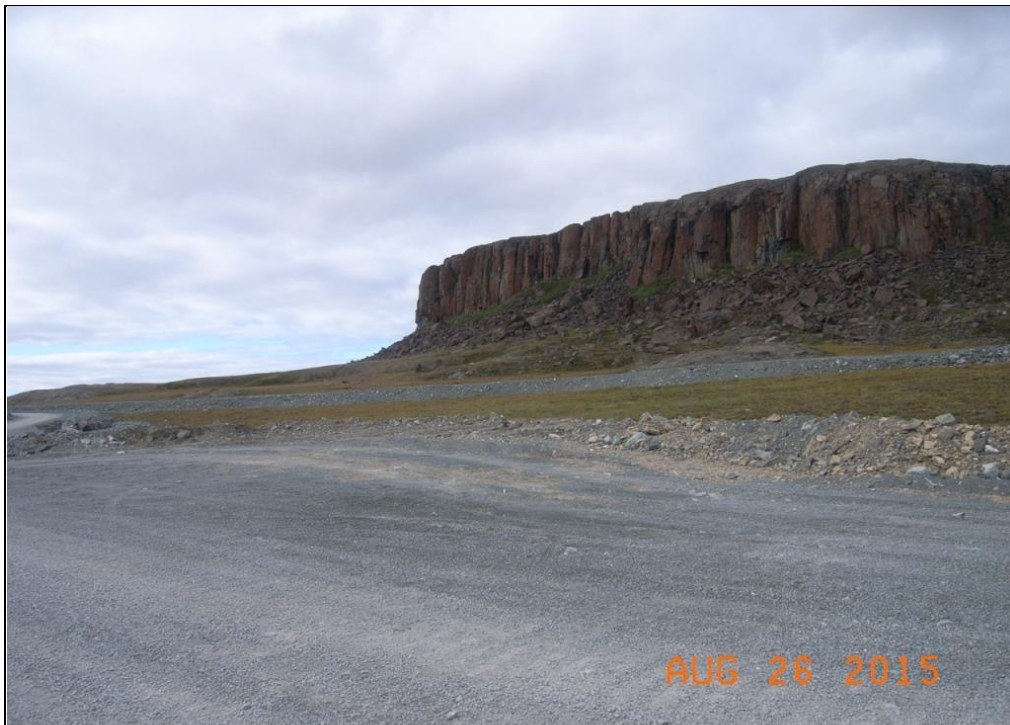
The diversion berm is in good condition.

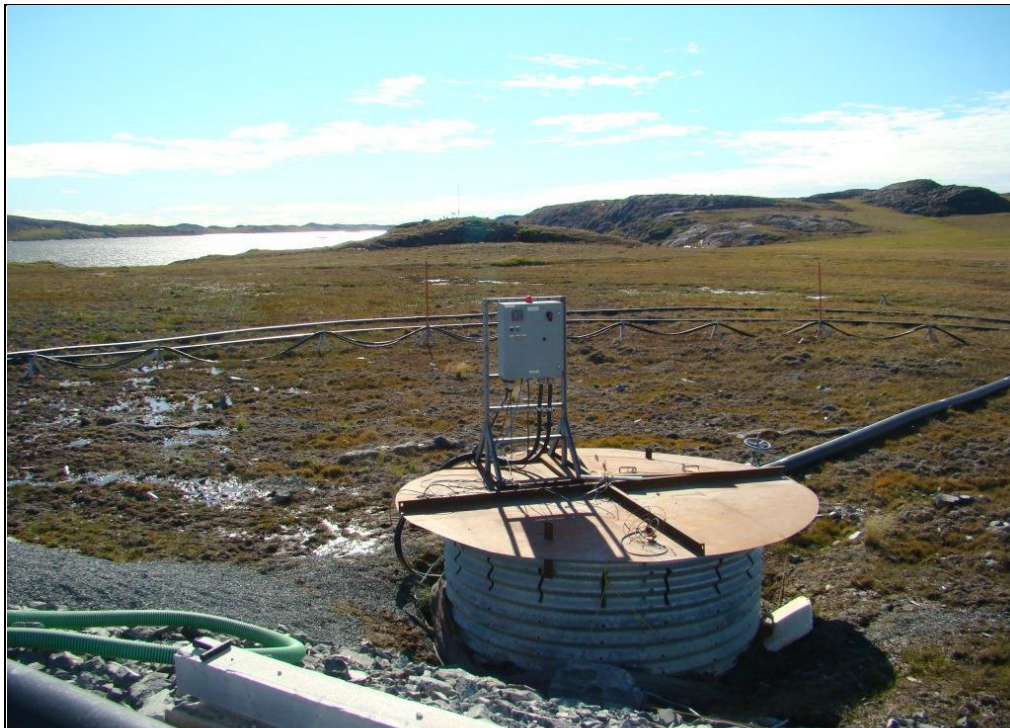
**Photo: 3.26-1**  
 Sump #1

The sumps appeared to be in good condition. There is disturbance to the vegetation and resulting degradation of the permafrost around Sump #1 where construction and pipeline work appears to have been carried out; however, this is not a new development. There was some minor standing water against the toe of the Primary Road and across the disturbed area.

A previous recommendation to backfill a low area around Sump #1 should be implemented to prevent standing water and further degradation of the permafrost.

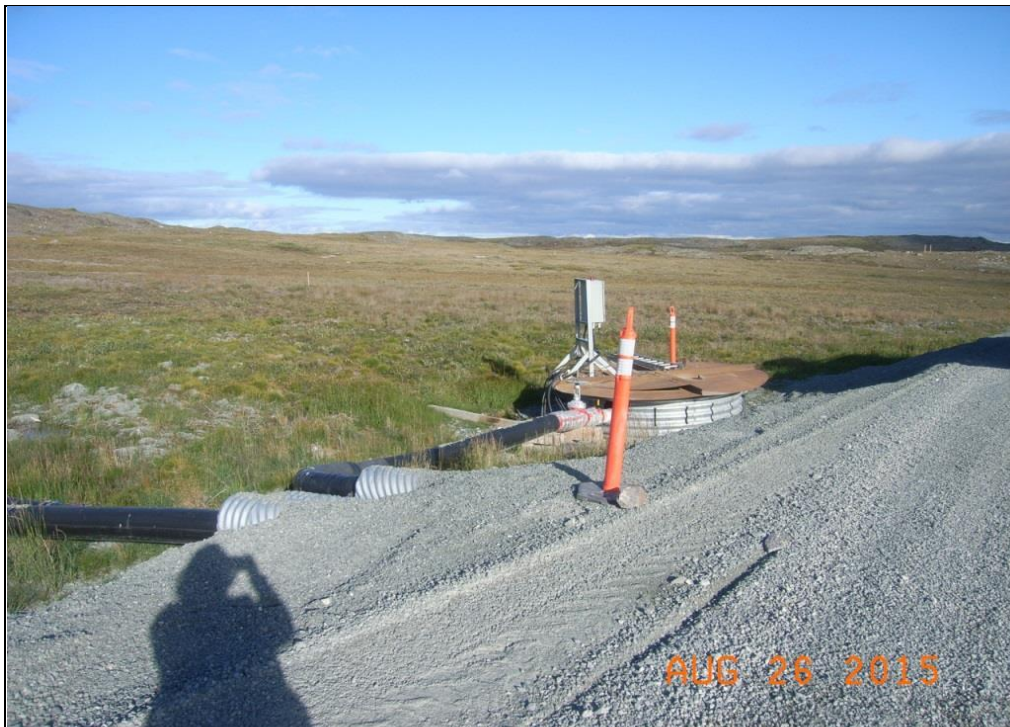
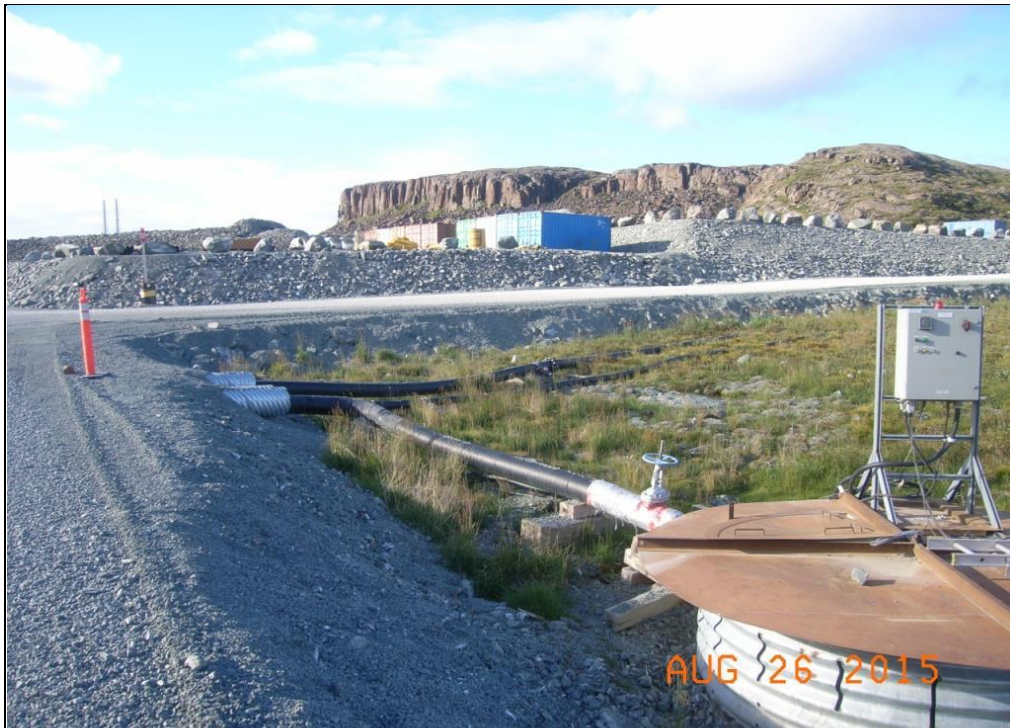
There is minor disturbance to the soil and permafrost degradation around Sump #2

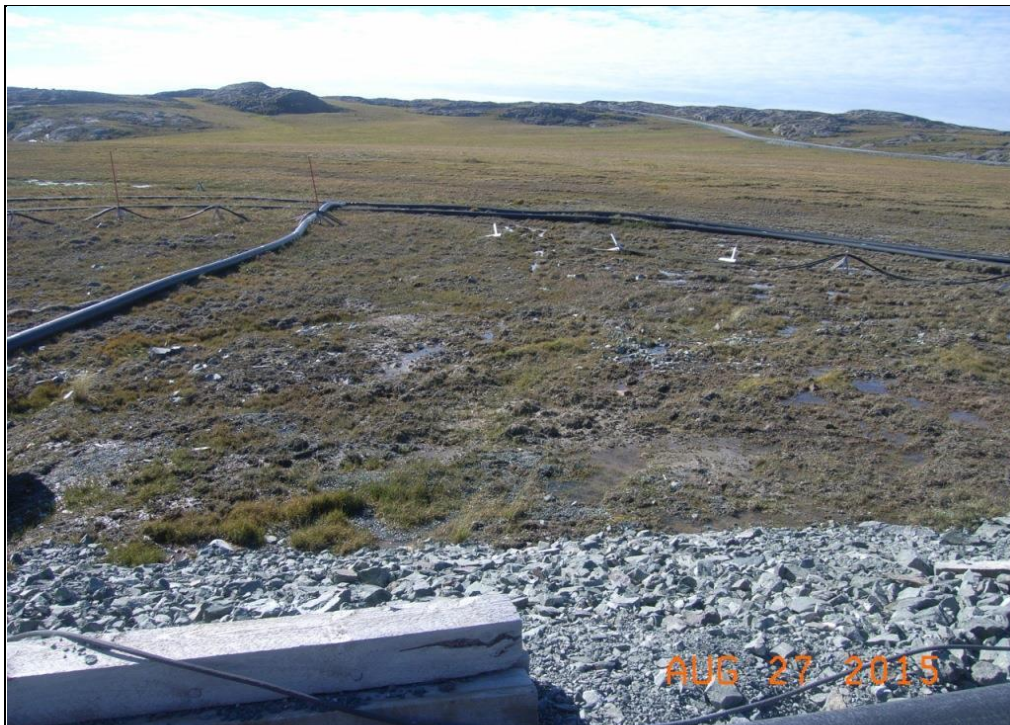
**Photo: 3.26-5**  
 Area south of Sump  
 #1

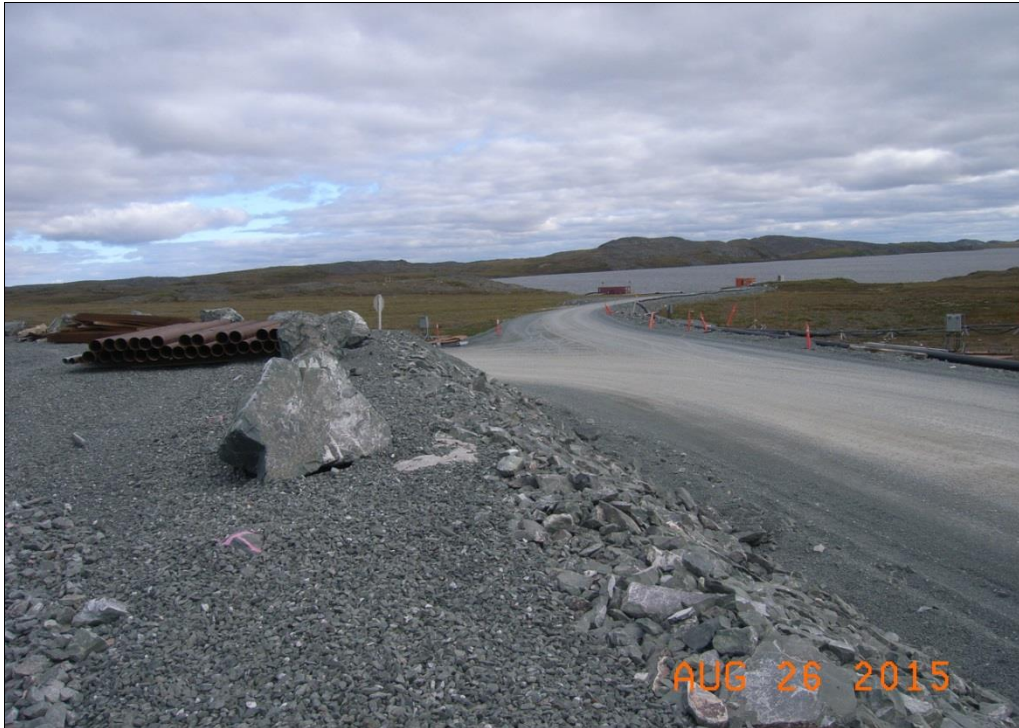
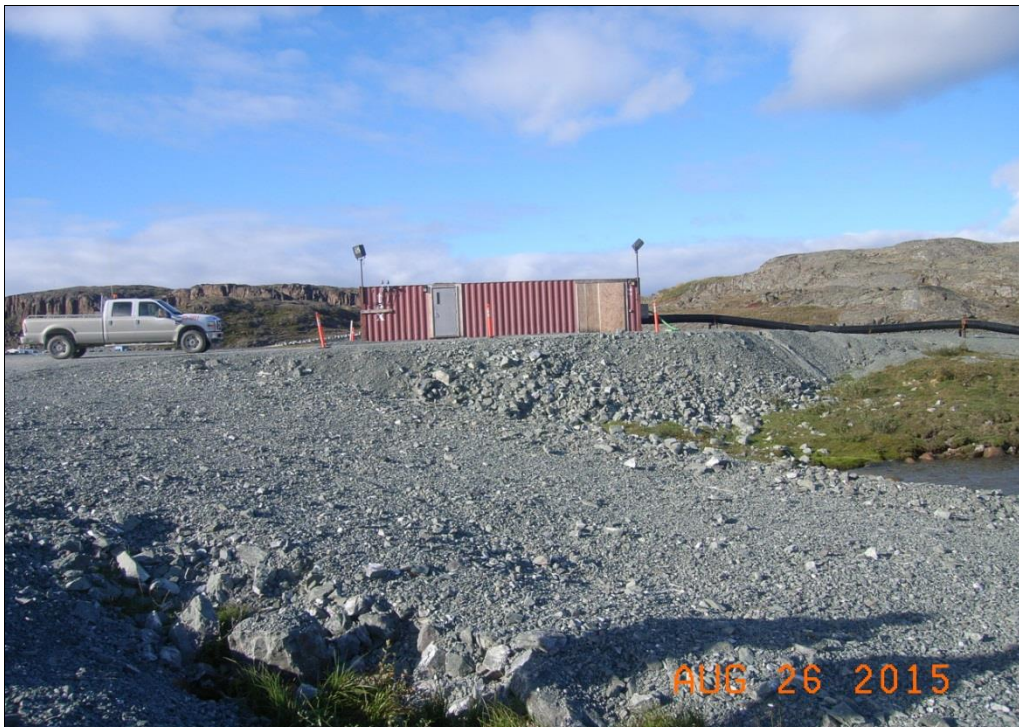
There were no signs of standing water on the surface of the pad and no areas of significant settlement. There was no standing water noted along the toe of the pad, and no tension cracks were observed along the crest of the pad.
