### **3.28 Doris Primary Vent Raise Pad**

### **3.30 Doris North Dam**

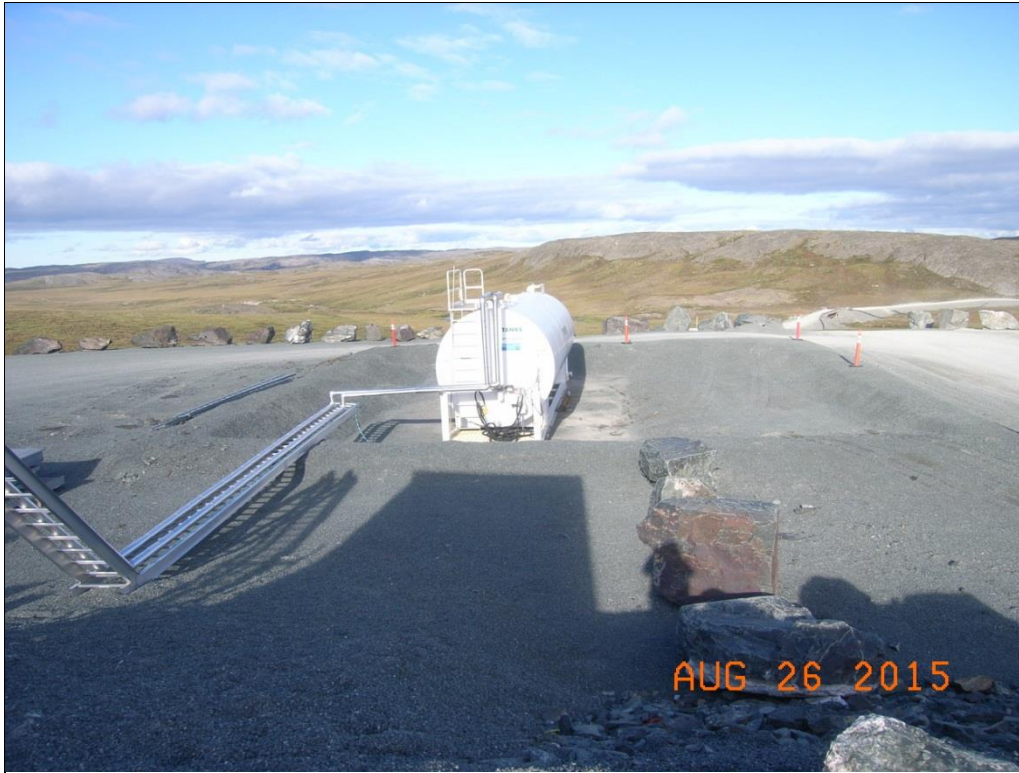
**Photo: 3.28-3**  
Doris Primary Vent  
Raise Pad; fuel  
containment bund

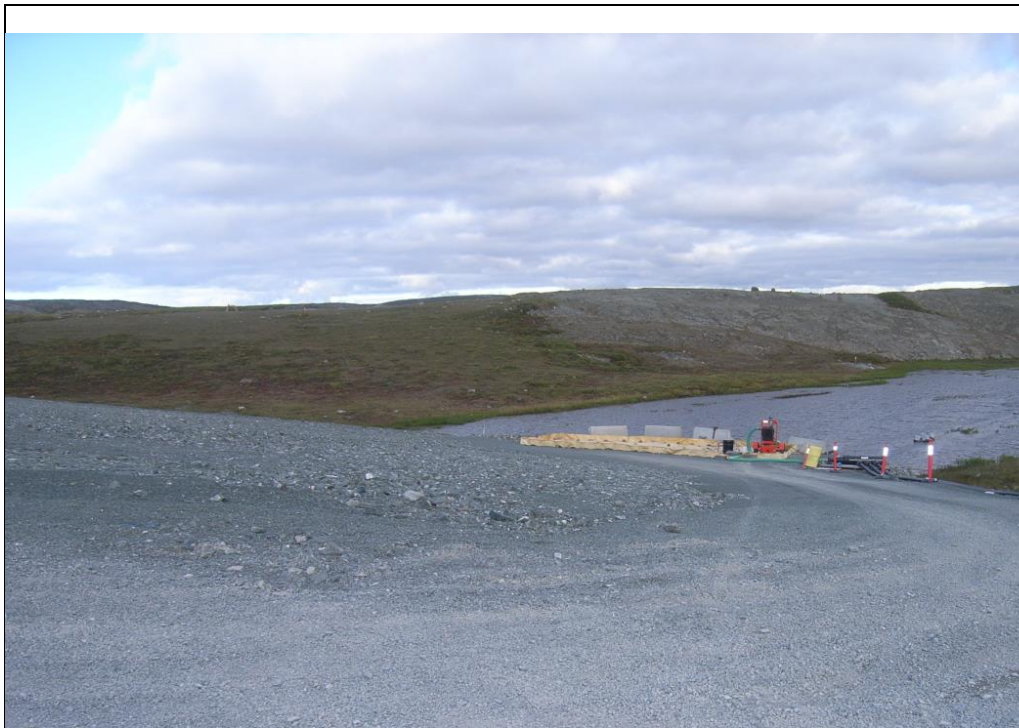
The shallow depressions observed across the upstream and downstream faces are being attributed at this time to either the loss of finer stone into the coarser rock within the shell layer, or as areas of poor surface grading, rather than indications of foundation settlement. The depressions are being monitored during the annual geotechnical inspection by TMAC's consultant, and by TMAC personnel.

**Photo: 3.30-5**  
 Doris North Dam;  
 depression along up  
 stream slope face  
 and pumping  
 equipment at toe

If not already implemented, a regular program should be carried out for the depressions across the upstream and downstream faces.

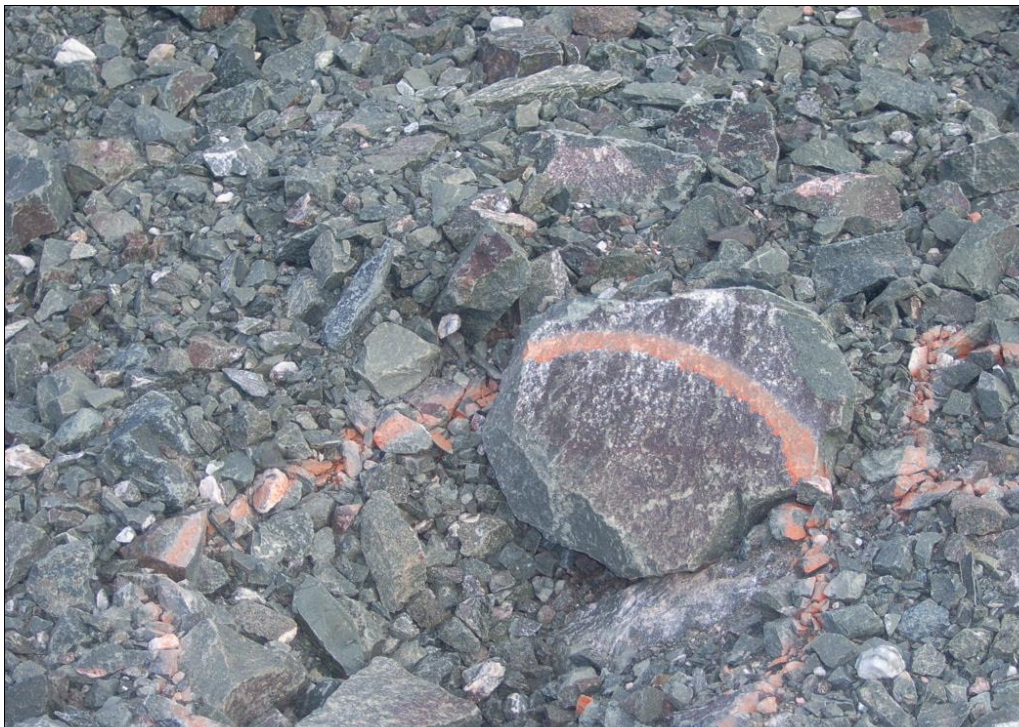
**Photo: 3.30-6**  
 Doris North Dam;  
 depression along  
 downstream slope  
 face

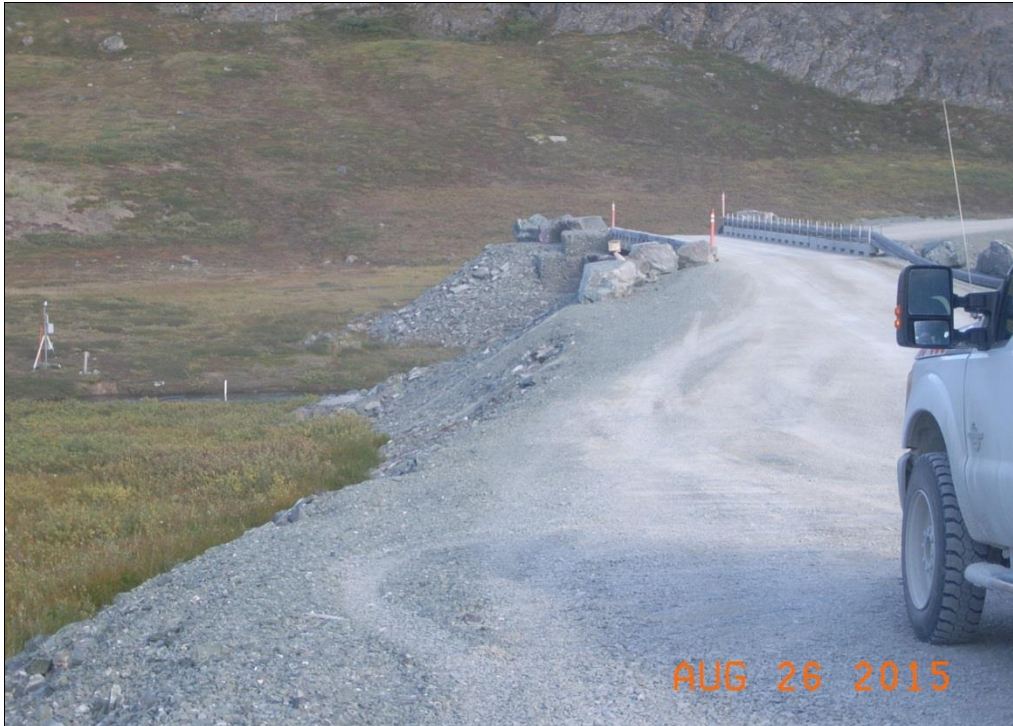
**Photo: 3.32-1**  
Doris Creek Bridge

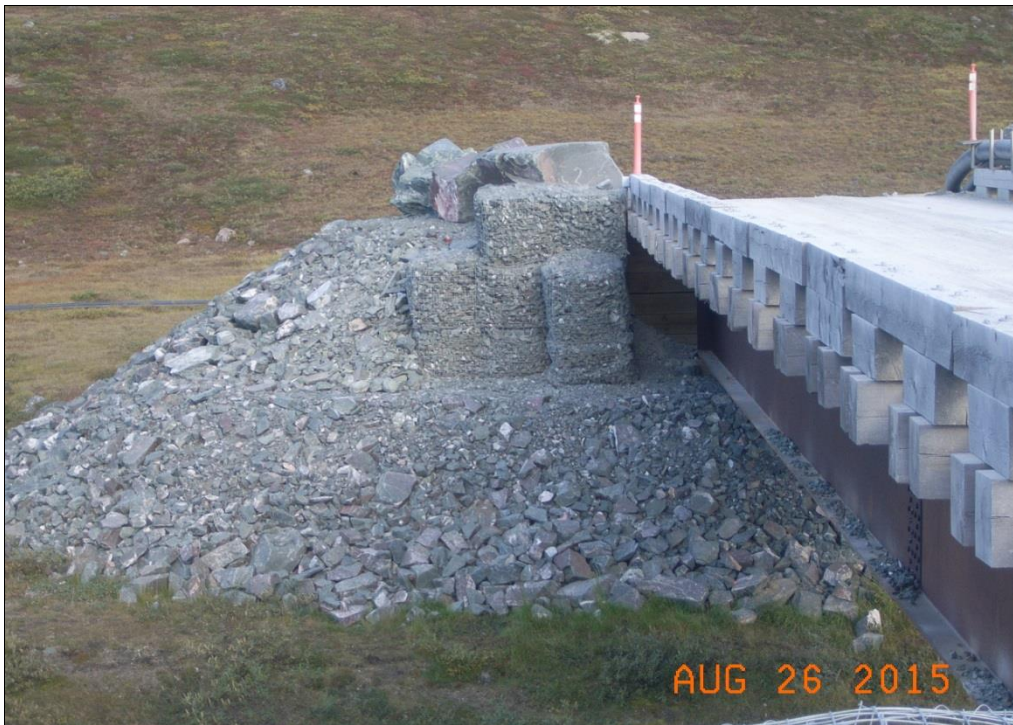
The bridge abutments appear to be in good condition. There is some deformation of the gabions around the top of the bridge abutment.

**Photo: 3.32-2**  
Doris Creek Bridge;  
north east abutment

The thermistors should continue to be used to monitor permafrost conditions at the bridge abutments. The gabions should be monitored to see if there is ongoing deformation.

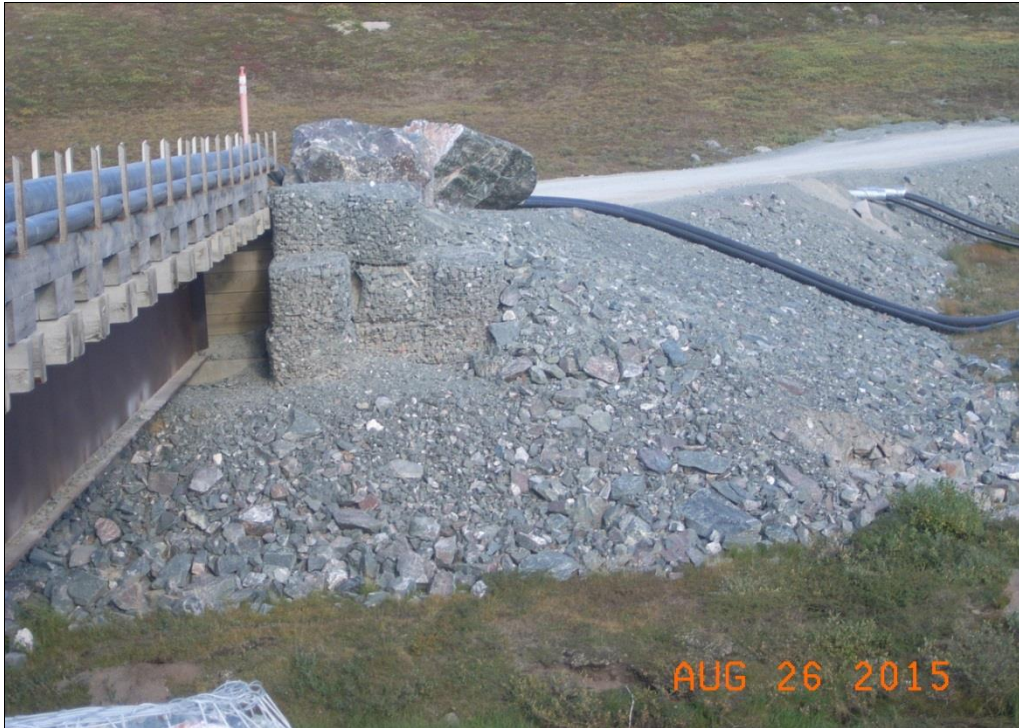
**Photo: 3.32-3**  
Doris Creek Bridge;  
south east abutment

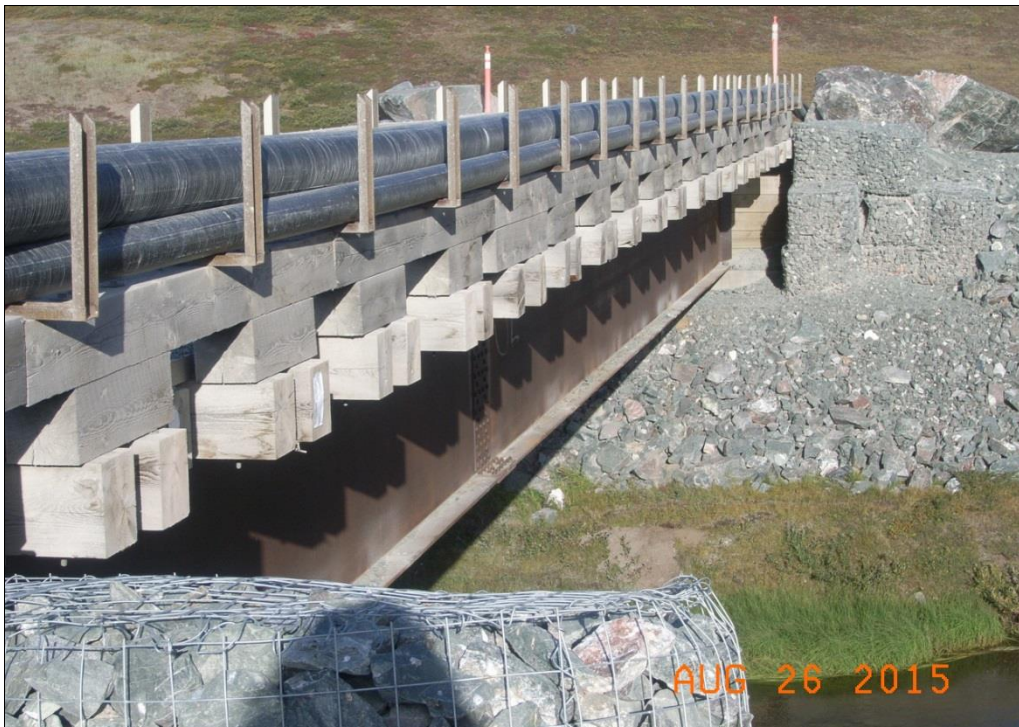
**Photo: 3.32-4**  
Doris Creek Bridge;  
south east abutment

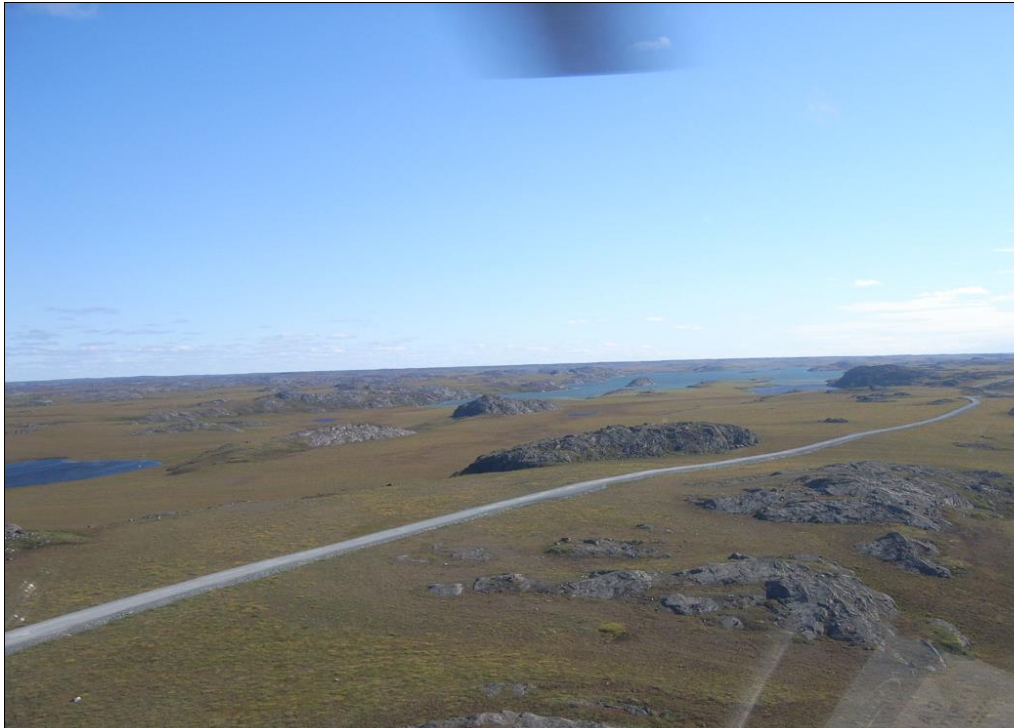
**Photo: 3.33-1**  
Doris Windy All-  
Weather Road

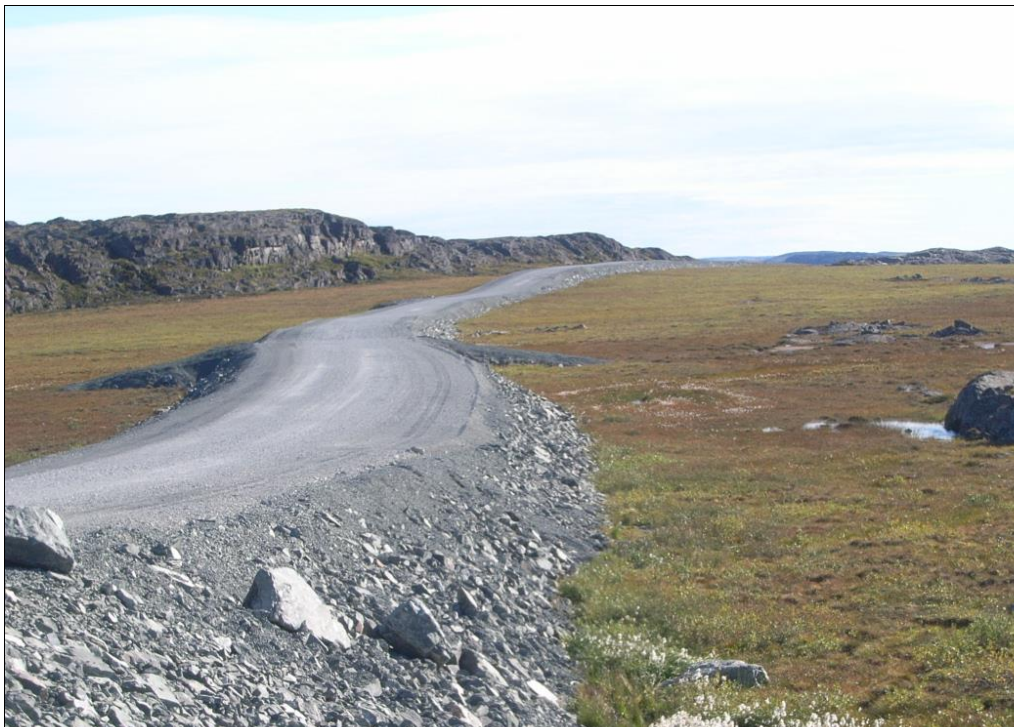
**Photo: 3.33-2**  
Doris Windy All-  
Weather Road;  
Caribou ramp

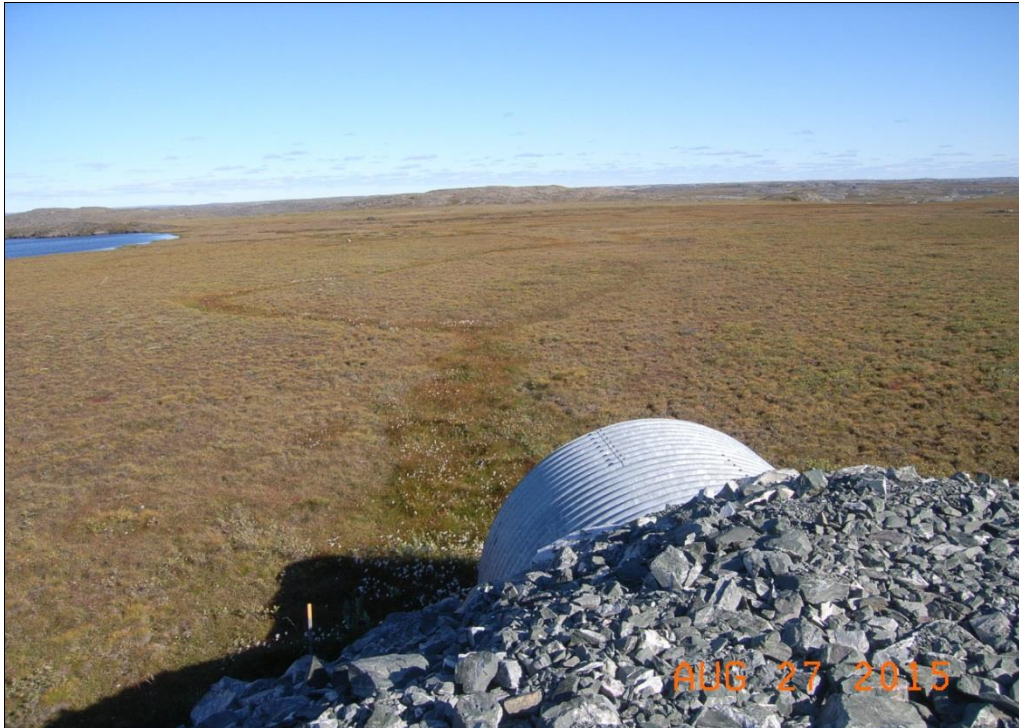
In earlier geotechnical inspections, it was noted that the web of the I-beam, on top of the fourth pile from the northwest corner of the arch culvert at stream crossing #1, was buckled, but that there had been no change since first noticed in 2012. Some damage to the bridge section was also noted at stream crossing #3. If notable changes are observed in subsequent inspections, structural assessments should be undertaken.

**Photo: 3.34-1**  
Doris-Windy All-  
Weather Road;  
Stream Crossing #1  
arch culvert

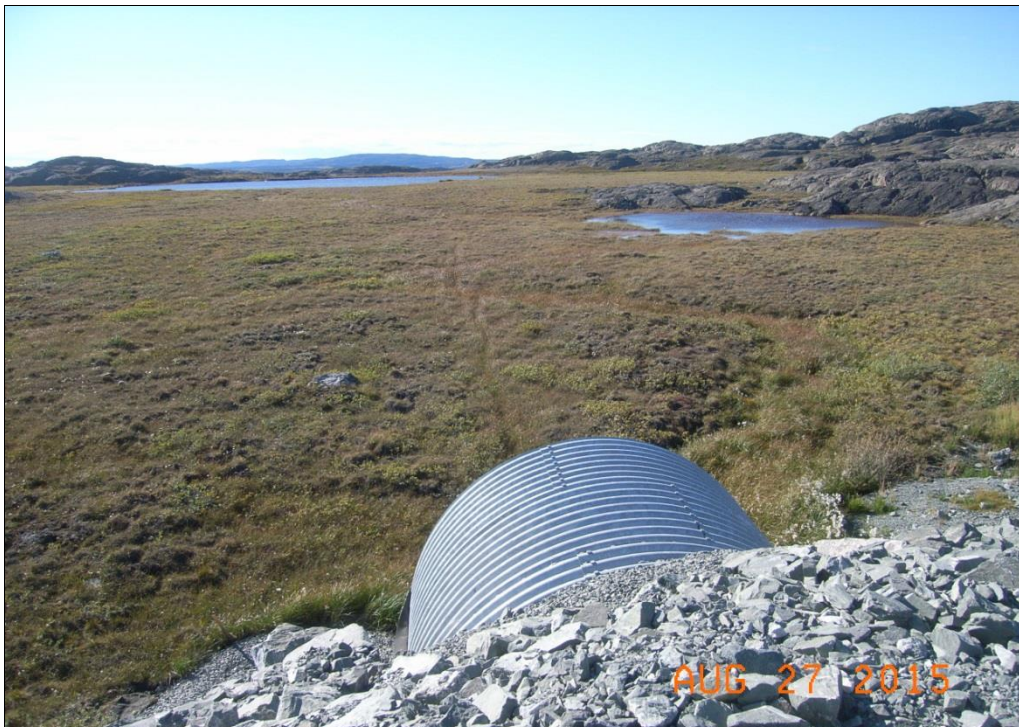
**Photo: 3.34-2**  
Doris-Windy All-  
Weather Road;  
Stream Crossing #1  
arch culvert

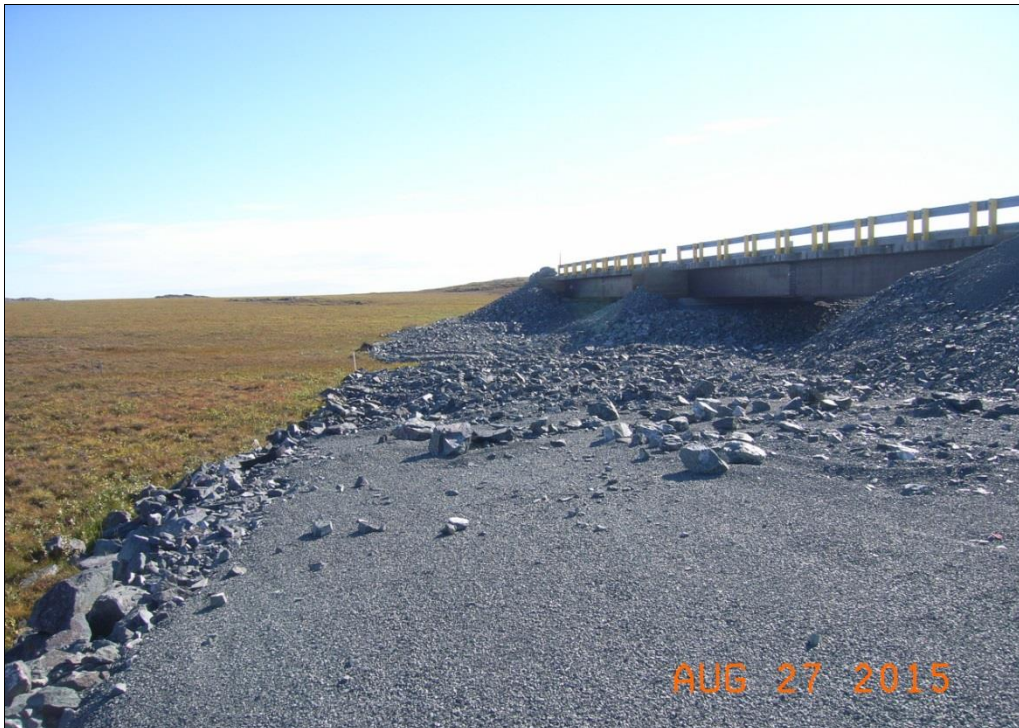
Generally, the bridge approaches and abutments appear to be in good condition. A few potholes were noted at the top of the approaches to the bridge structures. Standing water was observed against the toe of the west end of the middle abutment between stream crossings #2 and #3, and the west side of the north abutment at stream crossing #4.

**Photo: 3.34-3**  
 Doris-Windy All-  
 Weather Road;  
 Stream Crossing #2  
 and #3; east  
 abutments

Rock fill should be placed at locations where standing water is noted against the thermal bridge abutment pads to provide insulation and stabilize potential deterioration of the permafrost.

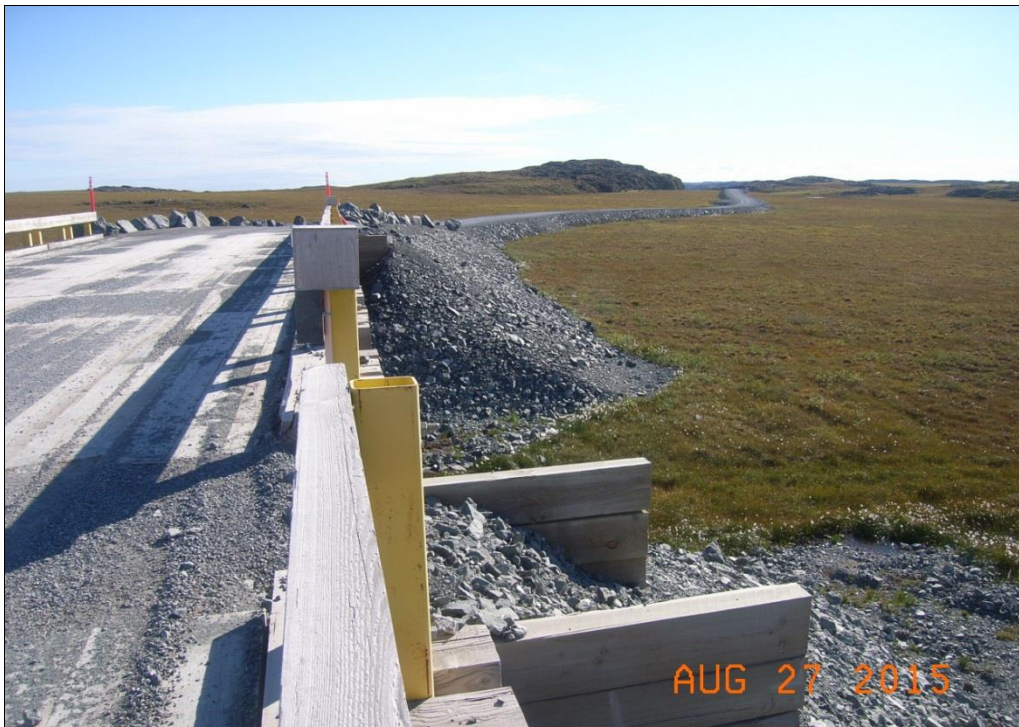
**Photo: 3.34-4**  
 Doris-Windy All-  
 Weather Road;  
 Stream Crossing #2  
 and #3; south west  
 abutment
