3.35 Doris-Windy All-Weather Road Quarries (A, B, and D)

Table 4.2 Summary of Recommendations for 2015 Geotechnical Inspection

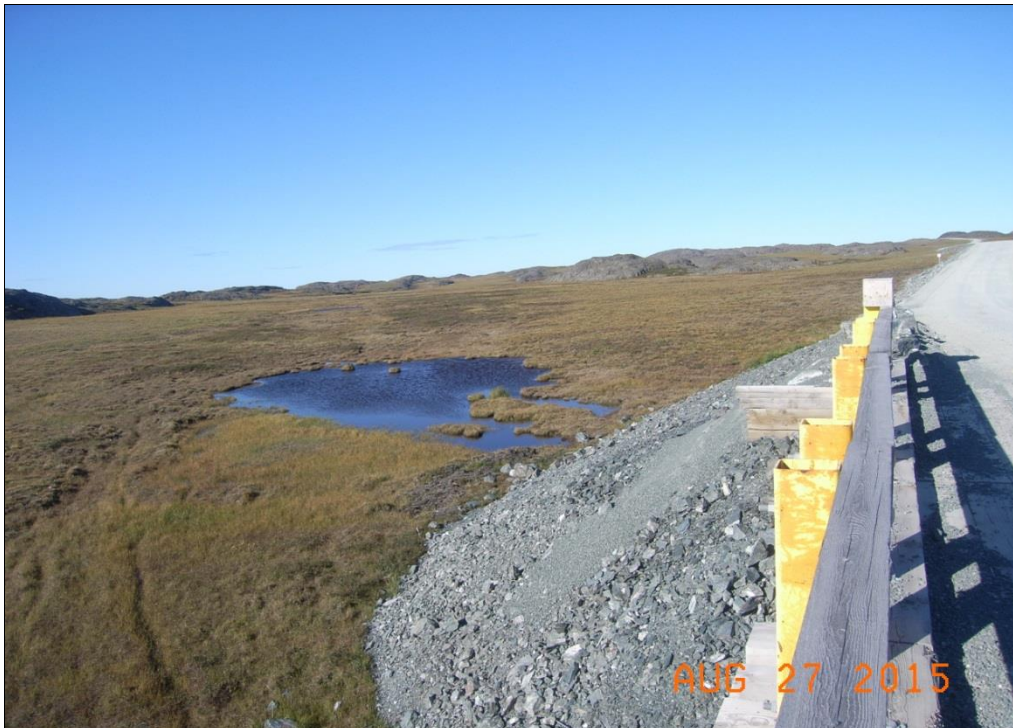
Photo: 3.34-5
 Doris-Windy All-
 Weather Road;
 Stream Crossing #4;
 northwest abutment

M	Doris-Windy All-Weather Road	Former roadside turnout areas should be visually monitored for signs of thermal settlement.
M	Doris-Windy All-Weather Road Stream Crossings	Rock fill should be placed at locations where standing water is notes against the thermal bridge abutment pads to provide insulation and stabilize potential deterioration of the permafrost. In earlier geotechnical inspections it was noted that the web of the I-beam, on top of the fourth pile from the northwest corner of the arch culvert at stream crossing #1, was buckled, but that there had been no change since first noticed in 2012. Some damage to the bridge section was also noted at stream crossing #3. If notable changes are observed in subsequent inspections, a structural assessments should be undertaken.
L	Doris-Windy All-Weather Road Quarries (A, B, and D)	Continue to manage the facility in accordance with the approved Quarry Management Plan.

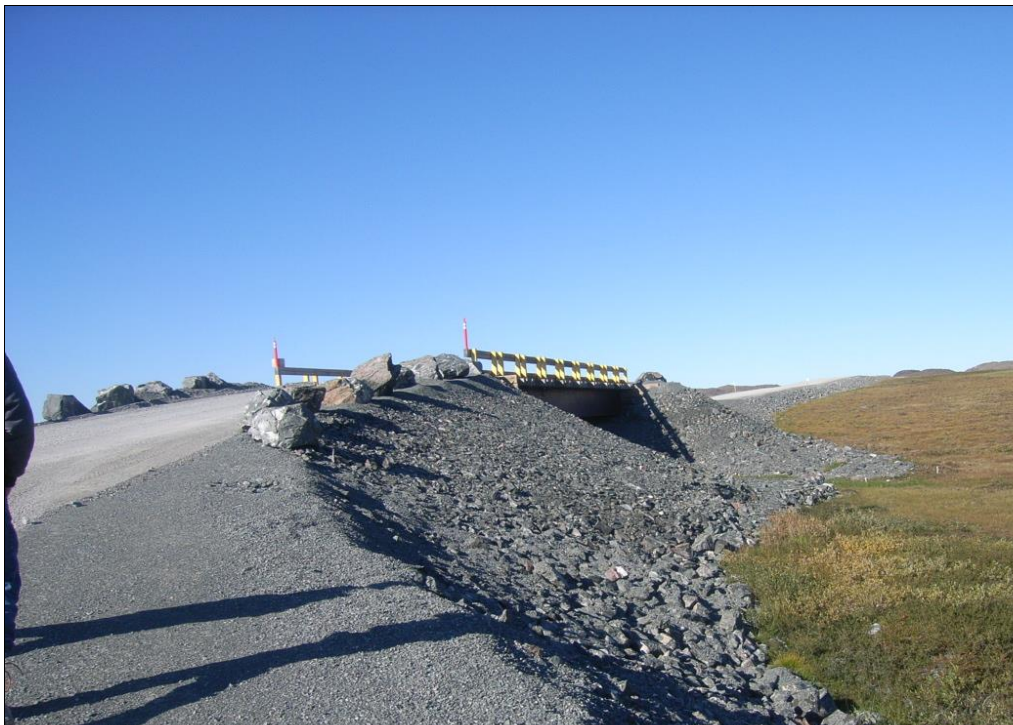
Photo: 3.34-6
 Doris-Windy All-
 Weather Road;
 Stream Crossing #4;
 east abutments

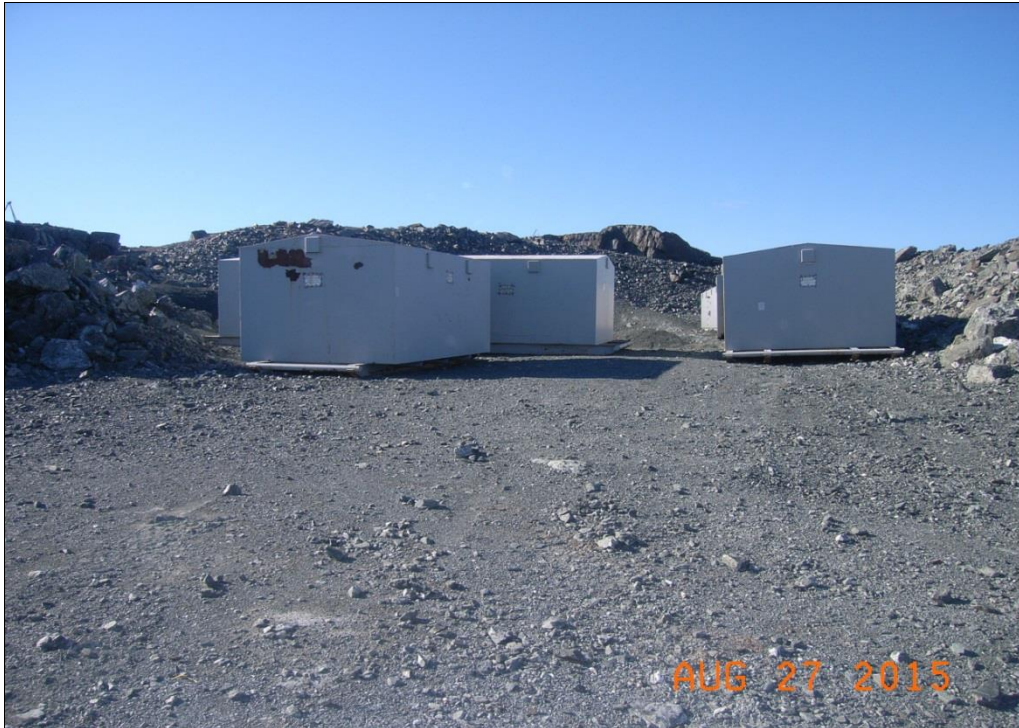
At the time of the inspection, none of these quarries was in use, although they may potentially be reopened in the future. Quarry A is being used as a temporary explosives storage area (Photo 3.35-1). Quarry D is being used for core and overburden storage (Photo 3.35-2). There is also a small, HDPE lined bunded area being used as secondary containment for several fuel drums.

Photo: 3.35-1
Doris-Windy All-
Weather Road
Quarry A

Continue to manage the facility in accordance with the approved Quarry Management Plan.

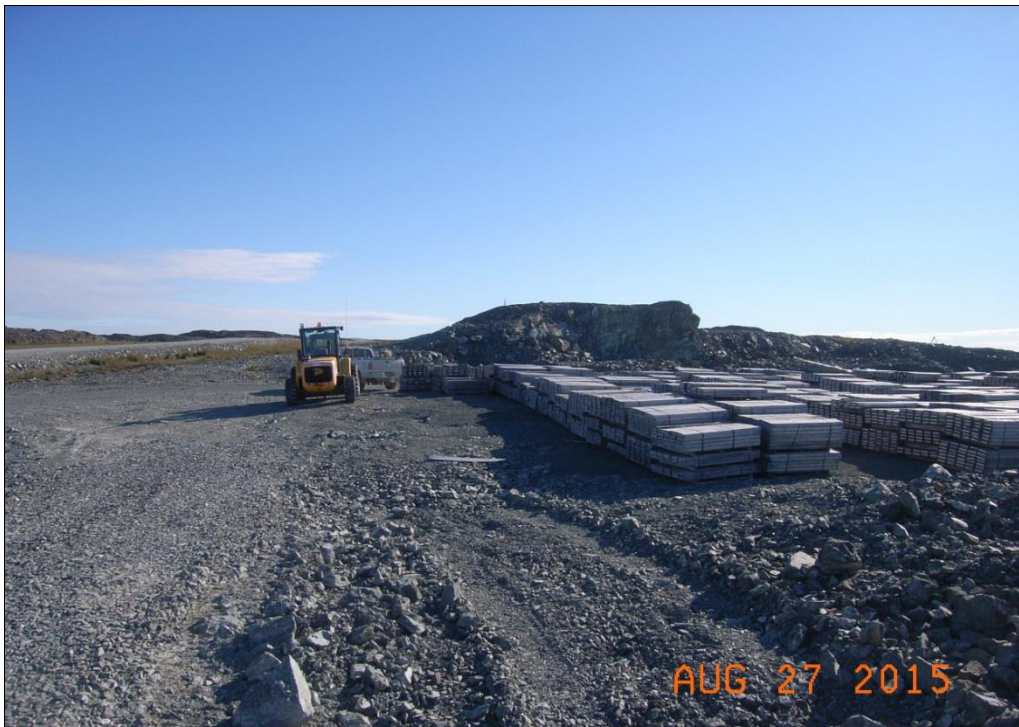
Photo: 3.35-2
Doris-Windy All-
Weather Road
Quarry D
