WATER LICENCE INSPECTION FORM

Licensee	Licensee Representative
TMAC Resources	John Roberts
Licence No. / Expiry	Representative's Title
2AM-DOH1323	VP Environment
Land/ Other Authorizations	Land/ Other Authorizations
77A/3-1-2	
Date of Inspection	Inspector
26/04/2017	Eva Paul
Activities Inspected	
<input checked="" type="checkbox"/> Camp	<input type="checkbox"/> Drilling
<input checked="" type="checkbox"/> Roads/Hauling	<input type="checkbox"/> Other:
<input checked="" type="checkbox"/> Mining	<input checked="" type="checkbox"/> Construction
	<input type="checkbox"/> Reclamation
	<input checked="" type="checkbox"/> Fuel Storage

PHOTOS OF INSPECTION – 2AM-DOH1323 APRIL 26-27 2017

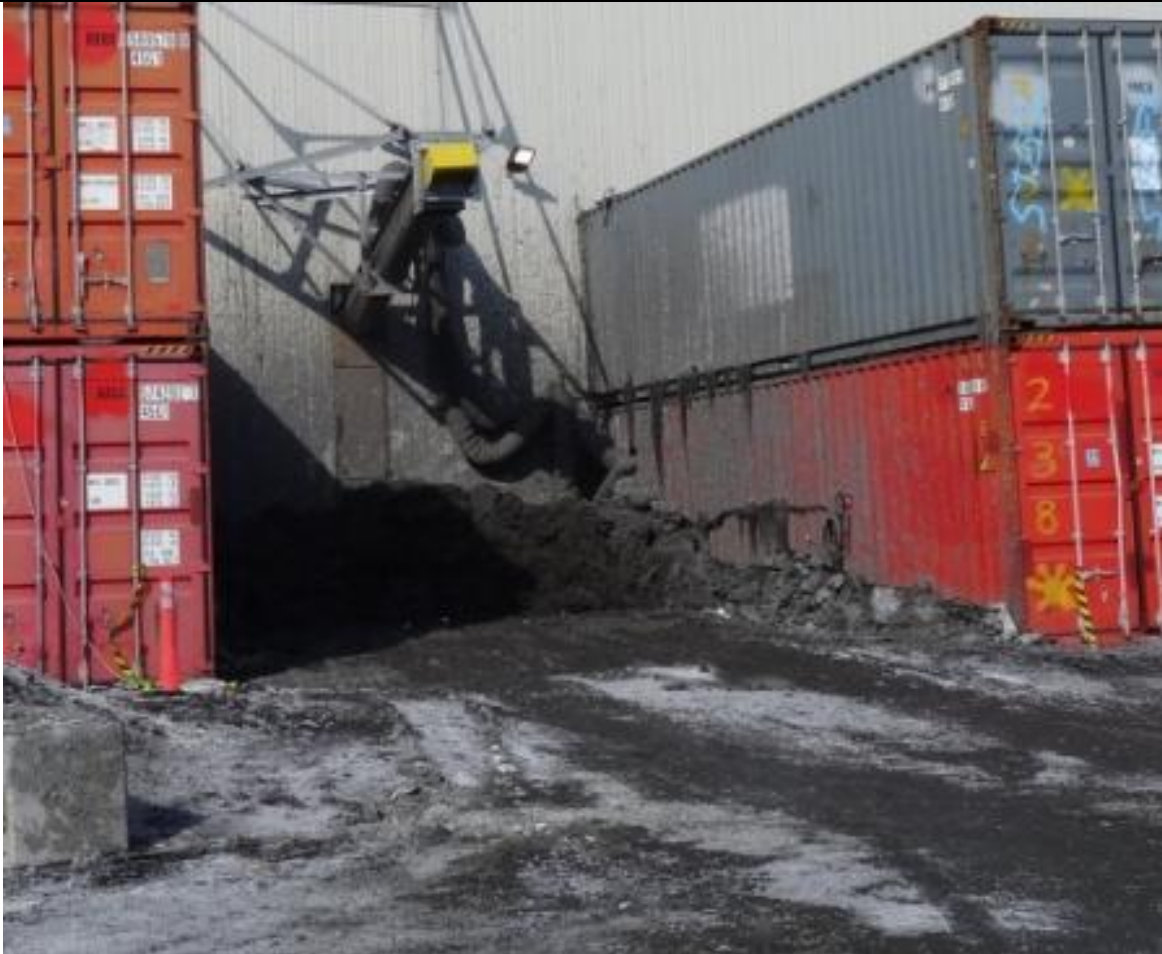
Date	Camera	Inspector	Authorization
26 04 2017	SONY DSC-HX50V	Eva Paul	2AM-DOH1323
Photo Log # 1		Location (NAD 83 DD MM SS.SS)	
Photo DSC06523 (cropped)		N68 08 16.1 W106 36 31.1

Description: Chute for loading the filtered cyanide leach residue into trucks for deposit underground. Dark staining in foreground is largely the same detoxified tails tracked around the pad area.

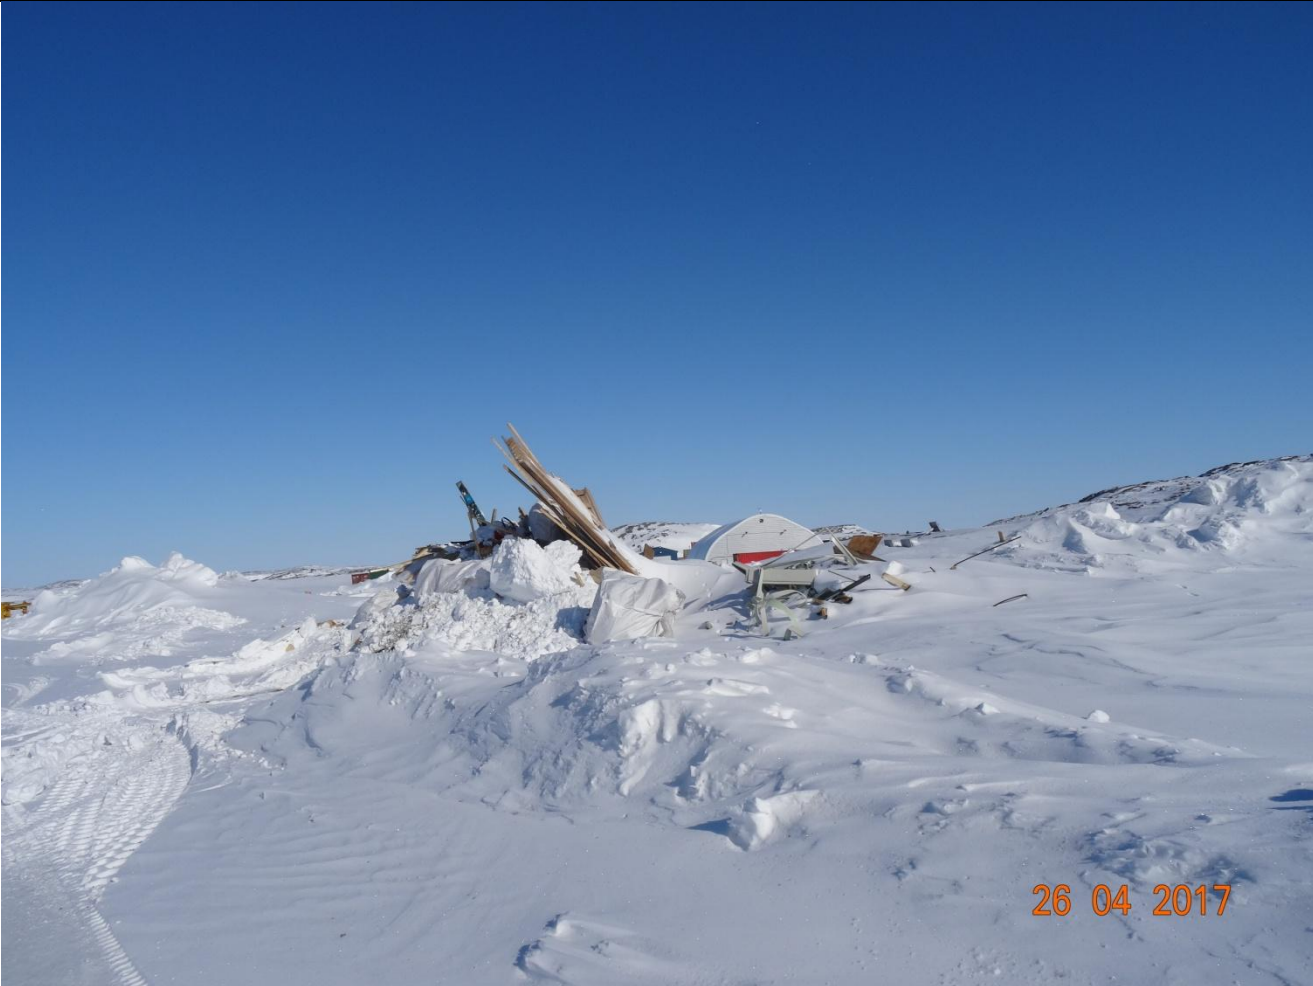
Photo Log # 3

Description: Construction waste near burn pan remaining to be sorted for proper disposal when time permits.

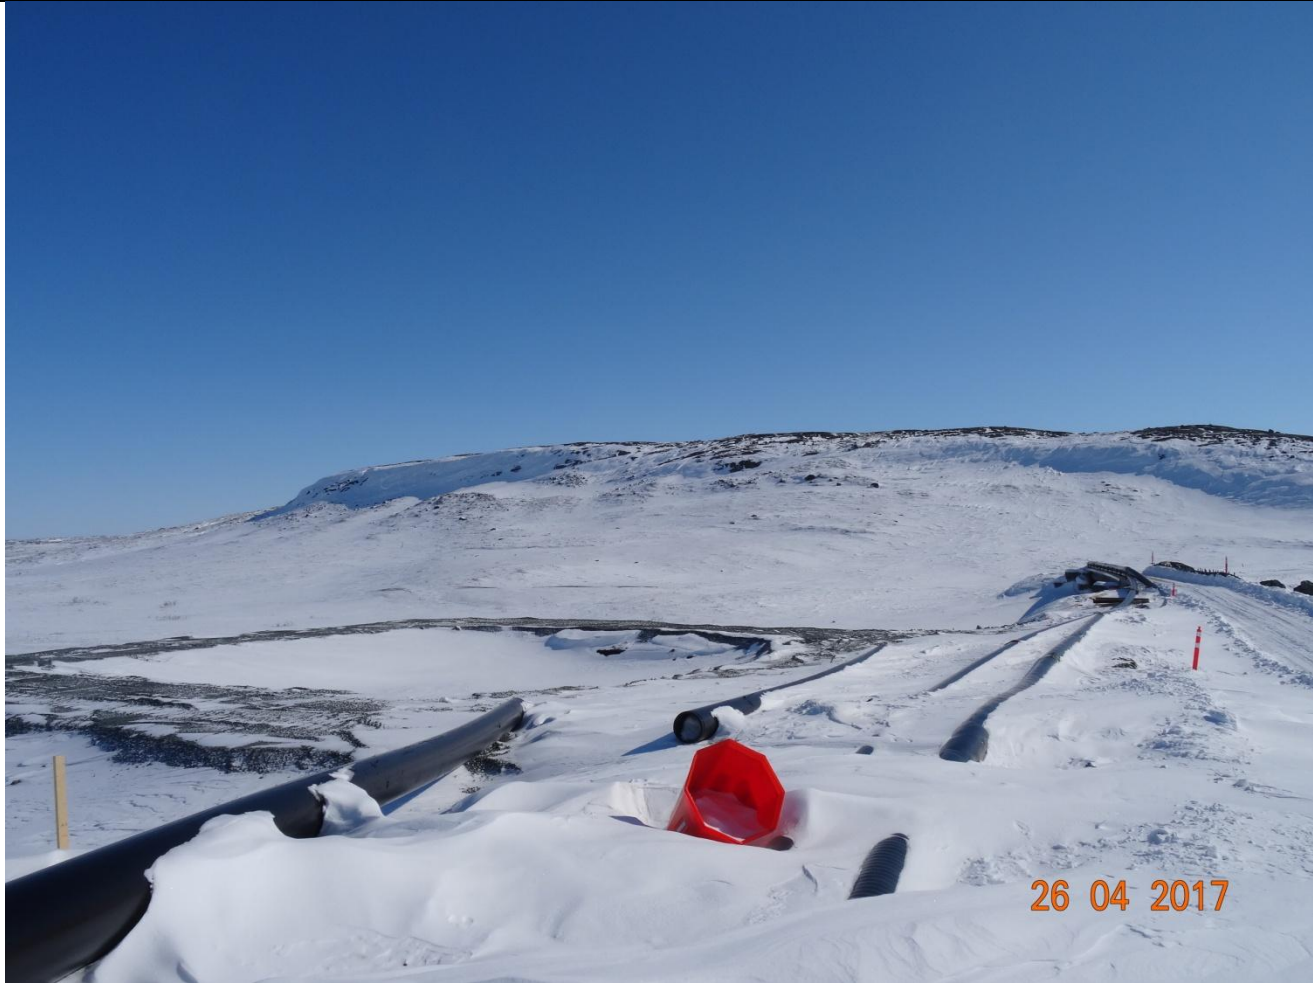
Photo Log # 4

Description: One of two catch basins (tailings line spill containment) anticipated at Doris Creek.

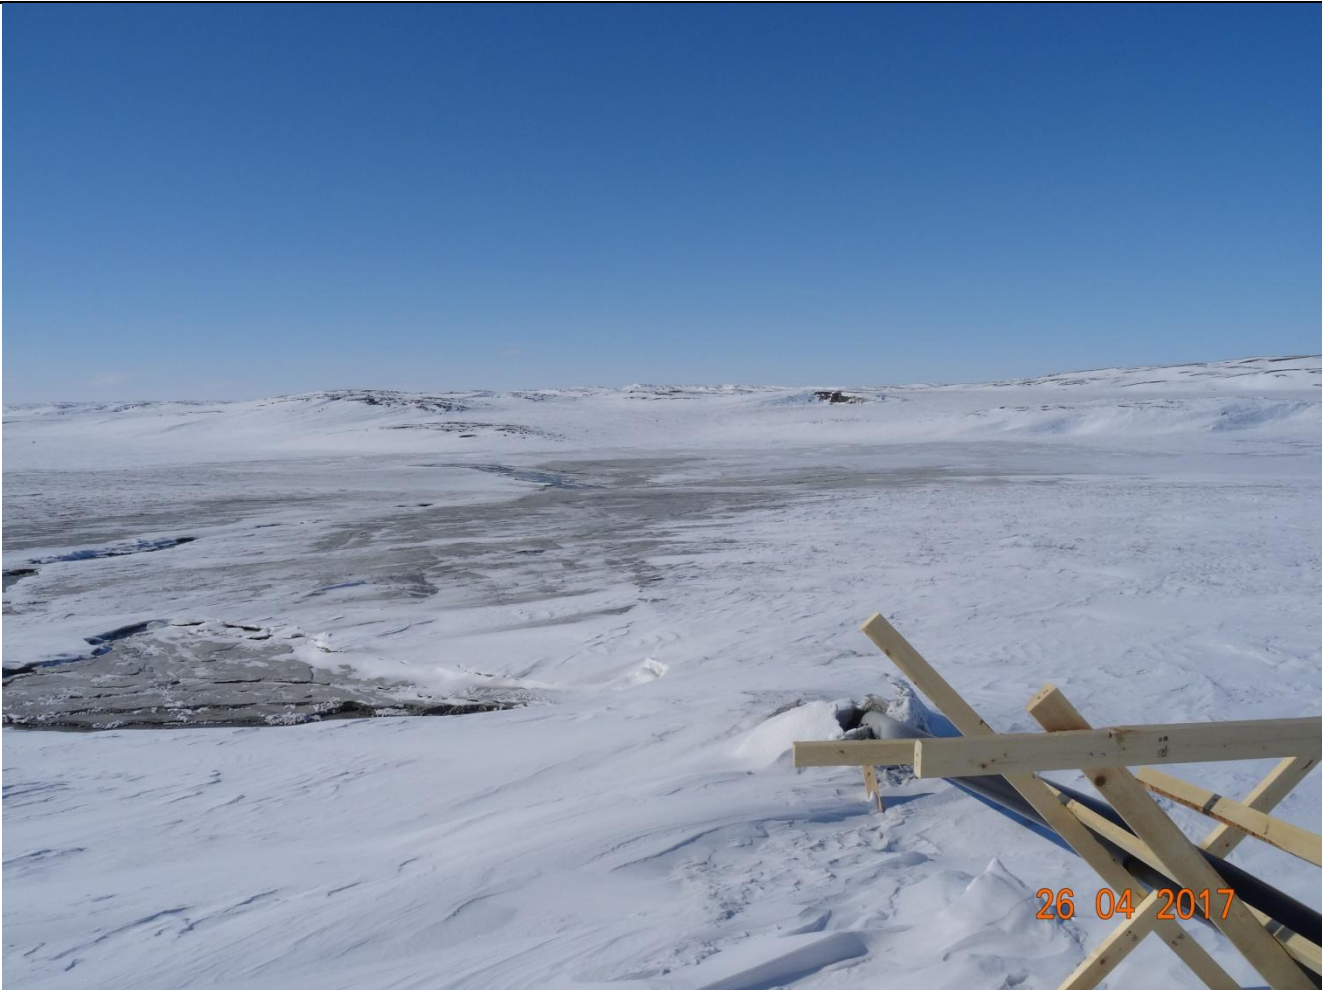
Photo Log # 5

Description: Current tailings discharge into TIA.
