WATER LICENCE INSPECTION FORM

Licensee	Licensee Representative
TMAC Resources	Sarah Warnock
Licence No. / Expiry	Representative's Title
2AM-DOH1323	Environmental Coordinator
Land / Other Authorizations	Land / Other Authorizations
77A/3-1-2	
Date of Inspection	Inspector
8-9 July 2017	Eva Paul
Activities Inspected	
<input checked="" type="checkbox"/> Camp	<input type="checkbox"/> Drilling
<input checked="" type="checkbox"/> Roads/Hauling	<input type="checkbox"/> Other:
<input checked="" type="checkbox"/> Mining	<input checked="" type="checkbox"/> Construction
	<input type="checkbox"/> Reclamation
	<input checked="" type="checkbox"/> Fuel Storage
	<input type="checkbox"/> Other:

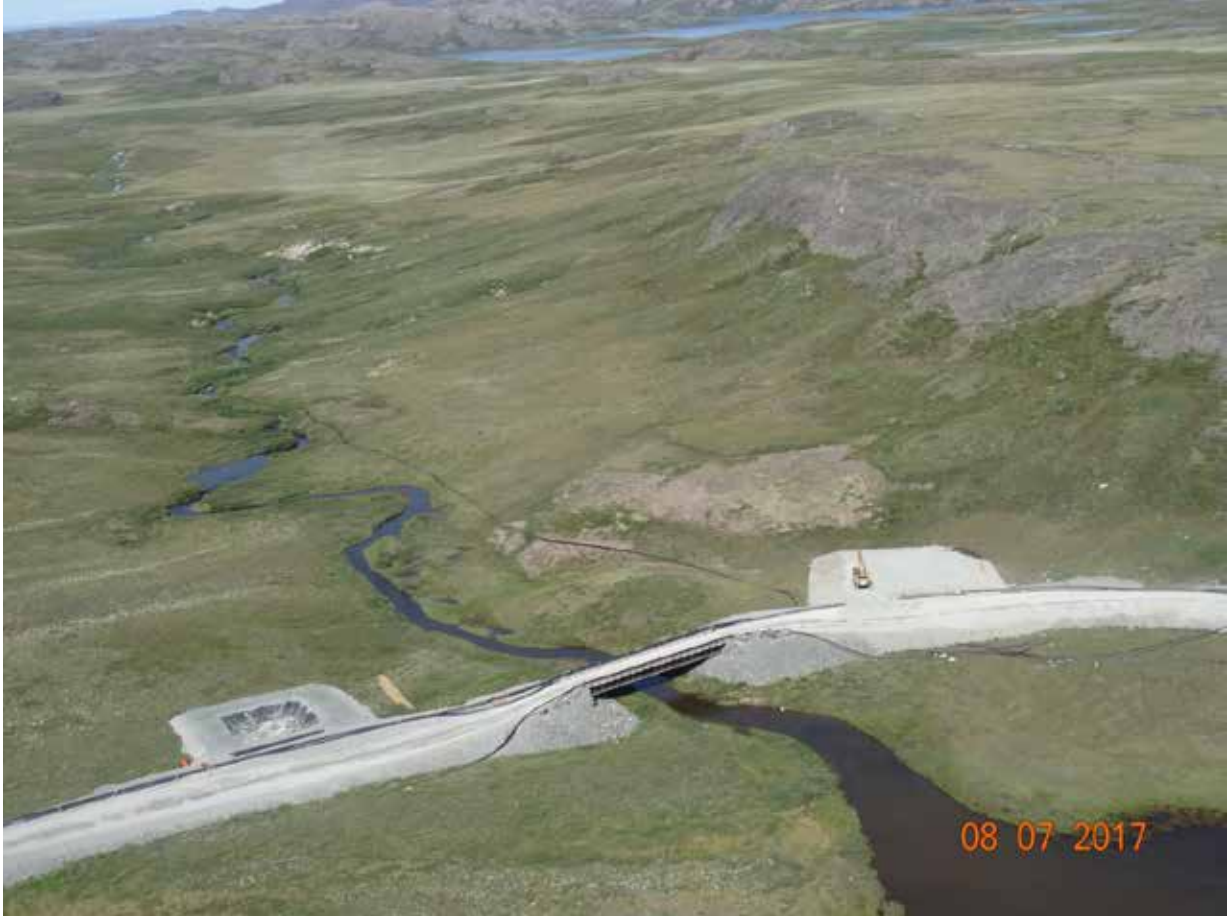
Date	Camera	Inspector	Authorization
July 8 2017	SONY DSC-HX50V	Eva Paul	2AM-DOH1323
Photo Log # 1		Location (NAD 83 DD MM SS.SS)	
Photo DSC06870		N68 08 16.2	W106 35 31.7 (Approx. from the air)

Description: Catchment basins on either side of Doris Creek. East basin was under construction at the time of the inspection.

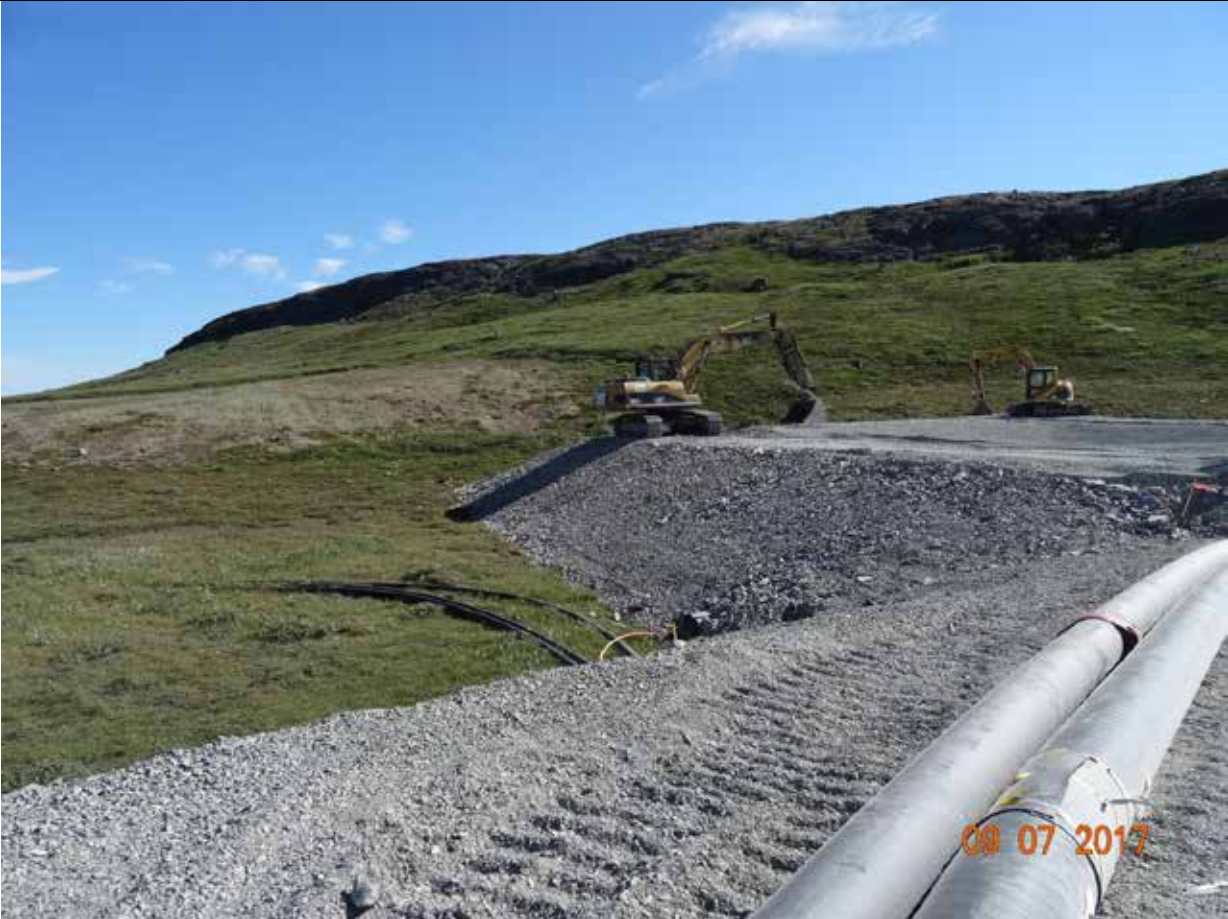
Photo Log # 2	Location (NAD 83 DD MM SS.SS)
Photo DSC06953	N68 08 28.8 W106 35 12.4

Description: East catchment basin; no sediment control measures in place.

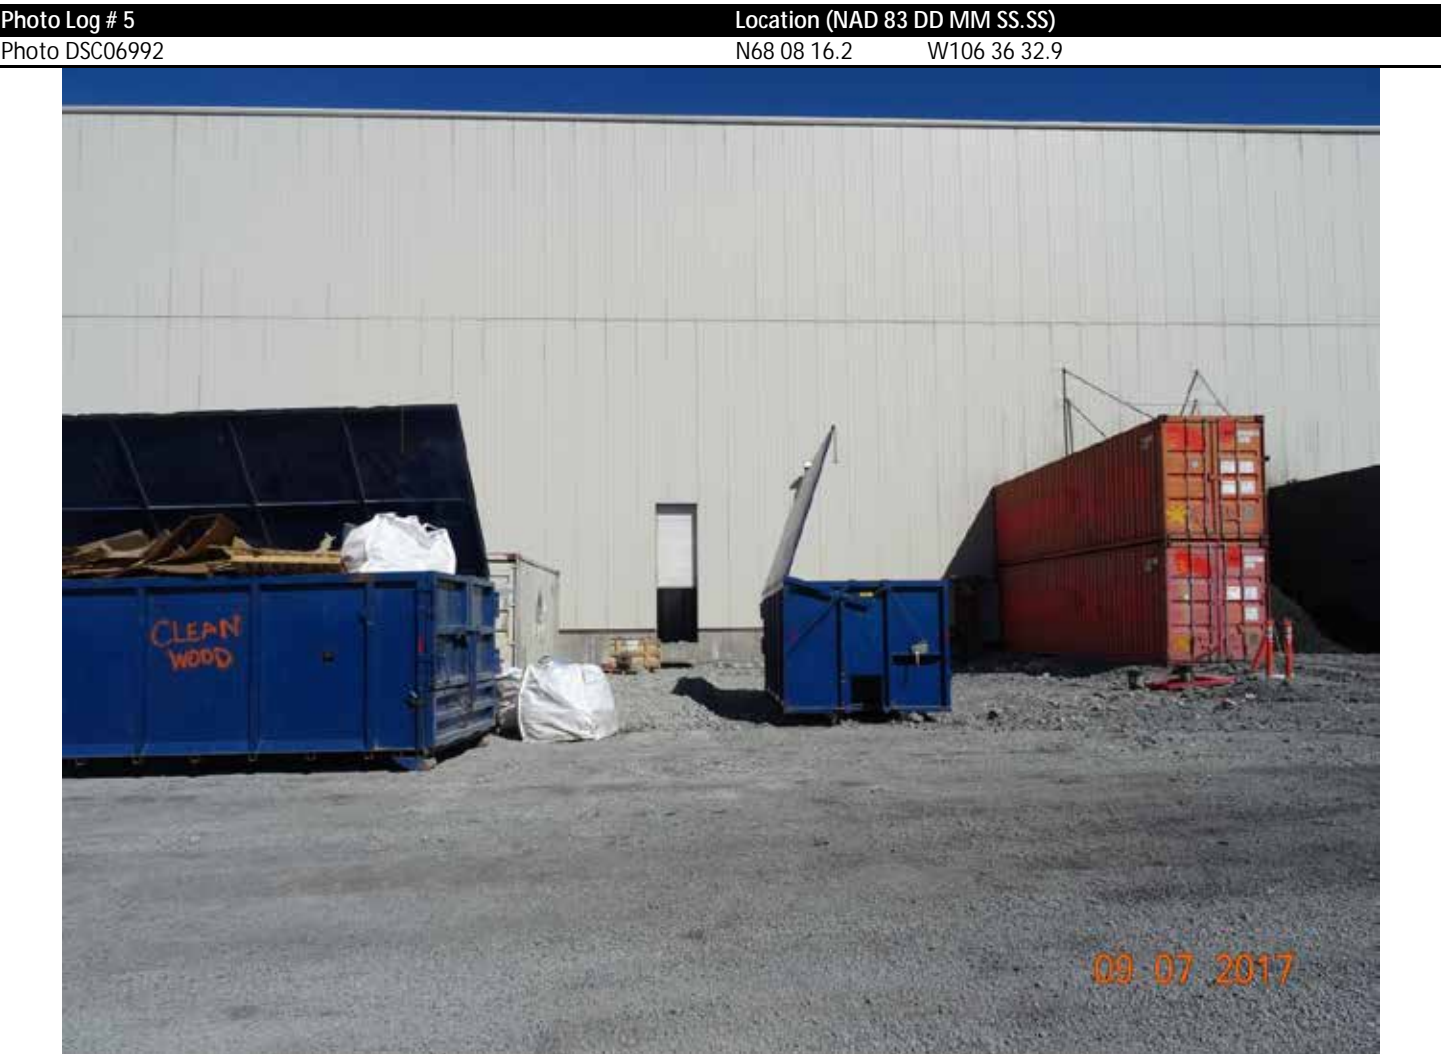
Description: Better waste management controls at the mill building. Labelled sea cans to segregate hazardous goods were also present.

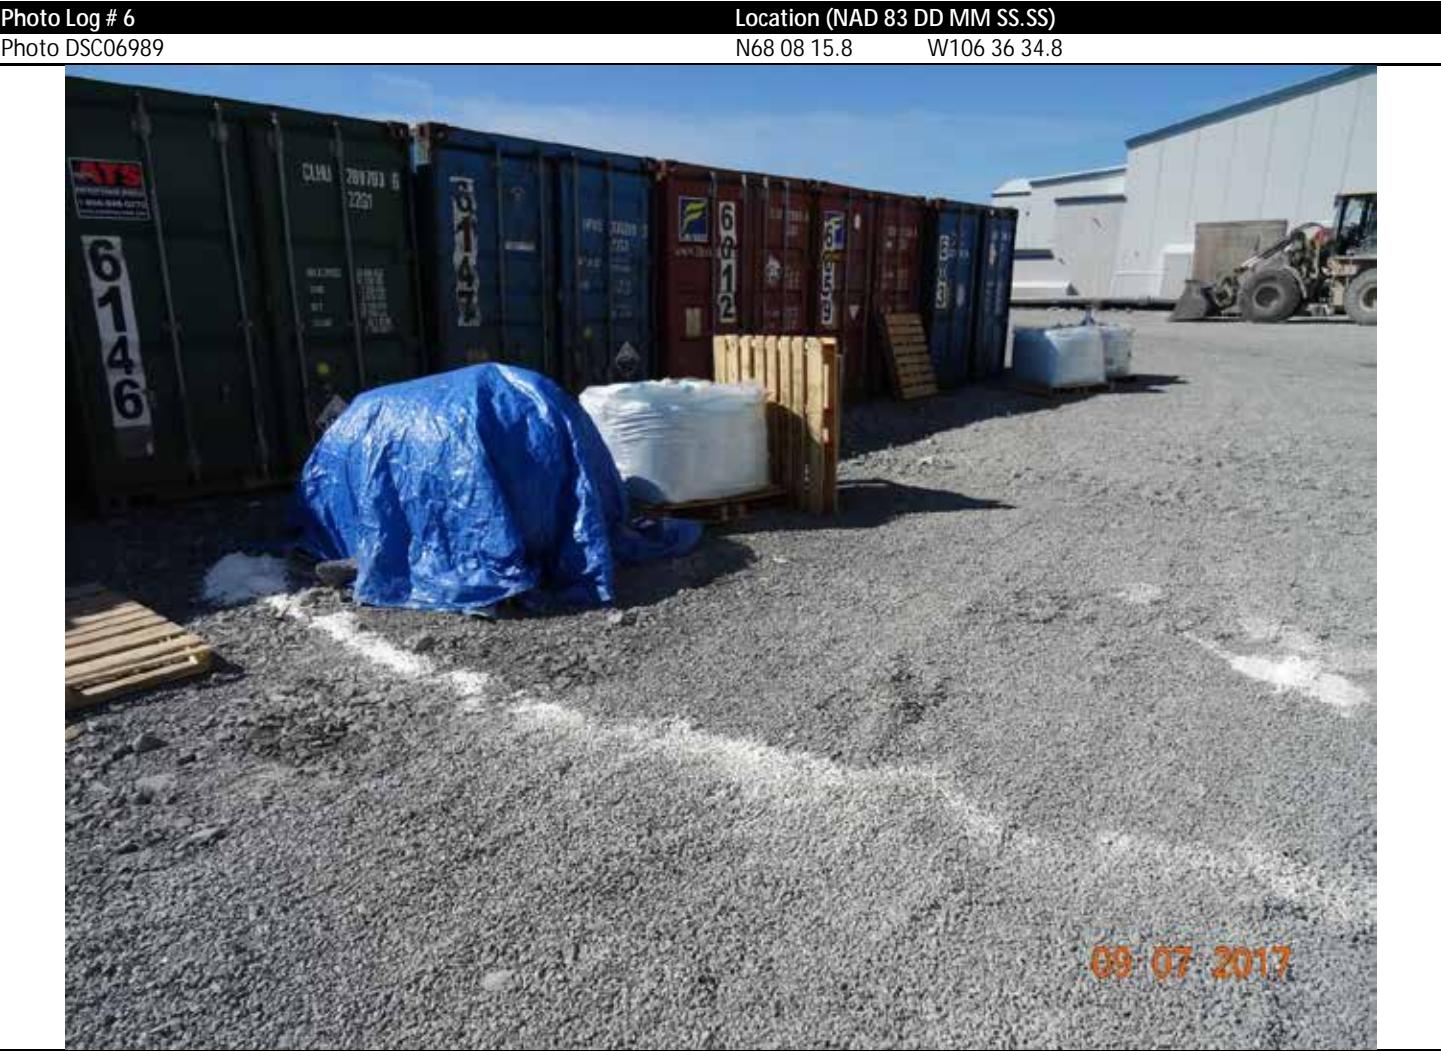
Description: Spillage of unknown powder outside mill building.

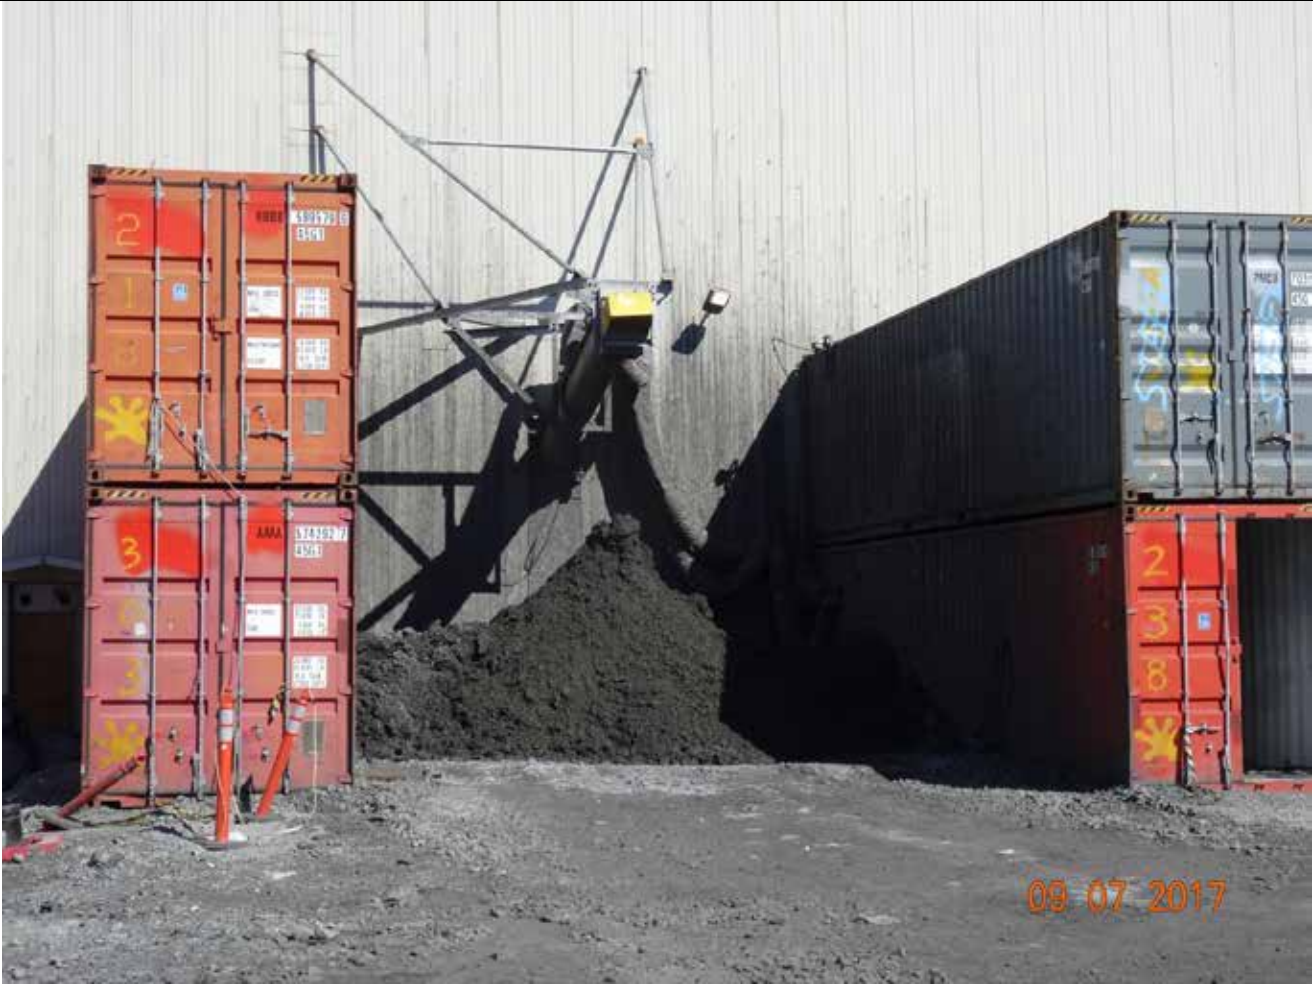
Photo Log # 7

Description: Detoxified tailings are now deposited on the pad, and moved by excavator into trucks.

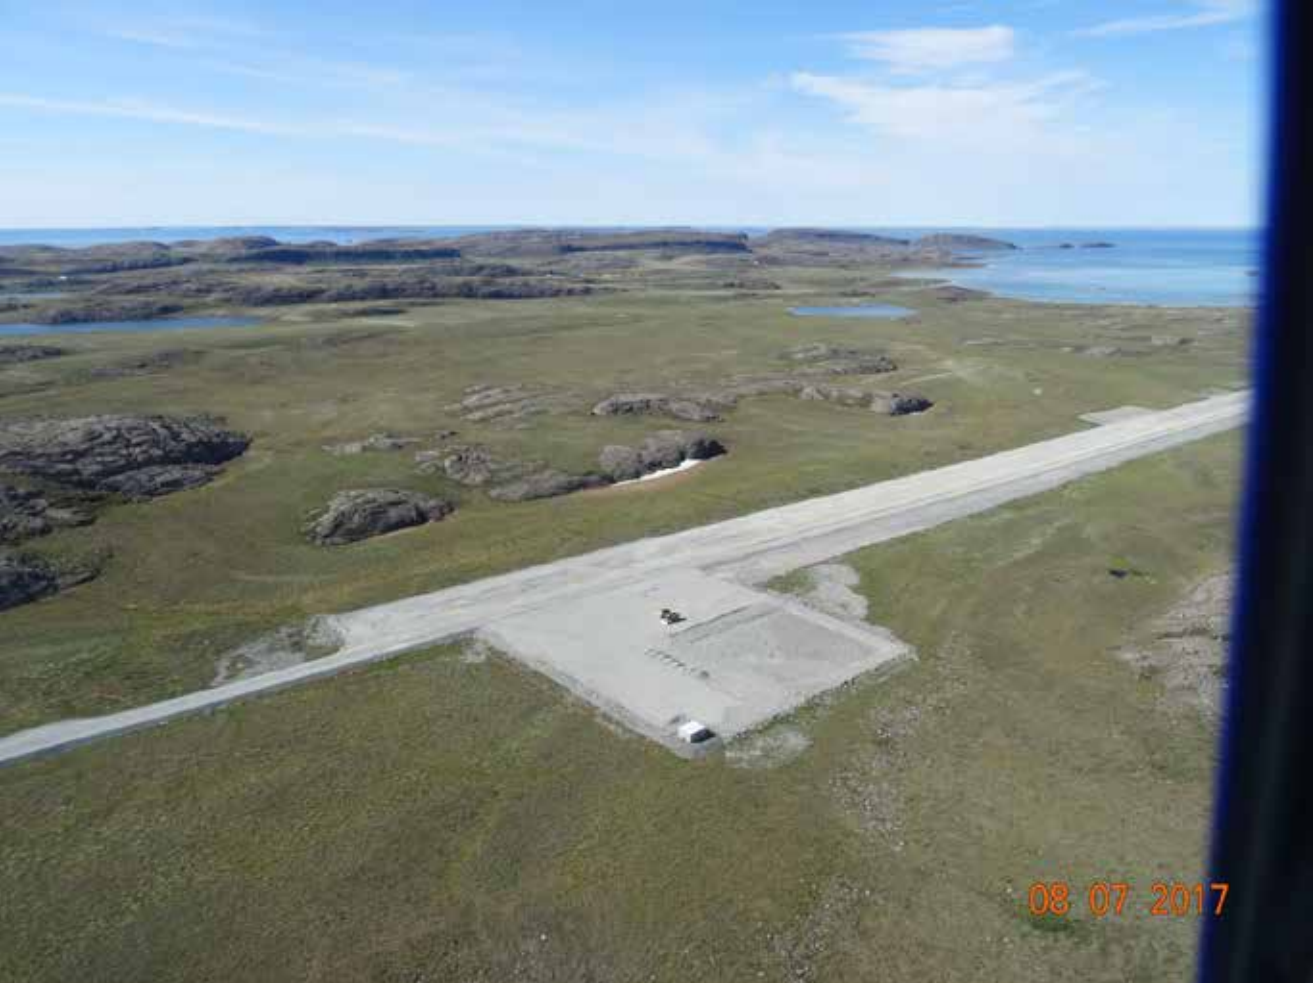
Photo Log # 8

6. It is noted that the construction of a pad for de-icing aircraft means that a plan to manage aircraft de-icing fluid and storage is likely in the works. Please note that this plan is to be submitted at least three months prior to the anticipated usage of de-icing fluid.

Description: Aircraft de-icing pad (under construction). Liner will be present to contain the fluid. No sediment control measures noted.
