Date	Camera	Inspector	Authorization
October 10-11 2017	SONY DSC-HX50V	Eva Paul	2AM-DOH1323
Photo Log # 1		Location (NAD 83 DD MM SS.SS)	
Photo DSC08378		N	W

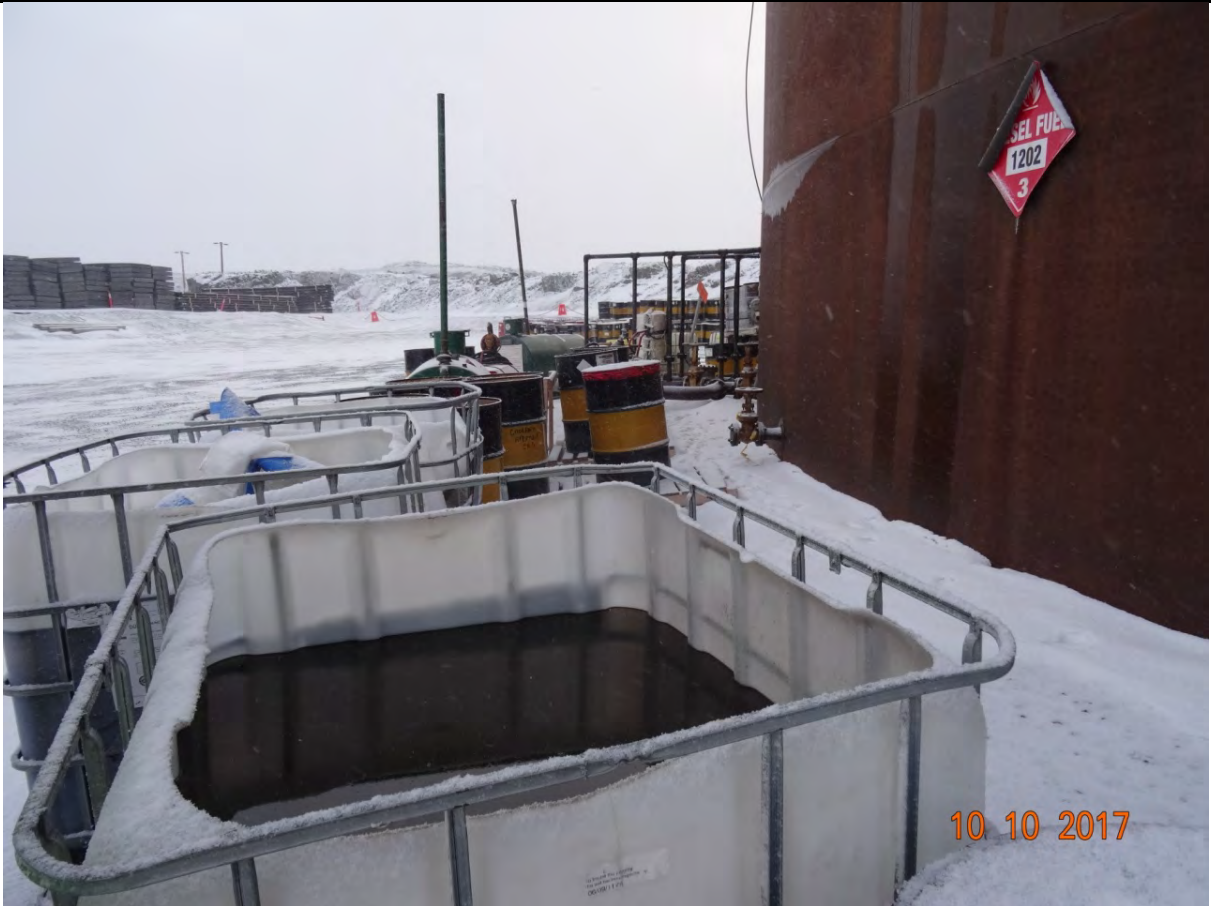
Photo Log # 5

Description: Several open totes and barrels of hazardous waste found in the Miramar berm.

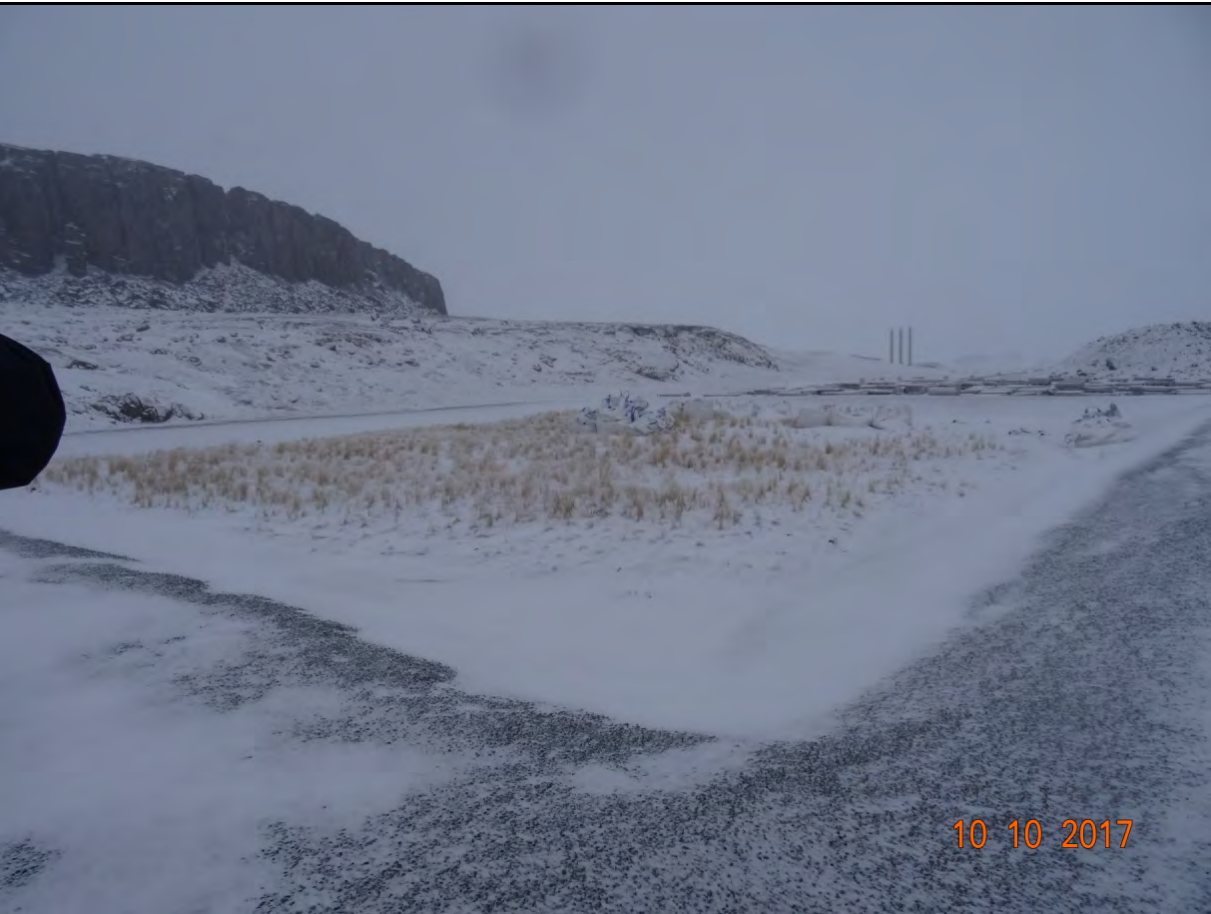
Photo Log # 6

Description: Landfarm's soil cell has not been turned or managed in several years.

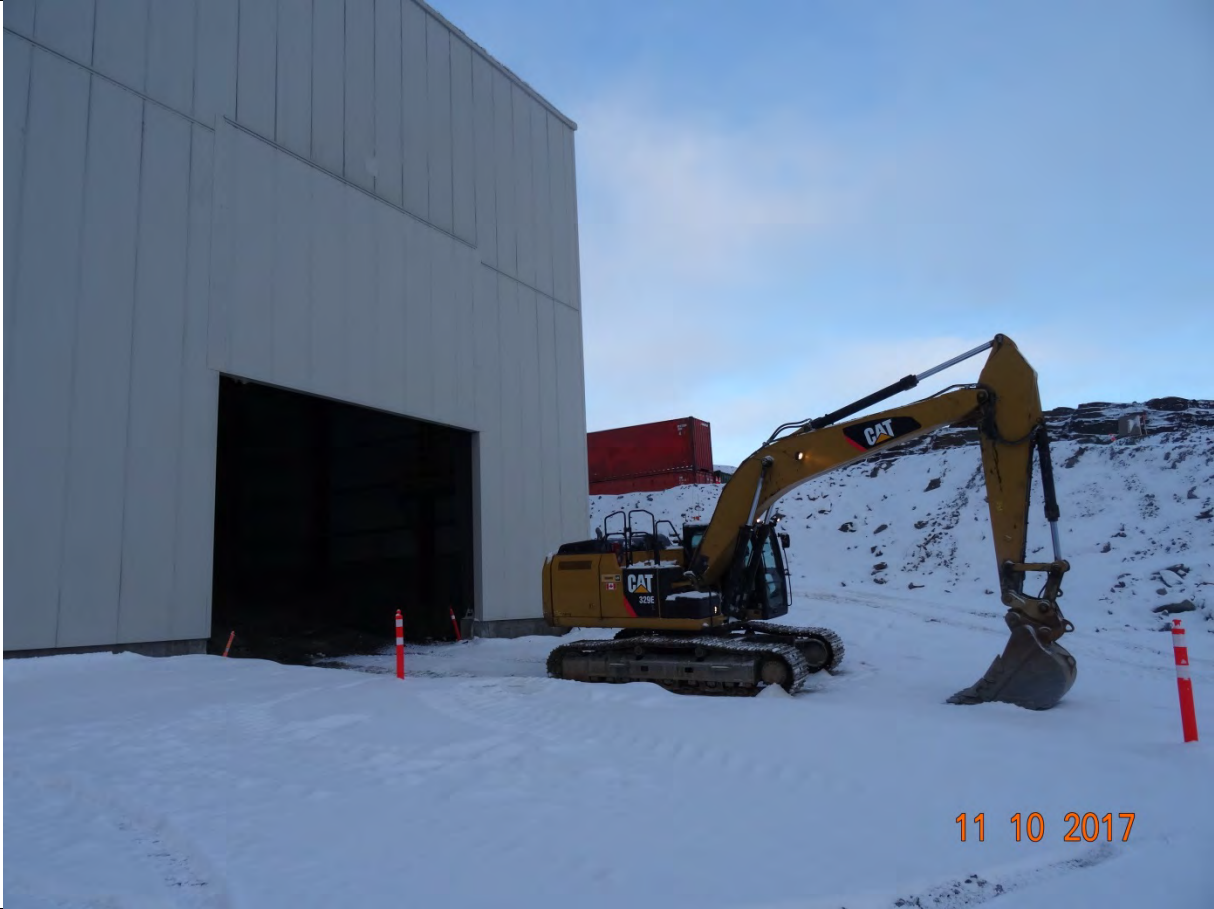
Photo Log # 7

Description: The one excavator currently used for all purposes at site, including loading detox tailings into the trucks.

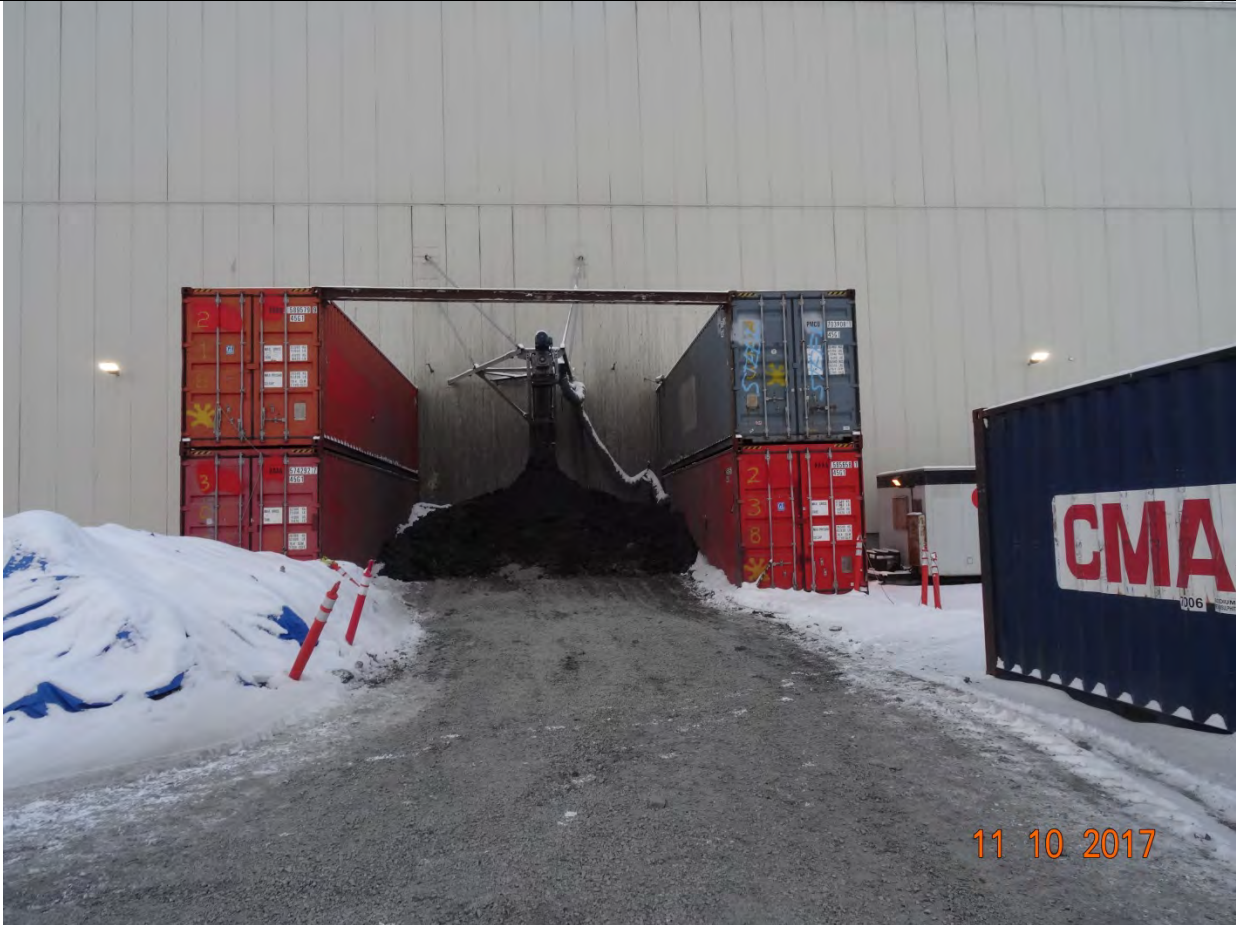
Photo Log # 8

Description: Detox tailings chute from Mill building. Tarpied pile to the left is frozen tails requiring re-processing.

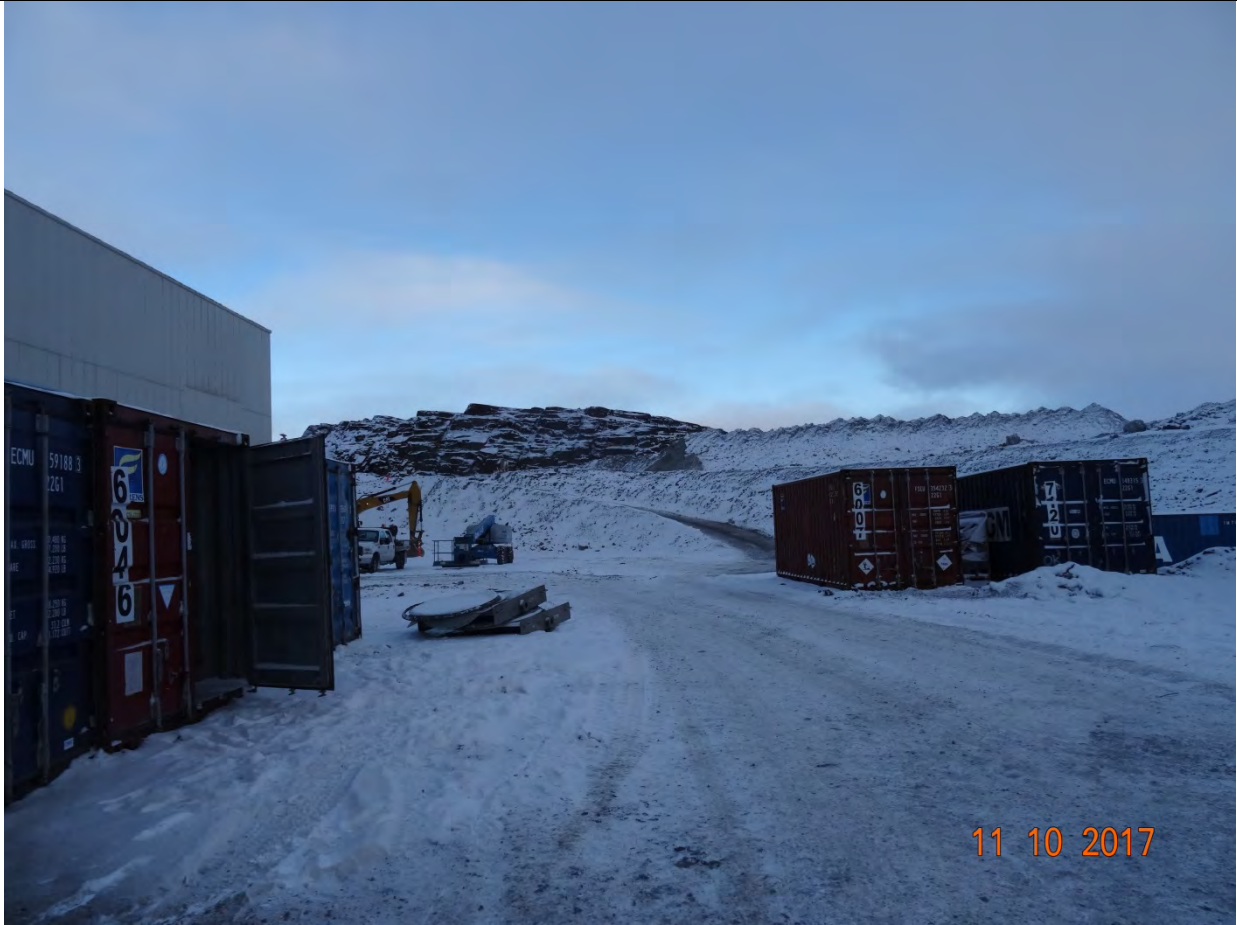
Photo Log # 9

Description: Photo looking east with Mill to North. Shortcut now exists directly back to portal for trucks hauling waste underground, rather than traveling outside the 'contact area' where all contact water reports to the Sed and PC ponds.

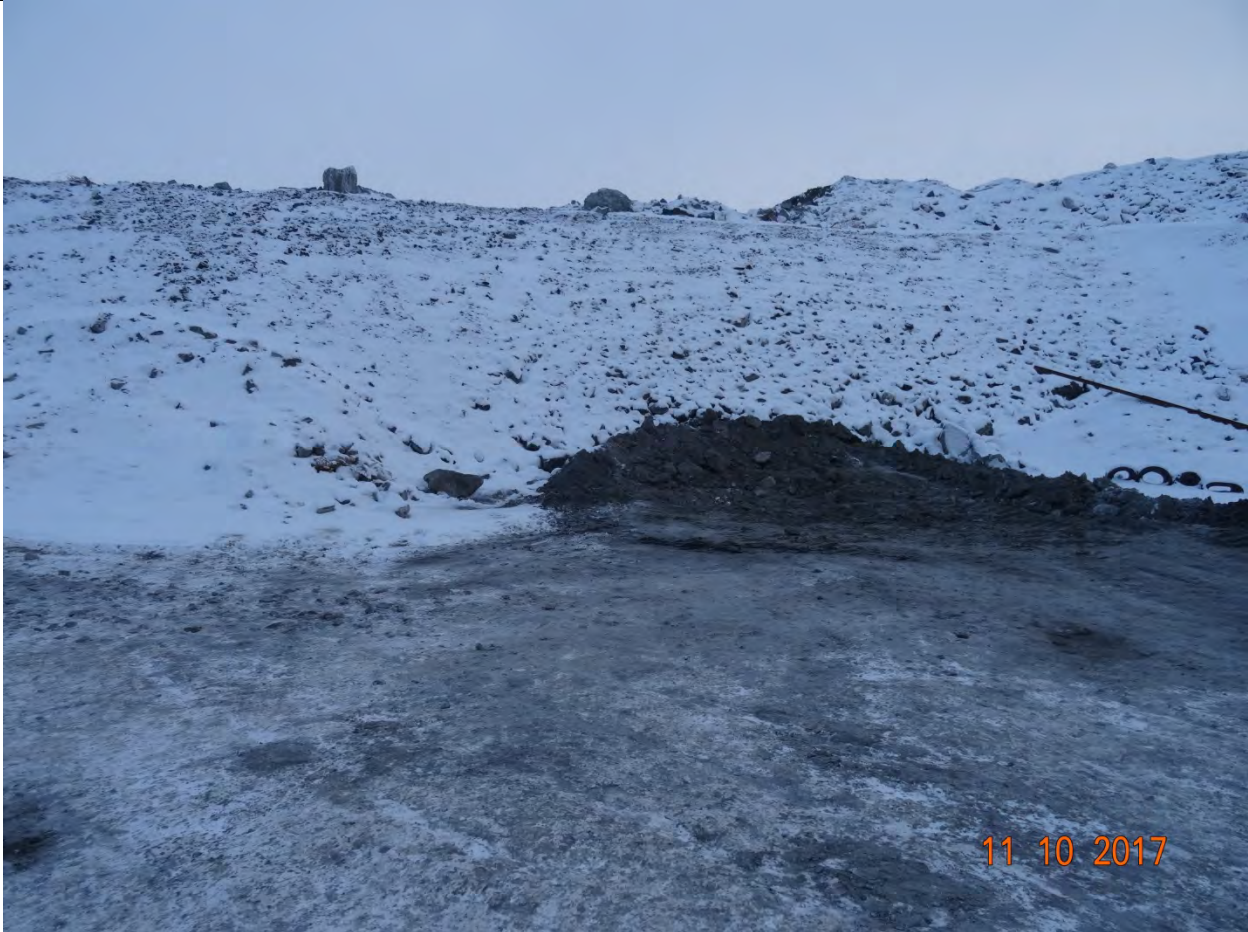
Photo Log # 10

Description: Photo looking south from Mill. Semi-processed materials dumped on the pad as a result of difficulties with the ball mill.
