WATER LICENCE INSPECTION FORM

Licensee	Licensee Representative
TMAC Resources Inc.	Oliver Curran
Licence No. / Expiry	Representative's Title
2AM-DOH1323	VP Environmental Affairs
Land / Other Authorizations	Land / Other Authorizations
Date of Inspection	Inspector
13 th -14 th / 02 / 2018	Eva Paul + Jeremy Fraser
Activities Inspected	
<input checked="" type="checkbox"/> Camp	<input checked="" type="checkbox"/> Drilling
<input checked="" type="checkbox"/> Roads/Hauling	<input type="checkbox"/> Other:
	<input checked="" type="checkbox"/> Mining
	<input checked="" type="checkbox"/> Construction
	<input type="checkbox"/> Reclamation
	<input checked="" type="checkbox"/> Fuel Storage

PHOTO LOG: 2AM-DOH1323 INSPECTION OF FEBRUARY 13-14 2018

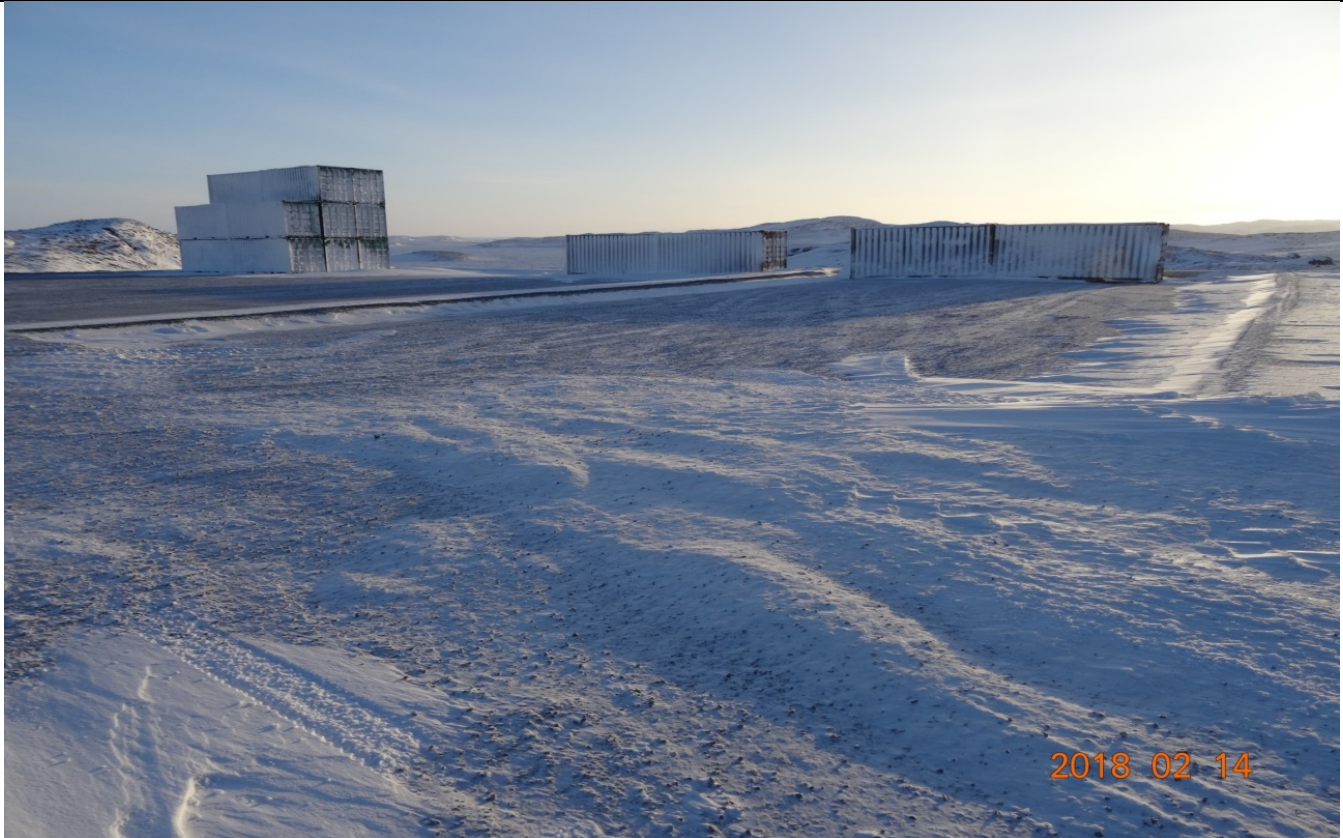
Photo Log # 3

Description: Reagent and Cyanide storage facility. Sump on right side of facility is exposed for inspection. The sump in the left side of facility is potentially under the seacans not exposed for inspection.

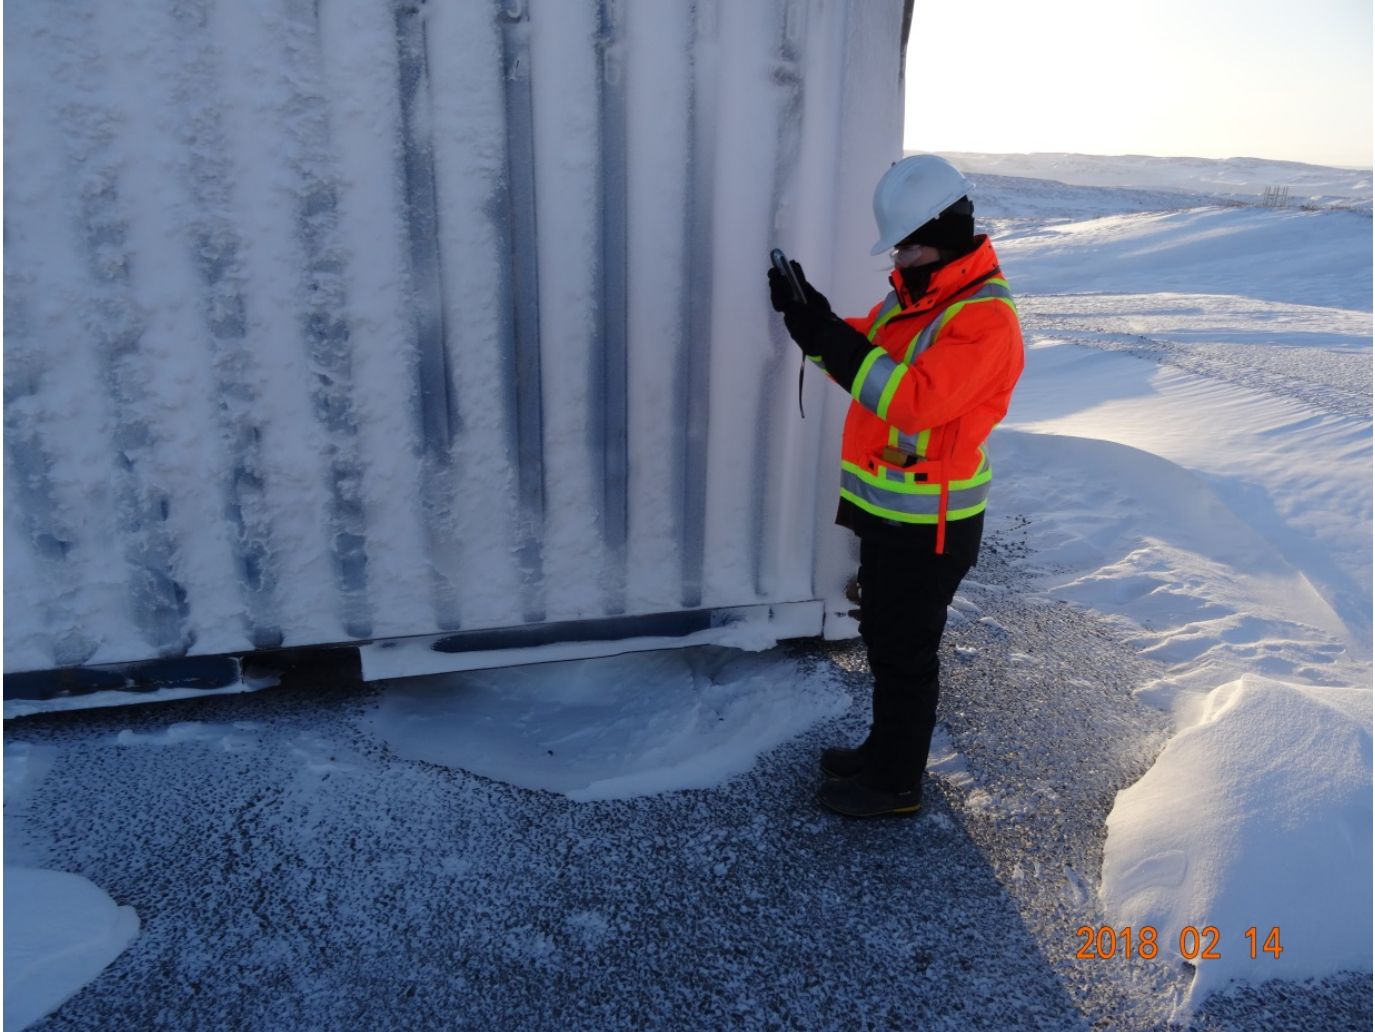
Photo Log # 4

Description: Reagent and Cyanide storage facility. Sump found on the right side of facility is exposed for inspection. No sump was found in the East cell.

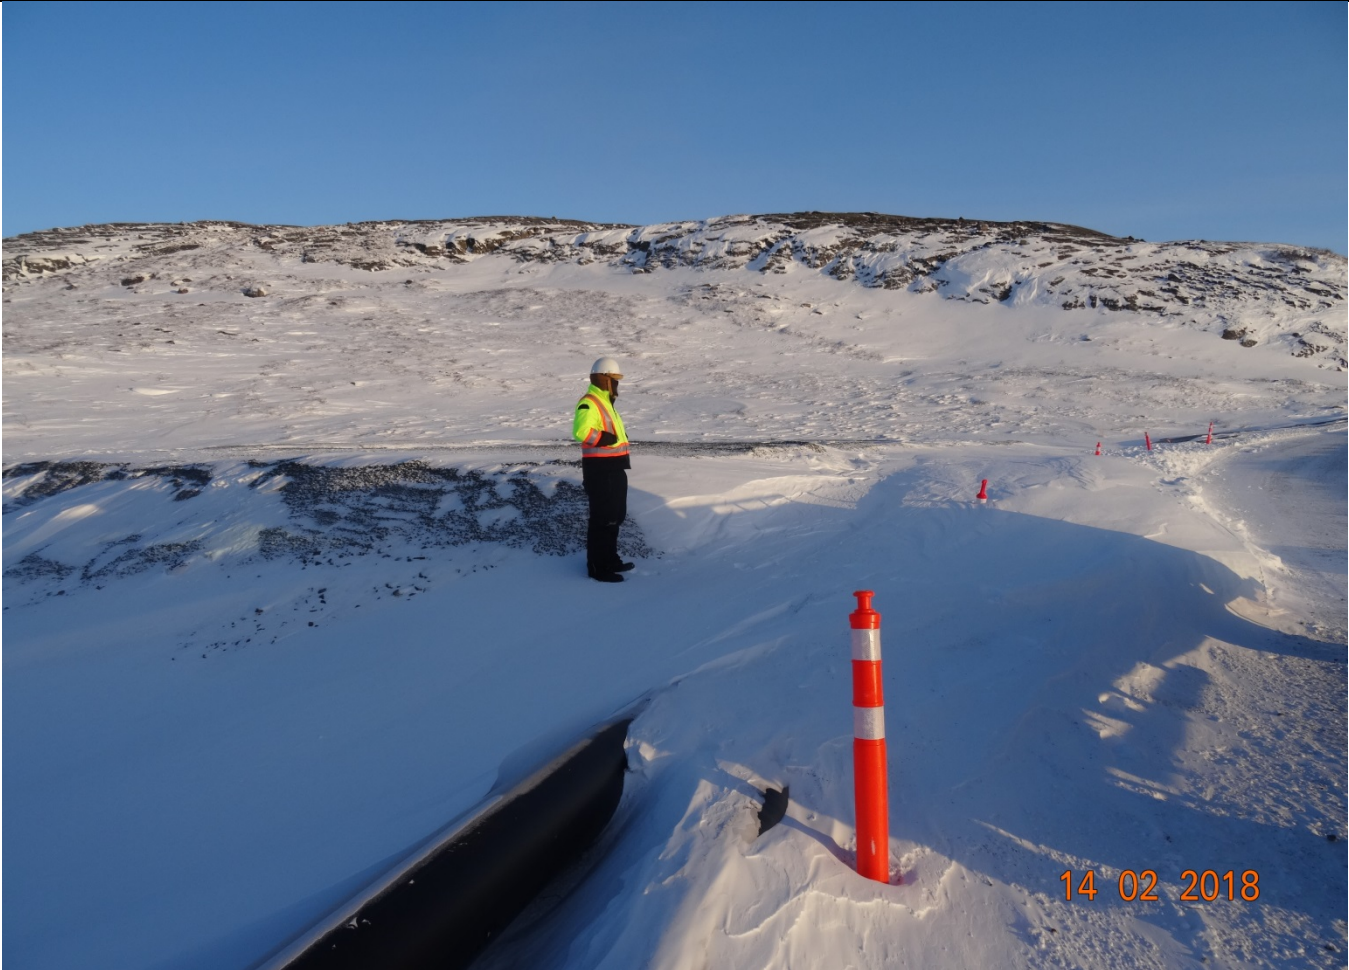
Photo Log # 5

6. During inspection of the Emergency Dump Catch Basins on either side of Doris Creek, the inspectors noticed the Tailings Transfer Pipe to be substantially lower than the walls of the engineered basins. It is unclear how the tailings will be diverted to these basins in case of an emergency. *See figure 5*
7. It is suggested that TMAC install intake flow meters at all raw water intake facilities due to the possible margin for error, this will ensure accurate tracking of water usage and minimize the human error aspect of TMAC water consumption.
8. Accurate coordinates for the sumps at the Reagent Pad, and other new structures are to be provided.

Description: Emergency Catch Basin on west side of Doris Creek. The Tailings pipe is under snow along the orange pylons with no indication of direction into Basin if necessary.

- A. Confirm that water from Windy Lake is only to be used for domestic purposes as per the licence. All industrial water usage must originate from sources approved under 2AM-DOH1323. Metering of water usage is preferable.
- B. All hazardous materials are to be stored in secondary containment as per Part I item 3 of the licence. Storage areas should be kept free of snow to the extent possible.
- C. Sump locations in both cells of the Reagent Pad are to be confirmed and must be left unobstructed.
- D. Demonstrate how the tailings are to be diverted to the Emergency Dump Catch Basin on the east side of Doris Creek.
