WATER LICENCE INSPECTION FORM

Licensee	Licensee Representative
TMAC Resources Inc.	Sarah WARNOCK
Licence No. / Expiry	Representative's Title
2AM-DOH1323	Environmental Supervisor
Date of Inspection	Inspector
11 October 2018	Jeremy FRASER
Activities Inspected	
<input checked="" type="checkbox"/> Camp	<input checked="" type="checkbox"/> Drilling
<input checked="" type="checkbox"/> Roads/Hauling	<input checked="" type="checkbox"/> Mining
	<input type="checkbox"/> Construction
	<input type="checkbox"/> Reclamation
	<input checked="" type="checkbox"/> Fuel Storage
	<input type="checkbox"/> Other:

On October 11, 2018 a Water Licence Inspection was conducted at the TMAC Doris camp (2AM-DOH1323) by inspectors Jeremy FRASER, Justin HACK and Candice PEDERSEN accompanied by Sarah WARNOCK. Facilities inspected include but not limited to Roberts Bay facilities, Doris Main Camp and mining activities associated with the water licence. Other areas include the Waste Management Area, the Bulk Fuel Storage Areas including the Three Tank Farm and the Single Tank Farm, the Jetty, the aircraft de-icing pad, Windy Lake raw water intake pump house, Doris Lake raw water intake, Windy road bridges and larg

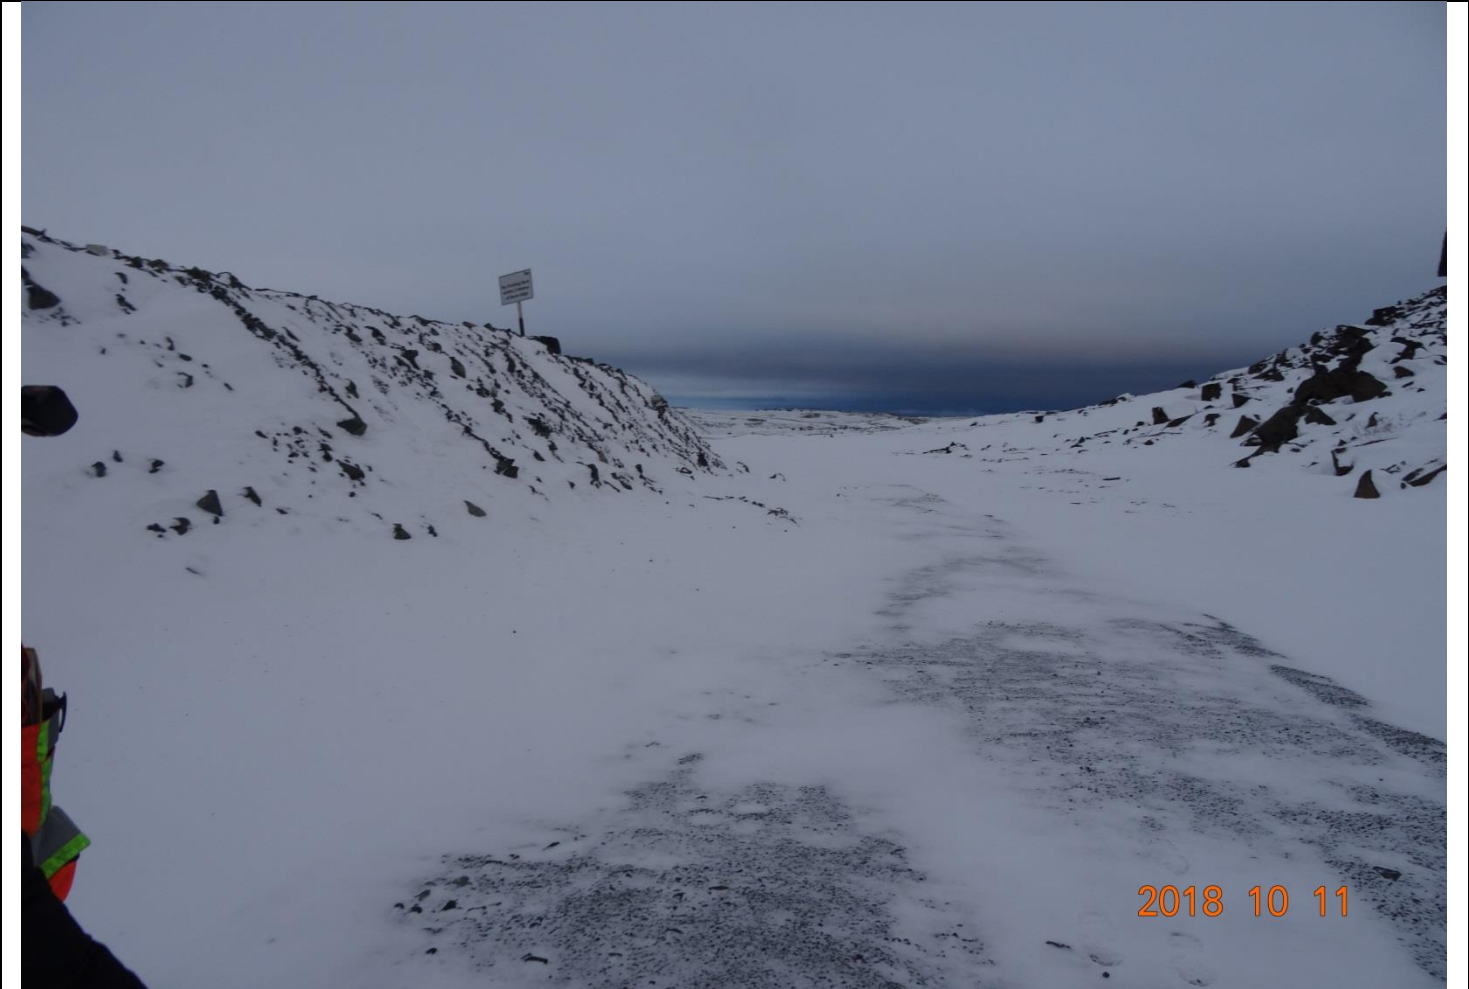
- Diversion Berm:** During inspection of the diversion berm separating contact and non-contact water of the mine site north of the Doris Camp Pad, it was noted that some waste rock from the waste rock pile appears to have been pushed past the buffer piles on top of the waste rock pile and encroaching onto

the diversion berm. It is recommended that TMAC remove waste rock from the berm to ensure contact water remain on the inside of the berm as per water license 2AM-DOH1323 Part D Item 24 and Item 27 (see figure #1).

Description: Waste rock pile pushed over the edge clearly marked with a large white sign.. Covered in snow during this inspection

- Maintenance of the berm of the Single Tank Farm at Robert’s Bay
- Maintenance of the Diversion Ditch at Doris North Camp to ensure proper management of contact water

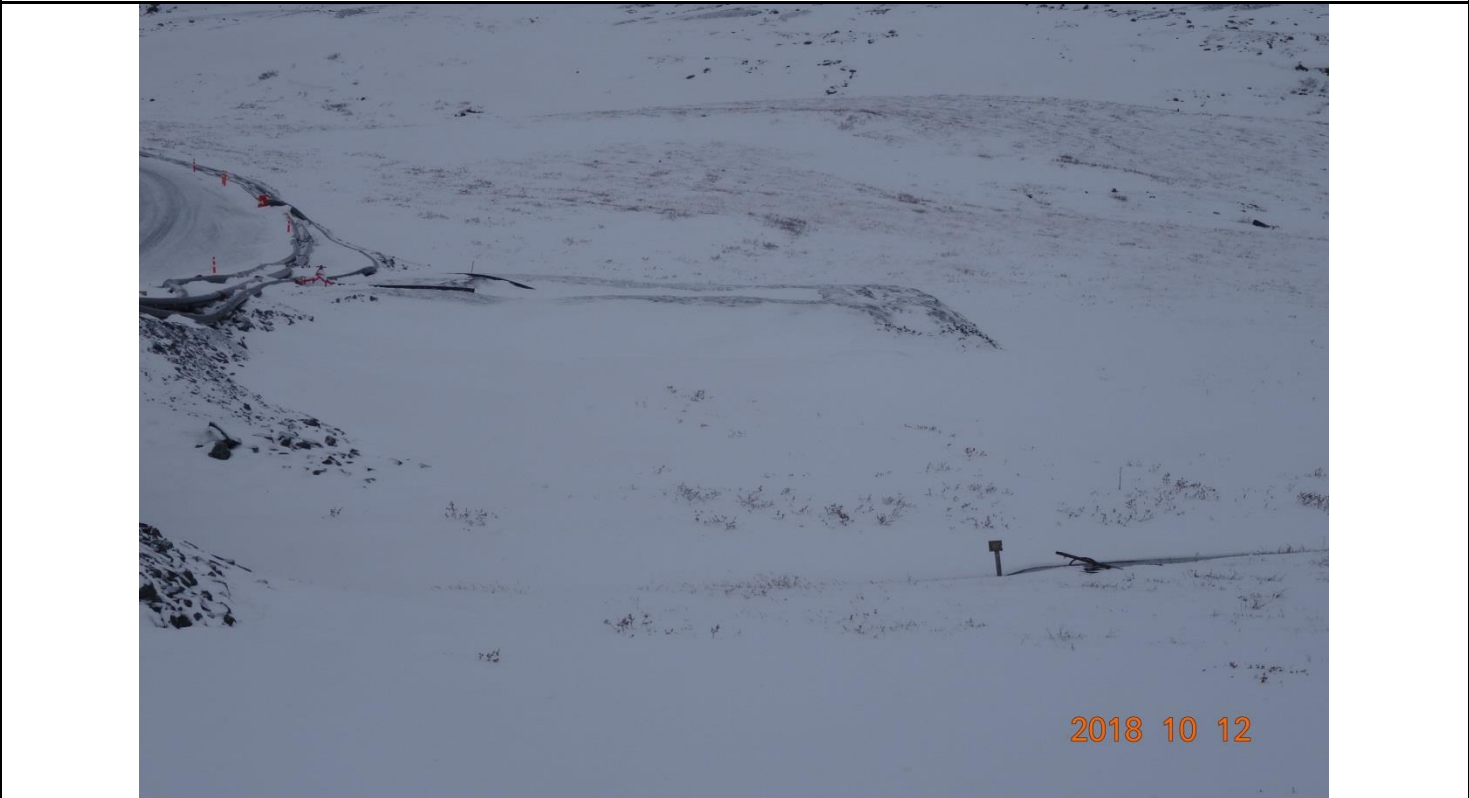
- **West Emergency Dump Catch Basin:** It was noted during this inspection that the east side of the west catchment basin has major slumping (see figure #2,3). Concerns with the facility have been addressed during a phone call with the TMAC and SRK consulting. The inspector has received a written letter from SRK consulting regarding the issues with the facility and TMAC has committed to completely rebuilding this Emergency Catchment Basin.

Description: east catchment basin closer to the vent raise. Slumping can be seen through the snow cover.
