WATER LICENCE INSPECTION FORM

Licensee	Licensee Representative
TMAC Resources Inc.	Sarah Warnock
Licence No. / Expiry	Representative's Title
2AM-DOH1335	Environment Supervisor
Land / Other Authorizations	Land / Other Authorizations
Date of Inspection	Inspector
13/08/19-15/08/19	Candice Pedersen
Activities Inspected	
<input checked="" type="checkbox"/> Camp	<input type="checkbox"/> Drilling
<input type="checkbox"/> Roads/Hauling	<input type="checkbox"/> Other:
<input checked="" type="checkbox"/> Mining	<input type="checkbox"/> Construction
	<input type="checkbox"/> Reclamation
	<input checked="" type="checkbox"/> Fuel Storage
	<input type="checkbox"/> Other:

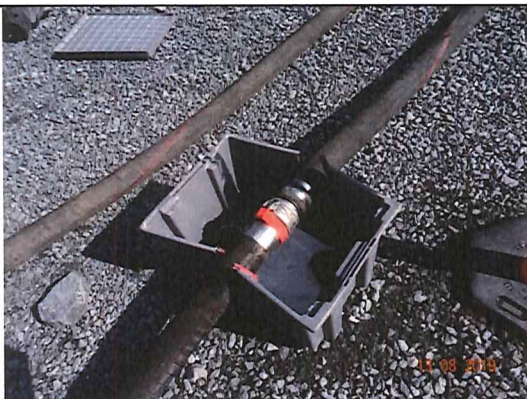
**Bulk Fuel Storage at the Four Tank Farm:** The Inspector is informed that a fuel transfer is being conducted from the fuel barge, to date they have transferred 6.5 million liters, at the end 25 million liters will be transferred. They are transferring fuel via barge, the barge takes fuel from the ship and it takes about 6-7 hours to empty the barge. The barge is stationed at the Jetty with a fuel line going from the barge into the bulk fuel storage. The fuel line connections have bins under then to prevent fuel from leaking (*see photo log #3*). Inspector is informed they have employees walking the lines as the fuel is being transferred to ensure no spills occur. The inspector notes spill kits and spill trays at each connecting in the fuel line.

Description: Fuel transfer pipe fittings with a bin to prevent spills			
Photo Log # 4		Location (NAD 83 DD MM SS.SS)	
Photo #4		N	W

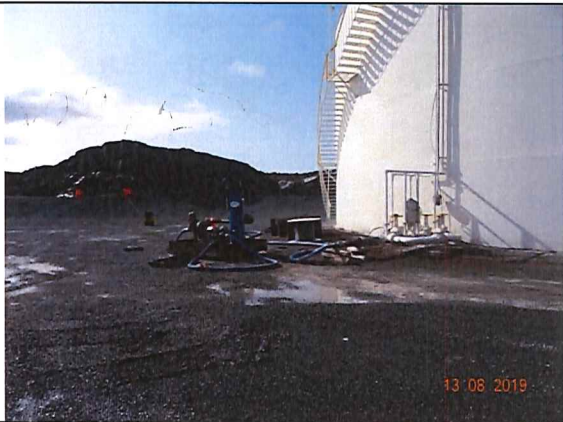
**Bulk Fuel Storage at the Single Tank Farm:** Prior to the replenishing of the fuel at the Robert’s Bay Bulk Fuel Storage Tanks Farms the fuel from the tanks were moved into the Doris Camp tank farms to make room for the new fuel including the fuel at the Signal Tank Farm. A pump is seen near the tank outflow as they have just finished pumping out the tank (*see photo log #4*), there are dip trays near the pump. Near the pump is a 45 gallon drum with no lid about 1/5<sup>th</sup> full of fuel (*see photo log #5*).

Description: Pump at Single Tank Farm

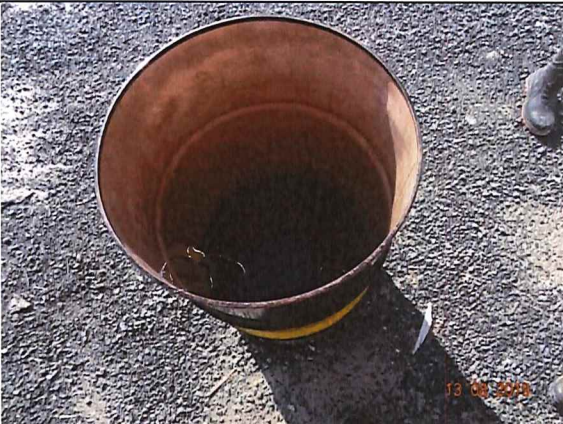
Description: Open drum with some fuel at Single Tank Farm

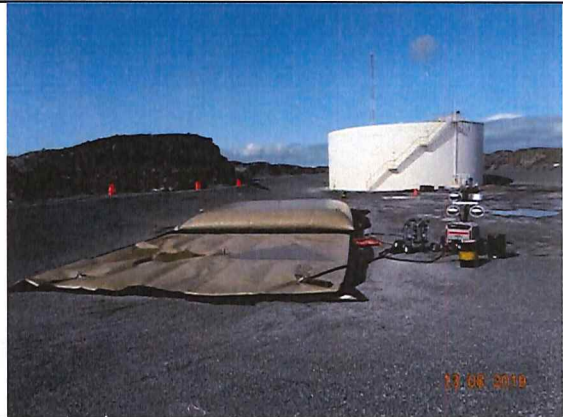
On the SW side of the bermed area are two fuel bladders that can hold up to 125,000 liters (*see photo log #6*), one bladder is about 90% full. When questioned about the capacity of the berm the Inspector was informed they calculated

Description: Two bladders inside Single Tank Farm

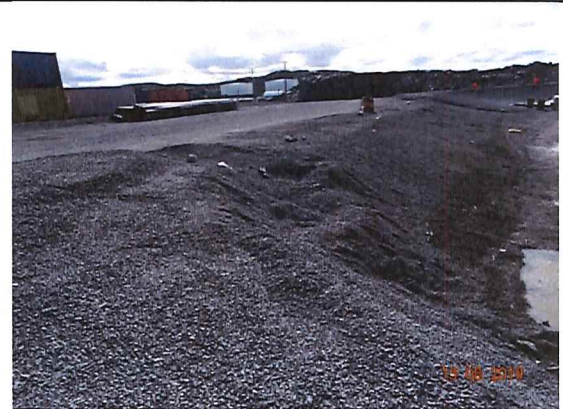
the capacity before placing and filling the fuel bladders.  
The SE corner of the berm is still sloping, (see photo log #7) this concern was noted in the October 2018 inspection. Inspector has been informed that a contractor will be arriving within the month of August to address this issue. Also on the SE corner has water build up, there is a stick in the middle with measurements, the water is currently at 4 centimetres (see photo log #8) in the deepest part. There is a blue hose from this pool of water into the approved water discharge area, they have been testing the water and when it meets criteria they have been discharging the water into the approved discharge location which is North of the berm, Inspector is informed the flow of the water is low enough as to not cause erosion.

Description: slooping SE corner of Single Tank Farm

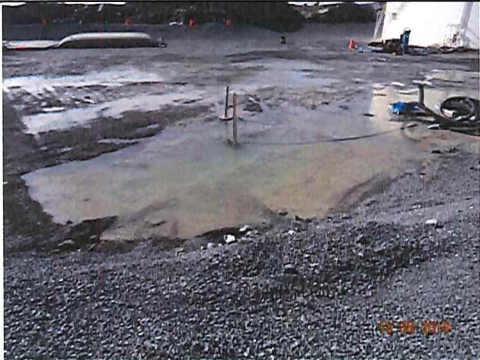
Description: Water collecting in SE corner of Single Tank Farm

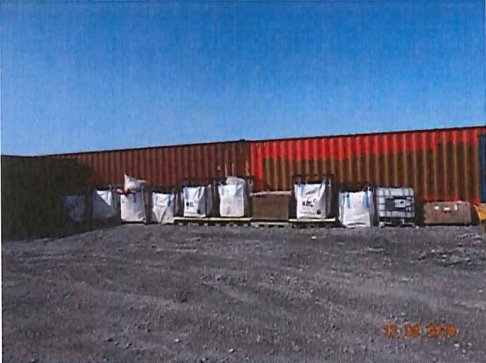
**Waste Management Area:** During the inspection it was noted that the waste management area has been reorganized and is now surrounded by sea cans (see photo log #9), the waste is being segregated and disposed of as required by the water licence. Such as aerosols, batteries, oily rags, oily plastic, electronics, and general garbage, all to be disposed in appropriate facilities such as the burn bit, land farm or to be sent out to appropriate facility.

Description: Waste Management Facility new location. Segregation location.

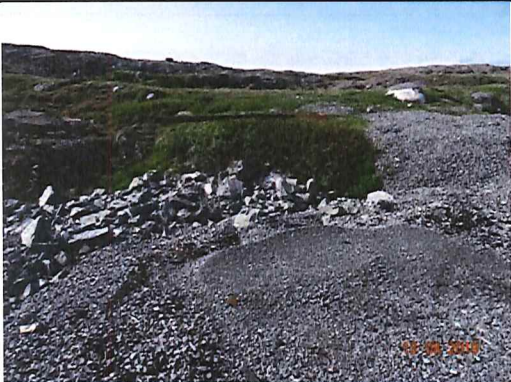
**Contract Drillers Laydown:** This is the site where the fire occurred on July 18, 2019 the area has been cleaned, the debris was segregated to appropriate facilities, such as clean wood went to the burn pan. In the back of the area at the end of the laydown area, a little bit of burnt debris was seen. (see photo log #10)

Description: Some black debris can be seen from the fire in Contract Drillers Laydown

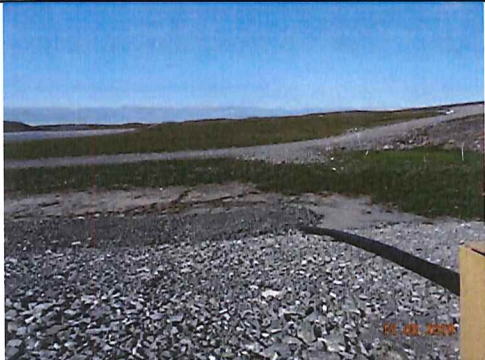
**South Dam:** The South Dam is operational, floating tailings are being discharged. Inspector is informed there is weekly inspection of the South Dam to ensure there is no steeping out of the dam.  
On the far East side of the South Dam Inspector notices tailings have been discharged, Inspector is informed that this is spigot number 3 and they discharged to test to ensure it is working and it will, in the future, become a discharge location. (see photo log #11)

Description: Spigot 3 discharge

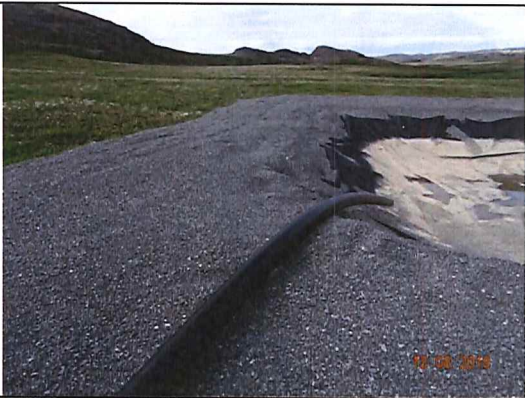
**Emergency Catch Basins:** Inspector checks North and South Emergency Catch Basins, the West one still has slopping (see photo log #12) sides as per the October 2018 inspection concern, Inspector is informed that contractors will be arriving to fix these ones as well. No concerns.

Description: Emergency Catch Basin slooping

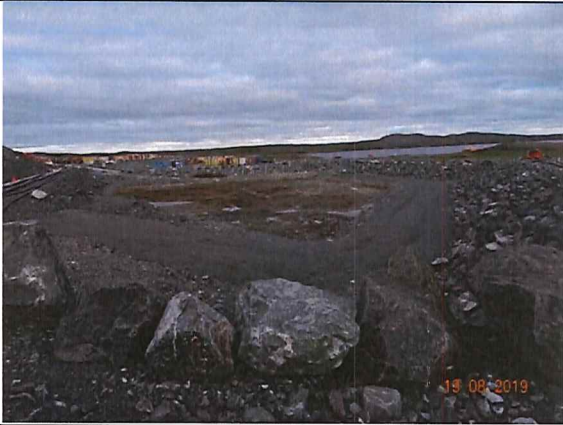
**Pollution Control Pond:** Inspector notes that the Pollution Control Pond is mainly empty. (see photo log#13) They have been pumping the water into the Sediment Control Pond.

Description: Pollution Control Pond

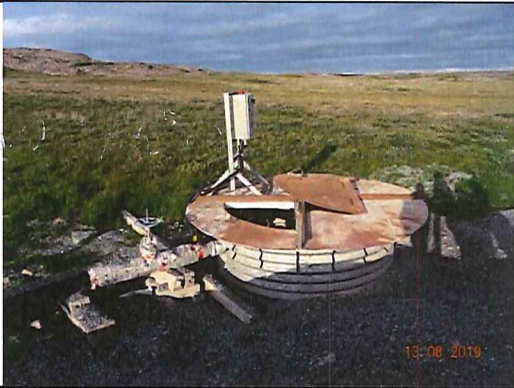
**Sump:** 3 water management sumps that capture run off that may bypass the Sediment Control Pond or emanating from Pad G/F and is returned to the water management system by automated float operated pumps. Sump #2 (See photo log #14) is constructed downstream of Pad F/G along the East edge of the TIA Access Road. Water from Sump #3 (the newest Sump) collects water from the direction of the Sediment Control Pond (see photo log #15) after further investigation, the proponent realized the water is coming from subsurface channel that is non-contact water and is captured by Sump #3 and placed into the Sediment Control Pond. Water from Sump #3 get pumped into Sump #1 with an automated system that senses how full the sump is and activates the pump. Water from Sump #1 get pumped into the Sediment Control Pond, water from Sump #2 also pumps directly into the Sediment Control Pond.  
No concerns were noted with this facility.

Description: Sump #2

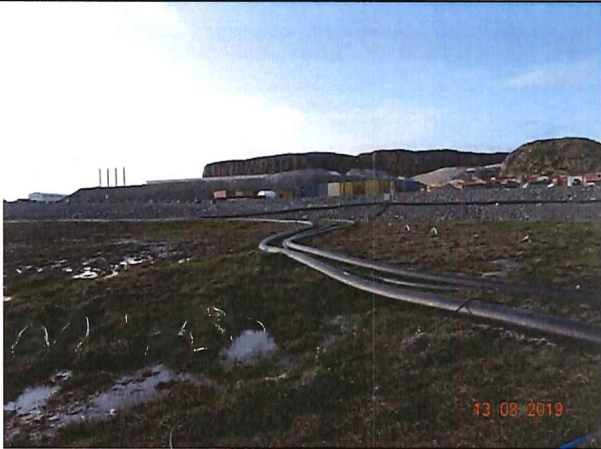
Description: Direction water is coming from going into sump #3

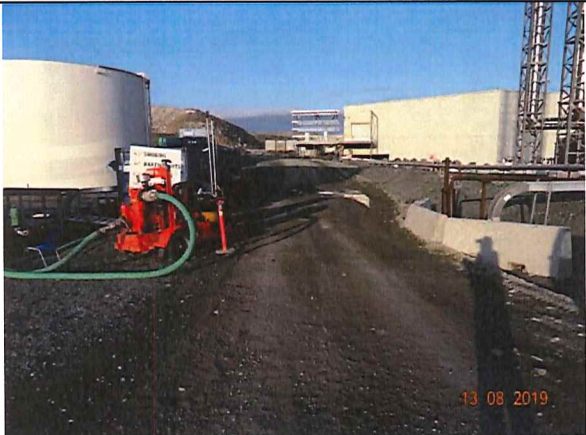
**Doris Tank Farm and Refuelling Station:** Some water is observed in the bermed area near the Tanks, no sheen is seen. The amount of water near the refueling station has dropped drastically since the May inspection (see photo log #16).  
No concerns where noted with this facility.

Description: Refuelling Station with significantly less water

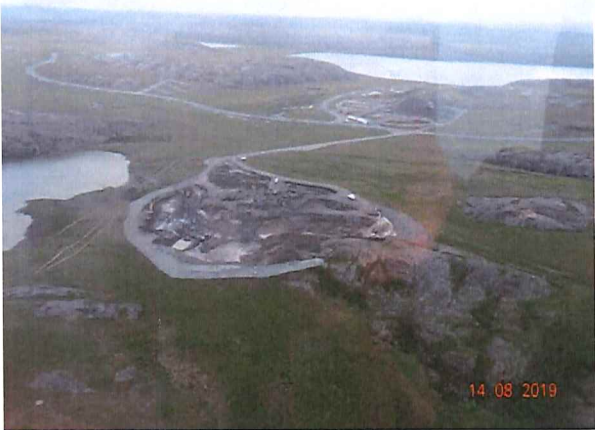
The Crown Pillar is currently being mined (see photo log#17), all the overburden is currently being removed and placed into the Overburden Stockpile/Storage (see photo log #18). The mining of the Crown Pillar started in Mid-July, all the ore will be processed at the Doris camp via truck. Currently they are still mining overburden, no ore has been removed. Some of the waste rock has been used to stabilize the cladding of the mine pit. Any water that is generated will be trucked into the Tailings impoundment Area.

Description: Crown Pillar at Madrid being mined

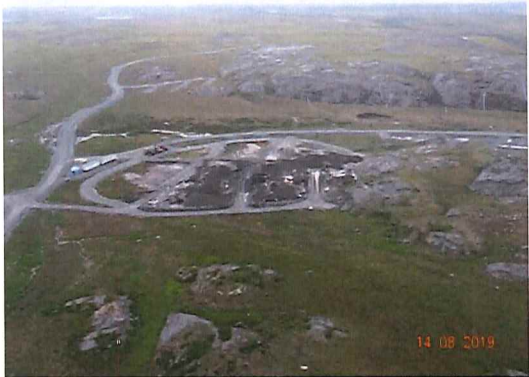
**Overburden Stockpile:** The Overburden Stockpile is not lined, 40,934 cubic meters have so far been placed into this facility. A culvert has been placed into the road leading into the stockpile (*see photo log #19*) no concerns where noted with this facility.

Description: Overburden Stockpile at Madrid

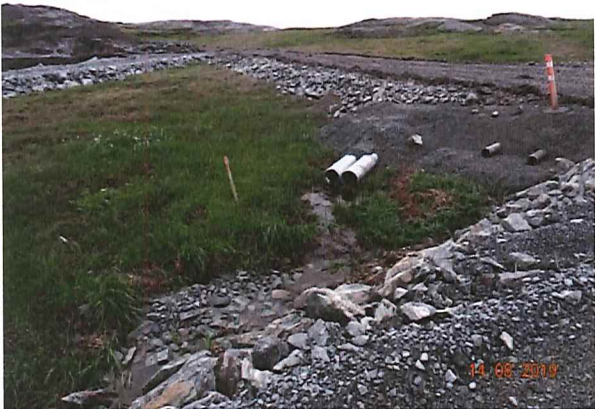
Description: Culvert at Overburden Stock pile

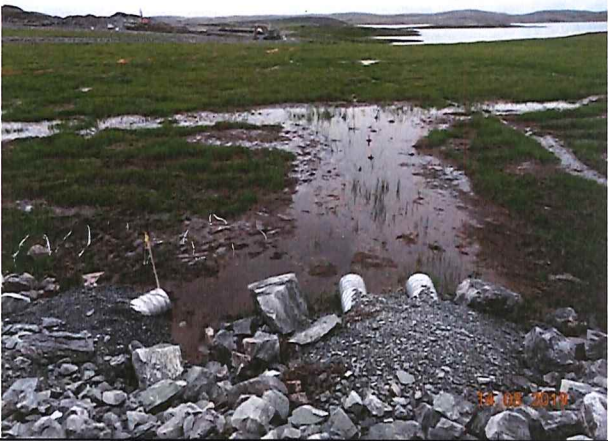
**Culverts:** The Kilometer 1 Madrid Culvert was installed on the first kilometer of the Madrid road. No debris is in the culvert (*see photo log #21*). No concerns where noted with this facility.

Description: Culvert at 1 <sup>st</sup> KM of Madrid road

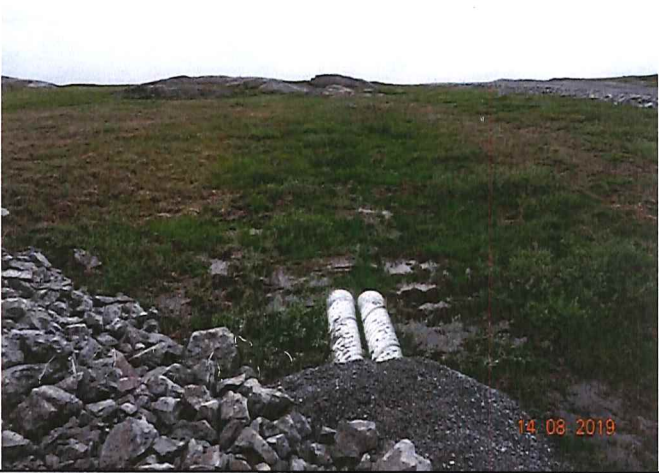
The Overburden Access Road Culvert was installed on the road accessing the Overburden Stock Pile. No debris was in the culvert. No concerns where noted with this facility. (*see photo log #22*)

Description: Culvert at overburden stock pile

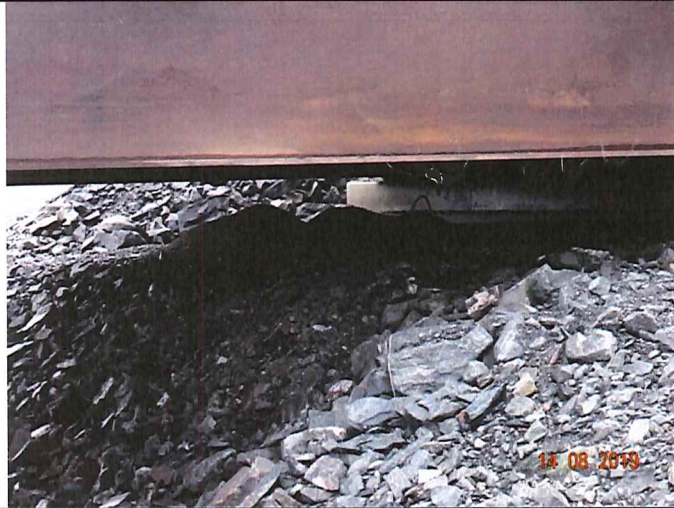
The Northern Bridge Culvert is a culvert that was installed on the road going to Windy Camp and was installed before TMAC purchased the project. No debris was noted in the culvert. Some sand build up can be seen under the gravel holding up the bridge(*see photo log #23*), it appears to be from adding sand onto the roads during the winter time then the sand being deposited between the bridge cracks as vehicles drive over the bridge, the sand is far enough from the steam as to not deposit into the stream. No concerns where noted with this facility.

Description: Build-up of sand at the Northern bridge
