Re: Agnico Response to CIRNAC Inspection Report June 20, 2022

Agnico Eagle Mines (**Agnico**) is providing this letter in response to actions items identified in the Inspection Report provided by Crown Indigenous Relations and Northern Affairs Canada under the Type A Water License (2AM-DOH1335). Please note the inspection report mentioned the license 2AM-DOH-1323, this water license and amendments have been incorporated, when appropriate, in the license 2AM-DOH-1335. Agnico's responses including timeline for implementation are detailed below:

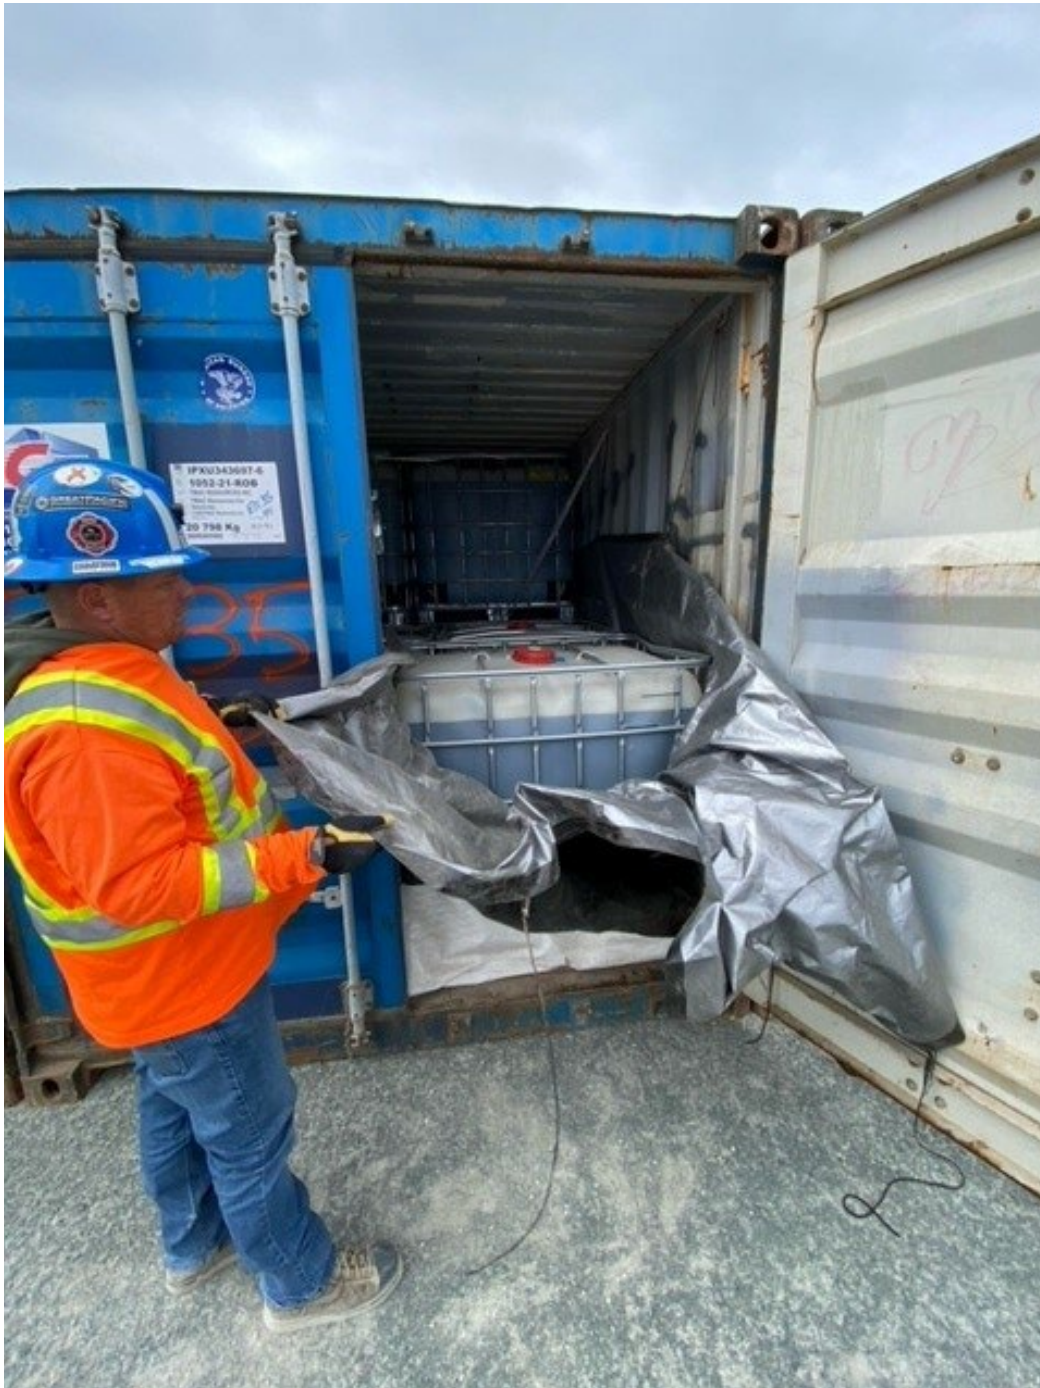
For managing hazardous waste material, waste management personnel has used seacan liners to ensure that liquid hazardous waste are within a lined containment at the waste storage facility, see photo 1.

Photo 1: Previously packaged waste oil in lined seacans, located at Roberts Bay Waste Management

To formalize this practice and ensure consistency, the operating procedure “Packaging and Labeling of Waste Materials” will be updated to require the installation of a seacan liner prior to packaging hazardous liquids for backhaul including spent or expired fuels. This will be completed by September 7, 2022.

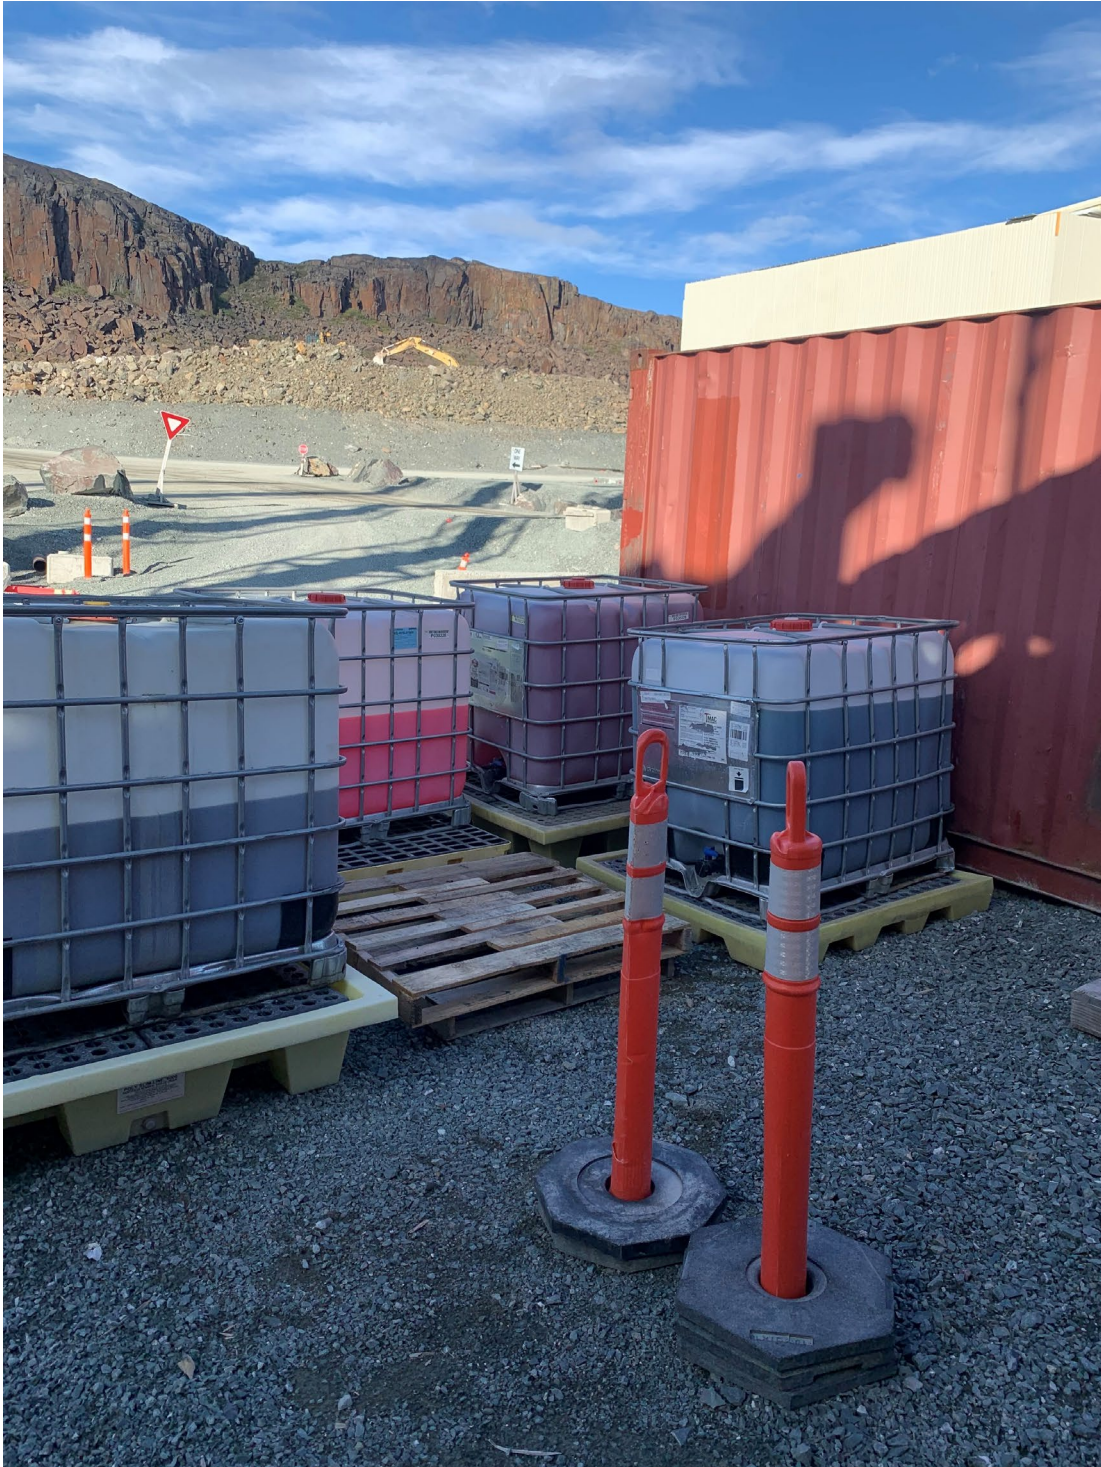
Photo 2 : Totes at the powerhouse placed on a secondary containment

1. The waste fuel will be move to the lined area of the Upper Reagent Pad by September 31st, 2022 while we are looking into the disposal of this product.
2. Glycol totes at the powerhouse were relocated into lined seacan and the tote that remains at the powerhouse was placed on a secondary containment, see photo 2.
3. The secondary containment for the aircraft fuel at the helicopter pad was removed and replaced with a double-walled tank and additional berm to contain potential drips from the fuel nozzle, see photo 3.
4. The sulfuric acid drums in the open seacan racks were repackaged into lined seacans and relocated to the upper laydown area see photo 4, 5 and 6.

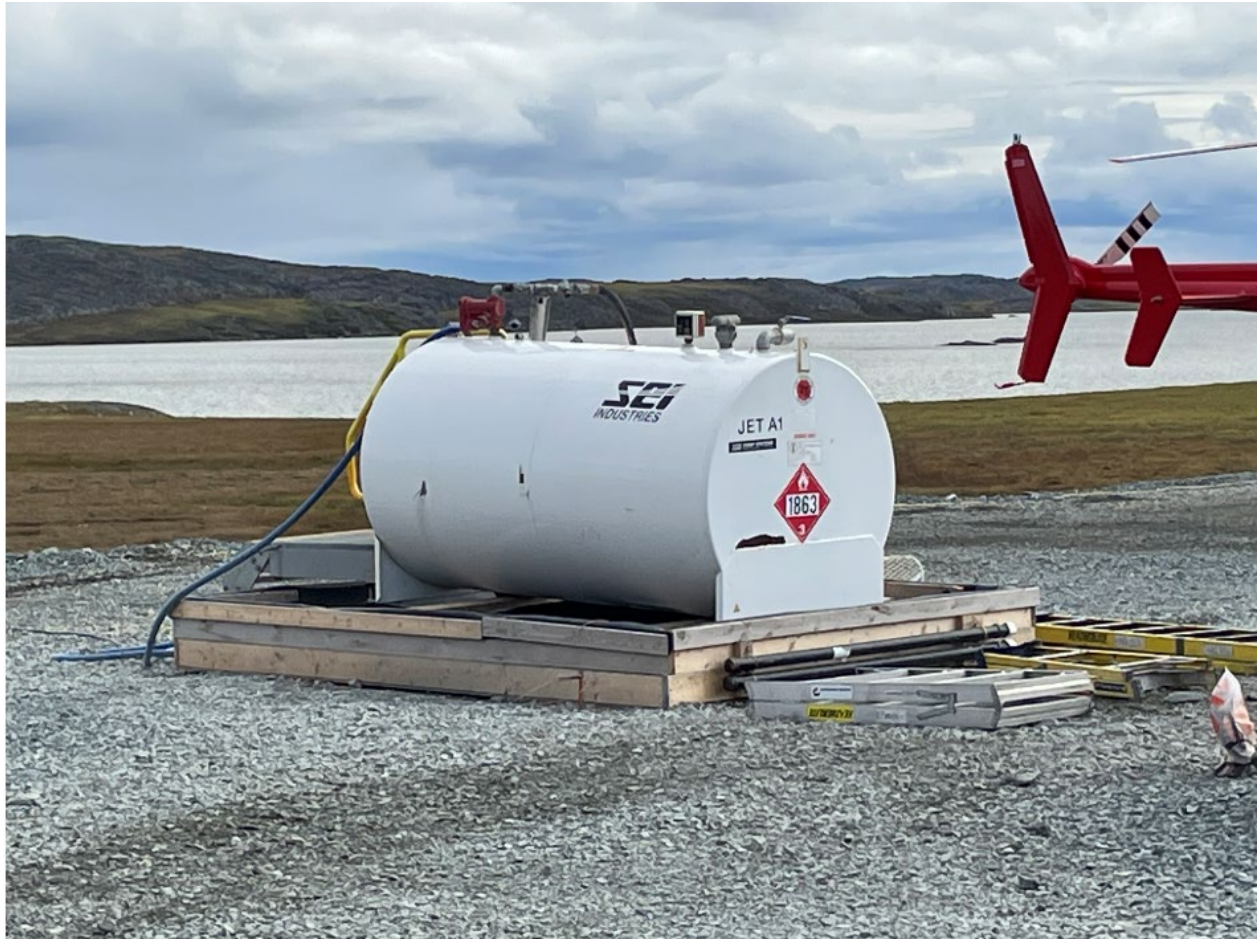
Photo 3 : Double-walled tank and additional berm to contain potential drips from the fuel nozzle
replace the cracked spill tray

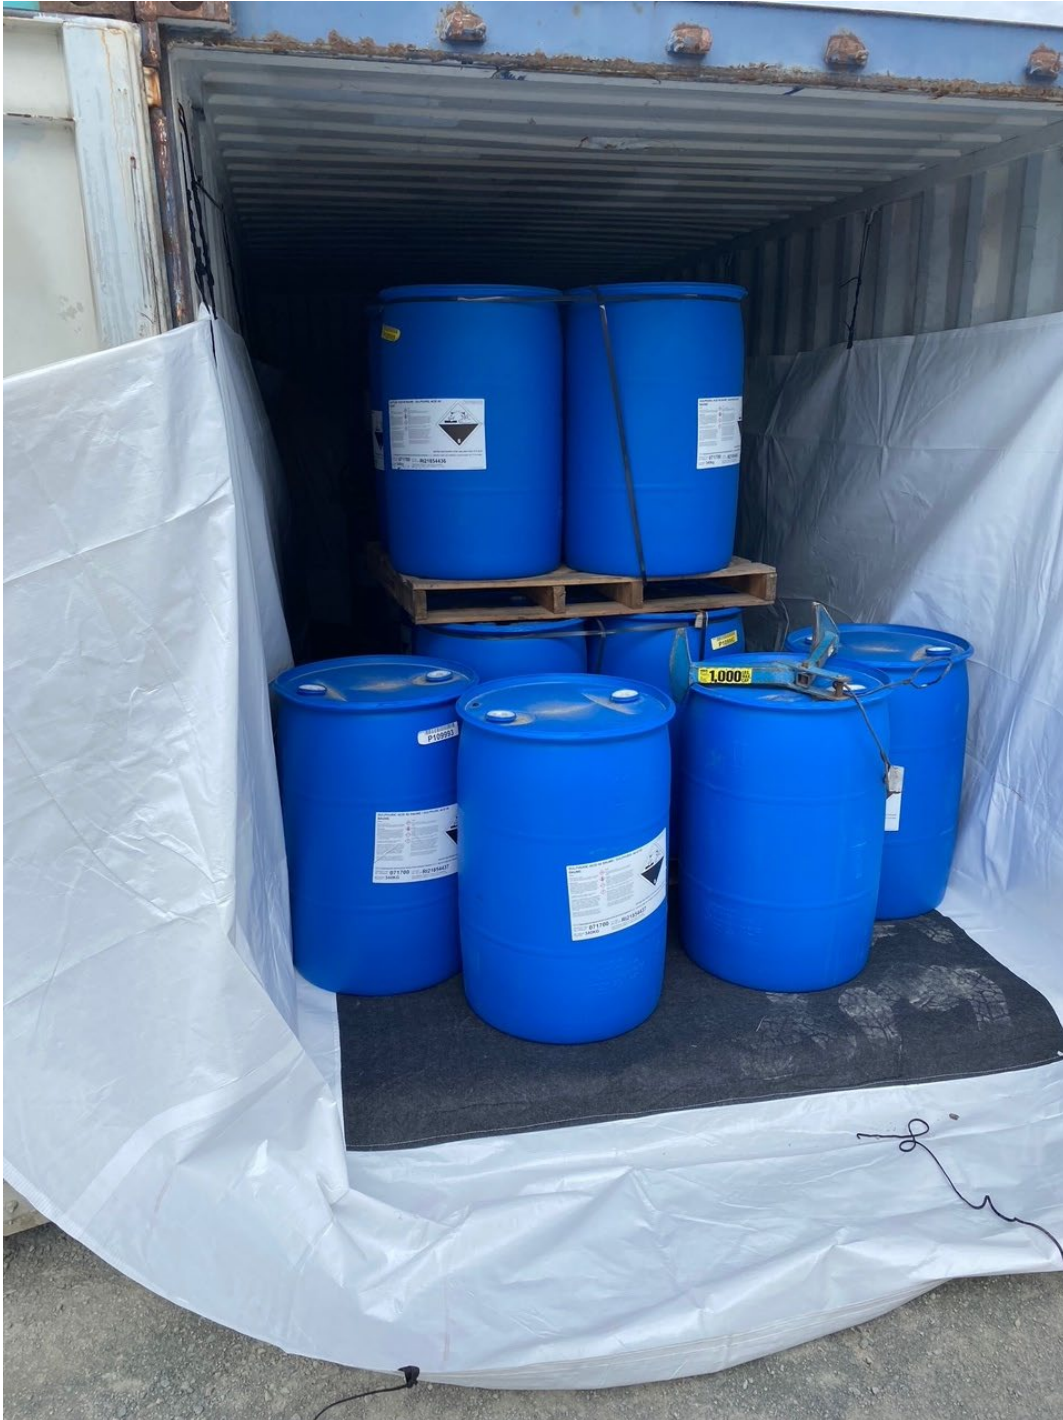
Photo 4: Repackaged sulfuric acid drums from Roberts Bay laydown area

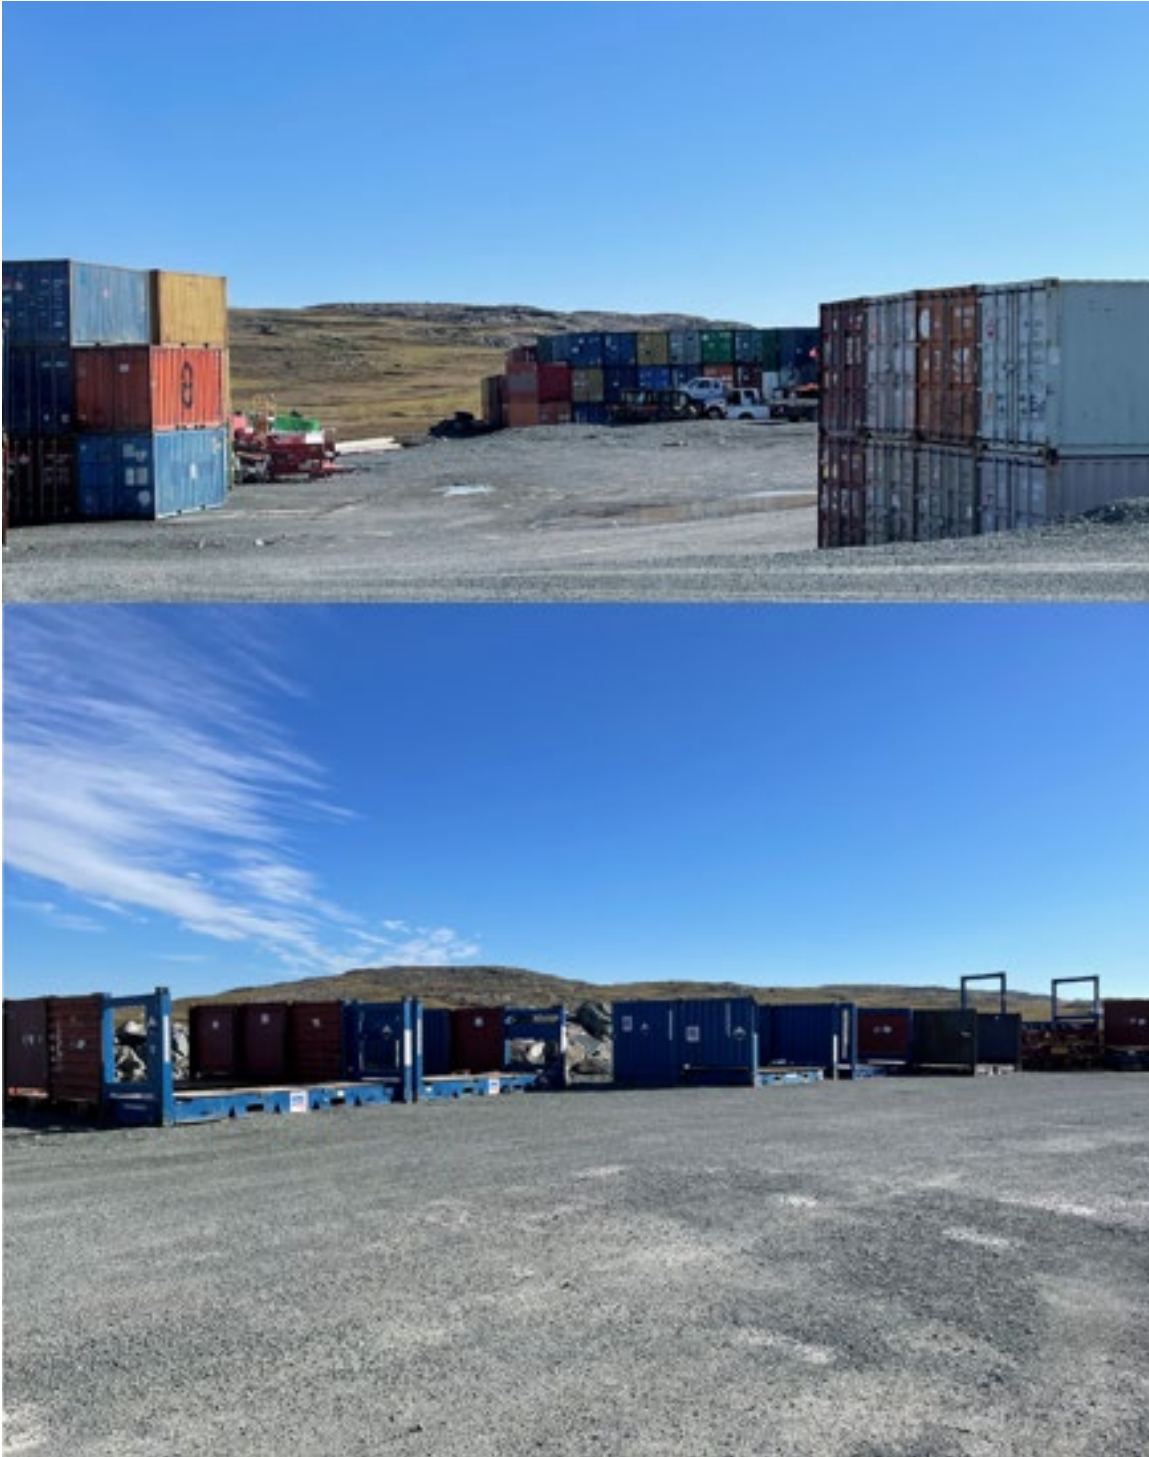
Photo 5 and 6 : Sulfuric acids drums have been removed from flat racks
