**Re: Agnico Response to CIRNAC Inspection Report June 20, 2022**

Agnico Eagle Mines (**Agnico**) is providing this letter in response to the comments received from CIRNAC on September 6, 2022, regarding Agnico's response to the CIRNAC Inspection Report (June 20, 2022) under the Type A Water License (2AM-DOH1335).

HOPE BAY

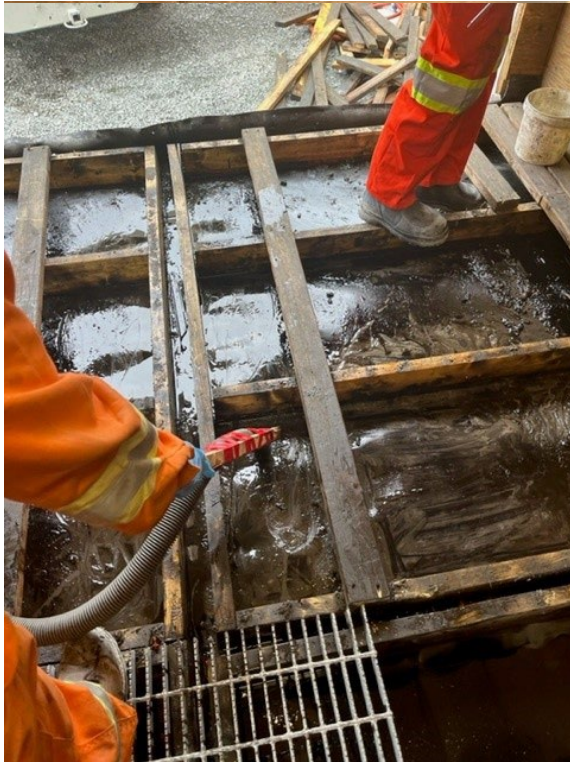
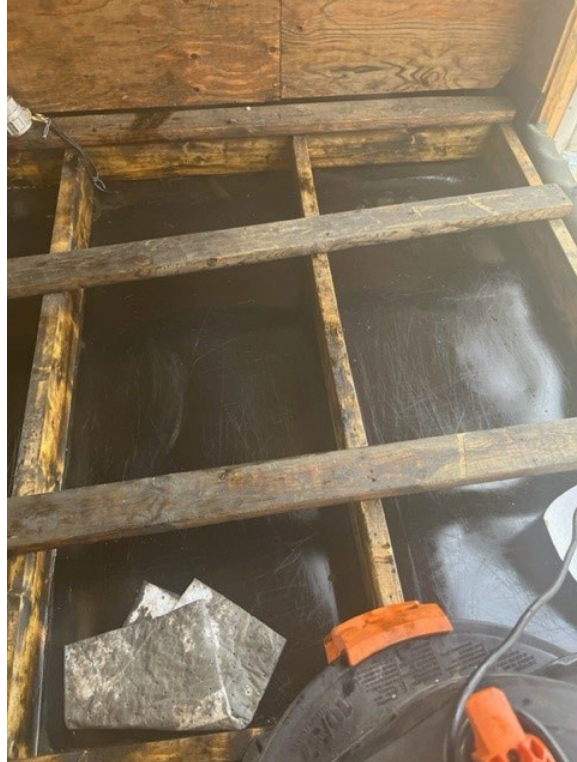
The response provided by Agnico on August 30th was not complete in explaining the different activities that occur at this location. Agnico would like to clarify the areas of concern identified in Photo 7 of the original CIRNAC Inspection Report (dated June 20, 2022) at the generator oil storage location. The areas of concern are listed below, along with an explanation of the source.

1. Oil tray beneath the building – The tray beneath the building structure is unrelated to any spills and is not placed there for leaks. It is placed there for storage and is used under the Kubota’s during the winter season. Agnico can confirm the containment is not leaking and the liner has not been compromised inside of the building.

Photo 1 and 2 – Oil containment inside building cleaned

3. Oil residue on gravel – These are recent residues that originate from the transferring of oily totes in and out of the oil room. Agnico will clean up the stained gravel and replace with new gravel. Since the inspection, the liner has been cleaned and new grating installed to better inspect the liner on a regular basis. The oil totes are now lifted onto a platform and a spill tray placed underneath the hose connection point to catch spills before going into the liner. See photos 1-4 below. The volume spilled did not meet the requirement to submit a spill report to the authorities as per Schedule B of the *Spill Contingency Planning and Reporting Regulations* (and shown on the Immediately Reportable Spills Table in the front section of Hope Bay’s Spill Contingency Plan). Nonetheless, at the request of CIRNAC, a spill report has been prepared and submitted. A follow up report will also be provided.

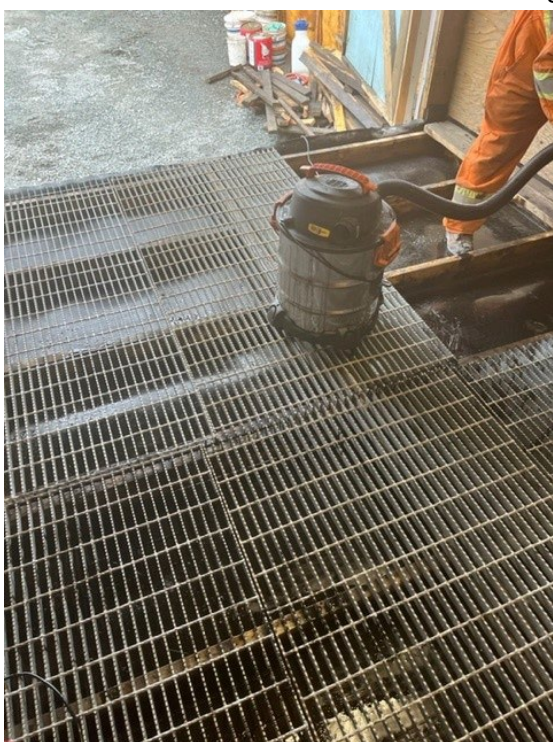
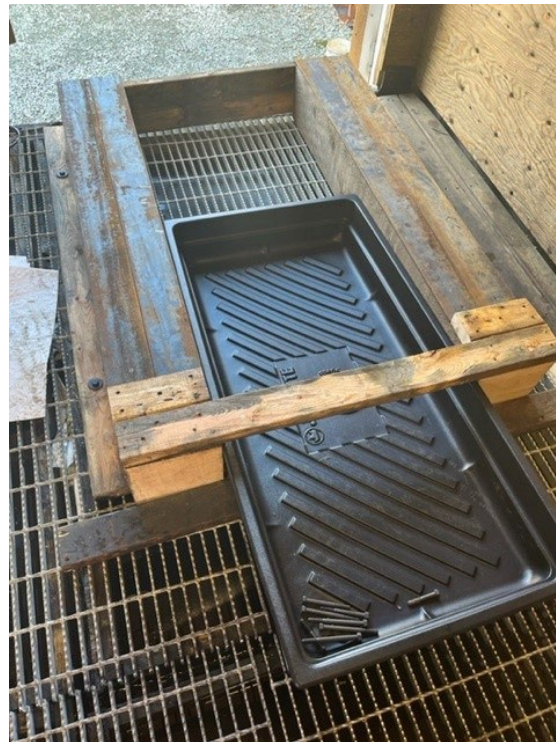
Photo 3 and 4 – Grating and spill tray installed

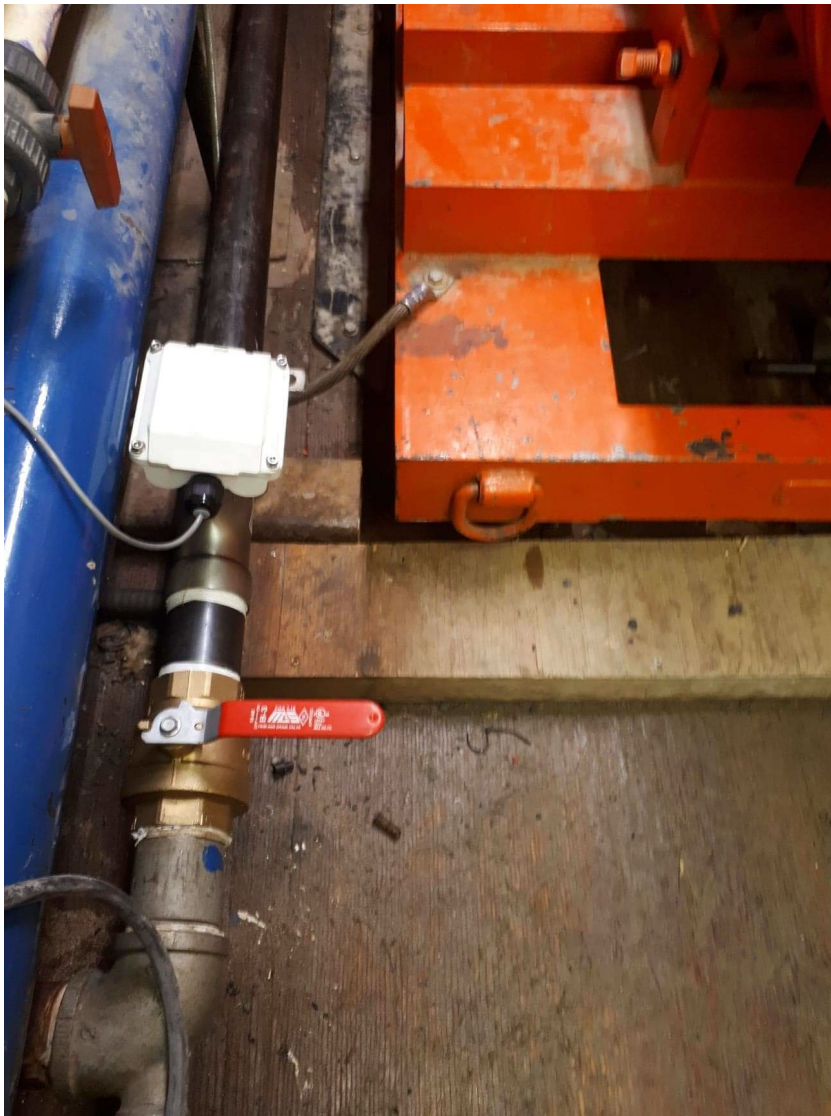
Photo 1 Doris Flow Meter

Flow meters have been installed at both the Doris (Photo 1 and 2) and Windy (Photo 3) pumphouses.

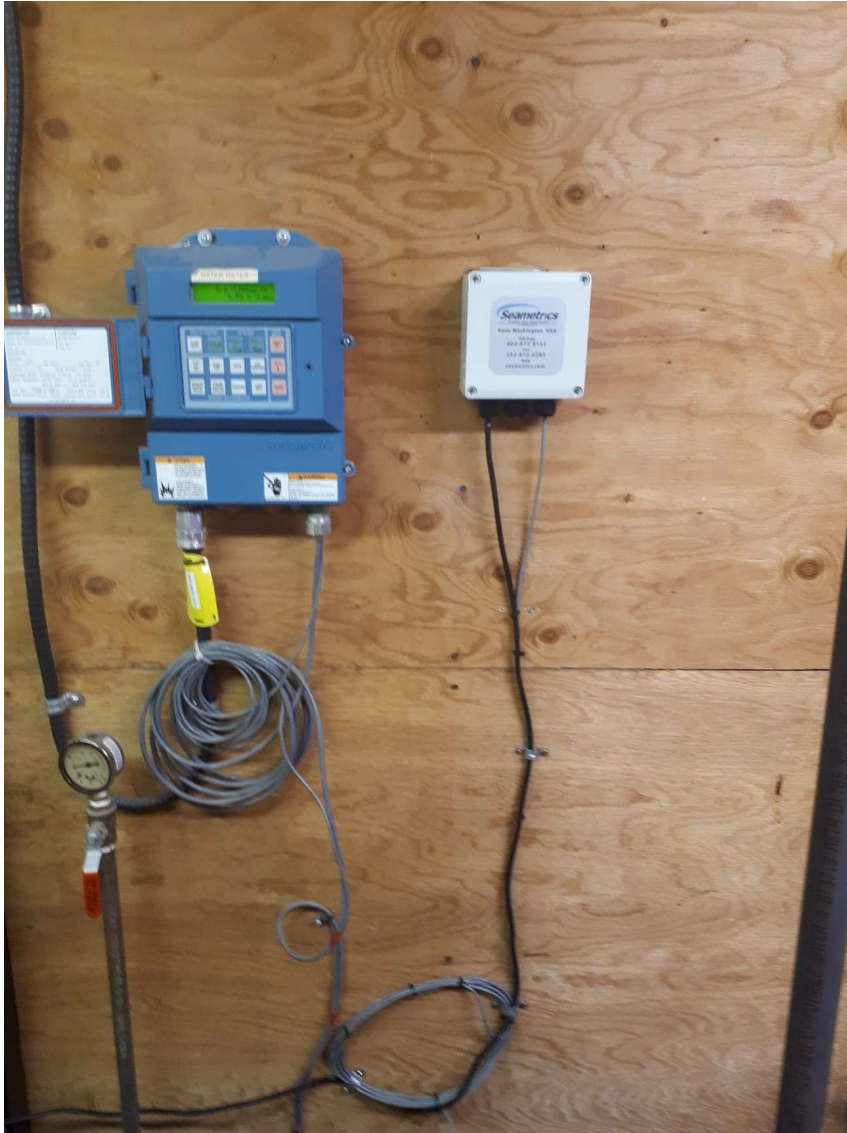
**Photo 2 Doris Flow Meter**

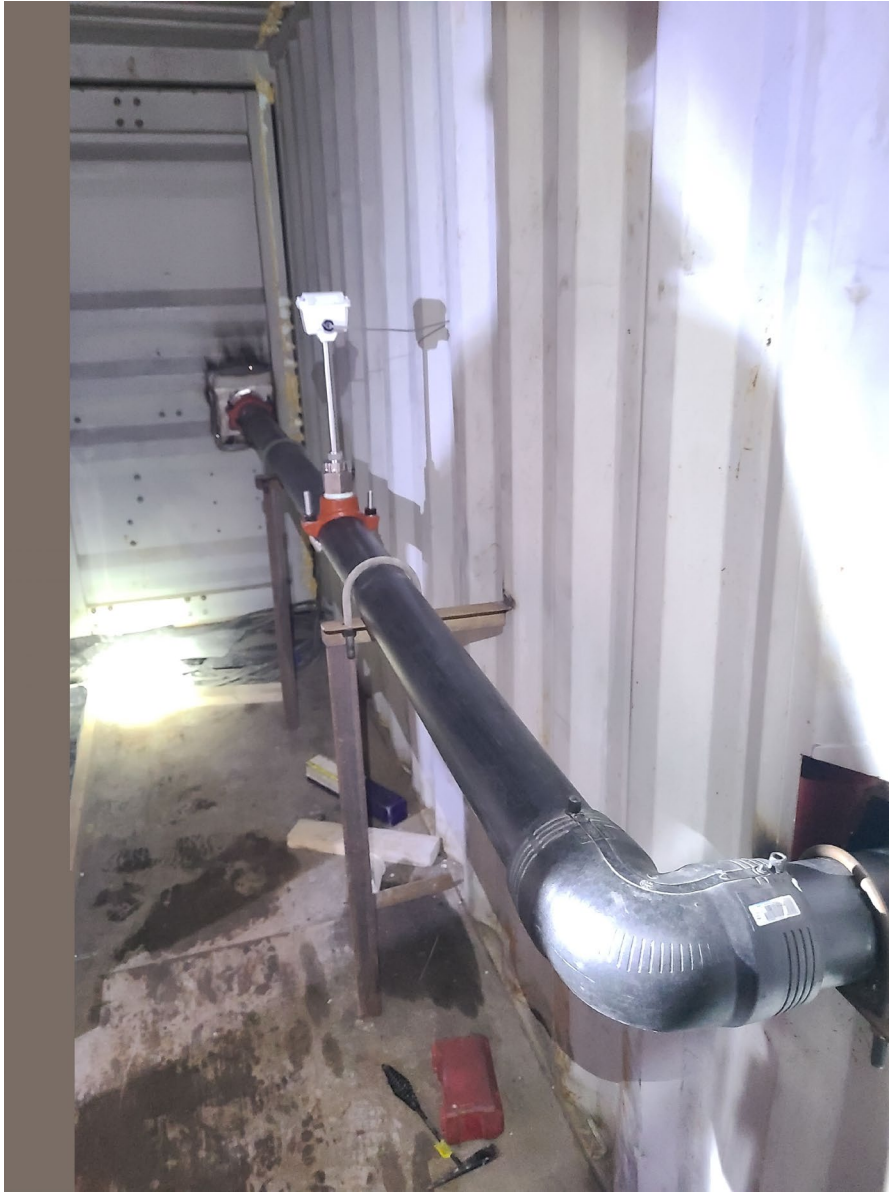
**Photo 3 Windy Flow Meter**
